PCB Mass Loading Phase II
Capitol Scrapyard
SIRS ID: DE-1171
Dover, Delaware

Appendix 5

CAPITOL SCRAPYARD

GENERAL SITE INFORMATION

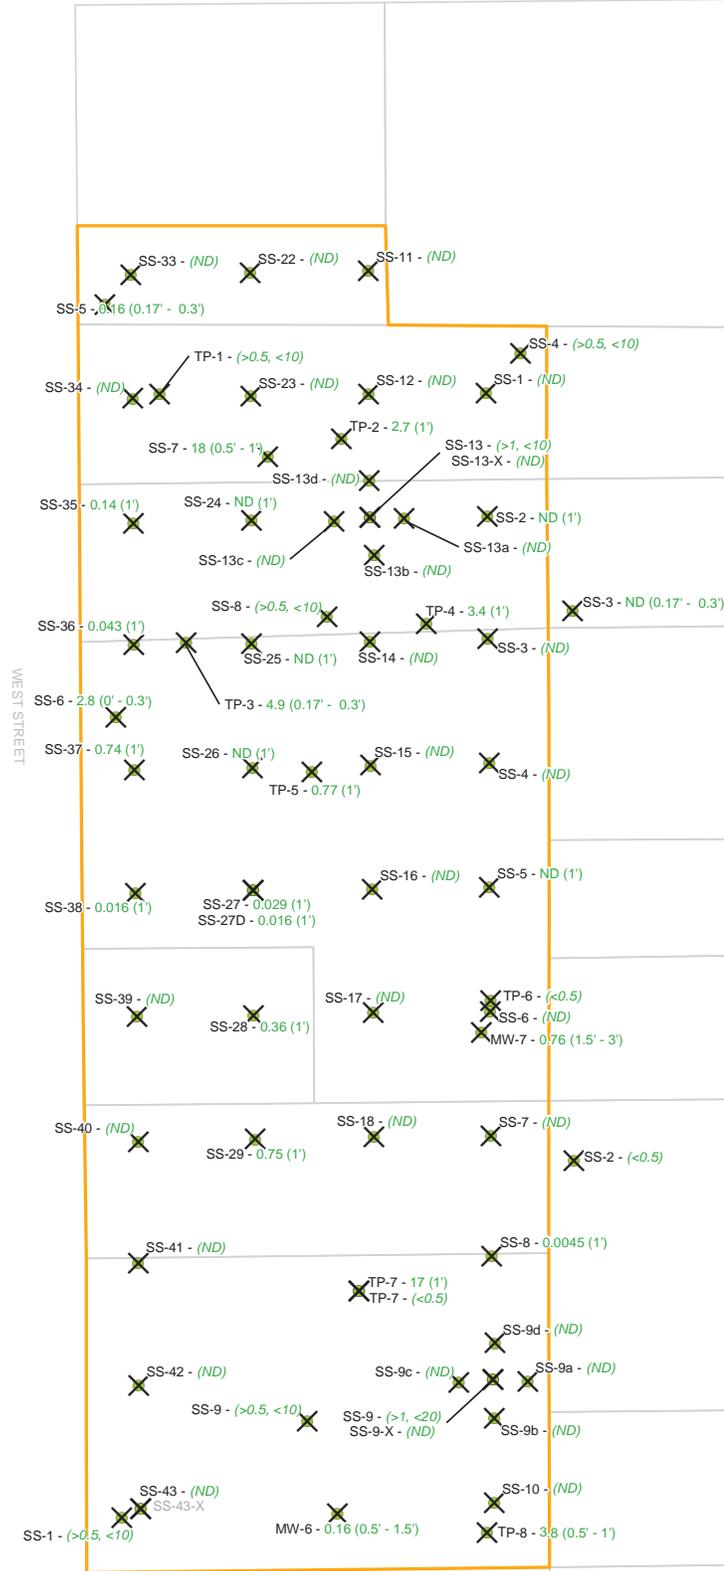
Drawn	By	Date	Scale:	File Name:
ADS	ADS	5/1/2014	1:480	Fig2DistSurf.mxd
Checked	JEH	5/1/2014	Fig. No.	
Project #	0985.69.51	Figure 2

Based on the data available and reviewed by BrightFields, the current surface soil is not impacted by PCBs, due the installation of a soil cap in 2008. The subsurface saturated soil could not be evaluated since samples were not analyzed for PCBs. The estimated subsurface unsaturated soil area impacted by PCBs is 0.58 acres (Figure 3). The estimated area of groundwater impacted by PCBs is 0.17 acres (Figure 5).

PCB Distribution in Surface Soil (0' - 2' bgs)
 Capitol Scrapyard
 Dover, Delaware

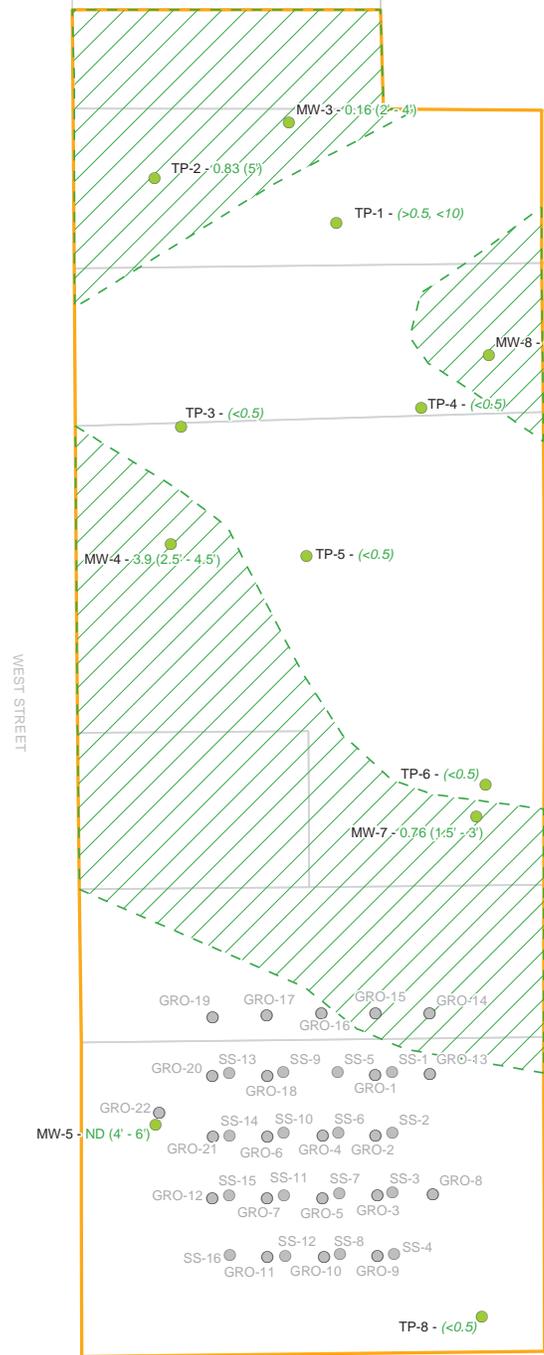
By	Date	Scale:	File Name:
Drawn ADS	5/1/2014	1:480	Fig3SS_UnSat.mxd
Checked JEH	5/1/2014	Fig. No.	
Project # 0985.69.51		Figure 3

PCB Distribution in Subsurface Unsaturated Soil
 Capitol Scrapyard
 Dover, Delaware

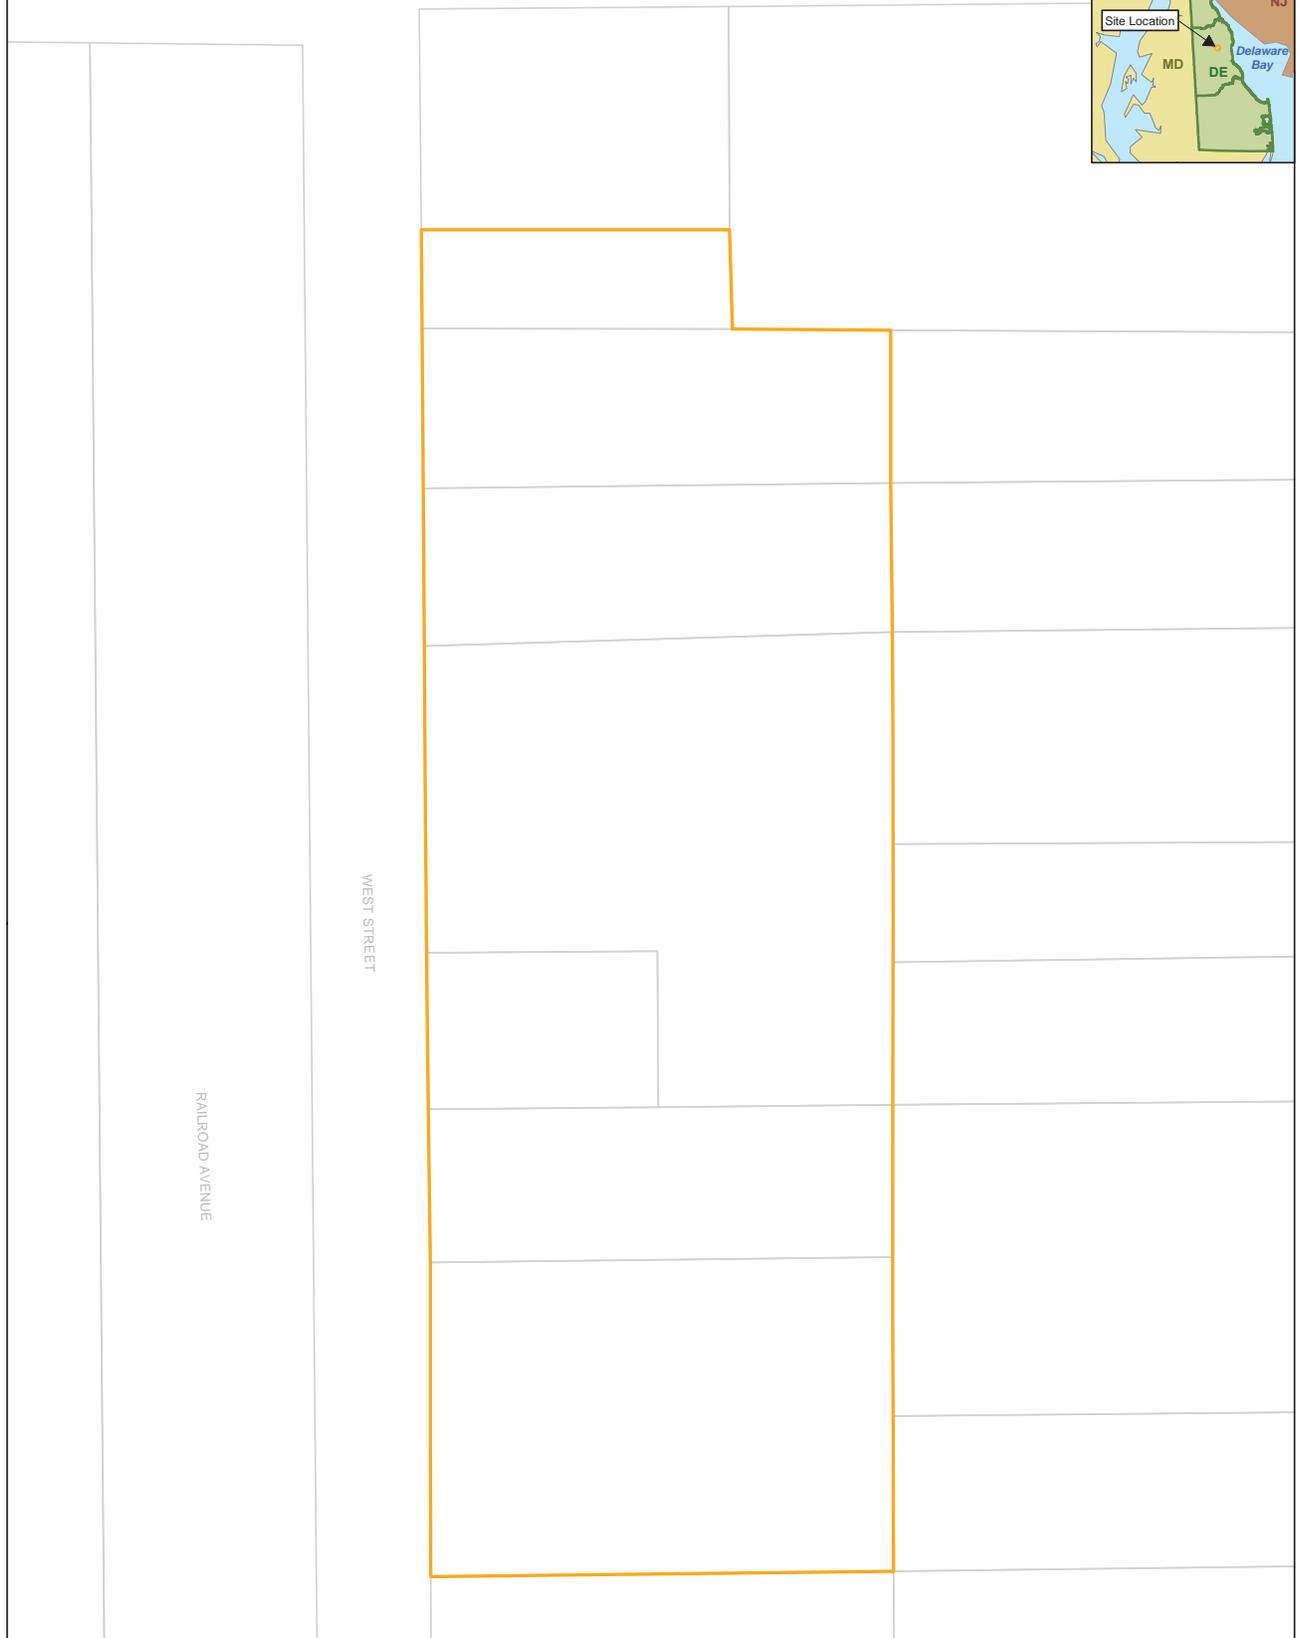
Drawn	By	Date	Scale:	File Name:
ADS	ADS	5/1/2014	1:480	Fig4SS_Sat.mxd
Checked	JEH	5/1/2014	Fig. No.	
Project #	0985.69.51		Figure 4

PCB Distribution in Subsurface Saturated Soil
 Capitol Scrapyard
 Dover, Delaware

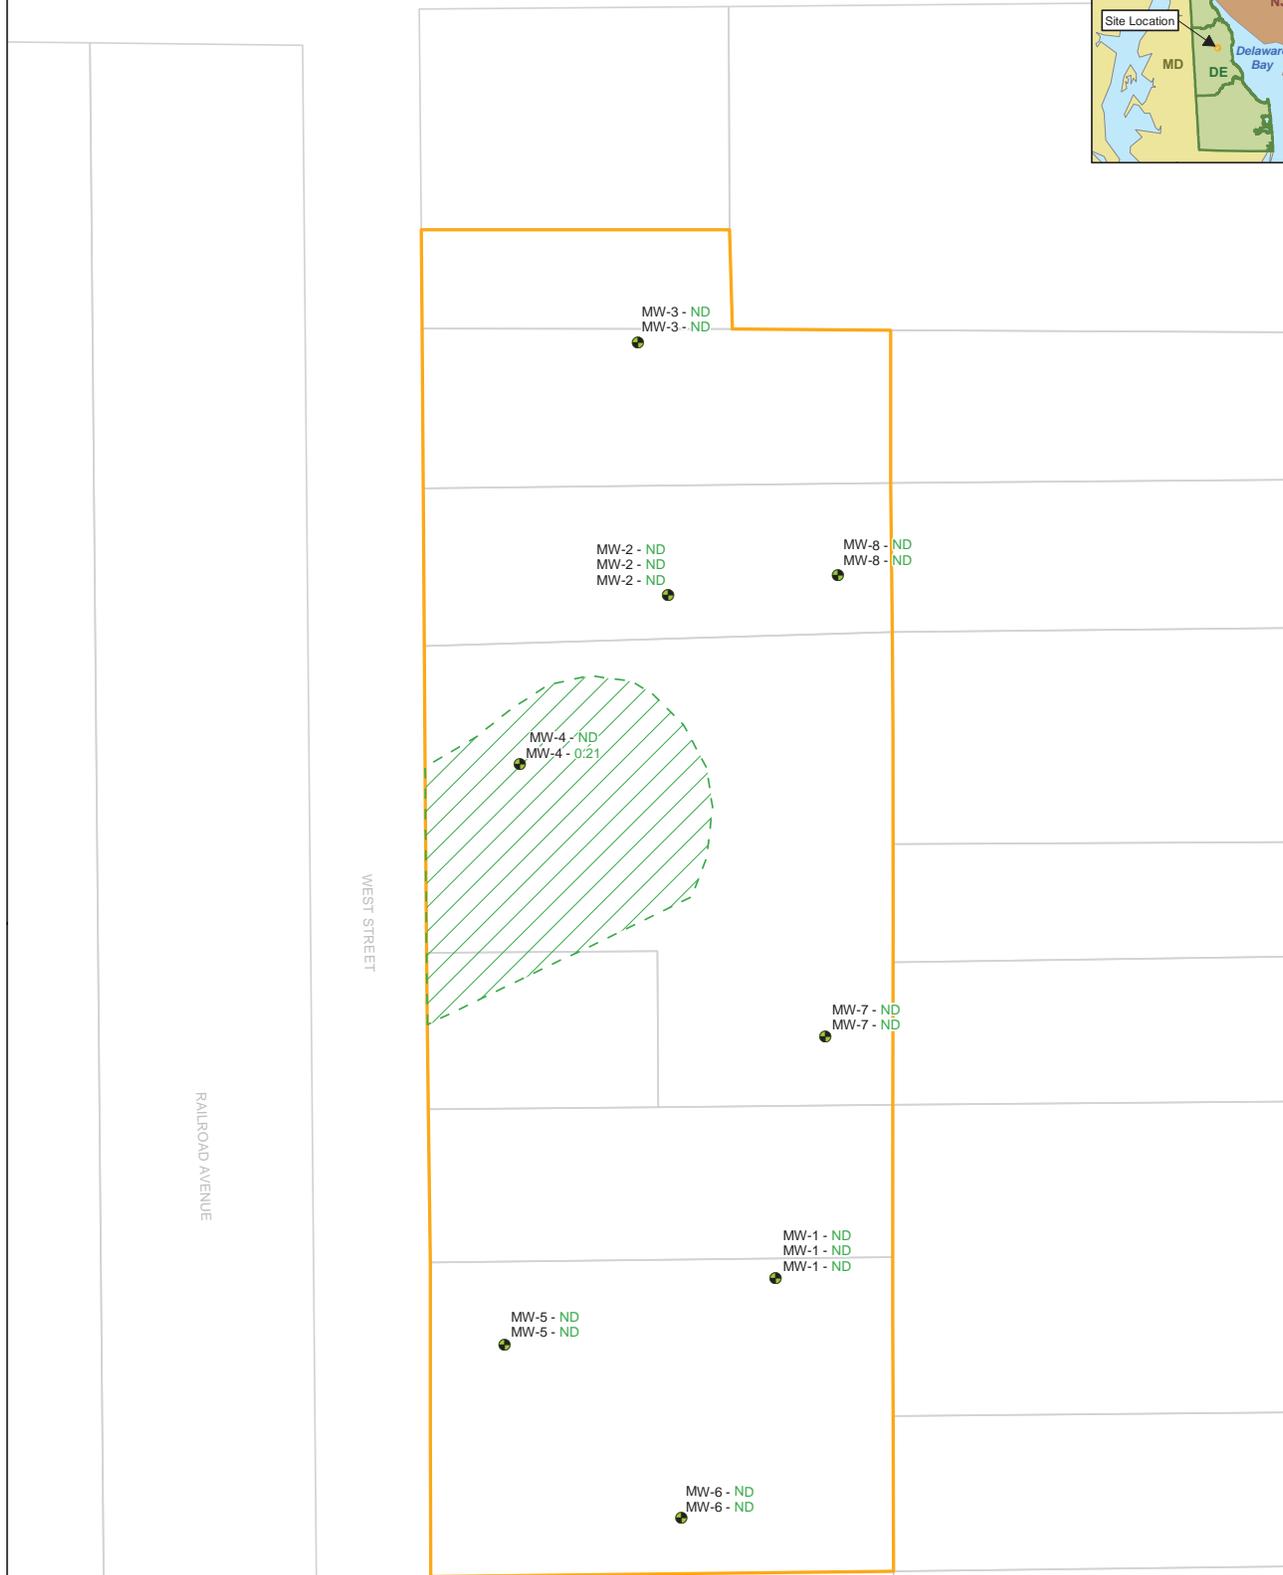
Drawn	By	Date	Scale:	File Name:
ADS	ADS	5/1/2014	1:480	Fig5GW.mxd
Checked	JEH	5/1/2014	Fig. No.	
Project #	0985.69.51		Figure 5

PCB Distribution in Groundwater
 Capitol Scrapyard
 Dover, Delaware

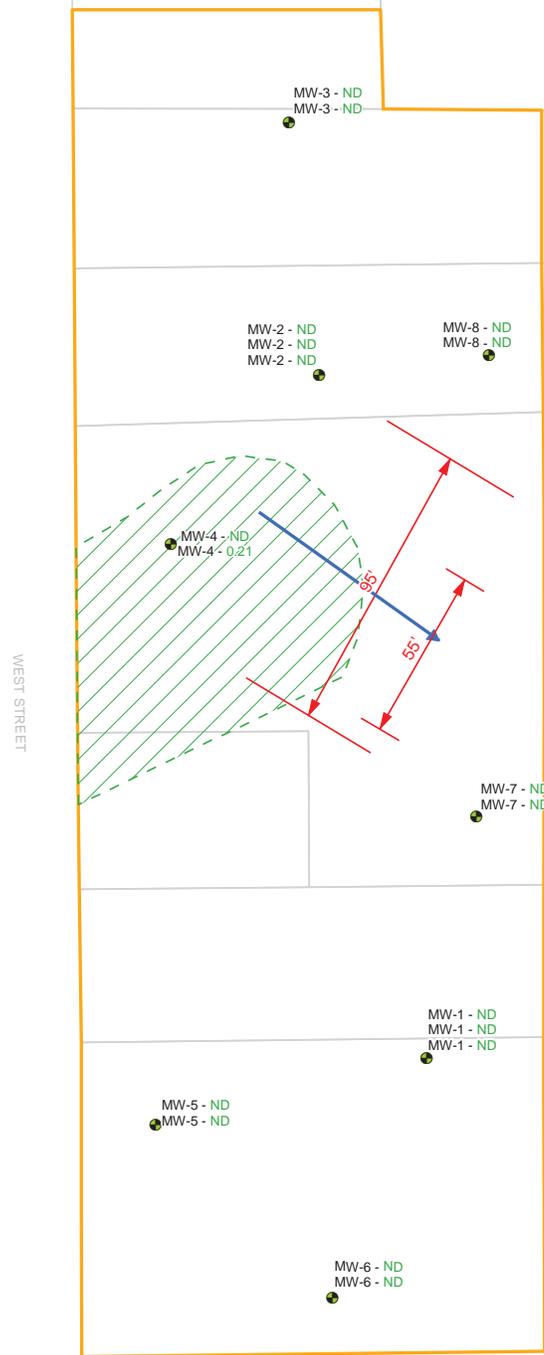
Drawn	By	Date	Scale:	File Name:
ADS	ADS	5/1/2014	1:480	Fig6Discharge.mxd
Checked	JEH	5/1/2014	Fig. No.	
Project #	0985.69.51		Figure 6

Groundwater discharge is based on the hydraulic conductivity of the soil, the groundwater gradient, and the cross-sectional area of the aquifer. A breakdown of the individual factors used in the Darcy equation is presented below. A groundwater discharge map is included as Figure 6.

The groundwater discharge is 580 to 72,000 L/day (see attached Table A). The maximum detected PCB concentration in groundwater (0.21 µg/L) was used to calculate the groundwater concentrations for the loading estimate (Table B). The estimated minimum and maximum contaminant mass loading contributions shown in Table C assume that there are no contaminant losses due to degradation, dispersion, sorption, volatilization, etc. (a very conservative assumption given the distance to discharge of 4,200 ft).

The total PCB loading via groundwater discharge is estimated to be between **0.04 and 5.5 grams per year** (Table C).

Groundwater Discharge Map
 Capitol Scrapyard
 Dover, Delaware

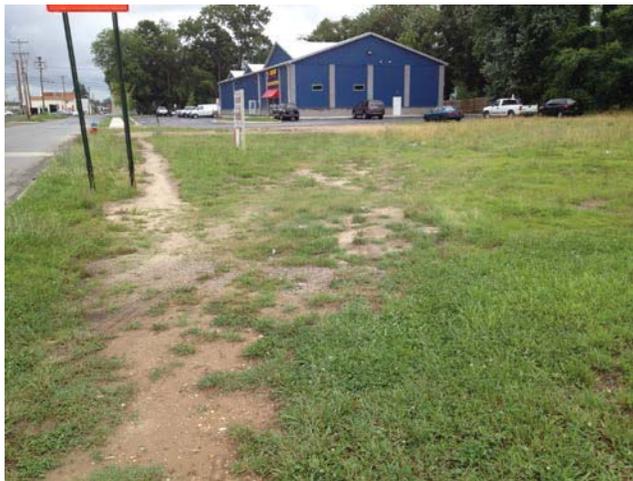
Looking north onto the site towards an auto parts store. There is a dirt path along West Street and some patchy areas in the grass.

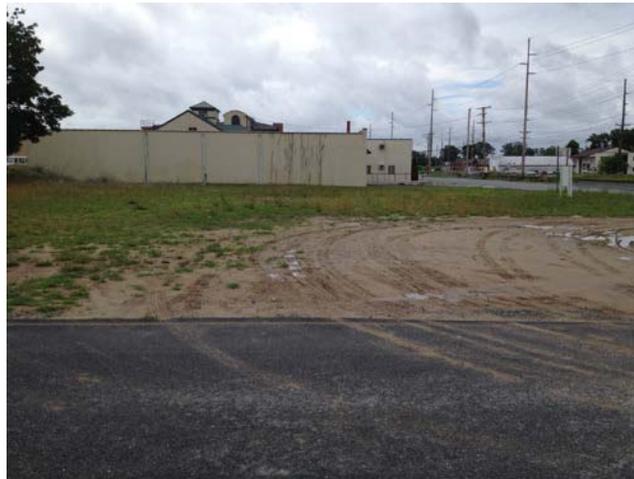
From the parking lot of the auto parts store north of the site, a large bare area can be seen which extends towards West Street.
