PCB Mass Loading Phase II  
Fitzgerald's Auto Salvage Property  
SIRS ID: DE-1315  
Lincoln, Delaware

## **Appendix 12**

# **FITZGERALD'S AUTO SALVAGE PROPERTY LINCOLN, DELAWARE**

**SIRS IDS: DE-1315**

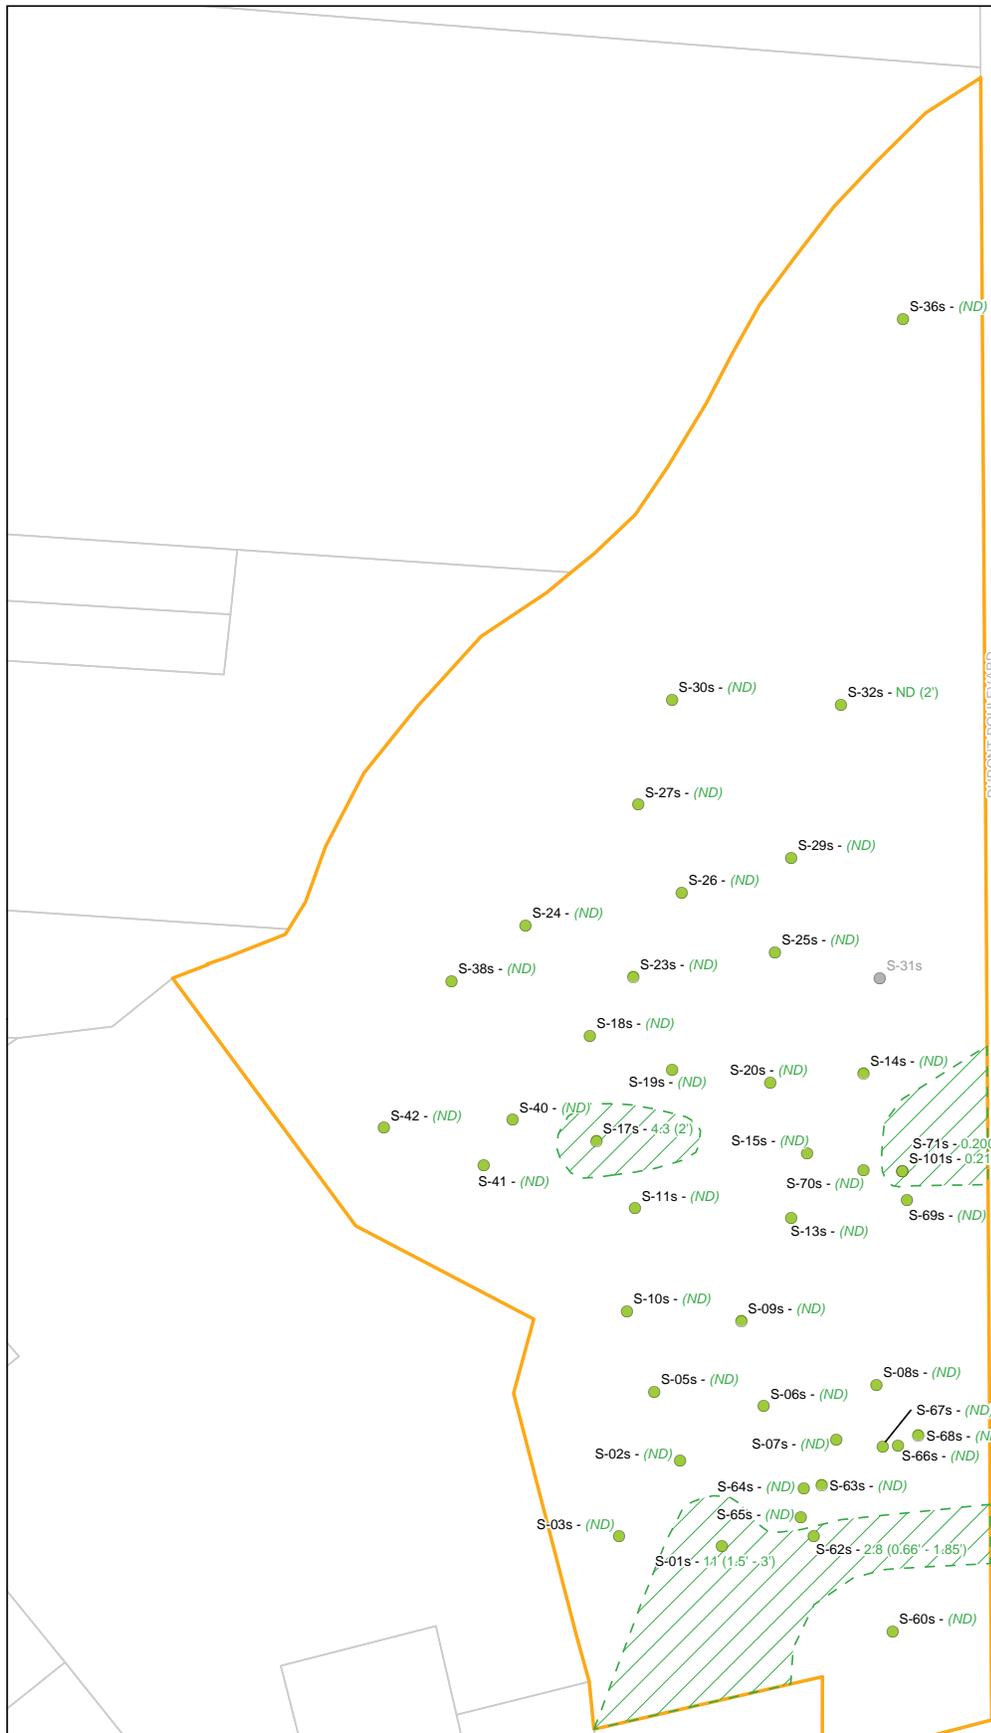
PCB Distribution in Surface Soil (0' - 2' bgs)  
 Fitzgerald's Auto Salvage  
 Lincoln, Delaware

PCBs were detected in the surface soil in 5 samples, ranging from 0.20 mg/kg to 11 mg/kg. In the unsaturated subsurface soil, PCBs were detected in 3 samples and ranged from 0.20 mg/kg to 11 mg/kg. No PCBs were detected in the saturated subsurface soil and groundwater.

The estimated surface soil impacted by PCBs is 3.7 acres (Figure 2). The estimated subsurface unsaturated soil impacted by PCBs is 3.6 acres (Figure 3). Based on the data available and reviewed by BrightFields, the subsurface saturated soil and groundwater are not impacted by PCBs.

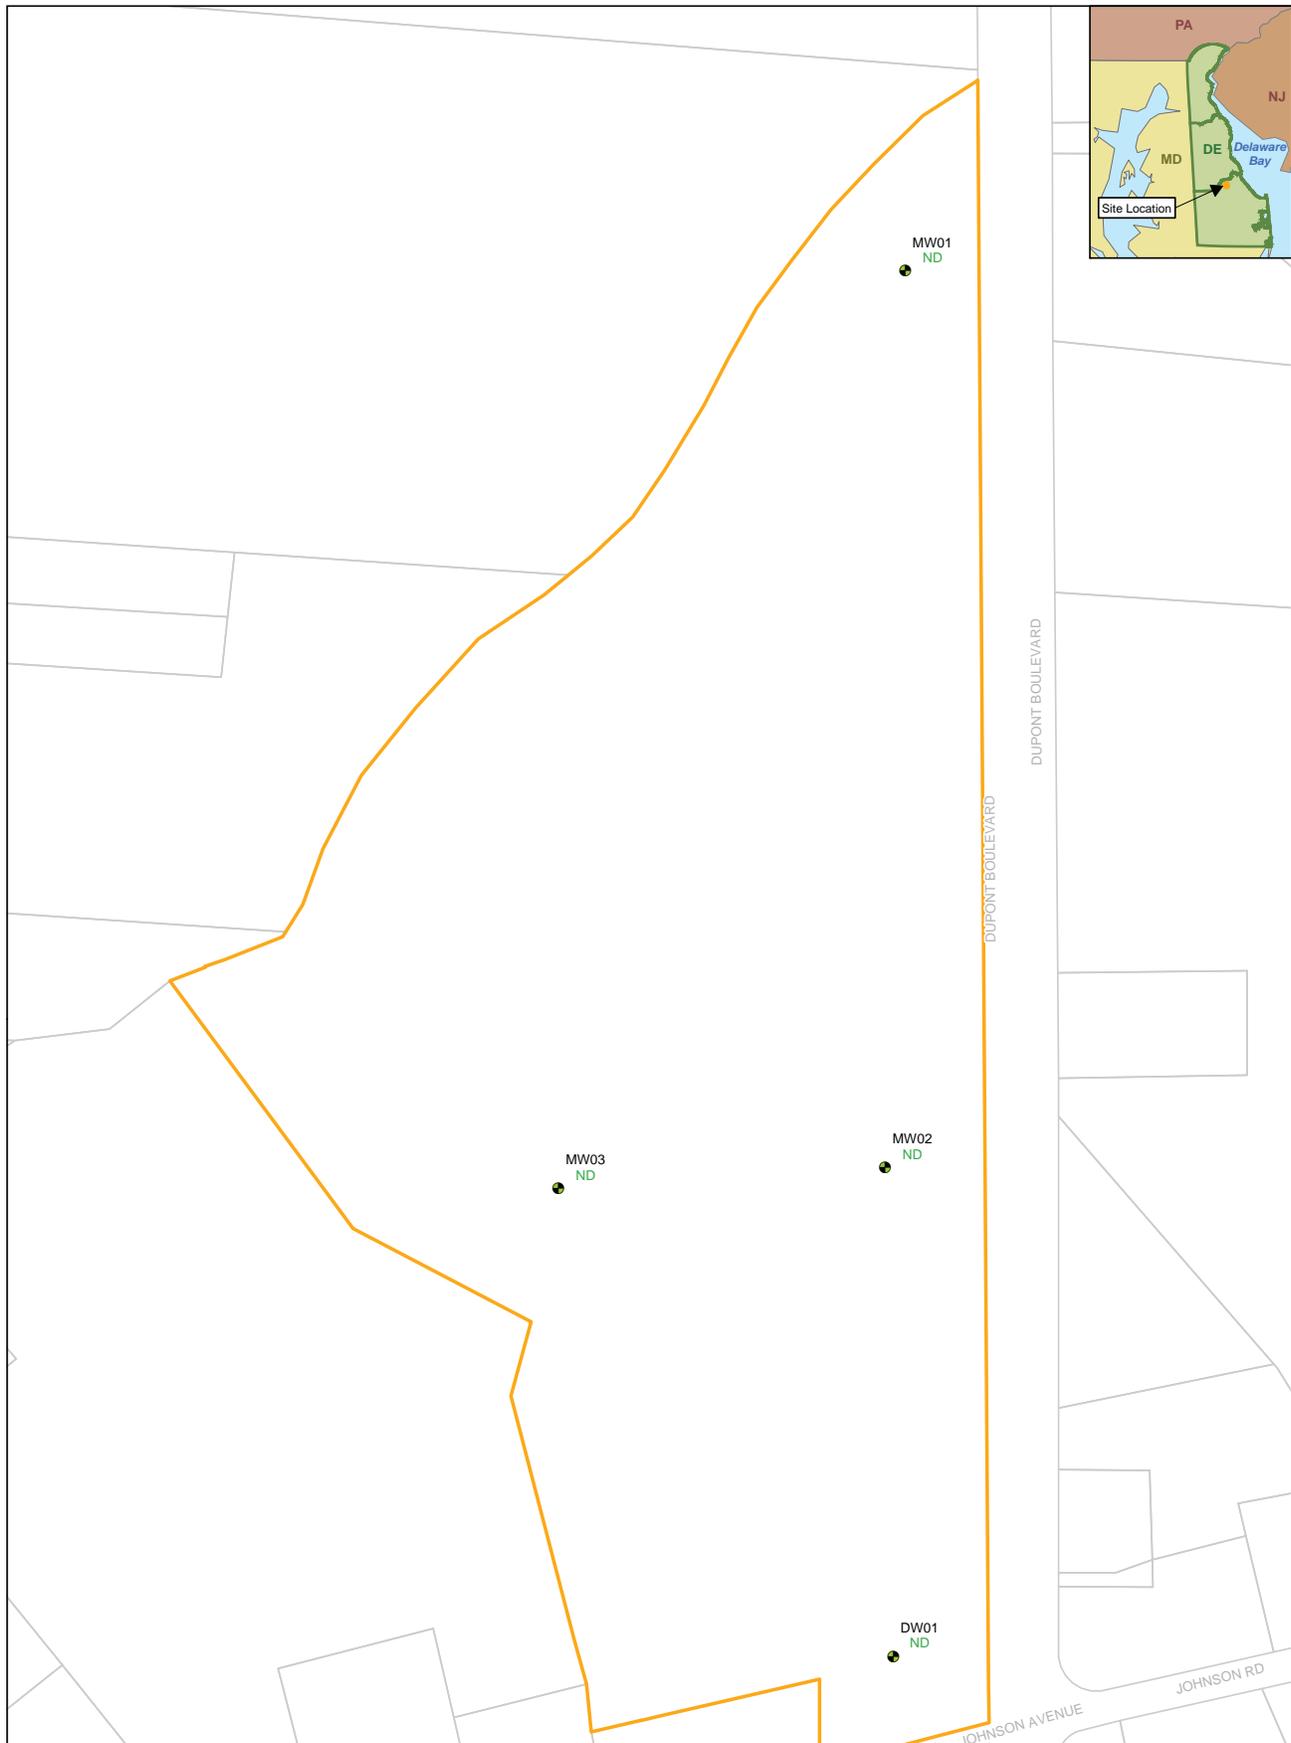
**PCB Distribution in Groundwater**  
**Fitzgerald's Auto Salvage**  
 Lincoln, Delaware

The calculated 95% upper confidence limit (UCL) of the mean of the concentration of total PCBs observed in the surface soil (for overland flow calculations) is 7.9 mg/kg. PCBs were not detected in groundwater samples.

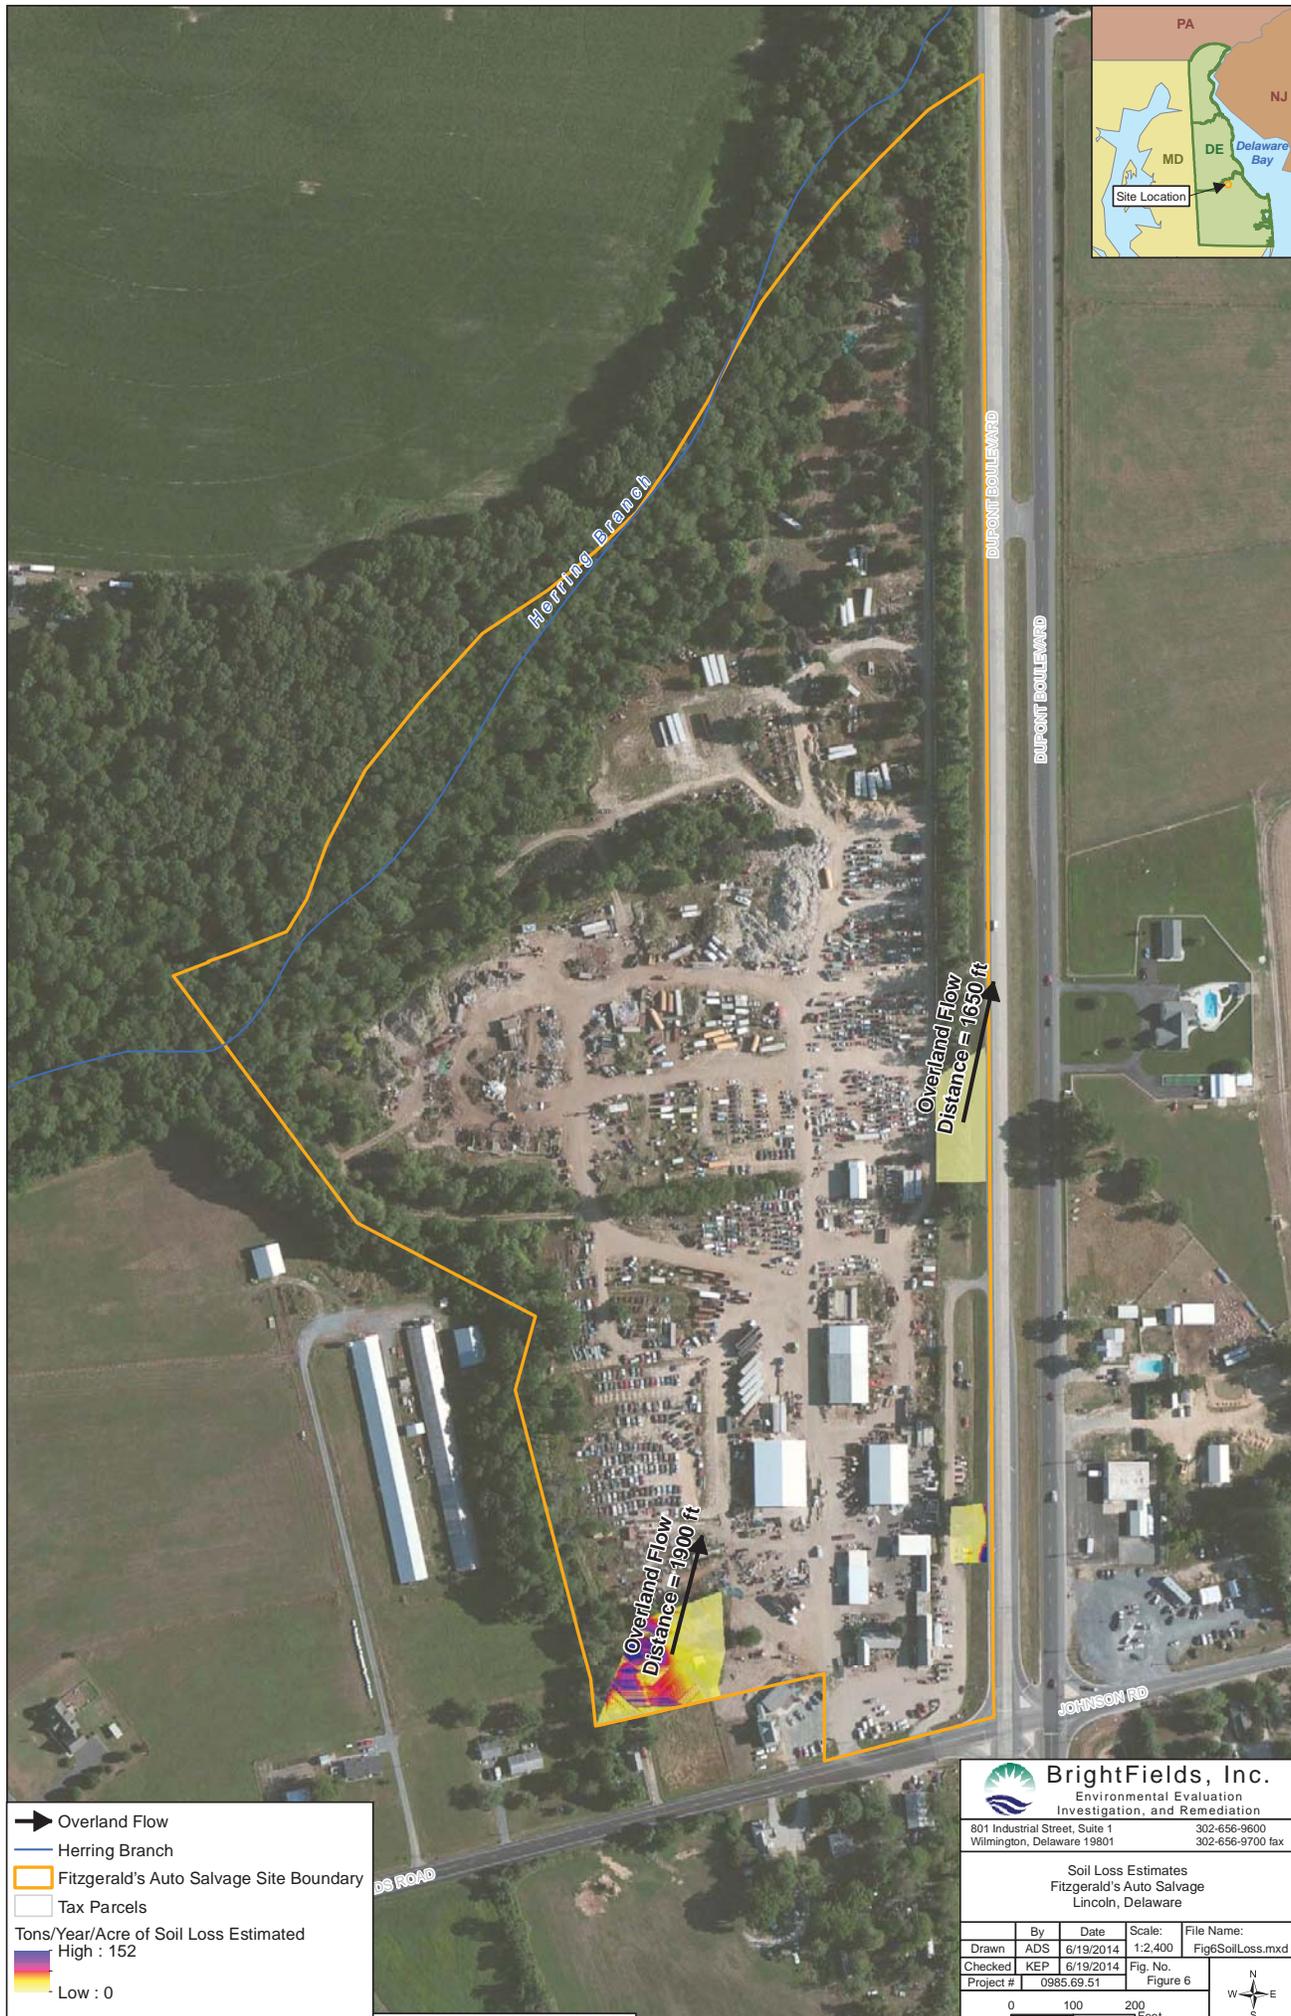
Soil Loss Estimates  
 Fitzgerald's Auto Salvage  
 Lincoln, Delaware

P = support practice factor (dimensionless)	1	No documentation was provided indicating that any sediment and erosion controls are in place.
A = average annual soil loss estimate (ton/ac-yr)	5.6	The average soil loss estimate was generated by ArcGIS using the input factors listed above.
Erodible Area (acres)	1.1	The erodible area was calculated based on the pervious surfaces within the area of concern polygon for surface soil (Figure 6).

The total estimated PCB loading via overland flow for the Fitzgerald's Auto Salvage Property is **44 grams per year**. Please see attached table for specific variables.
