PCB Mass Loading
Holly Oak Substation
SIRB ID: DE-1200
Wilmington, Delaware

Appendix 15

HOLLY OAK SUBSTATION WILMINGTON, DELAWARE

SIRB ID: DE-1200

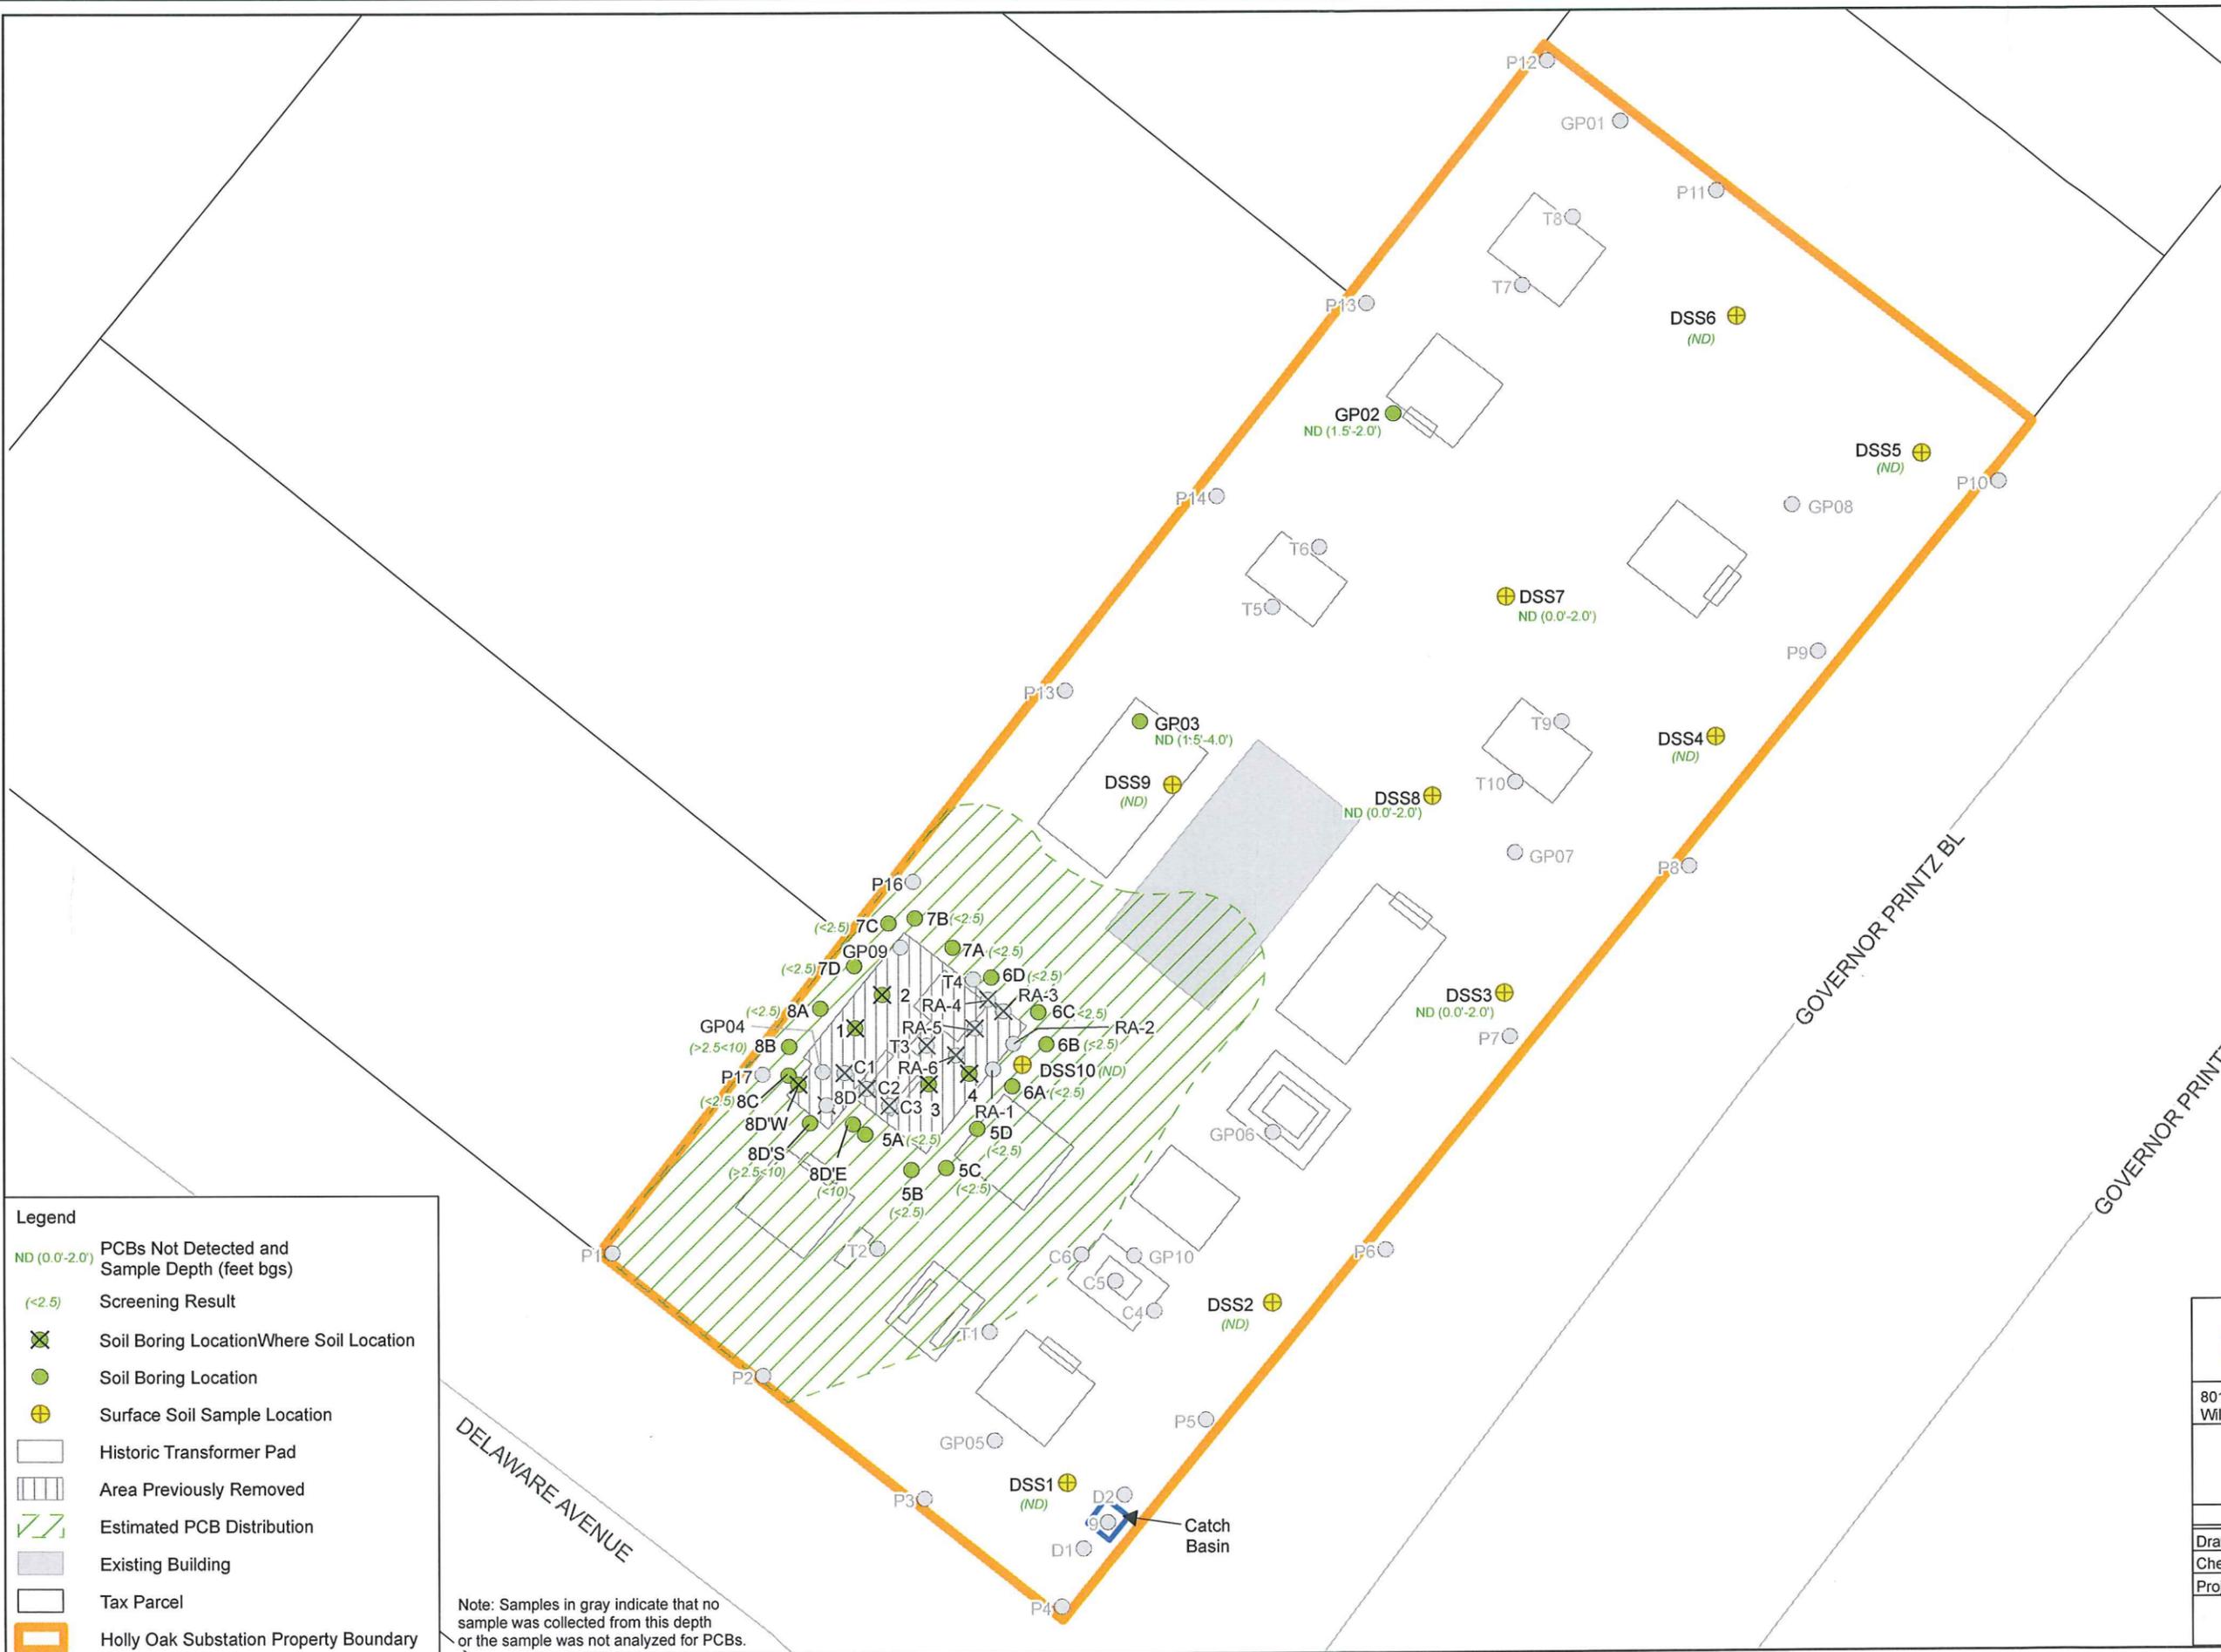
By	Date	Scale:	File Name:
SMD	8/22/08	1:240	holly oak 0-2.mxd
Checked	JPR	8/22/08	Fig. No.
Project #	0985.26.51	Figure 2

and confirmatory samples indicated that PCBs still remained in this area at concentrations above 10 ppm. This area is shown on attached Figure 2 of this report.

In 1990, approximately one foot of soil was removed from the area depicted on Figure 2. Confirmatory samples indicated that PCBs still remained in this area at concentrations above the remediation goal of 10 ppm.

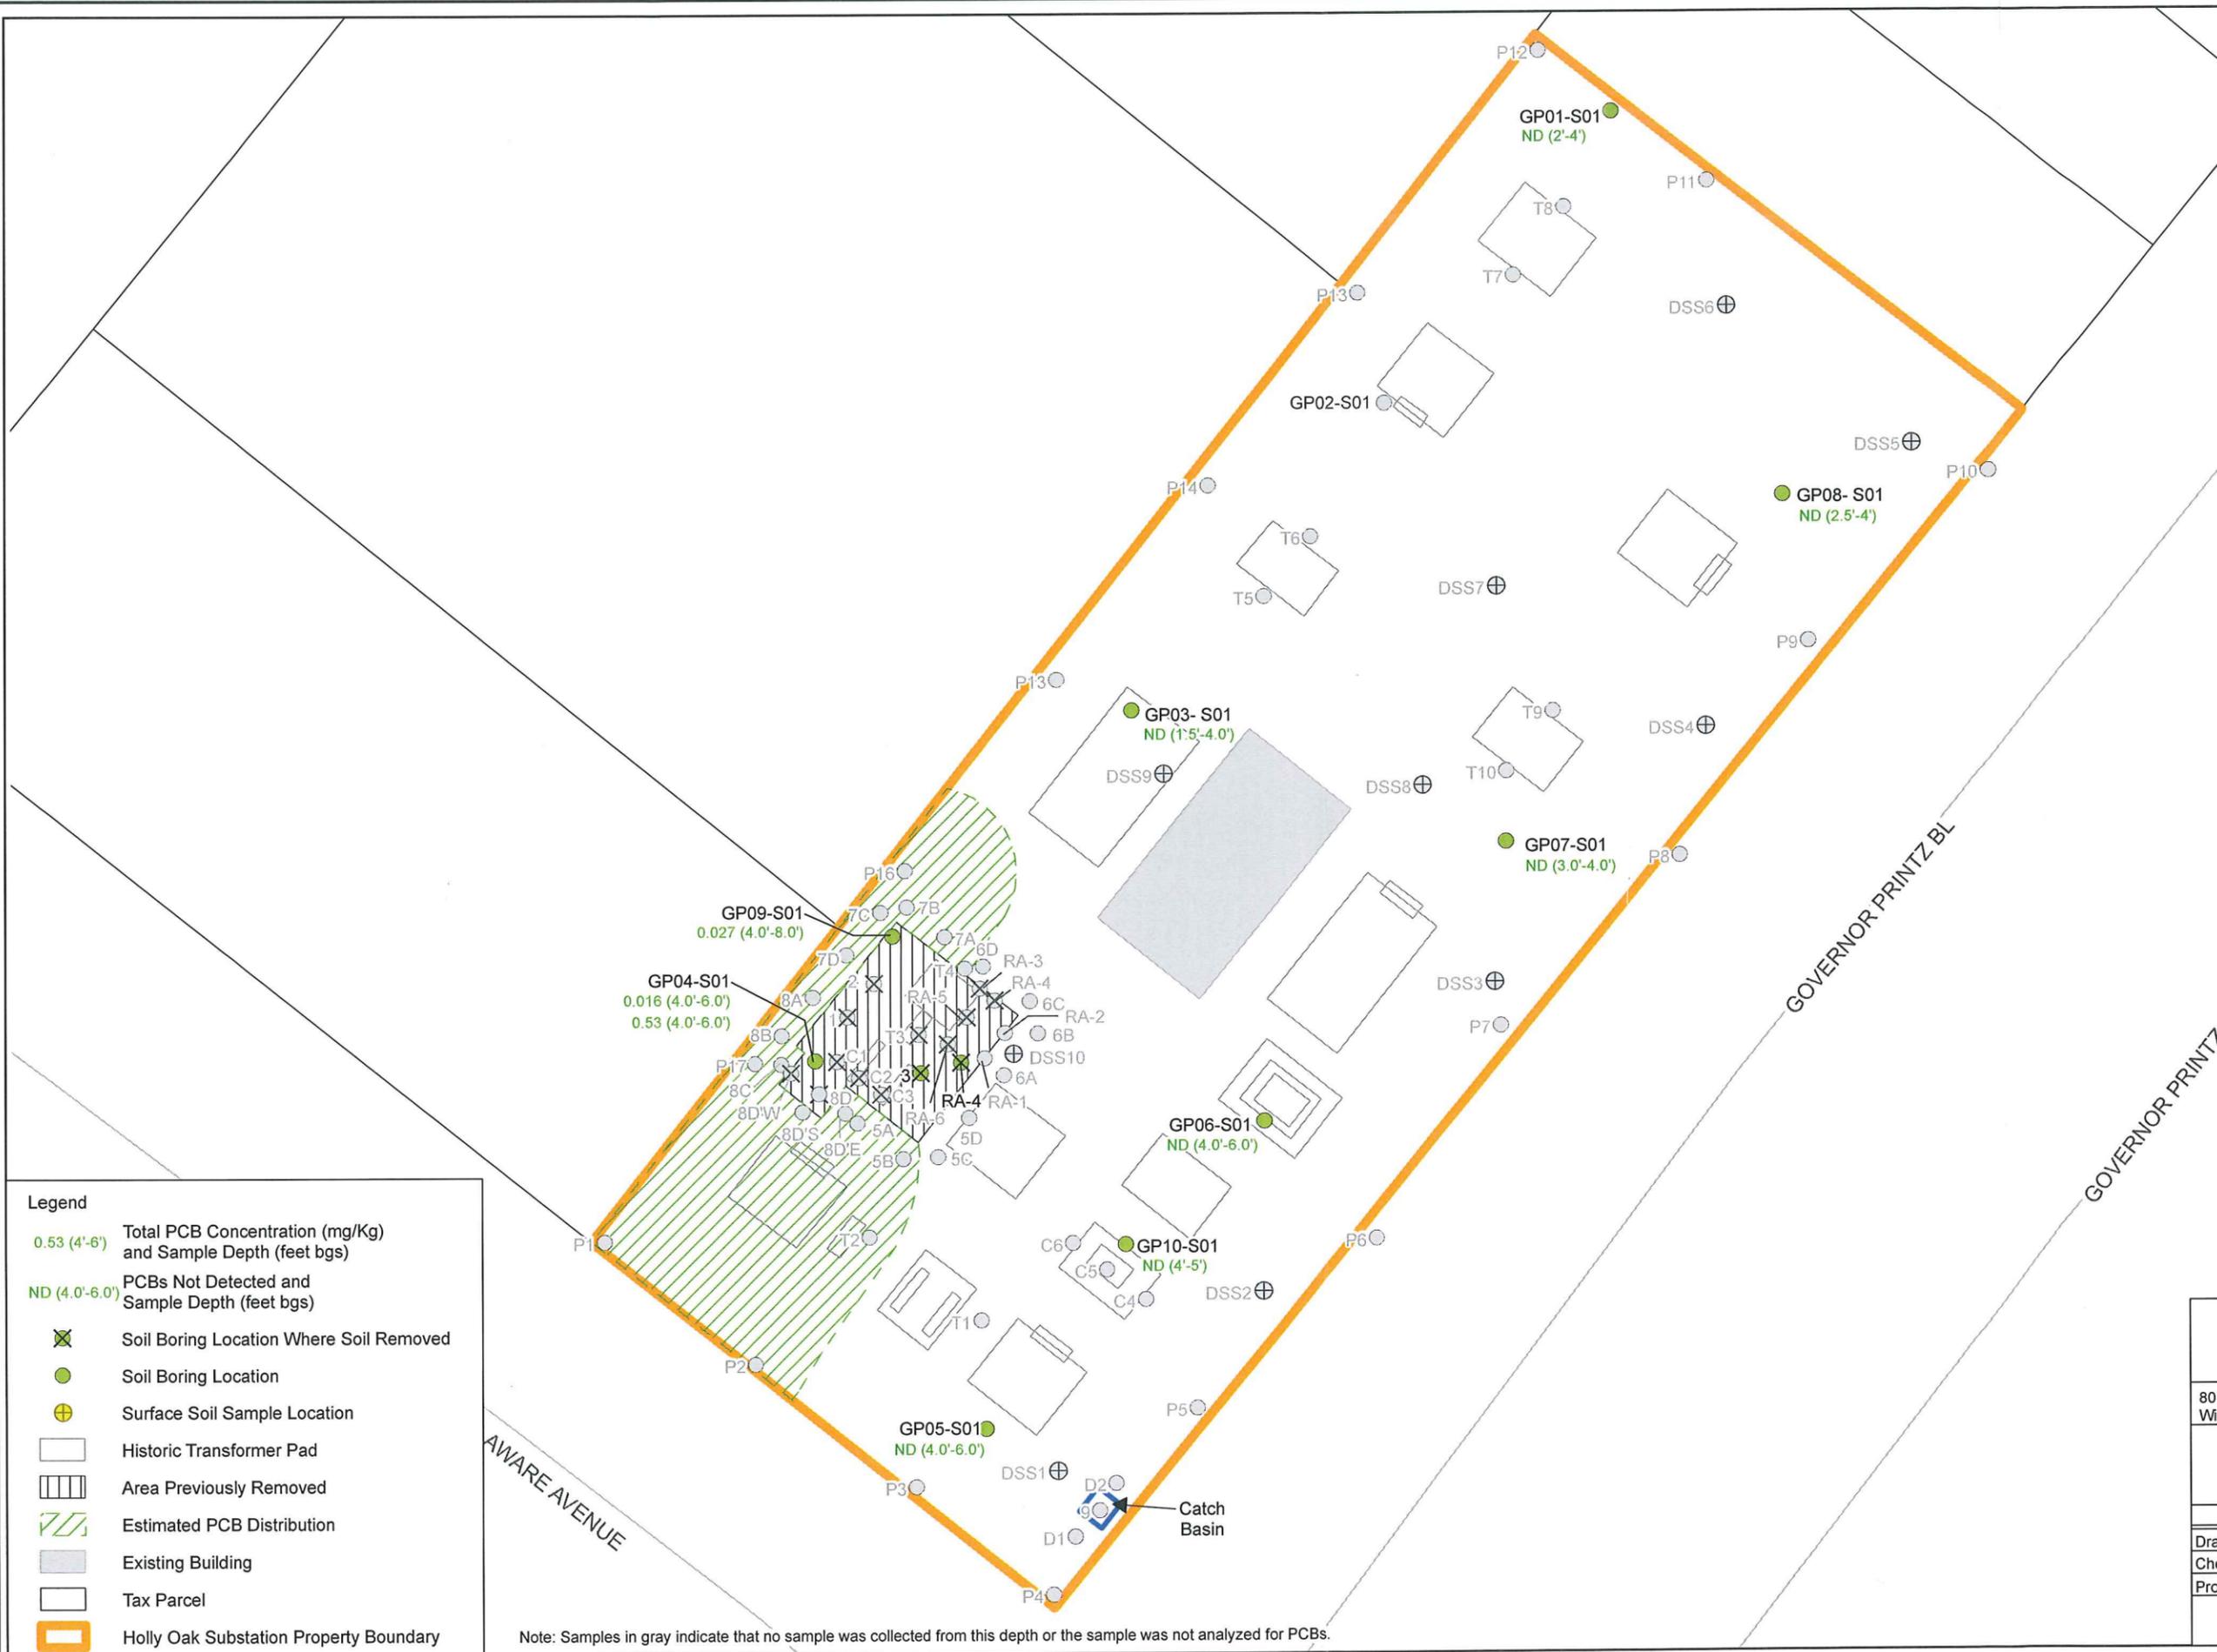
By	Date	Scale:	File Name:
Drawn SMD	8/22/08	1:240	hollyoak grt2 unsat.mxd
Checked JPR	8/22/08	Fig. No.	
Project #	0985.26.51	Figure 3

The estimated unsaturated subsurface soil area impacted by PCBs is 0.068 acres in the vicinity of the former removal area. The estimated unsaturated subsurface soil area impacted by PCBs is 0.03 acres in the vicinity of the former removal area, including GP04 and GP09. The estimated saturated subsurface soil area impacted by PCBs is 0.05 acres in the vicinity of GP09 (Figure 4).

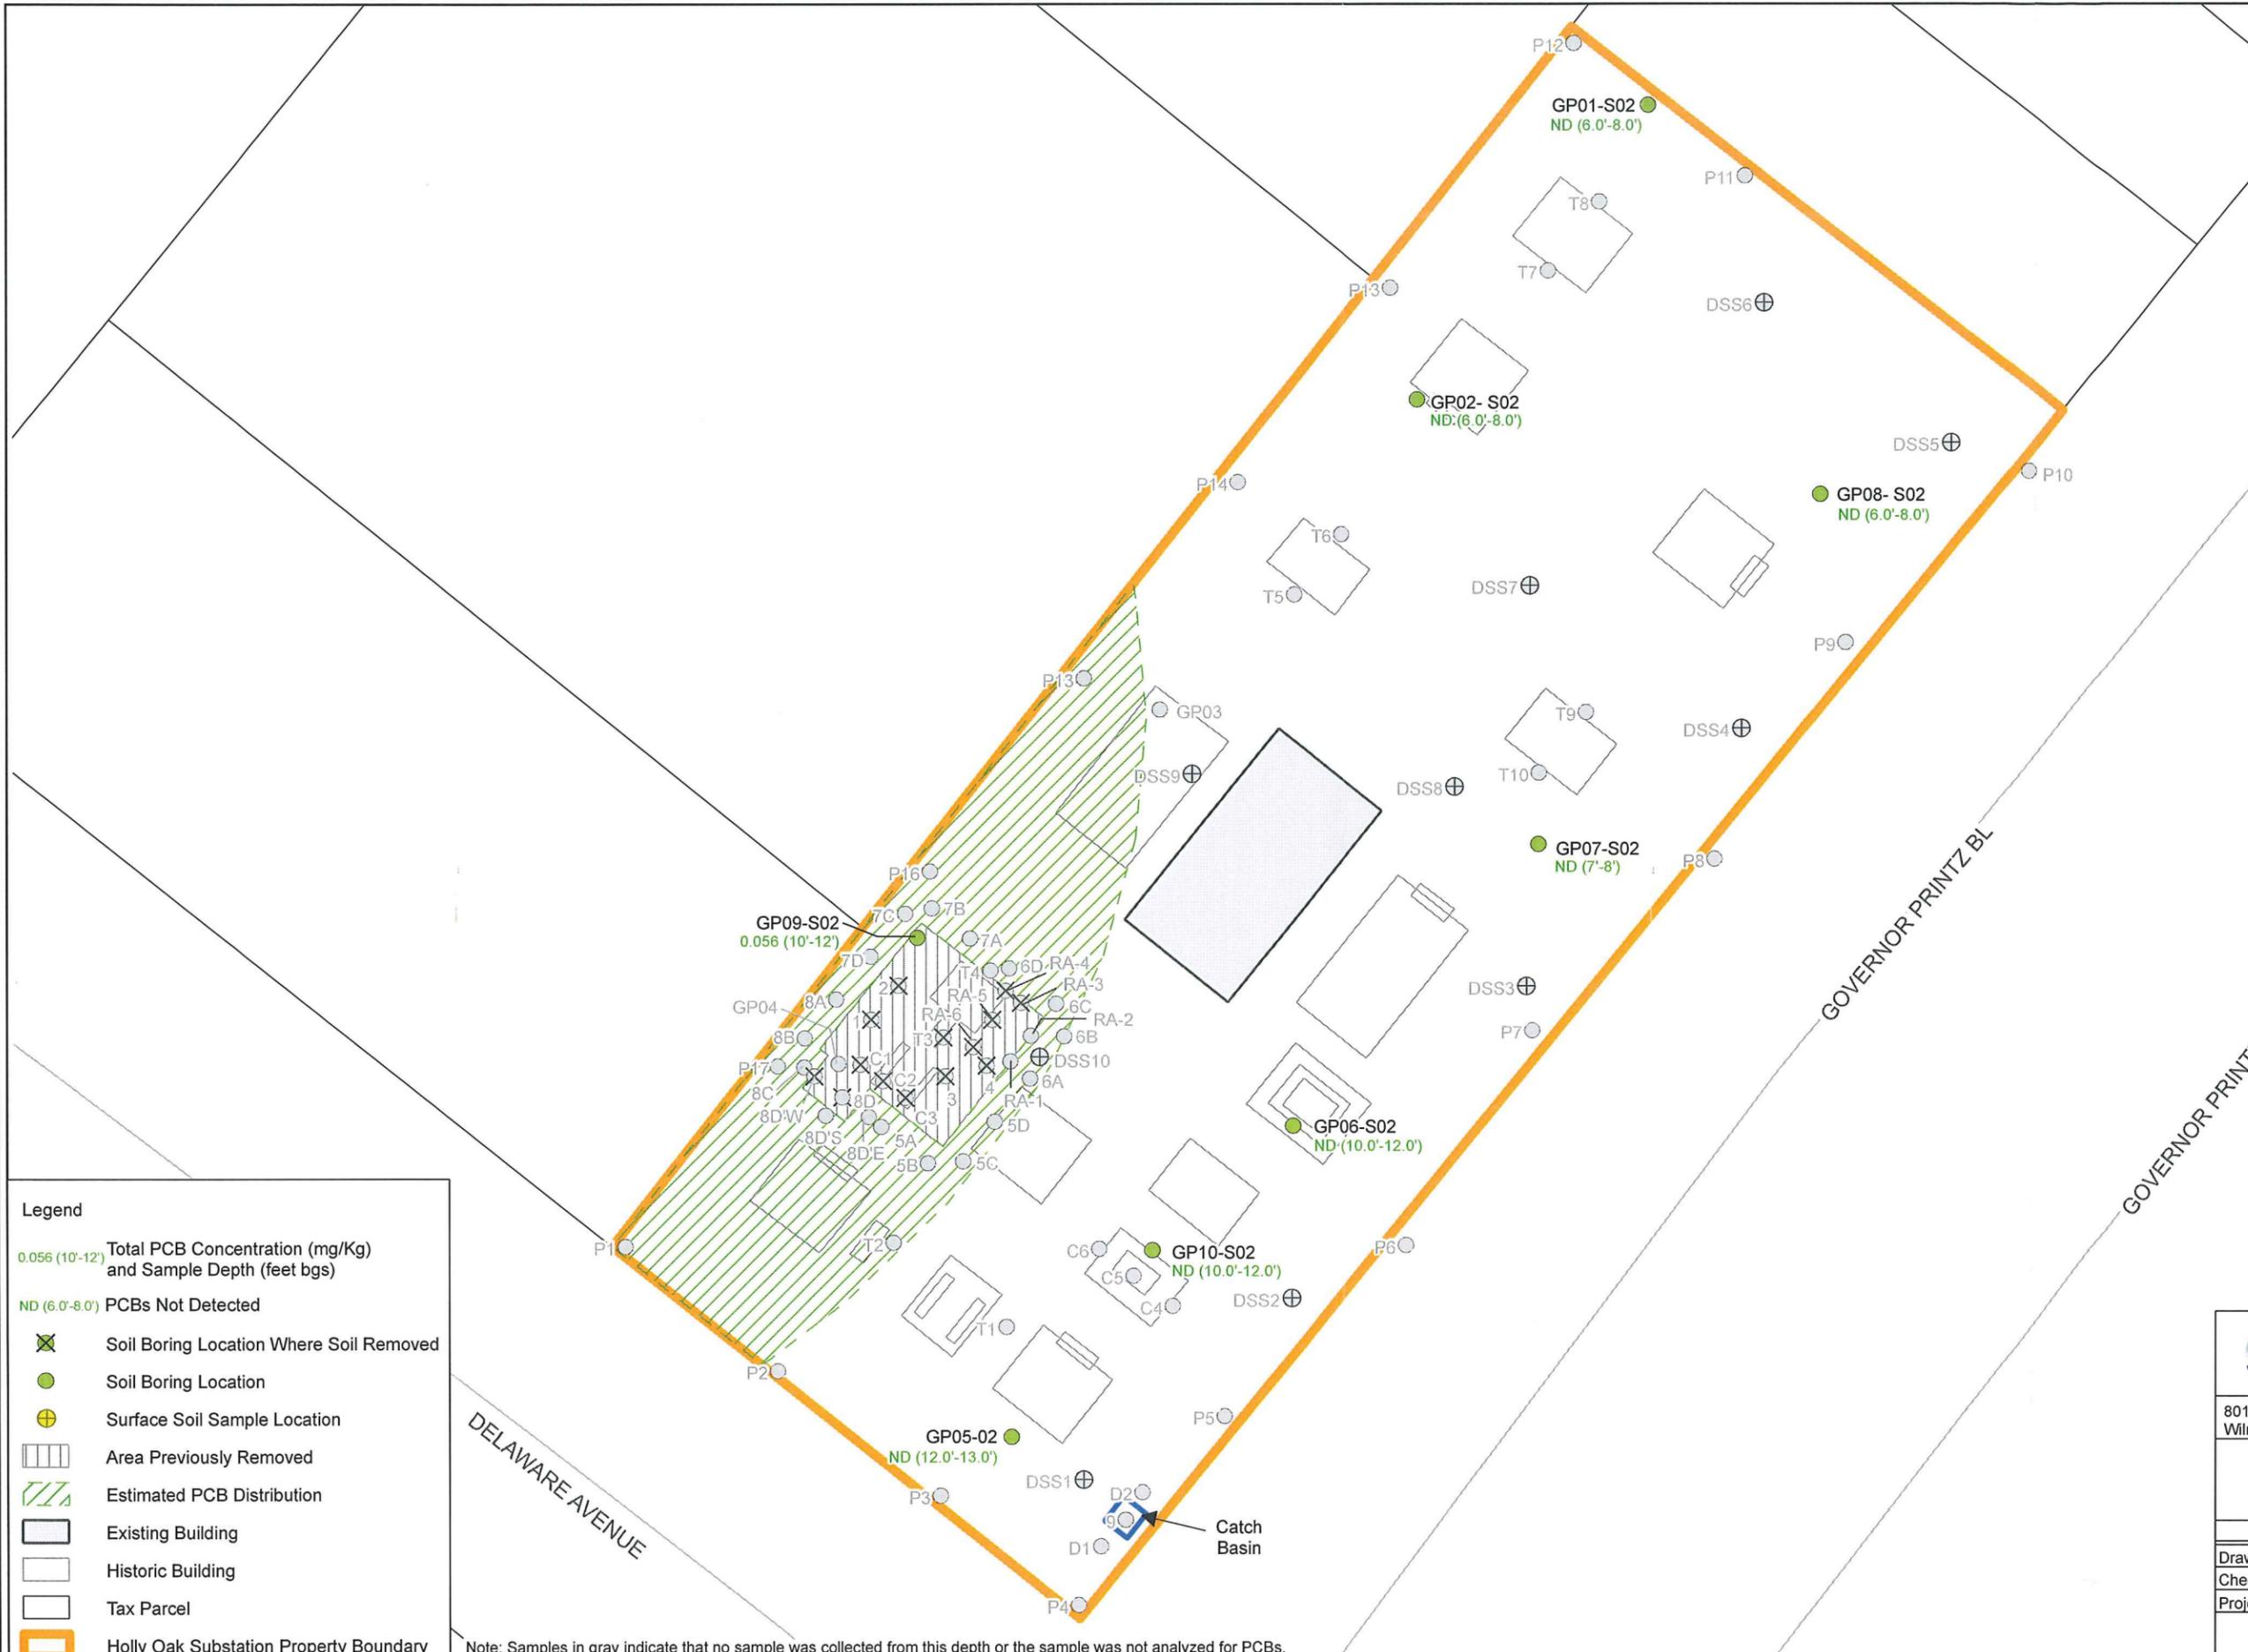
By	Date	Scale:	File Name:
SMD	8/22/08	1:240	hollyoak grt2 sat.mxd
Checked	JPR	8/22/08	Fig. No.
Project #	0985.26.51	Figure 4

PCBs (Aroclor-1254) were detected in two subsurface non-saturated soil samples (GP04 and GP09) and one subsurface saturated sample (GP09) at concentrations below both the unrestricted use and restricted use Uniform Risk-Based Remediation Standard (URS) values for human health for total PCBs during the initial laboratory analysis performed as part of the Remedial Investigation performed by WIK Associates (WIK 2003). Five confirmatory samples were sent to a HSCA certified laboratory, including GP04. GP04 was determined to have concentrations of Aroclor-1254 and Aroclor -1268 below the unrestricted and restricted URS values.

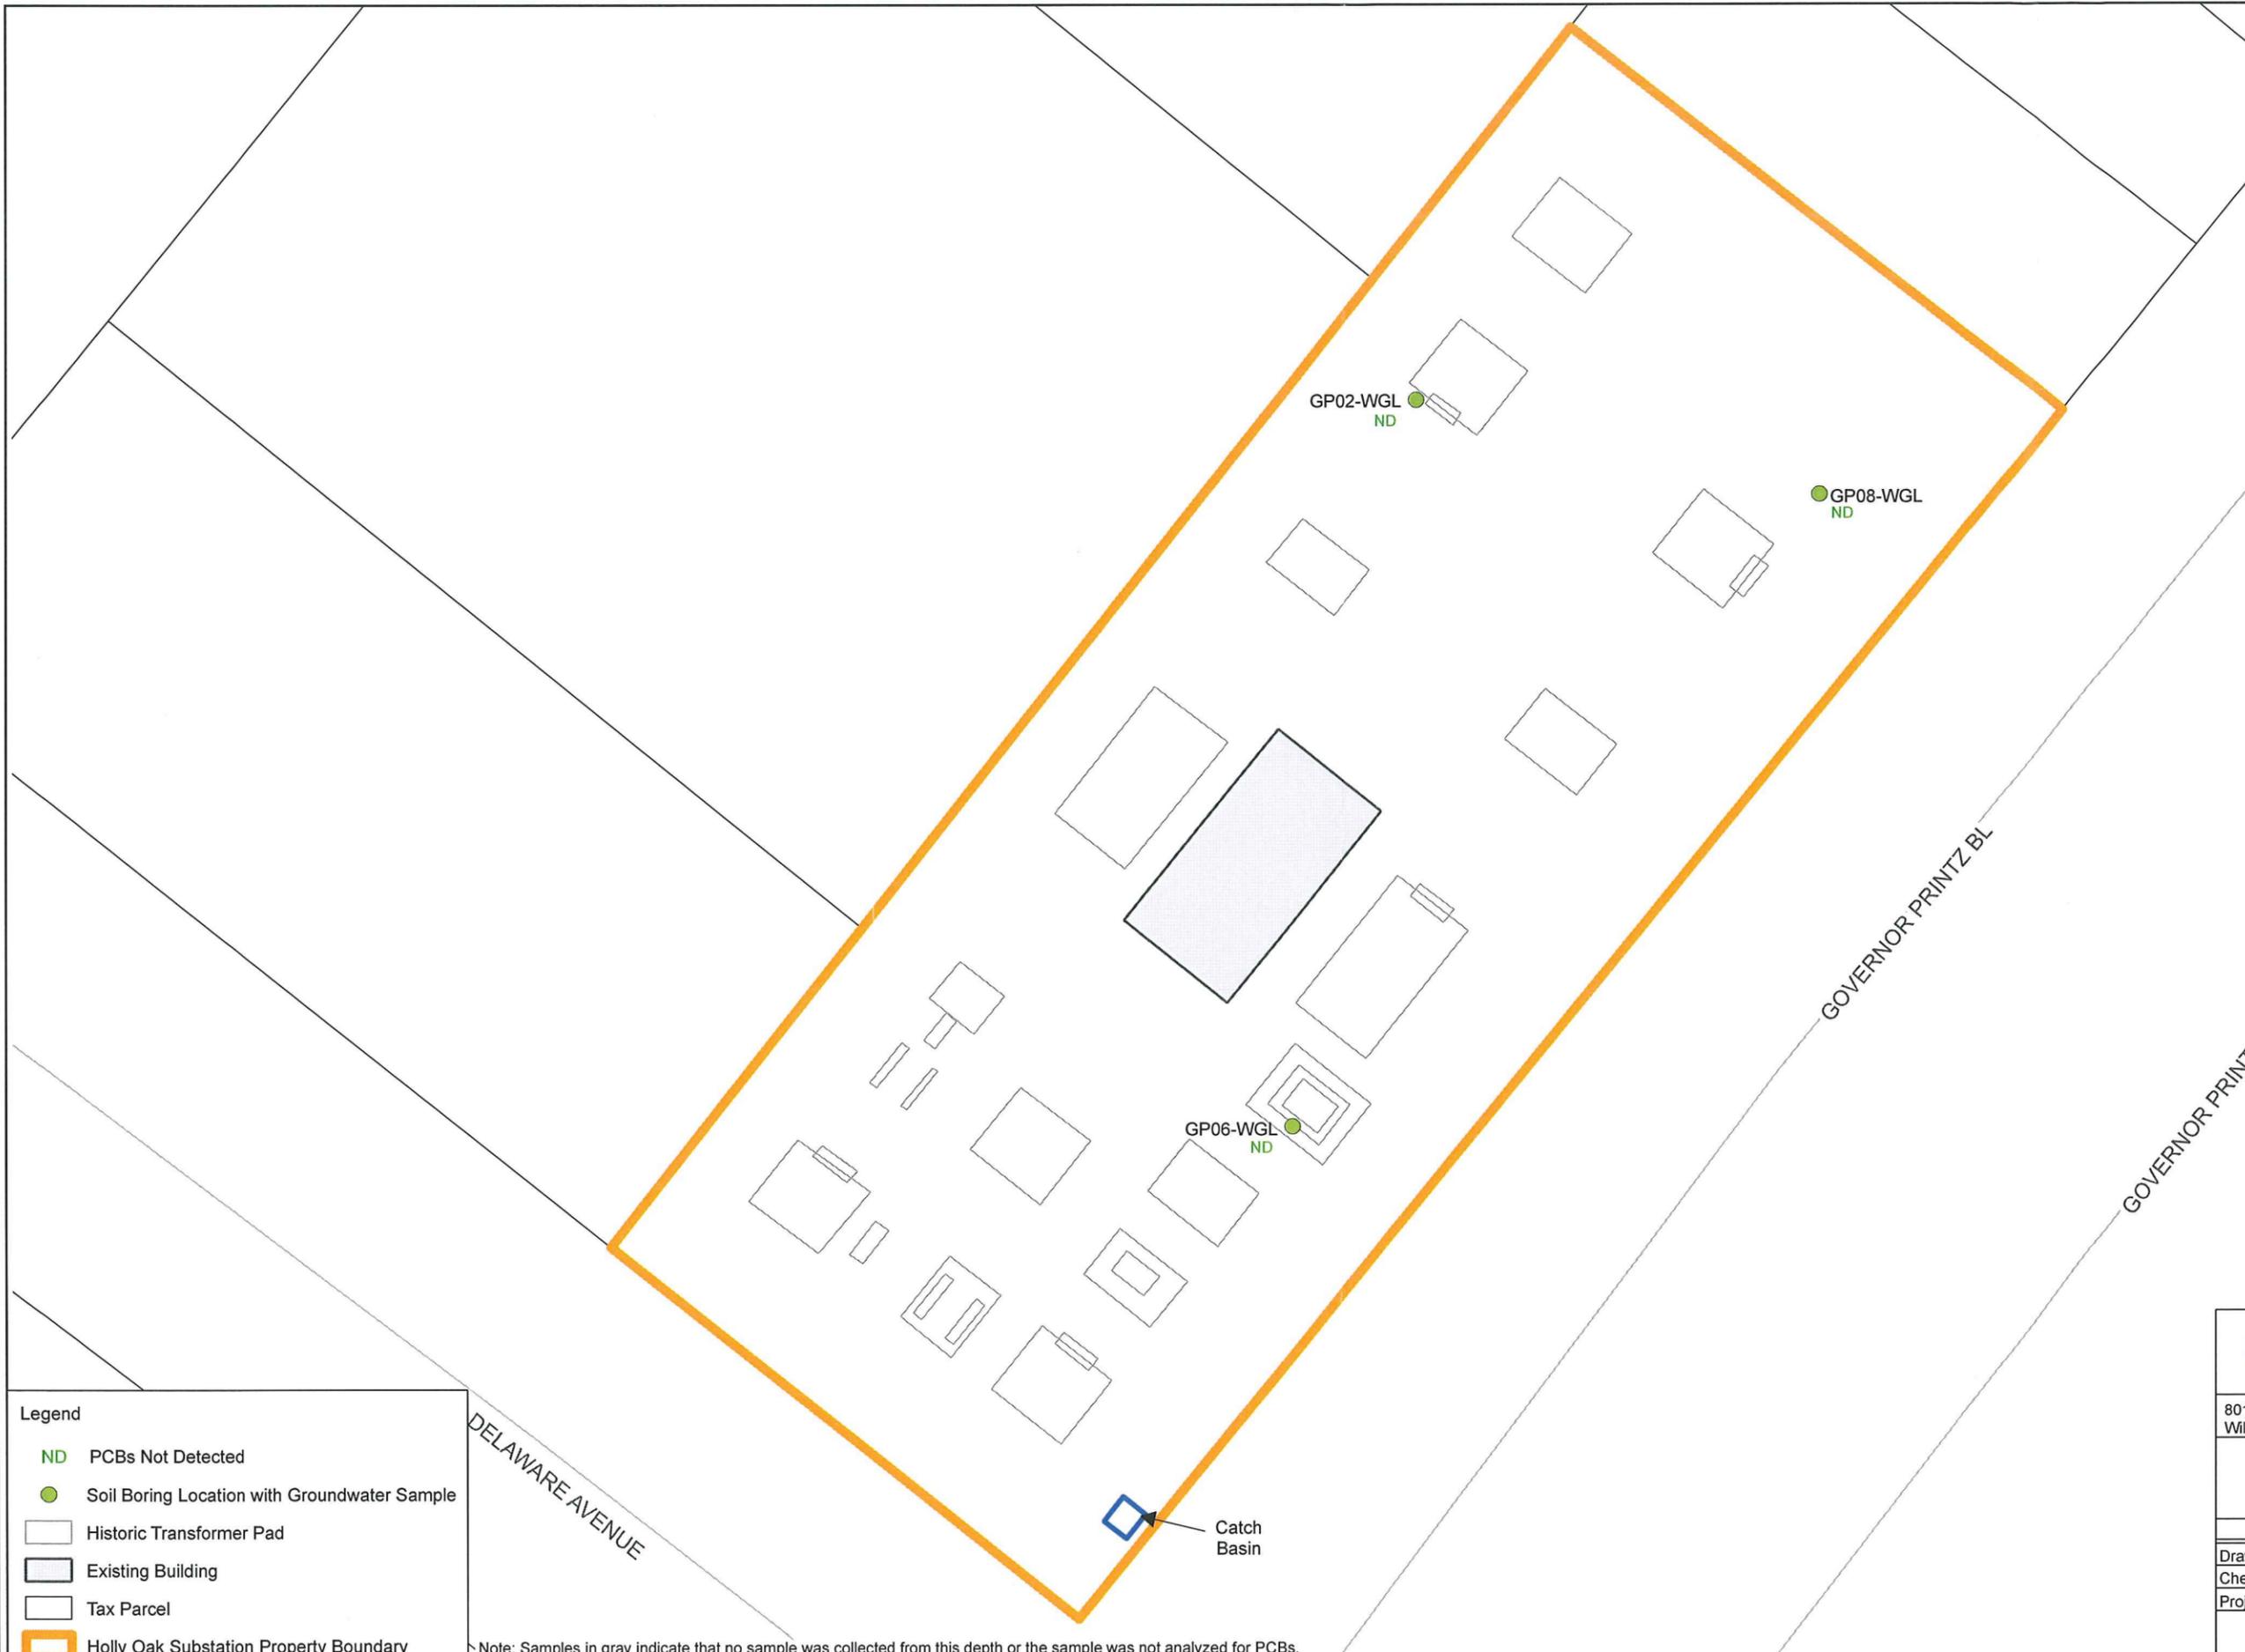
By	Date	Scale:	File Name:
Drawn	SMD	5/12/09	1:240	hollyoak grt2 sat.mxd
Checked	JPR	5/12/09	Fig. No.	
Project #	0985.26.51		Figure 5

Concentrations of PCBs on Site			
Sample Matrix	Corresponding Figure	Analytical Methods	Range of Total PCBs
Surface Soil	Figure 2	Immunoassay and Method 8082	Not detected to >2.5<10 mg/kg
Subsurface Soil (unsaturated)	Figure 3	Immunoassay and Method 8082	Not detected to 0.530 mg/kg
Subsurface Soil (saturated)	Figure 4	Method 8082	Not detected to 0.056 mg/kg
Groundwater	Figure 5	Method 8082	Not detected

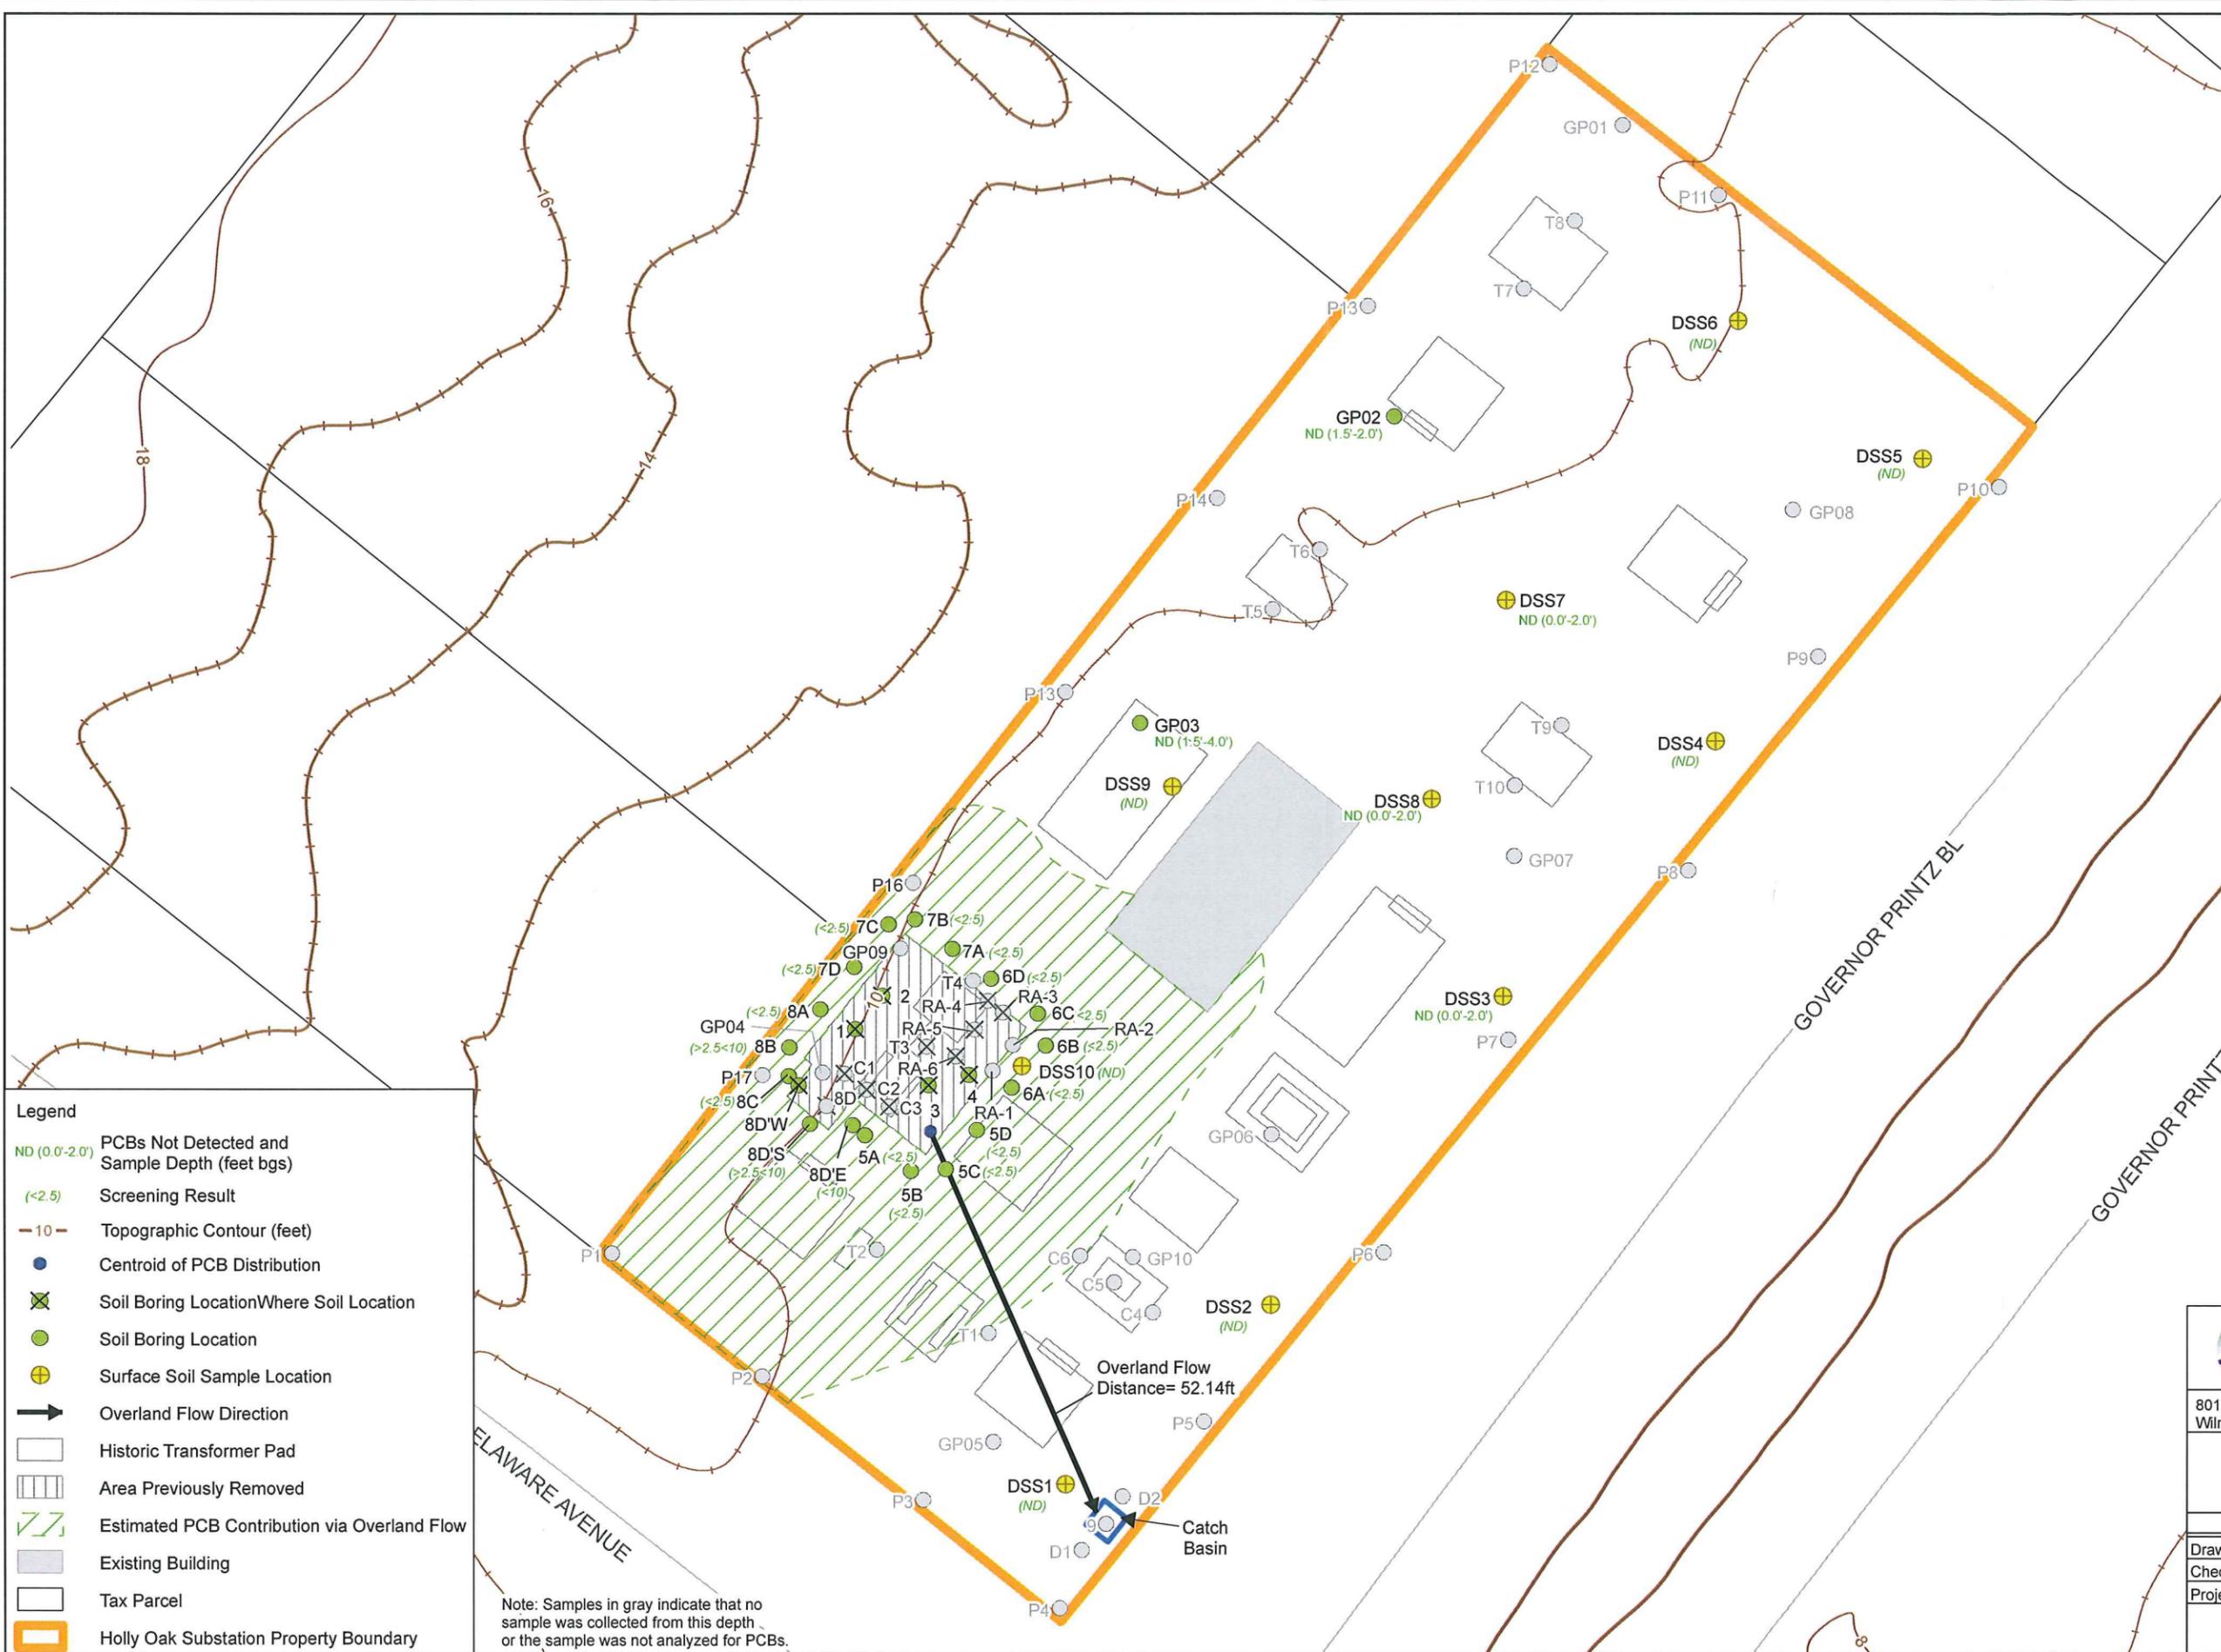
By	Date	Scale	File Name
Drawn SMD	12/30/08	1:240	holly oak topo.mxd
Checked JPR	12/30/08	Fig. No.	
Project #	0985.26.51	Figure 6

Overland Flow Distance = 52.14ft

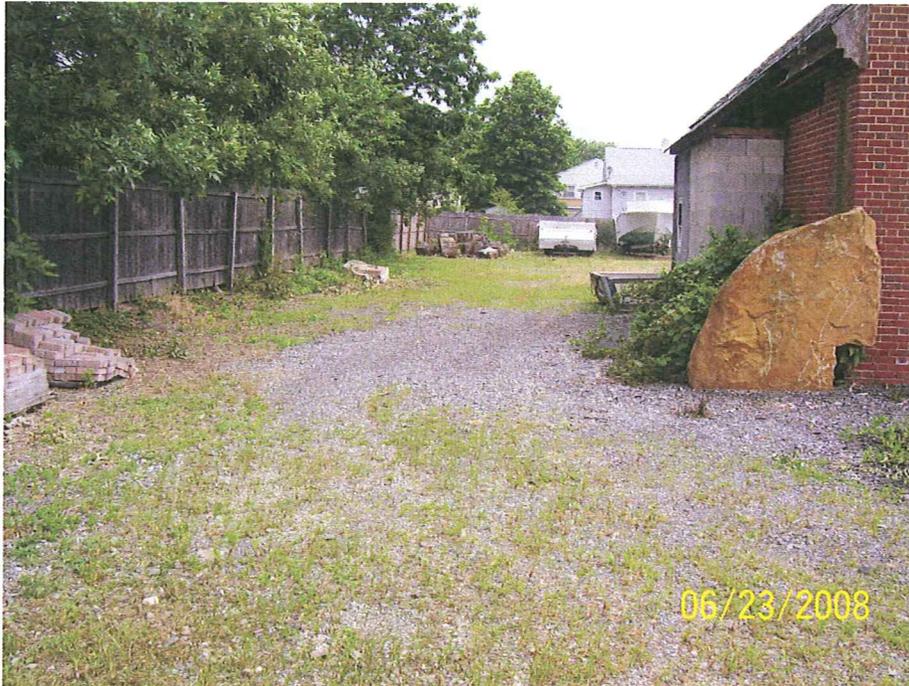
Behind former control house located on property.

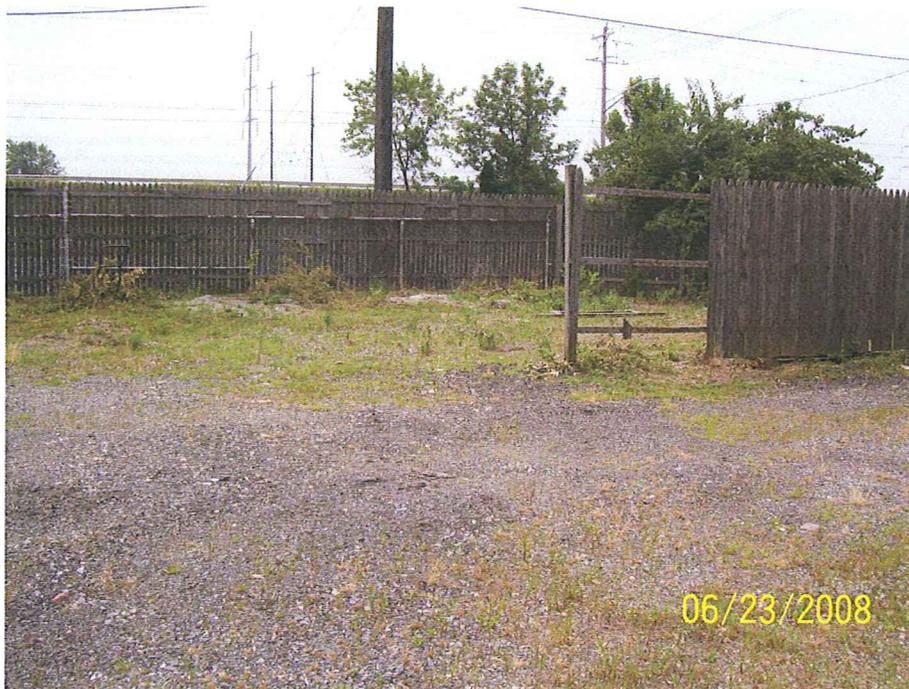
$\frac{1}{4}$ " to $\frac{1}{2}$ " Stone fill as top layer of site (approximately 2" thick).

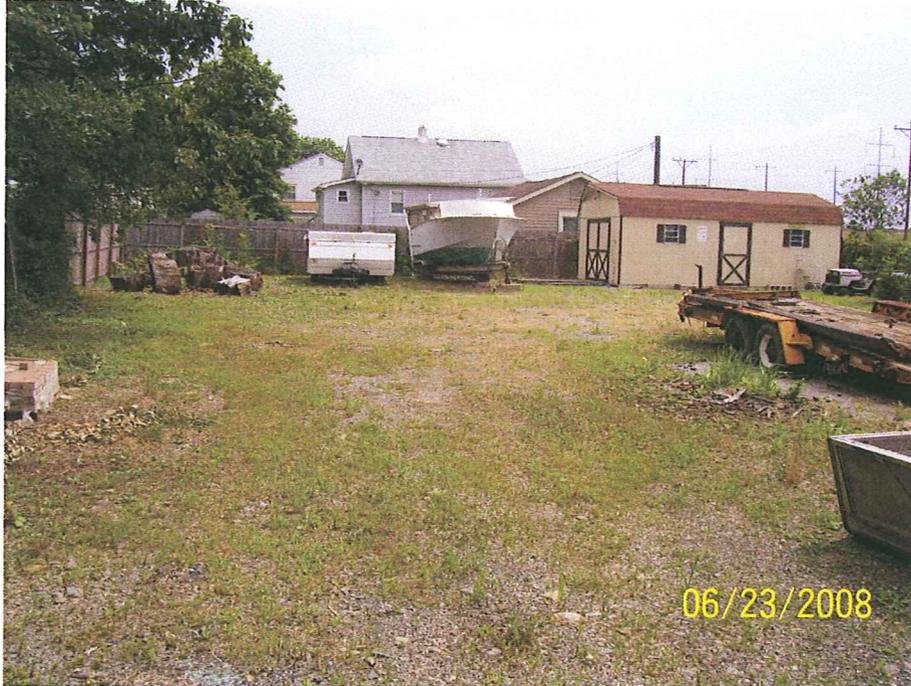
North side of the site displaying vegetation protruding through stone fill.

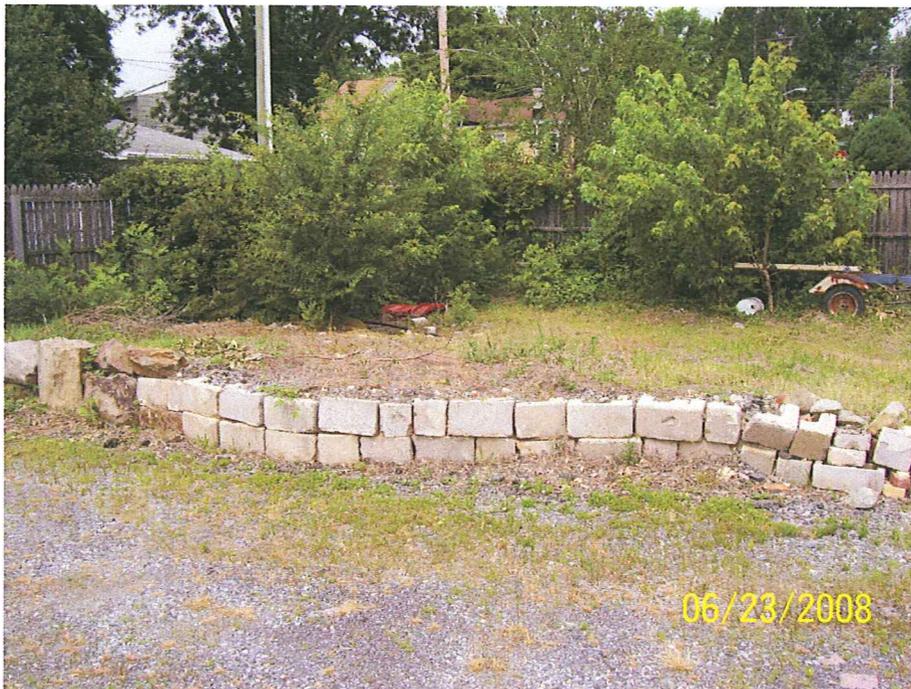
Elevated area of site directly adjacent to southern entrance.

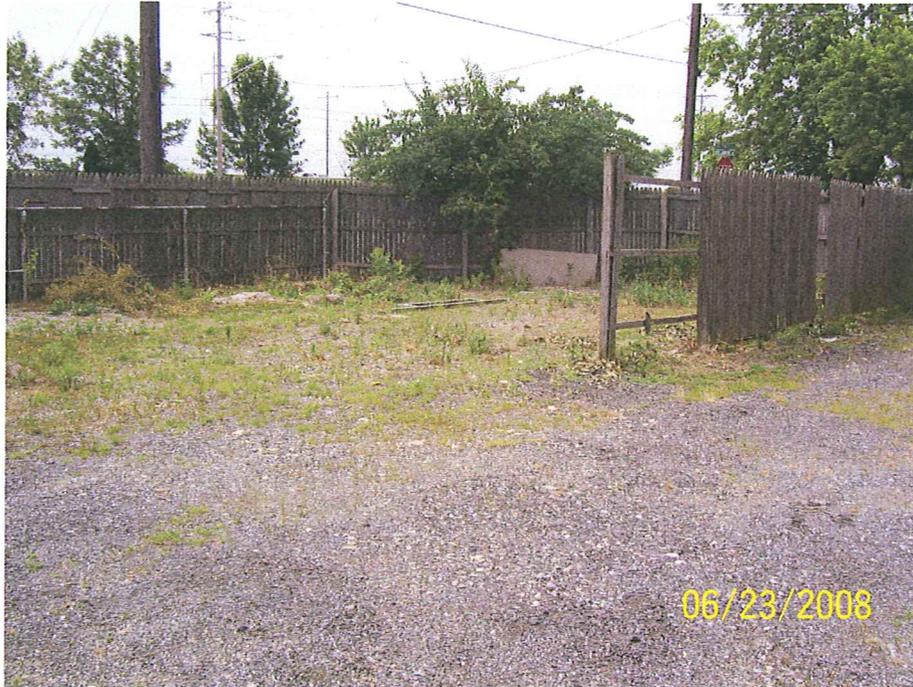
Overland pathway from location of former PCB contaminated area.
