PCB Mass Loading
Merkin Auto Spring Company
SIRB ID: DE-1175
Wilmington, Delaware

Appendix 1-B

**MERKIN AUTO SPRING COMPANY
WILMINGTON, DELAWARE**

SIRB ID: DE-1175

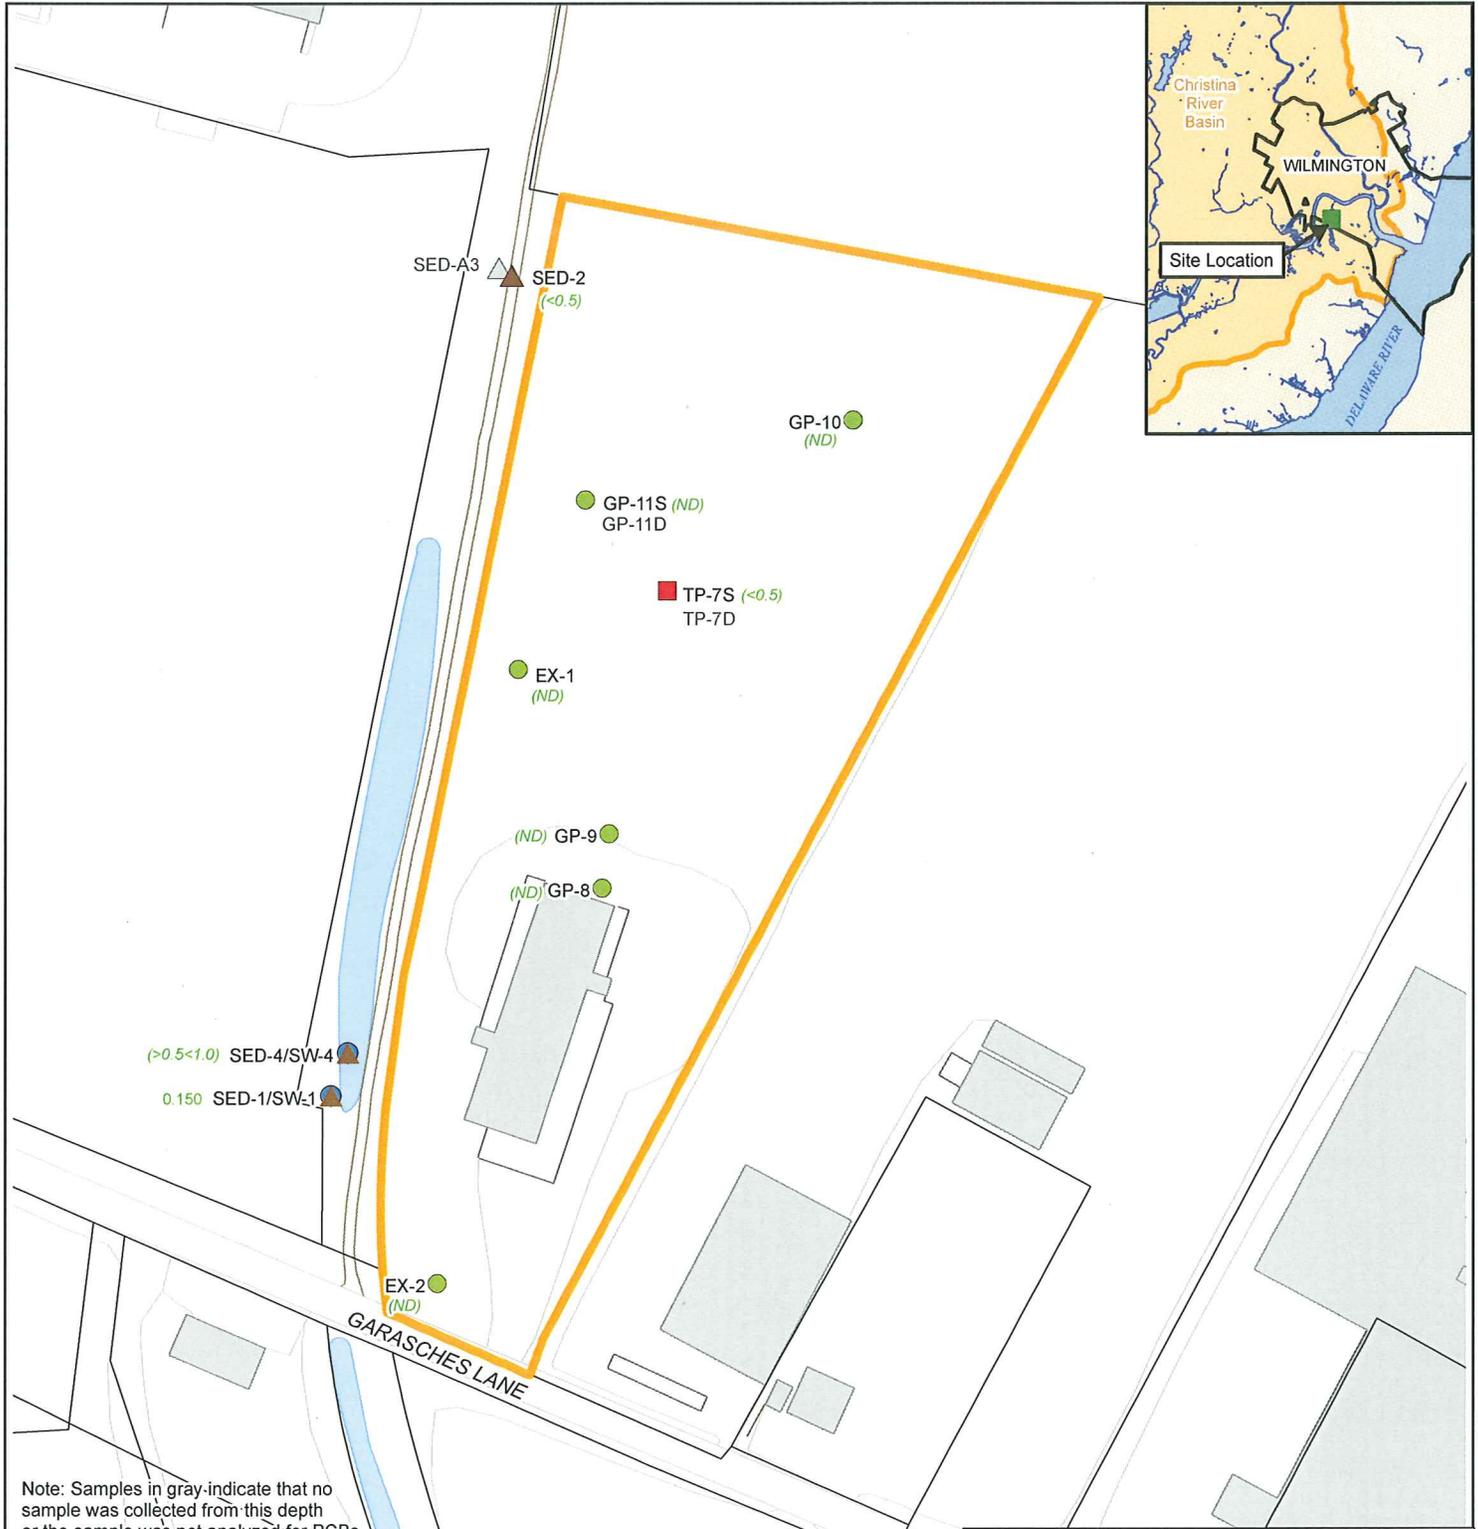
PCB Distribution in Surface Soil (0'-2' bgs)
Merkin Auto
Wilmington, Delaware

PCBs were not detected above their analytical reporting limits in any samples collected from the Merkin Auto Property. No samples collected on the Merkin Auto site were analyzed using confirmatory laboratory analytical procedures. Samples on the site were only screened using immunoassay kits. The detection limit for this analysis was 0.5 mg/kg. No samples collected indicated a concentration above this detection limit.

| Concentrations of PCBs on Site | | | |
|---|---|---|---|
| Surface Soil | Figure 2 | Immunoassay Kits | Not detected |

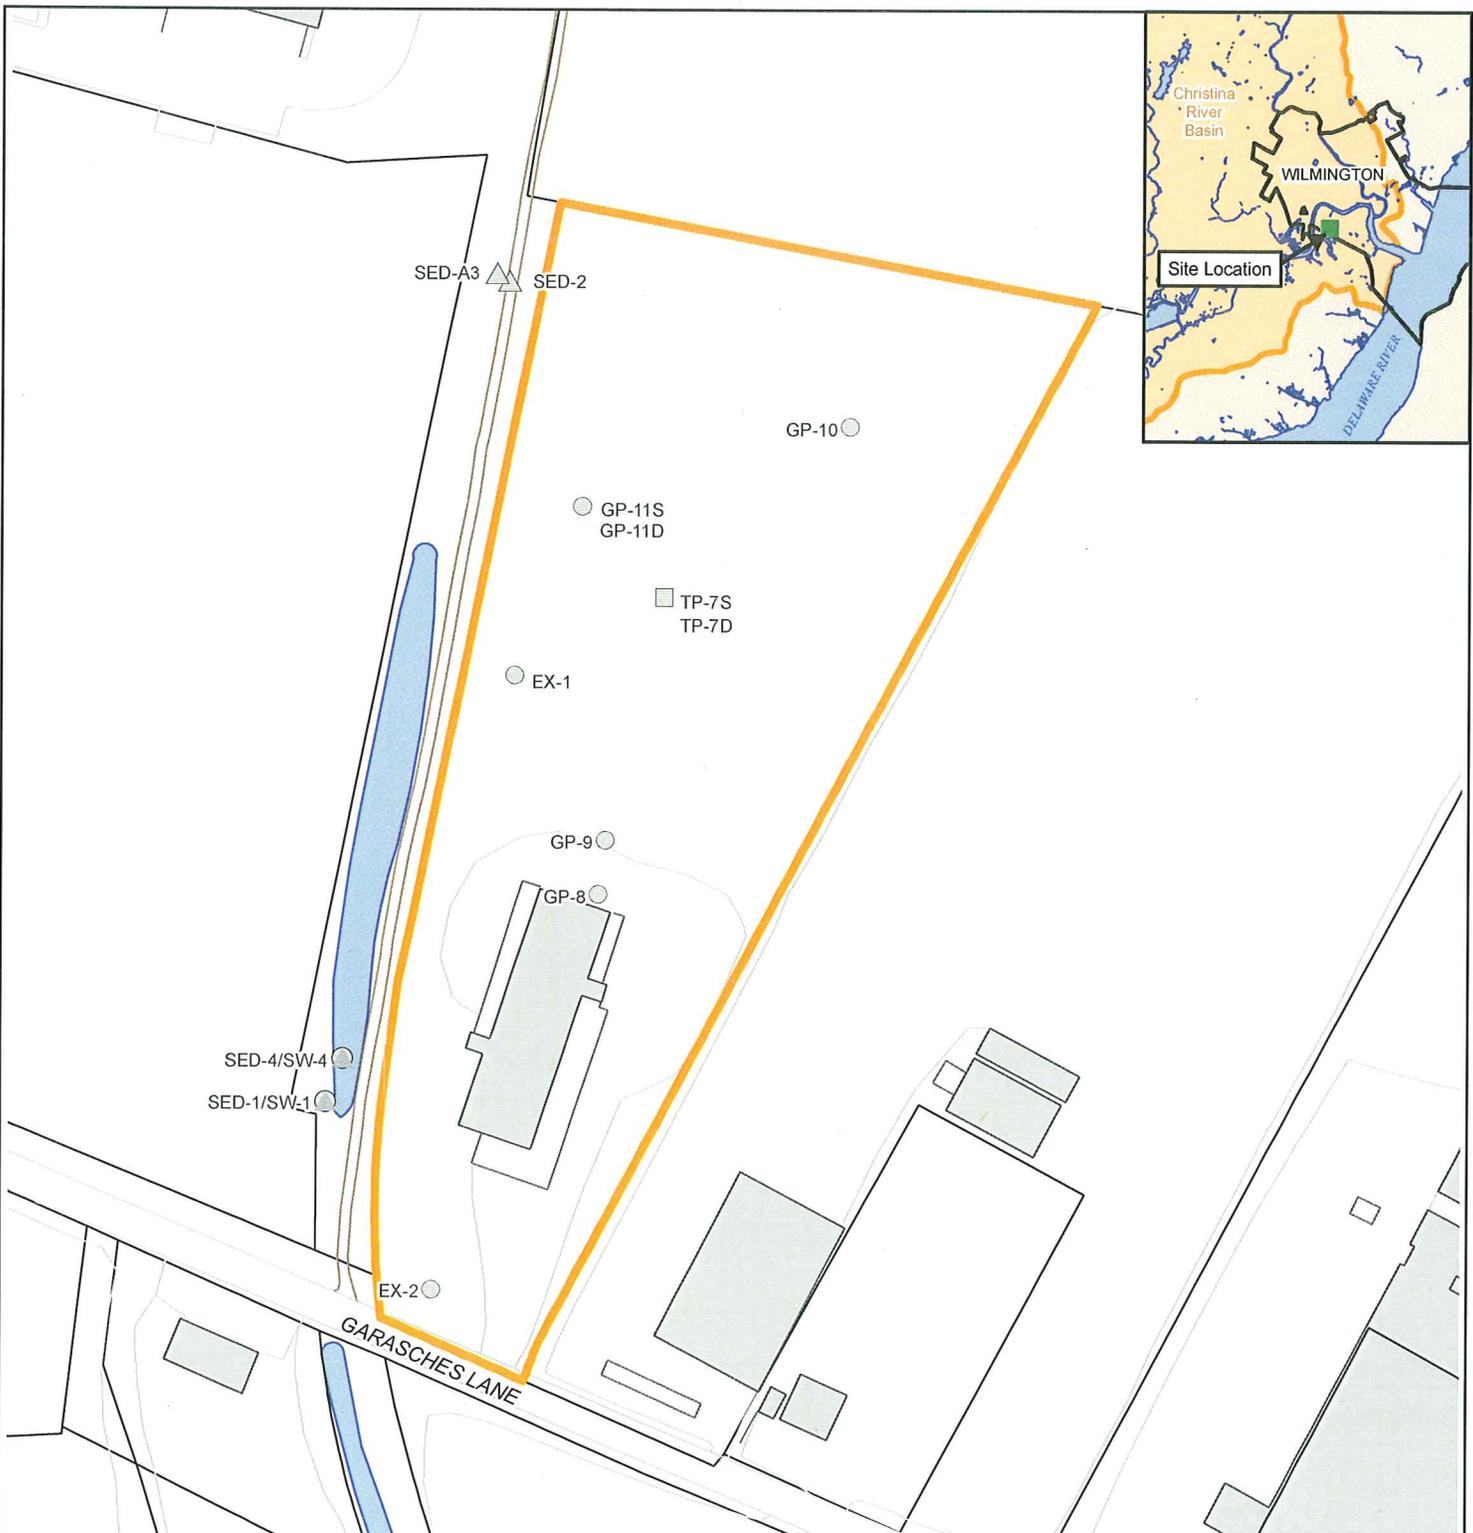
| PCB Distribution in Subsurface Unsaturated Soil Merkin Auto Wilmington, Delaware | | | | |

| Concentrations of PCBs on Site | | | |
|---|---|---|---|
| Subsurface Soil (unsaturated) | Figure 3 | None | Not Analyzed |

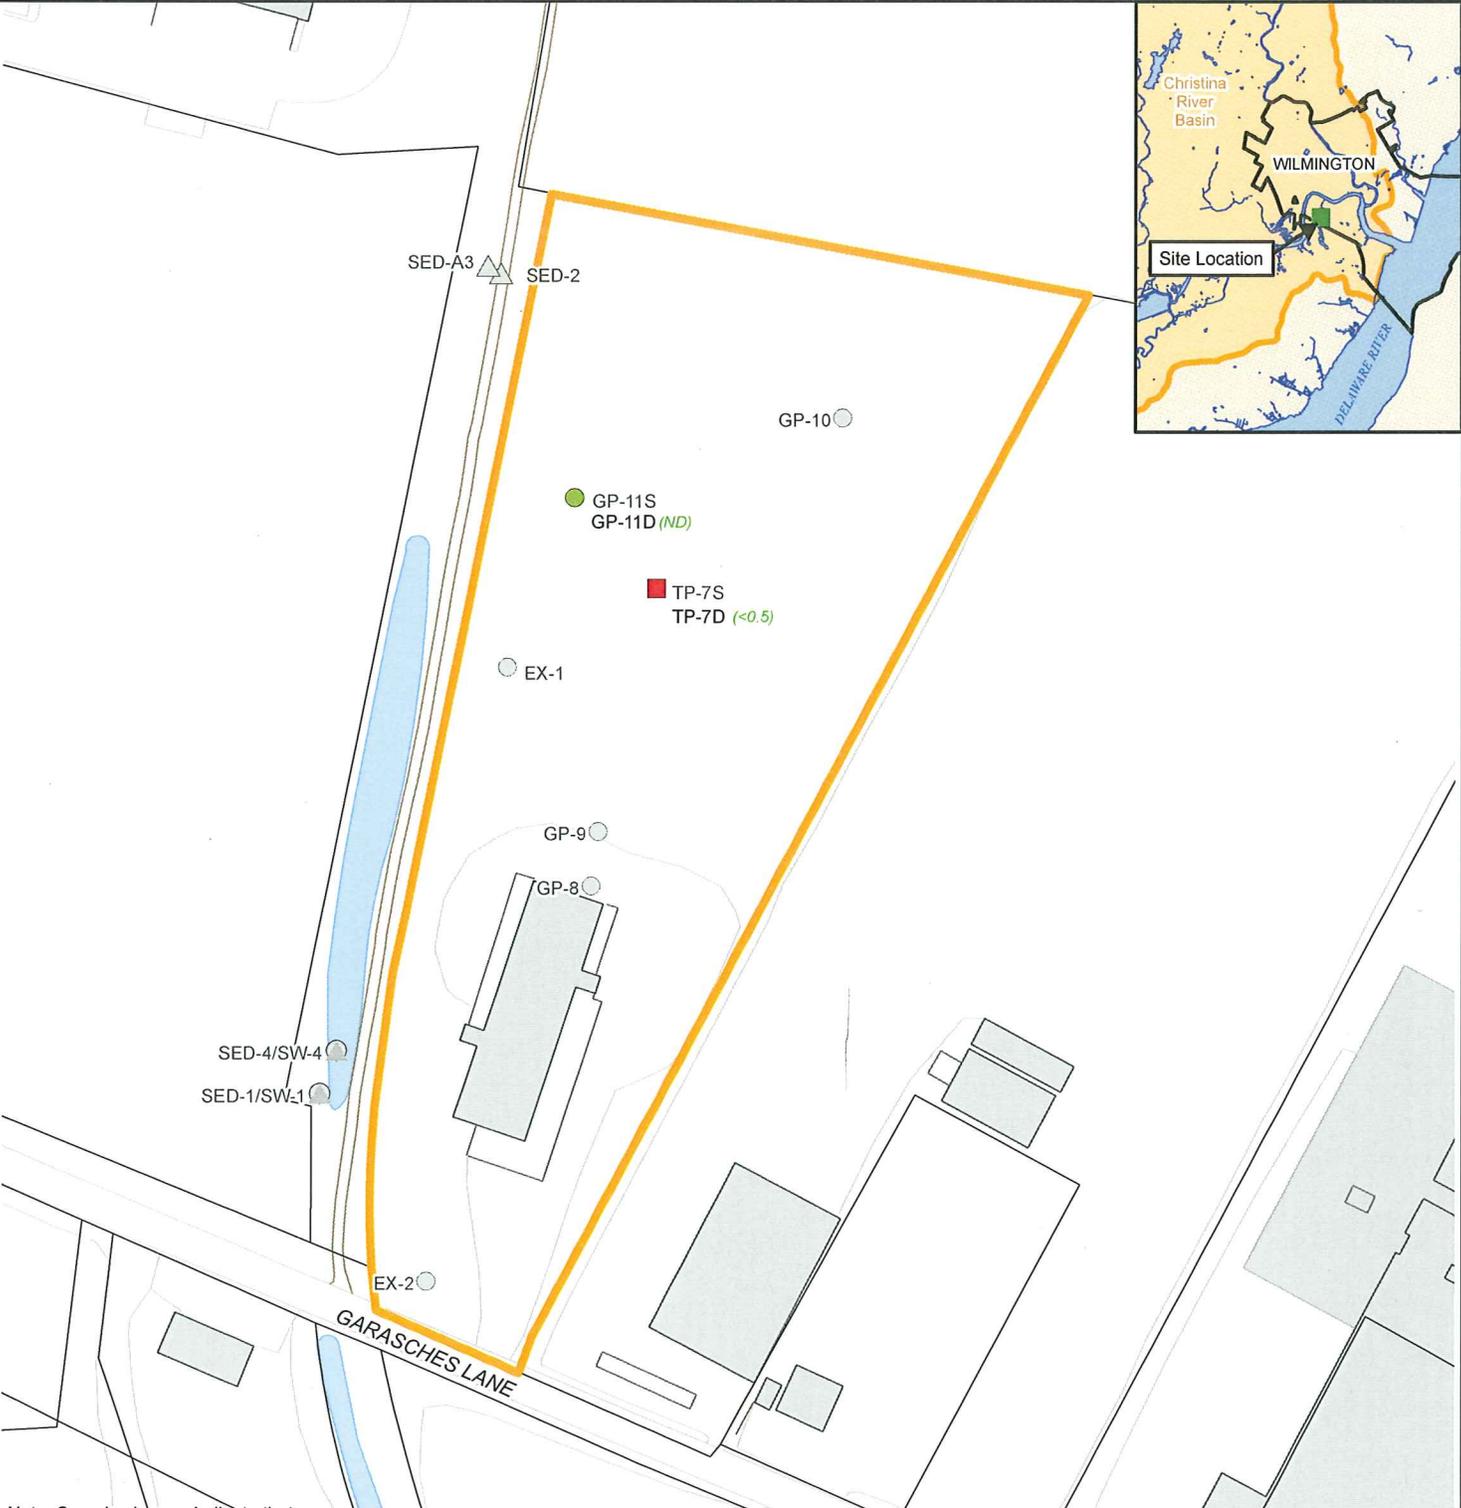
**PCB Distribution in Subsurface Saturated Soil
 Merkin Auto
 Wilmington, Delaware**

| Concentrations of PCBs on Site | | | |
|---|---|---|---|
| Subsurface Soil (saturated) | Figure 4 | Immunoassay Kits | Not detected |

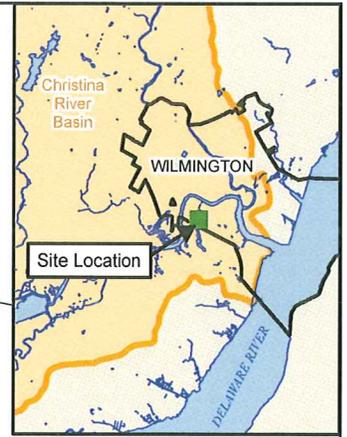
PCB Distribution in Groundwater
Merkin Auto
Wilmington, Delaware

A groundwater sample was collected from the GP-11 location and was analyzed for TCL, VOCs, TCL, SVOCs, and total metals. Iron and manganese were detected above their respective URS levels. All other parameters analyzed for were not detected or were below URS criteria.

| Concentrations of PCBs on Site | | | |
|---|---|---|---|
| Ground Water | Figure 5 | Method 8082 | Not detected |

A Memorandum of Agreement has been established by DNREC to restrict the use of groundwater in the area. No soil remediation is currently planned.

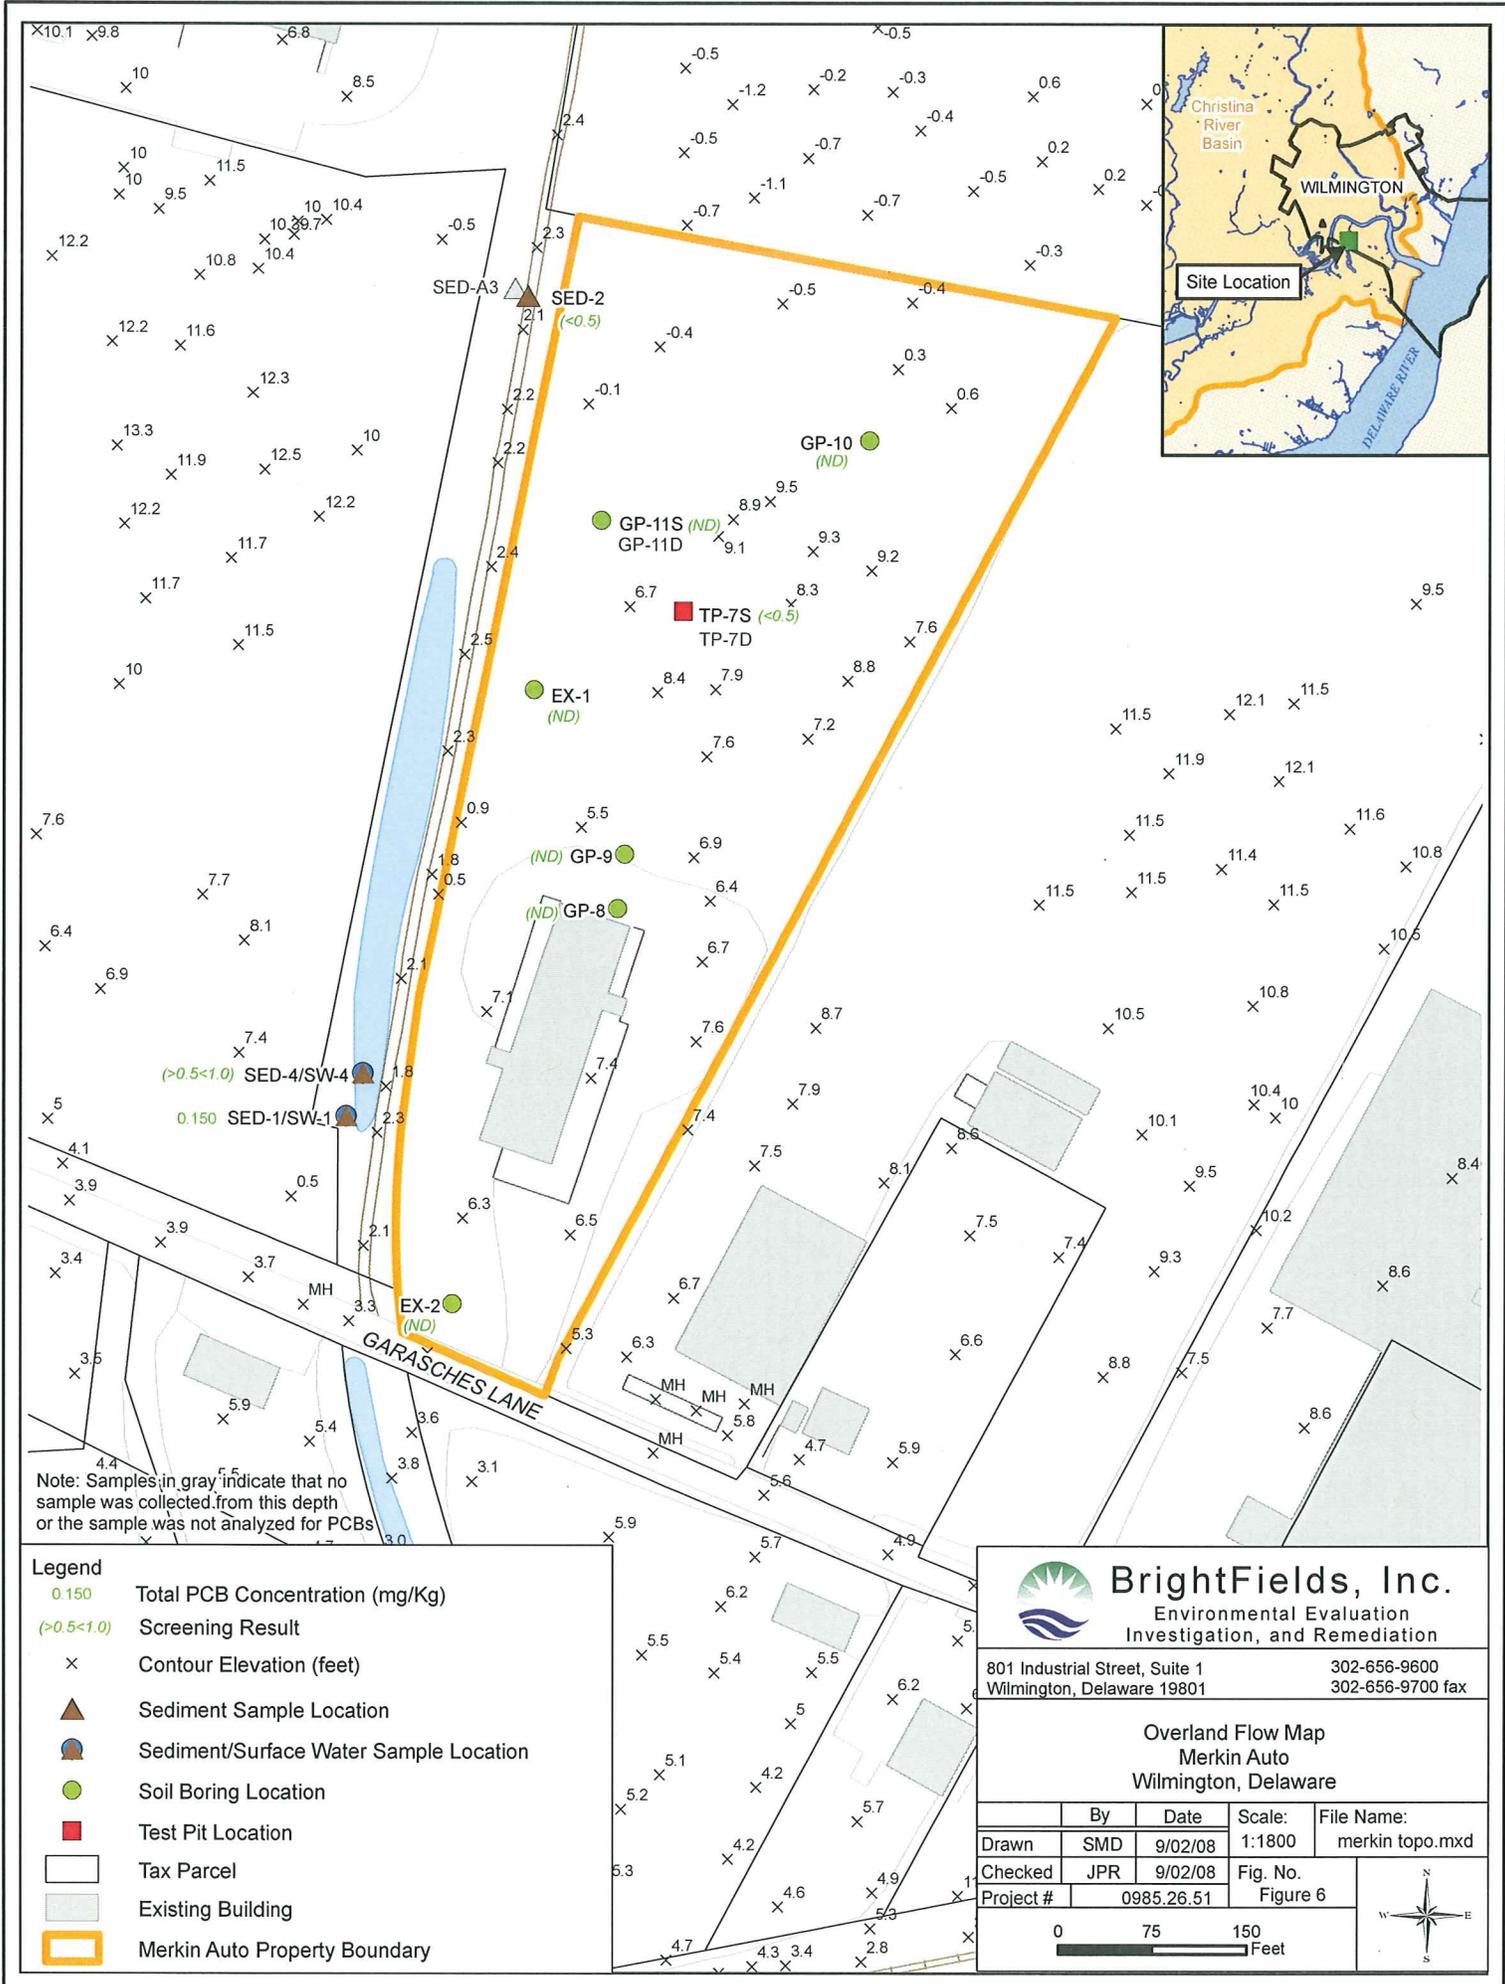
Overland Flow Map
 Merkin Auto
 Wilmington, Delaware

PCB mass loading calculations were not performed on the Merkin Auto Site due to the available PCB data indicate that there are no impacted areas. Groundwater and overland flow are not a mechanism of transport for PCBs on this site, since there are no reported concentrations of PCBs above the analytical procedure detection limit.

Based on the information available there is no potential for PCB impacted materials to be transported by overland flow processes.
