STRUCTURAL SURVEY

FORT DUPONT STATE PARK

GREDELL & ASSOCIATES
STRUCTURAL ENGINEERS

AUGUST 1993

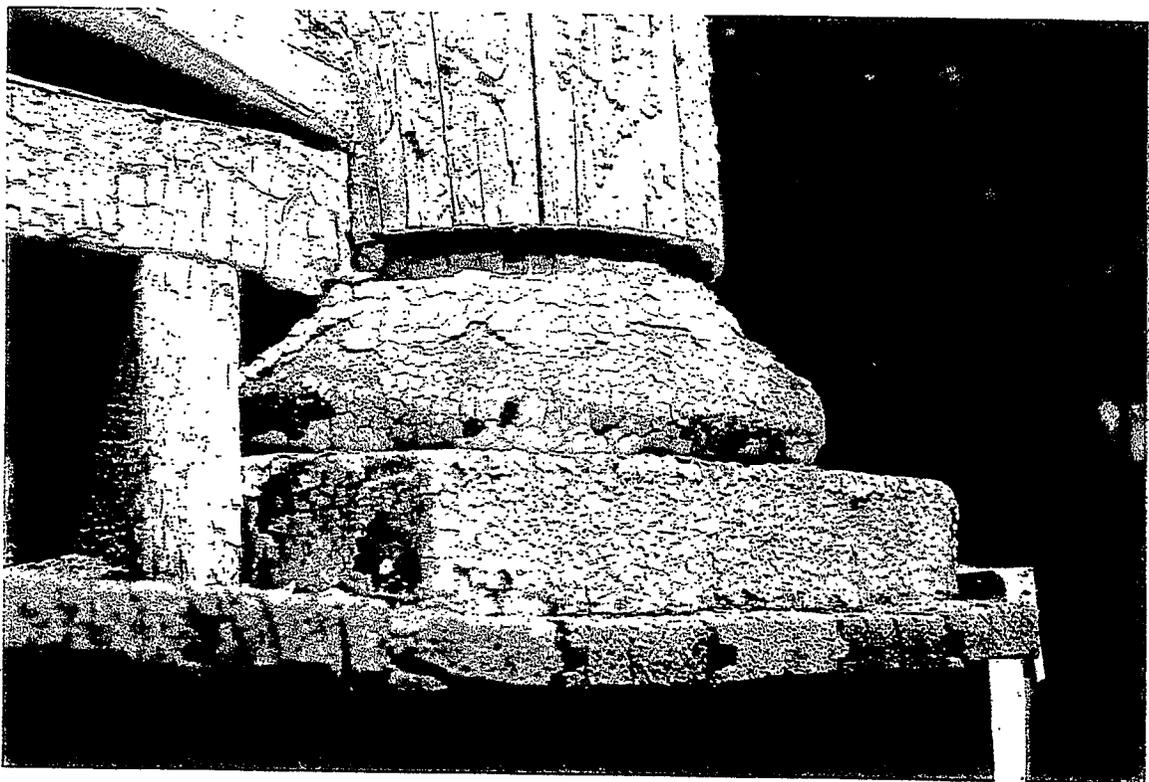
8

A majority of the porch decking is severely weathered with portions of the decking cupped and/or rotted. The porch framing at the outboard sections is deteriorated; especially at the post bearings.

See photos 6, 7, and 8. The porch stairs have several rotted/deteriorated treads and risers. See photo 7. At the front porch railing there is an accumulation of wood dust directly below the railing on the deck structure; evidence of an active infestation of wood boring insects (probably carpenter bees). See photos 9 and 10. The porch skirting frames are broken and cracked at several locations. See photo 6. The interior floor framing is in relatively good condition. There were no indications of structural distress.

The paint on the front porch is in extremely poor condition. See photo 8. The window trim, soffits, and fascia require stripping and repainting. It is highly probable that the existing paint is lead based, which will require special removal and disposal considerations. The rear deck requires repainting.

4. Replace front porch railing, decking, and deteriorated stair treads and risers.
5. Restore front porch skirting to allow for access below porch and to prevent access by unwanted animals.

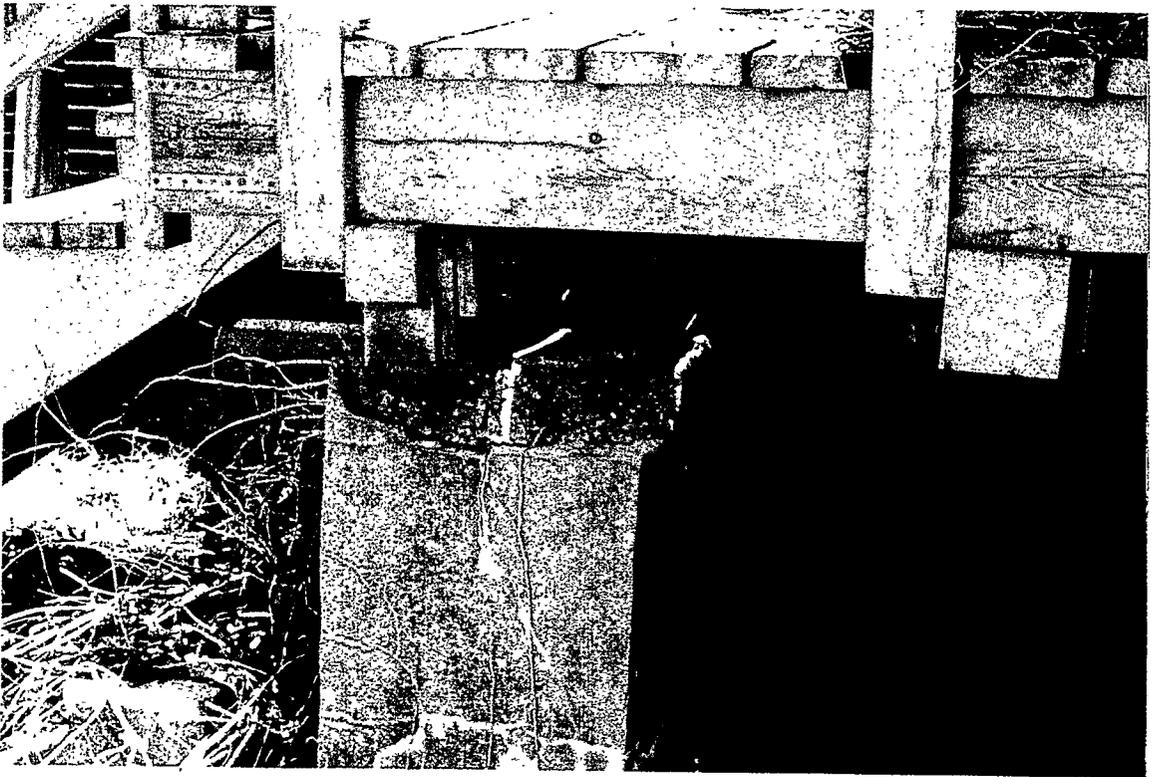
16

The concrete step located at the bottom of the front porch stairway is severely deteriorated due to freeze/thaw damage. See photos 7, 15 & 16. There are three piers supporting the rear deck that exhibit loose, spalled concrete which requires repair.

1. Repoint exterior walls. (Approximately 100 sq. ft. req'd.)
2. Repoint front porch piers.
3. Remove deteriorated concrete at porch step landings. Provide similar repairs at rear deck piers.

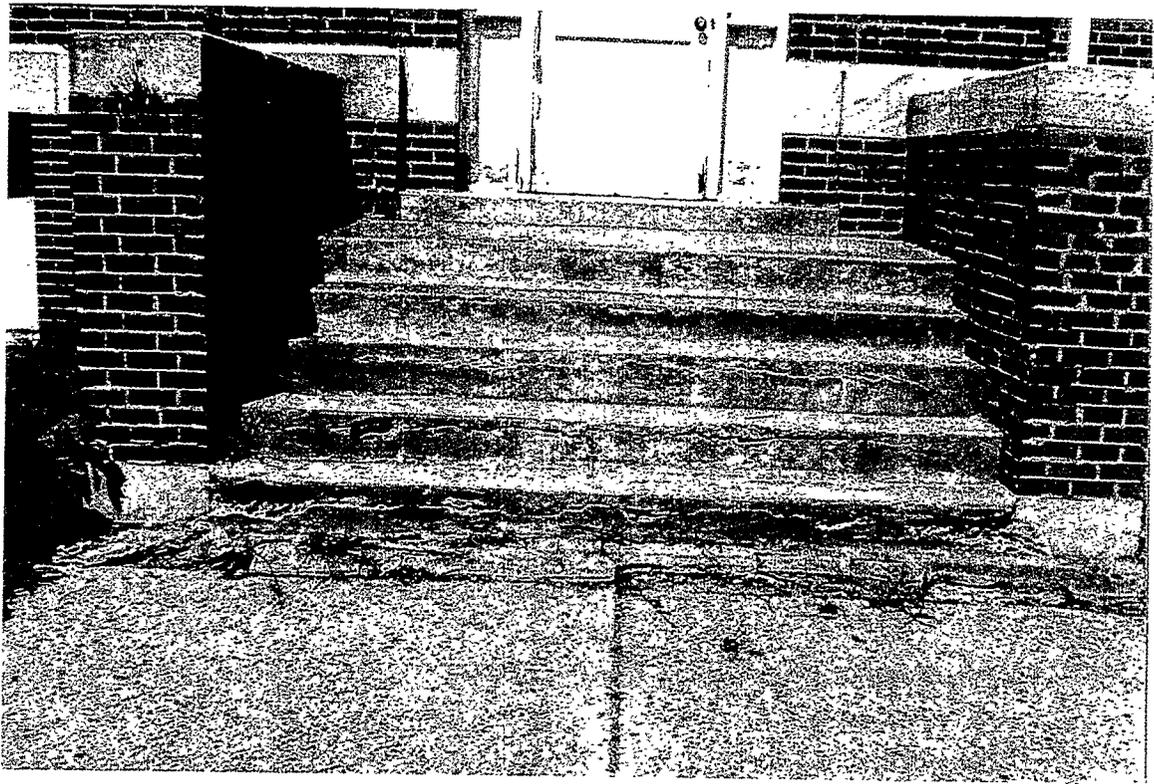
8

The concrete steps at the front entrance suffer from freeze/thaw damage and are cracked and spalled. See photo 8. The areaway steps are in similar condition.

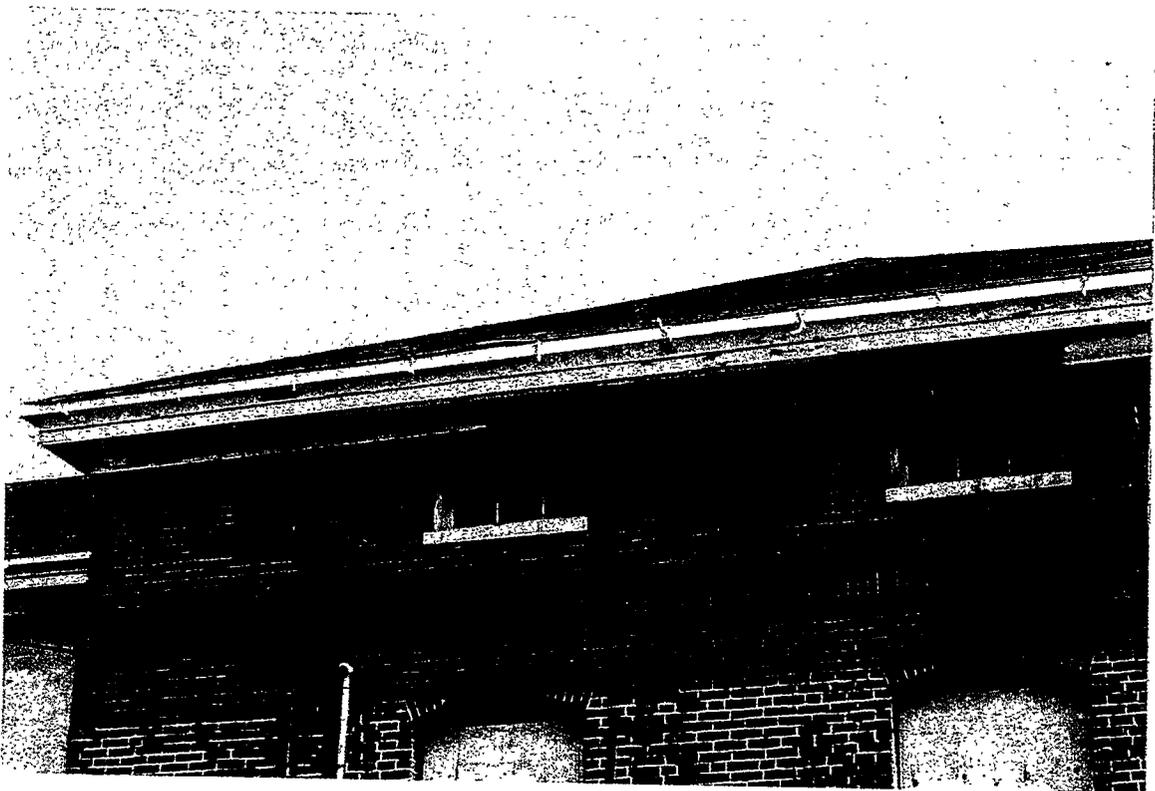
13

The cornice molding, fascia and soffit are rotted and deteriorated at several locations. See photo 12 and 13. All exterior wood trim, doors and windows require stripping and repainting. We suspect that the existing paint is lead based. Portions of the front door are missing and is need of paint and caulking. See photo 8. At the exterior gymnasium door, the head molding is missing exposing the wall cavity to the elements.

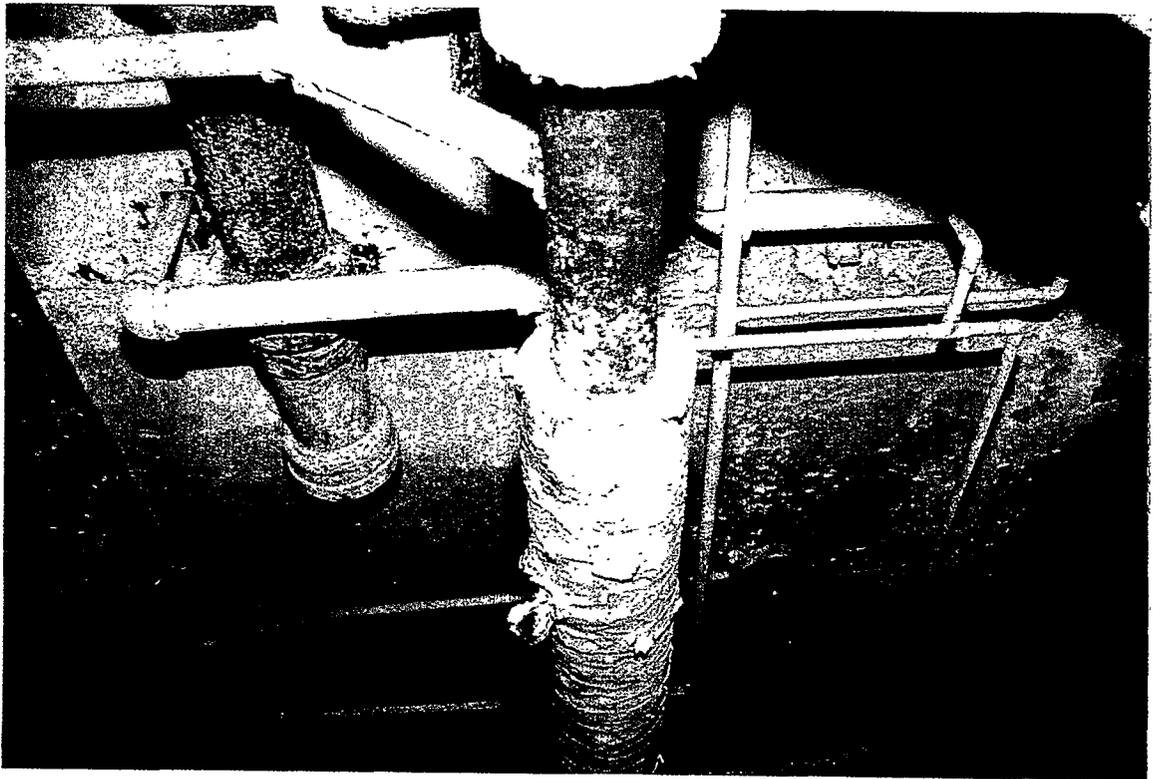
15

The gym is occupied by office furniture, chairs, desks and mattresses. Suspected asbestos insulation was found on many exposed pipes in the basement ceiling. See photo 15.

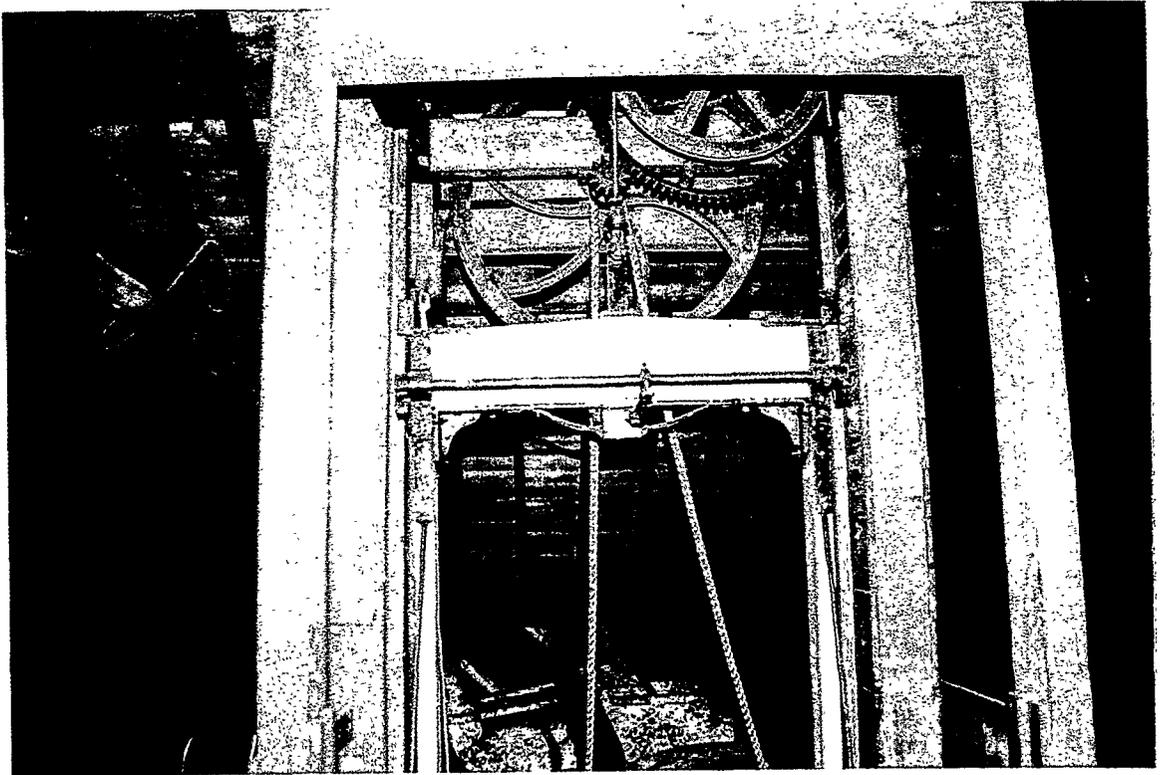
16

Interior paint is peeling, a result of inadequate ventilation and heating. Piping in first floor ceiling has suspected asbestos insulation. See photo 17. There is an original freight elevator which we understand is operable which is located near the center of the building. See photo 16.

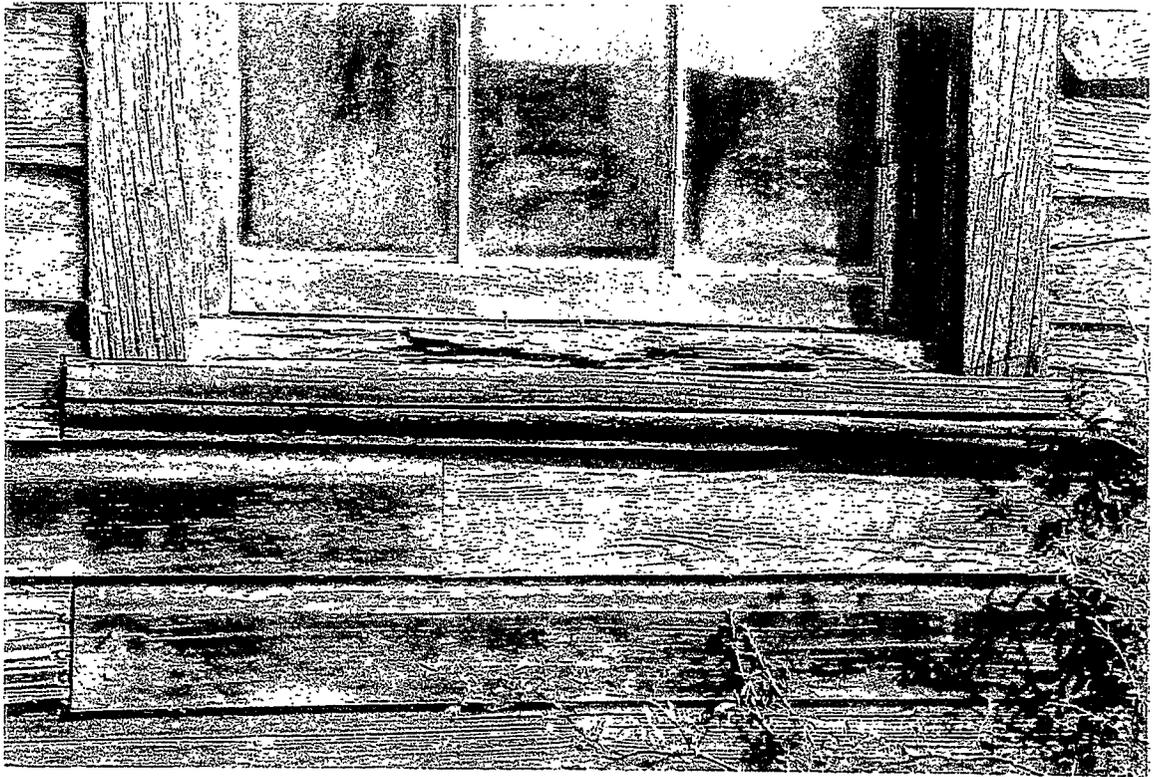
Approximately 50% of the windows are in need or repair. Many of the frames and sash are rotted. See photos 5, 16 & 22. The overhead door at the end of the longer building requires replacement. The adjacent windows need complete replacement. See photos 5 & 22. Along the courtyard side of the east building, towards the rear, a set of doors are bound shut. The door sill here is rotted. See photo 11. Adjacent to the rotted areas at the rear of the east building, the exterior doors are blocked by an oil line running from the tank outside. See photo 30.
