## **Appendix 21**

# **NECASTRO AUTO SALVAGE PROPERTY WILMINGTON, DELAWARE**

**SIRS ID: DE-0283**

PCB Mass Loading Phase II  
Necastro Auto Salvage Property  
SIRS ID: DE-0283  
Wilmington, Delaware

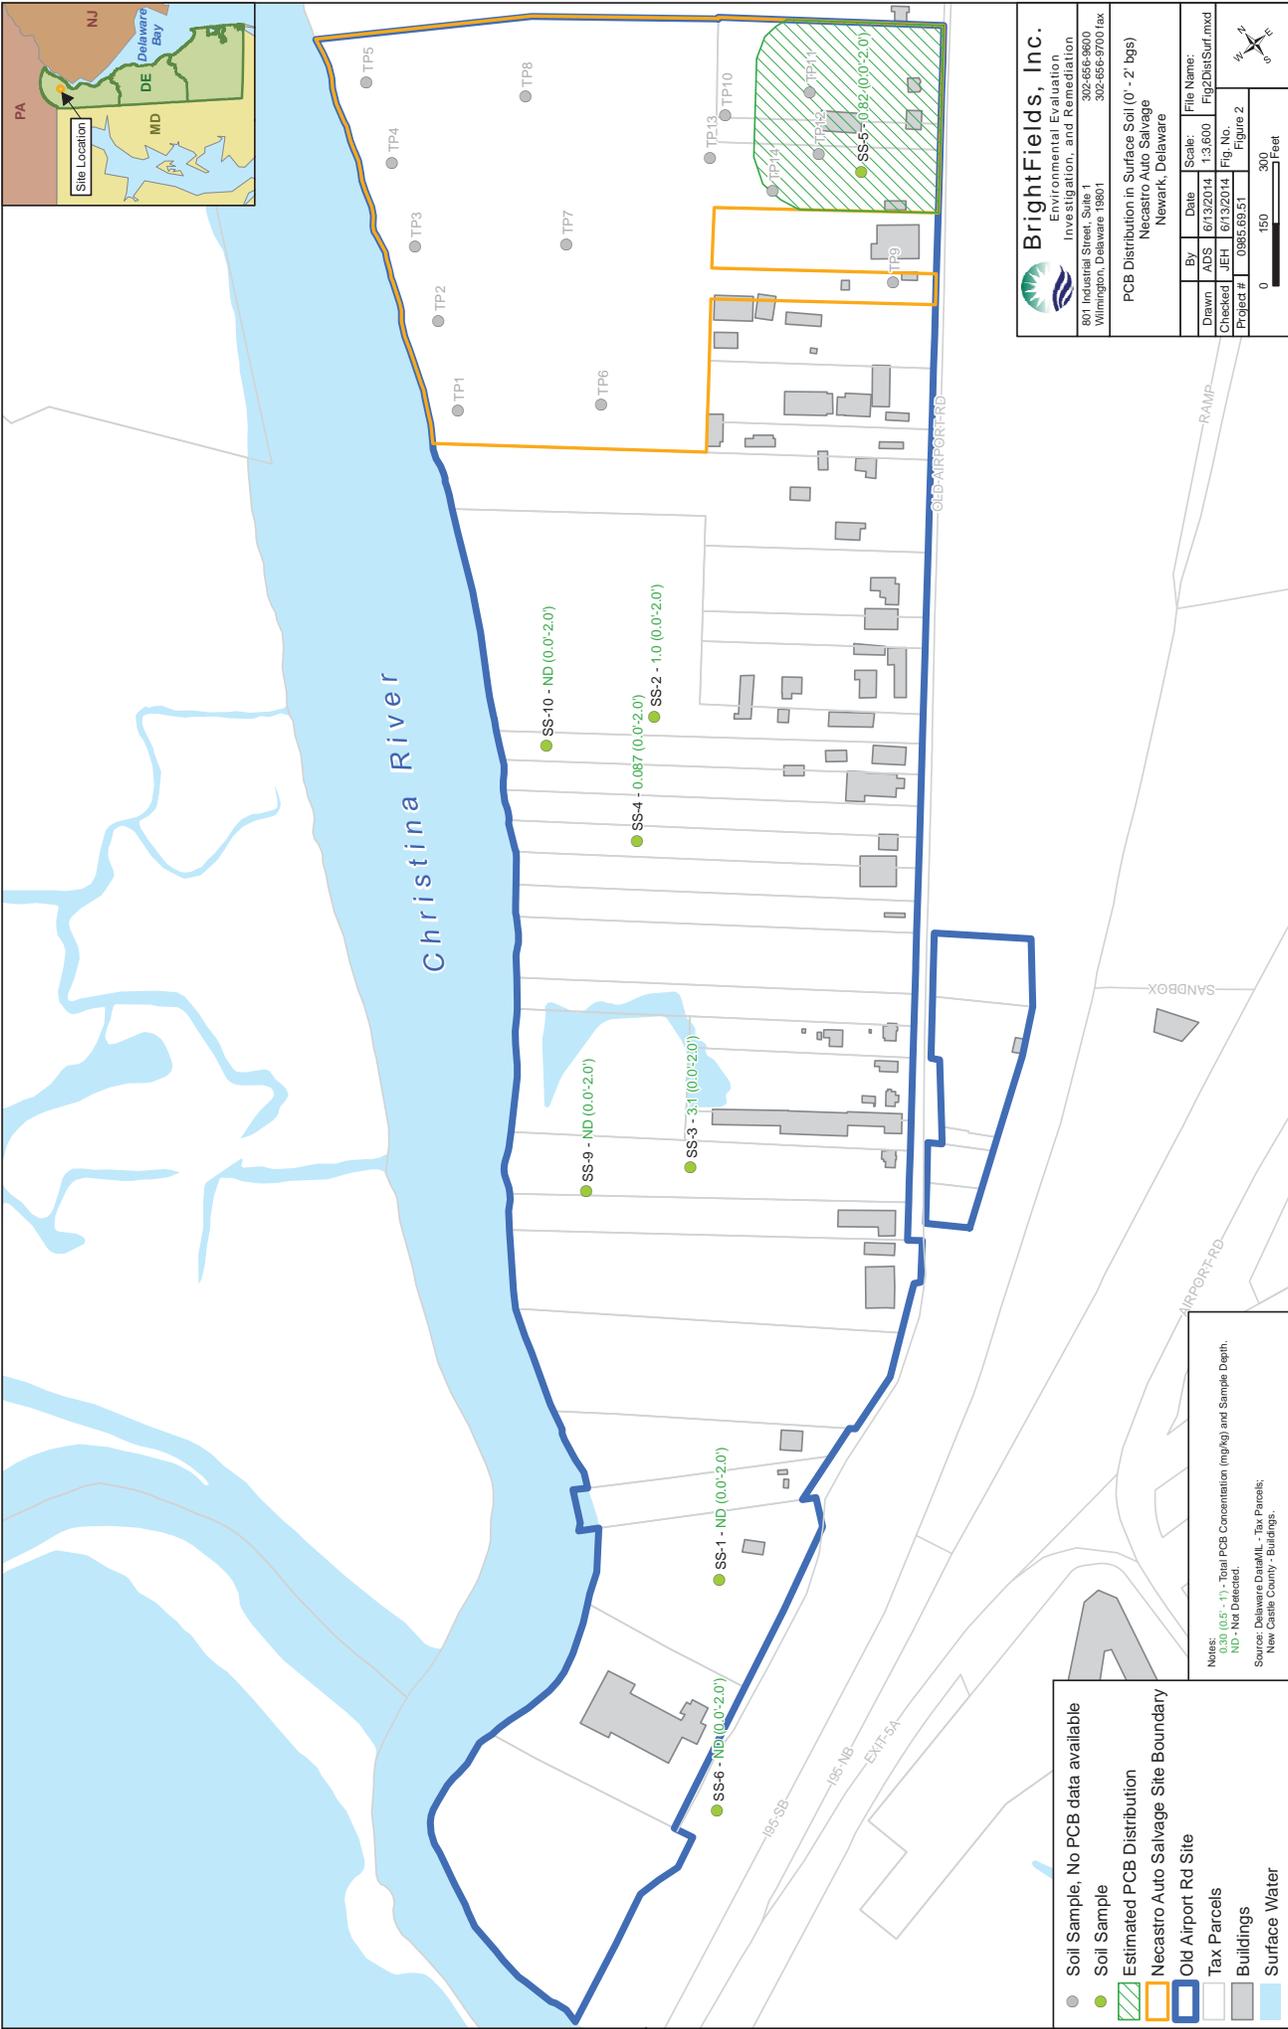
PCB Distribution in Surface Soil (0' - 2' bgs)  
 Necastro Auto Salvage  
 Newark, Delaware

PCBs were detected in the surface soil at four locations, with concentrations ranging from 0.087 mg/kg (SS-4 from 0 to 2.0 feet below ground surface (bgs)) to 3.1 mg/kg (SS-3 from 0 to 2.0 feet bgs). PCBs were detected in subsurface unsaturated soil at two locations, TP-5 (7 feet bgs) and TP-4 (7.0 feet bgs), at concentrations of 0.066 mg/kg and 0.15 mg/kg, respectively. No soil samples were analyzed for PCBs in the saturated subsurface soil.

The estimated surface soil area impacted by PCBs is 4.58 acres (Figure 2). The estimated subsurface unsaturated soil area impacted by PCBs is 4.58 acres (Figure 3). According the data reviewed and analyzed by BrightFields, no saturated subsurface soil samples were analyzed for PCBs so the respective area impacted by PCBs cannot be determined. Based on the data

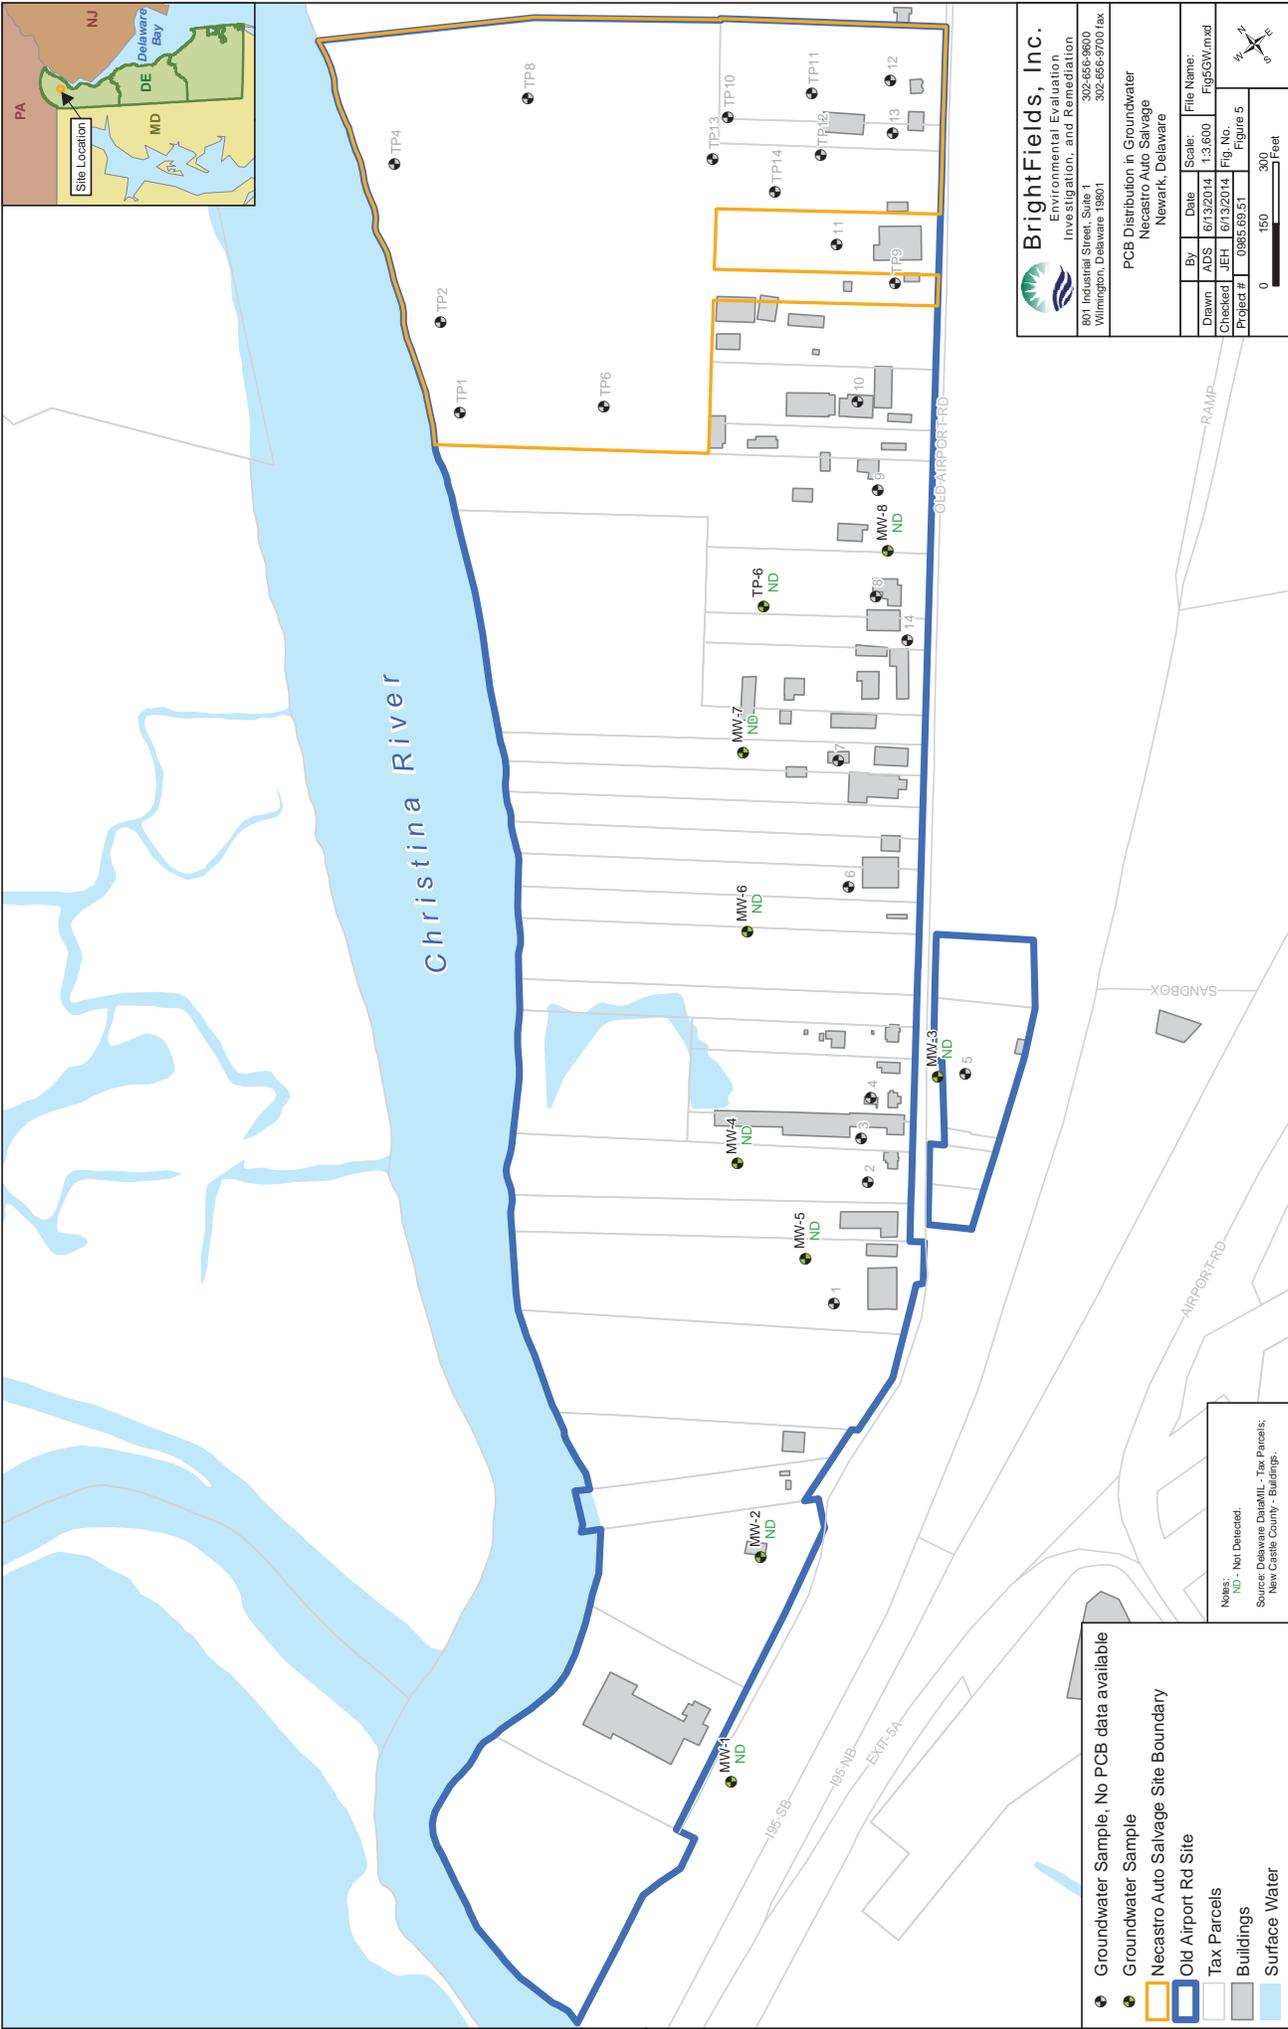
**PCB Distribution in Groundwater  
 Necastro Auto Salvage  
 Newark, Delaware**

reviewed and analyzed by BrightFields, the groundwater is not impacted by PCBs. Therefore, no groundwater loading estimates were prepared for the site.

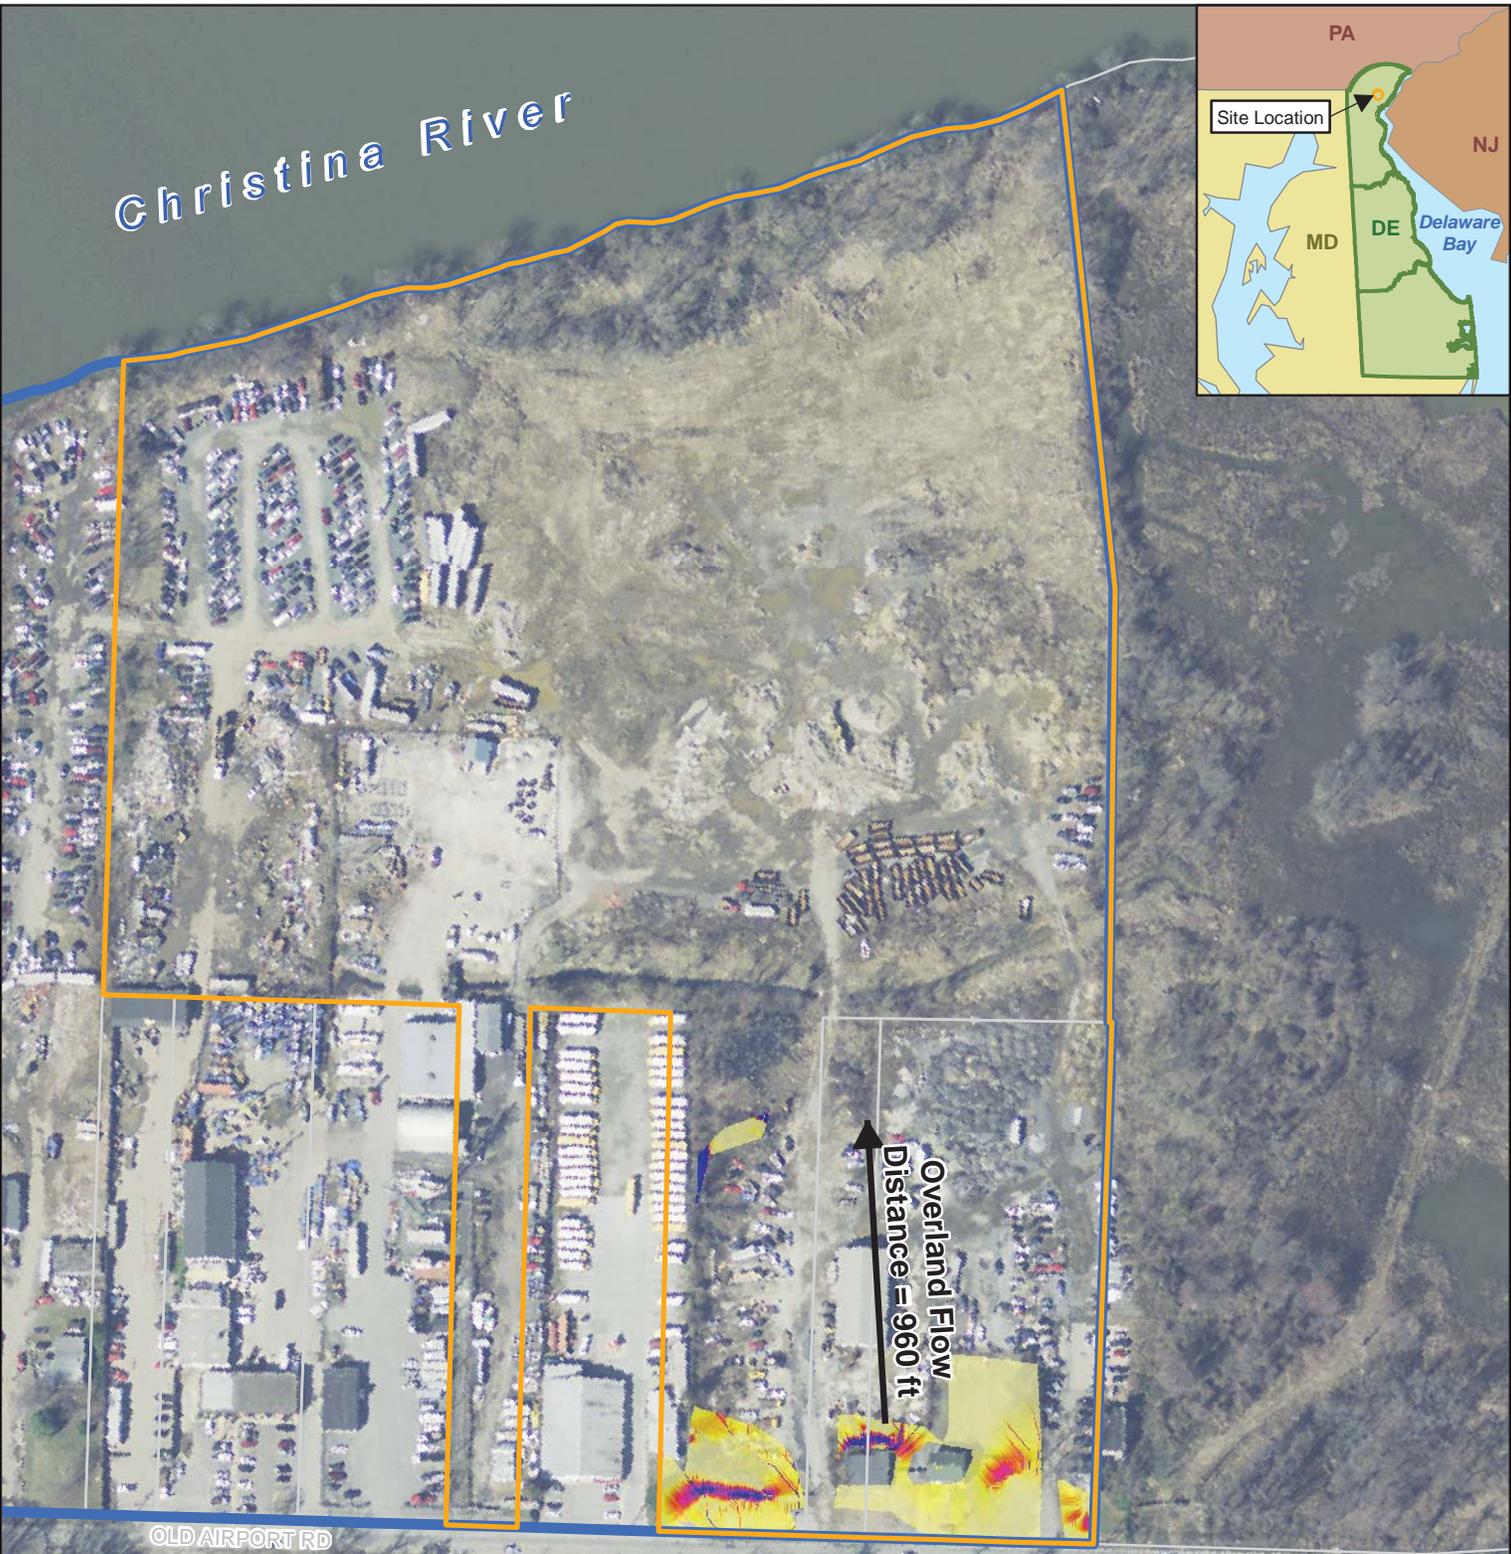
Soil Loss Estimates  
Necastro Auto Salvage  
Newark, Delaware

P = support practice factor (dimensionless)	1	No documentation was provided indicating that any sediment and erosion controls are in place.
A = average annual soil loss estimate (ton/ac-yr)	0.77	The average soil loss estimate was generated by ArcGIS using the input factors listed above.
Erodible Area (acres)	1.0	The erodible area was calculated based on the pervious surfaces within the area of concern polygon for surface soil (Figure 6).

The total estimated PCB loading via overland flow for the Necastro Auto Salvage Property is **2.2 grams per year**. Please see attached table for specific variables.

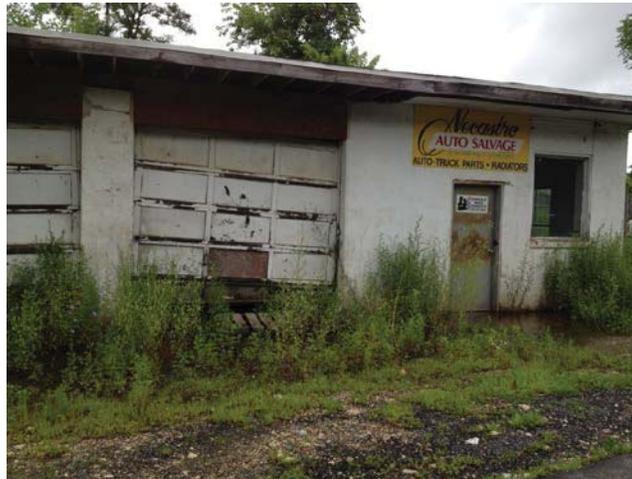
Building at the entrance to the site surrounded by overgrown weeds.

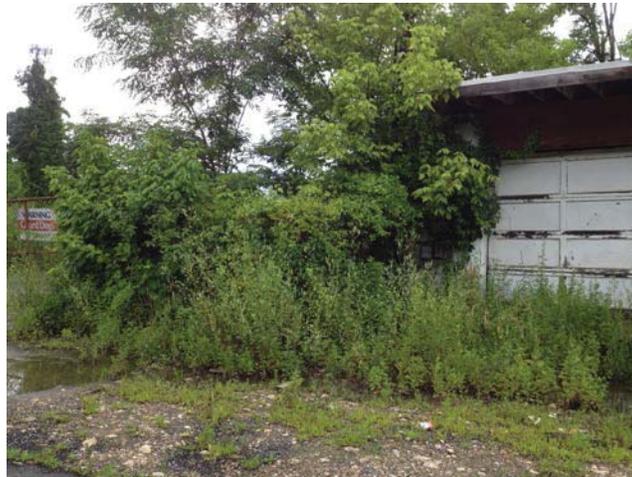
Vegetation lining the eastern corner near the site entrance.

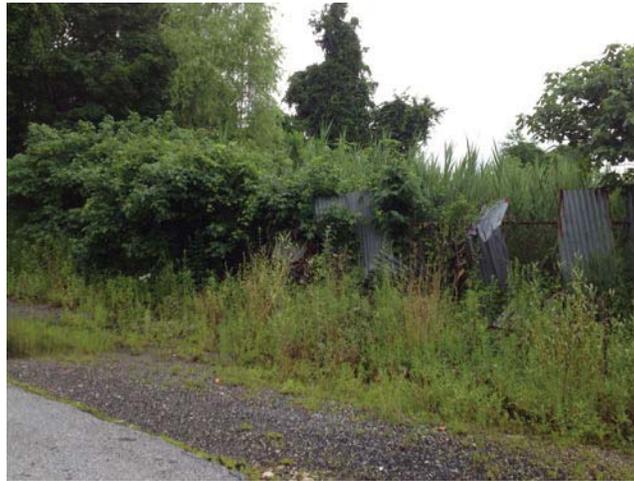
The southern property boundary with tall grasses, weeds, and trees lining the property's fence.

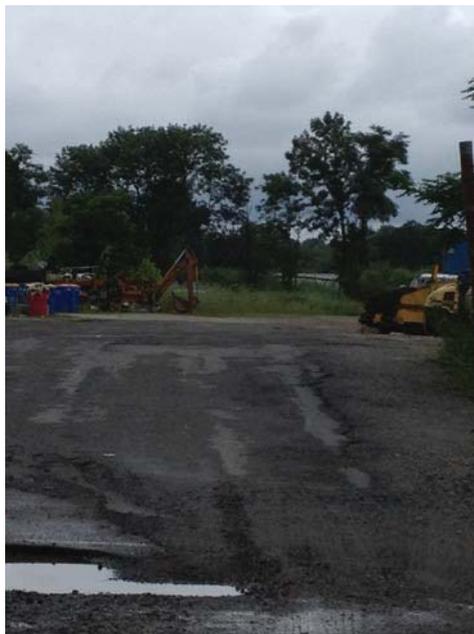
Looking into the site from the eastern corner with a tree line in the distance.
