APPLICATION FOR A COASTAL ZONE ACT PERMIT

Name: **Tapeta™ Footings, Inc.**
Address: **102 Piney Creek Lane**
North East, MD 21901

SOUTH WILMINGTON SPECIAL AREA MANAGEMENT PLAN

SUMMARY REPORT

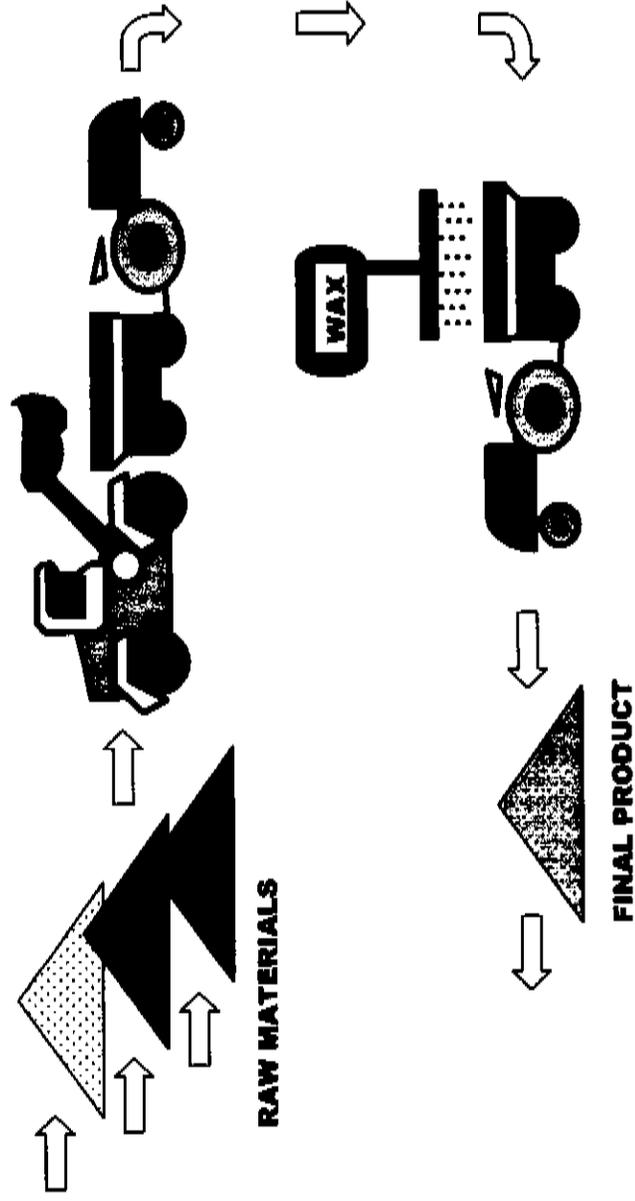
FLOW DIAGRAM

TAPETA™ MANUFACTURING PROCESS
