# **Current Developmental Trends in the Tidal Wetlands of the Delaware Estuary**

**Kurt R. Philipp<sup>1</sup>, Richard. T. Field<sup>2</sup>, Andrew Homsey<sup>2</sup>, and Young-Heon Jo<sup>2</sup>**

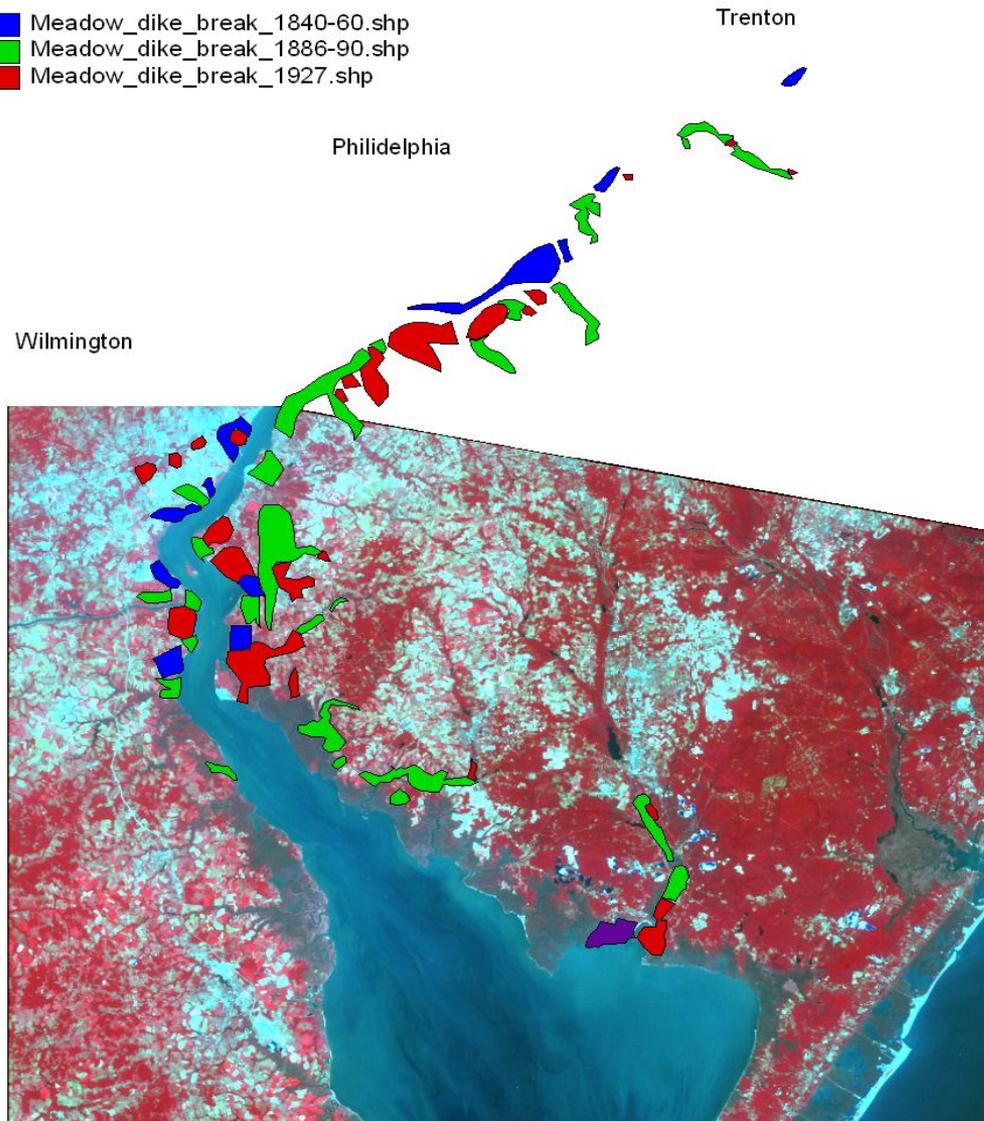
# Diked Meadow Failure Date

- Meadow\_dike\_break\_1840-60.shp
- Meadow\_dike\_break\_1886-90.shp
- Meadow\_dike\_break\_1927.shp

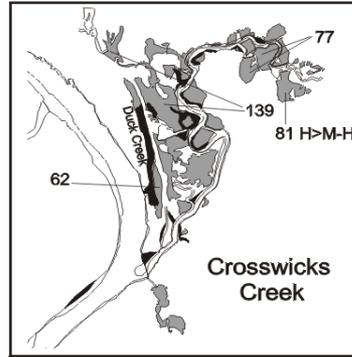
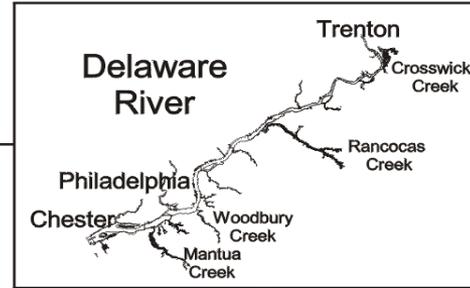
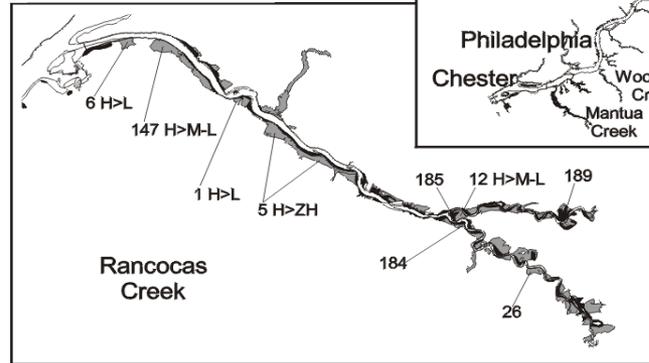
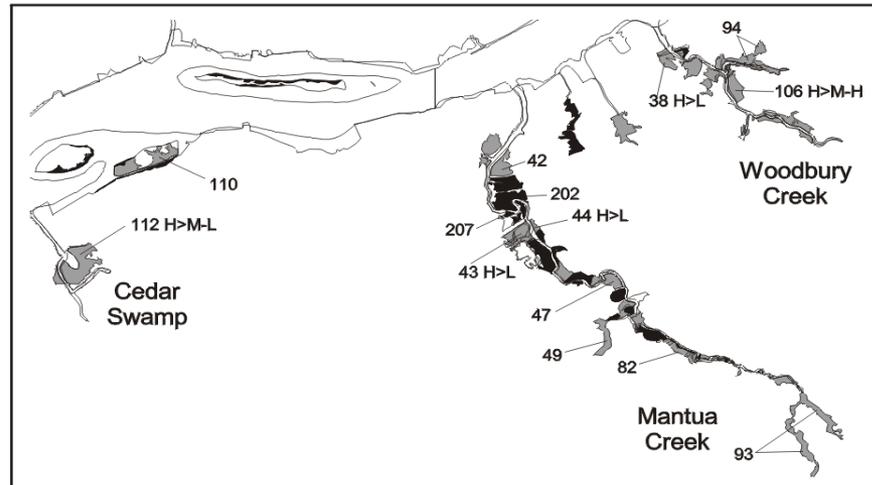
From 1978 to 1998, low marsh increased from 29% to 32% of all Delaware River fresh water marsh.

## Low and High Marsh Areas of Freshwater Tidal Marsh

for Selected Tributaries of the Delaware River

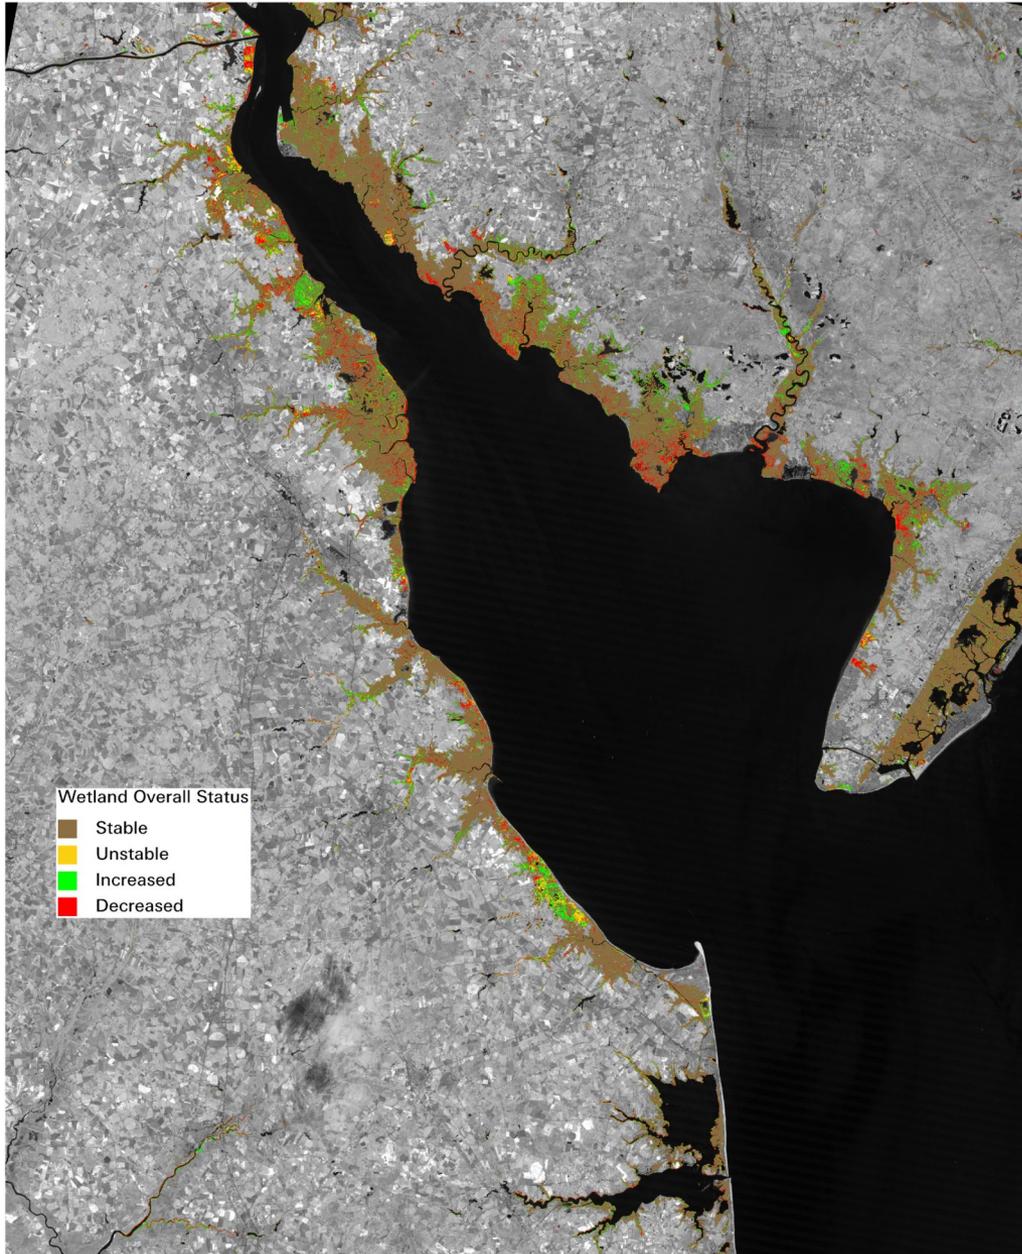
Delaware Bay Wetland Status (1984-1993)

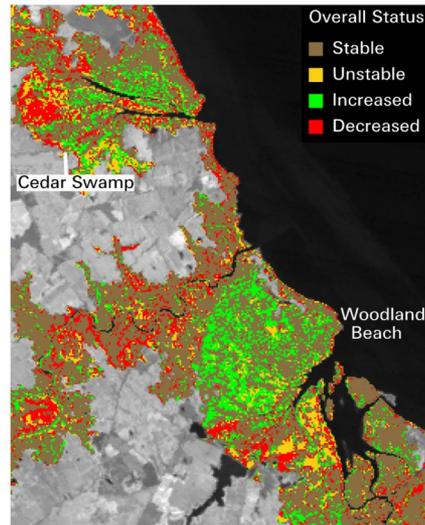
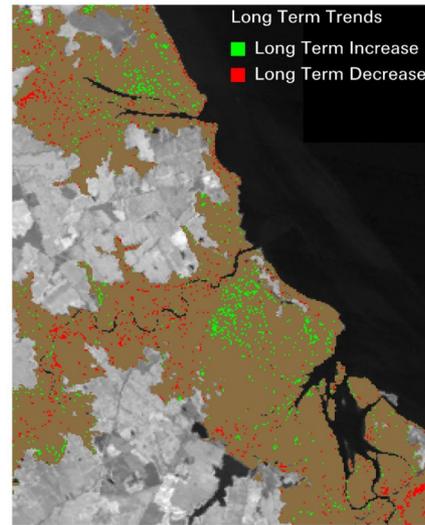
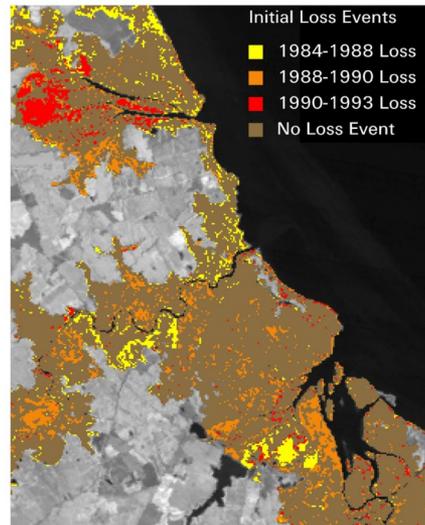
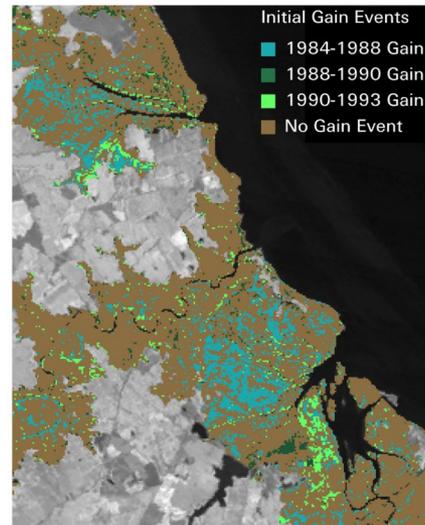
### Cedar Swamp and Woodland Beach Area

Here changes are attributable to Phragmites management intervention.

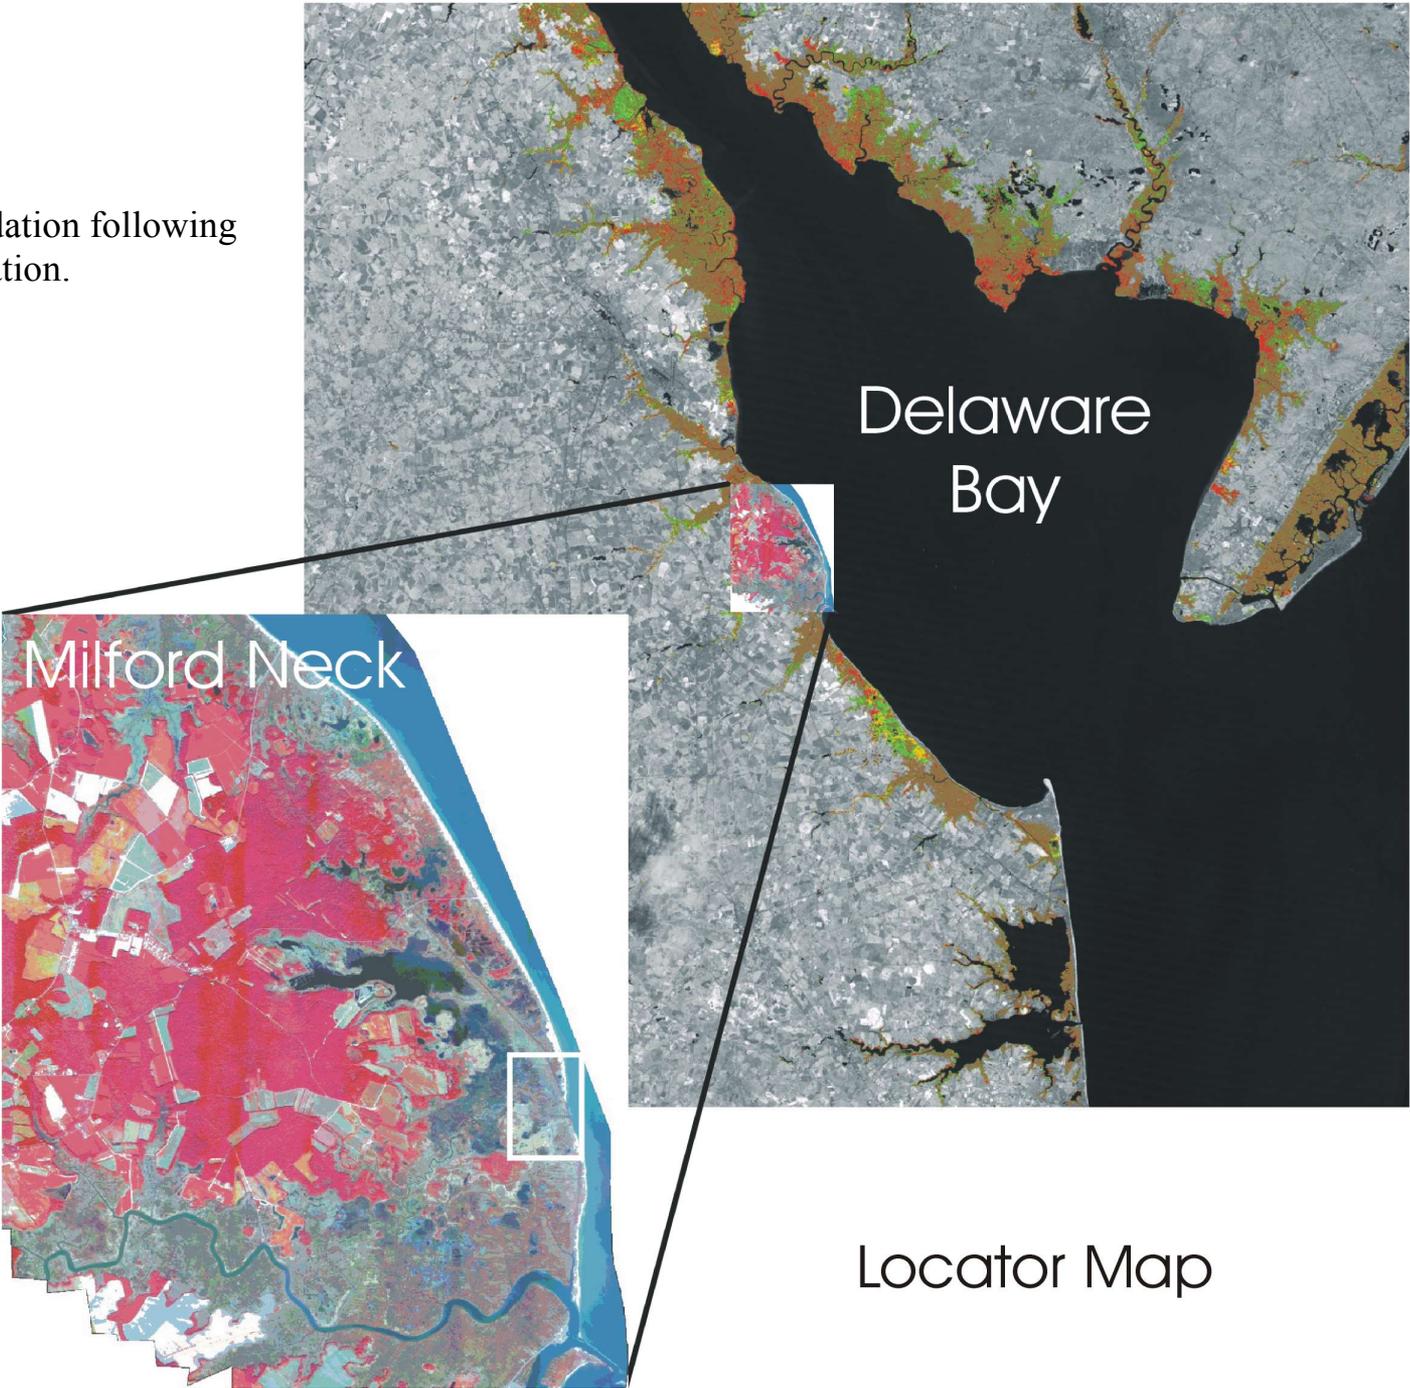
A case of inundation following sediment starvation.

2007 Orthophoto showing sediment accumulation and obstruction at the breach.

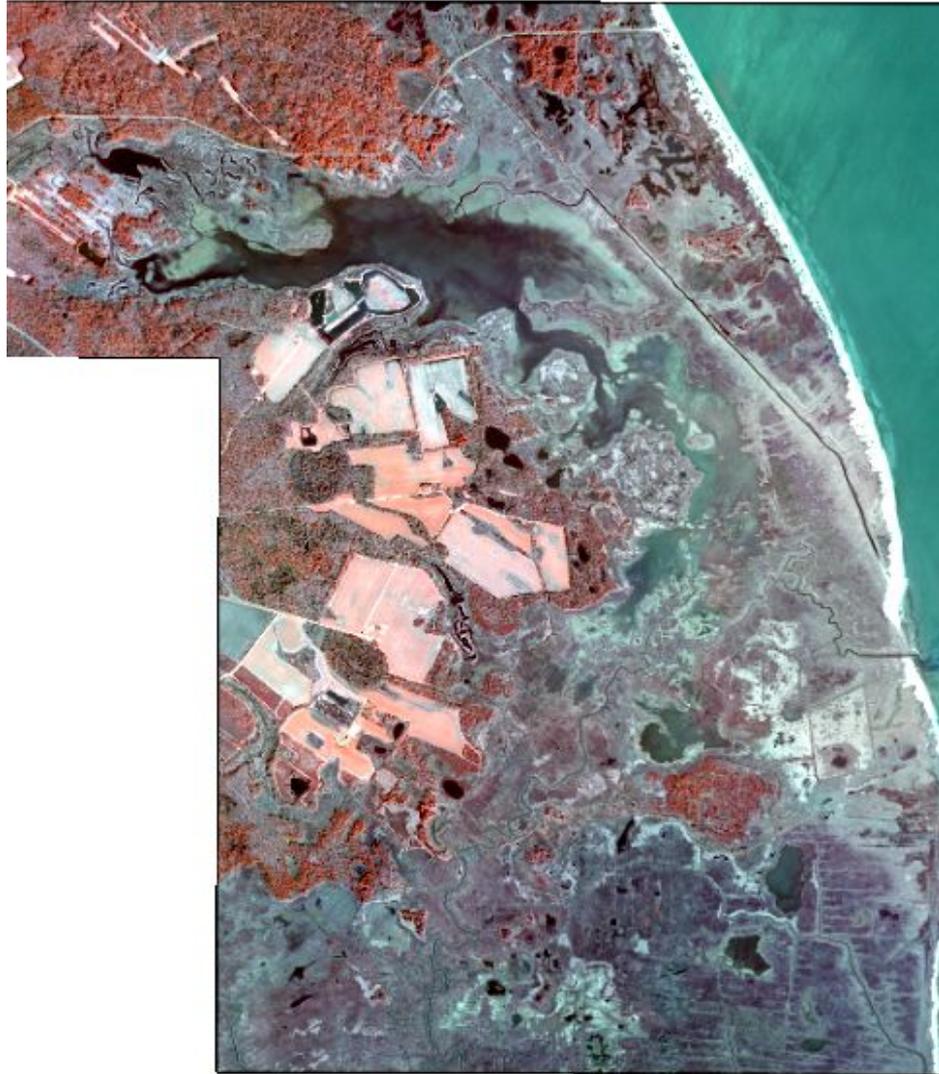
Note northern  
vz southern  
channels.

Construction of Grecos Canal  
reduced sediment nourishment  
of the marsh interior.

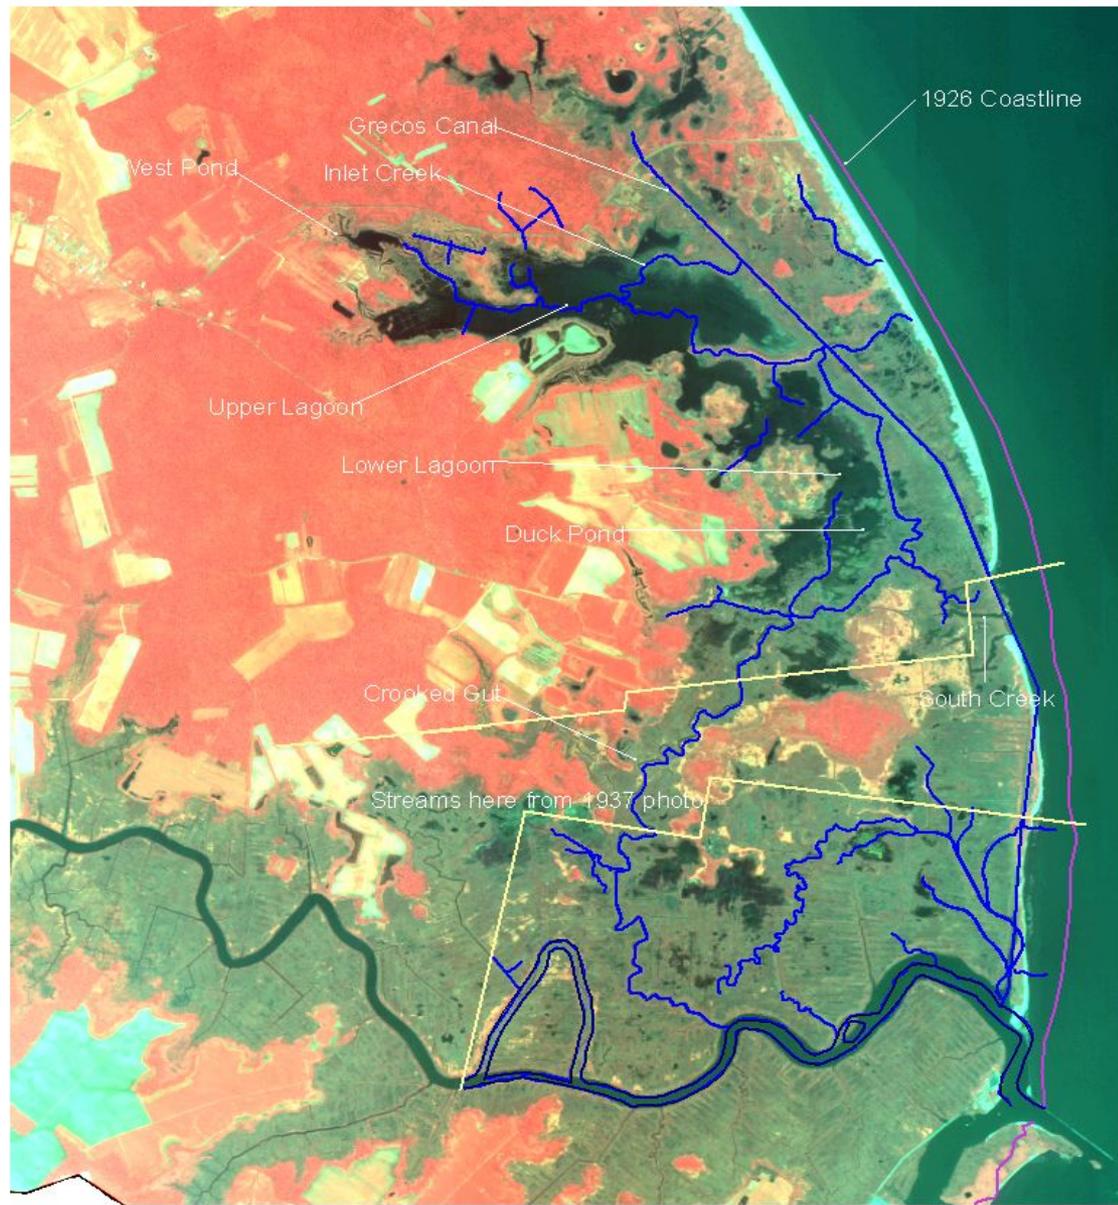
**Figure 1**  
 Milford Neck  
 1926 Coastline and Water Courses  
 Overlay on Enhanced 2004 IKONOS

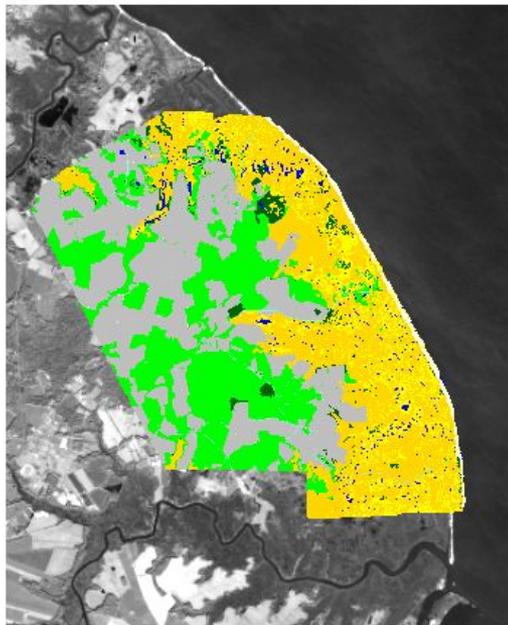
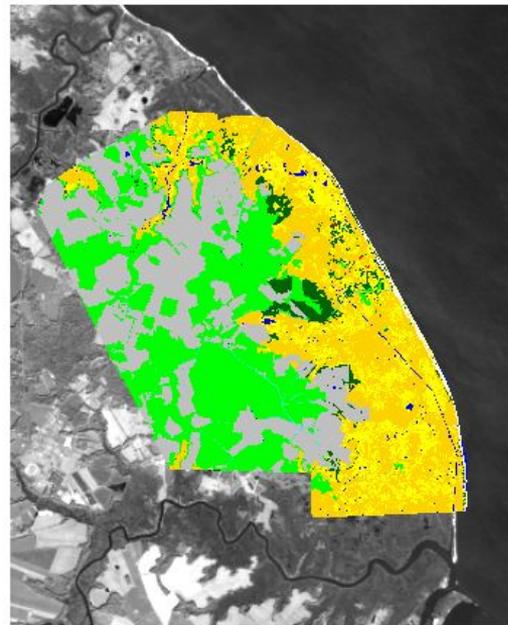
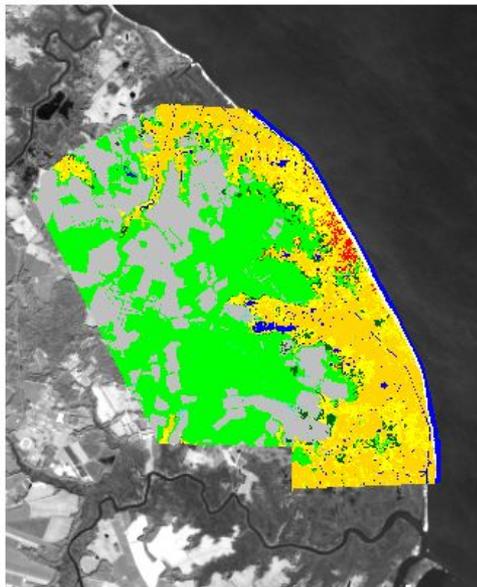
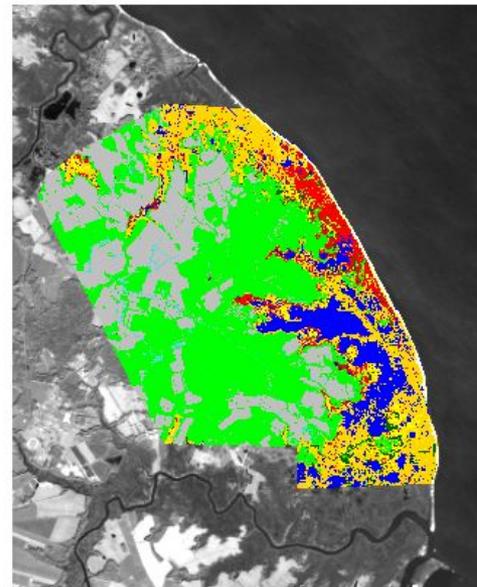
Vegetation trend shows drying after ditching, followed by gradual wetting, then inundation and Phragmites expansion.

Milford Neck Cover Change 1937-1999  
Overlay on IKONOS 29 Oct 2000

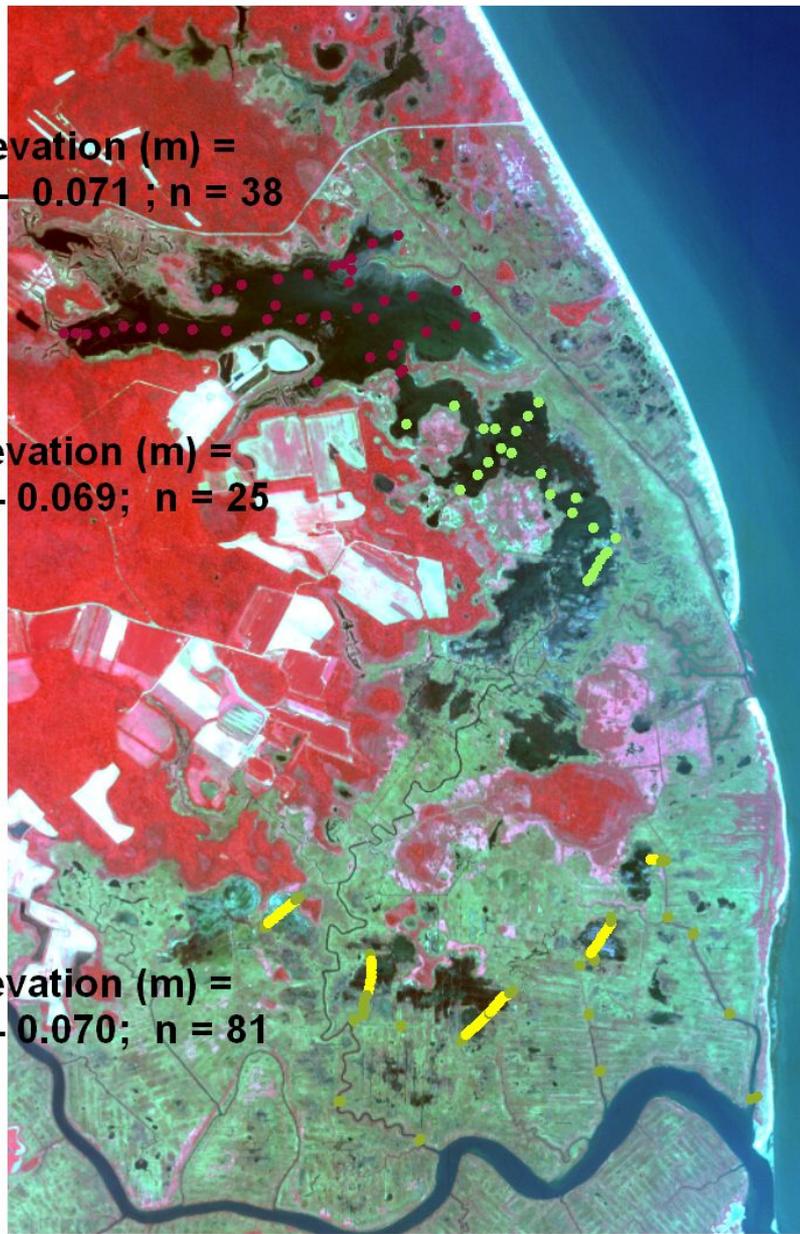
Mean elevation (m) =  
0.356 +/- 0.071 ; n = 38

Mean elevation (m) =  
0.335 +/- 0.069; n = 25

Mean elevation (m) =  
0.503 +/- 0.070; n = 81

Open water  
bottom elevations

Elevation of Open Water Bottoms  
North and South of Rawley Island

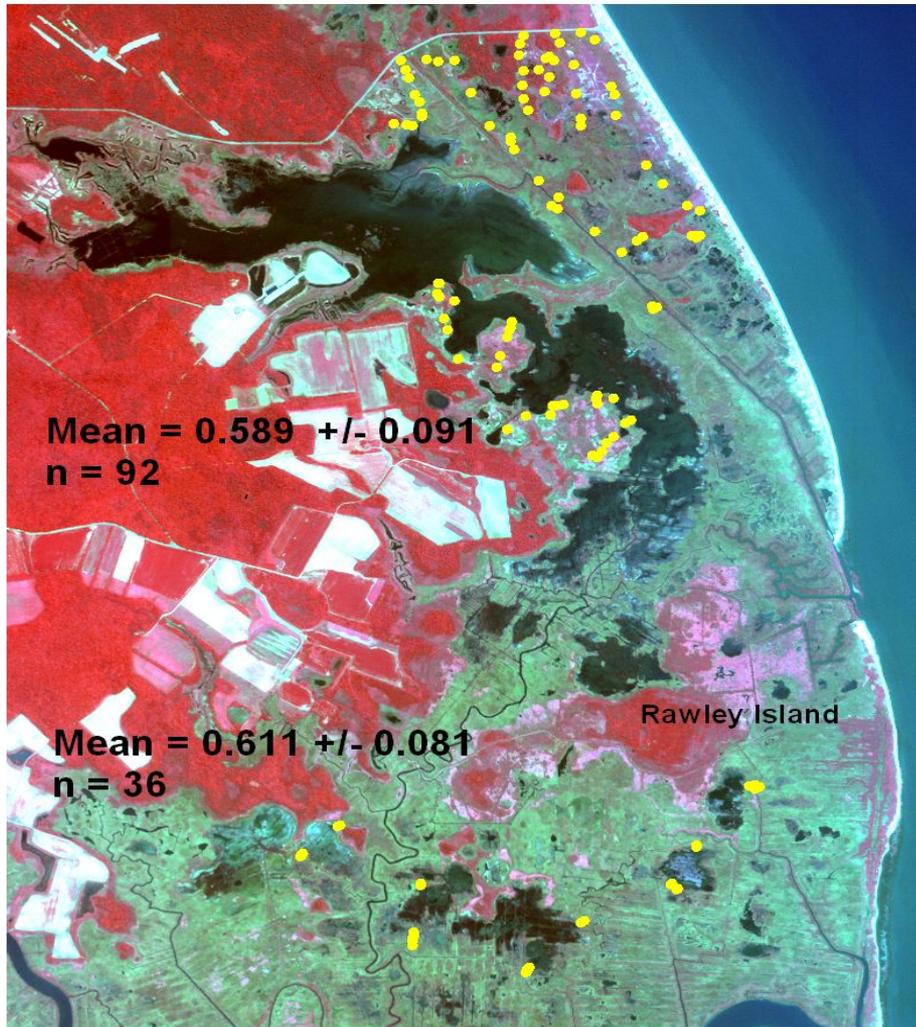
**Mean Elevation of Marsh Plane Vegetation  
North and South of Rawley Island in Meters**

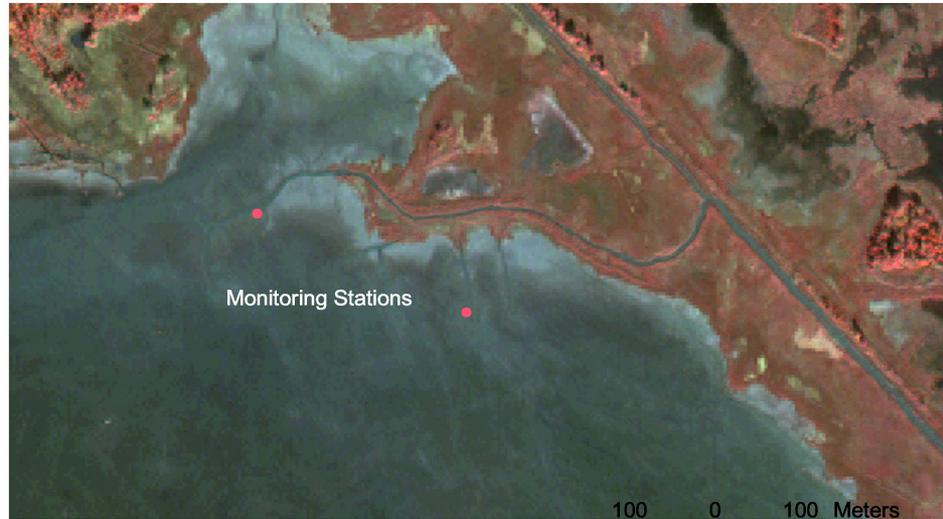
Rebuilding  
Marsh;  
sediment  
accretion

Lagoon Inlet 29 Oct 2000

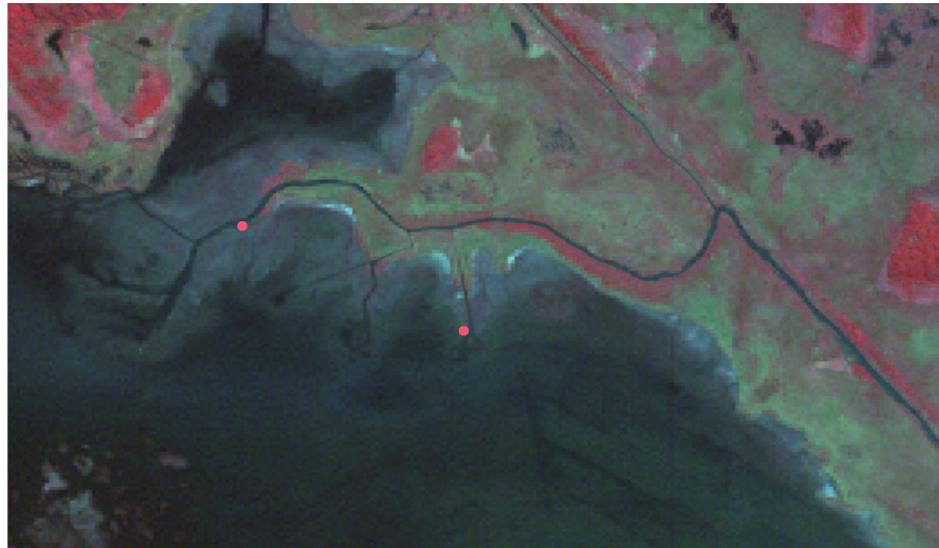
Lagoon Inlet 2 July 2004

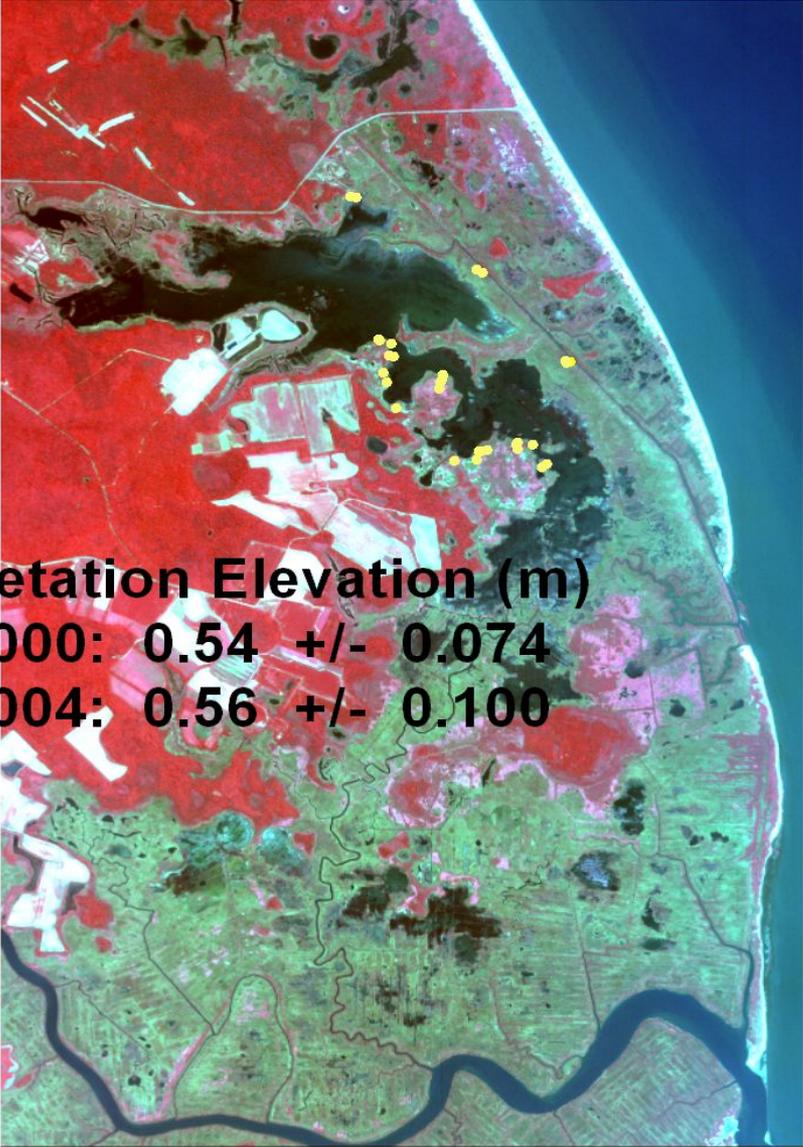
Marsh plain  
elevation increase

**Vegetation Elevation (m)**  
**In 2000: 0.54 +/- 0.074**  
**In 2004: 0.56 +/- 0.100**

**Elevation of revisited vegetation sites in  
2000 and 2004**

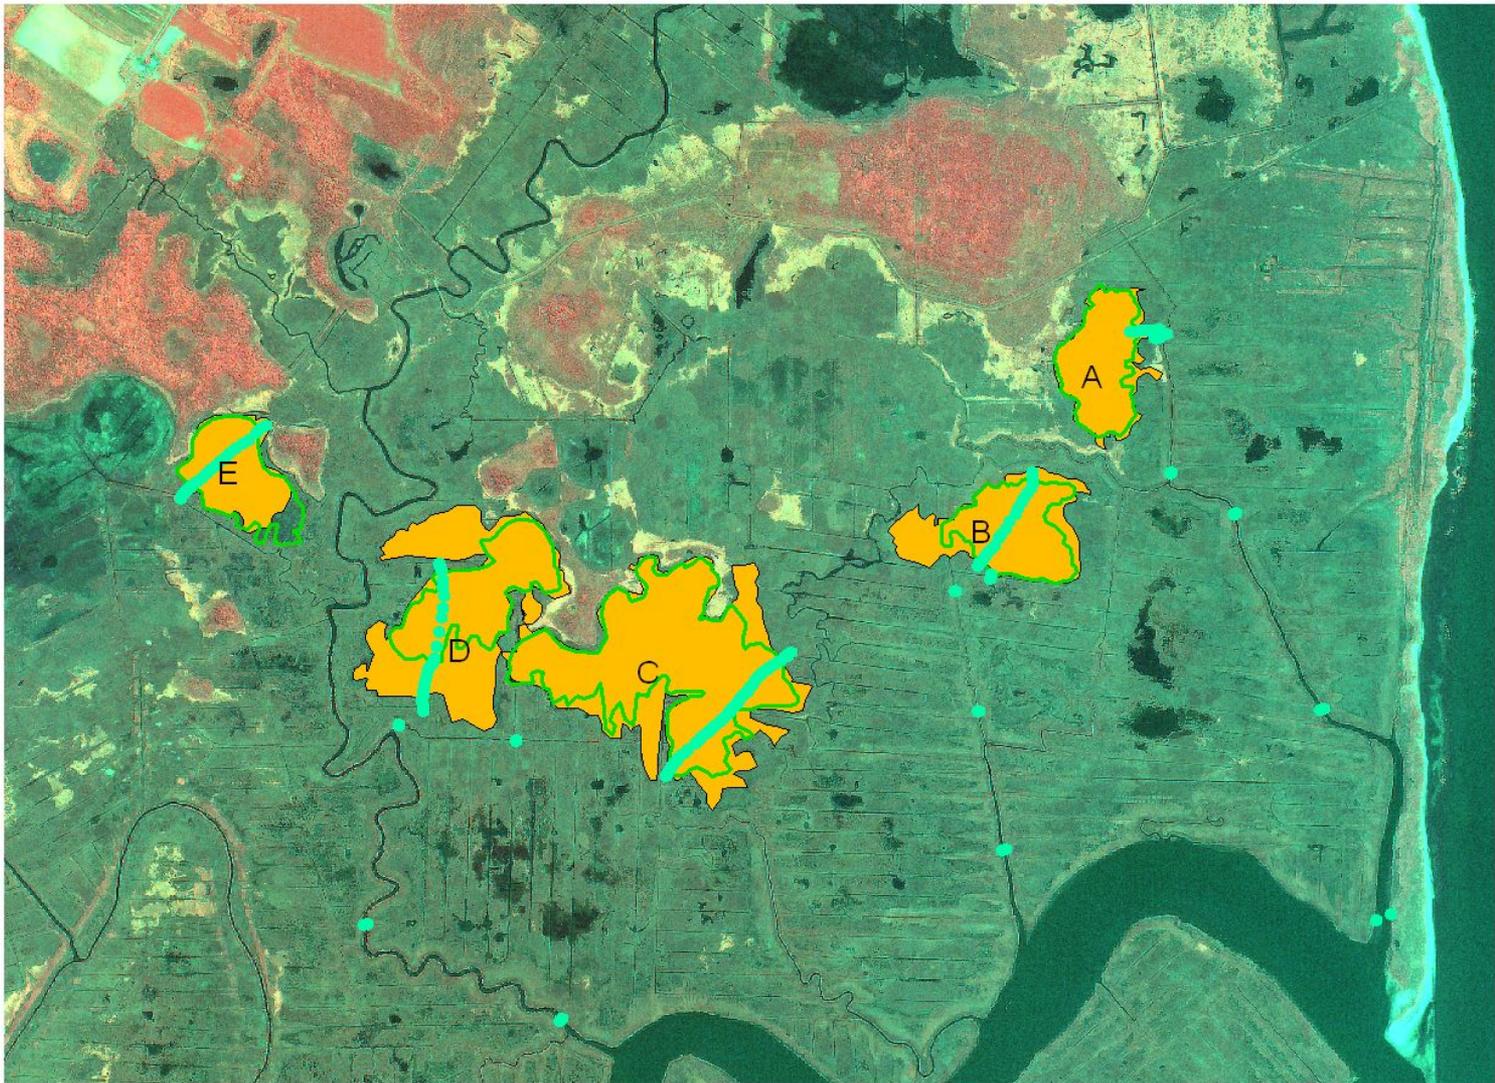
Figure 8. Five Sample Areas of Open Water and Mud Flat

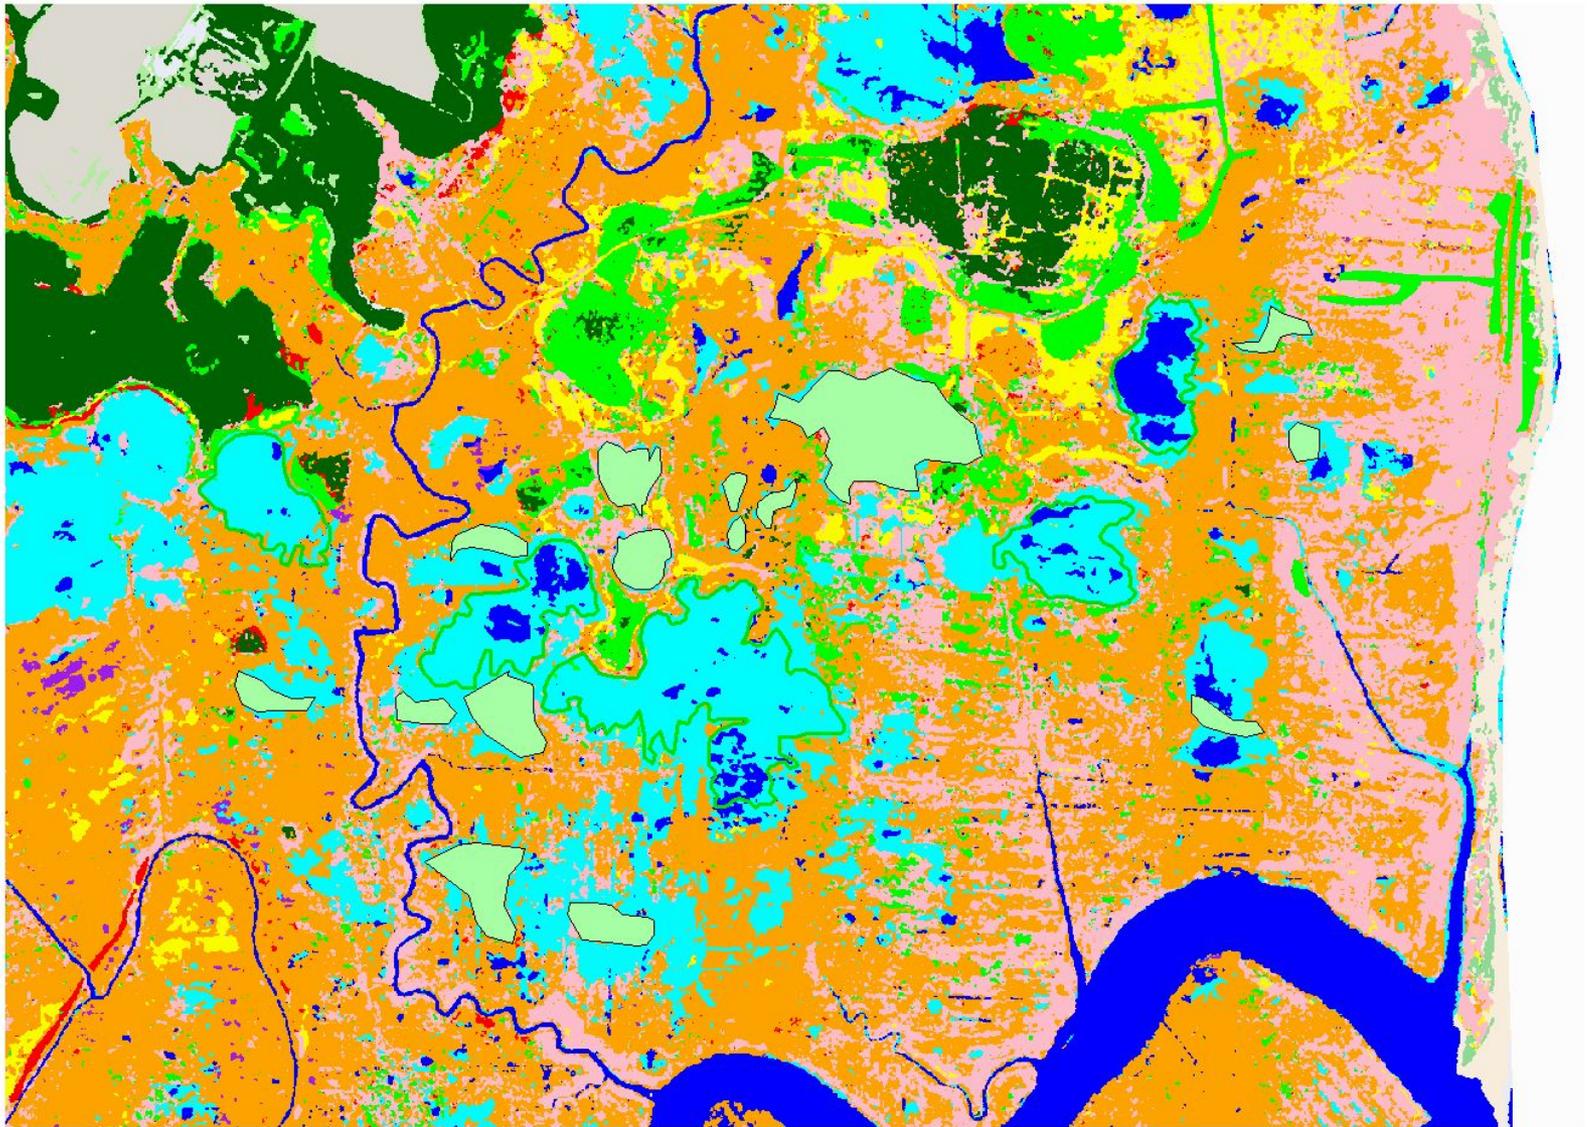
Figure 9 Areas of Apparently Reestablished Emergent Vegetation South of Rawley Island Overlaid on 1999 Classification of Open Water/Mudflat Areas

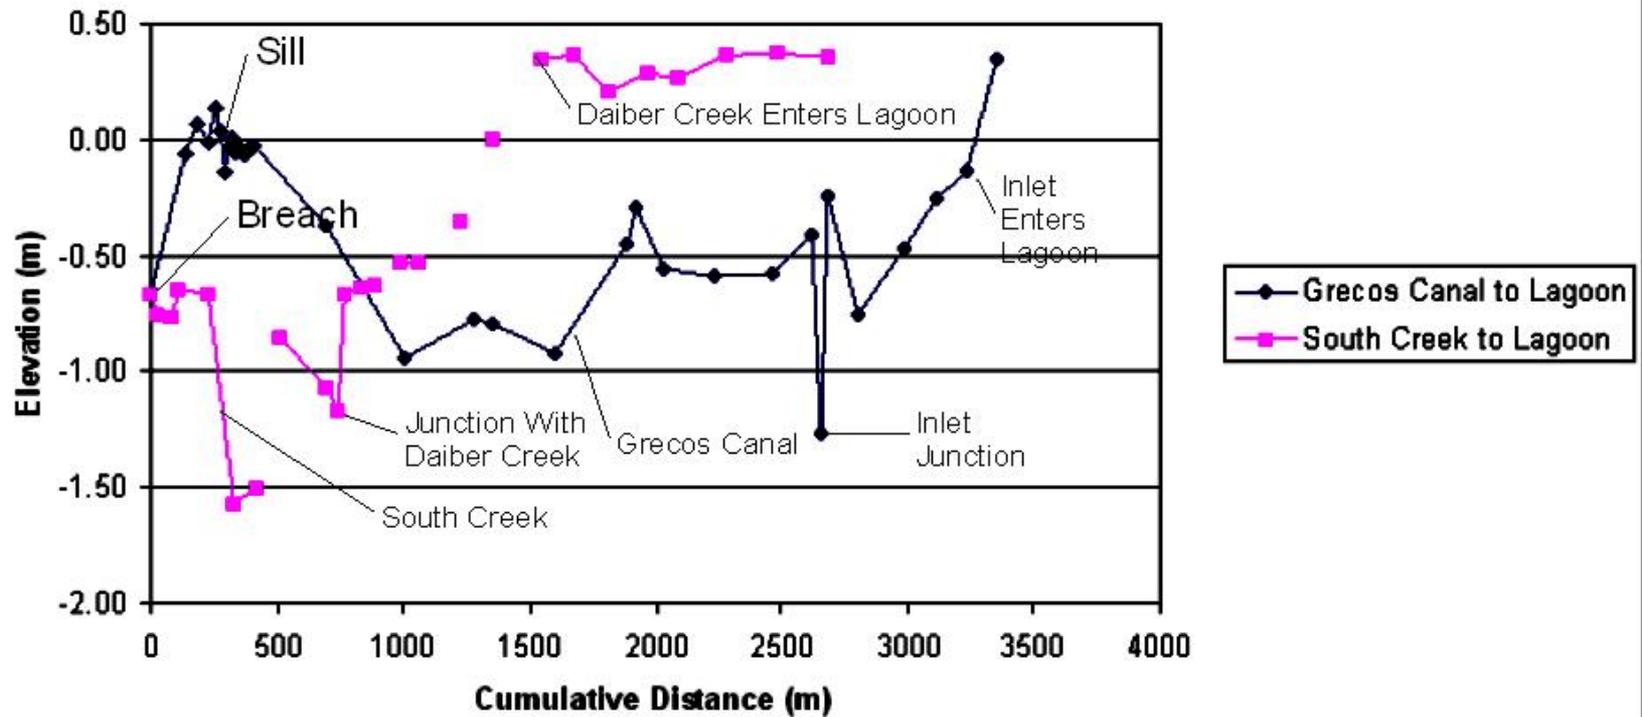
### Bottom Elevations of Grecos Canal And South Creek Channels

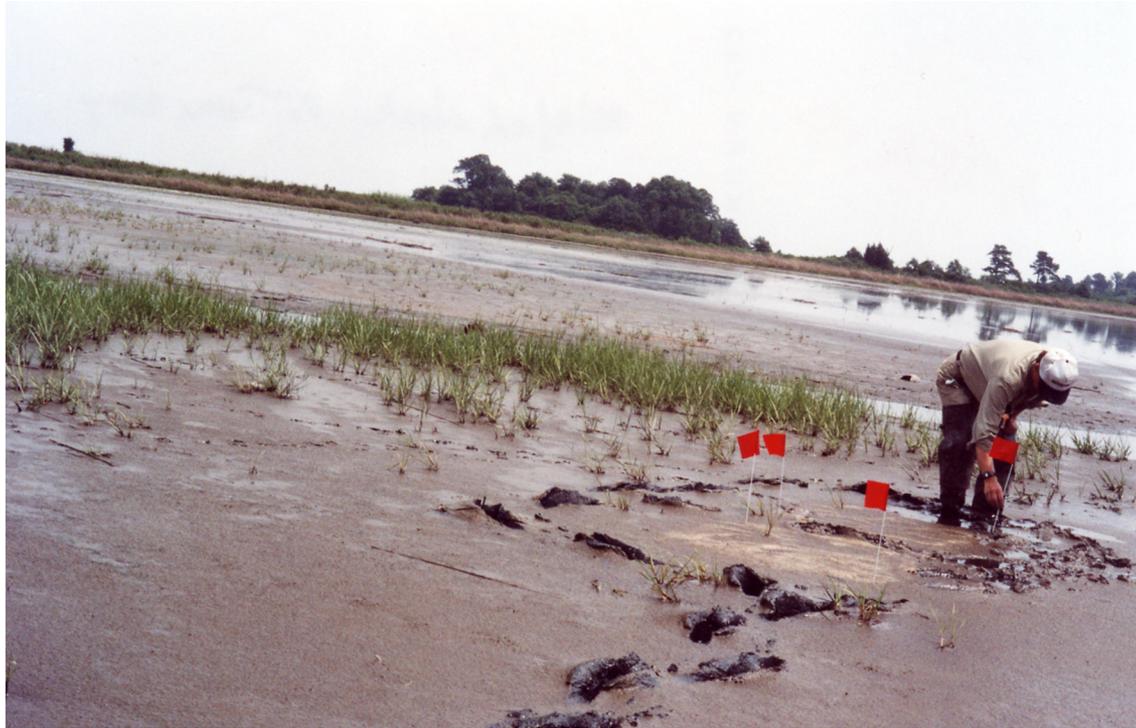
Placing sediment station in 2004

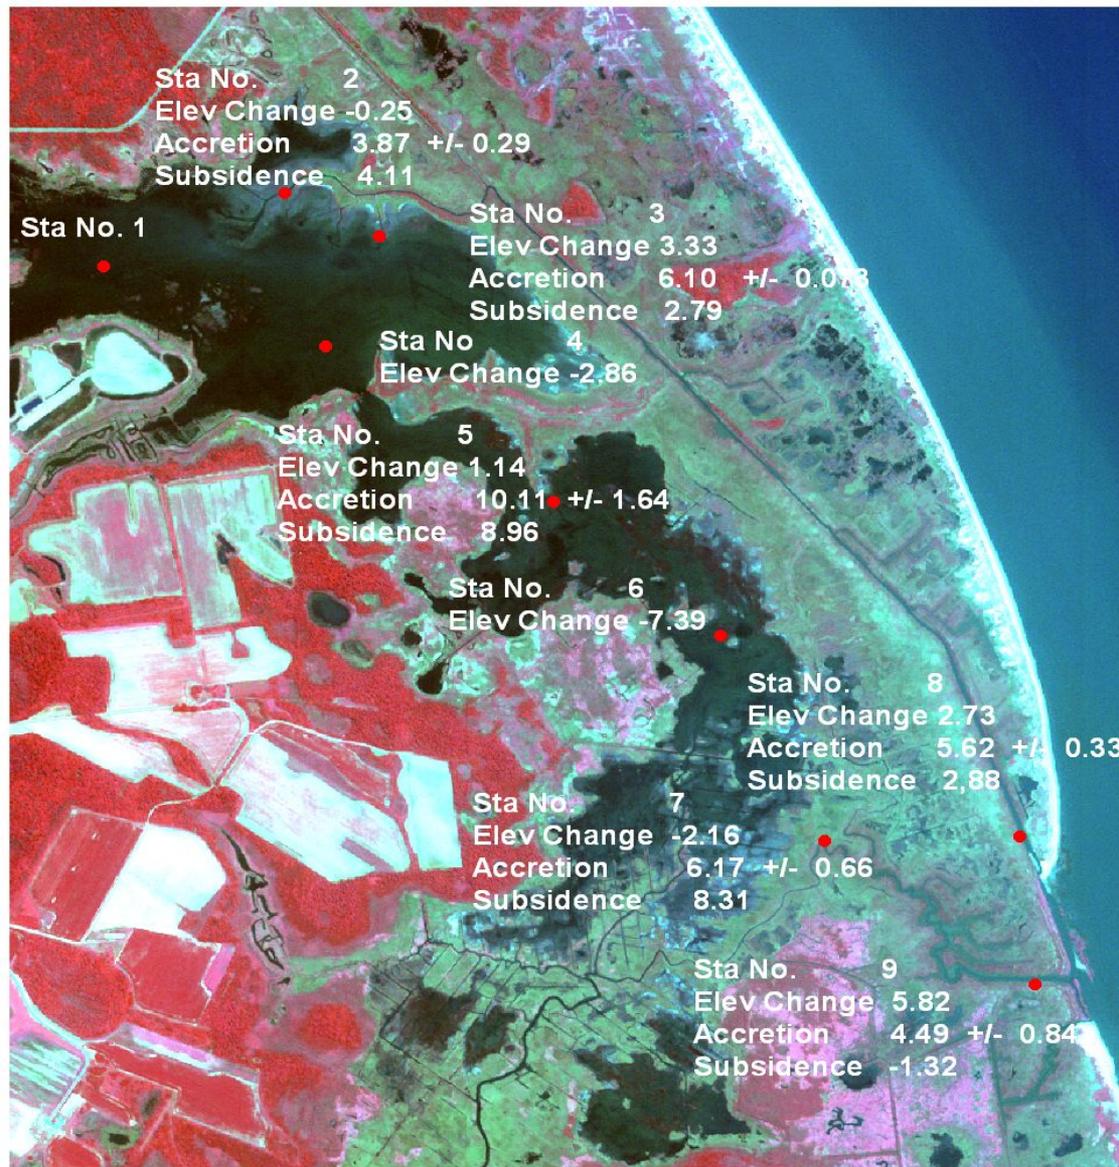
Nine months  
of change.

**Sediment Observations in cm/yr**  
**June 2004 - March 2005**  
**(271 days)**

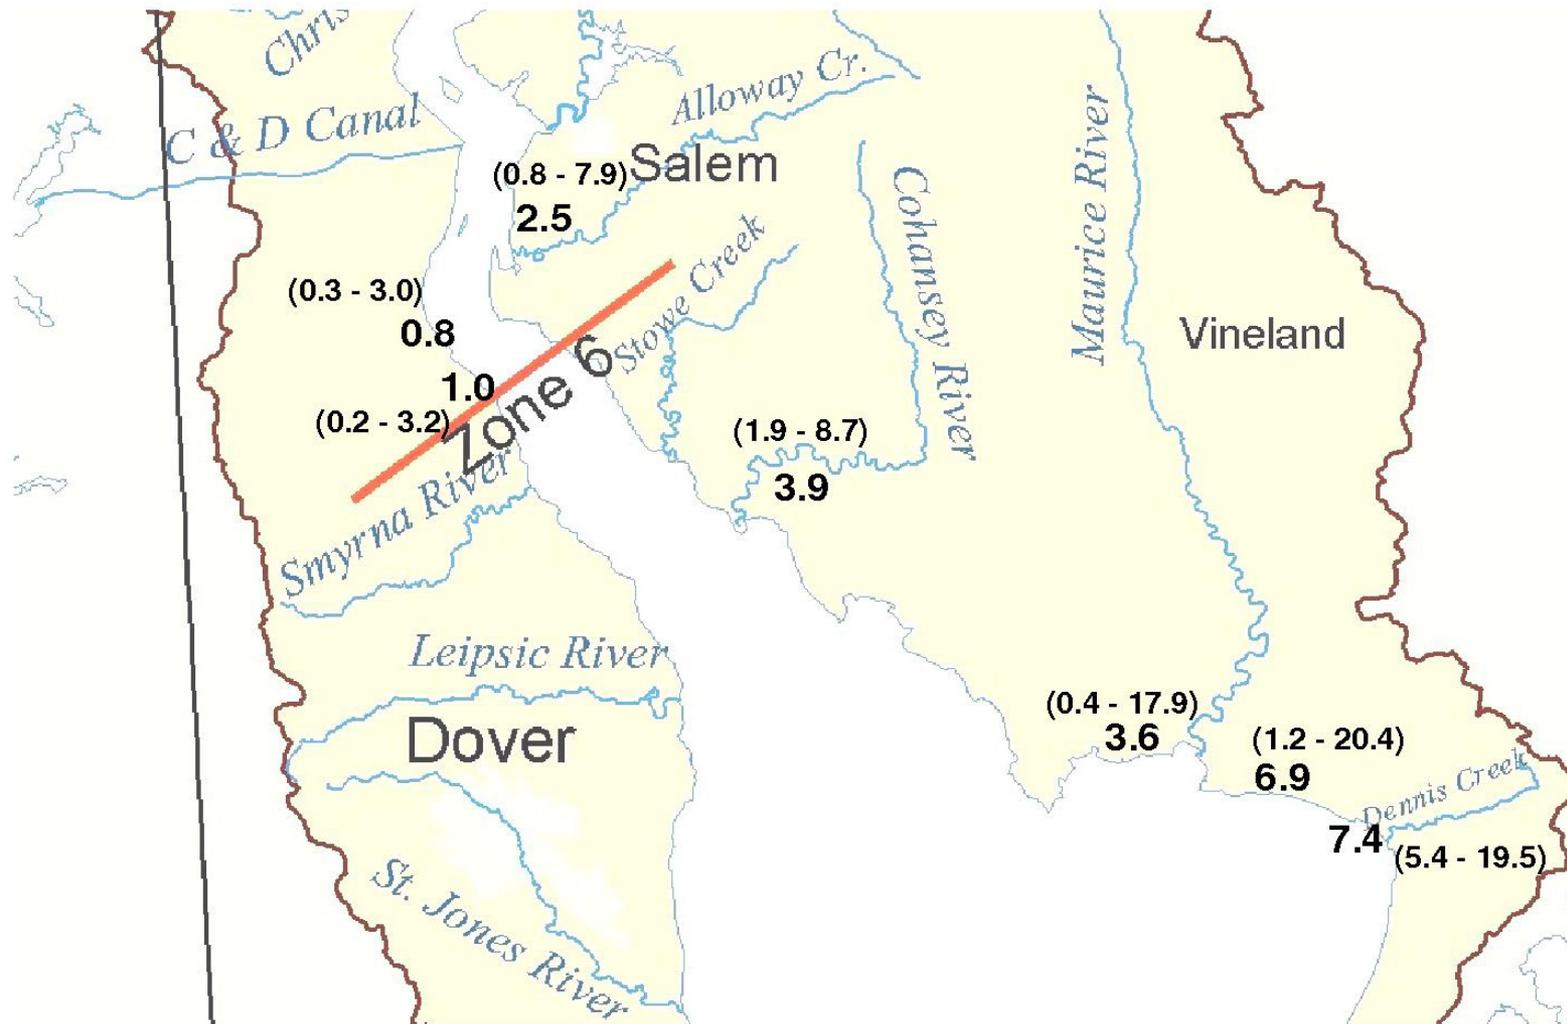
# Accretion Rate (CM/YR)

Site Average and (Range)
