# **Current Developmental Trends in the Tidal Wetlands of the Delaware Estuary**

**Kurt R. Philipp<sup>1</sup>, Richard. T. Field<sup>2</sup>, Andrew Homsey<sup>2</sup>, and Young-Heon Jo<sup>2</sup>**

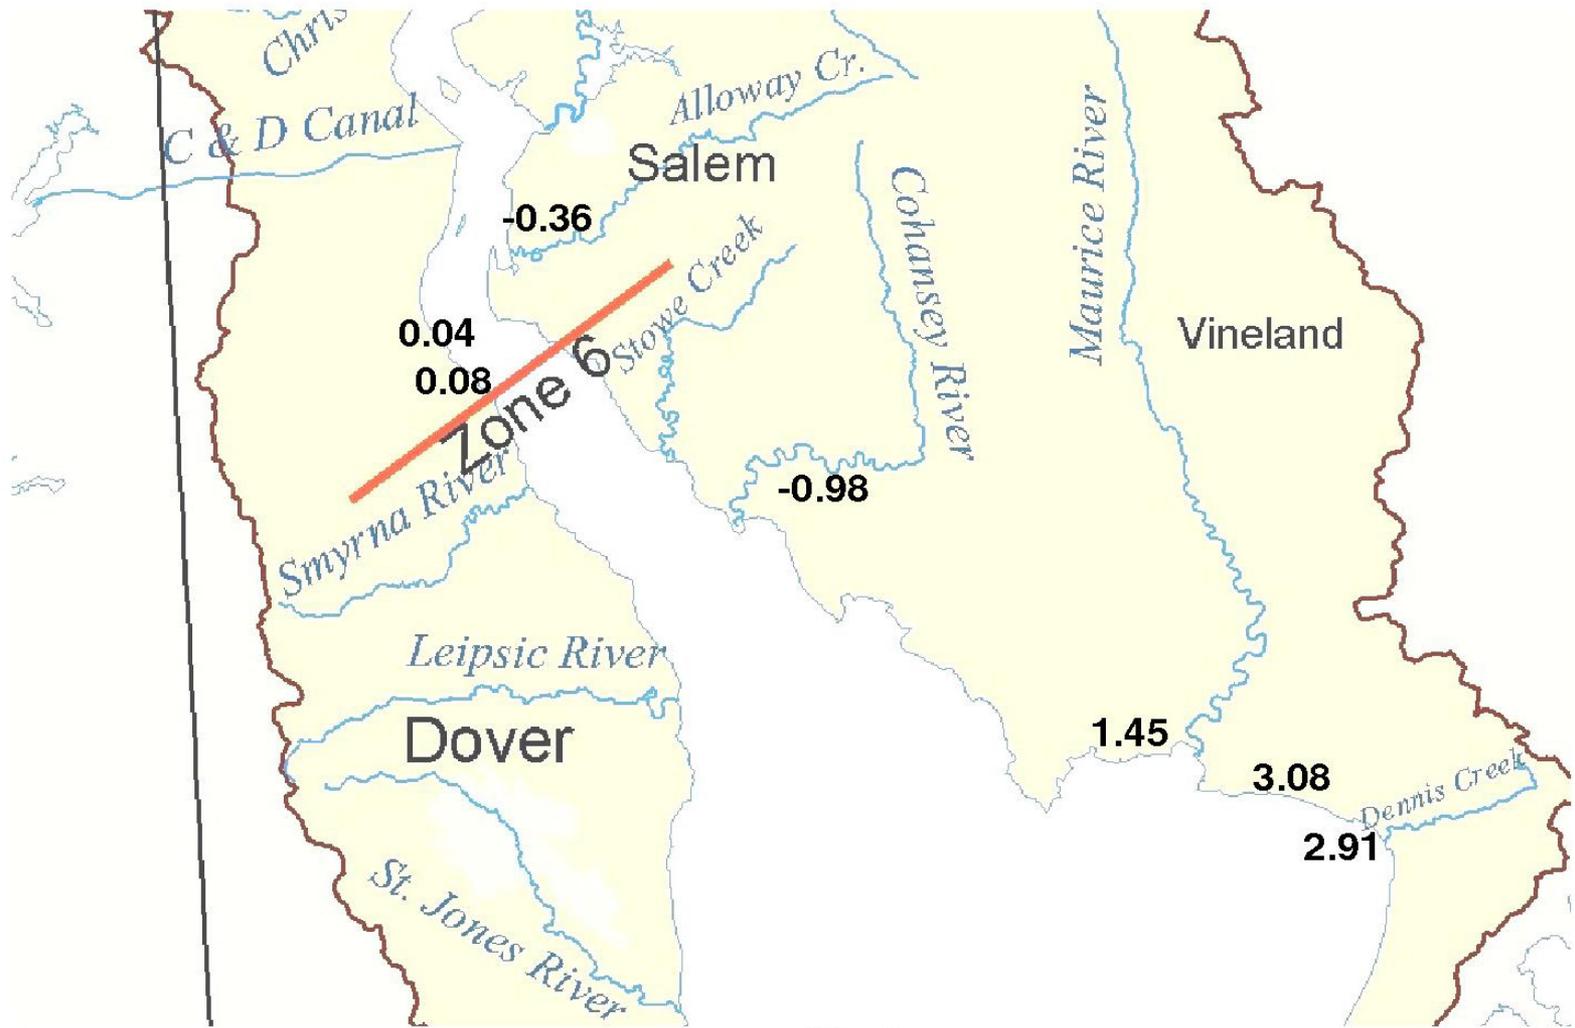
# Elevation Change Rate (CM/YR)

Site Average

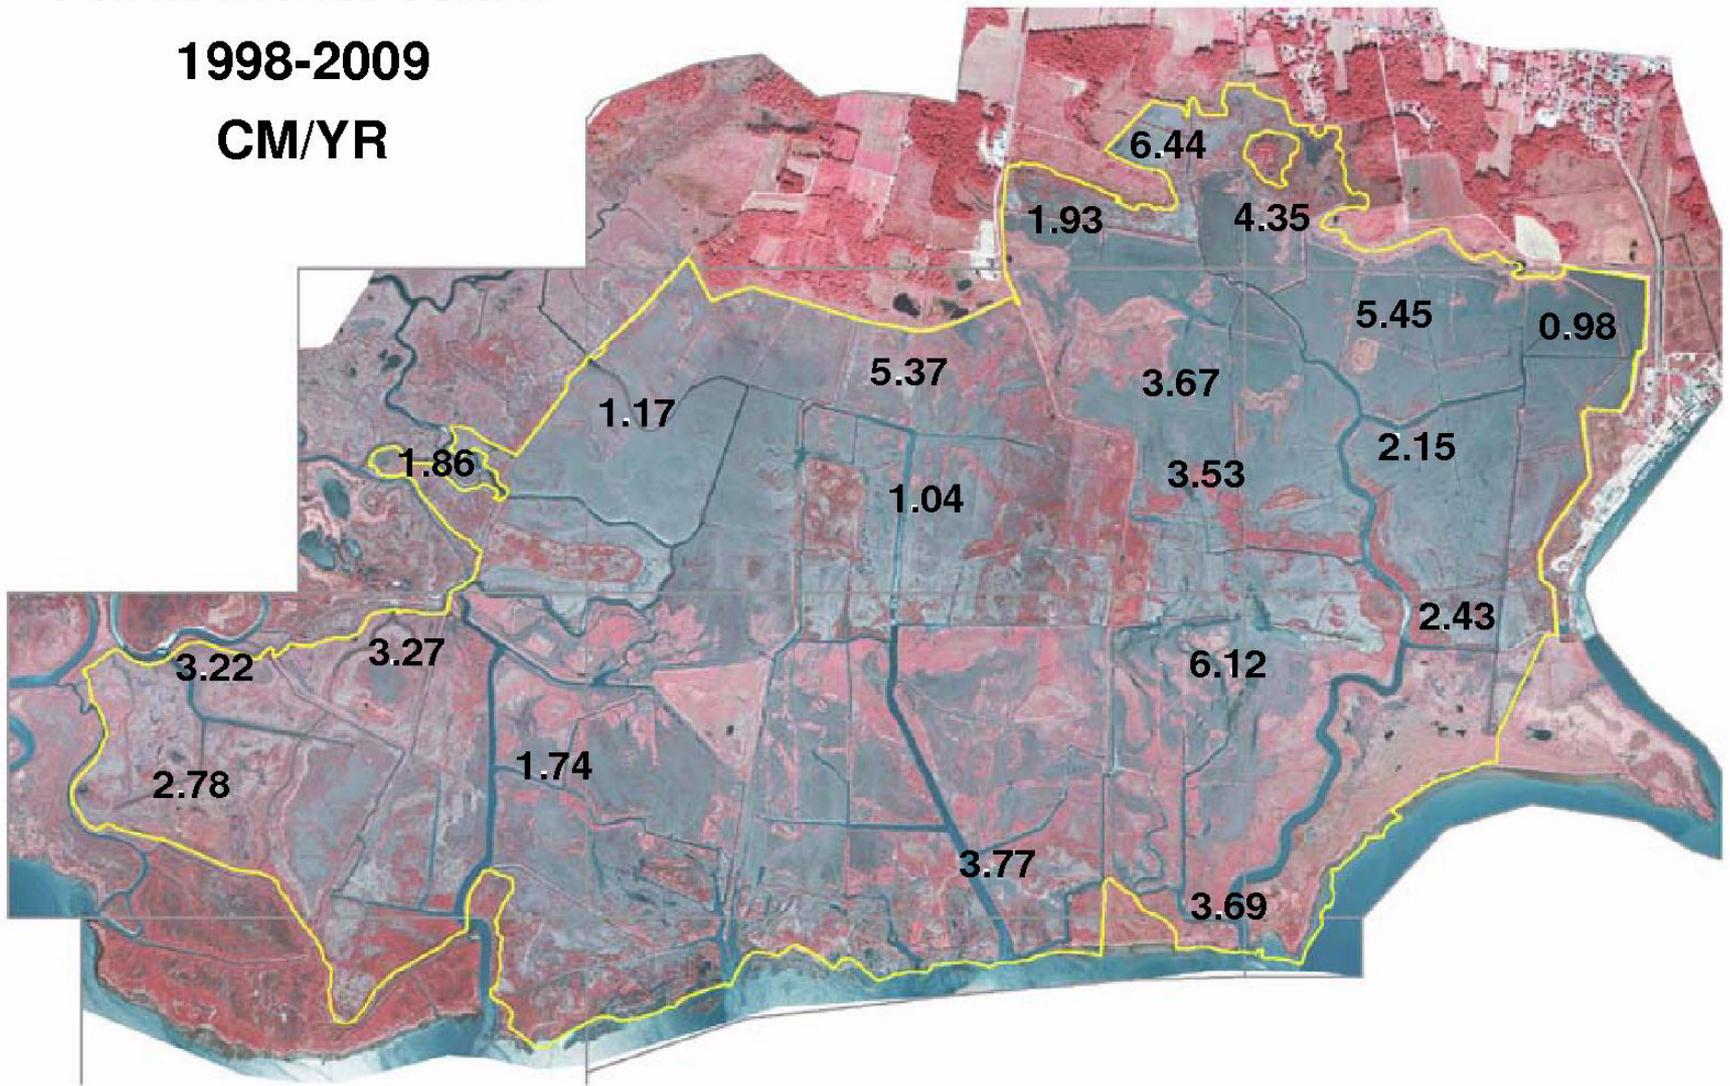
# Accretion Rate

1998-2009

Commercial Twp Site

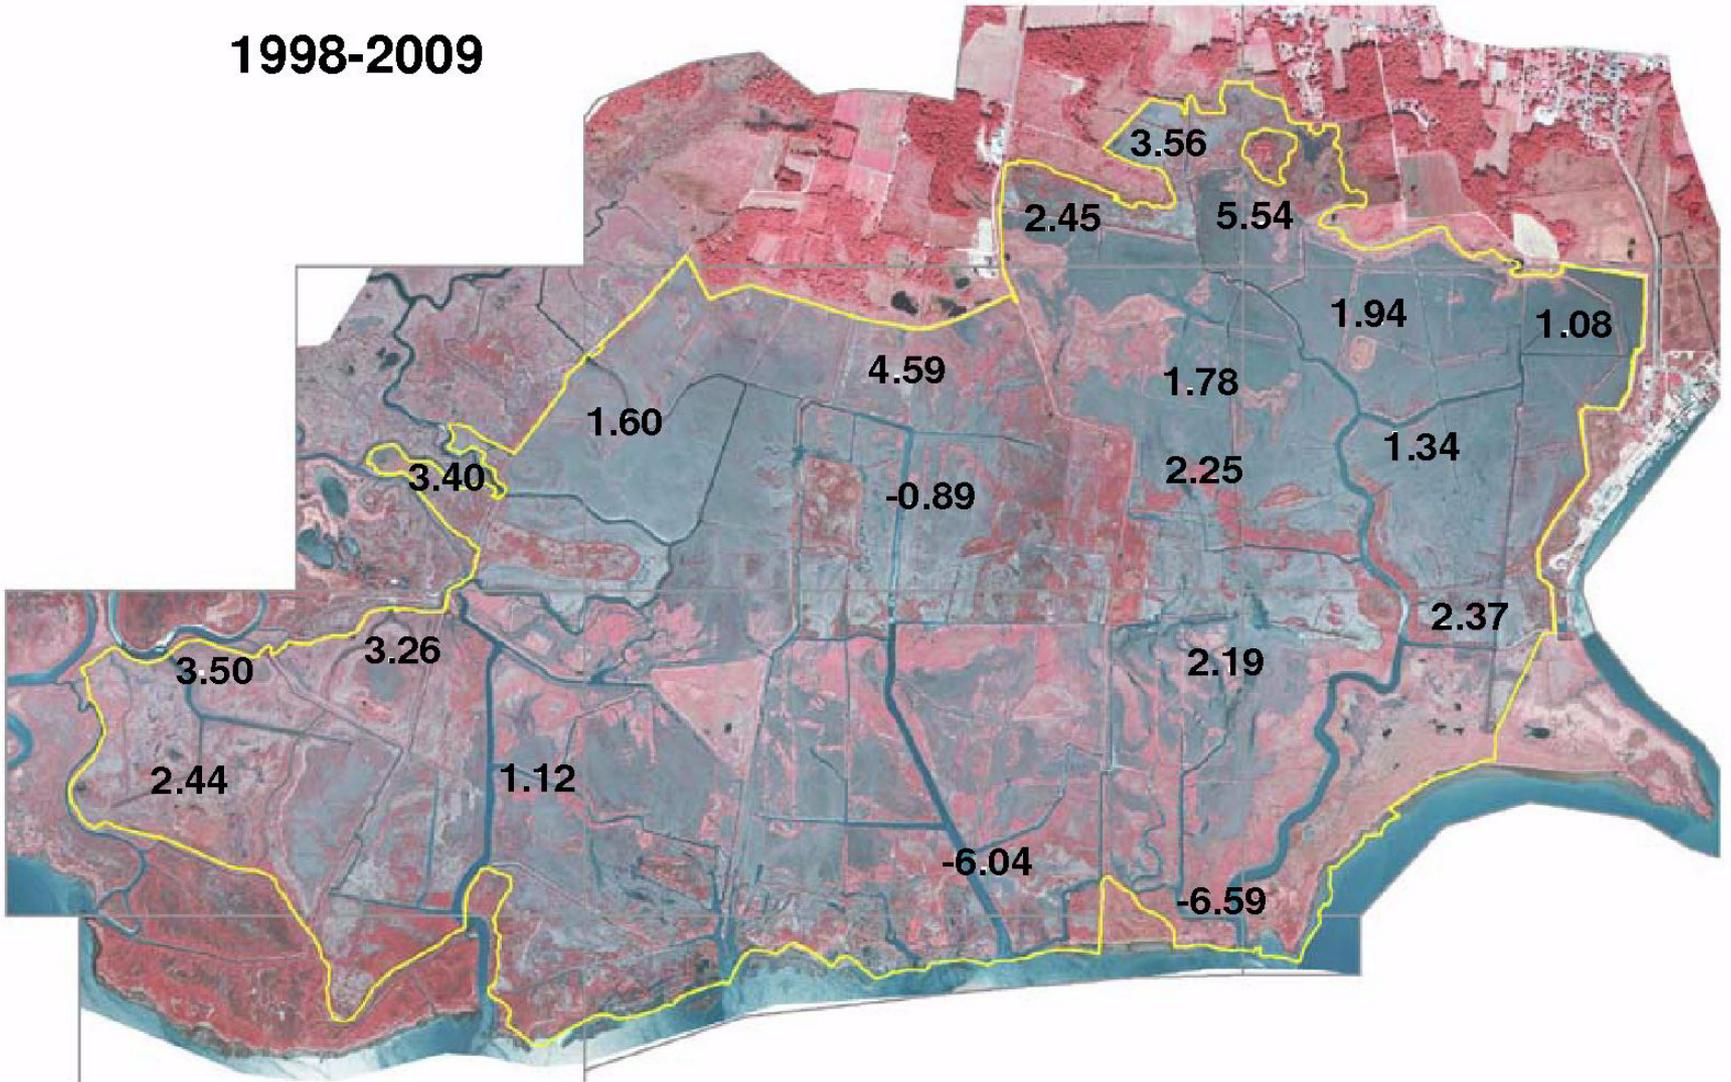
# Accretion / Subsidence

1998-2009

Commercial Twp Site

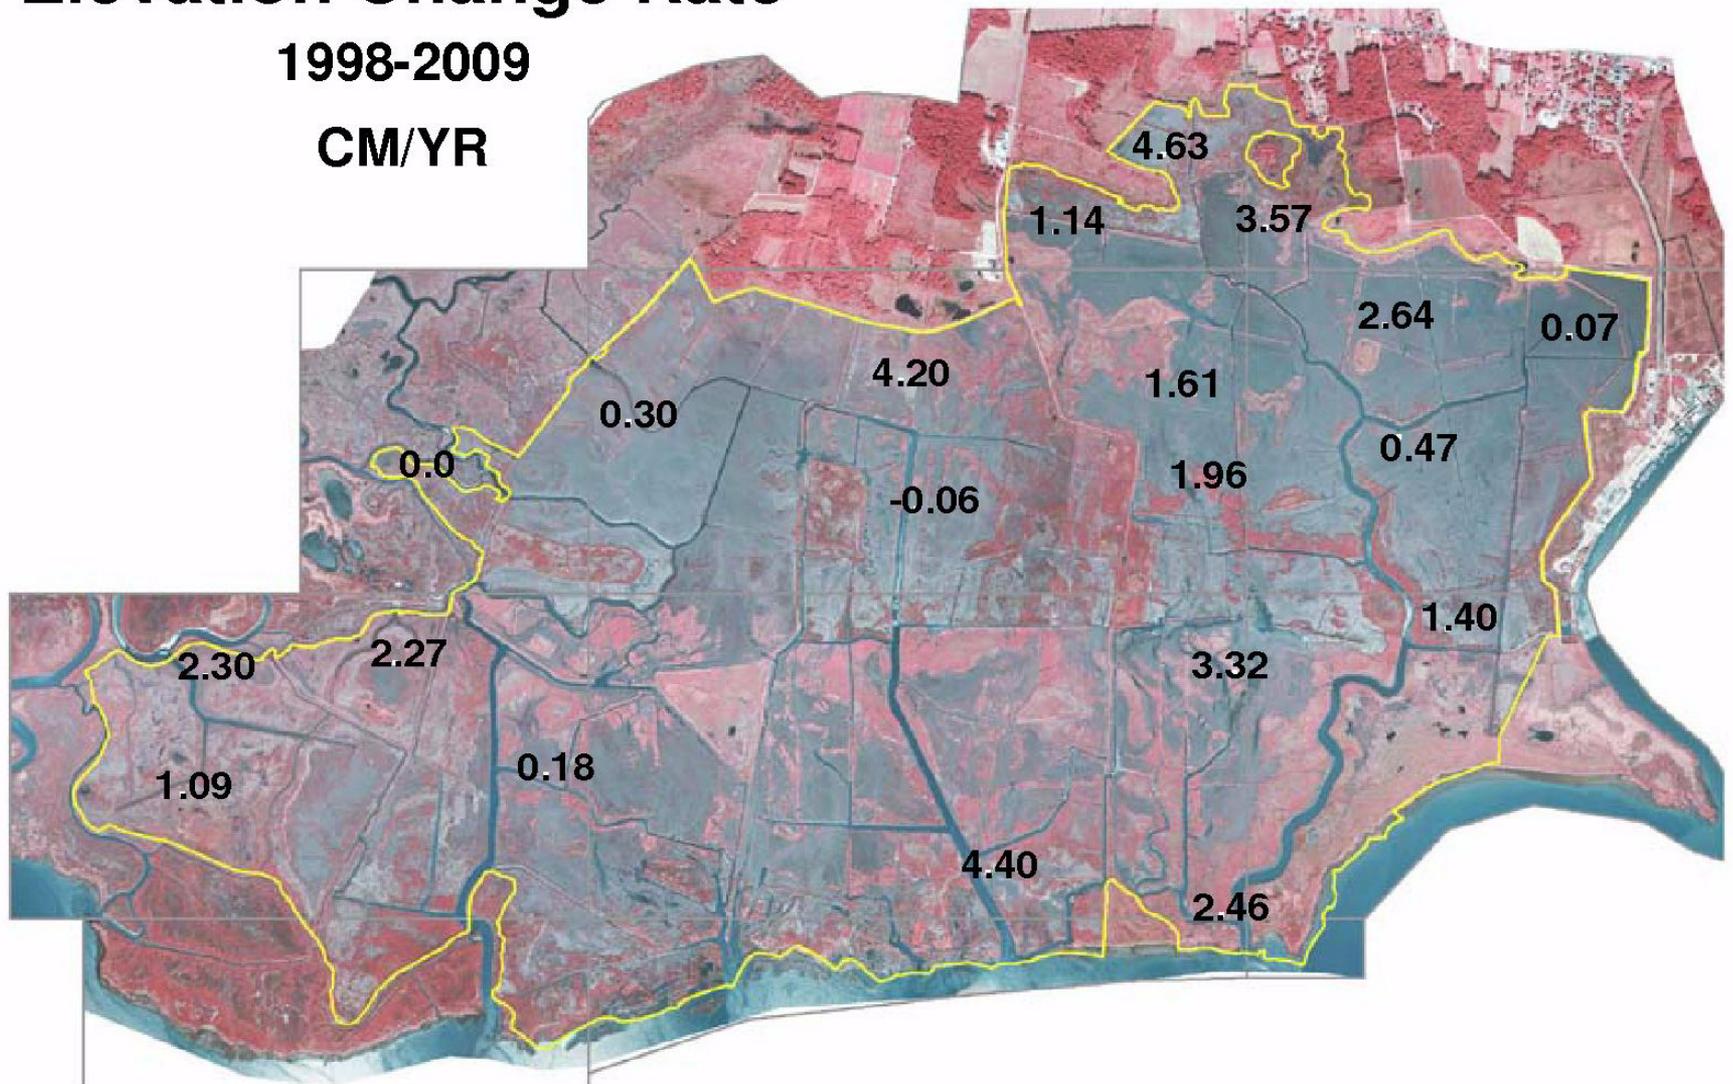
# Elevation Change Rate

1998-2009

Commercial Twp Site

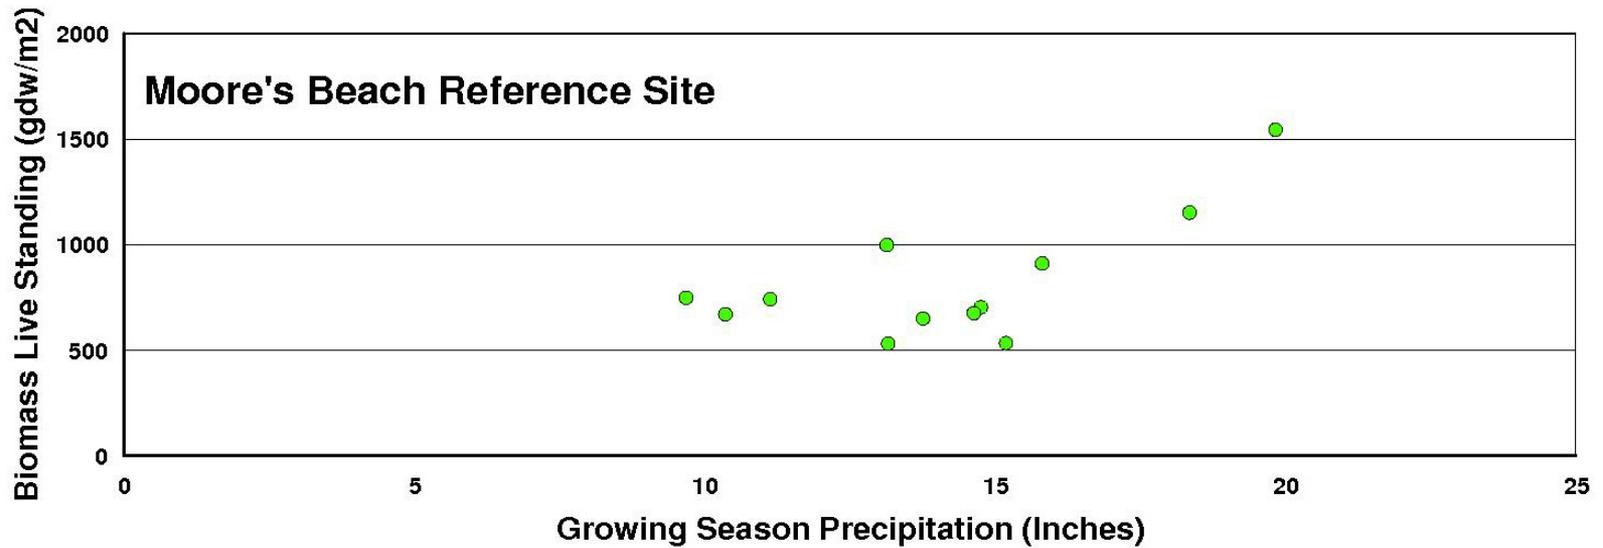
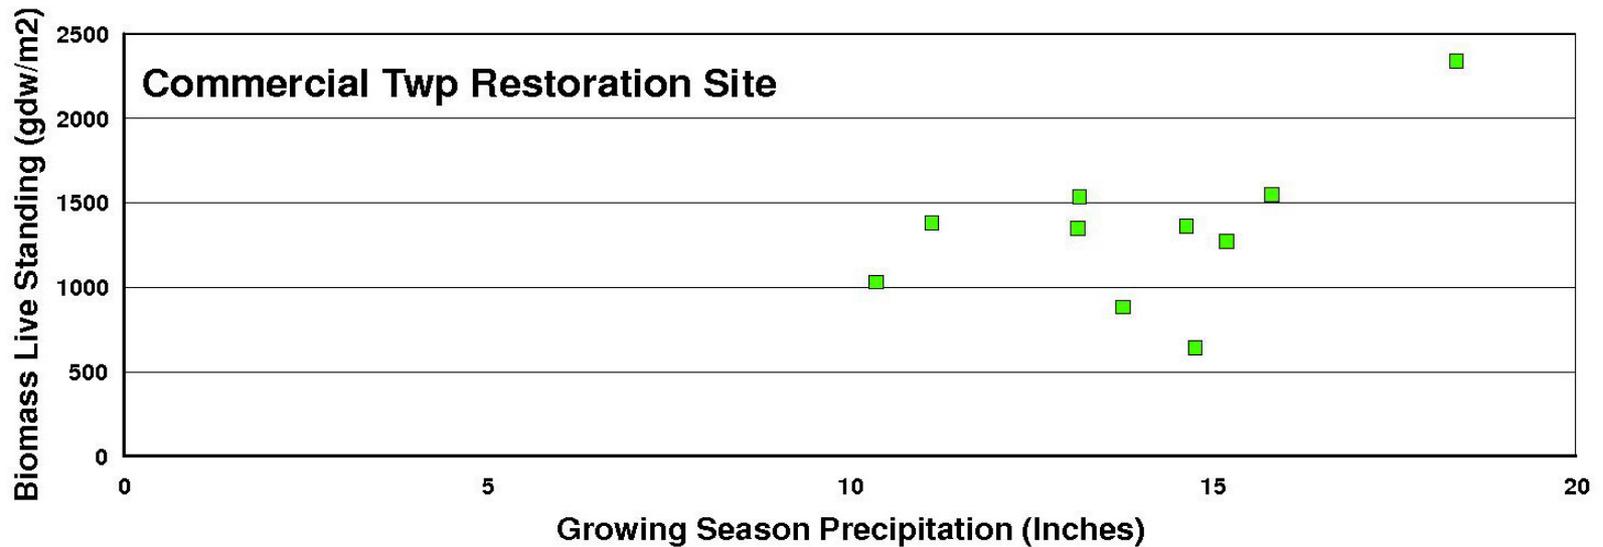
# Above Ground Biomass & Precipitation
