WETLAND DELINEATION REPORT

DIAMOND STATE PORT CORPORATION
4600 HAY ROAD
WILMINGTON, DELAWARE

October 23, 2019

Project No. 11139.LH

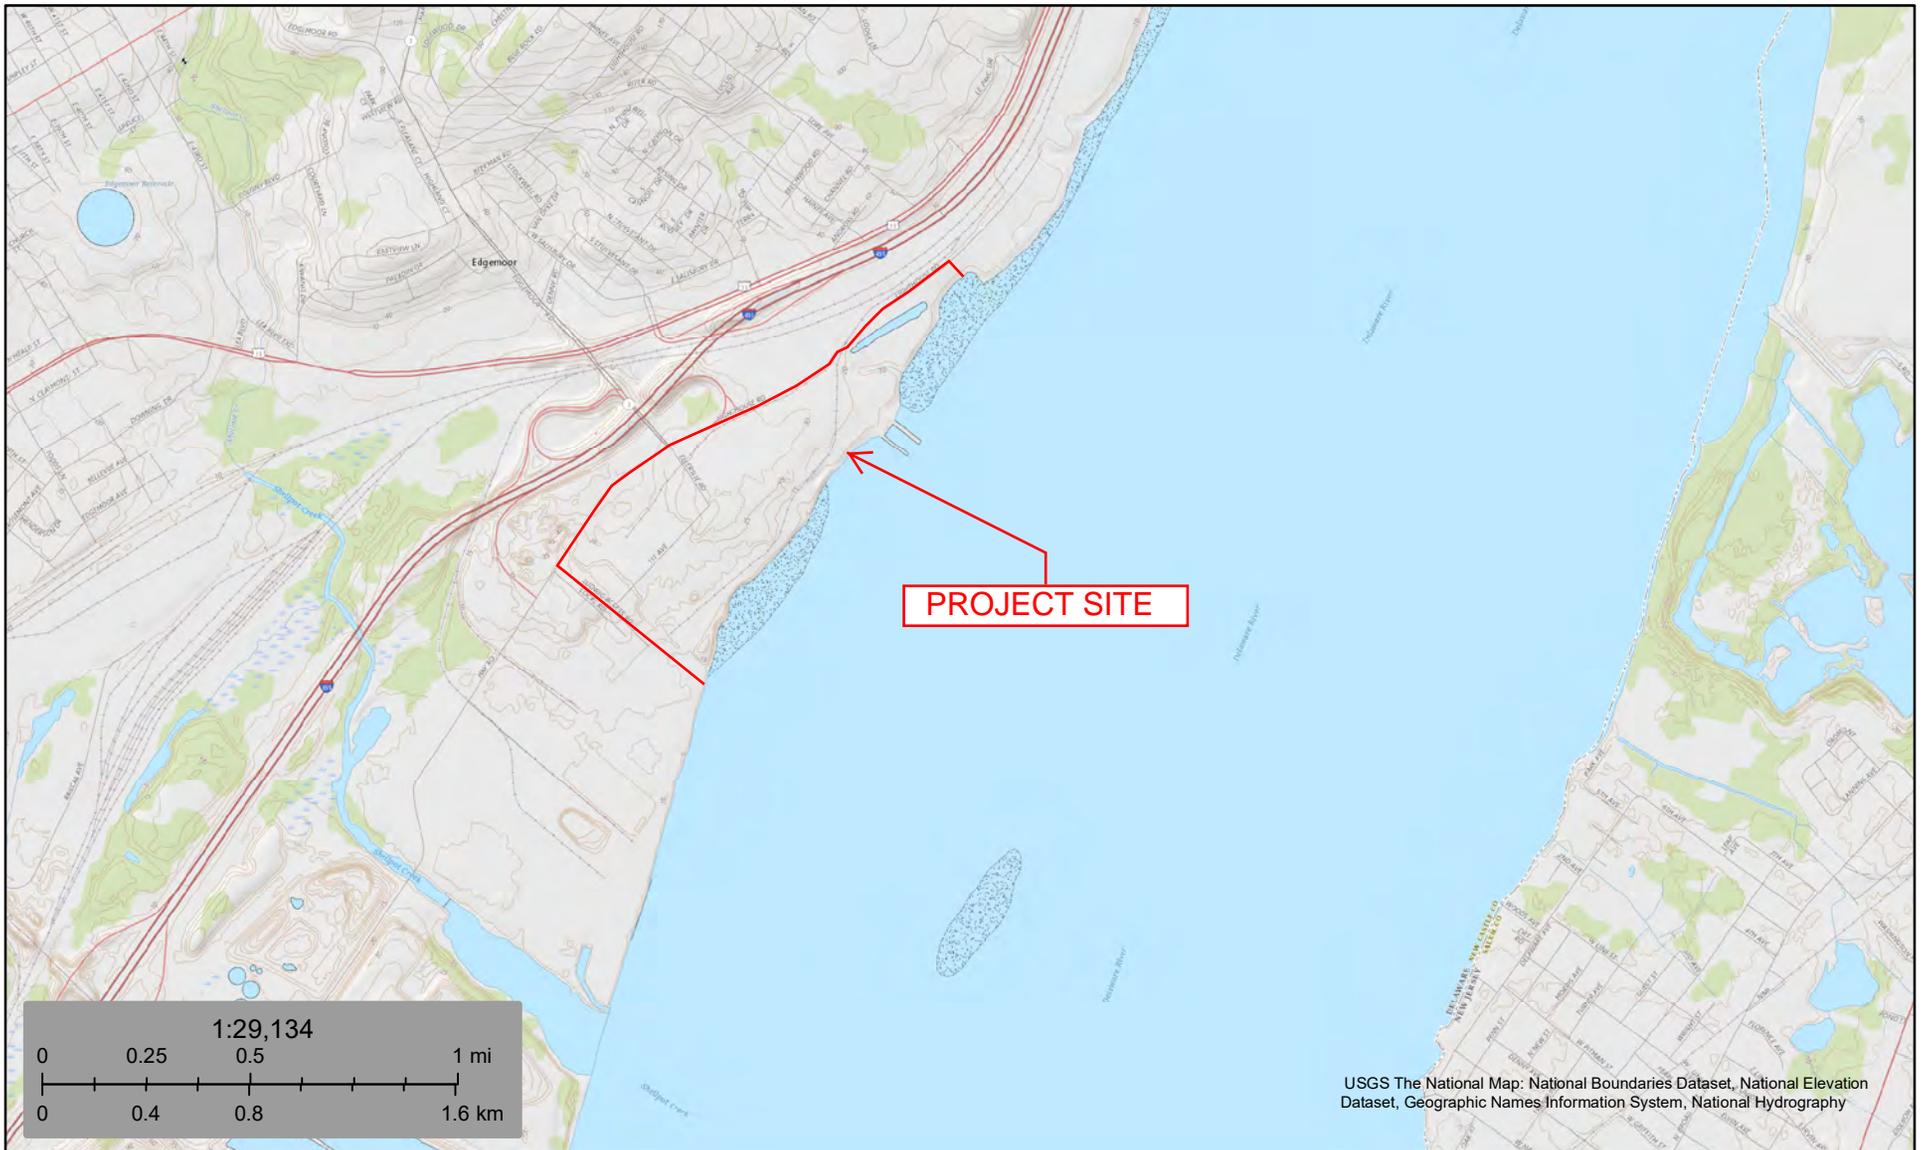
FIGURE 1: USGS TOPO MAP

According to the USGS Map (see Figure 1) the project site is located south of Lighthouse Road and Hay Road in Edgemoor, Delaware. The project site is bordered by Fox Point State Park to the north and Ludwig Access Road to the southwest. The Delaware River defines the entire eastern boundary of the project site. The adjoining properties to the west and south appear to be used for commercial and industrial purposes.

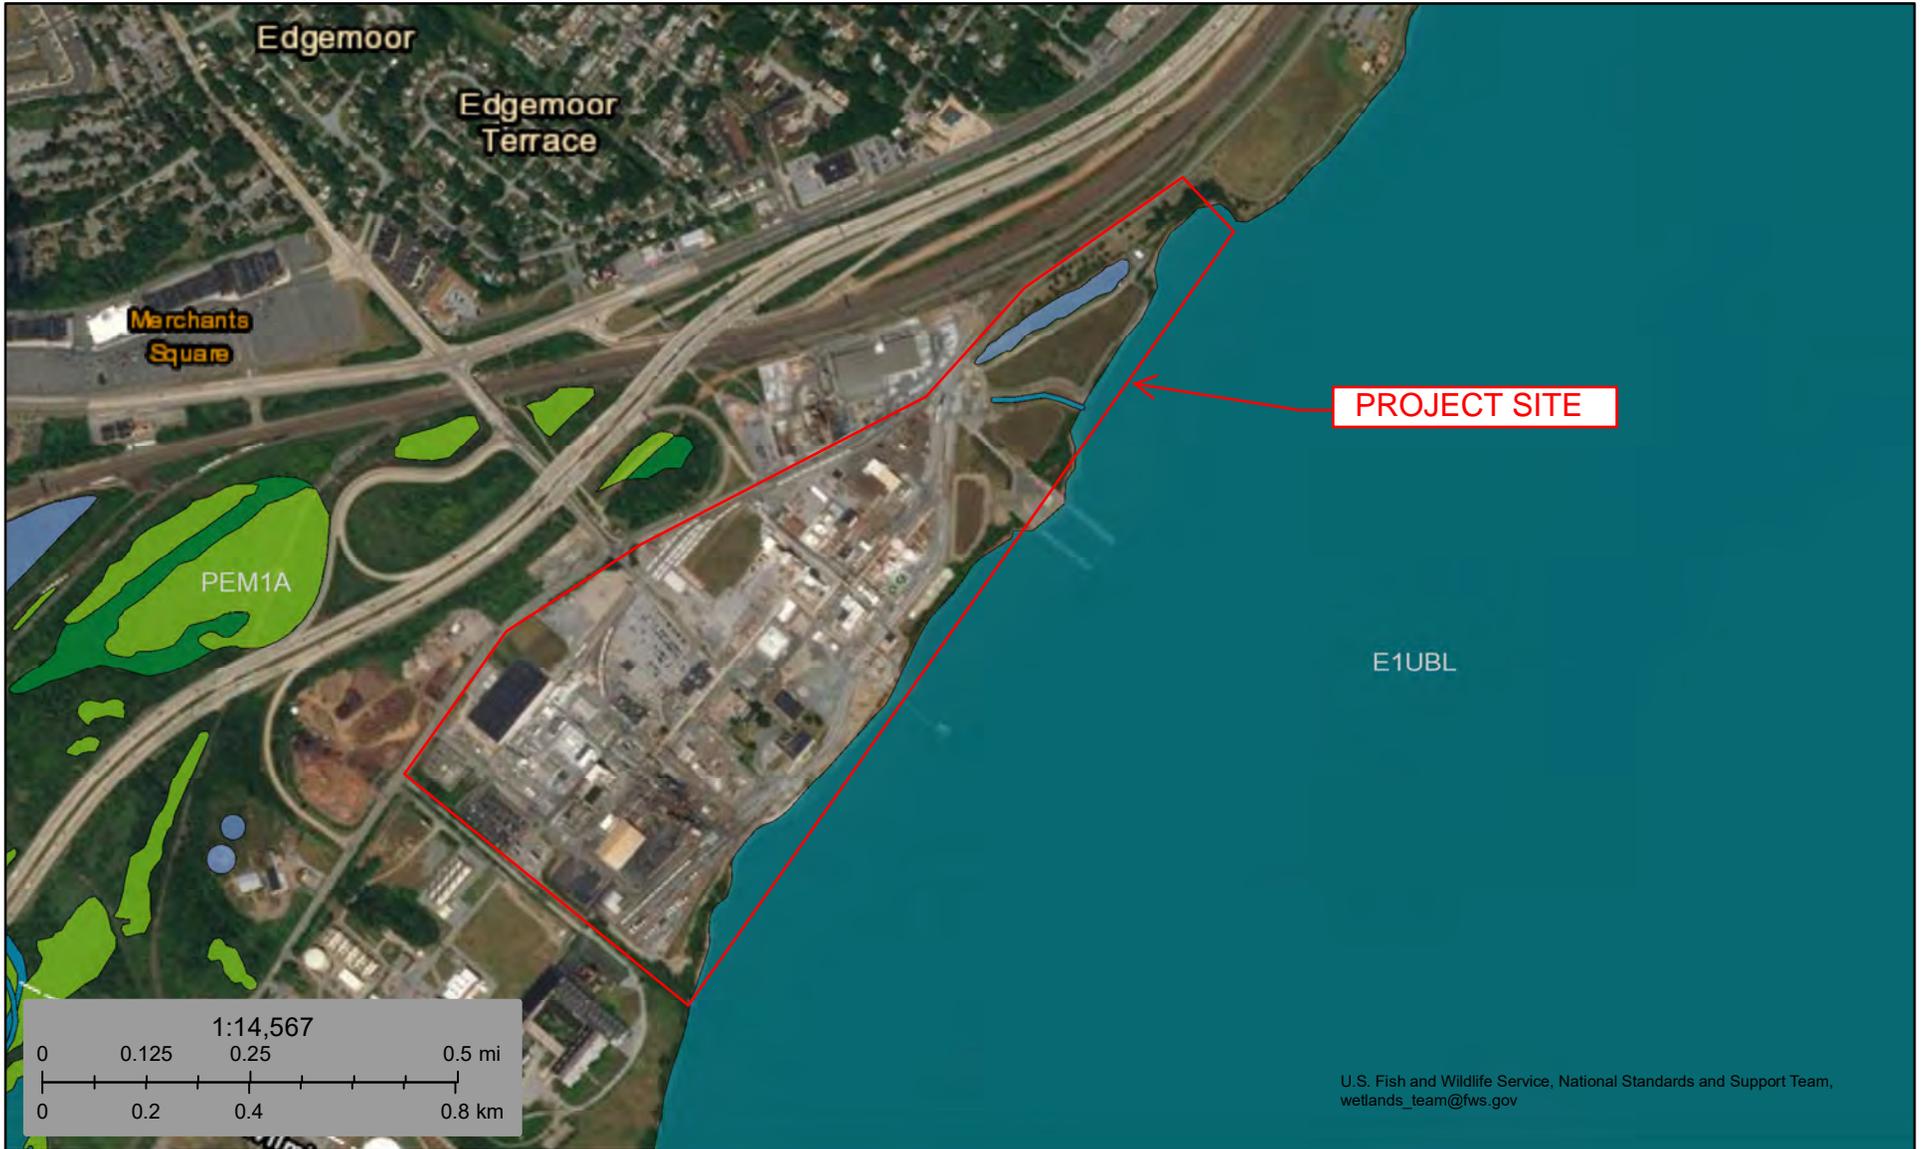
FIGURE 2: NWI MAP

Online NWI Mapping (see Figure 2) lists the Delaware River as an Estuarine Subtidal, Unconsolidated Bottom, Subtidal wetland (E1UB1). The channel that flows into the Delaware River in the northern portion of the project site is a Riverine, Lower Perennial, Unconsolidated Bottom, Permanently Flooded wetland (R2UBH). A Palustrine, Unconsolidated Bottom, Permanently Flooded, Excavated wetland (PUBHx) is located in the northeast corner of the project site.

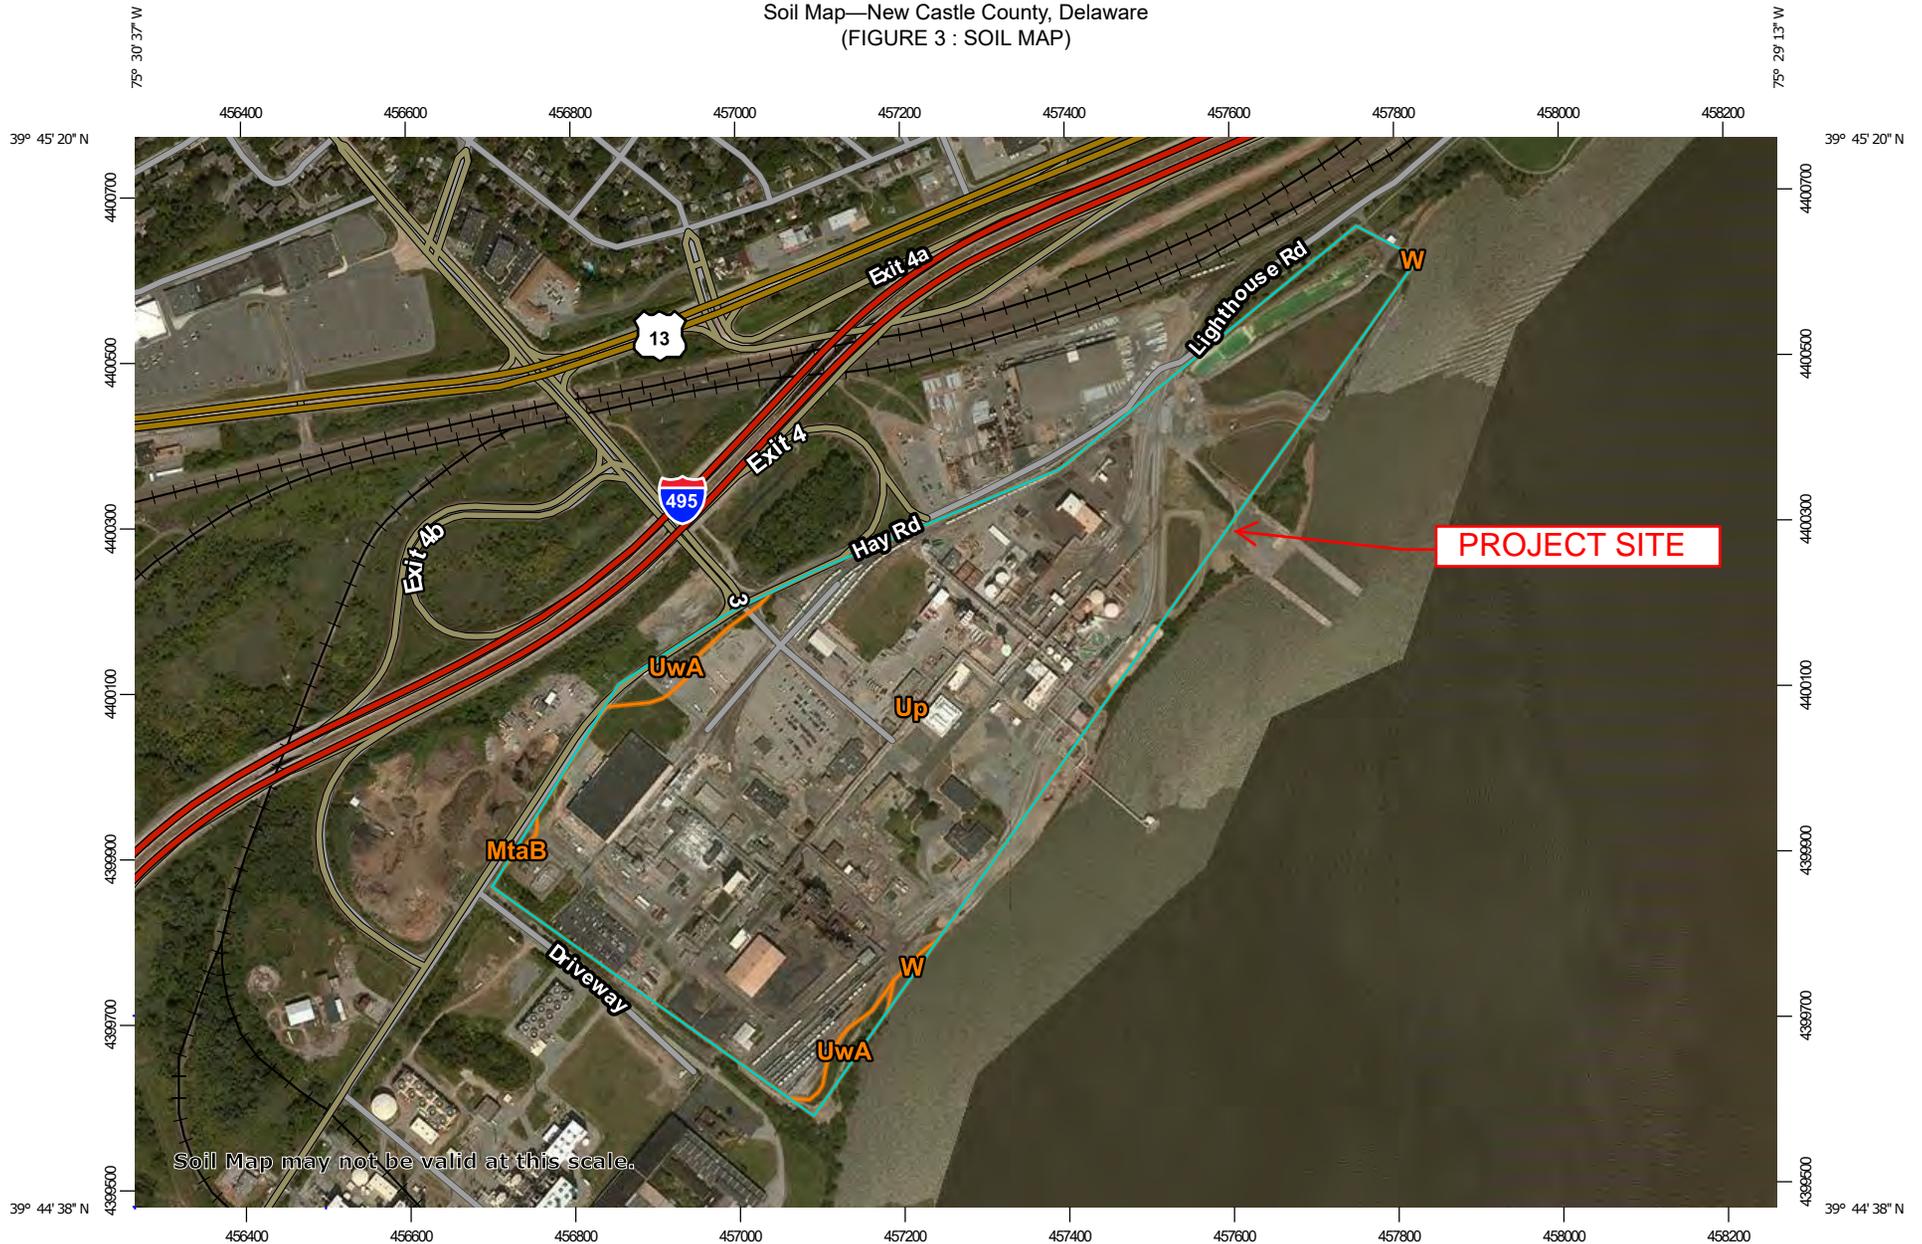
Soil Map—New Castle County, Delaware
(FIGURE 3 : SOIL MAP)

The Web Soil Survey (see Figure 3) shows three (3) soil-mapping units that underlie the project site. The Urban land (Up) unit is mapped across the majority of the project site. The Up soil unit is not defined as a hydric soil on the project site. The depth to the water table is not specified for this soil unit. Udorthents, wet

substratum (UwA) soils are mapped in small areas in the eastern and southeastern portions of the project site. The UwA soil map unit is common to flats and has a depth to water table of about 20 to 40 inches. The soil unit is moderately well drained and is not listed as a hydric soil. The Mattapex Soil Series (MtaB) is mapped in a small area in the western corner of the project site. The MtaB soil map unit is common to flats and has a depth to water table of about 20 to 40 inches. The Mattapex Soil Series is not listed as a hydric soil. The Delaware River is underlain by the map unit Water (W), which denotes open water.

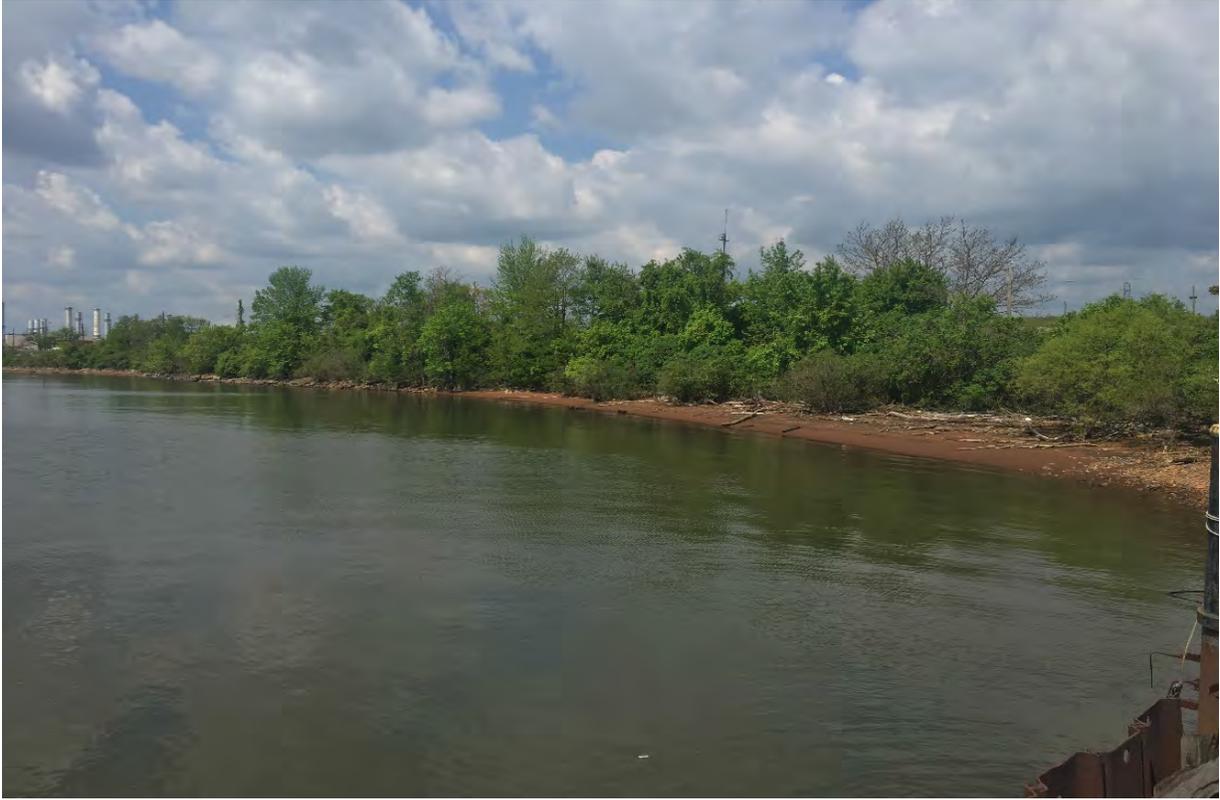
Photograph 1 -View of southern portion of the Delaware Riverbank on the project site.

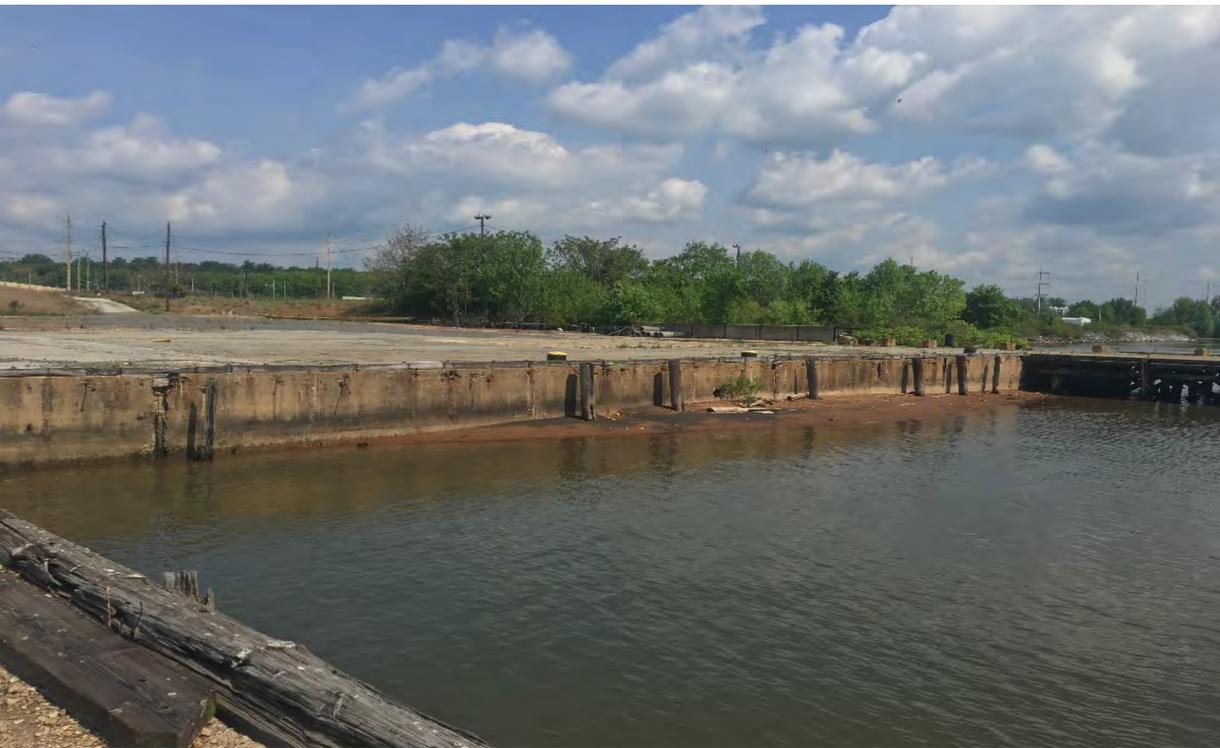
Photograph 2 - View of central portion of the Delaware Riverbank on the project site.

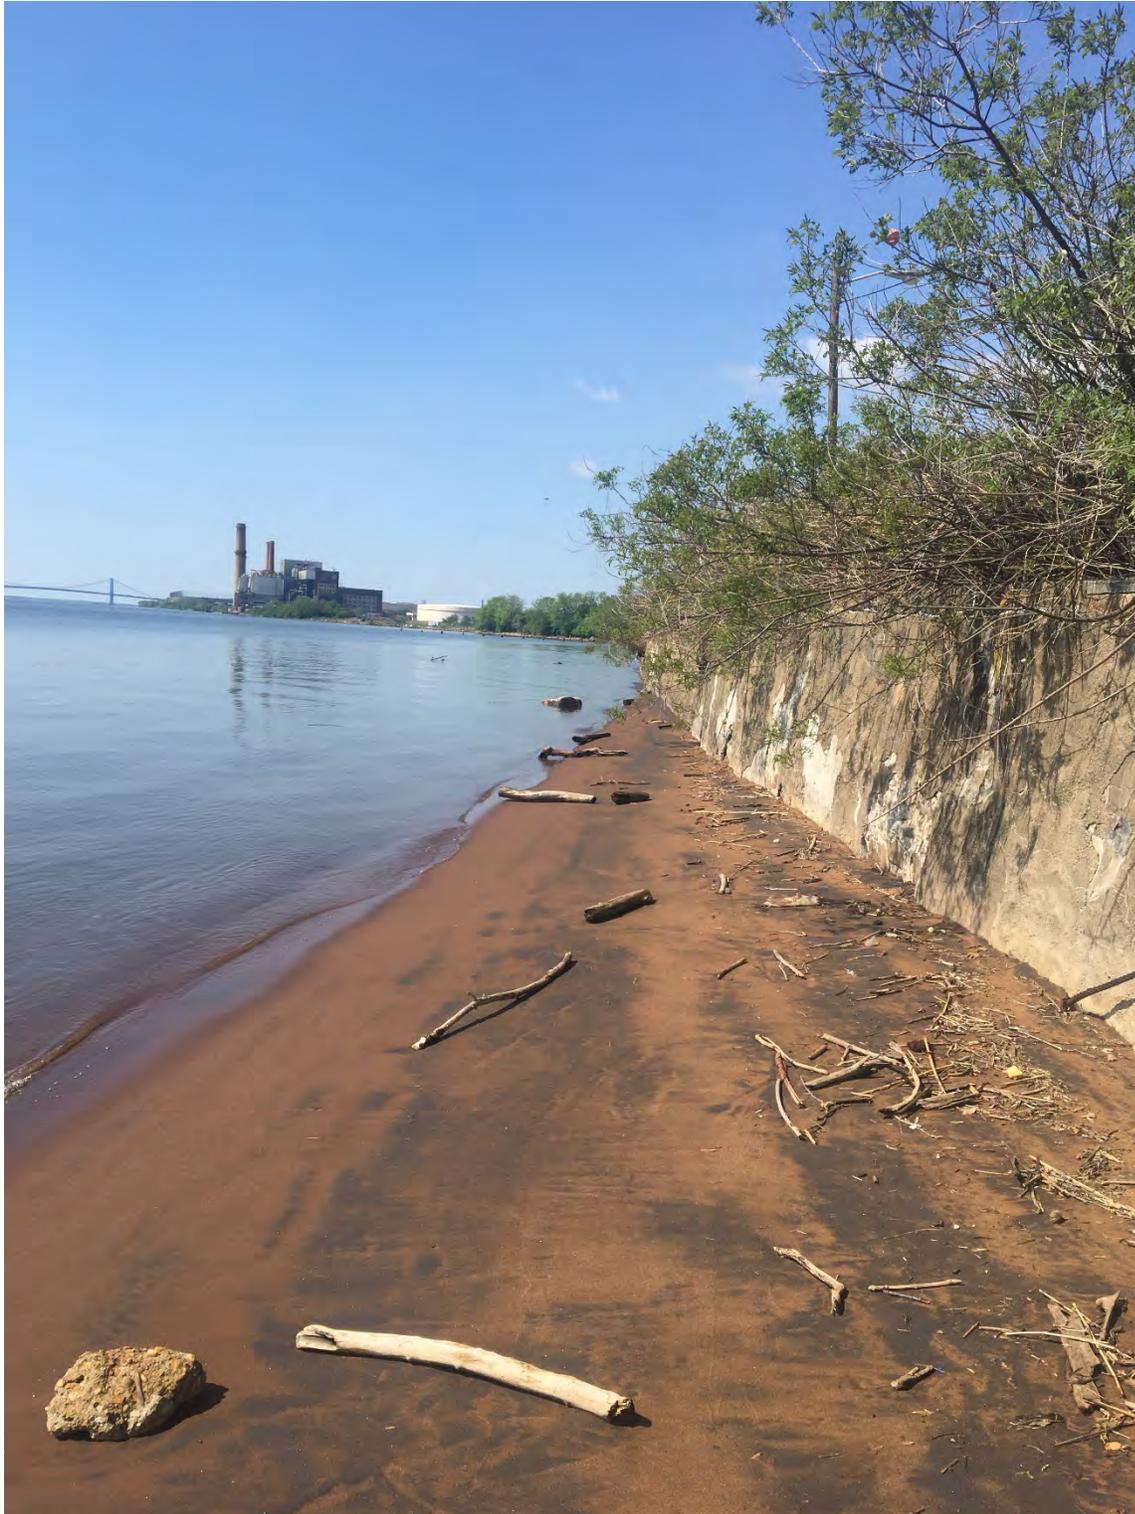
Photograph 3 – View of seawall along the Delaware River, looking south. Drift deposits along the seawall depict the approximate location of the Mean High Waterline.

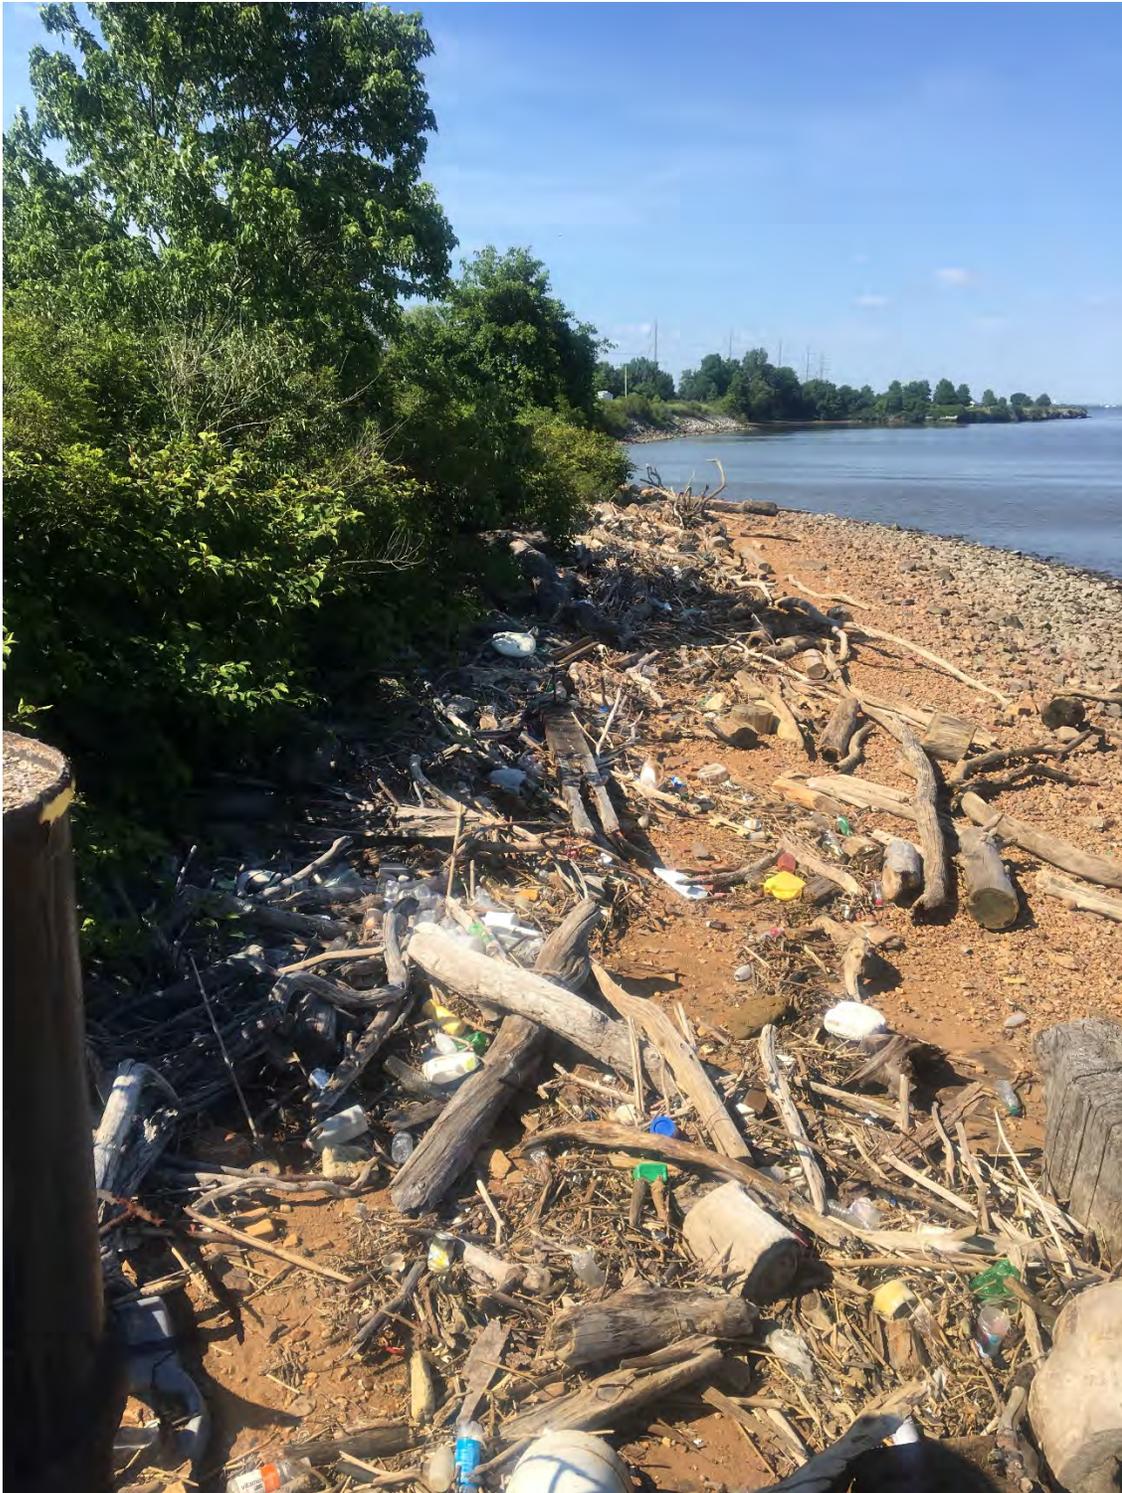
Photograph 4 – Trash and driftwood along the Delaware Riverbank depicting the approximate location of the Mean High Waterline.

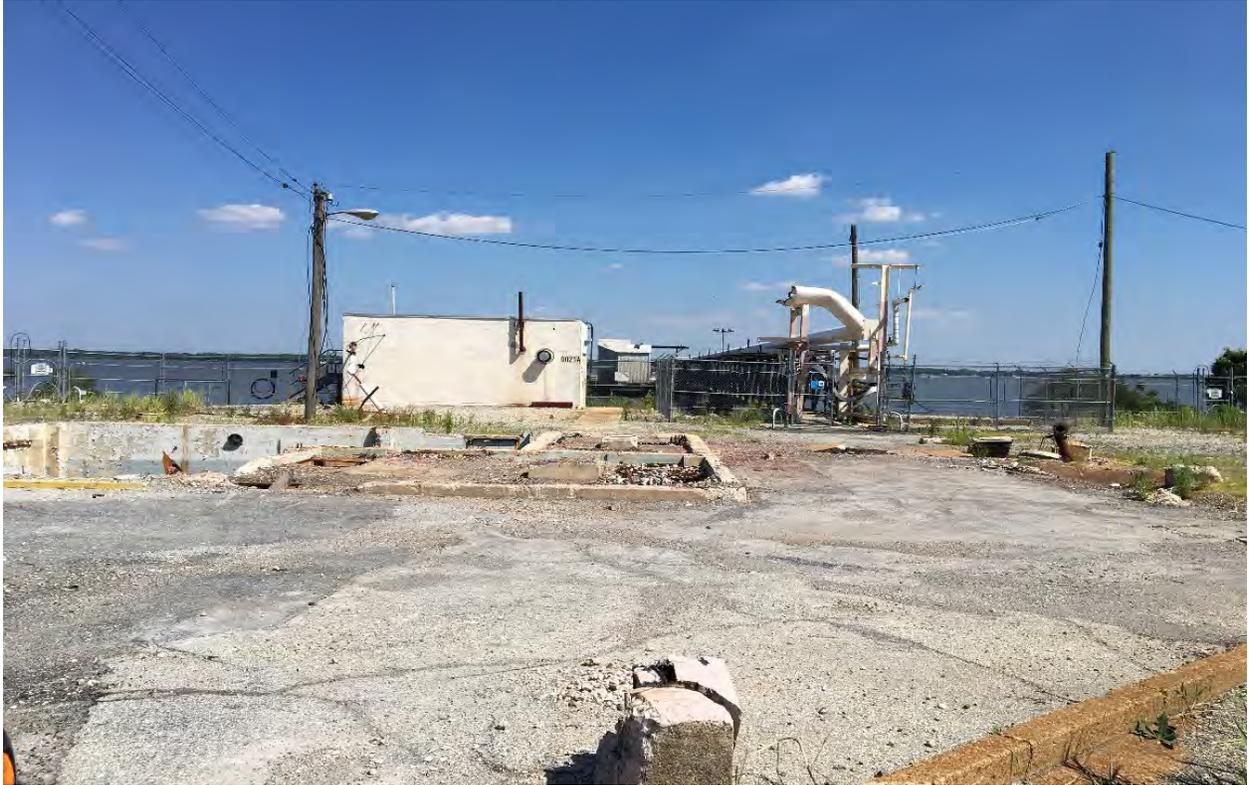
Photograph 5 – View of bridge and infrastructure debris in the center of the project site, looking east towards the Delaware River.

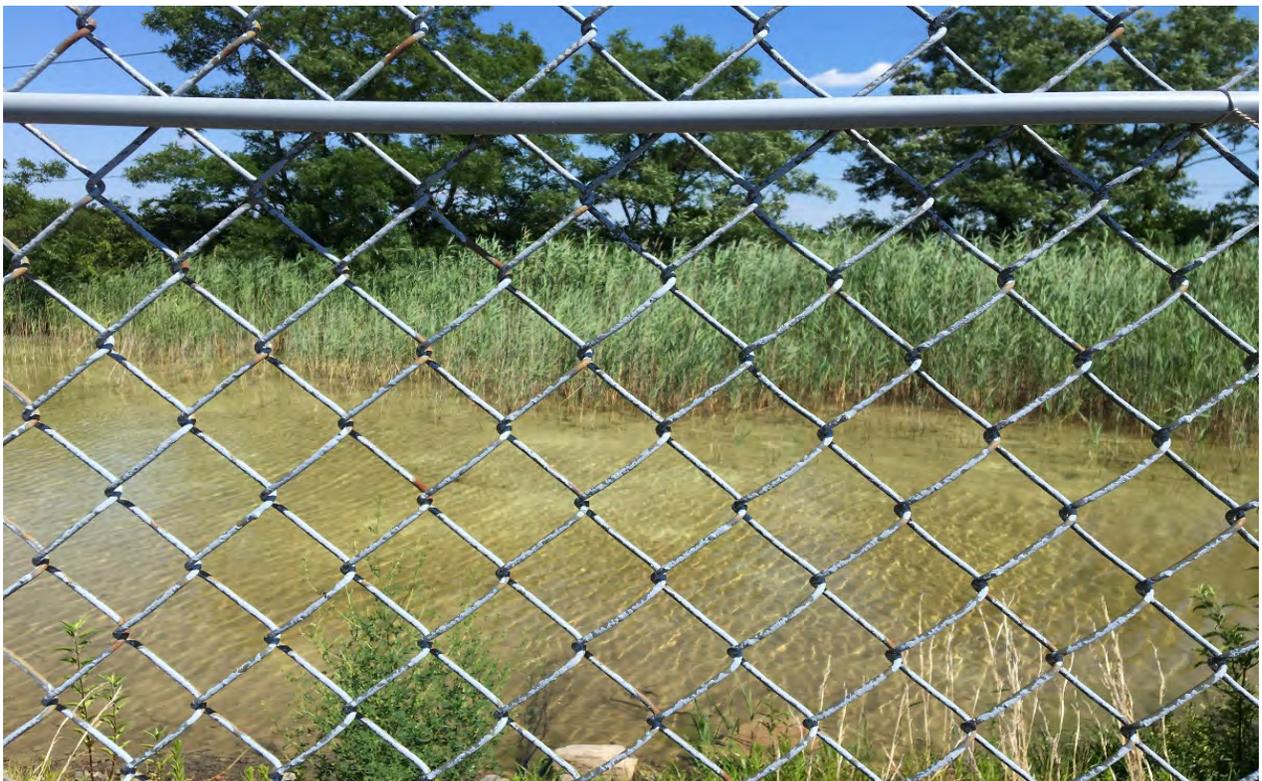
Photograph 6 – View of existing lagoon.

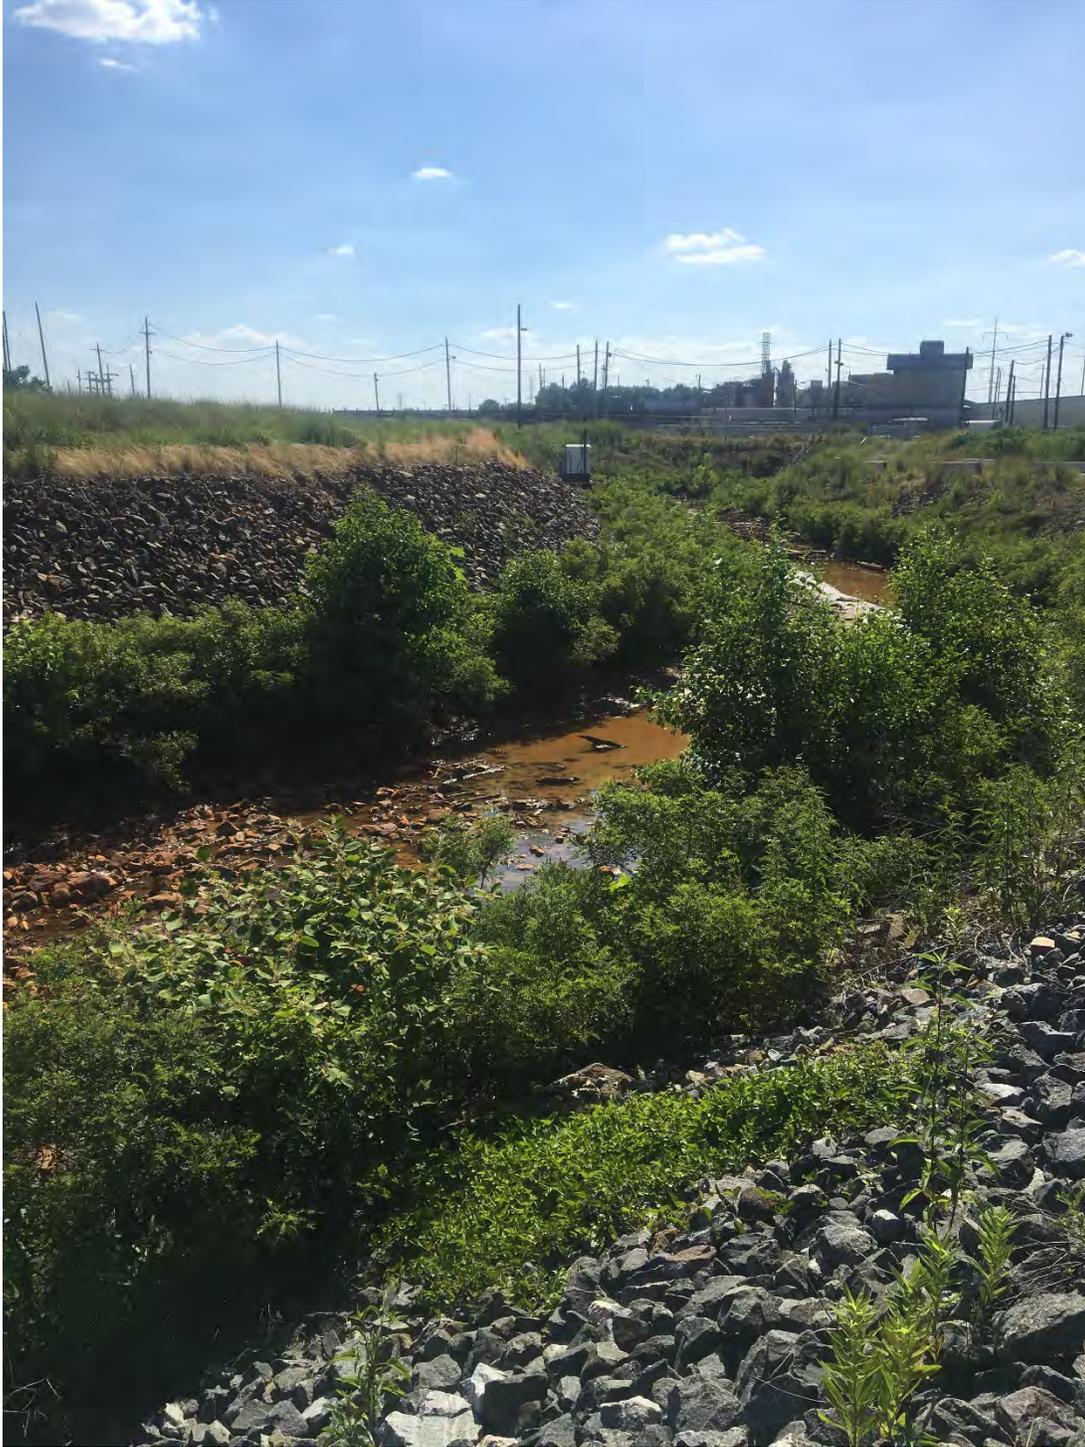
Photograph 7 – View of channel located on the project site, looking west. The channel drains from and offsite location into the Delaware River.

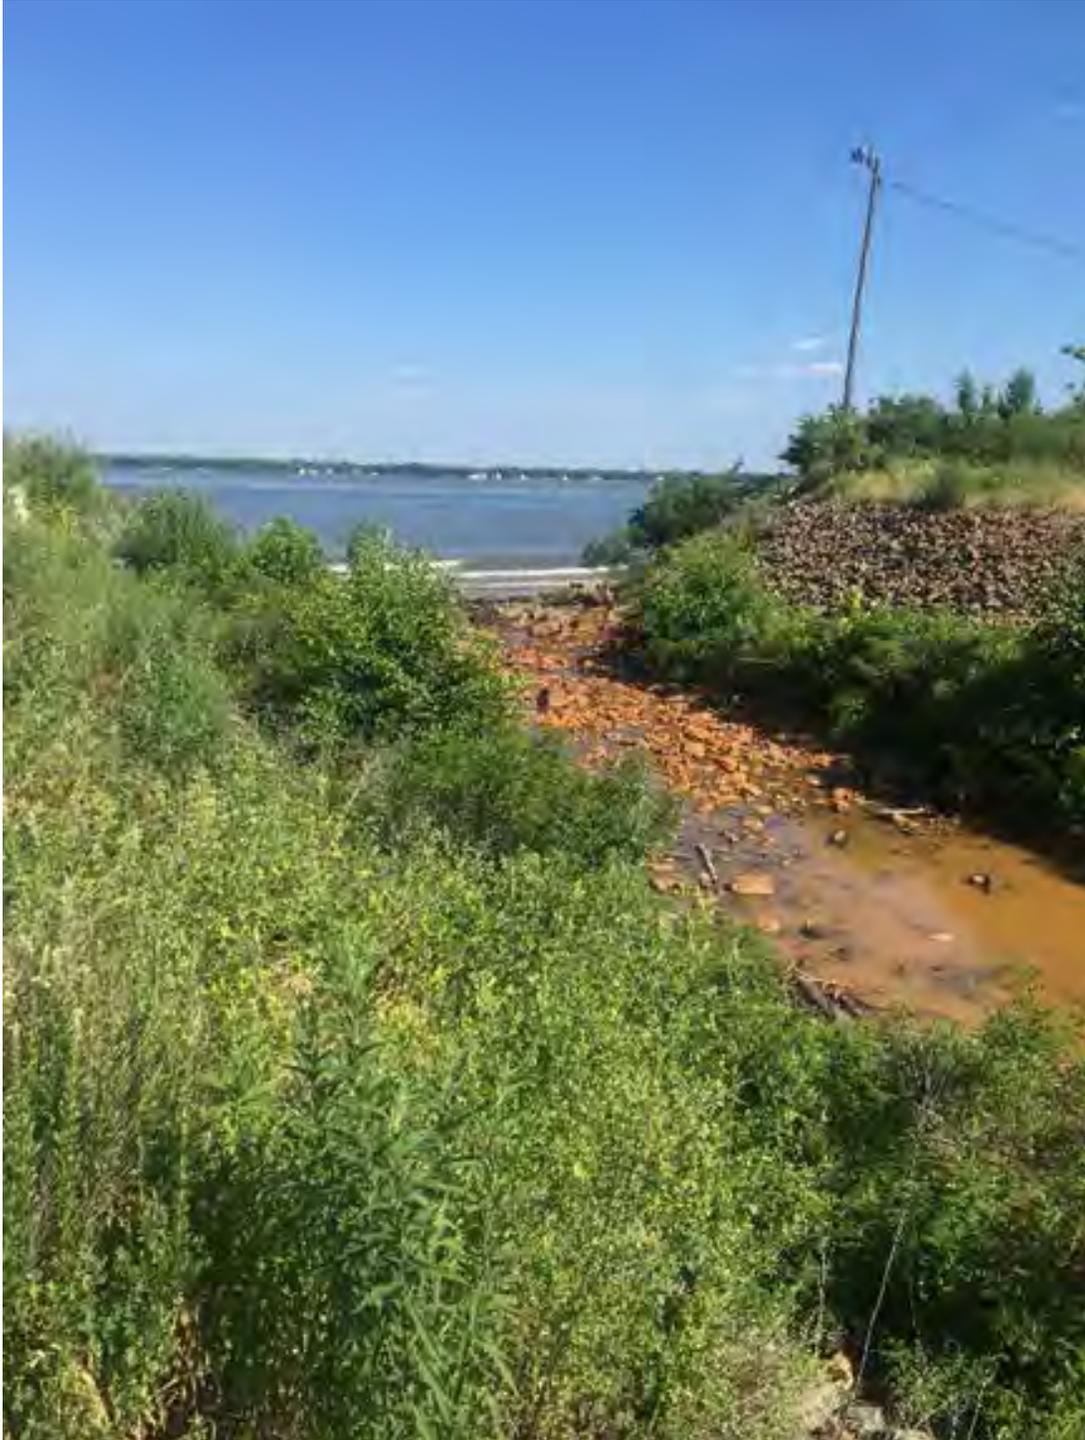
Photograph 8 – View of channel flowing into the Delaware River, looking east.

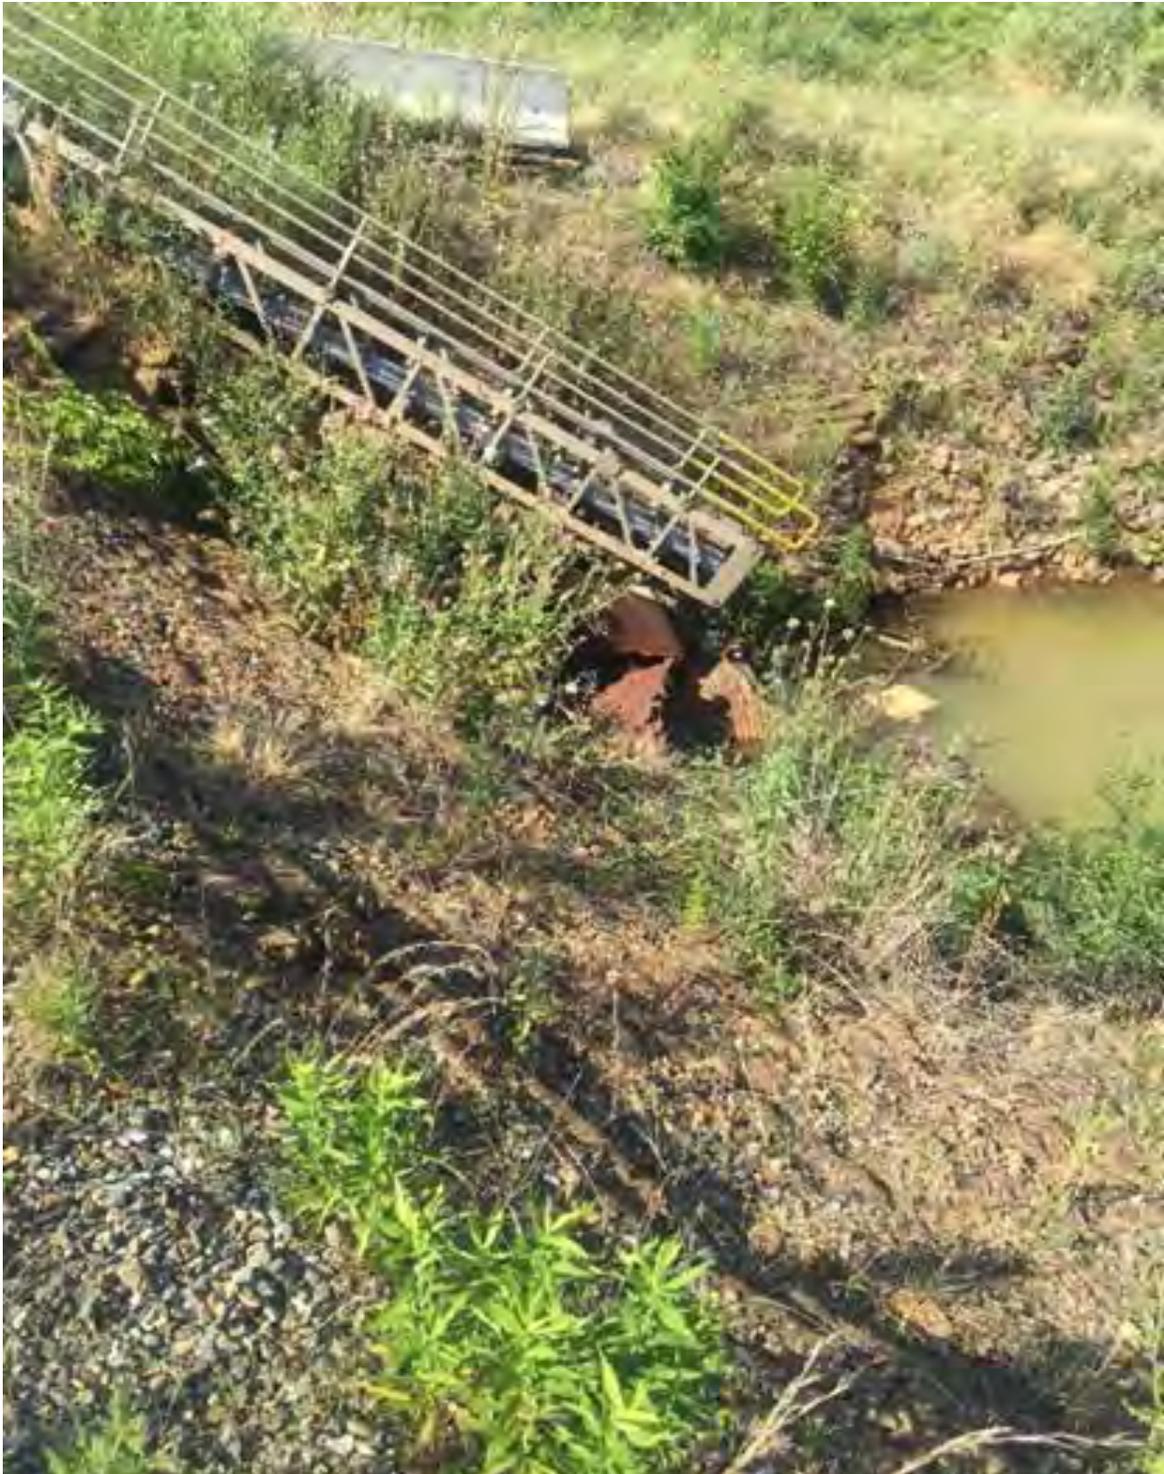
Photograph 9 – View of pipe that carries flow from an offsite location into the channel.

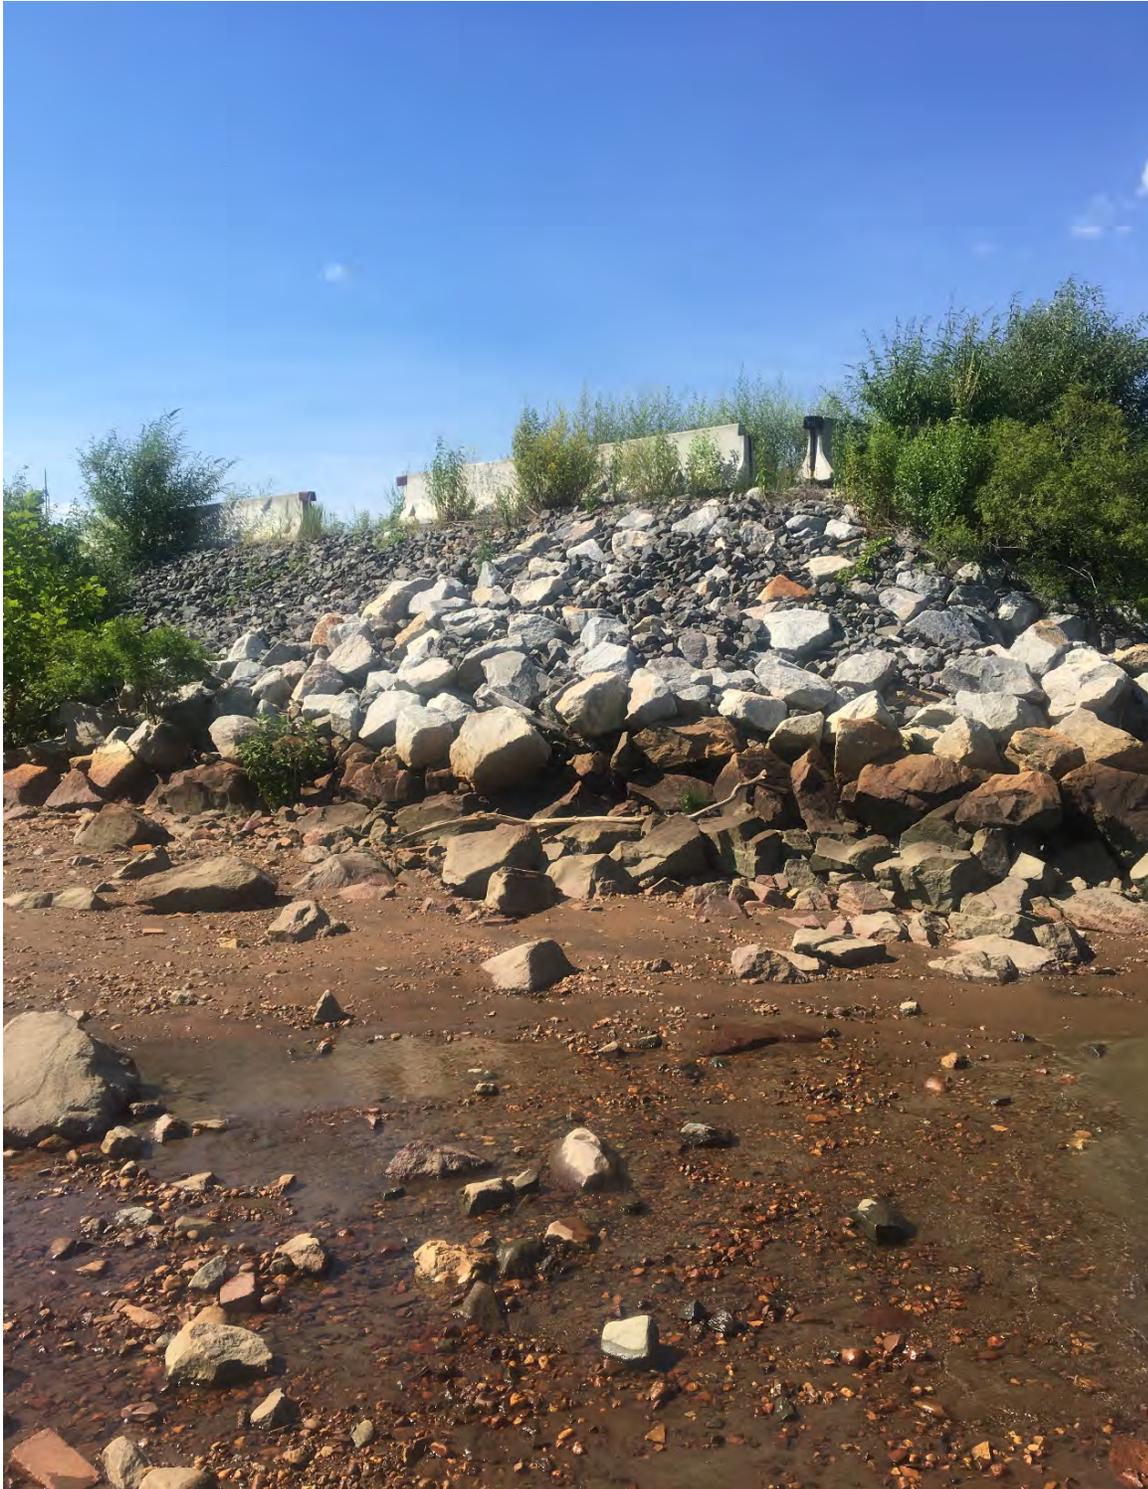
Photograph 10 – View of riprap along the channel, looking north.

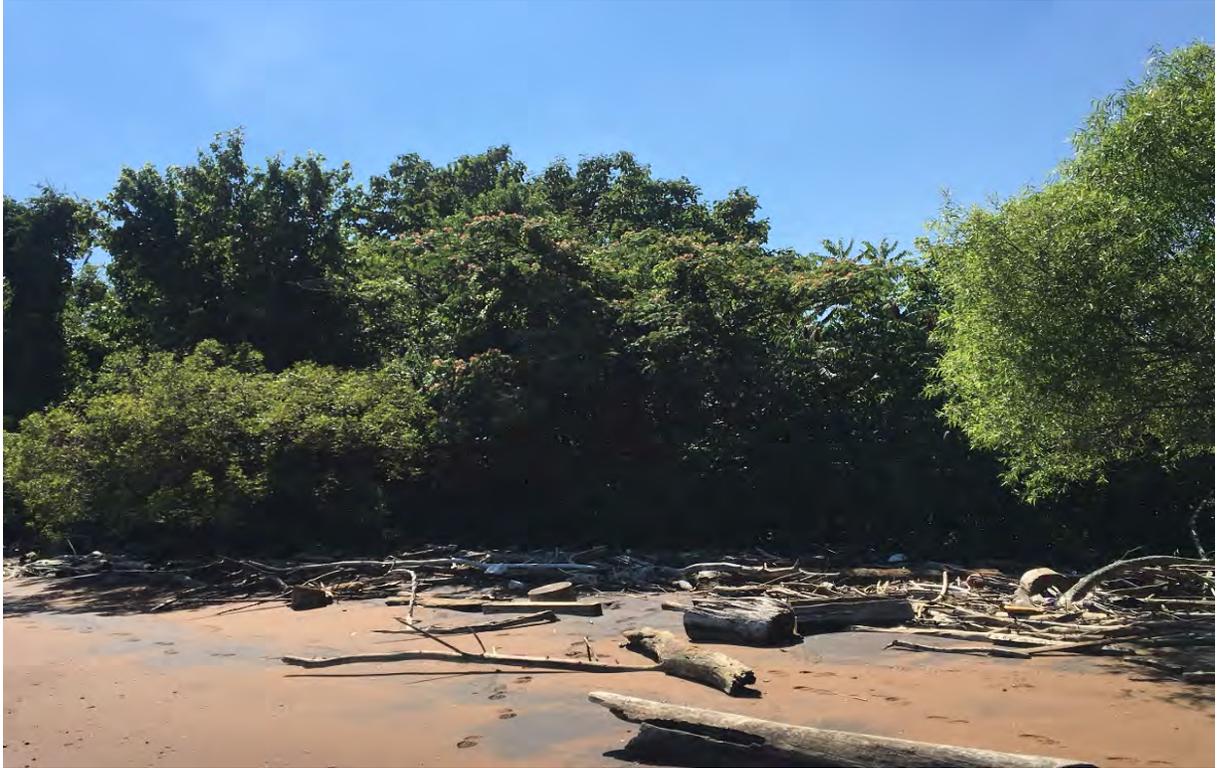
Photograph 11 – Location of Sample Point 1.

Refer to the data form in Appendix B for Data Point 1 that was completed in the Forested Upland community for additional information. The sample point was collected approximately 6 feet above the watercourse, during a low-tide event.
