WETLAND DELINEATION REPORT

DIAMOND STATE PORT CORPORATION
4600 HAY ROAD
WILMINGTON, DELAWARE

October 23, 2019

Project No. 11139.LH

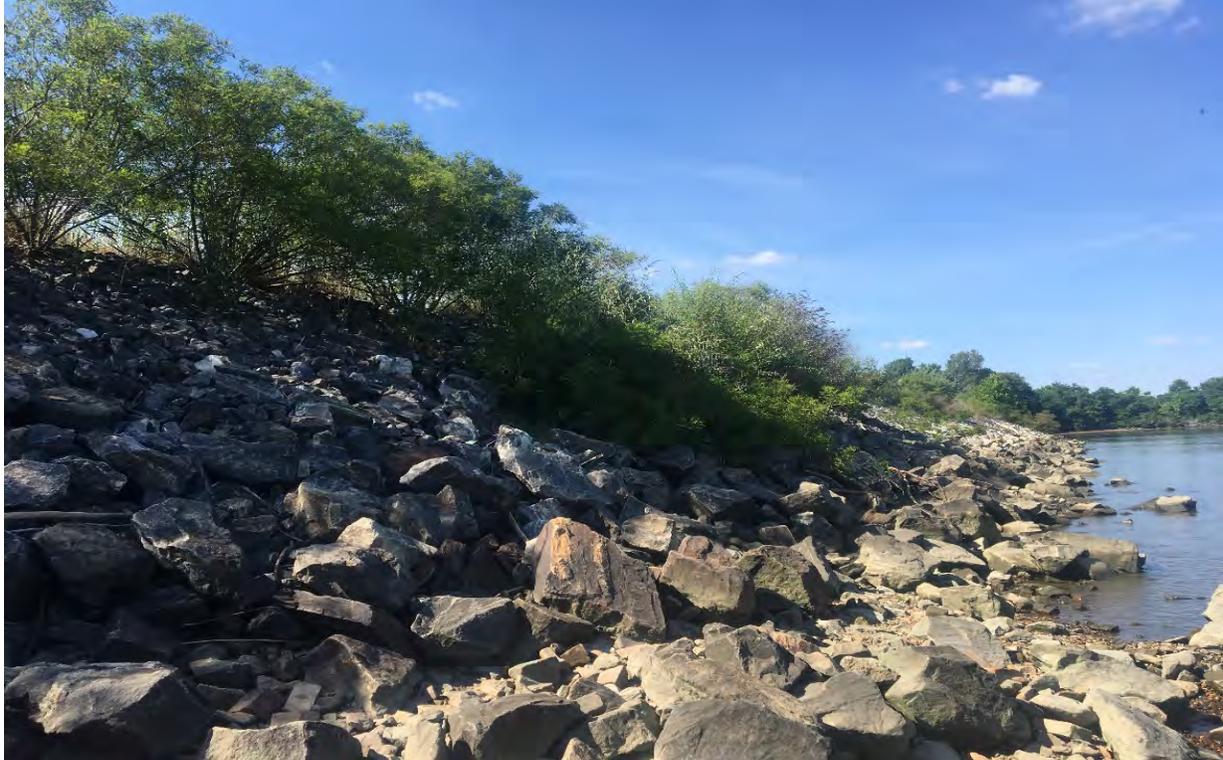
Photograph 12 – Location of Sample Point 2.

Refer to the data form in Appendix B for Data Point 2 that was completed in the Scrub-shrub Upland community for additional information. The sample

point was collected approximately 6 feet above the watercourse, during a low-tide event.
