PCB Mass Loading Phase II  
Chicago Bridge & Iron Site  
SIRS IDs: DE-0038, DE-1038  
New Castle, Delaware

# **CHICAGO BRIDGE & IRON SITE**

## **PCB MASS LOADING SUMMARY**

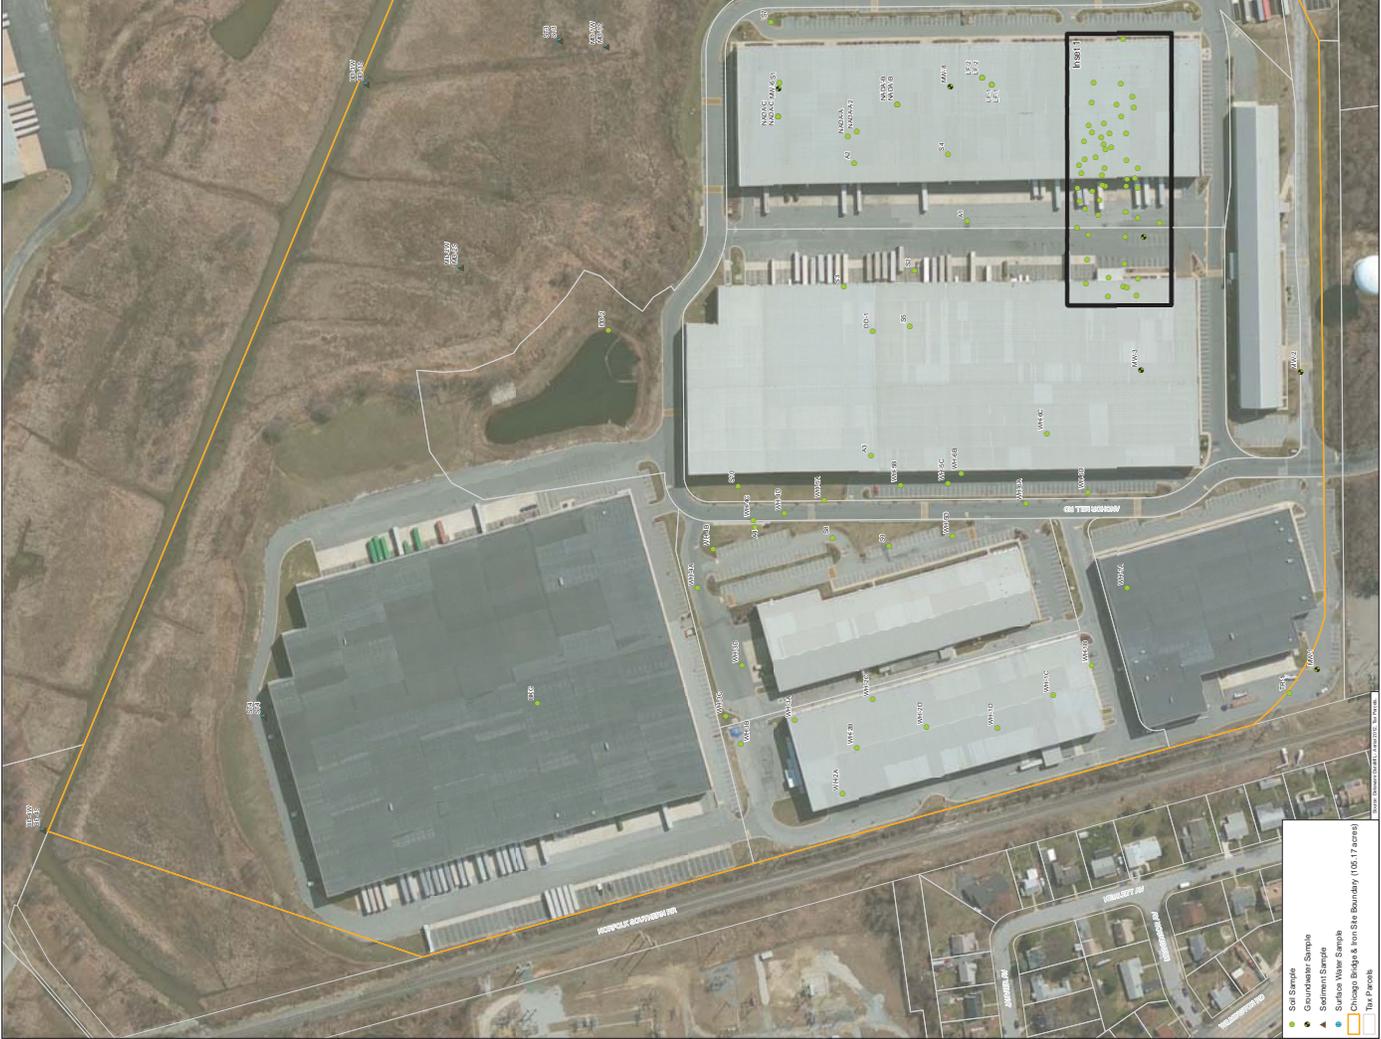
**Historic Sample Locations**  
Chicago Bridge & Iron Site  
New Castle, Delaware

- Soil Sample
- Groundwater Sample
- ▲ Surface Water Sample
- Chicago Bridge & Iron Site Boundary (100-17 acres)
- The Pools

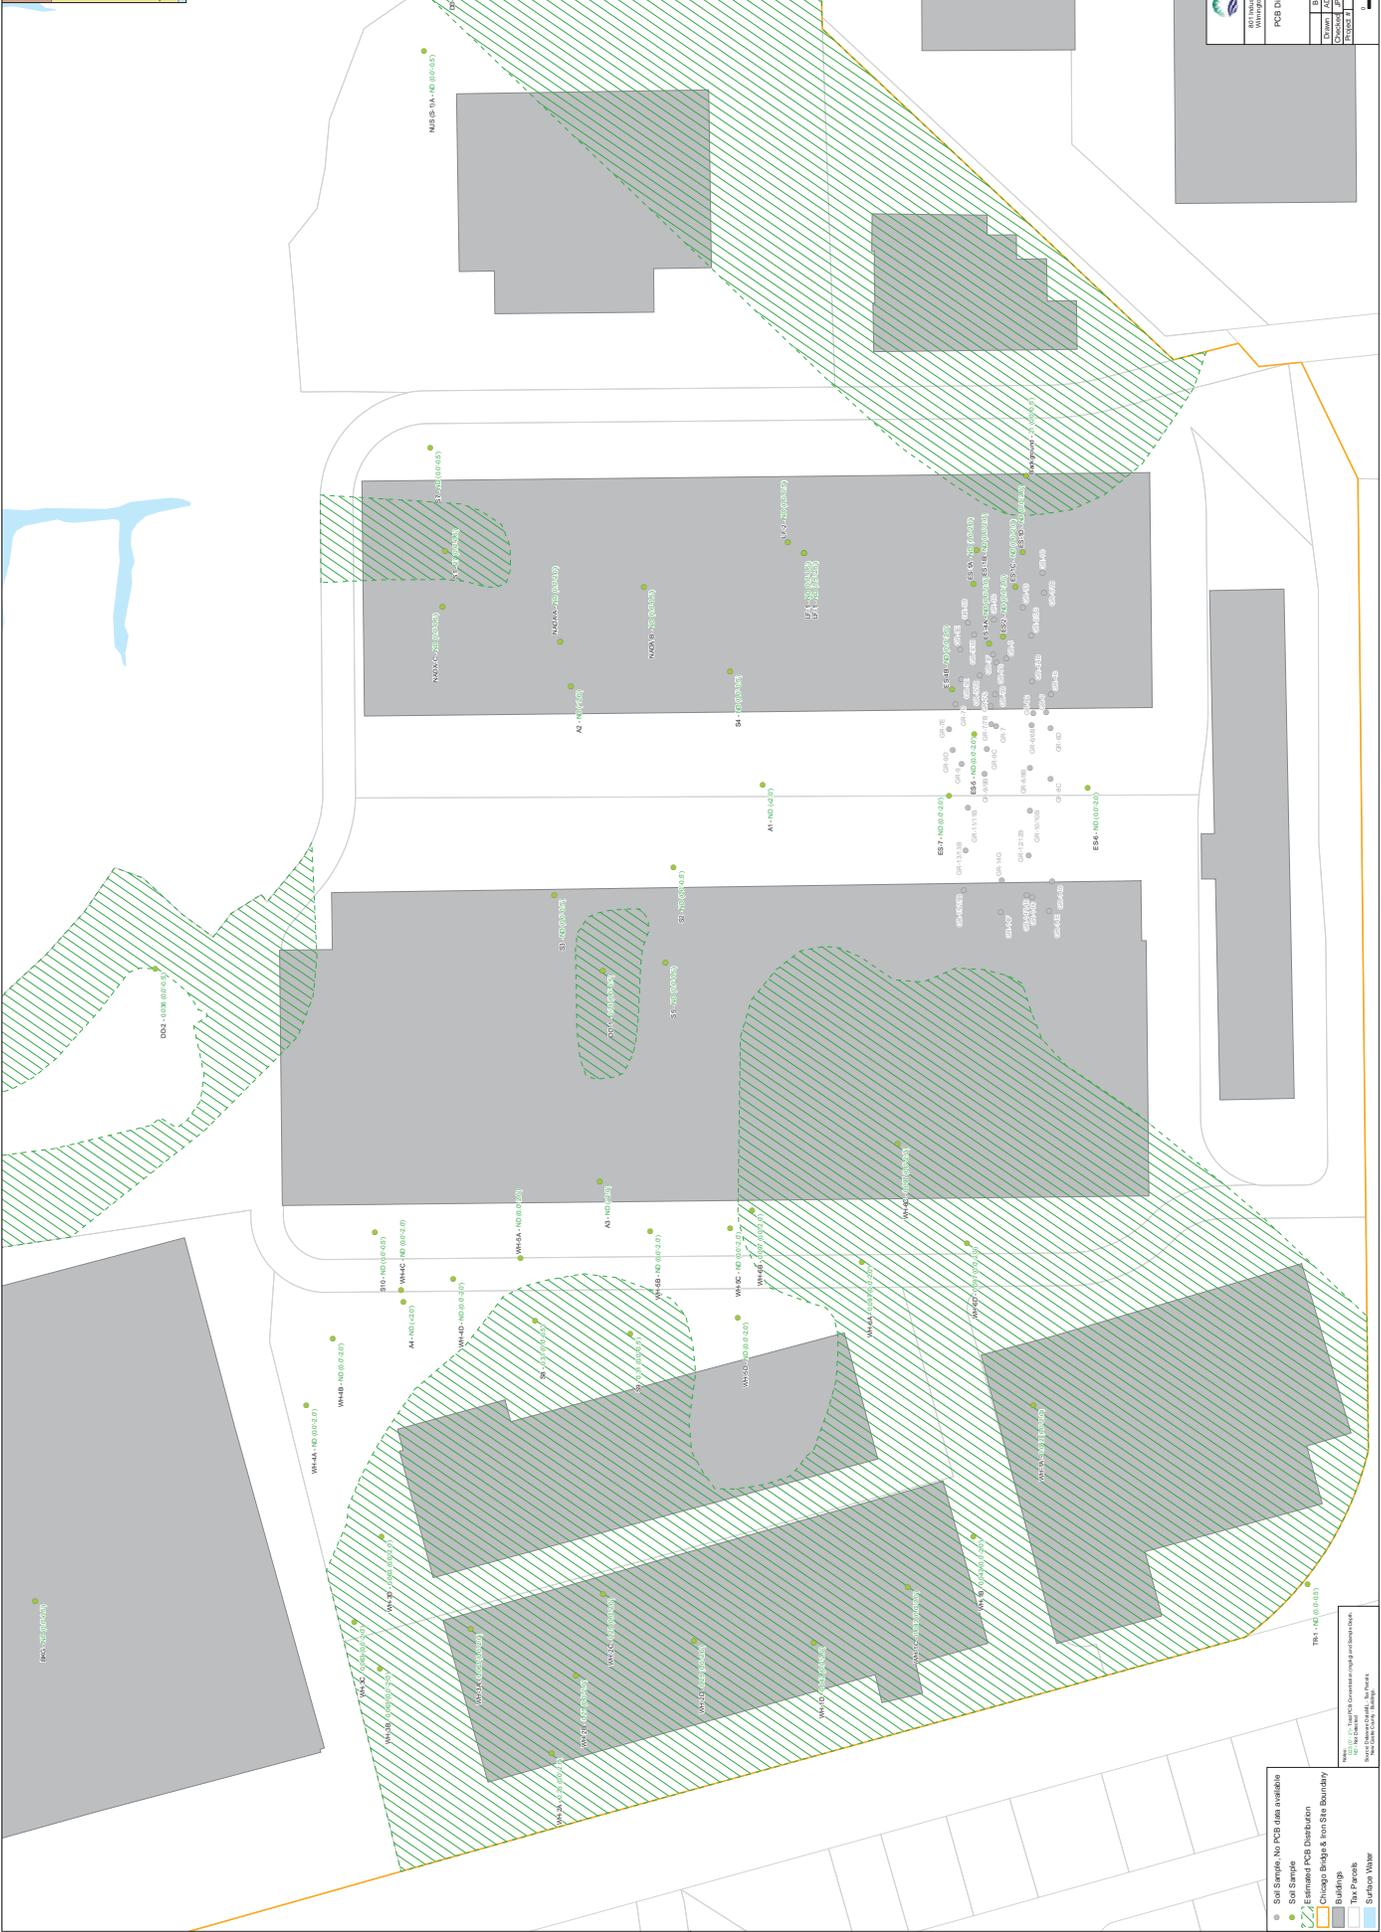
**PCB Distribution in Surface Soil (P - 2 pg)**  
 Chicago Bridge & Iron Site  
 Near Coast, Indiana

- Soil Sample, No PCB data available
- Soil Sample
- Estimated PCB Distribution
- Chicago Bridge & Iron Site Boundary
- Buildings
- Tax Parcels
- Surface Water

Notes:  
 1. "N" indicates No Data available for this sample and sample depth.  
 2. "D" indicates Data available for this sample and sample depth.  
 3. "P" indicates PCBs detected in this sample and sample depth.

Concentrations of PCBs on Site			
Sample Matrix	Corresponding Figure	Analytical Methods	Range of Total PCBs
Surface Soil	Figure 2	Method 8082	Not detected to 27 mg/kg
Subsurface Soil (unsaturated)	Figure 3	Method 8082	Not Detected
Subsurface Soil (saturated)	Figure 4	Not Analyzed	Not Analyzed
Groundwater	Figure 5	Method 8082	Not Detected

The estimated surface soil impacted by PCBs is 24.5 acres (Figure 2). Based on the data available and reviewed by BrightFields, the subsurface soil and groundwater are not impacted by PCBs.

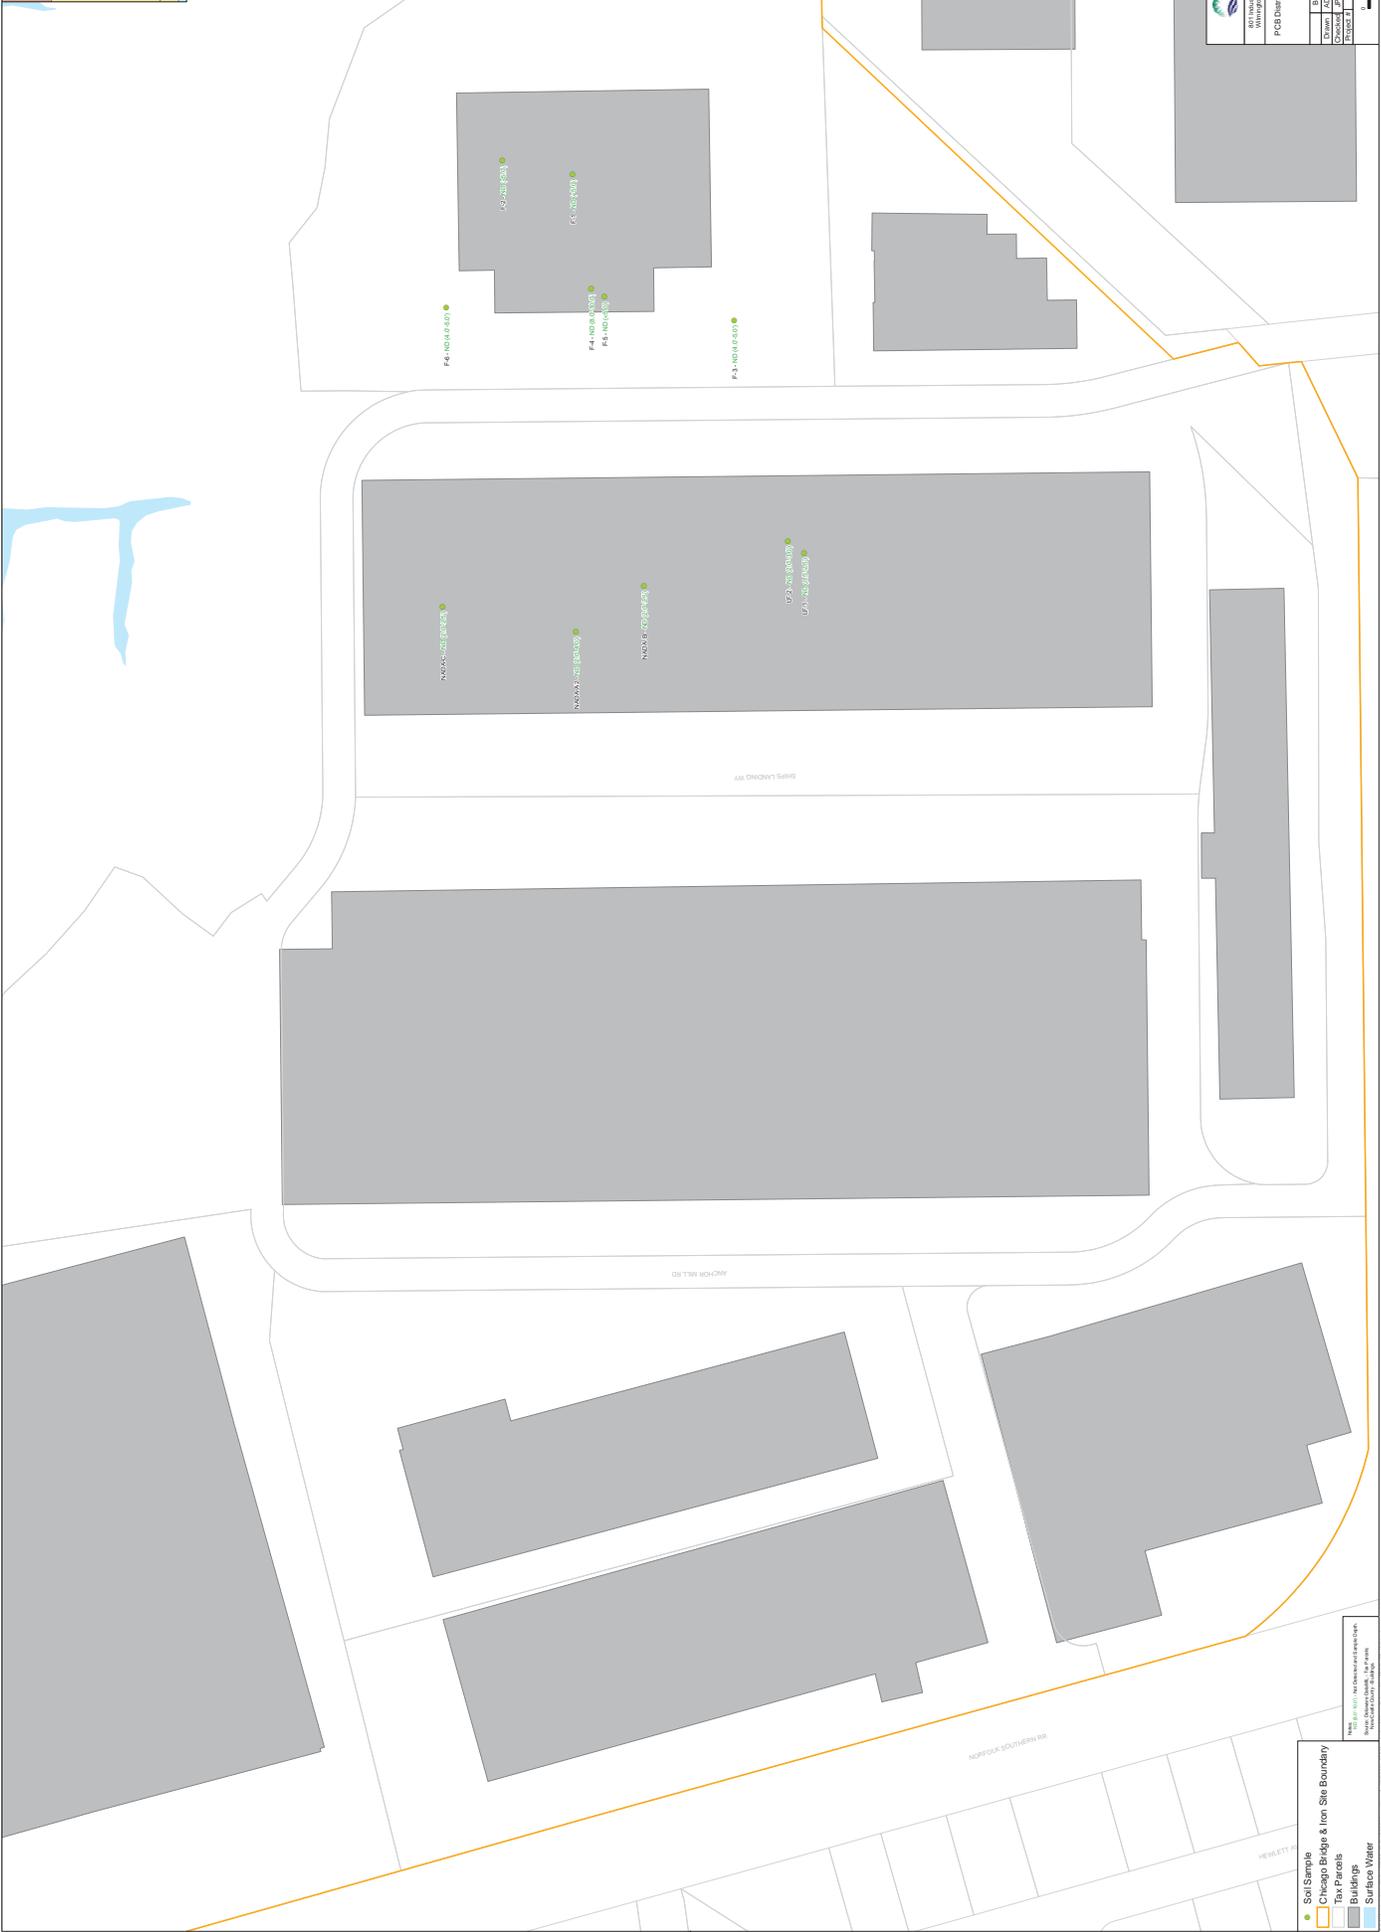
PCB Distribution at Surface Unsatrated Soil  
 Chicago Bridge & Iron Site  
 Westmont, Indiana

- Soil Sample
- ▭ Chicago Bridge & Iron Site Boundary
- ▭ Tax Parcels
- ▭ Buildings
- ▭ Surface Water

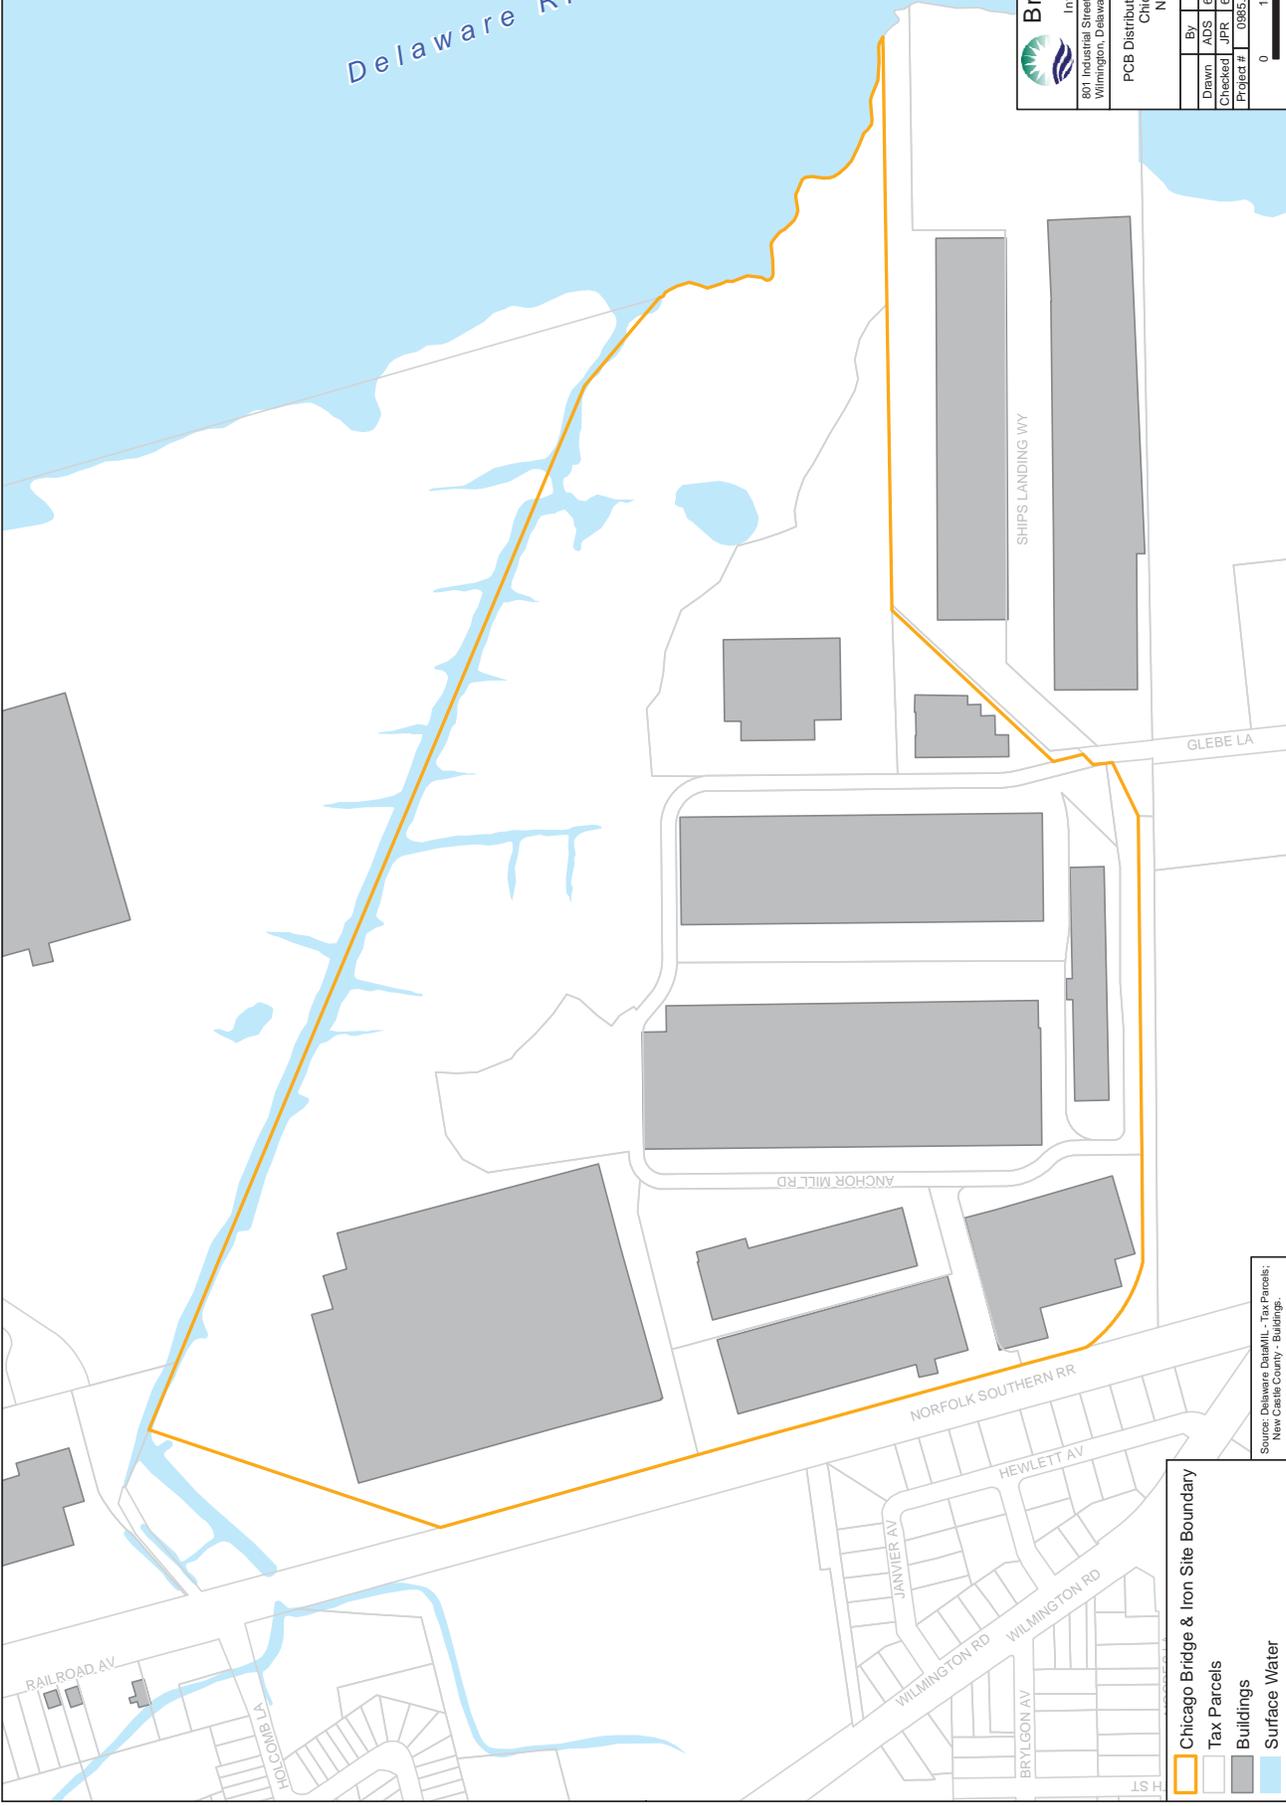
PCB Distribution in Subsurface Saturated Soil  
 Chicago Bridge & Iron Site  
 New Castle, Delaware

- Chicago Bridge & Iron Site Boundary
- Tax Parcels
- Buildings
- Surface Water

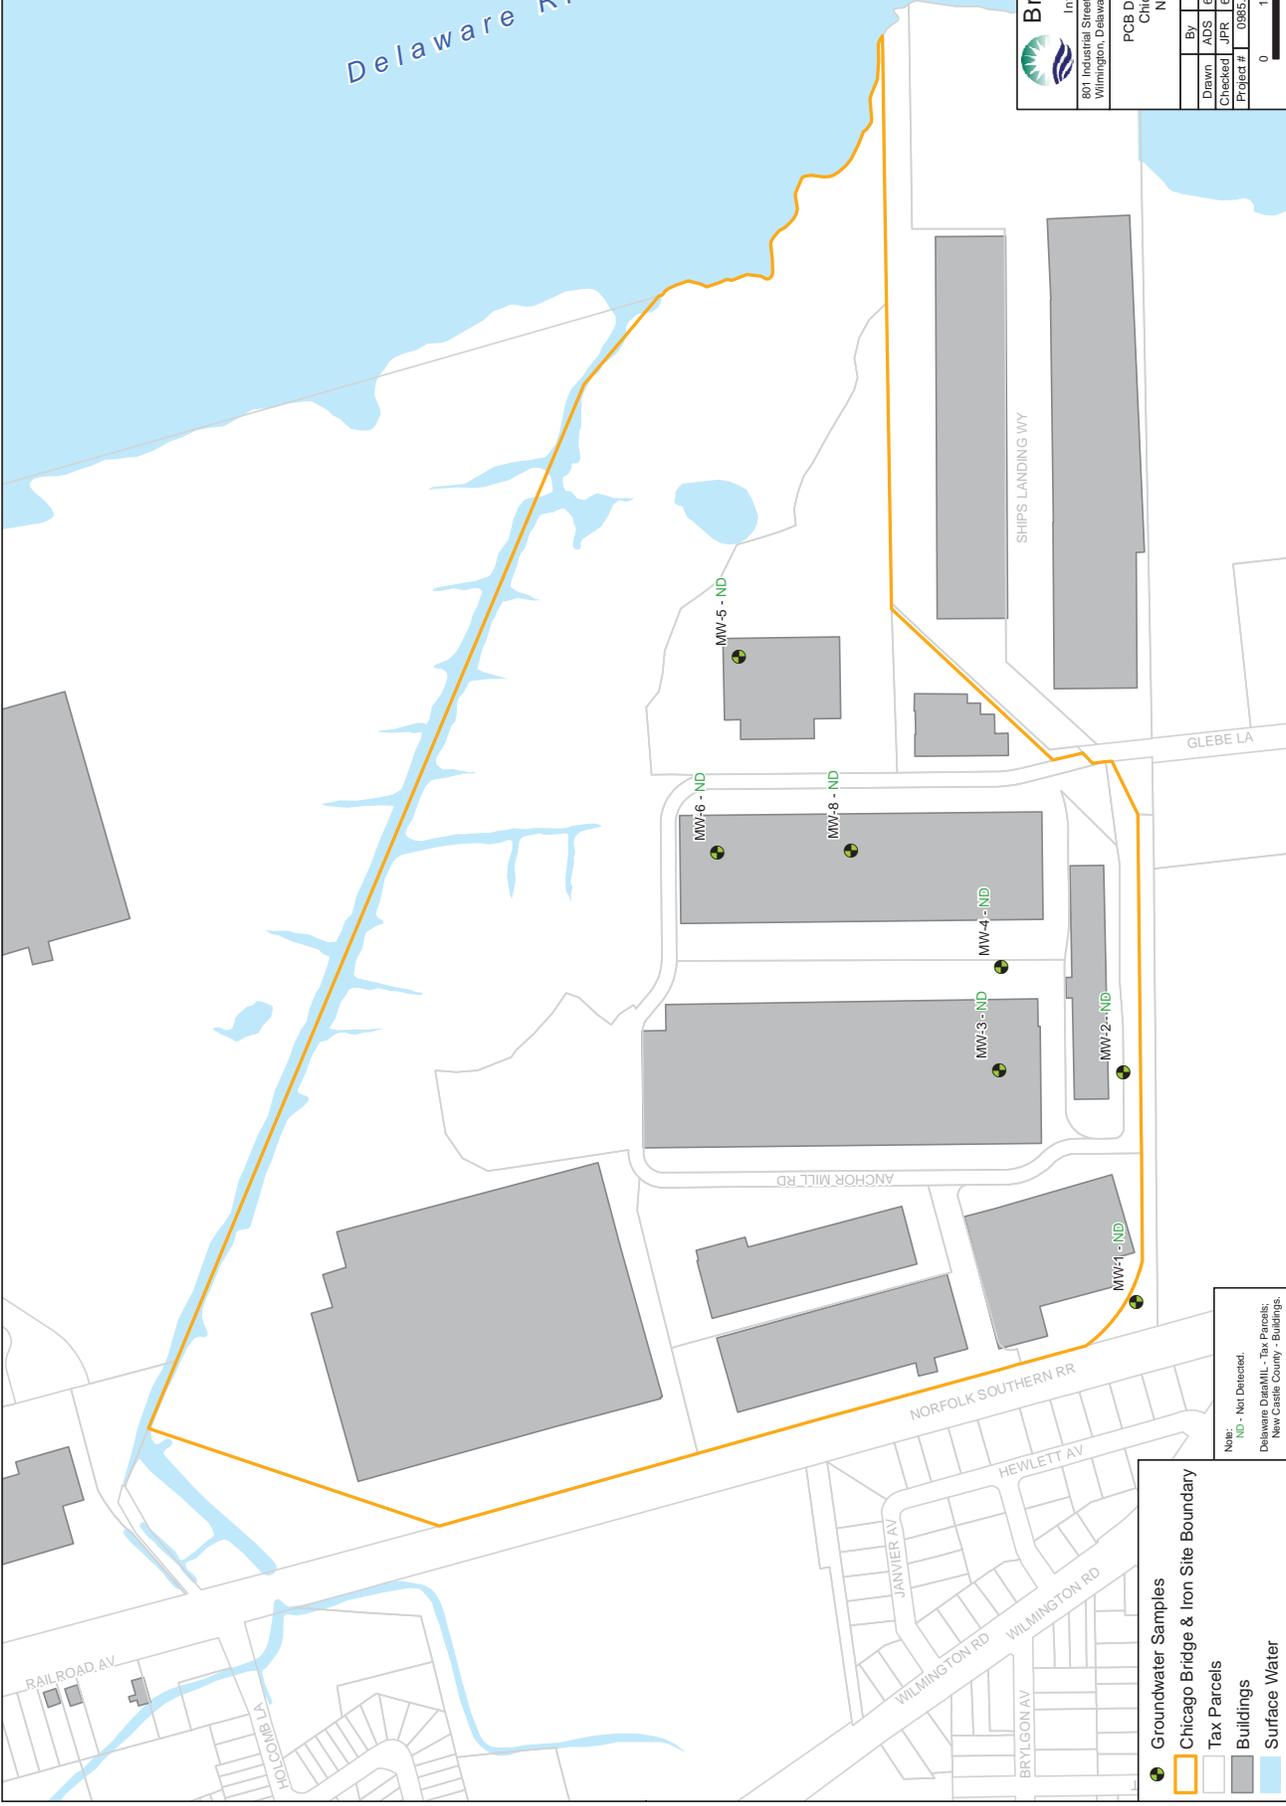
PCB Distribution in Groundwater  
 Chicago Bridge & Iron Site  
 New Castle, Delaware

Note:  
 ND - Not Detected.  
 Delaware DataMILL - Tax Parcels;  
 New Castle County - Buildings.

- Groundwater Samples
- Chicago Bridge & Iron Site Boundary
- Tax Parcels
- Buildings
- Surface Water

FIG. 5 - PCB DISTRIBUTION IN GROUNDWATER, CHICAGO BRIDGE & IRON SITE, NEW CASTLE COUNTY, DELAWARE. DATE: 6/19/2014. PROJECT: 0985.69.51. FIG. NO.: 5. SCALE: 1:3,000. DRAWN: ADS. CHECKED: JPR.

There were no PCBs detected in groundwater.

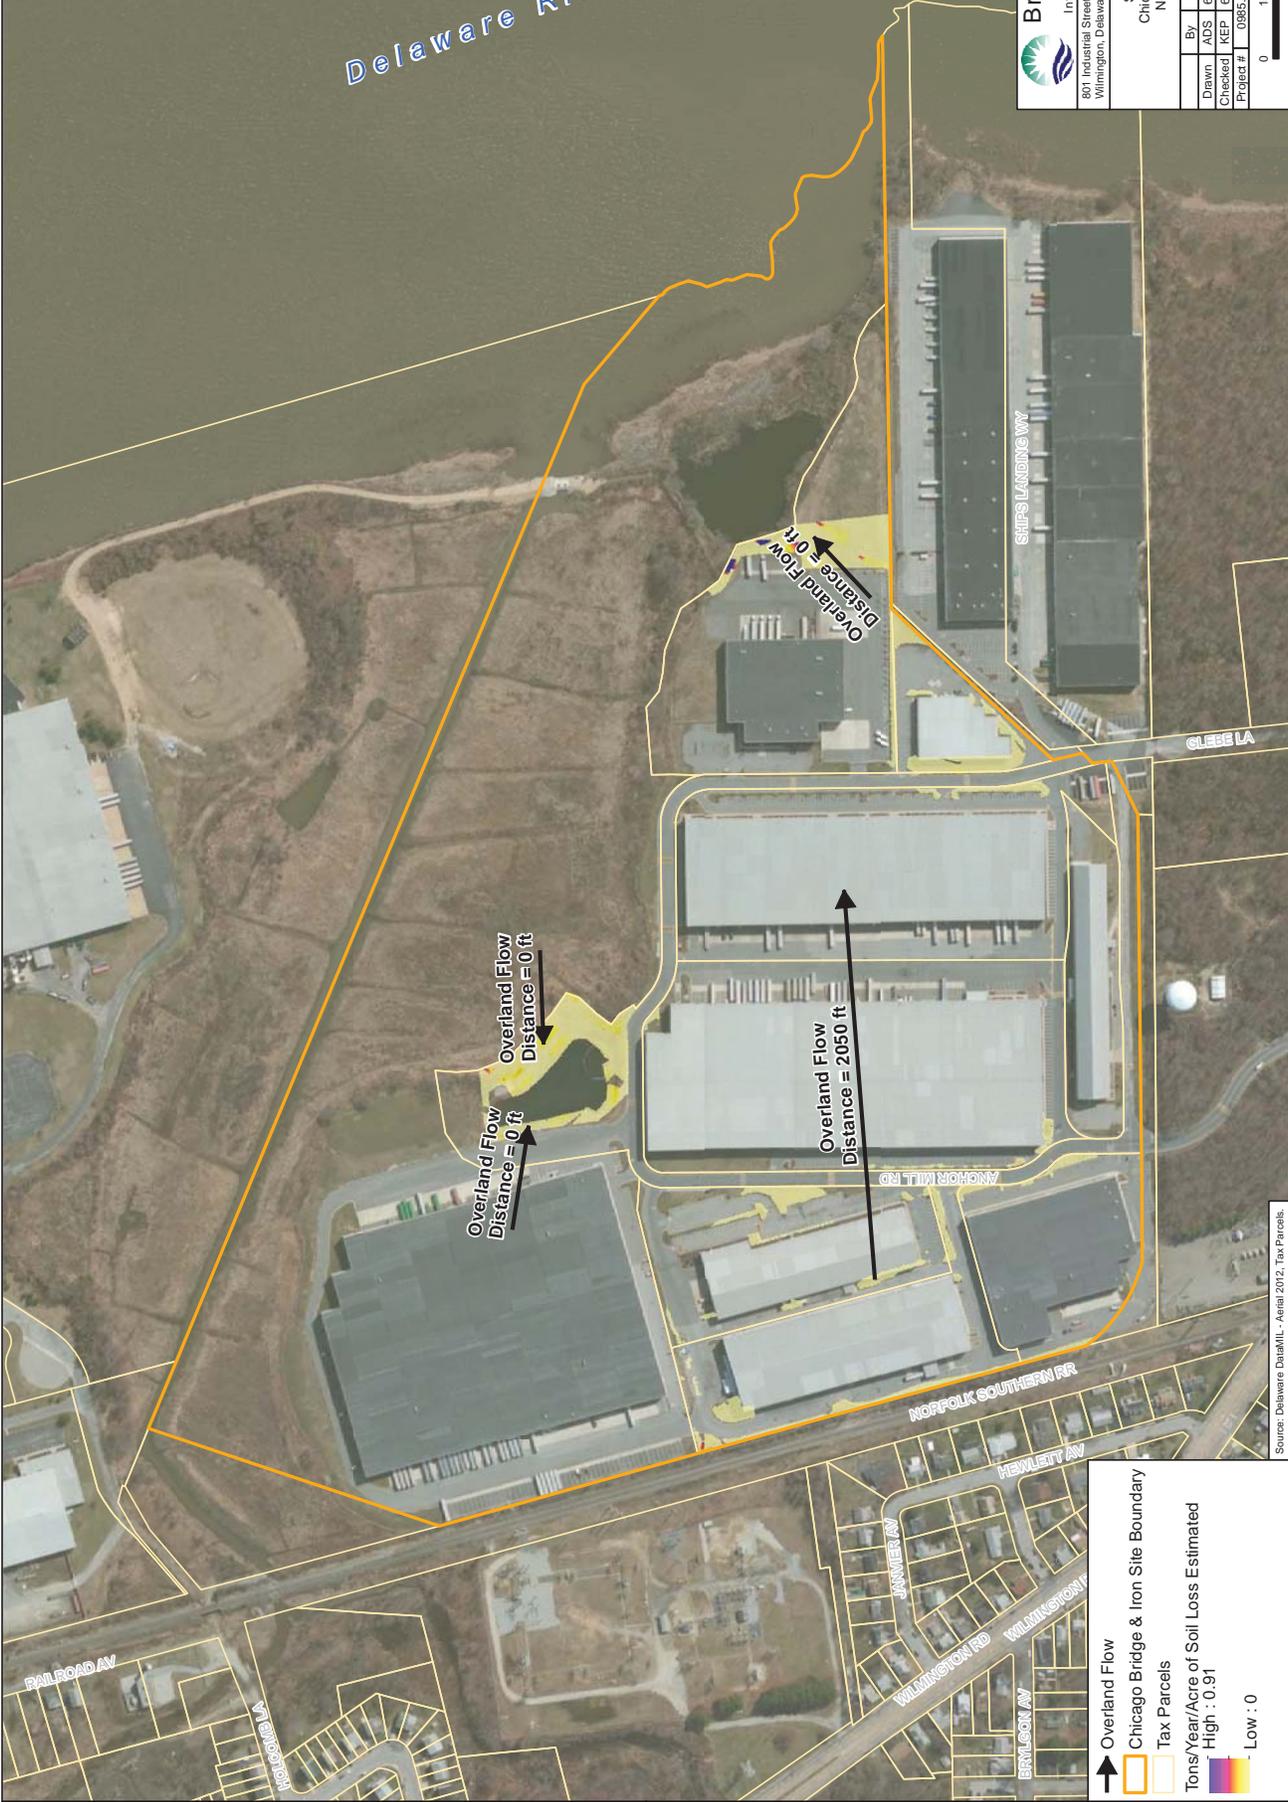
Soil Loss Estimates  
 Chicago Bridge & Iron Site  
 New Castle, Delaware

↑ Overland Flow  
 □ Chicago Bridge & Iron Site Boundary  
 □ Tax Parcels  
 Tons/Year/Acre of Soil Loss Estimated  
 High : 0.91  
 Low : 0

P = support practice factor (dimensionless)	1	There are two retention ponds located on the Site, but a support practice factor of 1 was utilized to be conservative.
A = average annual soil loss estimate (ton/ac-yr)	0.0083	The average soil loss estimate was generated by ArcGIS using the input factors listed above.
Erodible Area (acres)	3.6	The erodible area was calculated based on the pervious surfaces within the area of concern polygon for surface soil (Figure 6).

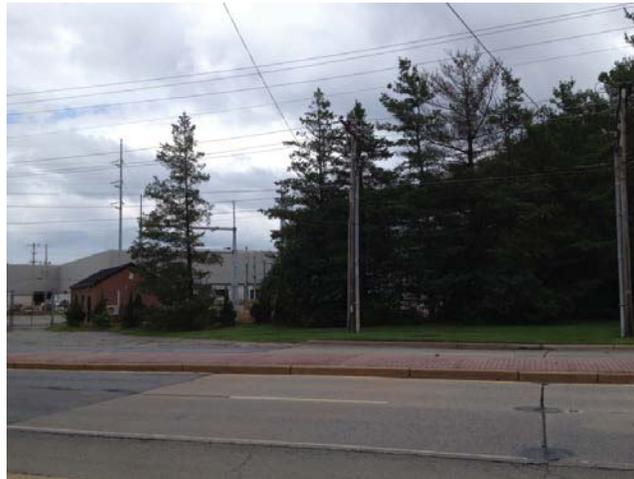
The site from across Route 9 looking onto the western corner of the site. The site looks fairly flat with large trees along the border.

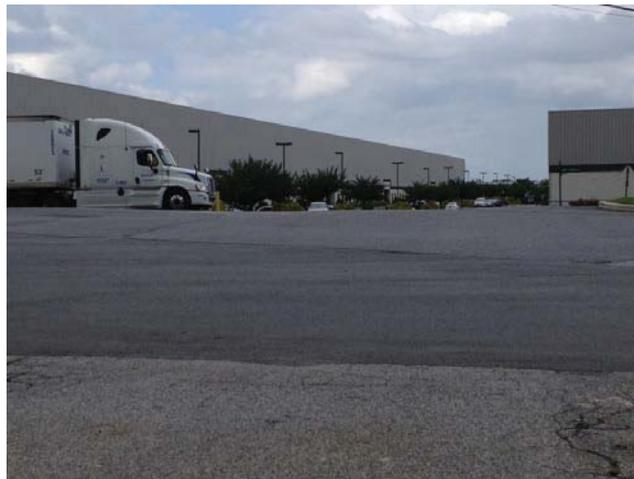
Looking towards the middle of the site from the south where the paved area looks flat but slopes downwards in the distance. There are some trees and landscaped areas in the middle around the buildings as well.

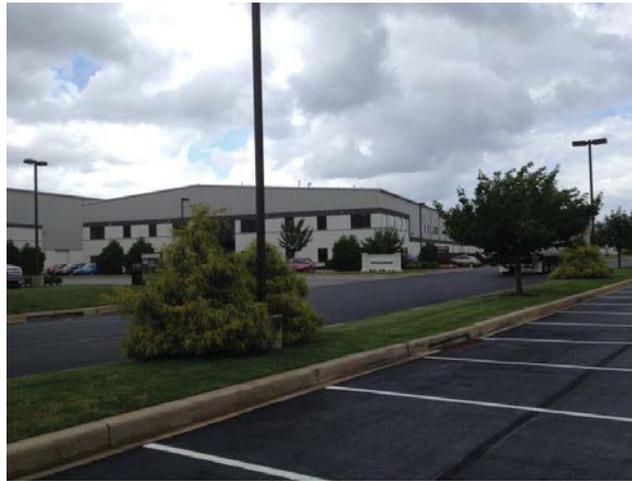
In the middle of the site where there are parking lots and landscaped areas between the large warehouse buildings.

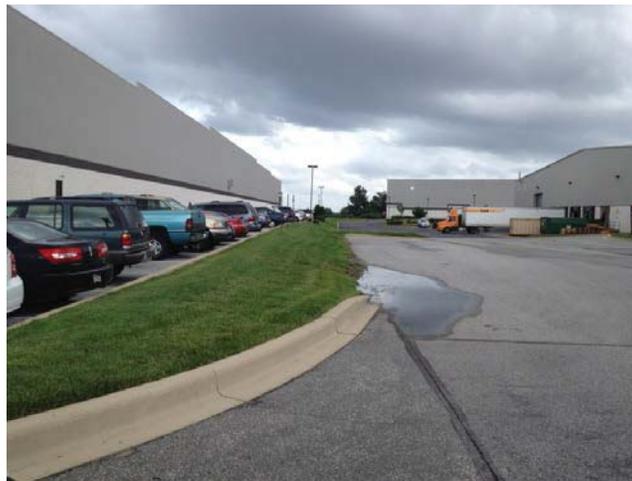
A gently sloped area between two buildings in the northern portion of the site.

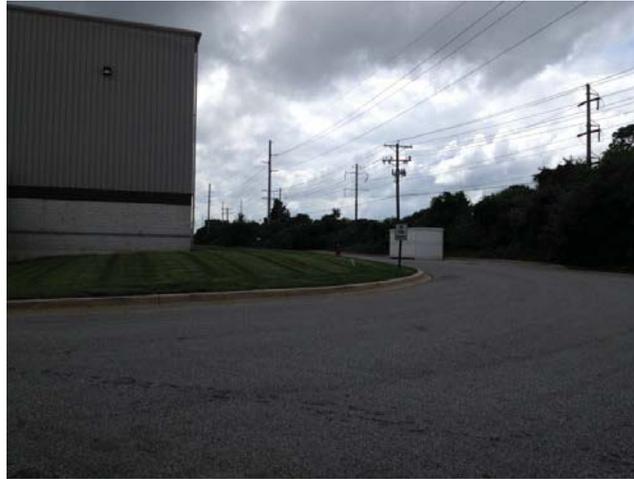
The edge of the site in the northern portion which is bordered by thick trees. The land is gently sloped up towards the boundary.
