PCB Mass Loading Phase II
RSC Realty Property
SIRS IDs: DE-0121, DE-1268
Wilmington, Delaware

Appendix 28

RSC REALTY PROPERTY WILMINGTON, DELAWARE

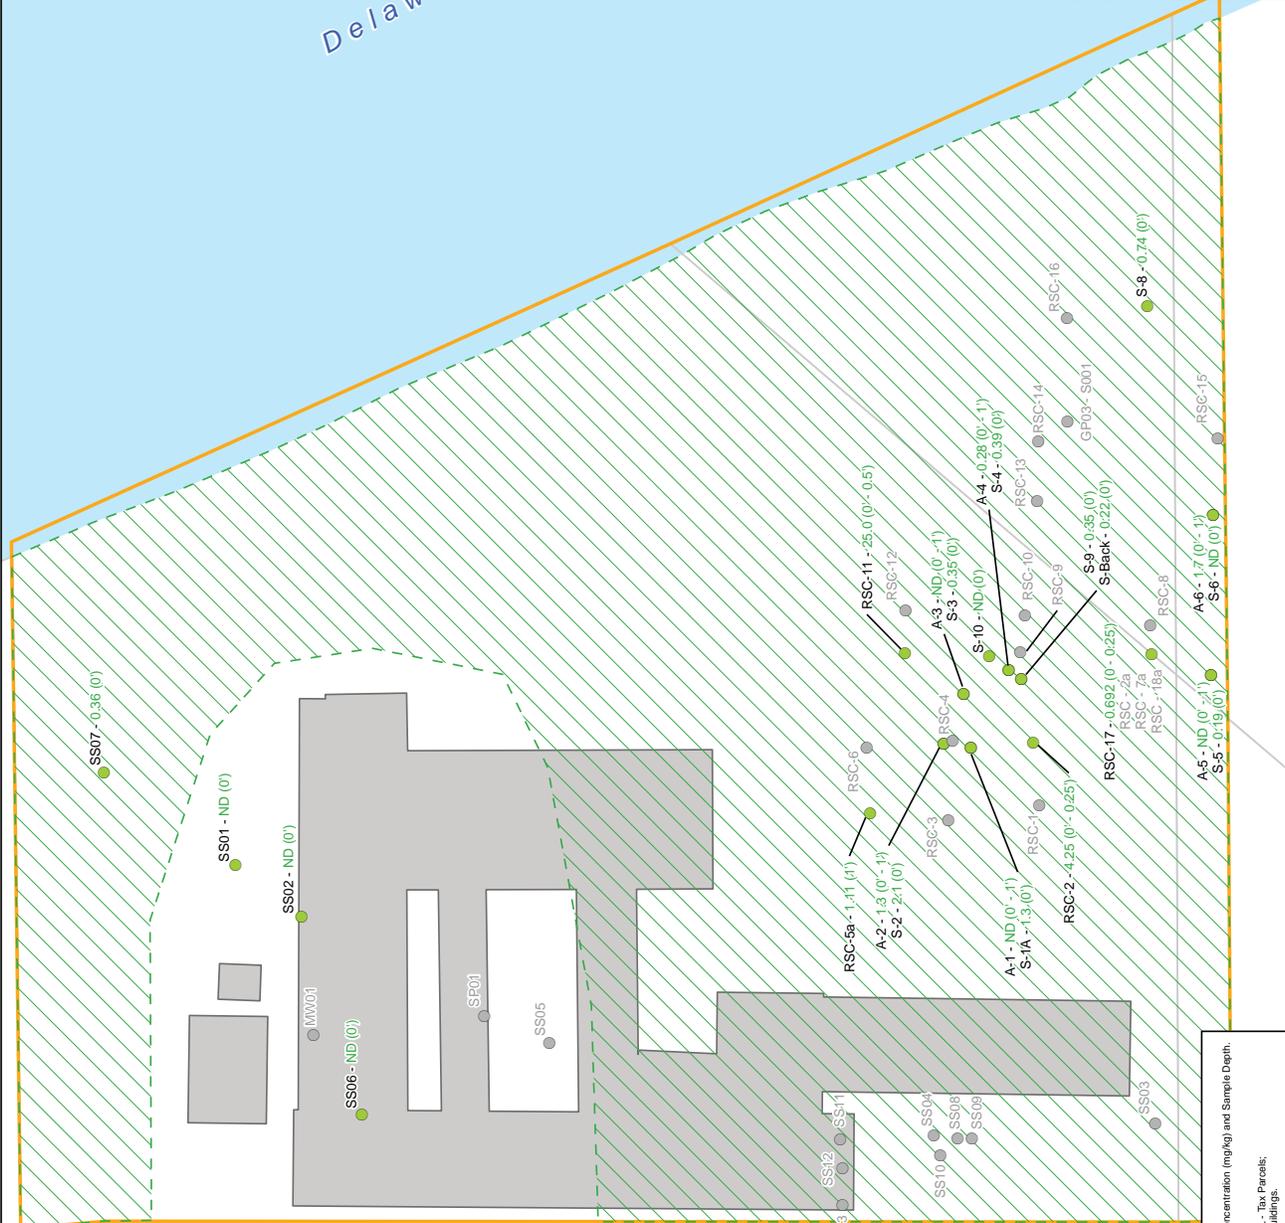
By	Date	Scale	File Name
ADS	12/17/2013	1:1,440	Fig2DistSurf.mxd
Checked	JPR	12/17/2013	Fig. No.
Project #	0985.69.51		Figure 2
	0	60	120
			Feet

Notes:
 0.36 (0) - Total PCB Concentration (mg/kg) and Sample Depth.
 ND - Not Detected

Fig. 2: PCB Distribution in Surface Soil (0' - 2' bgs)

PCBs were detected in 16 surface samples collected across the Site ranging from 0.19 mg/kg to 25 mg/kg. PCBs were also detected in three subsurface unsaturated soil at concentrations ranging from 0.61 to 1.3 mg/kg. No soil samples were collected and analyzed for PCBs in the subsurface saturated zone. In addition, there were no groundwater samples collected that were analyzed for PCBs.

Concentrations of PCBs on Site			
Sample Matrix	Corresponding Figure	Analytical Methods	Range of Total PCBs
Surface Soil	Figure 2	Method 8082	Not detected to 25 mg/kg
Subsurface Soil (unsaturated)	Figure 3	Method 8082	Not detected to 1.3 mg/kg
Subsurface Soil (saturated)	Figure 4	Not Analyzed	Not Analyzed
Groundwater	Figure 5	Not Analyzed	Not Analyzed

The estimated surface area impacted by PCBs is 19.6 acres (Figure 2) and the estimated subsurface unsaturated area impacted by PCBs is 8.1 acres (Figure 3). According to the information available and reviewed by BrightFields, no subsurface saturated soil or groundwater samples were analyzed for PCBs so the respective areas impacted by PCBs cannot be determined. Therefore, no groundwater loading estimates were prepared for the site.

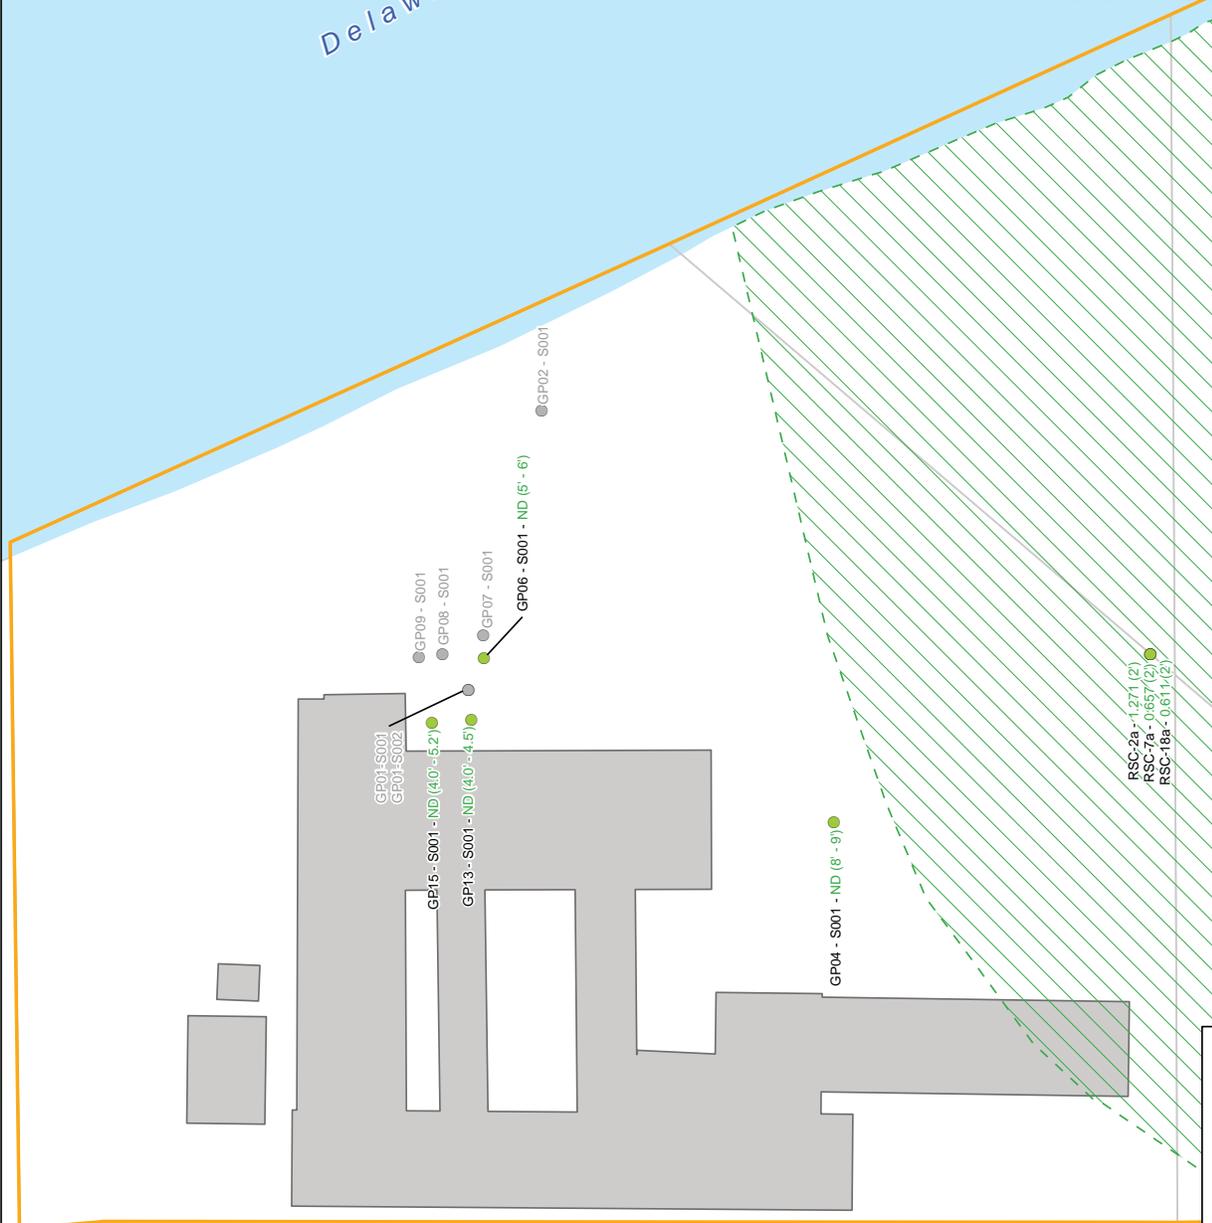
By	Date	Scale	File Name:
ADS	12/17/2013	1:1,140	FigGSS_Unsat.mxd
Checked	JPR	12/17/2013	Fig. No.
Project #	0985.69.51		Figure 3

PCB Distribution in Subsurface Unsaturated Soil
 RSC Realty
 Wilmington, Delaware

Notes:
 0.36 (0) - Total PCB Concentration (mg/kg) and Sample Depth;
 ND - Not Detected
 Source: Delaware Dismill, Tax Parcels;
 New Castle County - Buildings.

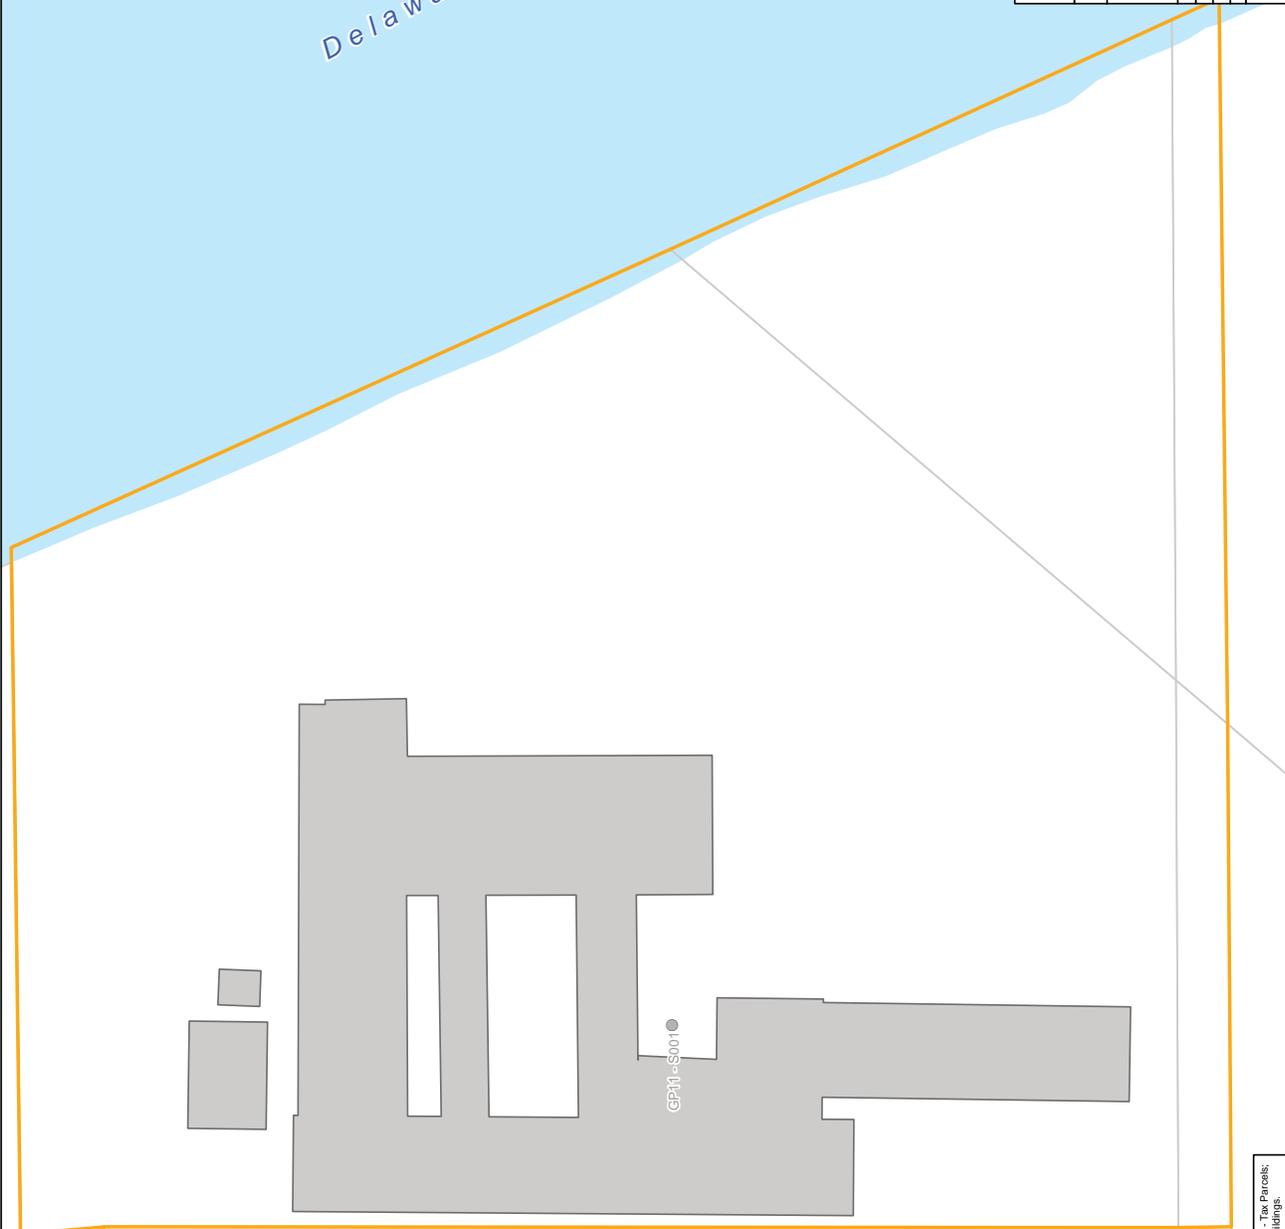
By	Date	Scale	File Name
ADS	12/17/2013	1:1,440	Fig4SS_Sat.mxd
Checked	JPR	12/17/2013	Fig. No.
Project #	0985,69.51		Figure 4
	0	60	120
			Feet

PCE Distribution in Subsurface Saturated Soil
 RSC Realty
 Wilmington, Delaware

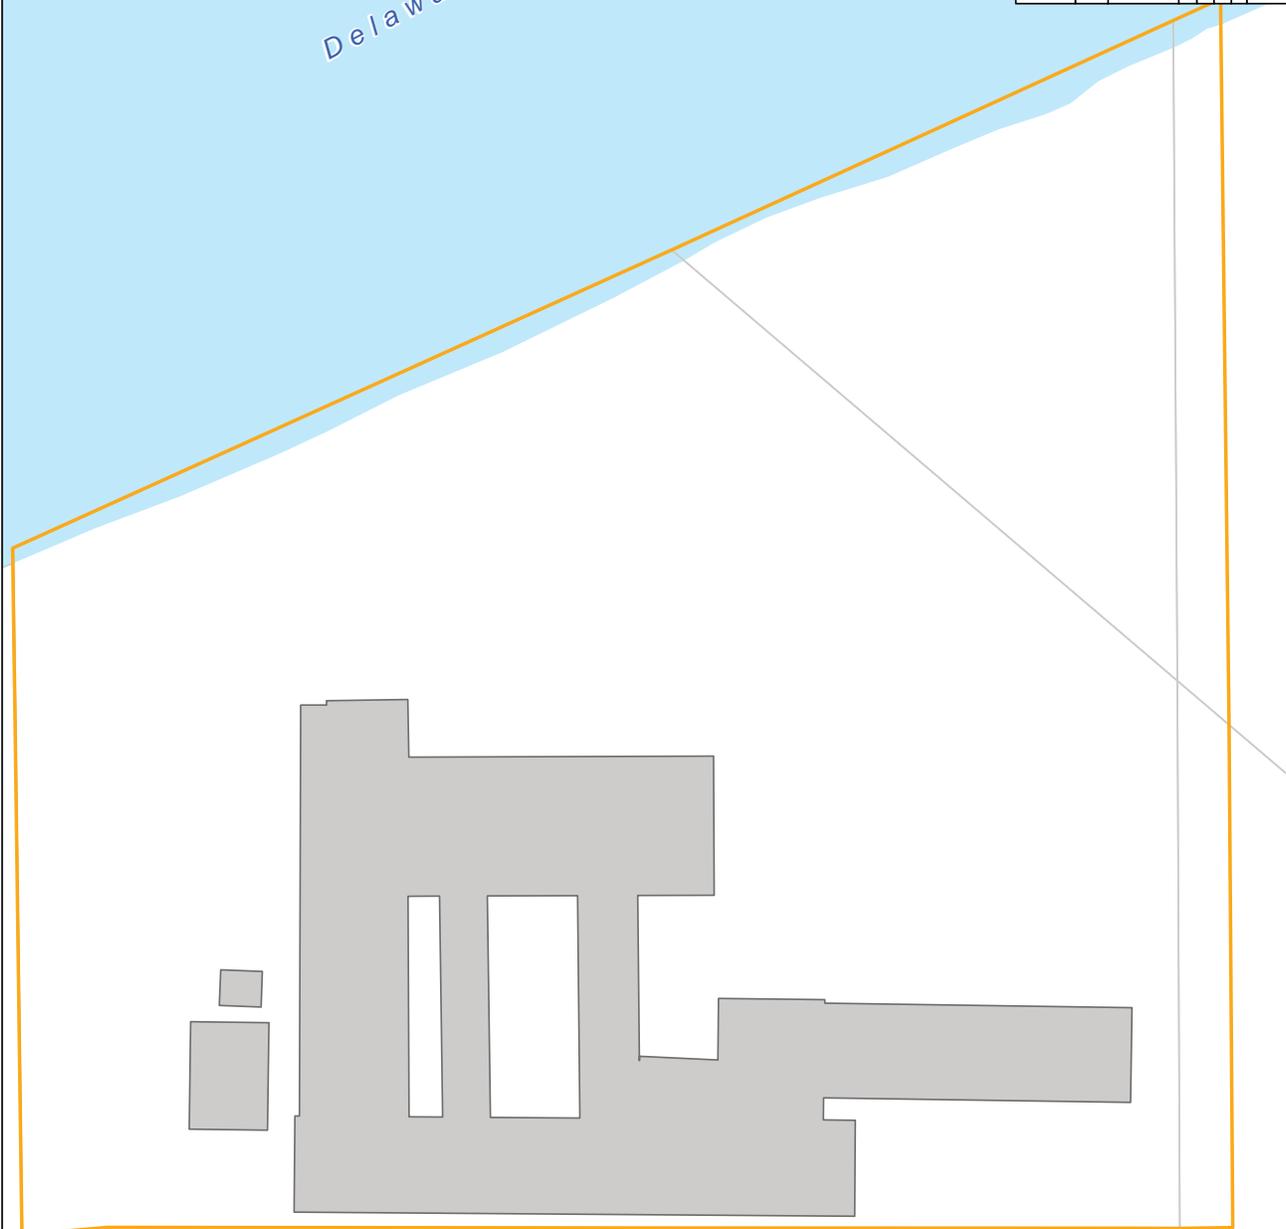
By	Date	Scale	File Name
ADS	12/17/2013	1:1,440	FigsGW.mxd
Checked	JPR	12/17/2013	Fig. No.
Project #	0985,69.51		Figure 5

PCB Distribution in Groundwater
 RSC Realty
 Wilmington, Delaware

Note: No Groundwater data available.
 Source: Delaware DataMIL - Tax Parcels
 New Castle County - Buildings.

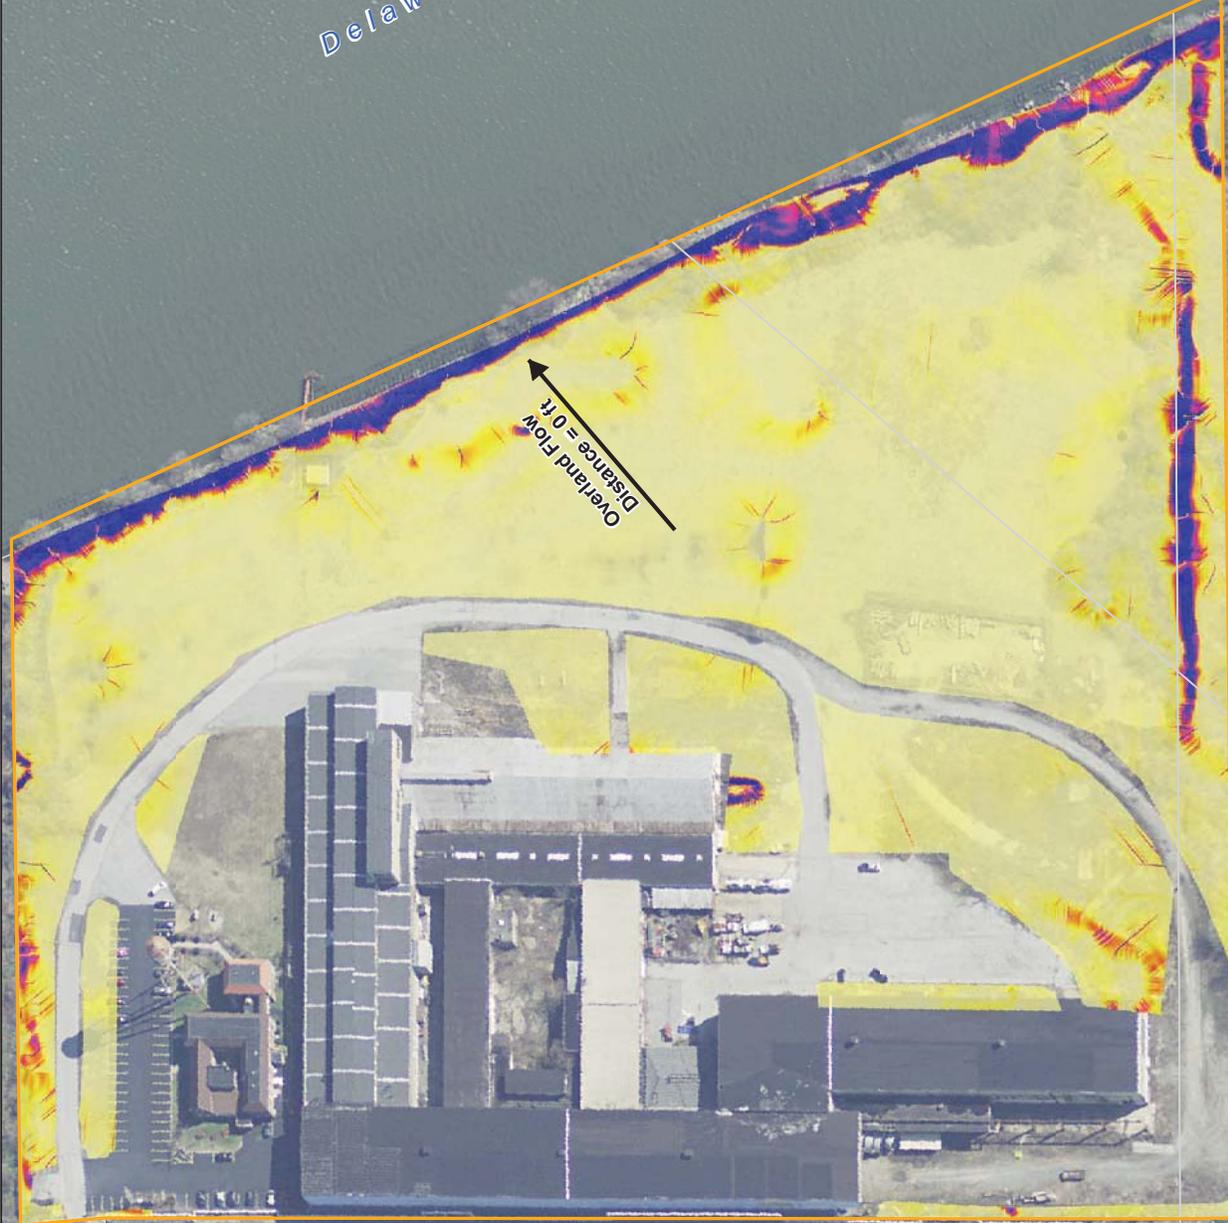
By	Date	Scale	File Name
ADS	6/18/2014	1:1,440	Fig6SoilLoss.mxd
Checked	KEP	6/18/2014	Fig. No.
Project #	0985.69.51		Figure 6

Overland Flow
Distance = 0 ft

Soil Loss Estimates
RSC Realty
Wilmington, Delaware

Overland Flow
RSC Realty Site Boundary
Tax Parcels
Tons/Year/Acre of Soil Loss Estimated
High : 12
Low : 0

P = support practice factor (dimensionless)	1	No documentation was provided indicating that any sediment and erosion controls are in place.
A = average annual soil loss estimate (ton/ac-yr)	0.088	The average soil loss estimate was generated by ArcGIS using the input factors listed above.
Erodible Area (acres)	13.4	The erodible area was calculated based on the pervious surfaces within the area of concern polygon for surface soil (Figure 6).

For factors that were not consistent across the site, rasters were used to characterize the variations. Due to the methodology utilized to derive the soil loss estimate, the numbers listed above cannot simply be multiplied.

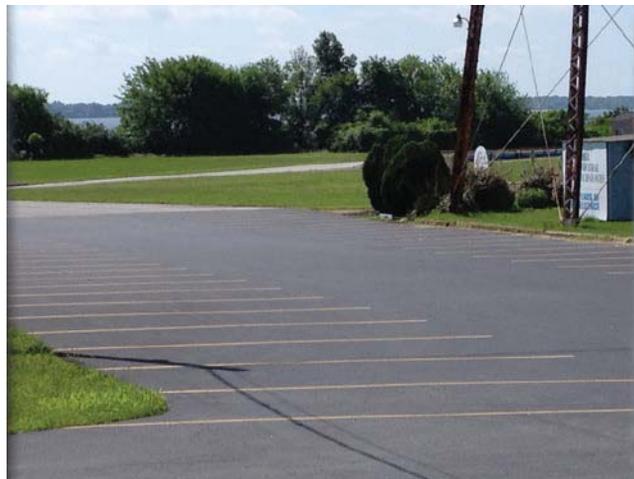
Mixed grass and pavement which slopes down towards the Delaware River in the distance.

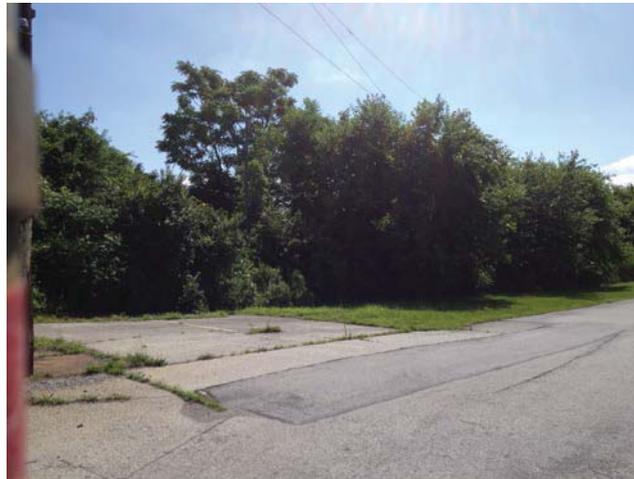
Thick vegetation bordering the paved area to the east.
