PCB Mass Loading Phase II  
Rogers Corner Dump Site  
SIRS ID: DE-0246  
Wilmington, Delaware

## **Appendix 27**

# **ROGERS CORNER DUMP SITE WILMINGTON, DELAWARE**

**SIRS ID: DE-0246**

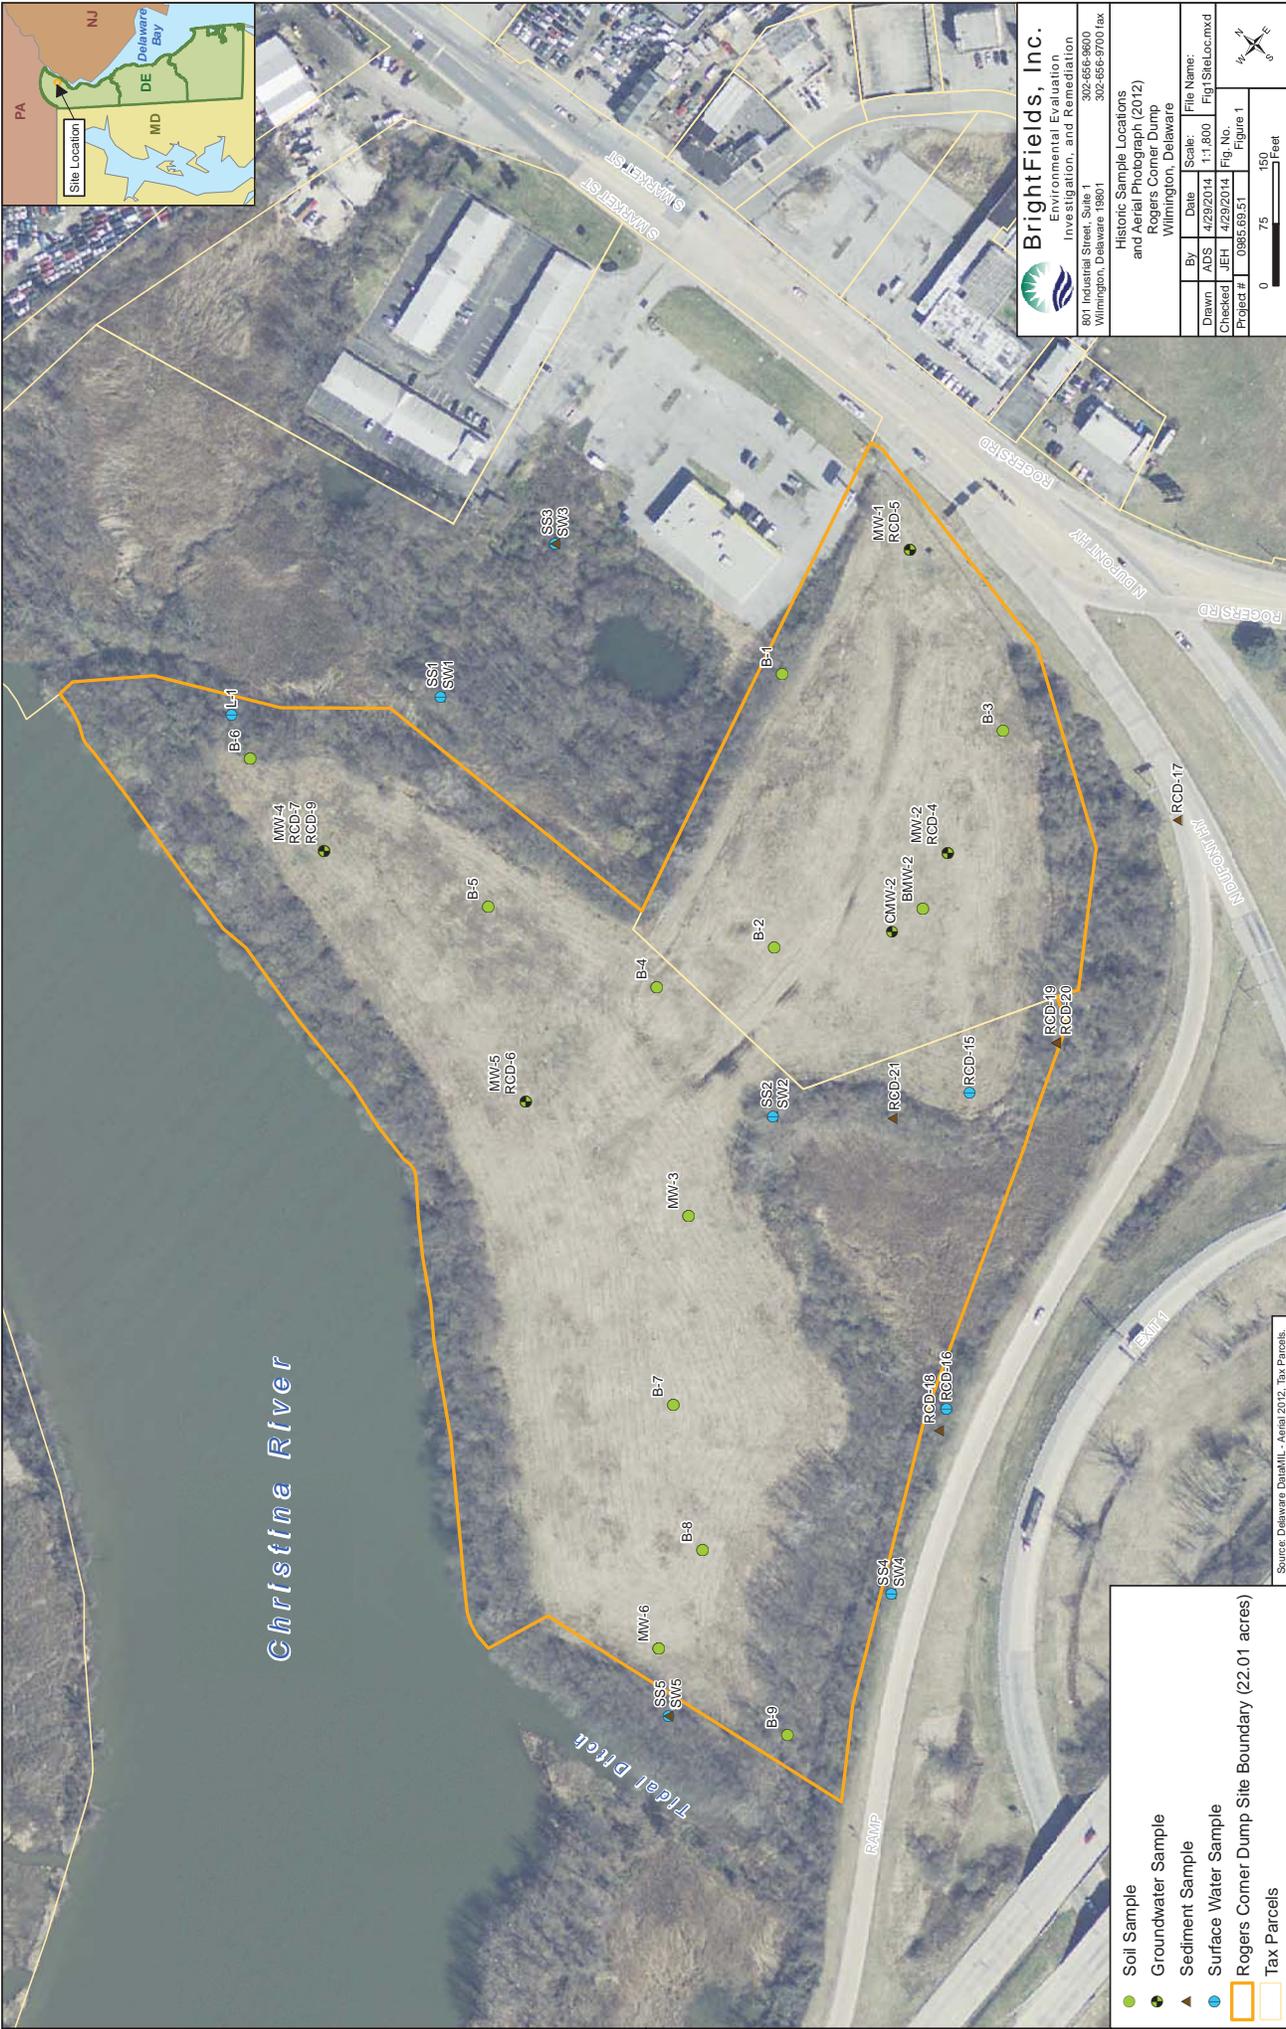
By	Date	Scale	File Name:
Drawn	ADS 4/29/2014	1:1,000	Fig1SiteLoc.mxd
Checked	JEH 4/29/2014		Fig. No.
Project #	0985.69.51		Figure 1

Historic Sample Locations  
 and Aerial Photograph (2012)  
 Rogers Corner Dump  
 Wilmington, Delaware

The Rogers Corner Dump site is located to the northwest of the intersection of US Route 13 (South Market Street) and Interstate 495 (Figure 1). The Christina River is located adjacent to the west of the site. This site is approximately 22 acres in size and is comprised of two tax parcels (#1000100013 and #1000100014). The site currently is owned by Donald W. Booker, Homer W. Booker Jr., and William J. Ryan.

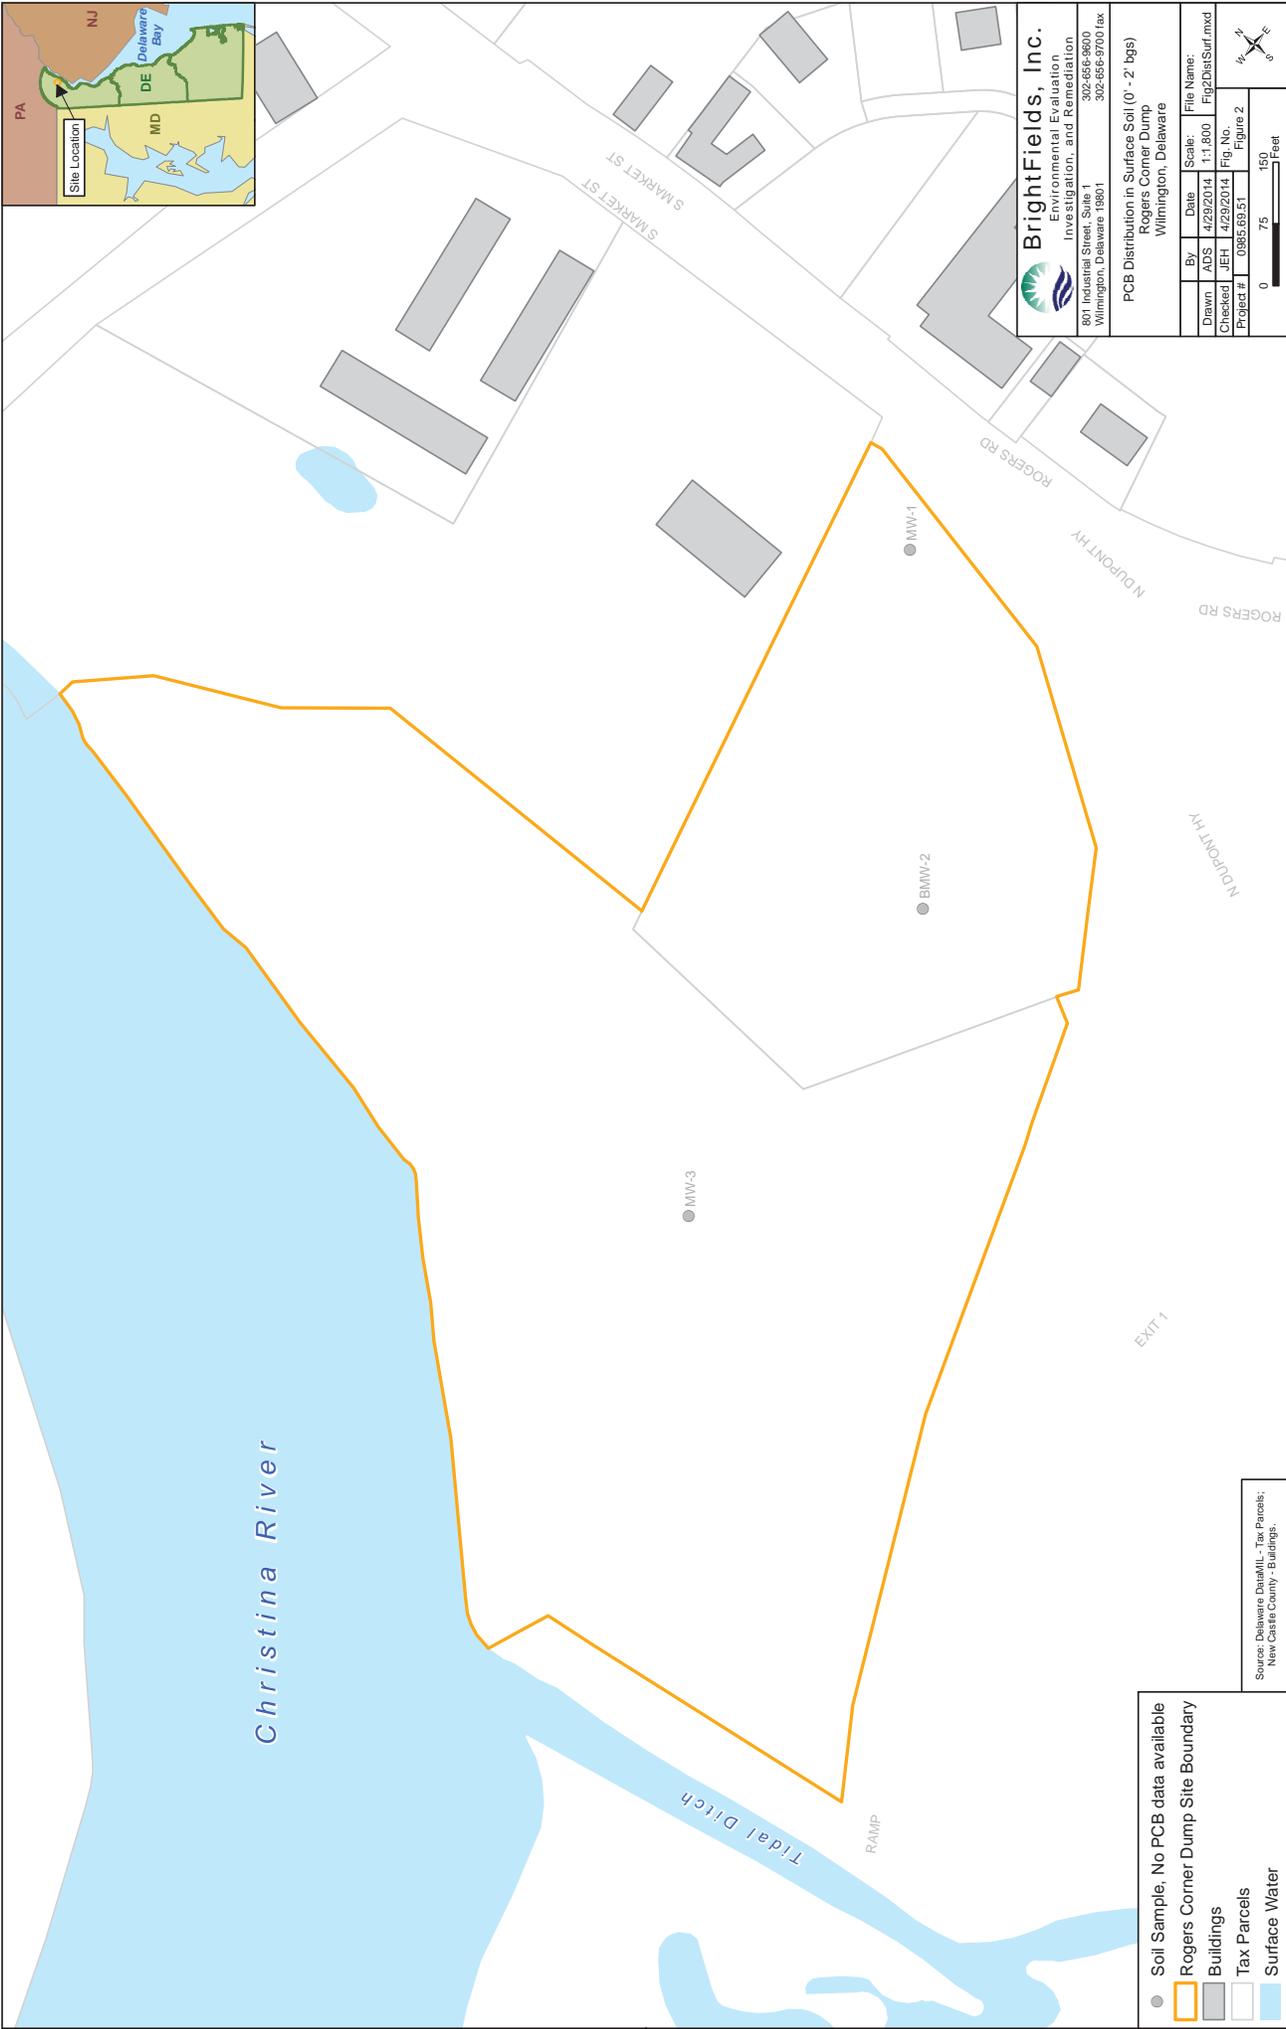
By	Date	Scale:	File Name:
Drawn	ADS 4/29/2014	1:1,800	Fig2BstSurf.mxd
Checked	JEH 4/29/2014		Fig. No.
Project #	0985.69.51		Figure 2

PCB Distribution in Surface Soil (0' - 2' bgs)  
 Rogers Corner Dump  
 Wilmington, Delaware

According to the information available and reviewed by BrightFields, no surface soil samples were analyzed for PCBs so the respective area impacted by PCBs cannot be determined (Figure 2). Therefore, overland flow estimates were not prepared for this site. Based on the data available and reviewed by BrightFields, the subsurface soil is not impacted by PCBs (Figure 3 and 4). The groundwater is not expected to be impacted by PCBs since they were not detected in the more recent groundwater data (Figure 5).

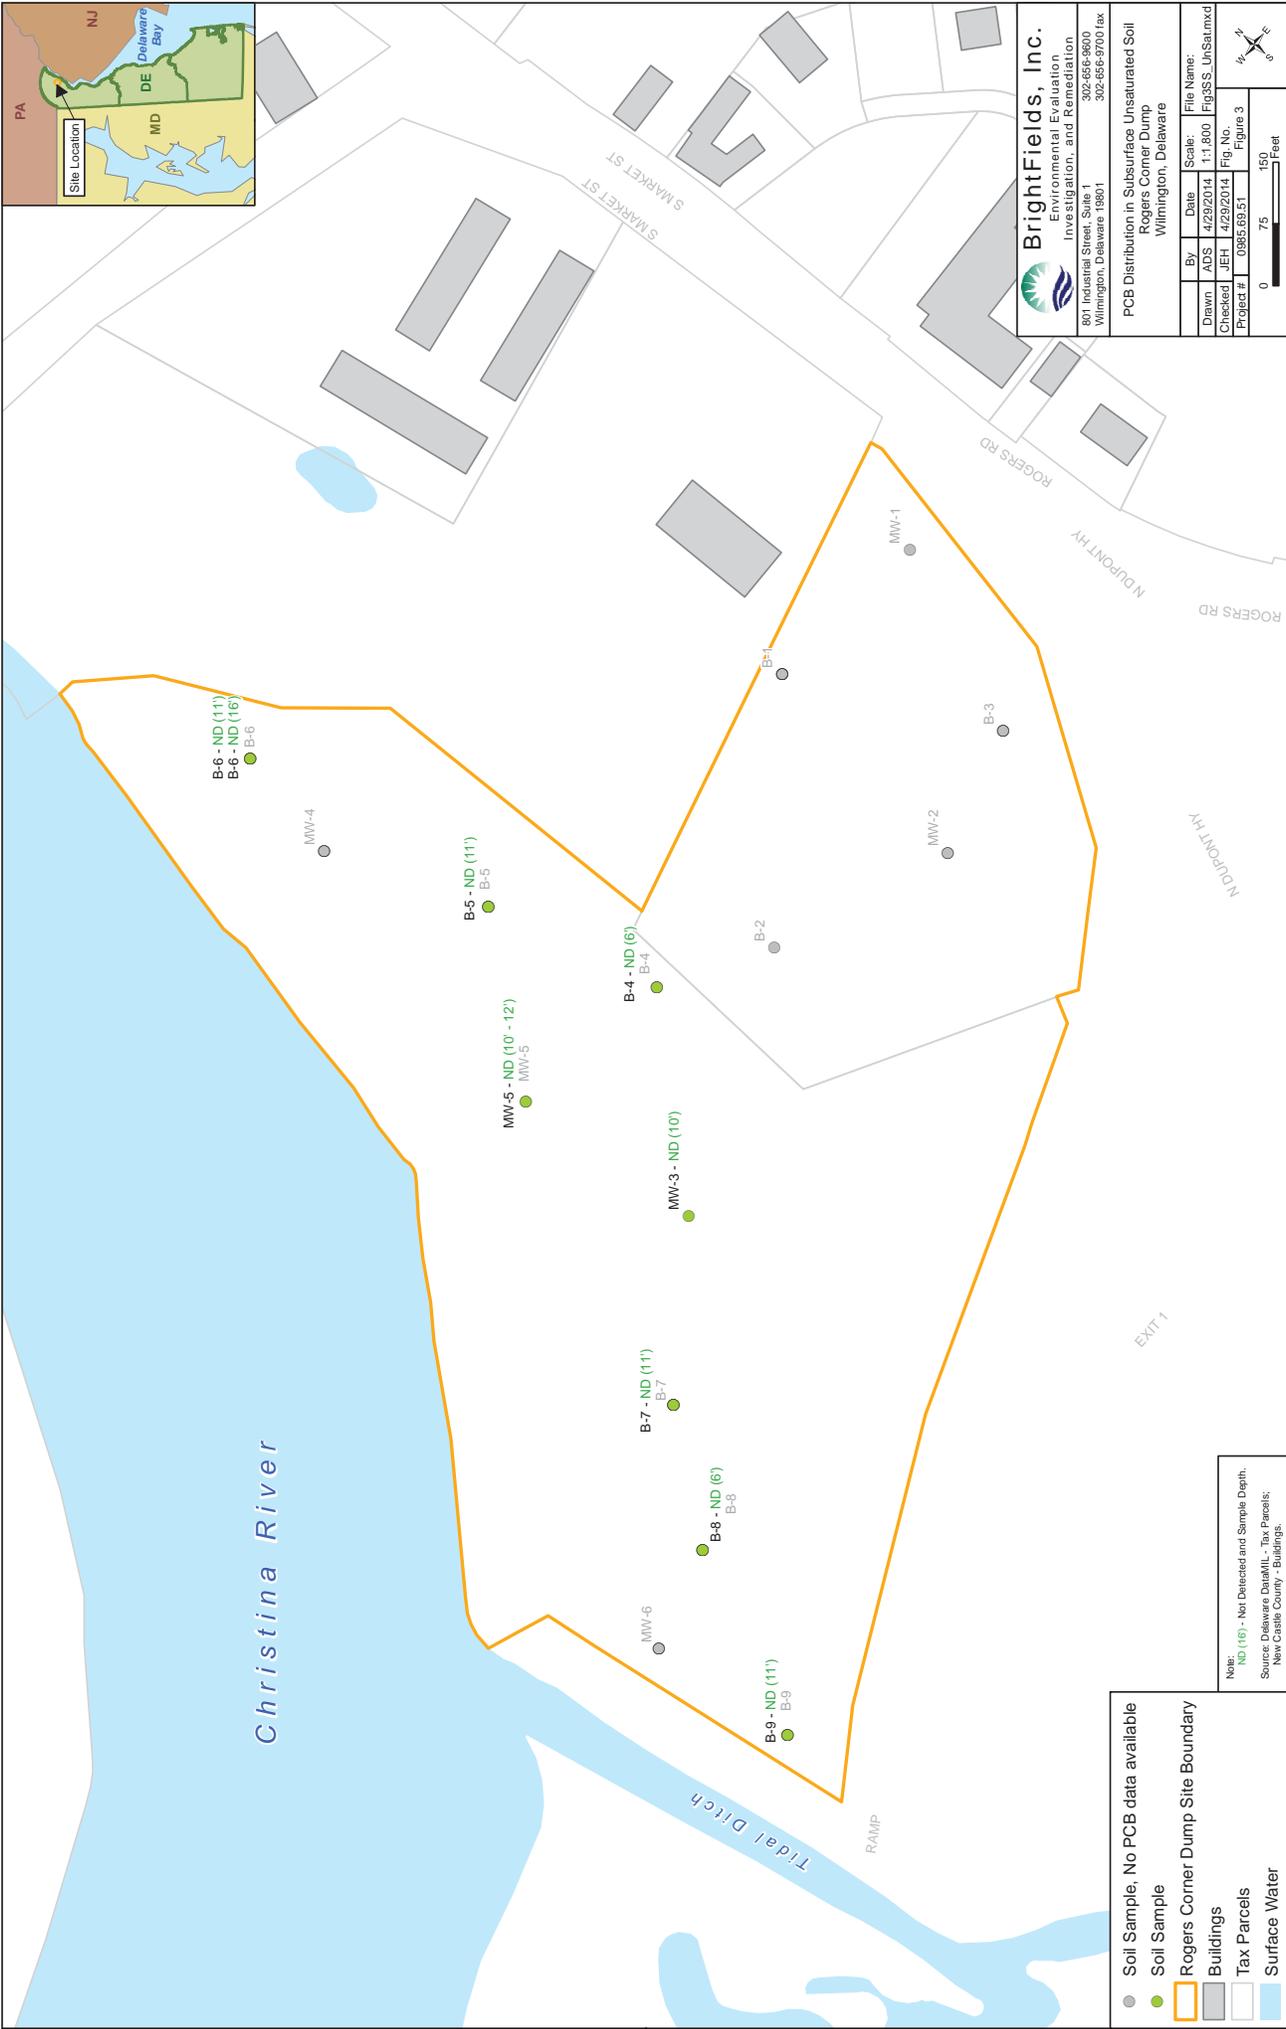
By	Date	Scale:	File Name:
Drawn ADS	4/29/2014	1:1,800	FigSSS_UnSat.mxd
Checked JEH	4/29/2014	Fig. No.	Figure 3
Project #	0985.69.51	Figure 3

PCB Distribution in Subsurface Unsaturated Soil  
 Rogers Corner Dump  
 Wilmington, Delaware

Note: ND (16) - Not Detected and Sample Depth.  
 Source: Delaware Databases - Tax Parcels,  
 New Castle County - Buildings

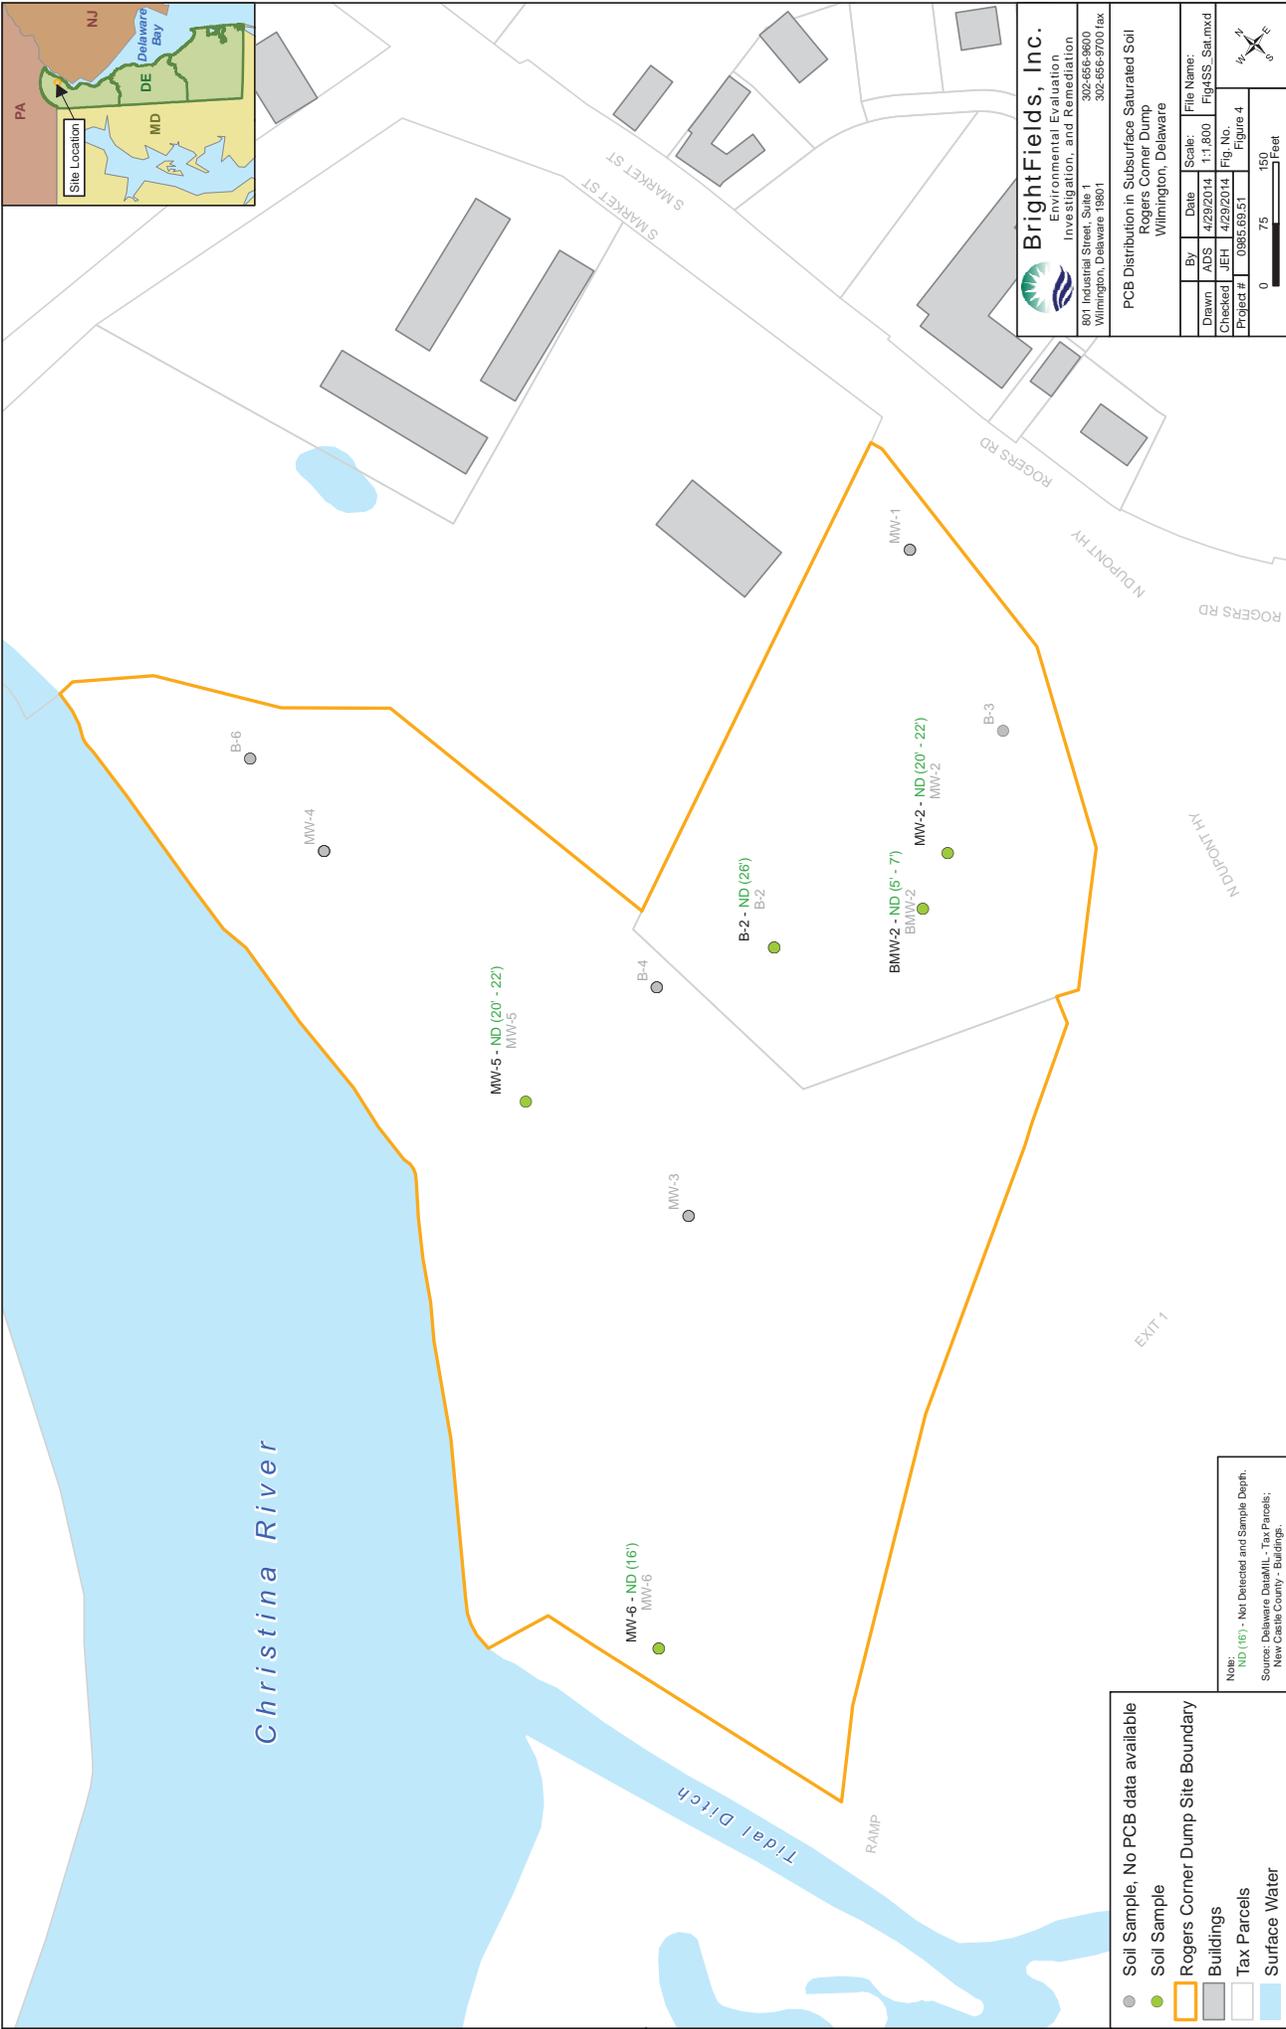
By	Date	Scale:	File Name:
Drawn	ADS 4/29/2014	1:1,800	Fig4SS_Sat.mxd
Checked	JEH 4/29/2014	Figure 4	Figure 4
Project #	0985.69.51	0 75 150	Feet

PCB Distribution in Subsurface Saturated Soil  
 Rogers Corner Dump  
 Wilmington, Delaware

Note: ND (16) - Not Detected and Sample Depth.  
 Sources: Delaware Dept. of Transportation, Tax Parcels,  
 New Castle County - Buildings.

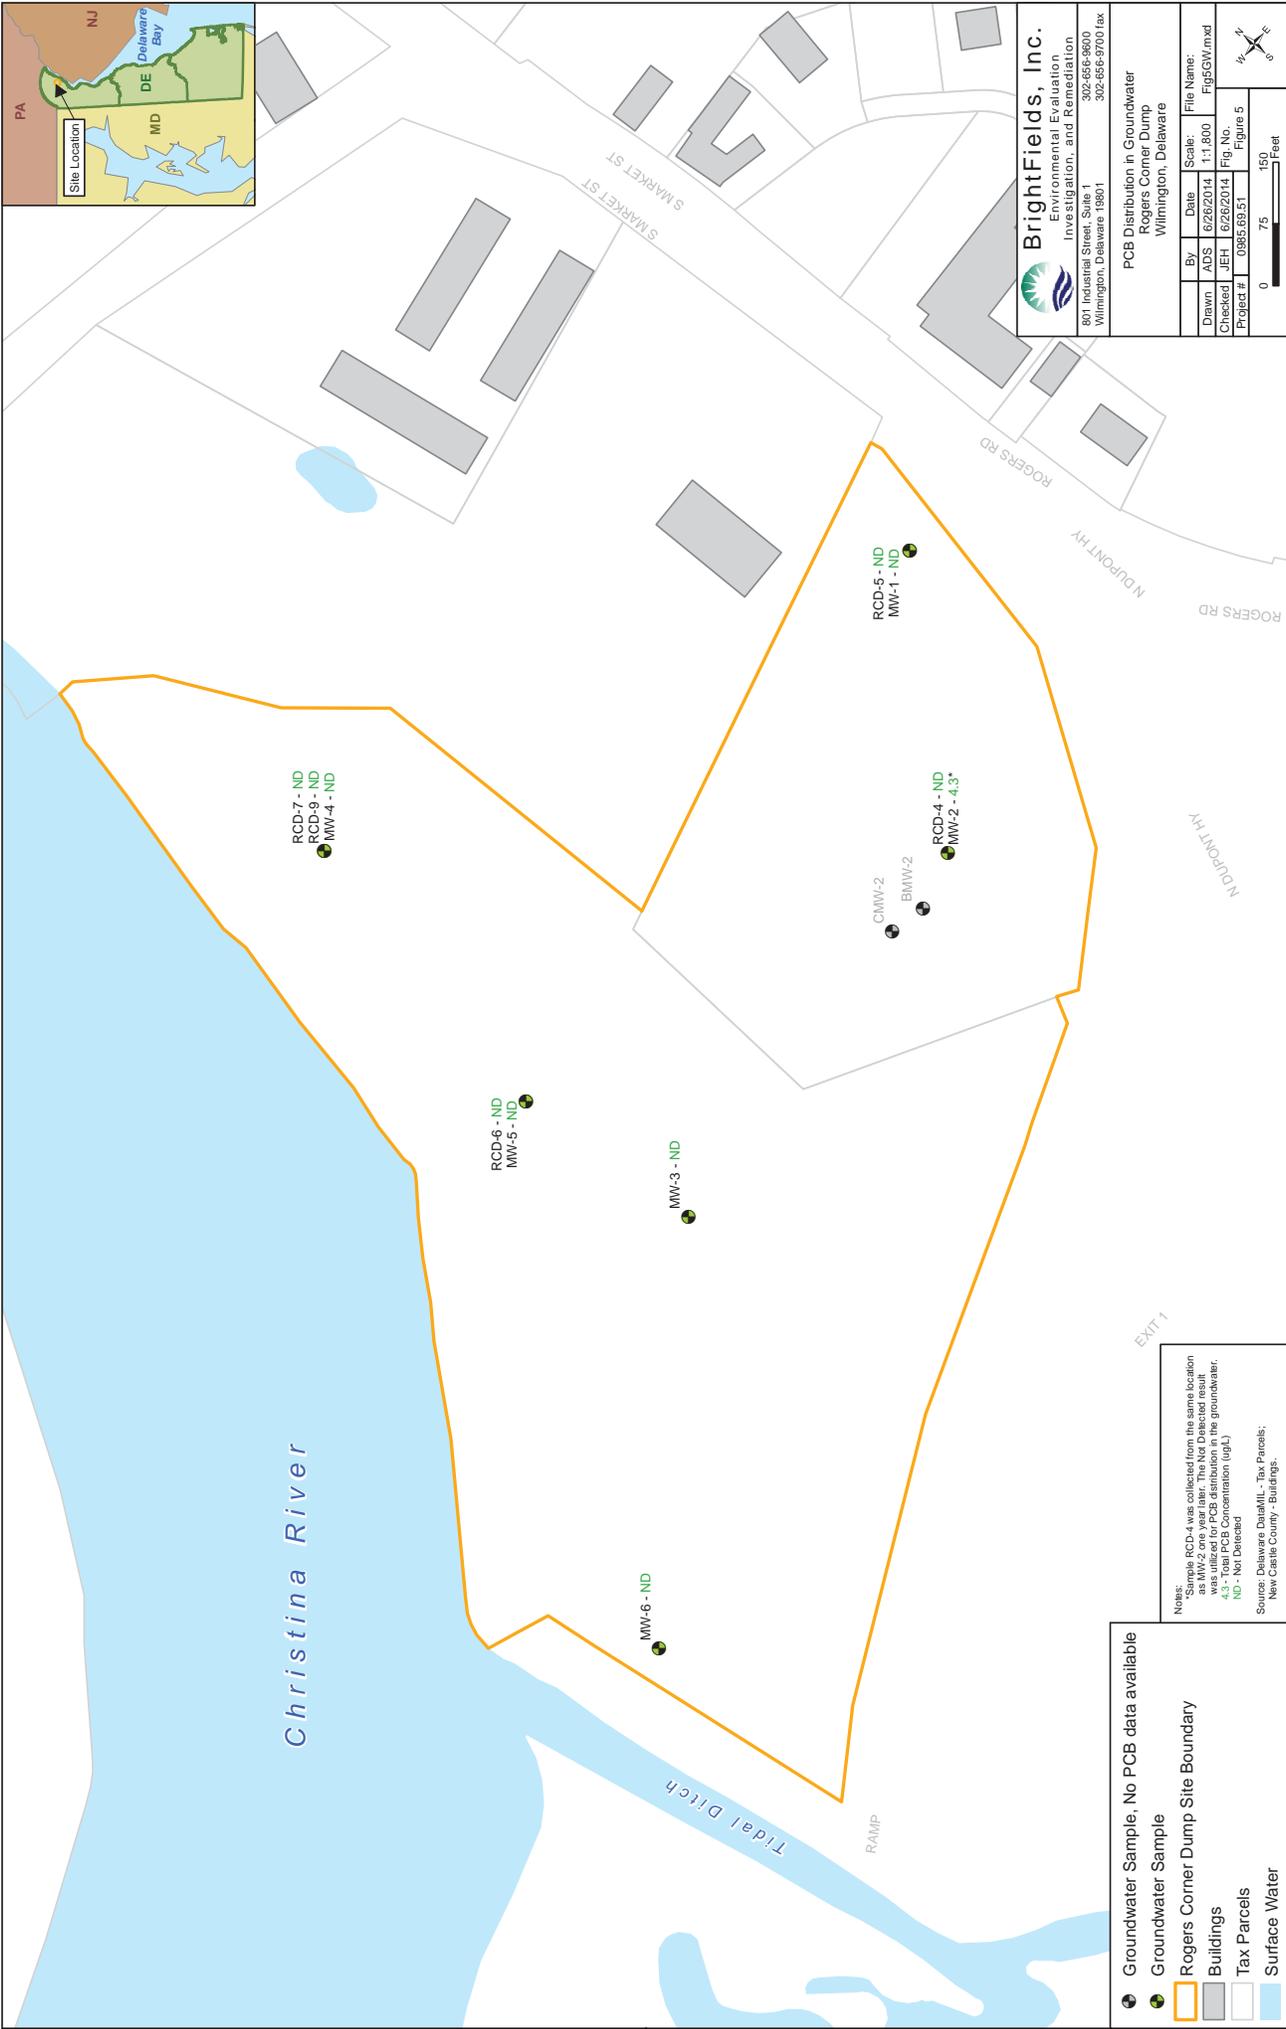
By	Date	Scale	File Name
Drawn ADS	6/26/2014	1:1,800	Fig5GW.mxd
Checked JEH	6/26/2014	Fig. No.	Figure 5
Project #	0985.69.51	Figure 5

PCB Distribution in Groundwater  
 Rogers Corner Dump  
 Wilmington, Delaware

Notes:  
 \*Sample RCD-4 was collected from the same location as the sample RCD-4. The sample RCD-4 was utilized for PCB distribution in the groundwater.  
 4.3 - Total PCB Concentration (ug/L)  
 ND - Not Detected  
 Source: Delaware DataMILL - Tax Parcels; New Castle County - Buildings.

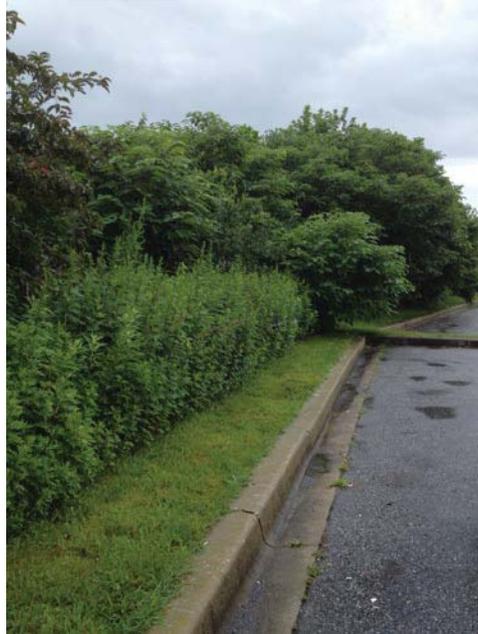
Thick vegetation along the northwest of the site.
