PCB Mass Loading Phase II  
1600 Bowers Street  
SIRS ID: DE-0280  
Wilmington, Delaware

## **Appendix 1**

**1600 BOWERS STREET  
(ATLAS SANITATION)  
WILMINGTON, DELAWARE**

**SIRS ID: DE-0280**

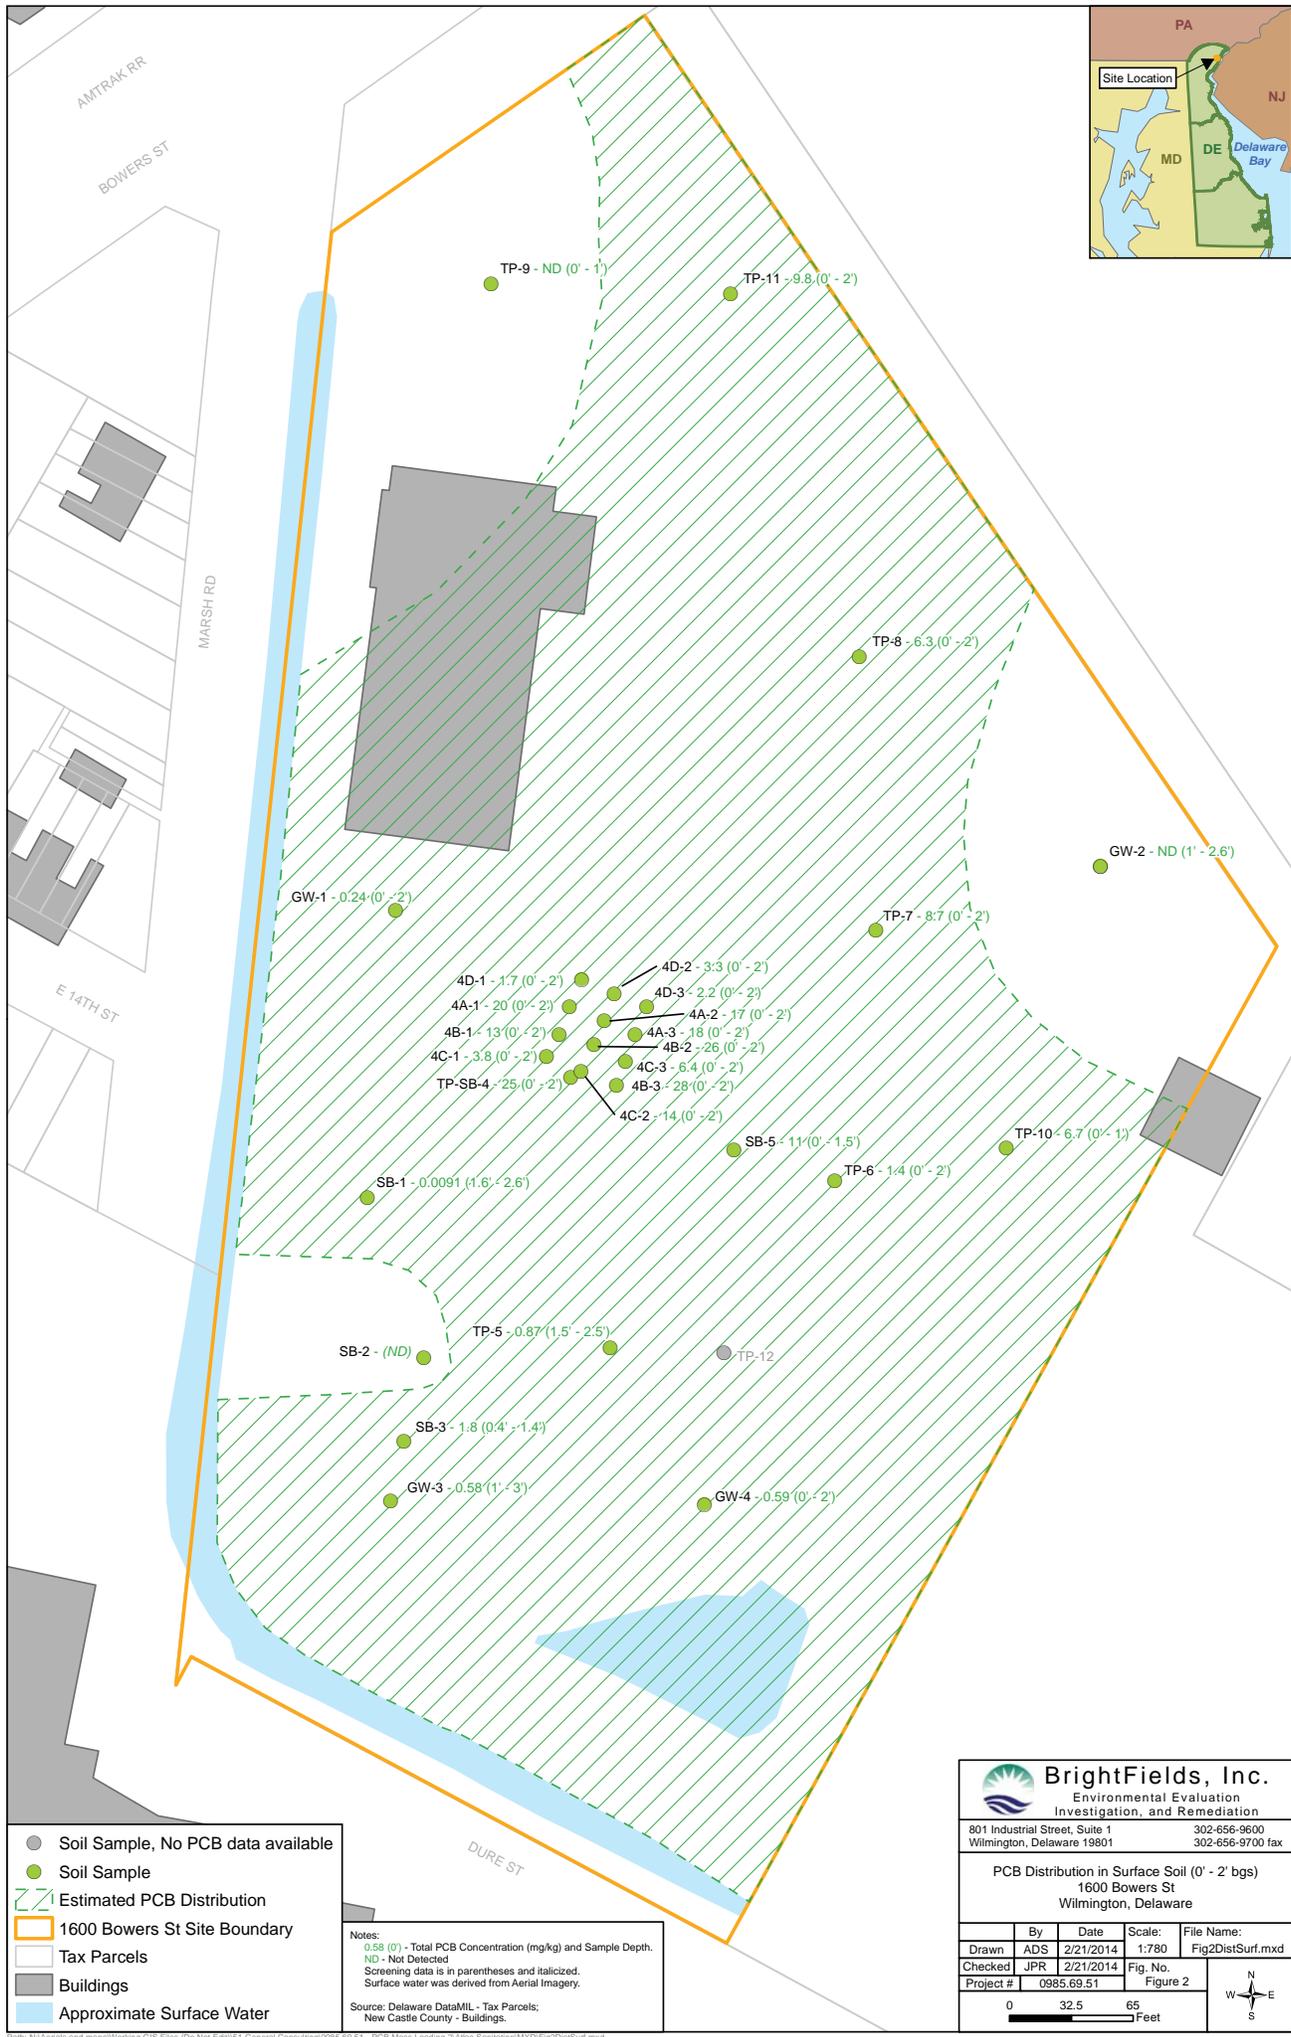
Drawn	By	Date	Scale:	File Name:
ADS	ADS	2/21/2014	1:780	Fig2DistSurf.mxd
Checked	JPR	2/21/2014	Fig. No.	
Project #	0985.69.51		Figure 2

PCB Distribution in Surface Soil (0' - 2' bgs)  
 1600 Bowers St  
 Wilmington, Delaware

<b>Concentrations of PCBs on Site</b>			
<b>Sample Matrix</b>	<b>Corresponding Figure</b>	<b>Analytical Methods</b>	<b>Range of Total PCBs</b>
Surface Soil	Figure 2	Method 8082 and Screening Data	Not detected to 28 mg/kg
Subsurface Soil (unsaturated)	Figure 3	Method 8082	Not detected to 9.0 mg/kg
Subsurface Soil (saturated)	Figure 4	Method 8082	Not detected to 2.6 mg/kg
Groundwater	Figure 5	Method 8082	Not detected to 0.50 µg/L

The estimated surface area impacted by PCBs is 6.4 acres (Figure 2). The estimated subsurface non-saturated area impacted by PCBs is 6.8 acres (Figure 3) and the estimated subsurface saturated area is 7.7 (Figure 4). An estimated 2.7 acres of groundwater are impacted by PCBs (Figure 5).

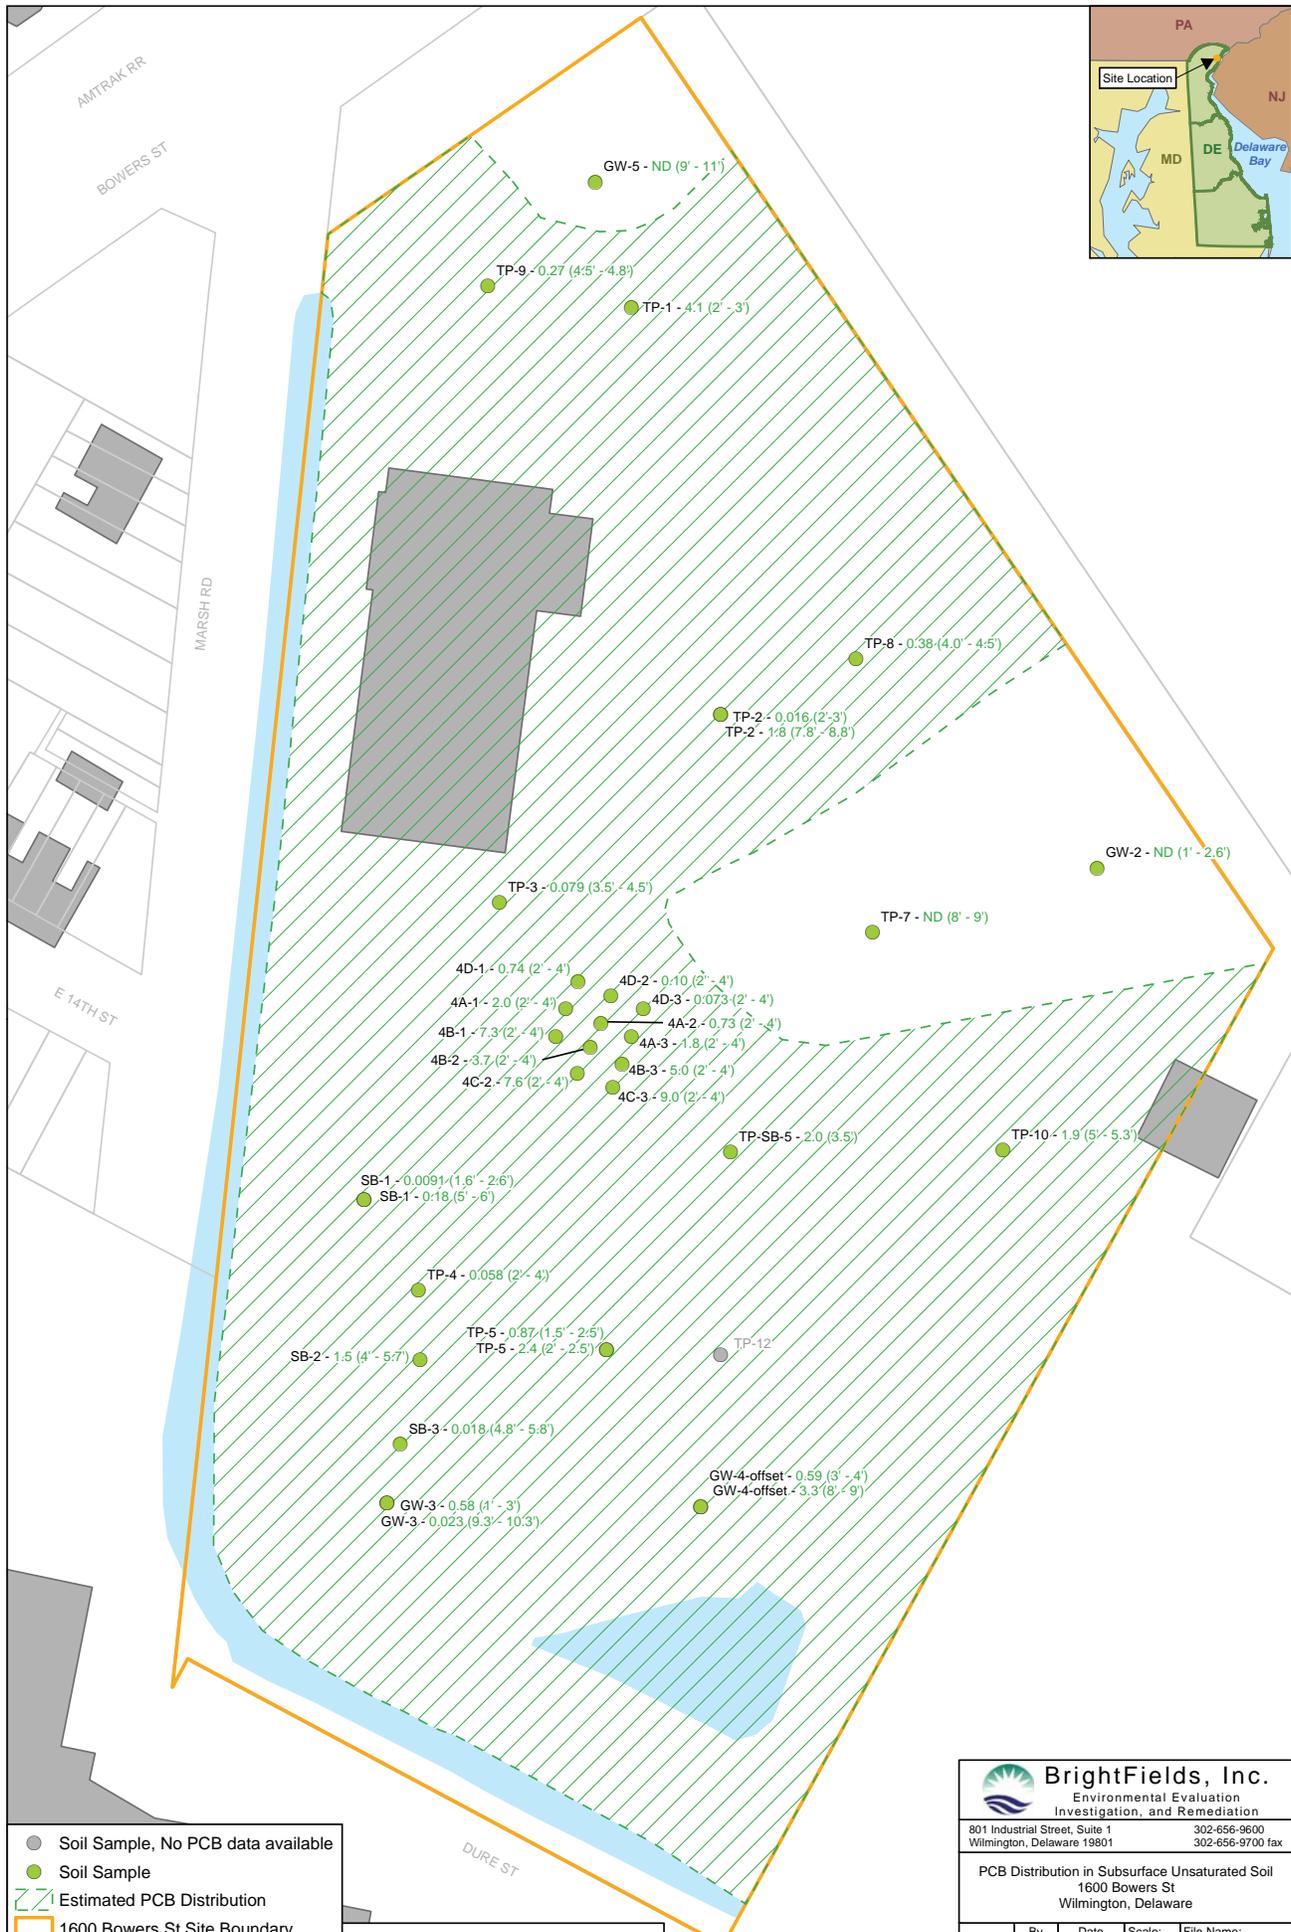
Drawn	By	Date	Scale	File Name:
ADS	ADS	12/16/2013	1:780	Fig3SS_UnSat.mxd
Checked	JPR	12/16/2013	Fig. No.	
Project #	0985.69.51		Figure 3

PCB Distribution in Subsurface Unsaturated Soil  
 1600 Bowers St  
 Wilmington, Delaware

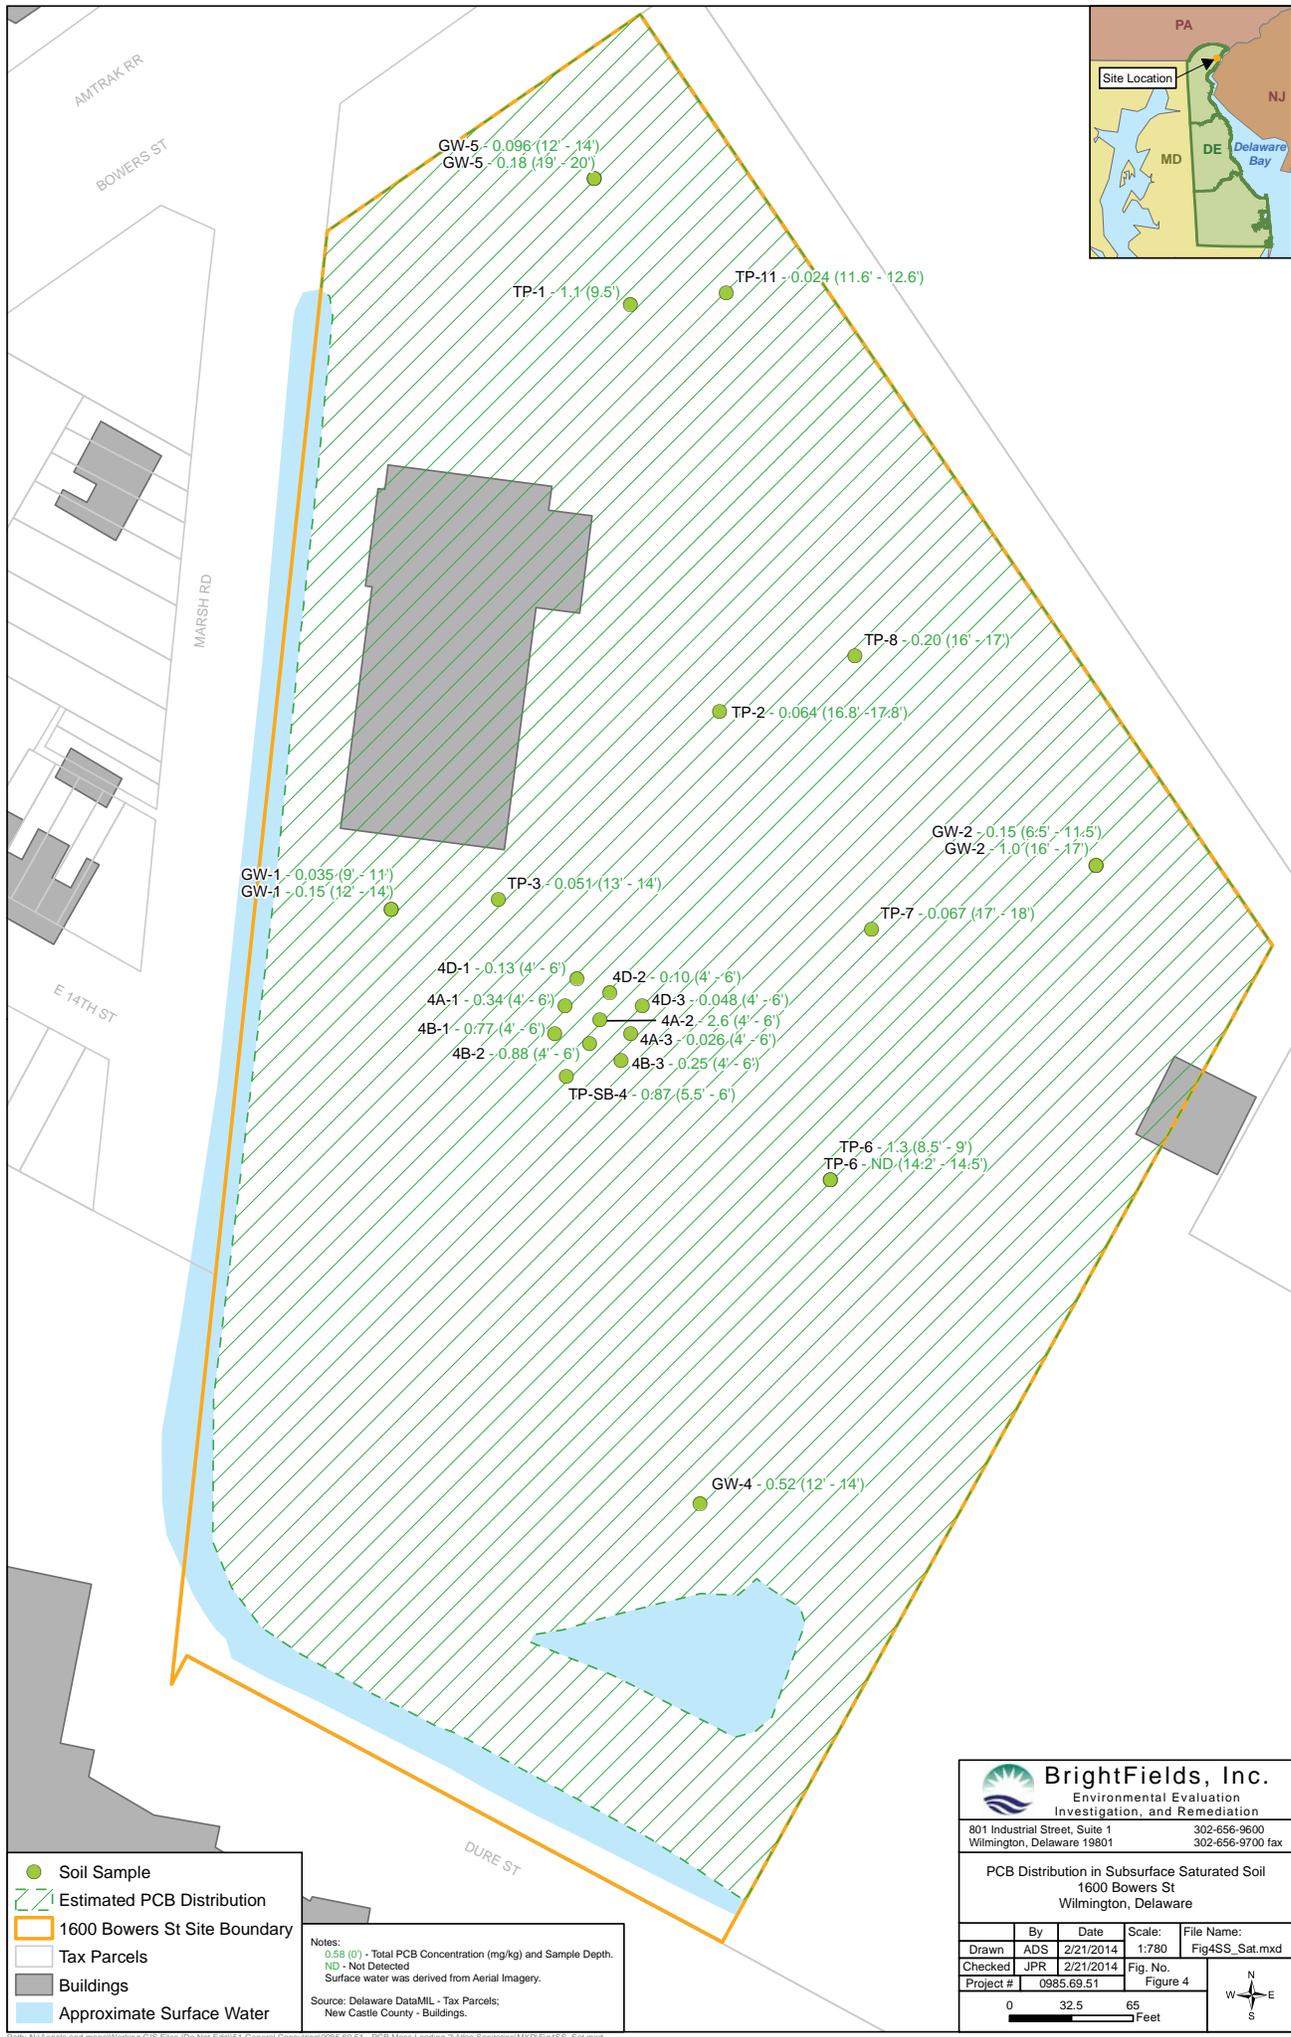
Drawn	By	Date	Scale	File Name:
ADS	ADS	2/21/2014	1:780	Fig4SS_Sat.mxd
Checked	Project #		Fig. No.	Fig. No.
JPR	0985.69.51		Figure 4	Figure 4

PCB Distribution in Subsurface Saturated Soil  
 1600 Bowers St  
 Wilmington, Delaware

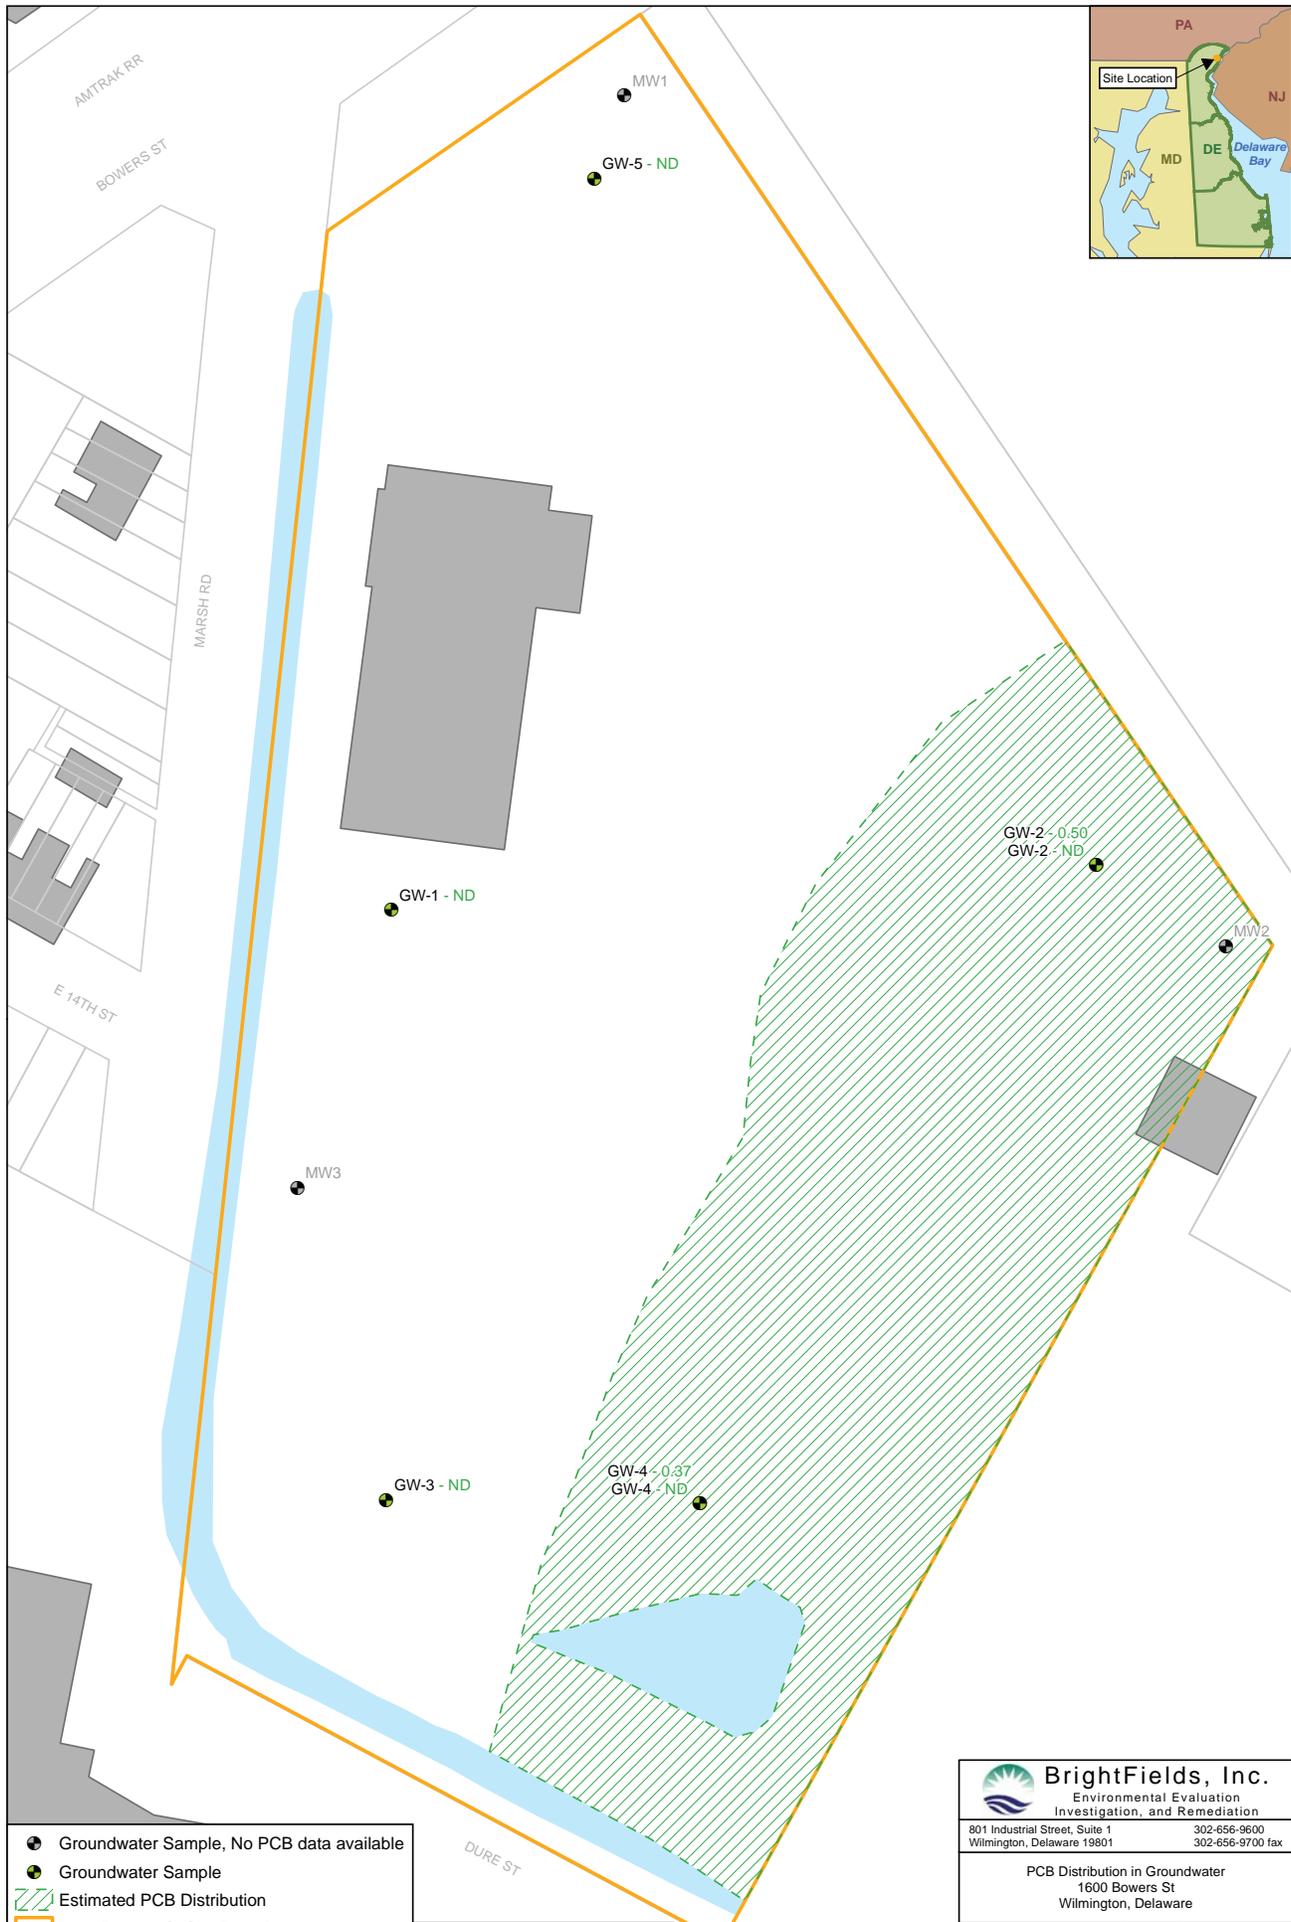
Drawn	By	Date	Scale:	File Name:
ADS	ADS	7/29/2013	1:780	Fig5GW.mxd
Checked	Project #		Fig. No.	Figure 5
JPR	0985.69.51		7/29/2013

PCB Distribution in Groundwater  
 1600 Bowers St  
 Wilmington, Delaware

PCBs were detected in groundwater samples GW-2 (screen depth of 4 feet to 14 feet) and GW-4 (screen depth of 6 feet to 16 feet) at concentrations of 0.50 µg/L and 0.37 µg/L, respectively.

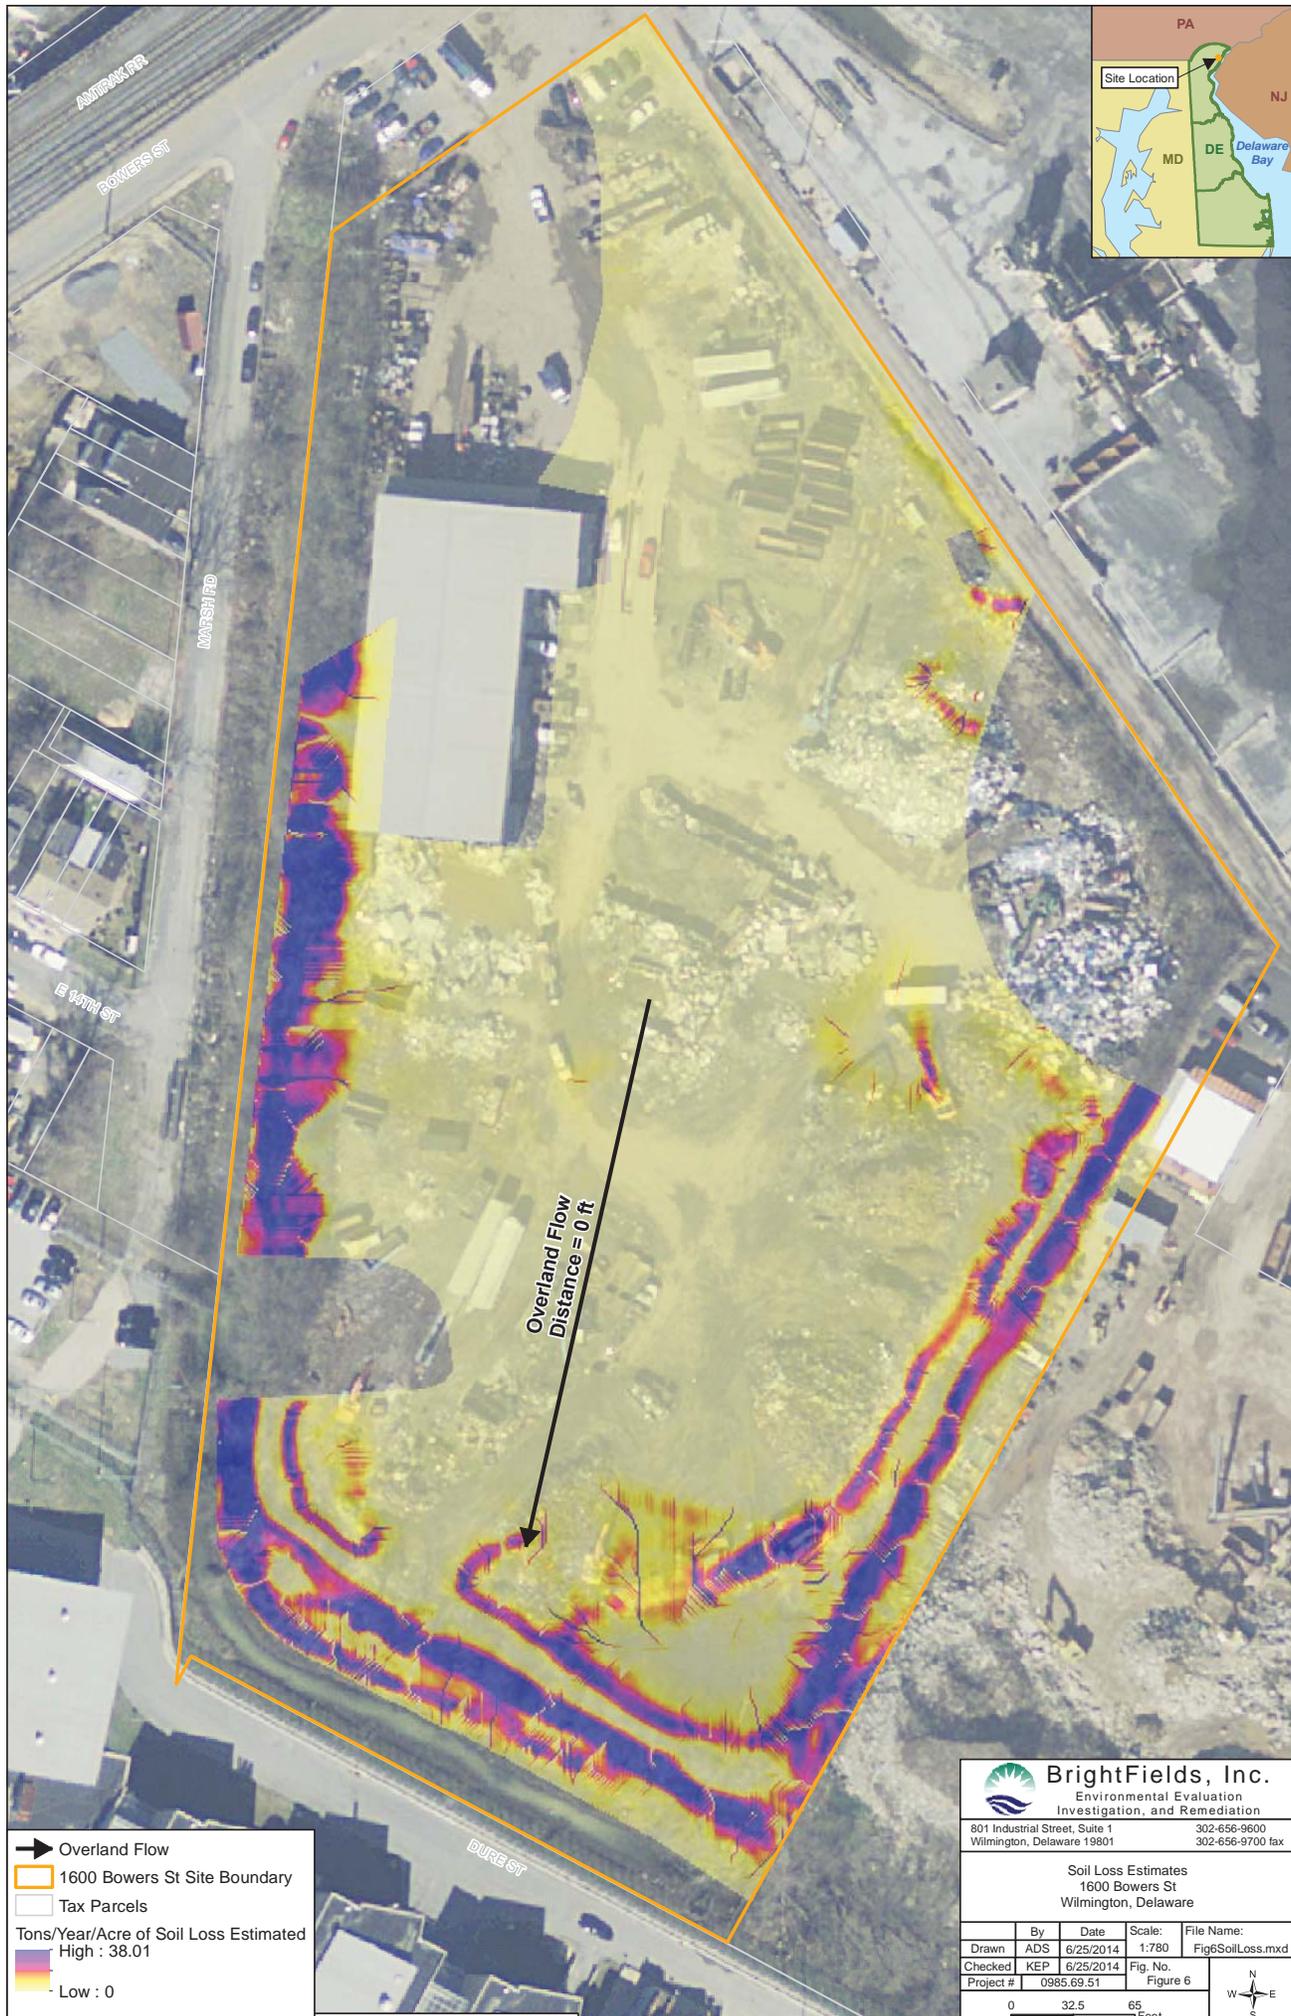
Drawn	ADS	6/25/2014	Scale:	File Name:
Checked	KEP	6/25/2014	1:780	Fig6SoilLoss.mxd
Project #	0985.69.51	Figure 6

→ Overland Flow  
 1600 Bowers St Site Boundary  
 Tax Parcels  
 Tons/Year/Acre of Soil Loss Estimated  
 High : 38.01  
 Low : 0

Soil Loss Estimates  
 1600 Bowers St  
 Wilmington, Delaware

P = support practice factor (dimensionless)	0.05	The support practice factor was calculated in the RUSLE2 program based on the vegetative berm and lined retention pond located onsite.
A = average annual soil loss estimate (ton/ac-yr)	0.4	The average soil loss estimate was generated by ArcGIS using the input factors listed above.
Erodible Area (acres)	6.0	The erodible area was calculated based on the pervious surfaces within the area of concern polygon for surface soil (Figure 6).

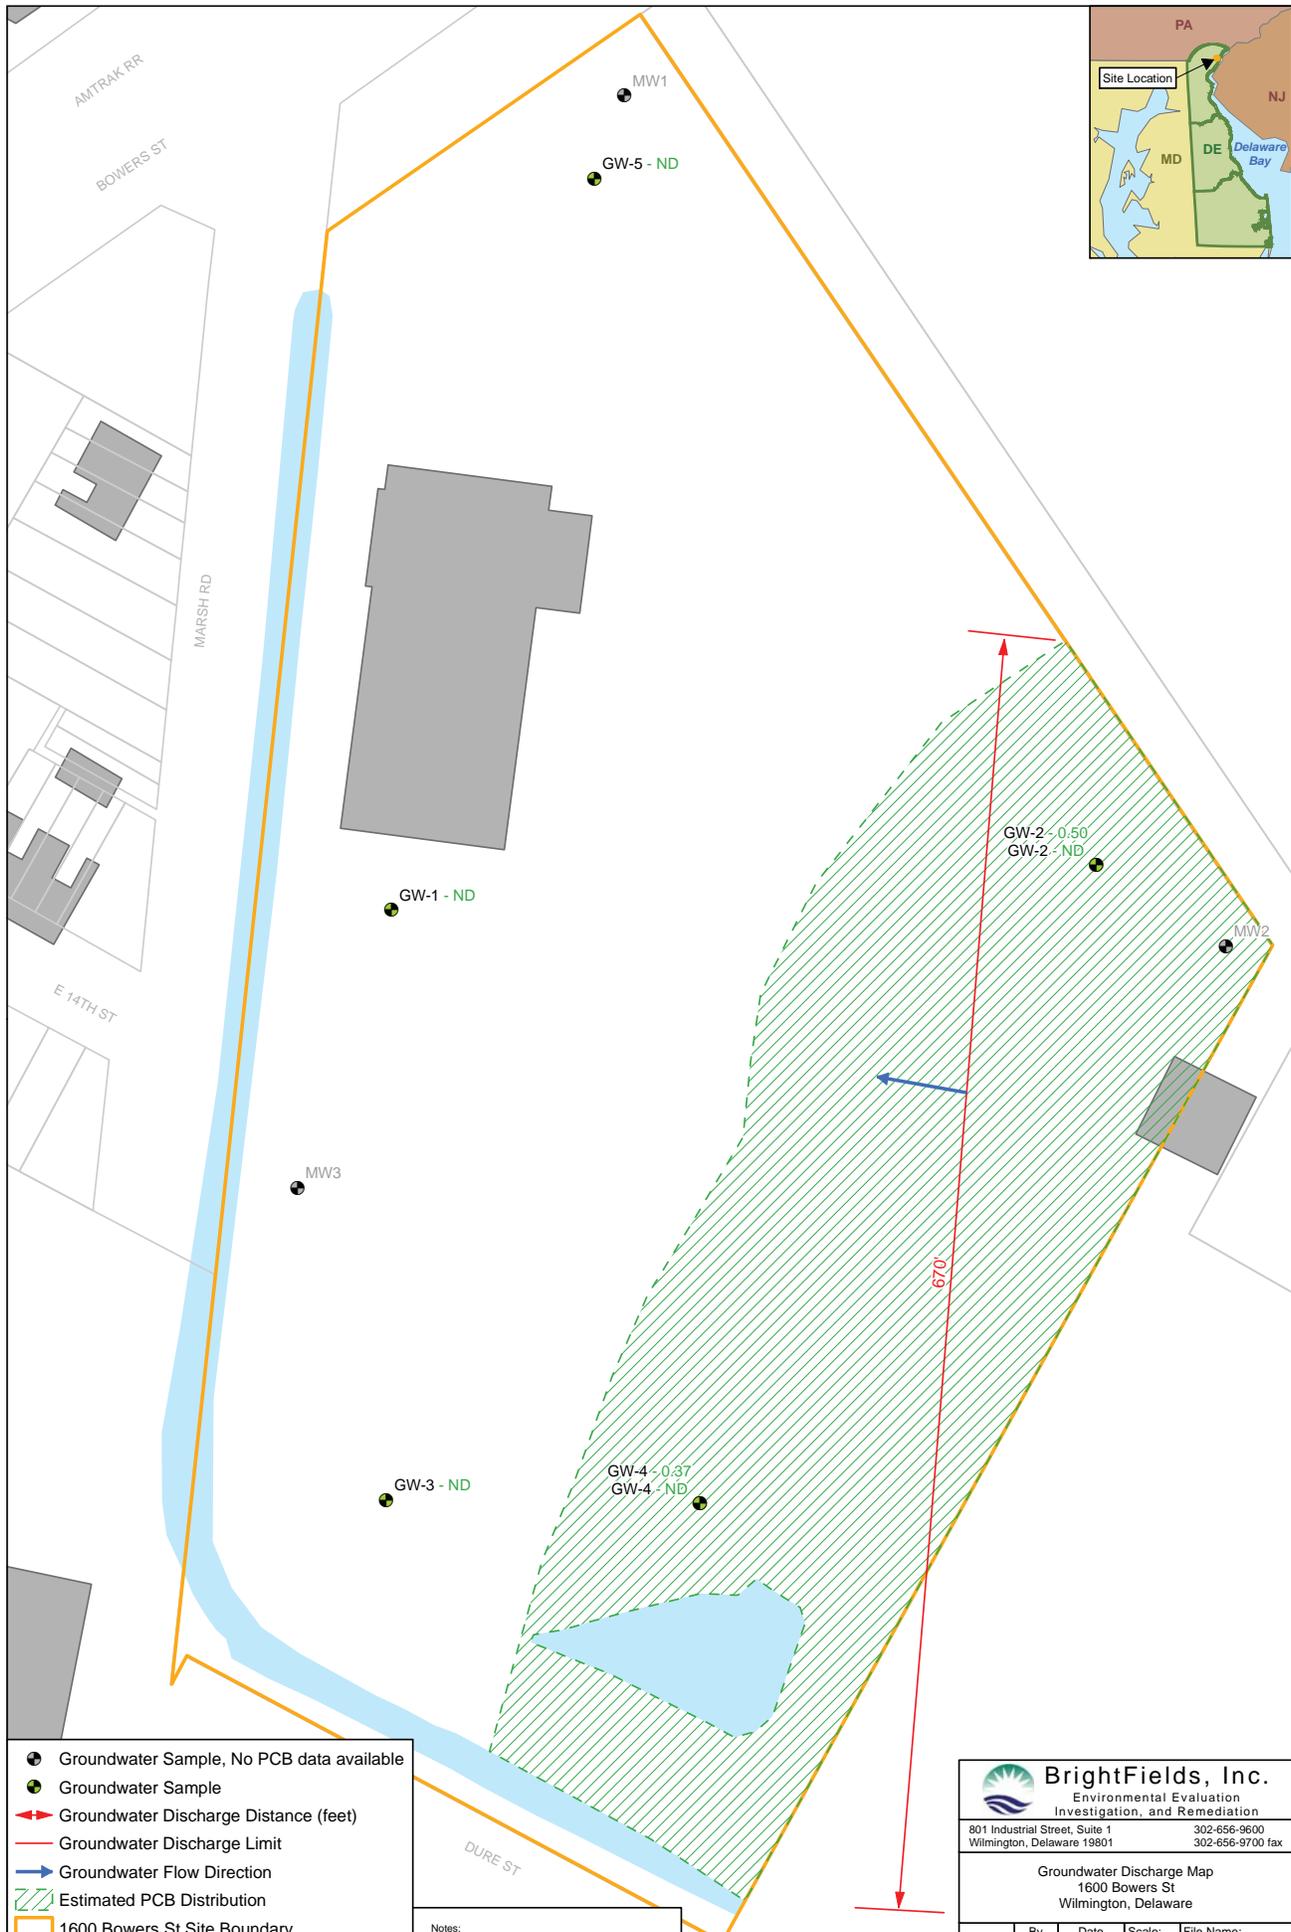
Drawn	By	Date	Scale	File Name:
ADS	ADS	12/17/2013	1:780	Fig7Discharge.mxd
Checked	JPR		12/17/2013	Fig. No.
Project #	0985.69.51		Figure 7

Notes:  
 0.70 - Groundwater Discharge Distance in feet  
 0.37 - Total PCB Concentration (ug/L)  
 ND - Not Detected  
 Surface water was derived from Aerial Imagery.  
 Source: Delaware DataMIL - Tax Parcels;  
 New Castle County - Buildings.

Groundwater Discharge Map  
 1600 Bowers St  
 Wilmington, Delaware

Groundwater discharge is based on the hydraulic conductivity of the soil, the groundwater gradient, and the cross-sectional area of the aquifer. A breakdown of the individual factors used in the Darcy equation is presented below. A groundwater discharge map is included as Figure 7.

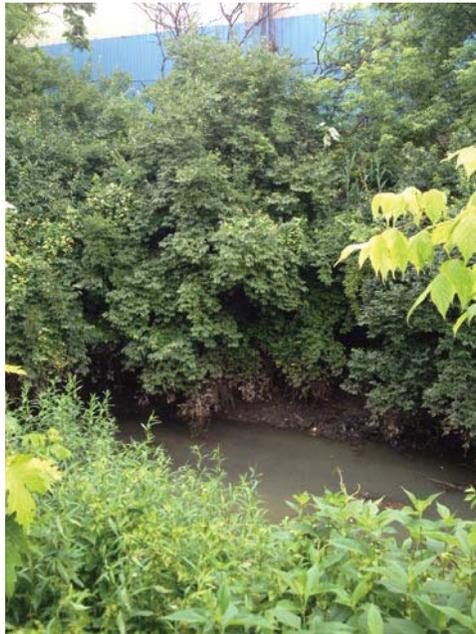
From the west of the site on Marsh Road, the land slopes down towards the river and is covered in weeds then has a steep slope up towards the site and is covered in trees.

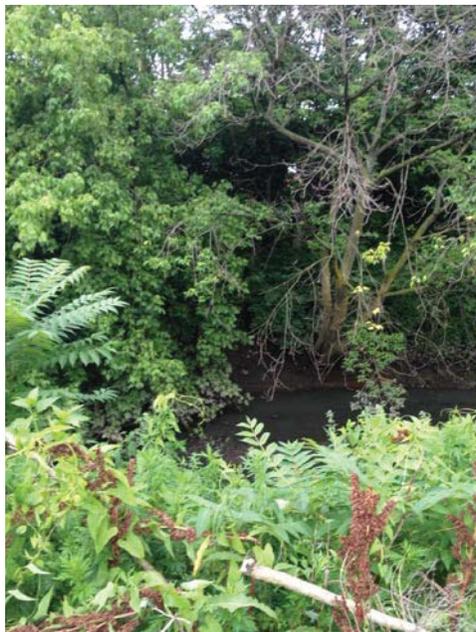
Vegetation along the river to the west of the site.

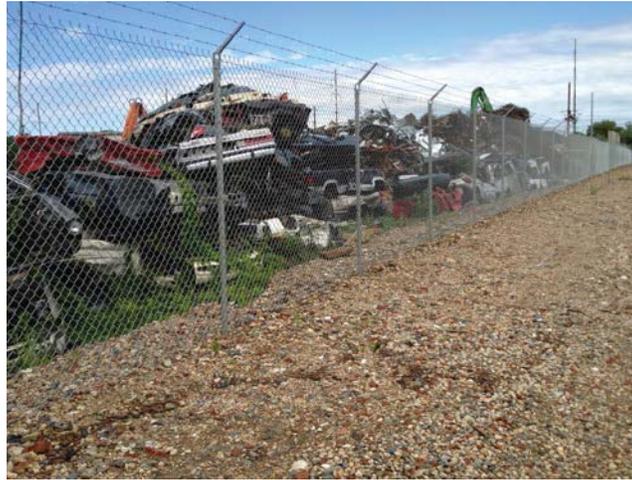
Debris and weeds within the site along the gravel road.

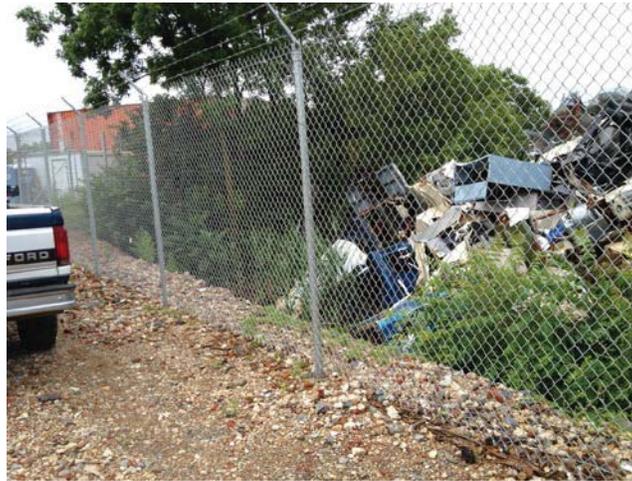
Debris pile within the site with weeds and trees interspersed.
