Appendix 16

GOVERNOR BACON HEALTH CENTER/ FORT DUPONT WILMINGTON, DELAWARE

SIRS ID: DE-1007

PCB Mass Loading Phase II
Governor Bacon Health Center/Fort DuPont
SIRS ID: DE-1007
Wilmington, Delaware

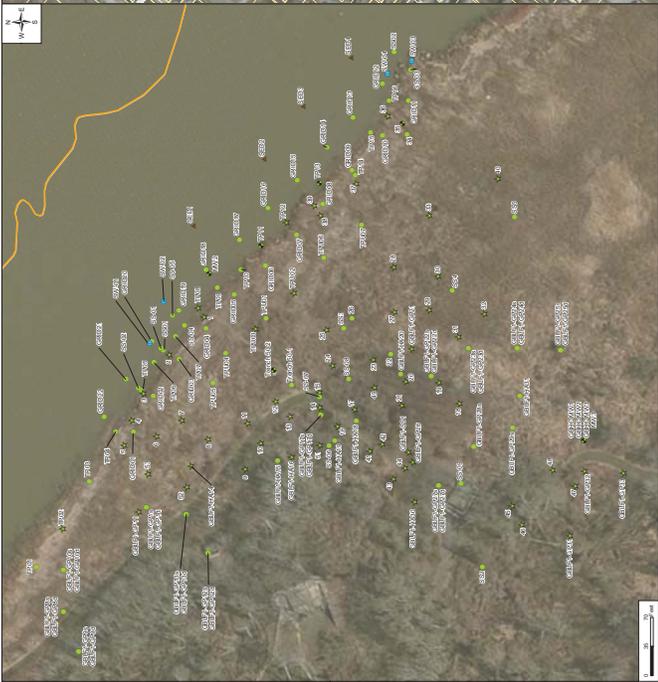
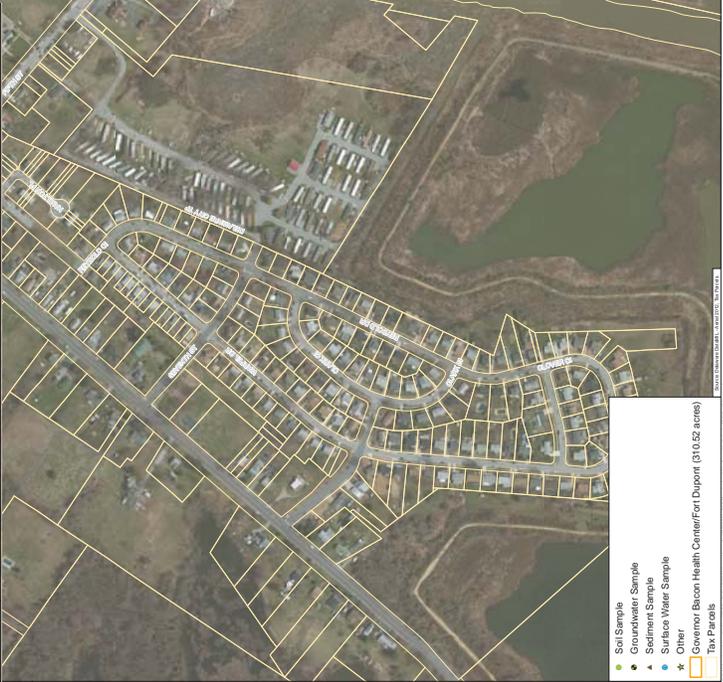
Heavy Metals Location:
Governor Bacon Health Center/Fort Dupont
Delaware City, Delaware

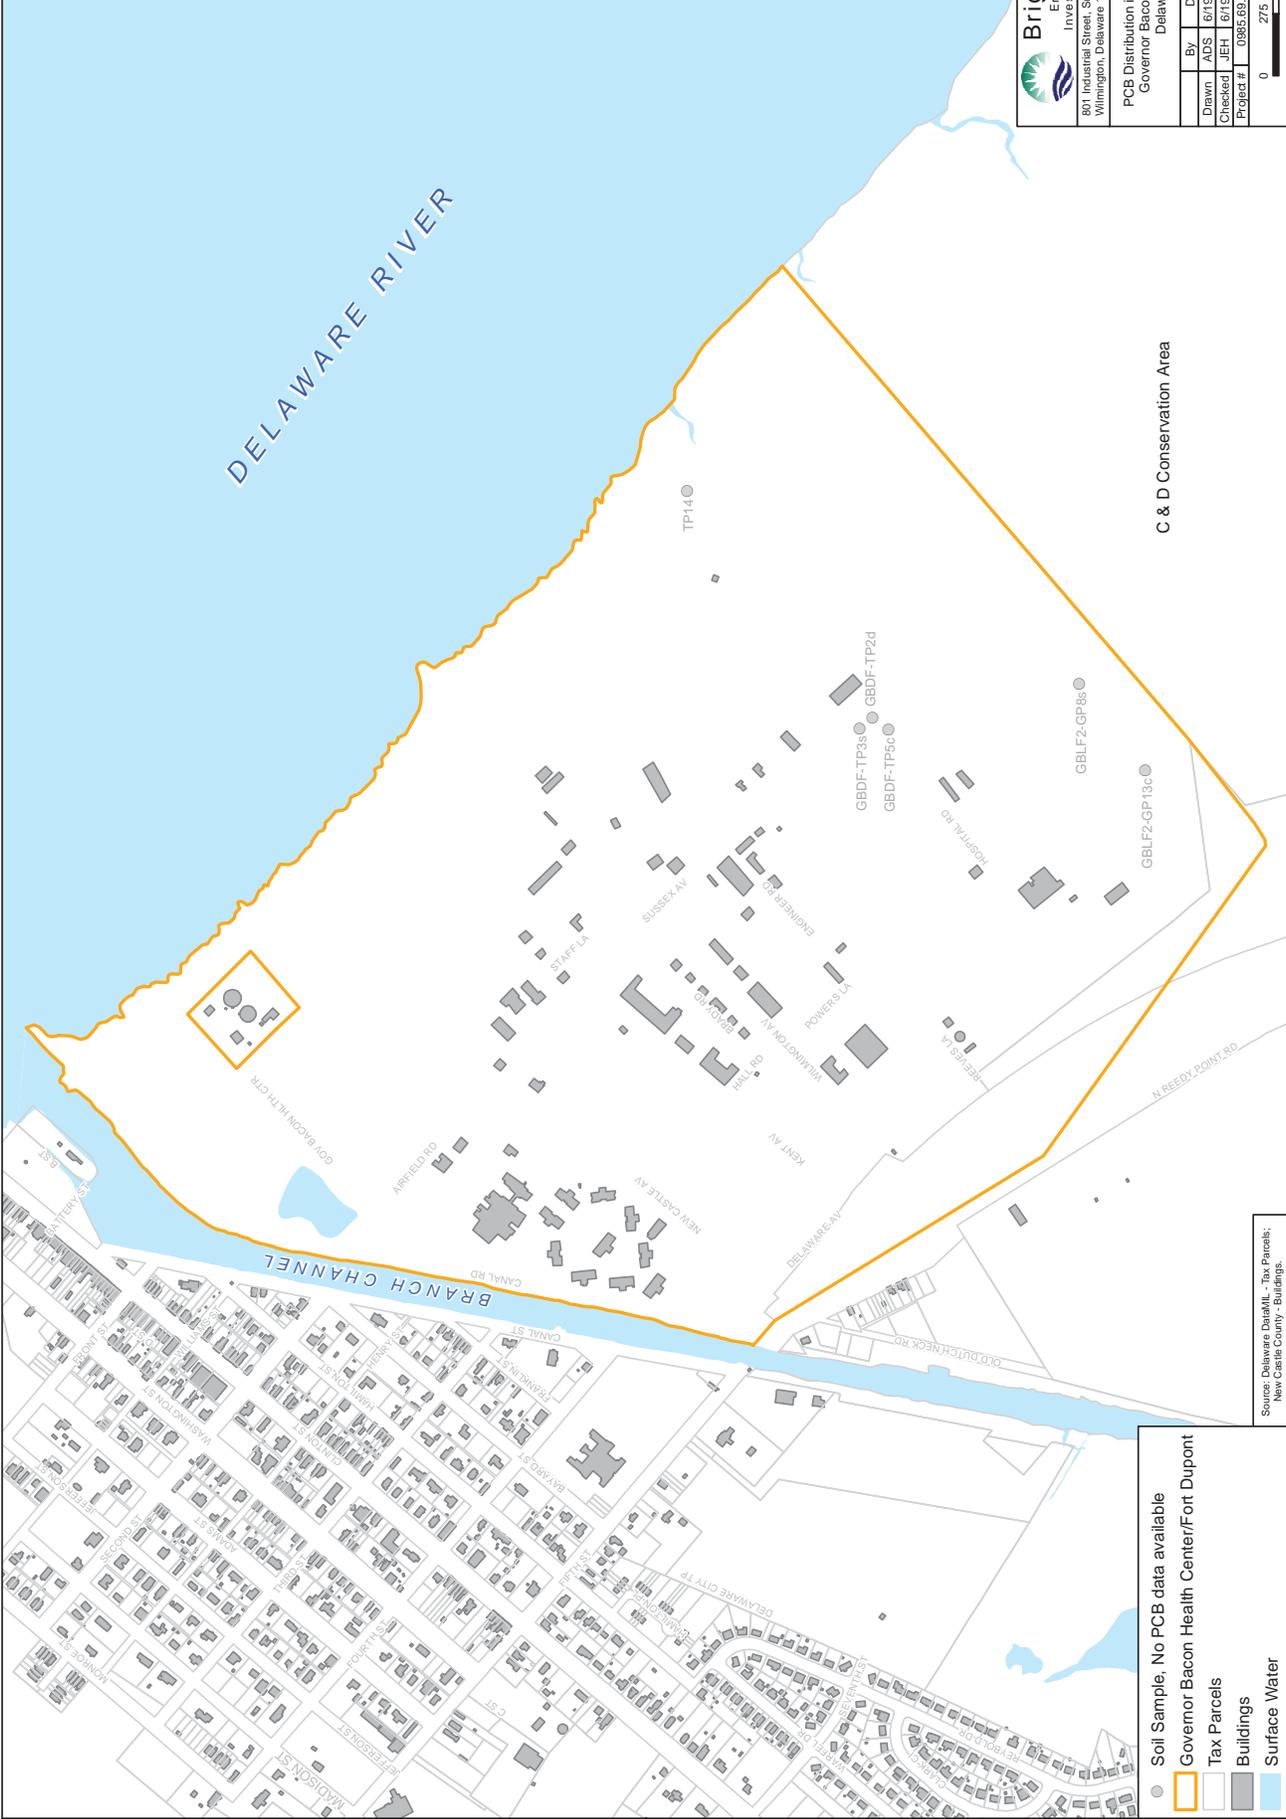
By	Date	Scale	File Name
ADS	6/19/2014	1:6,000	Fig3SS_UnSat.mxd
Checked	JEH	6/19/2014	Fig. No.
Project #	0985.69.51	Figure 3	
	0	275	550
			Feet

PCB Distribution in Subsurface Unsaturated Soil
 Governor Bacon Health Center/Fort DuPont
 Delaware City, Delaware

● Soil Sample, No PCB data available
 ■ Governor Bacon Health Center/Fort Dupont
 ■ Tax Parcels
 ■ Buildings
 ■ Surface Water

The estimated surface soil area impacted by PCBs is 30.3 acres (Figure 2). According to the information available and reviewed by BrightFields, no subsurface unsaturated soil samples were analyzed for PCBs so the respective area impacted by PCBs cannot be determined. Based on the data available and reviewed by BrightFields, subsurface saturated soil and groundwater are not impacted by PCBs.

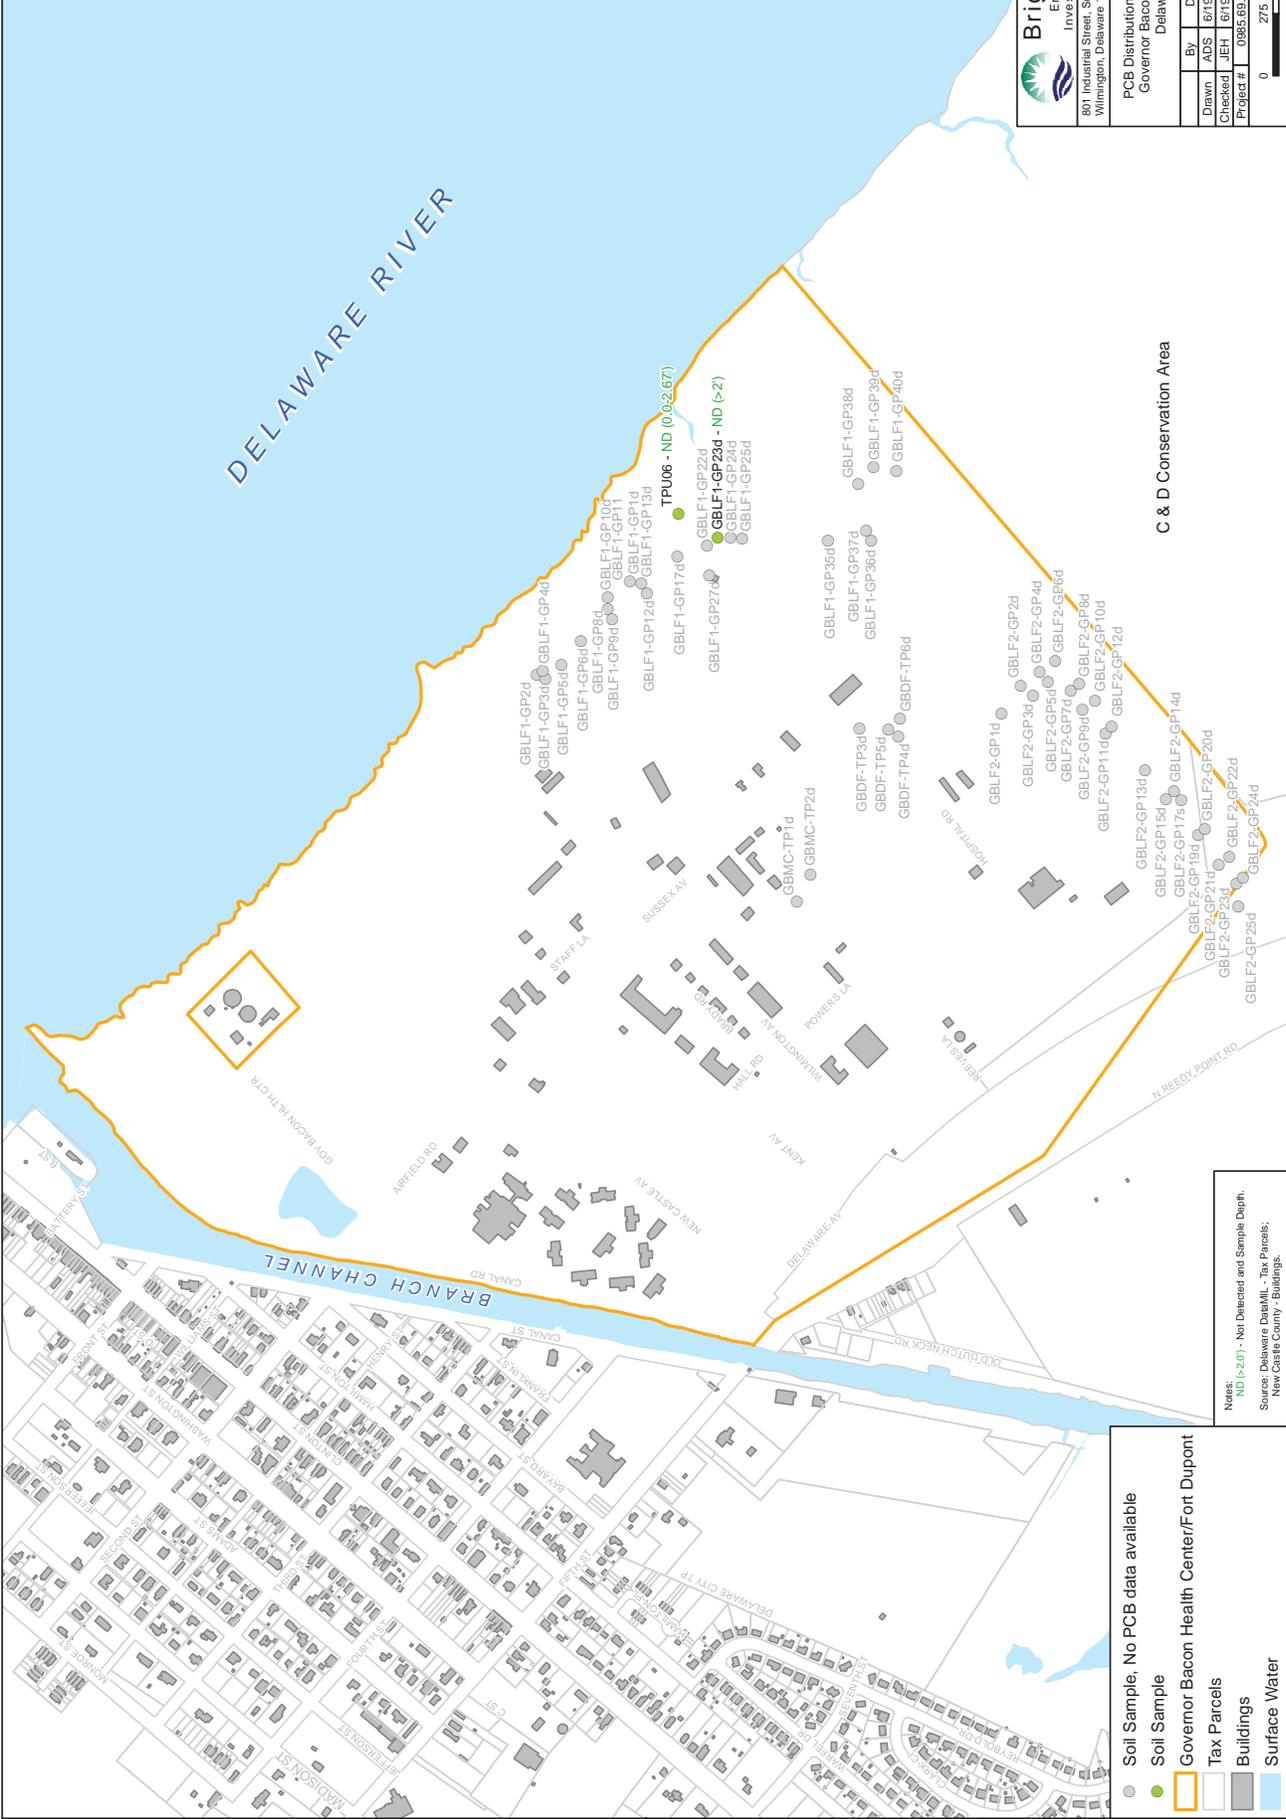
Fig. 4: PCB Distribution in Subsurface Saturated Soil - Governor Bacon Health Center/Fort DuPont, Delaware City, Delaware

PCB Distribution in Subsurface Saturated Soil
 Governor Bacon Health Center/Fort DuPont
 Delaware City, Delaware

Notes:
 ND 16-201 - Not Detected and Sample Depth.
 Source: Delaware DataMill - Tax Parcels,
 New Castle County - Buildings.

- Soil Sample, No PCB data available
- Soil Sample
- Governor Bacon Health Center/Fort Dupont
- Tax Parcels
- Buildings
- Surface Water

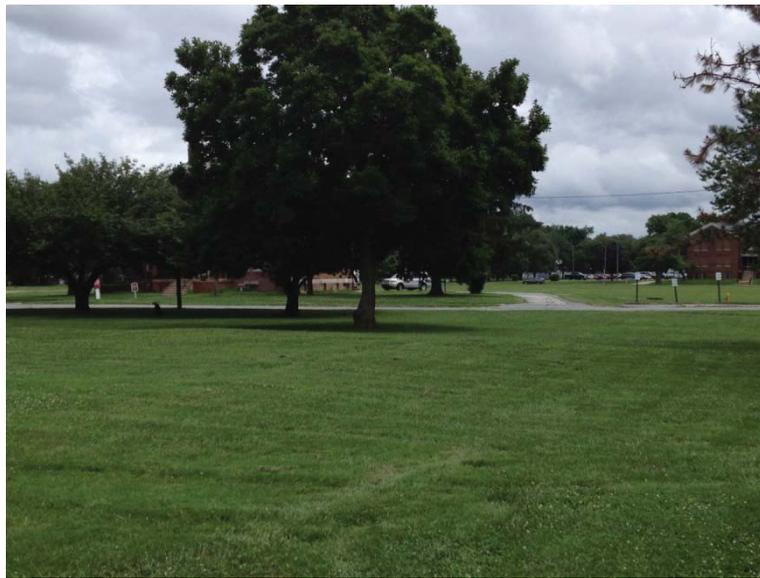
Near the intersection of New Castle Avenue and Sussex Avenue towards the north of the site.

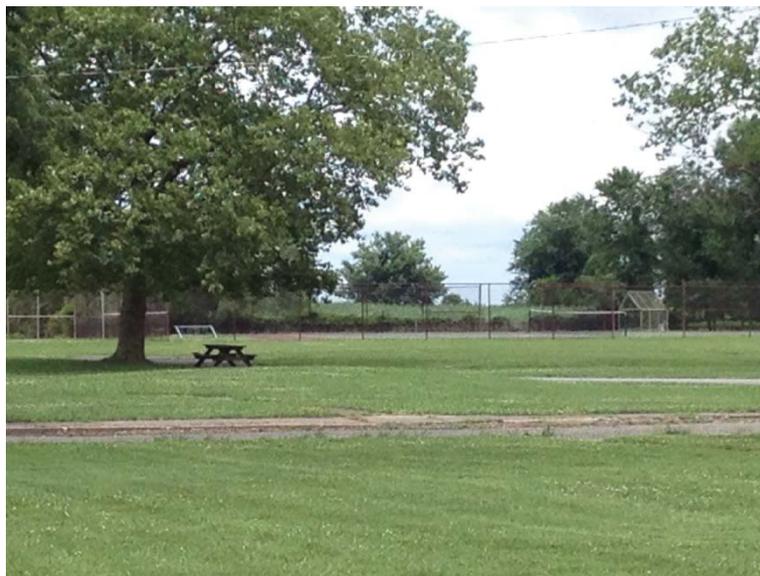
Looking towards the Delaware River from the building at the intersection of New Castle Avenue and Sussex Avenue. The site is mostly covered in grass but is more heavily vegetated towards the water, where the land appears to be sloping down.

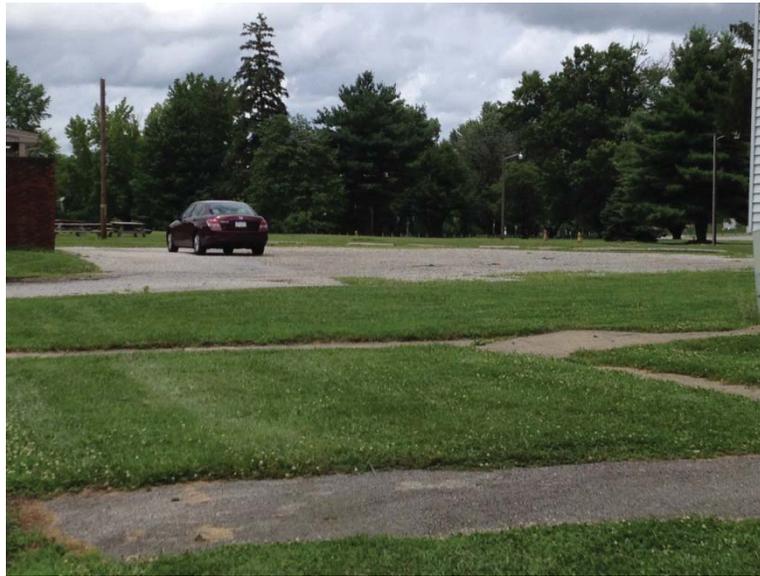
Looking northwest by the building at the intersection of New Castle Avenue and Sussex Avenue there is a thick tree line, beyond which there are parking lots (shown in next picture).

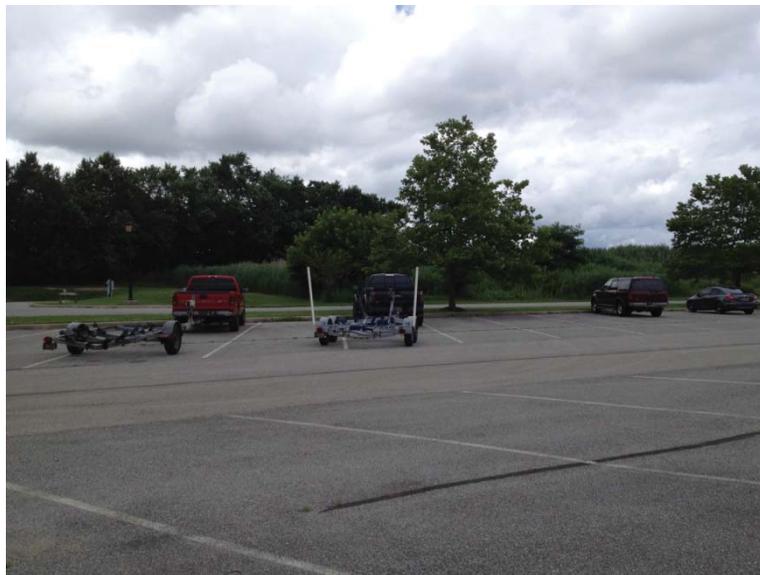
Looking north from the northern corner of the site towards the canal there is tall, thick grass and some trees.

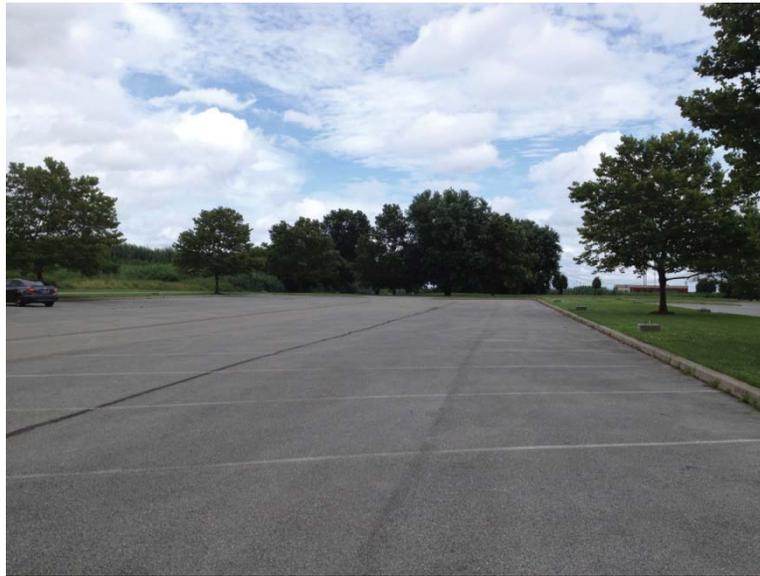
Looking northeast towards the Delaware River from the northernmost parking lot which slopes down slightly towards the northwest.

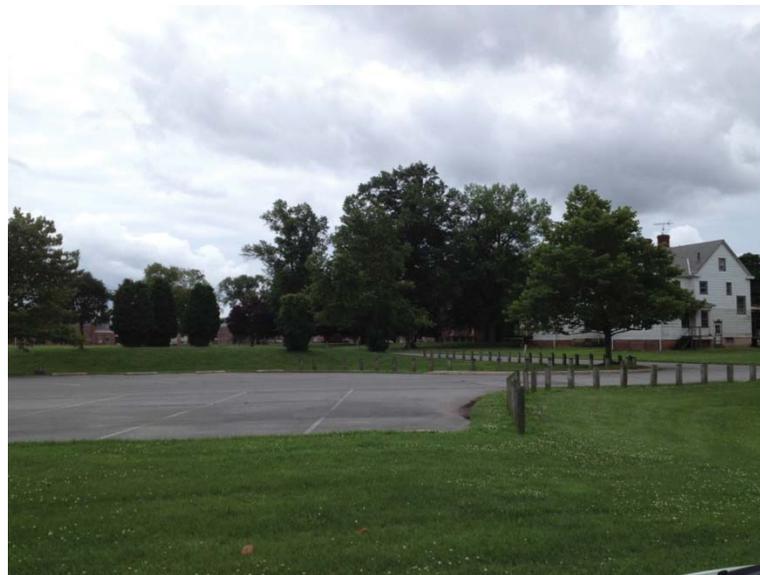
Looking southeast from the northernmost parking lot, there are some buildings surrounded by foliage.

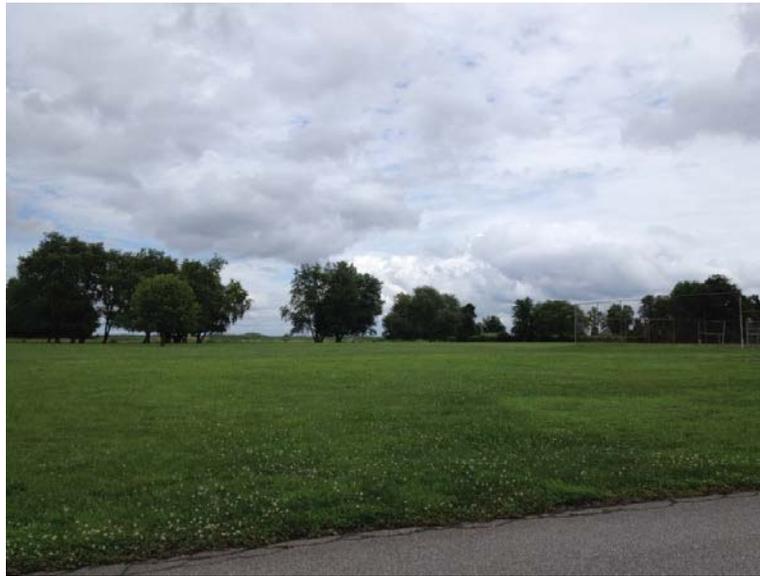
Courts and a large open area in the northern portion of the site next to the bend in Airfield Road.
The Delaware River is in the distance beyond the trees.

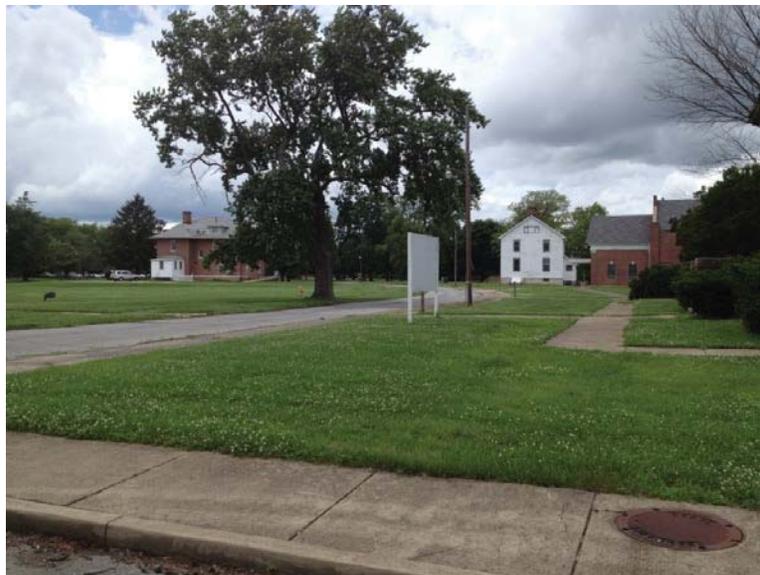
Mixed buildings, pavement, grass, and trees at the intersection of Sussex Avenue and Exchange Road.

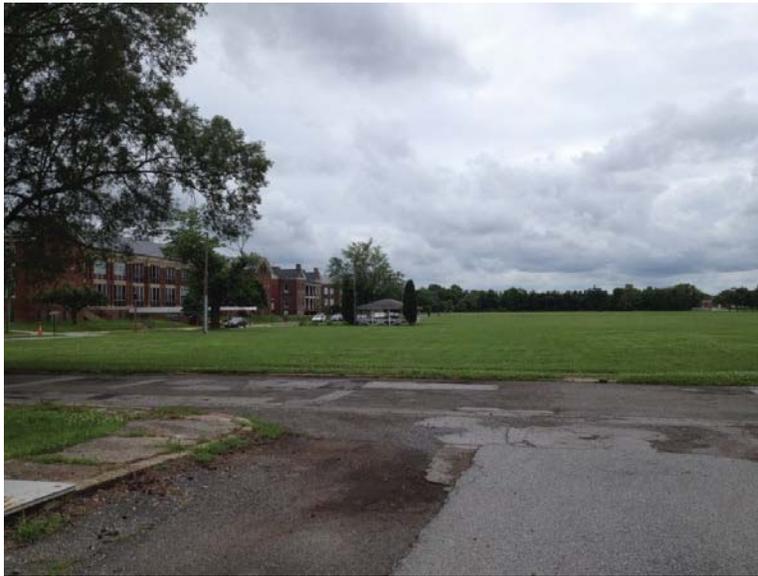
At the intersection of Sussex Avenue and Exchange Road looking southwest towards the middle of the site.

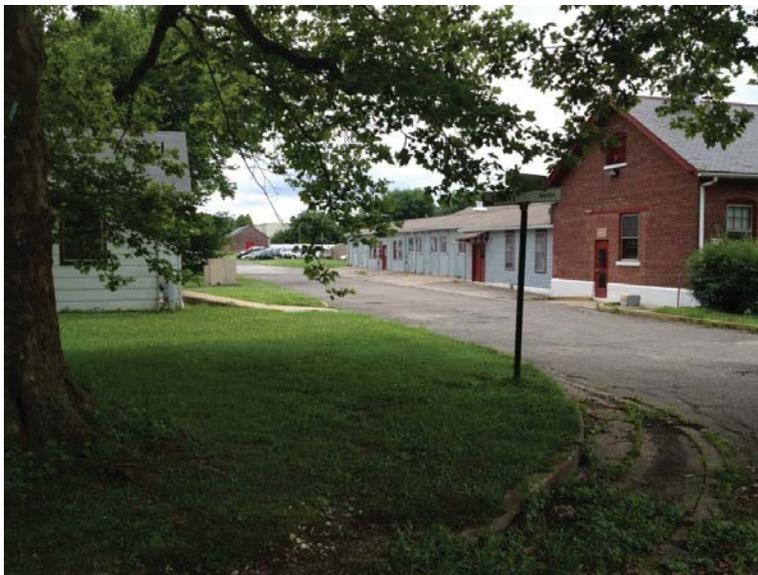
At the intersection of Sussex Avenue and Engineer Road near the western corner of the site where there are numerous buildings and parking areas.

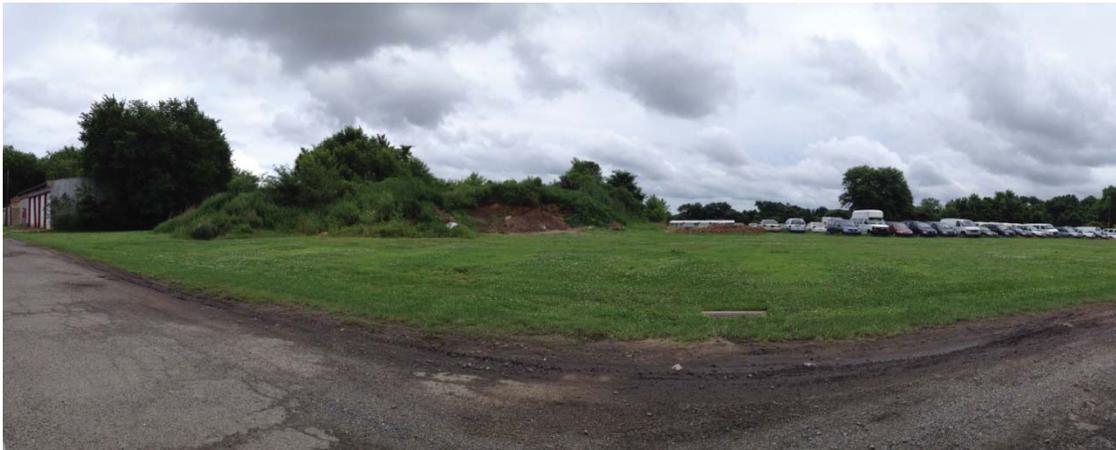
On Engineer Road near the intersection with Hall Powers Lane in the southern portion of the site where there is a large dirt mound partially covered in vegetation and a lot with cars for sale.

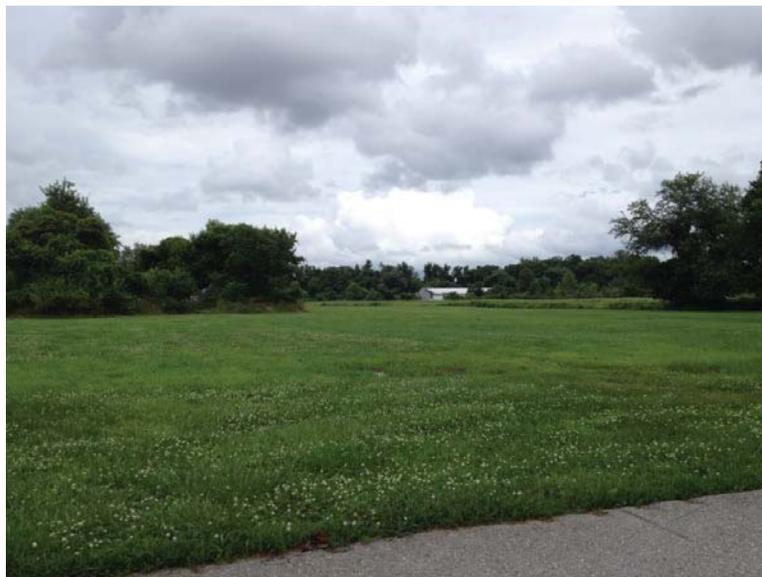
Near the western end of Delaware Avenue where shorter grass meets taller, thicker grass and there is a forested area in the background.

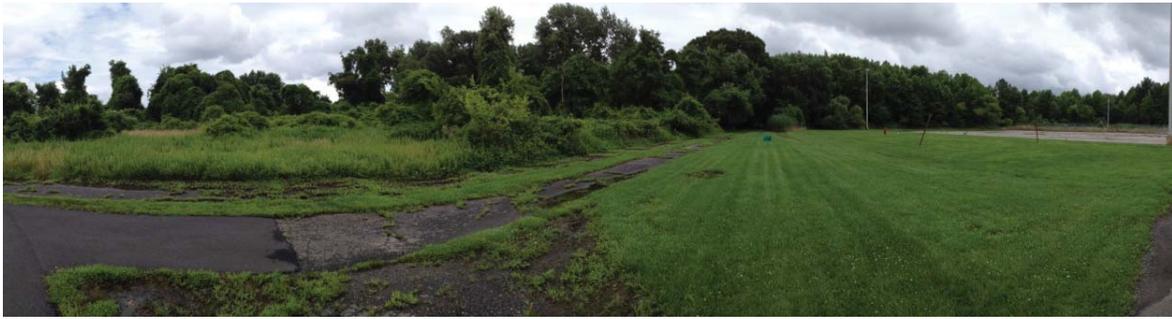
At the eastern end of Delaware Avenue in the southern corner of the site looking southeast into the woods with areas of grass, thick bushes and weeds, and a wooded area.

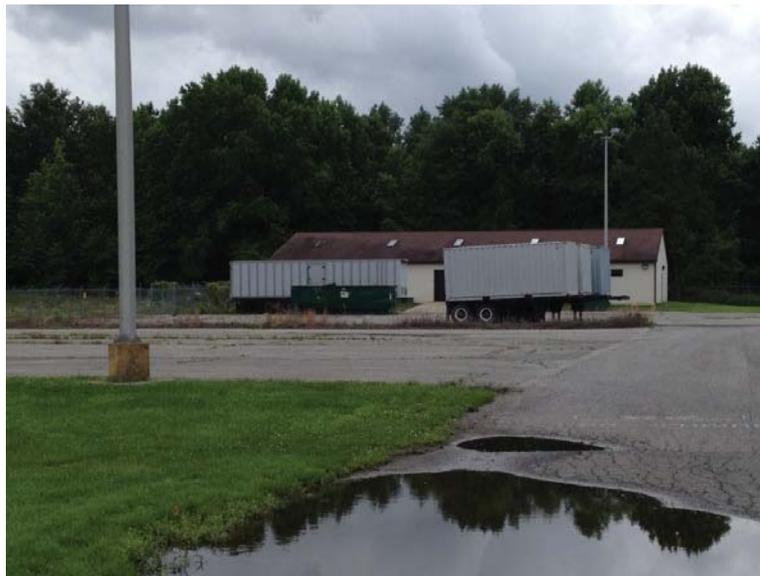
A parking lot for a building at the eastern end of Delaware Avenue where water has ponded and there is thick forest in the background.

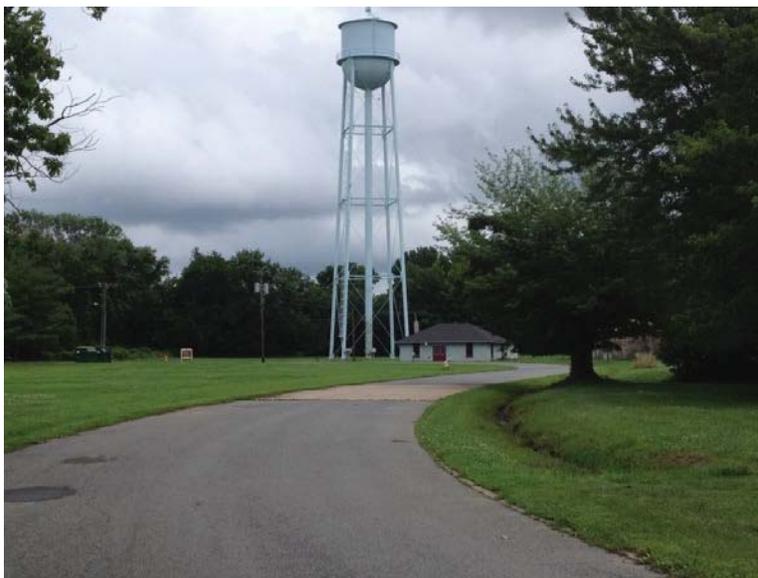
On Canal Road near the intersection with Kent Avenue where there are small streams on either side of the road.
