PCB Mass Loading Phase II
DuPont Louviers/MBNA
SIRS ID: DE-1049
Newark, Delaware

Appendix 11

GENERAL SITE INFORMATION

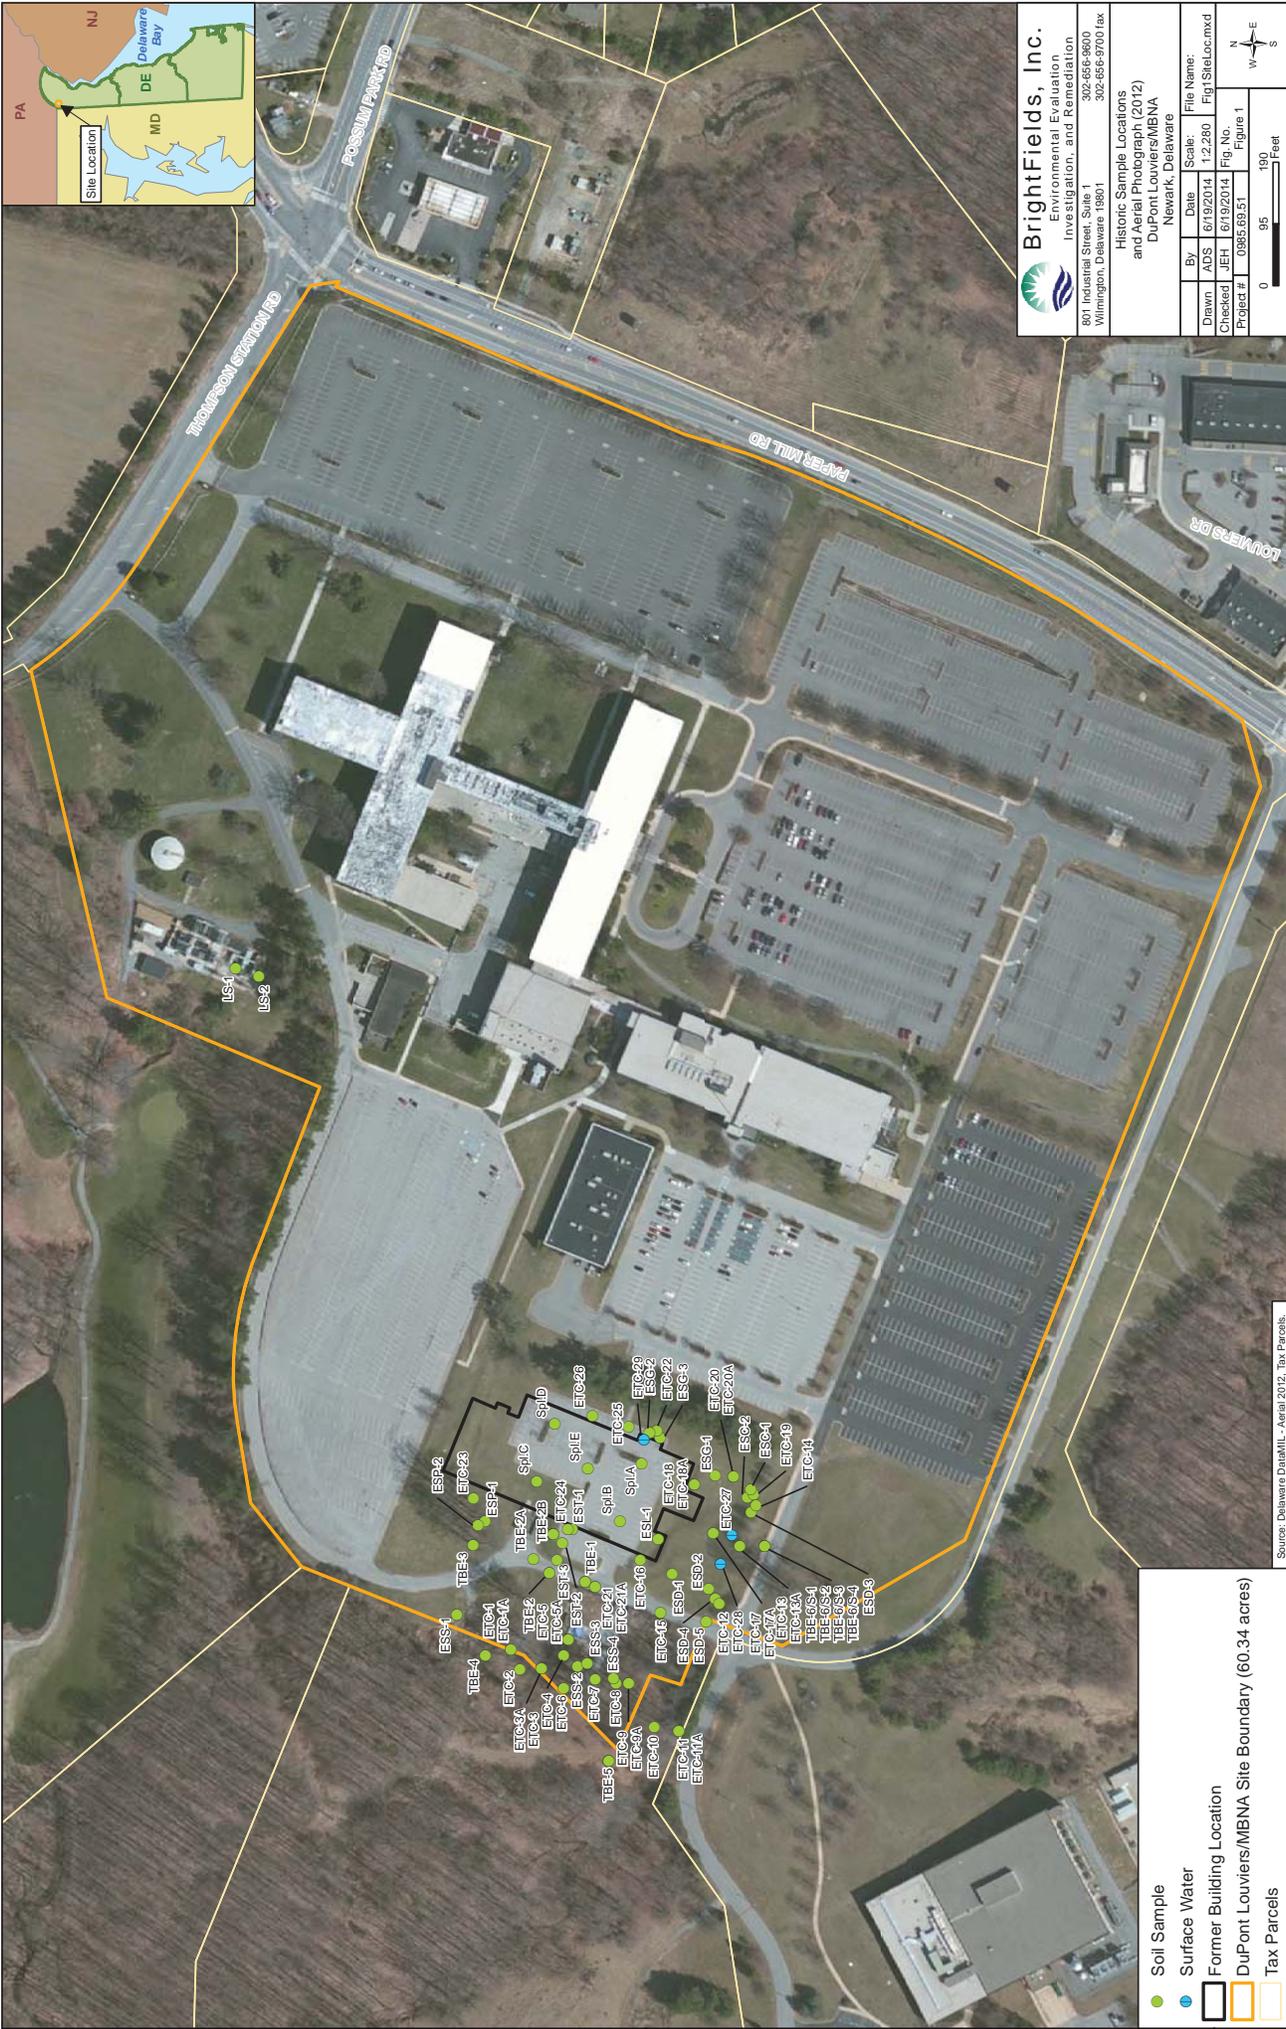
By	Date	Scale	File Name:
Drawn	ADS 6/19/2014	1:2,280	Fig1SiteLoc.mxd
Checked	JEH 6/19/2014		Fig. No.
Project #	0985.69.51		Figure 1
	0	95	190

Historic Sample Locations
 and Aerial Photograph (2012)
 DuPont Louvers/MBNA
 Newark, Delaware

The DuPont Louviers/MBNA site is located at 655 Paper Mill Road in Newark, Delaware. The site is approximately 60.3 acres in size and is comprised of one tax parcel (#0804600008) located in the southwest quadrant created by the intersection of Paper Mill Road and Thompson Station Road (Figure 1). The property is bounded to the north by Thompson Station road, beyond which is state parkland; to the east by Paper Mill Road, beyond which are commercial and residential properties; to the south by wooded land and a small commercial office complex; and to the west by state parkland. The head of an unnamed, perennial tributary of White Clay Creek is located approximately 1,000 feet west of the western site boundary; this tributary discharges into White Clay Creek approximately 3,000 feet from the same site boundary. Two other unnamed tributaries have headwaters within 1,000 feet of the site boundary; however, these other tributaries flow further to discharge into the White Clay Creek. Northwest of the site is a golf course, formerly associated with the DuPont Louviers/MBNA site, but outside the scope of this and historical environmental investigations. The surrounding land is generally recreational, residential, and commercial.

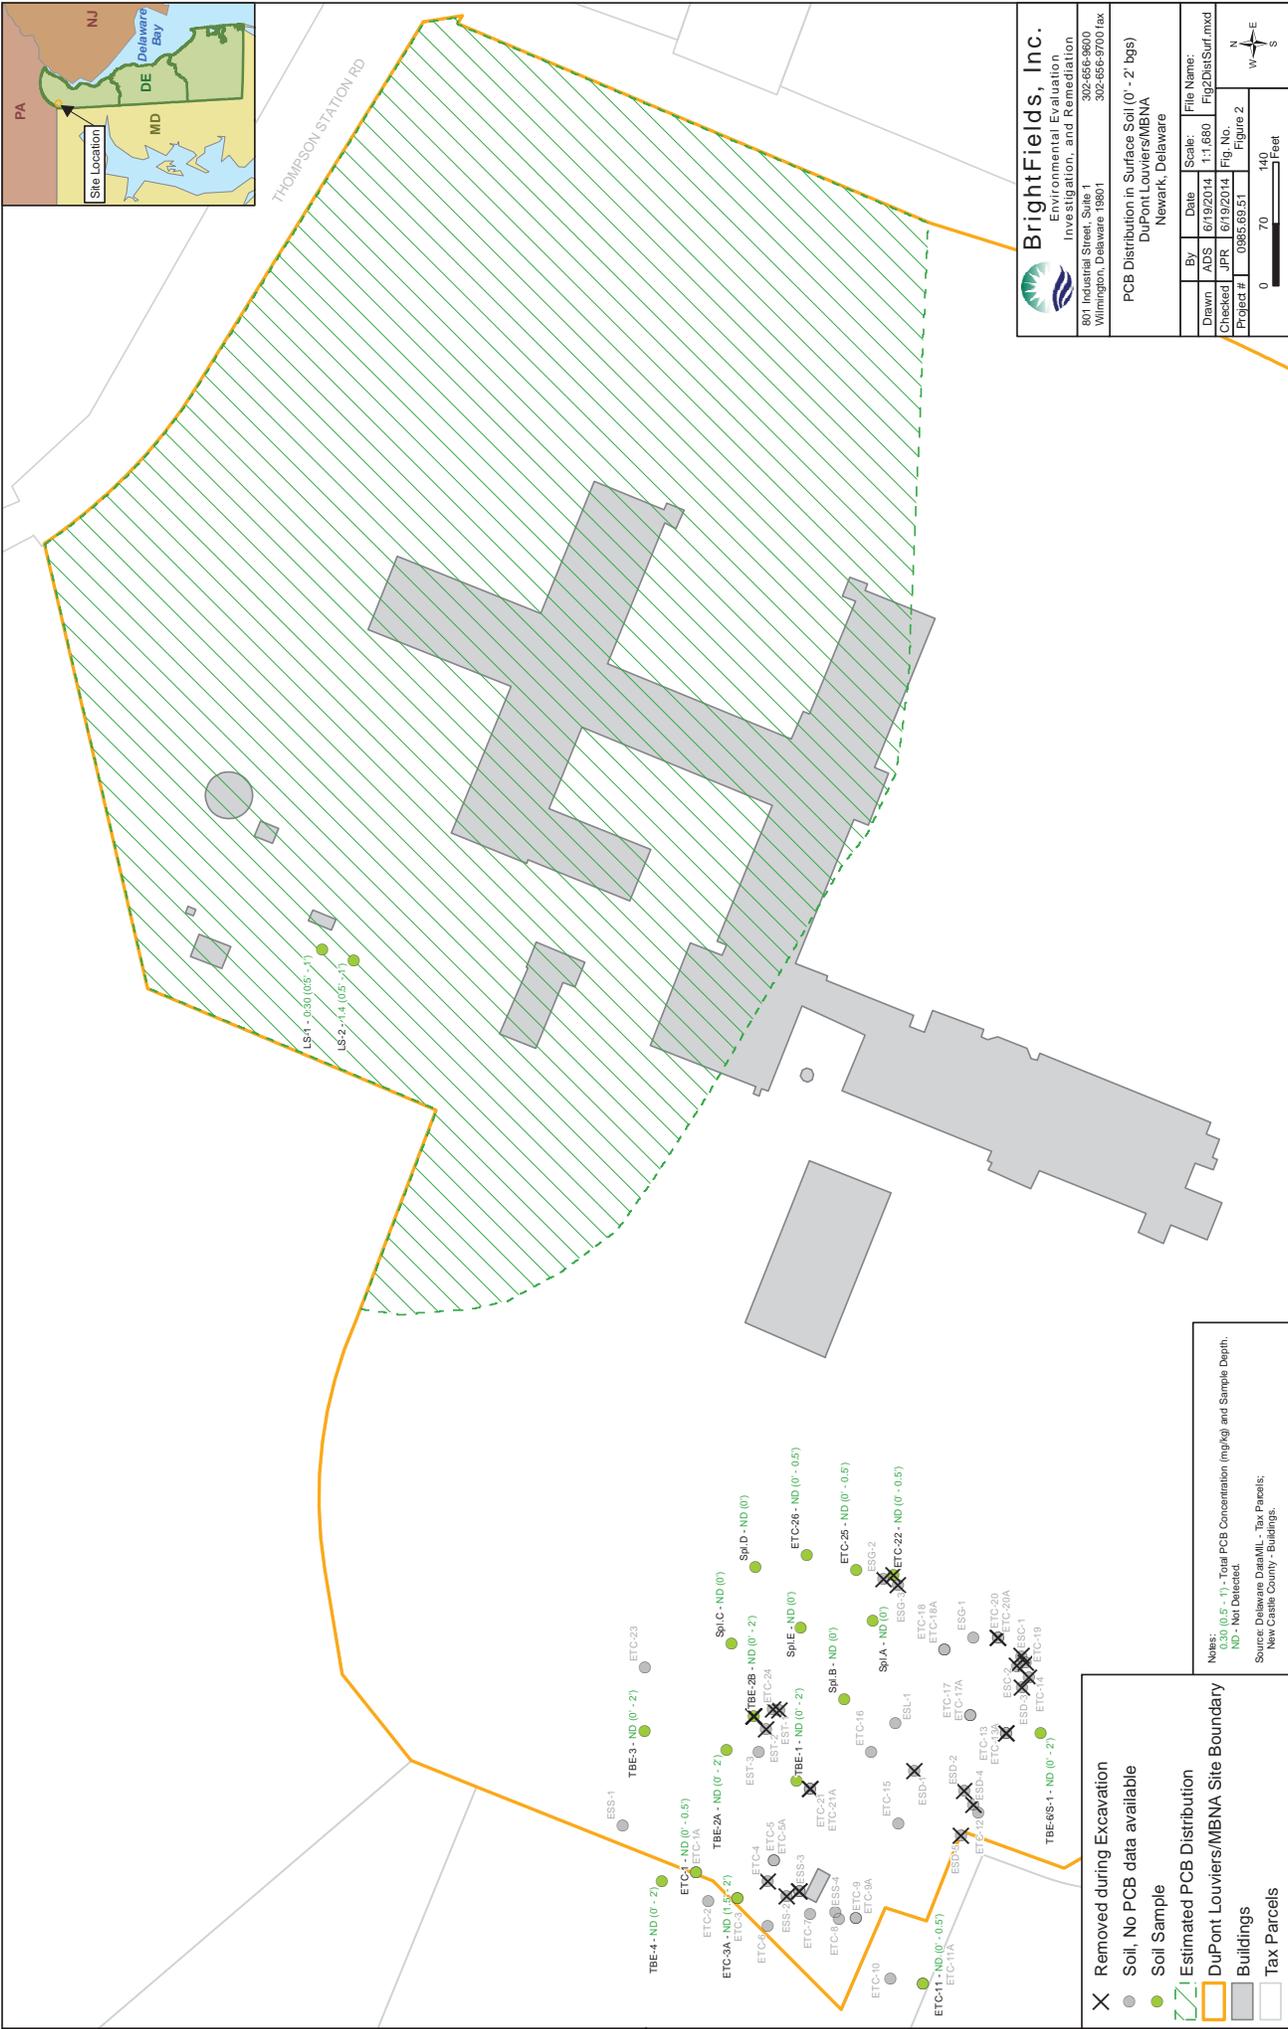
By	Date	Scale	File Name
ADS	6/19/2014	1:1,680	Fig2BatSurf.mxd
JPR	6/19/2014	Fig. No.	Figure 2
Project #	0985.69.51	Figure 2	
0 70 140		Feet

PCB Distribution in Surface Soil (0' - 2' bgs)
 DuPont Louvers/MBNA
 Newark, Delaware

Notes:
 0.30 (0.5 - 1) - Total PCB Concentration (mg/kg) and Sample Depth.
 ND - Not Detected.
 Source: Delaware DataMIL - Tax Parcels;
 New Castle County - Buildings.

PCBs were detected in surface soil at two locations, LS-1 (0.5 to 1.0 feet below ground surface (bgs)) and LS-2 (0.5 to 1 feet bgs) at concentrations of 0.3 mg/kg and 1.4 mg/kg, respectively. PCBs were not detected in the unsaturated subsurface soil. No saturated subsurface soil samples were analyzed for PCBs.

The estimated surface soil area impacted by PCBs is 21.9 acres in the vicinity of LS-1 and LS-2 (Figure 2). The impacted area may be overestimated due to the lack of additional PCB analytical data in the vicinity of LS-1 and LS-2. This uncertainty is reflected in the uncertainty analysis, where the average number of samples per acre is calculated as less than 1. Based on the data available and reviewed by BrightFields, the subsurface unsaturated soil is not impacted by PCBs. Since no saturated subsurface soil samples or groundwater samples were analyzed for PCBs, BrightFields cannot determine the respective areas impacted by PCBs.

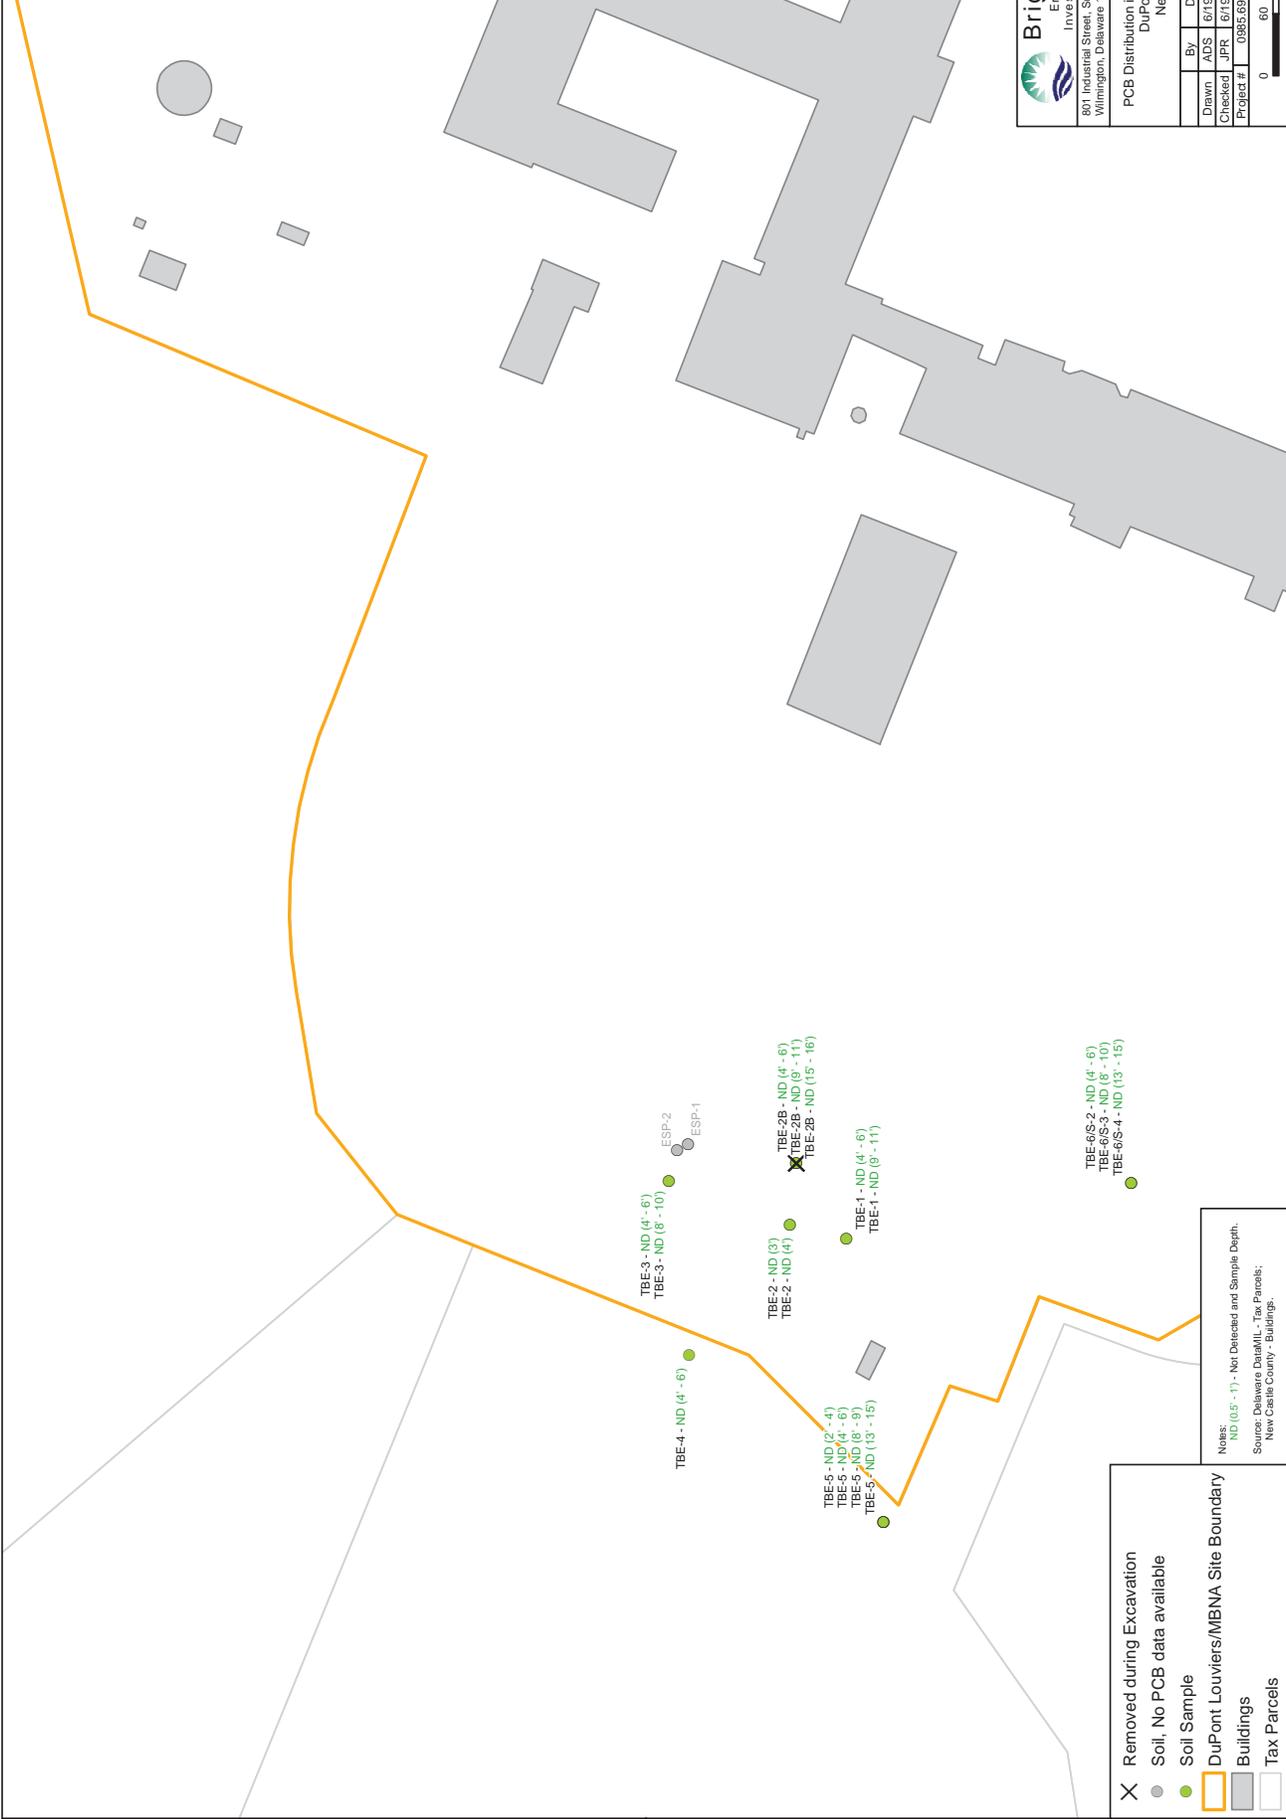
By	Date	Scale	File Name
ADS	6/19/2014	1:1,440	FigSSS_UnSat.mxd
Checked	JPR	6/19/2014	Fig. No.
Project #	0985.69.51	Figure 3	
	0	60	120
			Feet

PCB Distribution in Subsurface Unsaturated Soil
 DuPont Louviers/MBNA
 Newark, Delaware

Notes:
 ND (0.5' - 1') - Not Detected and Sample Depth.
 Source: Delaware DataMILL - Tax Parcels;
 New Castle County - Buildings.

Concentrations of PCBs on Site			
Sample Matrix	Corresponding Figure	Analytical Methods	Range of Total PCBs
Surface Soil	Figure 2	Method 8082	Not detected to 1.4 mg/kg
Subsurface Soil (unsaturated)	Figure 3	Method 8082	Not Detected
Subsurface Soil (saturated)	Figure 4	Not Analyzed	Not Analyzed
Groundwater	Figure 5	Not Analyzed	Not Analyzed

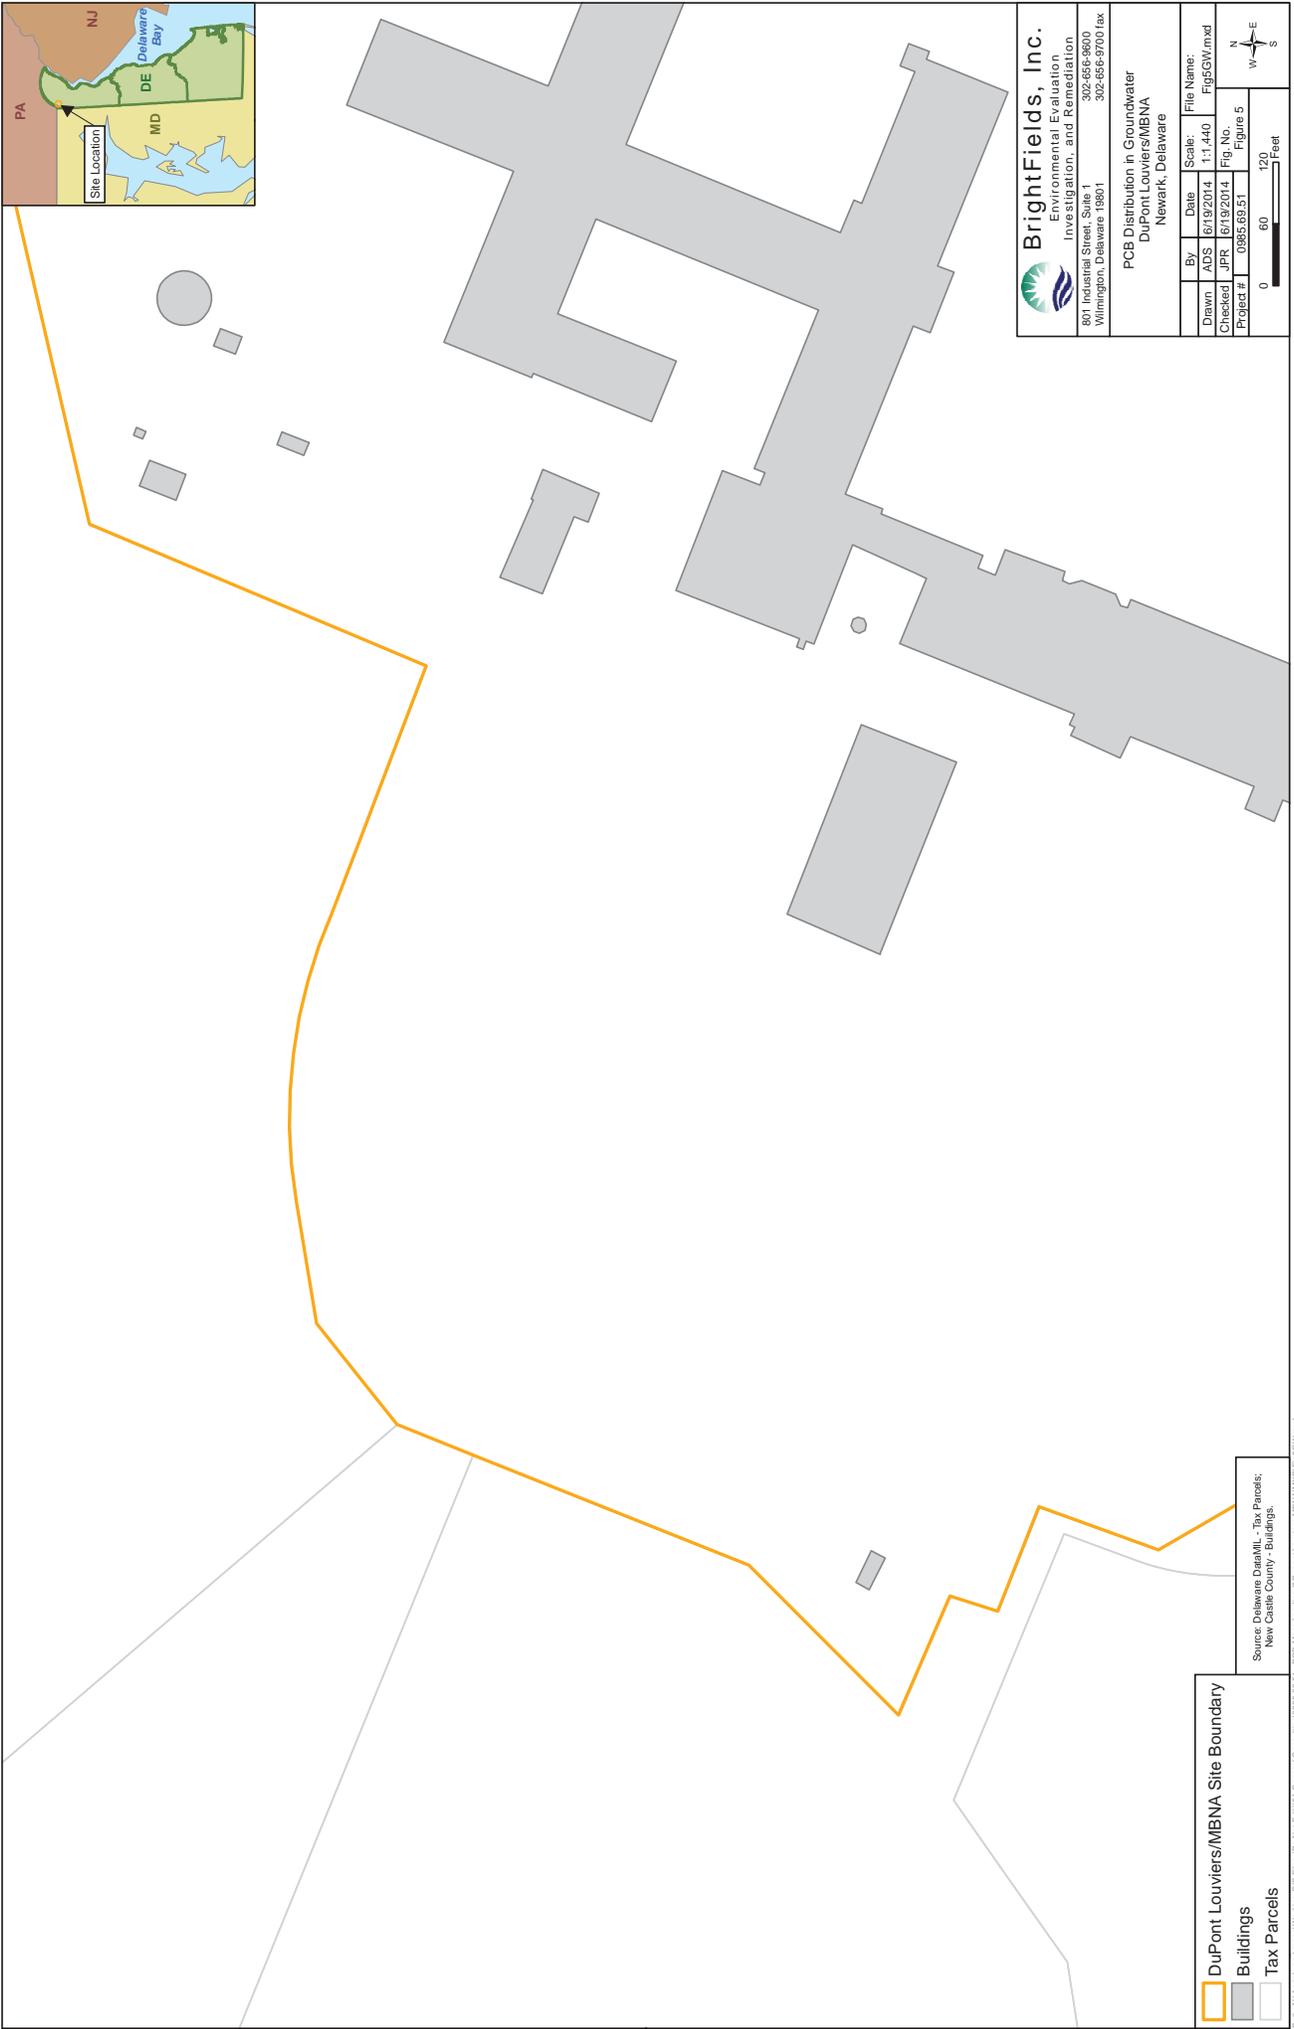
By	Date	Scale	File Name
ADS	6/19/2014	1:1,440	Fig5GW.mxd
Checked	JPR	6/19/2014	Fig. No.
Project #	0985.69.51	Figure 5	
0	60	120	0
			Feet

PCB Distribution in Groundwater
 DuPont Louviers/MBNA
 Newark, Delaware

According to the information available and reviewed by BrightFields, no subsurface saturated soil or groundwater samples were analyzed for PCBs so the respective areas impacted by PCBs cannot be determined. Therefore, no groundwater loading estimates were prepared for the site.

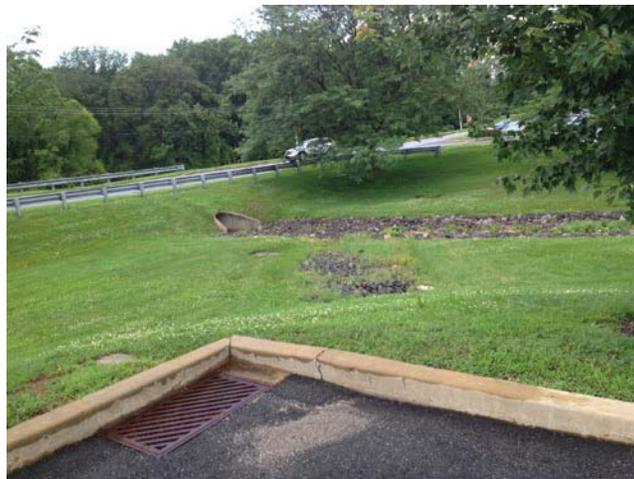
Drainage ditch in the southwestern portion of the site between two parking lots.

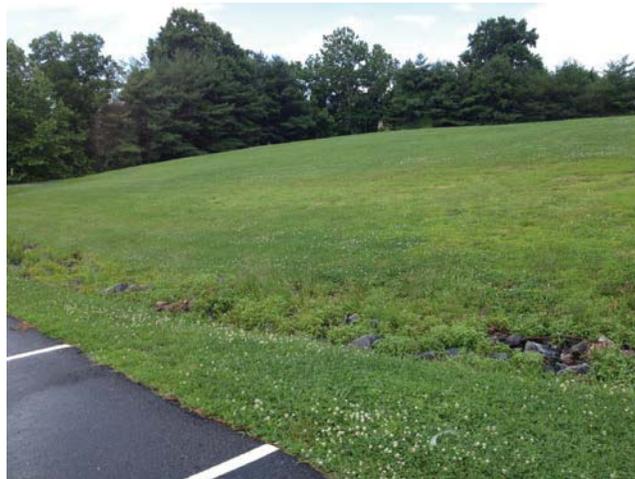
The western corner of the site at the edge of the parking lot where there is a grassy hill and a wooded area. There is also another drainage ditch which runs parallel to the parking lot edge.

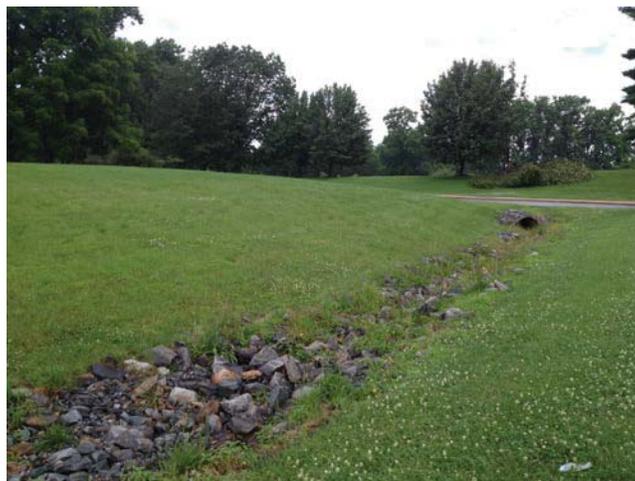
A side view of the drainage ditch looking northeast.

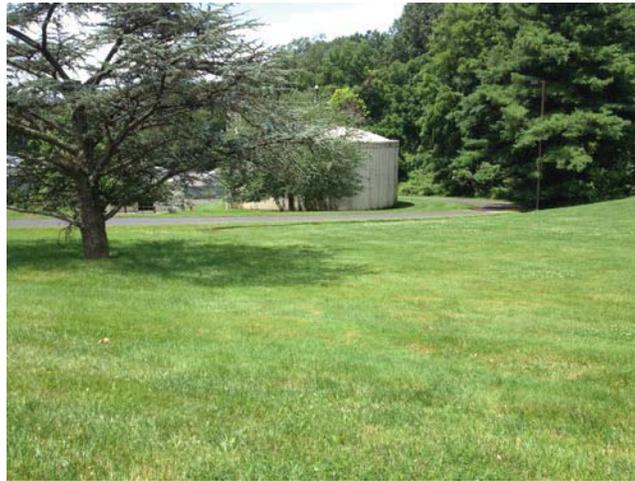
Land outside of the main building in the northwestern portion of the site sloped down steeply towards the north.
