PCB Mass Loading Phase II
Wilmington Rolling Mill Property
SIRS ID: DE-1198
Wilmington, Delaware

Appendix 29

WILMINGTON ROLLING MILL PROPERTY WILMINGTON, DELAWARE

SIRS ID: DE-1198

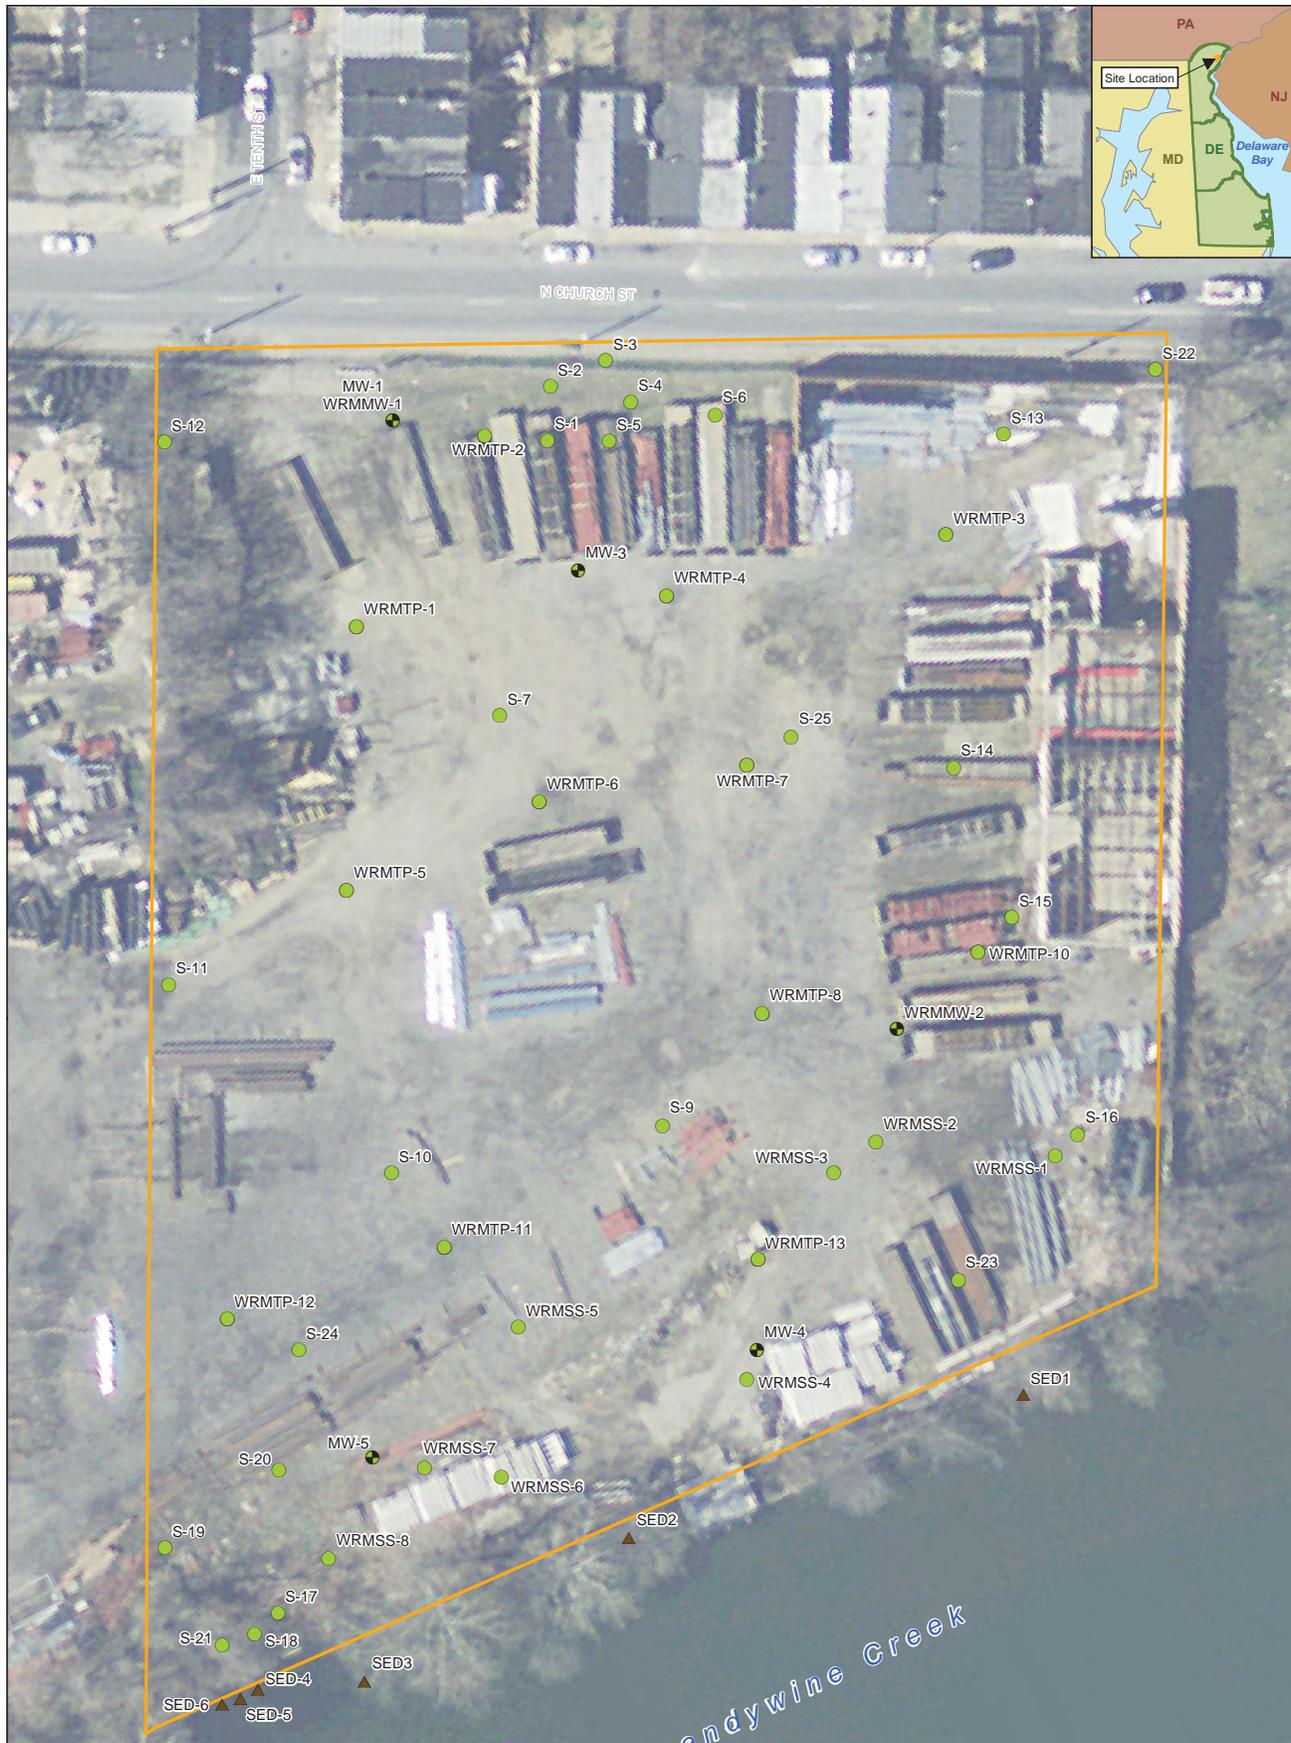
Drawn	By	Date	Scale	File Name:
ADS	ADS	5/30/2014	1:480	Fig1SiteLoc.mxd
Checked	JPR	5/30/2014	Fig. No.	
			Figure 1	
Project #	0985.69.51

The Wilmington Rolling Mill Property is located at 1020 Church Street in Wilmington, Delaware (Figure 1). The site is approximately 2.8 acres in size and is comprised of two parcels (#2603630706 and #2603630707). The site is bounded to the north by a City of Wilmington parcel to the east by the Brandywine Creek, to the south by O'Brien Industries, and to the west by Church Street.

Historic Sample Locations
 and Aerial Photograph (2012)
 Wilmington Rolling Mill
 Wilmington, Delaware

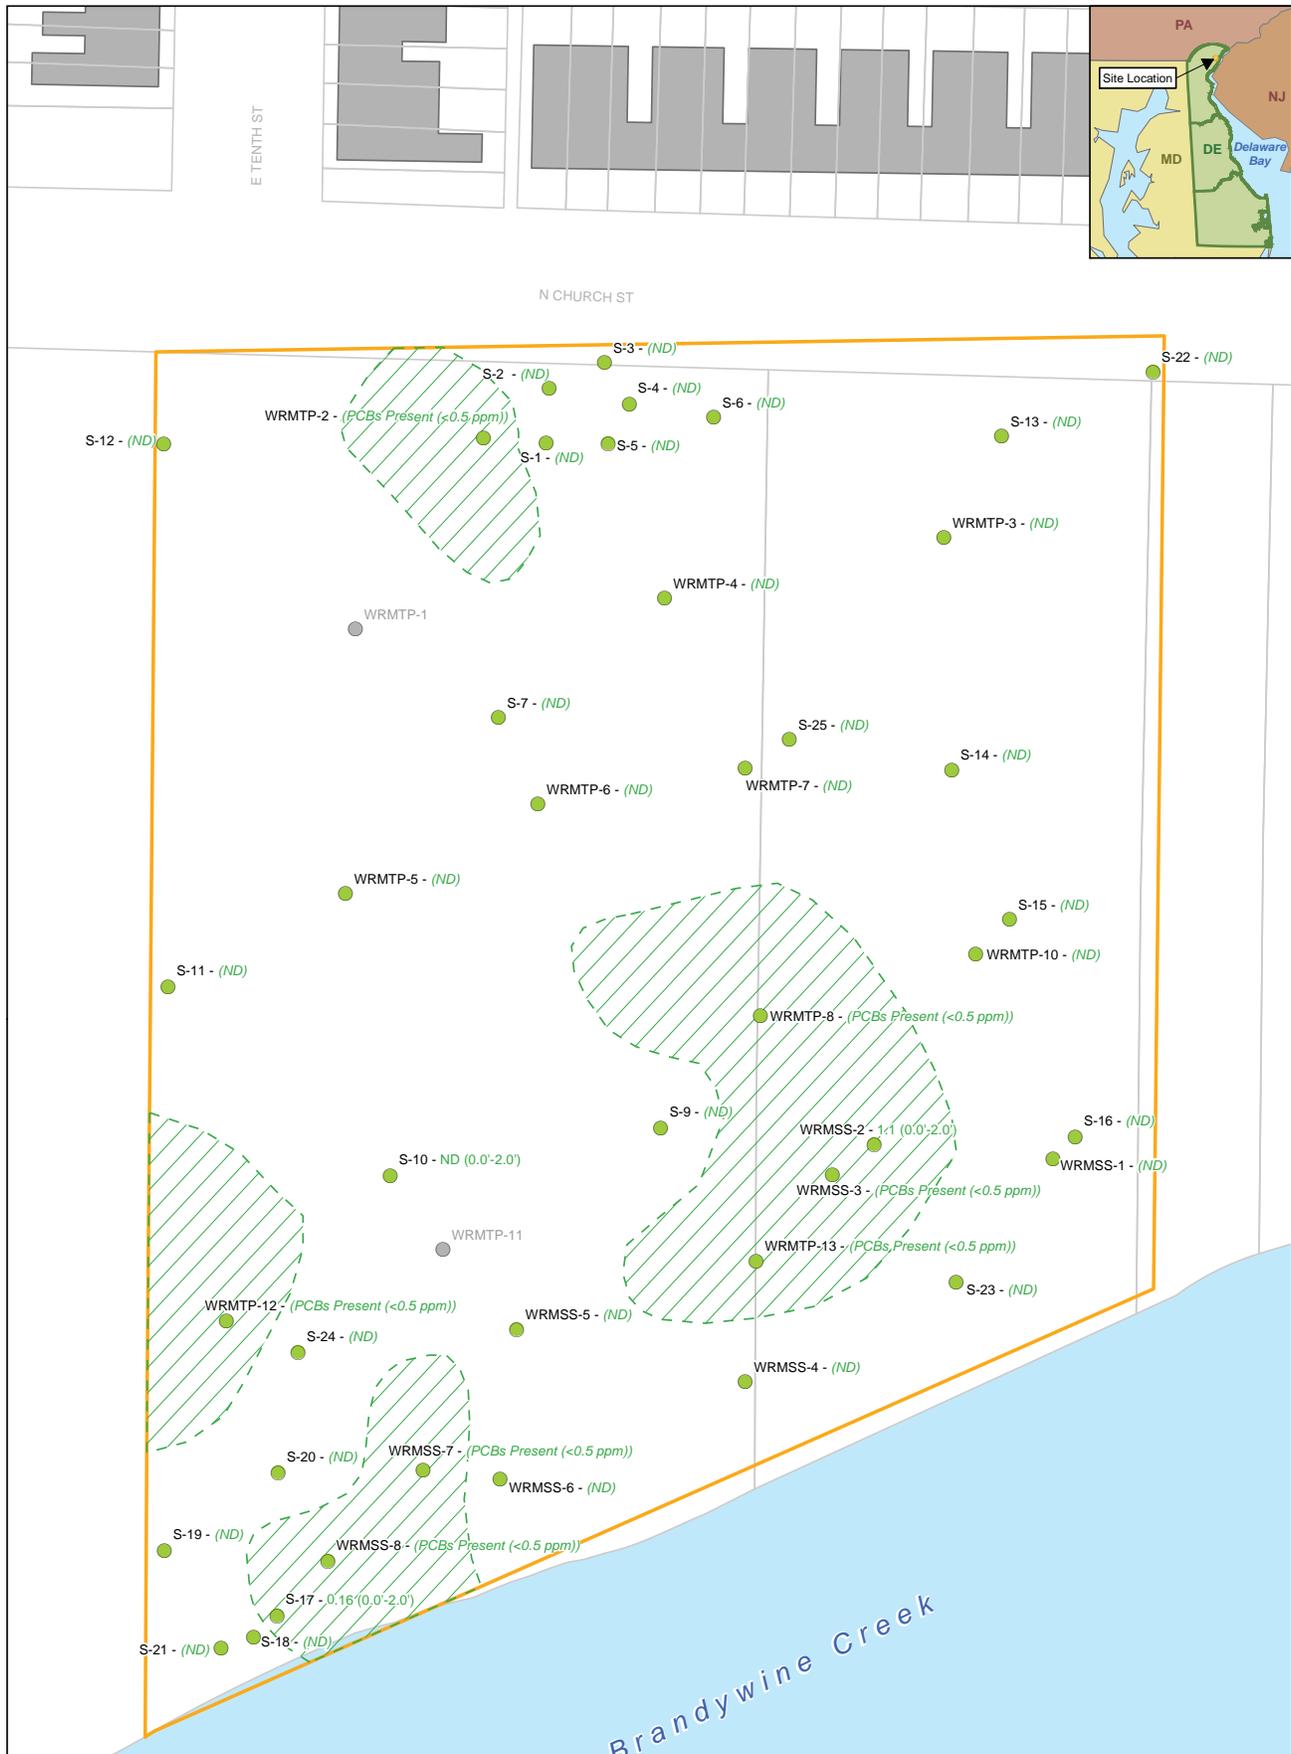
Drawn	By	Date	Scale	File Name:
ADS	ADS	7/8/2013	1:480	Fig2DistSurf.mxd
Checked	By	Date	Fig. No.	
JPR	JPR	7/8/2013	Figure 2	
Project #	0985.69.51

Notes:
 0.55 (0) - Total PCB Concentration (mg/kg) and Sample Depth.
 ND - Not Detected
 Screening data is in parentheses and italicized.
 Source: Delaware DataMIL - Tax Parcels;
 New Castle County - Buildings.

PCB Distribution in Surface Soil (0' - 2' bgs)
 Wilmington Rolling Mill
 Wilmington, Delaware

PCBs were detected in two surface soil samples, S-17 (0 to 2 feet below ground surface (bgs)) and WRMSS-2 (0 to 2 feet bgs), at concentrations of 0.16 mg/kg and 1.1 mg/kg, respectively. Additional detections in screened surface soil samples include six samples with PCBs present at a concentration <0.5 mg/kg and one samples with unconfirmed PCBs. In the unsaturated subsurface soil, PCBs were present based on screening analysis at a concentration less than 0.5 mg/kg for one sample, WRMTP-3 (8 feet bgs). In the saturated subsurface soil, PCBs were present based on screening analysis at a concentration less than 0.5 mg/kg in two samples, WRMTP-10 (6 feet bgs) and WRMTP-12 (12 to 12.5 feet bgs).

Due to the fact that there were only two detections in the surface soil, the maximum detected value (1.1 mg/kg) was used in the overland flow calculations instead of calculating the 95% upper confidence limit (UCL) of the mean of the concentration of total PCBs observed in the surface soil. There were no PCBs detected in groundwater.

The estimated surface soil area impacted by PCBs is 0.52 acres (Figure 2). In the subsurface unsaturated soil, 0.28 acres are impacted by PCBs (Figure 3). The estimated subsurface saturated soil area impacted by PCBs is 0.90 acres (Figure 4). Based on the data available and reviewed by BrightFields, the groundwater is not impacted by PCBs.

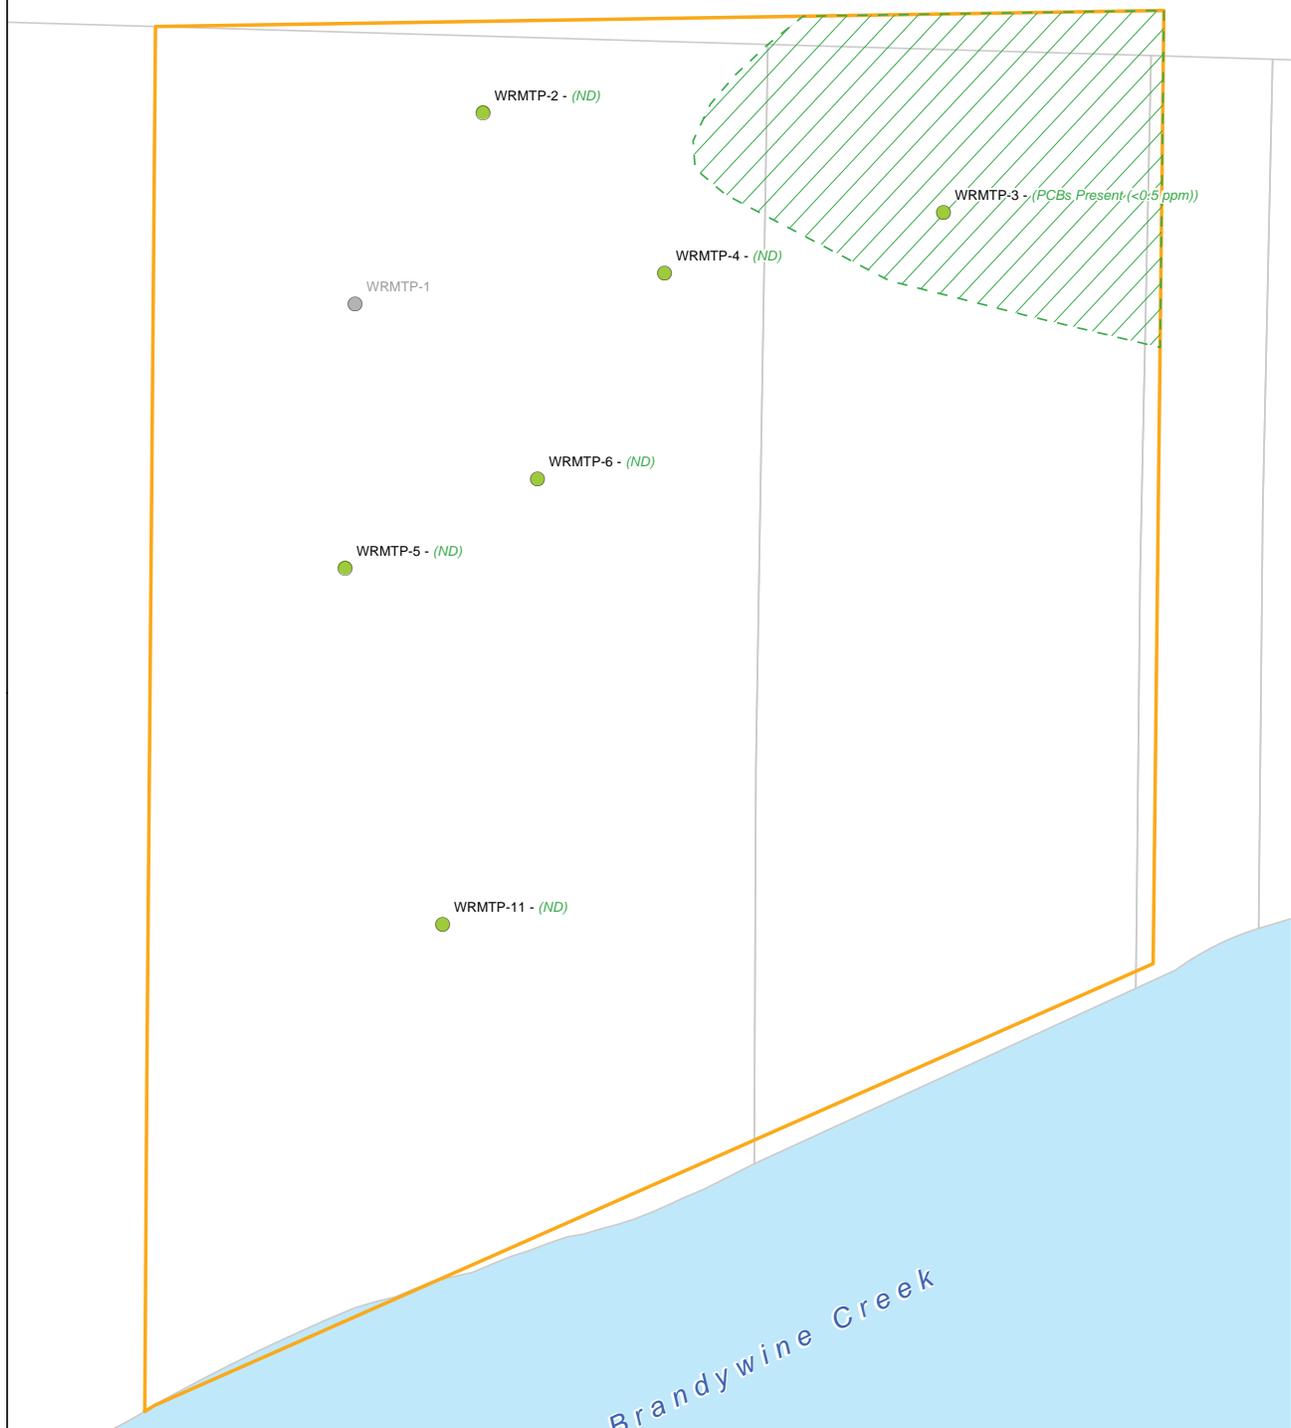
Drawn	By	Date	Scale:	File Name:
ADS	ADS	12/17/2013	1:480	Fig3SS_UnSat.mxd
Checked	JPR		12/17/2013	Fig. No.
Project #	0985.69.51		Figure 3

PCB Distribution in Subsurface Unsaturated Soil
 Wilmington Rolling Mill
 Wilmington, Delaware

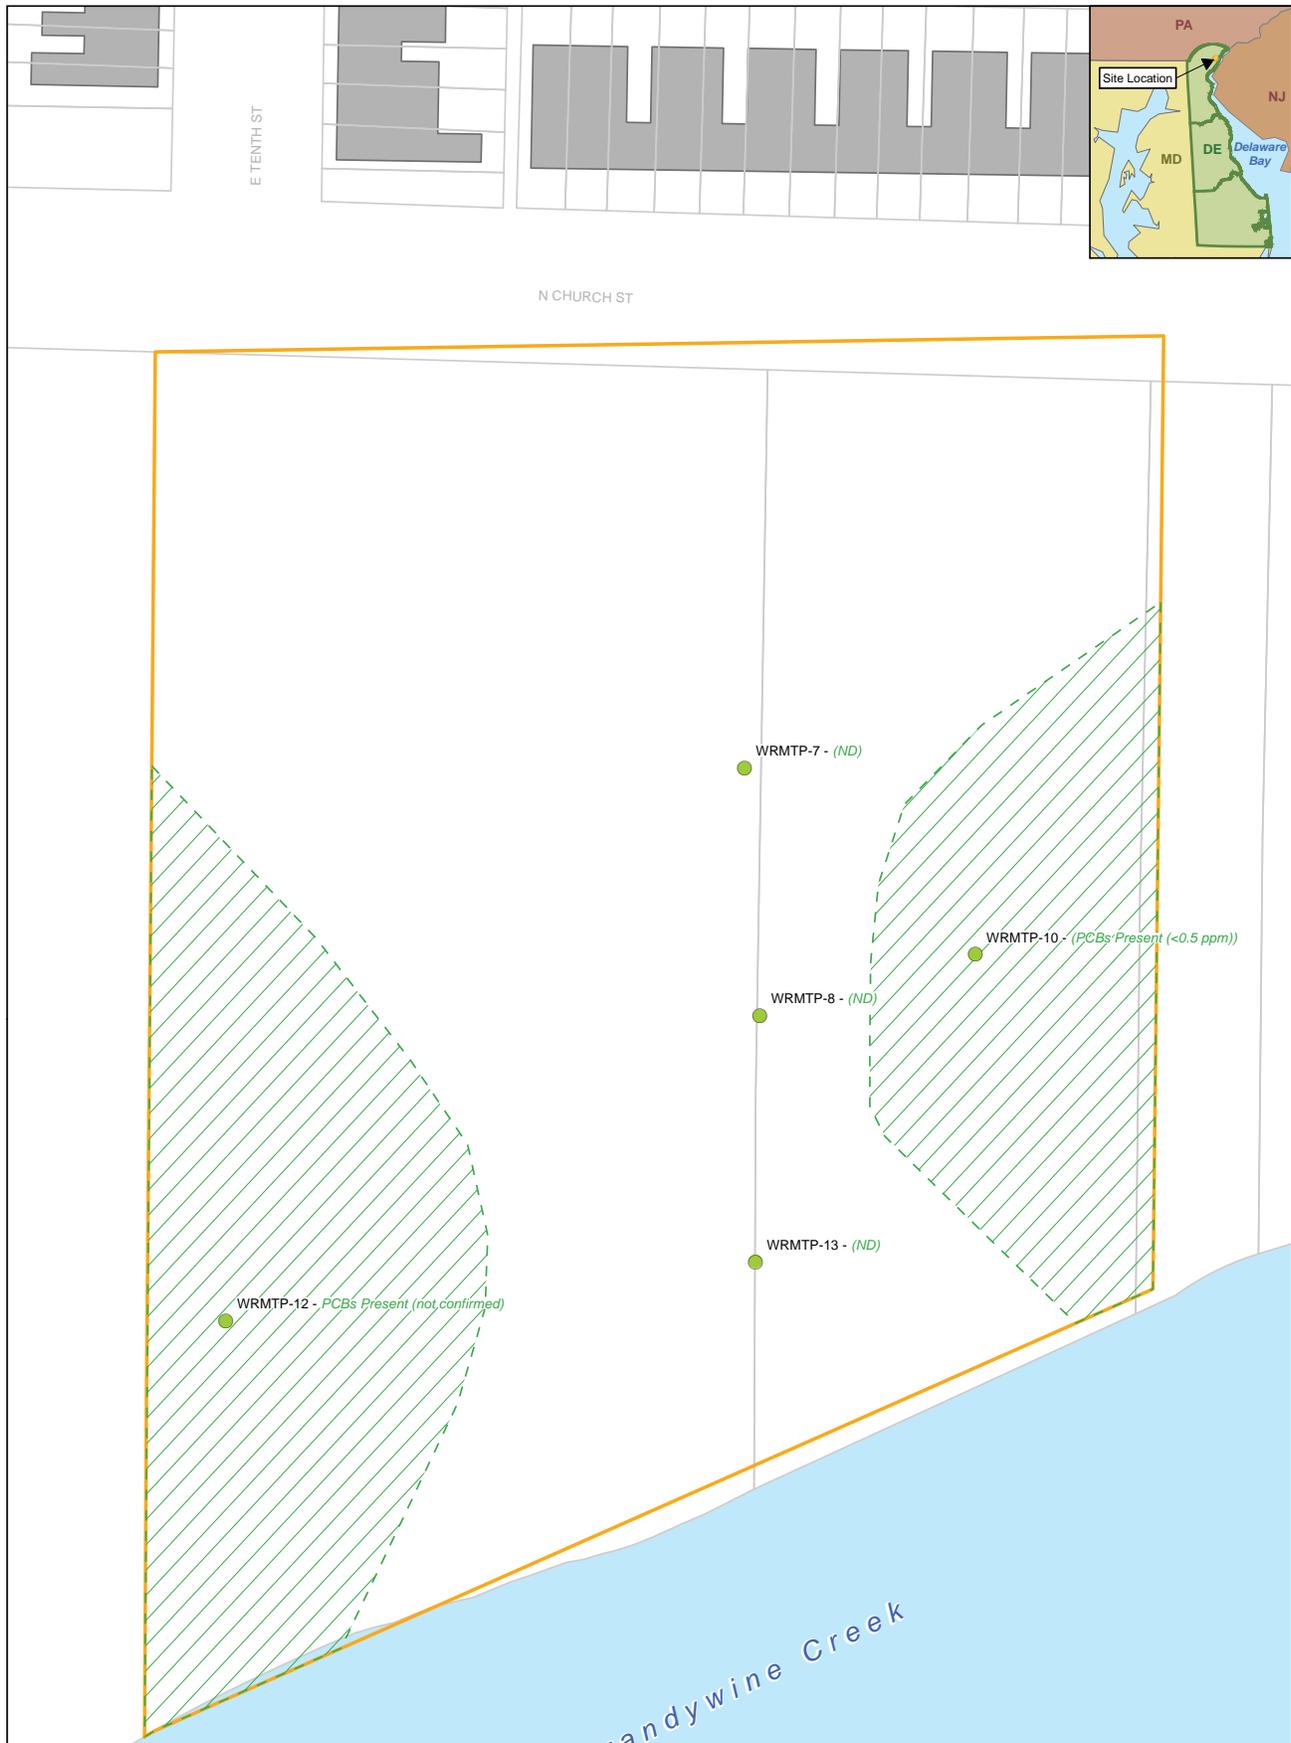
Drawn	By	Date	Scale	File Name
ADS	ADS	12/17/2013	1:480	Fig4SS_Sat.mxd
Checked	Project #	Fig. No.		
JPR	0985.69.51	Figure 4

WRMTP-12 - PCBs Present (not confirmed)

WRMTP-10 - (PCBs Present (<0.5 ppm))

PCB Distribution in Subsurface Saturated Soil
 Wilmington Rolling Mill
 Wilmington, Delaware

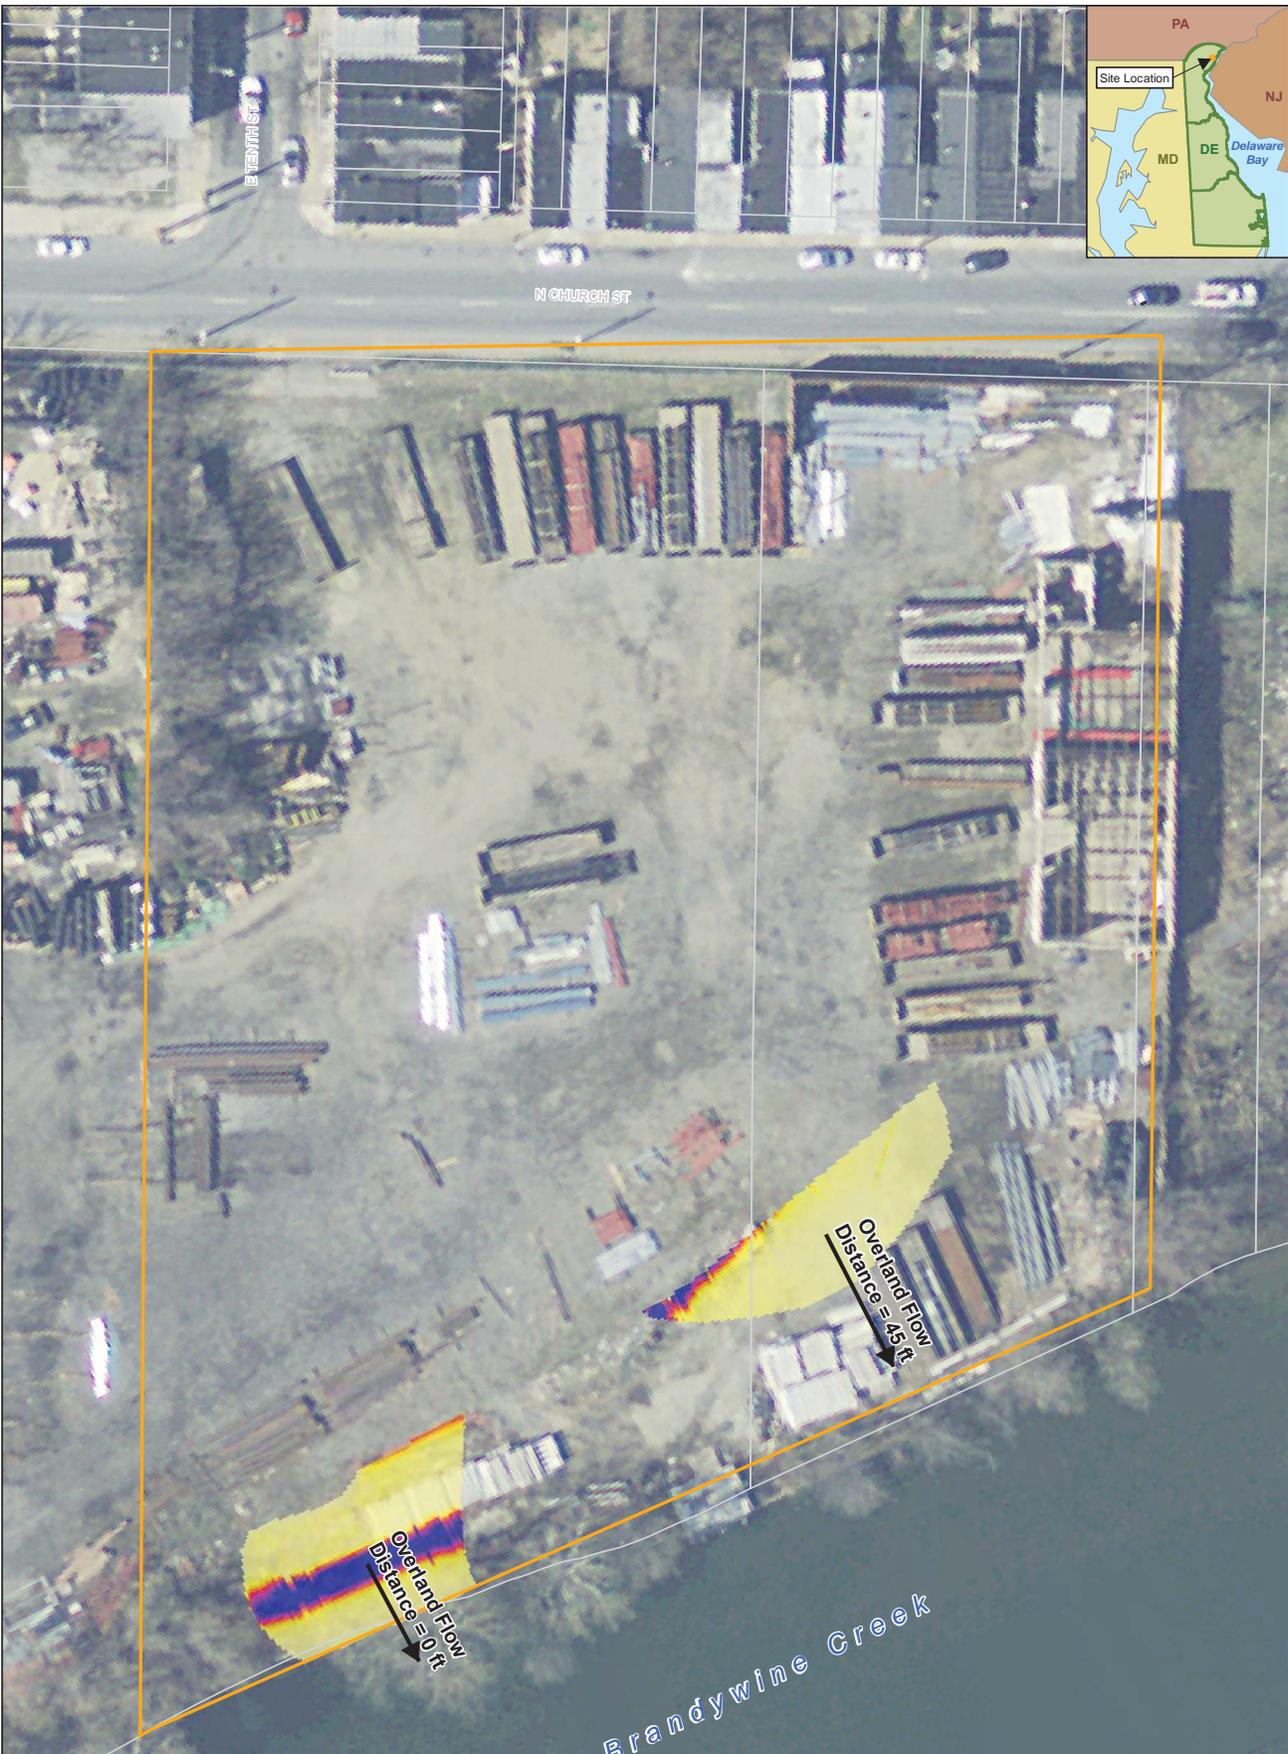
Drawn	By	Date	Scale:	File Name:
ADS	ADS	6/18/2014	1:480	Fig6SoilLoss.mxd
Checked	KEP	6/18/2014	Fig. No.	
Project #	0985.69.51		Figure 6

→ Overland Flow
 [Orange Outline] Wilmington Rolling Mill Site Boundary
 [White Outline] Tax Parcels
 Tons/Year/Acre of Soil Loss Estimated
 High : 60.65
 [Color Gradient] Low : 0

Soil Loss Estimates
 Wilmington Rolling Mill
 Wilmington, Delaware

P = support practice factor (dimensionless)	1	No documentation was provided indicating that any sediment and erosion controls are in place.
A = average annual soil loss estimate (ton/ac-yr)	5.0	The average soil loss estimate was generated by ArcGIS using the input factors listed above.
Erodible Area (acres)	0.15	The erodible area was calculated based on the pervious surfaces within the area of concern polygon for surface soil (Figure 6).

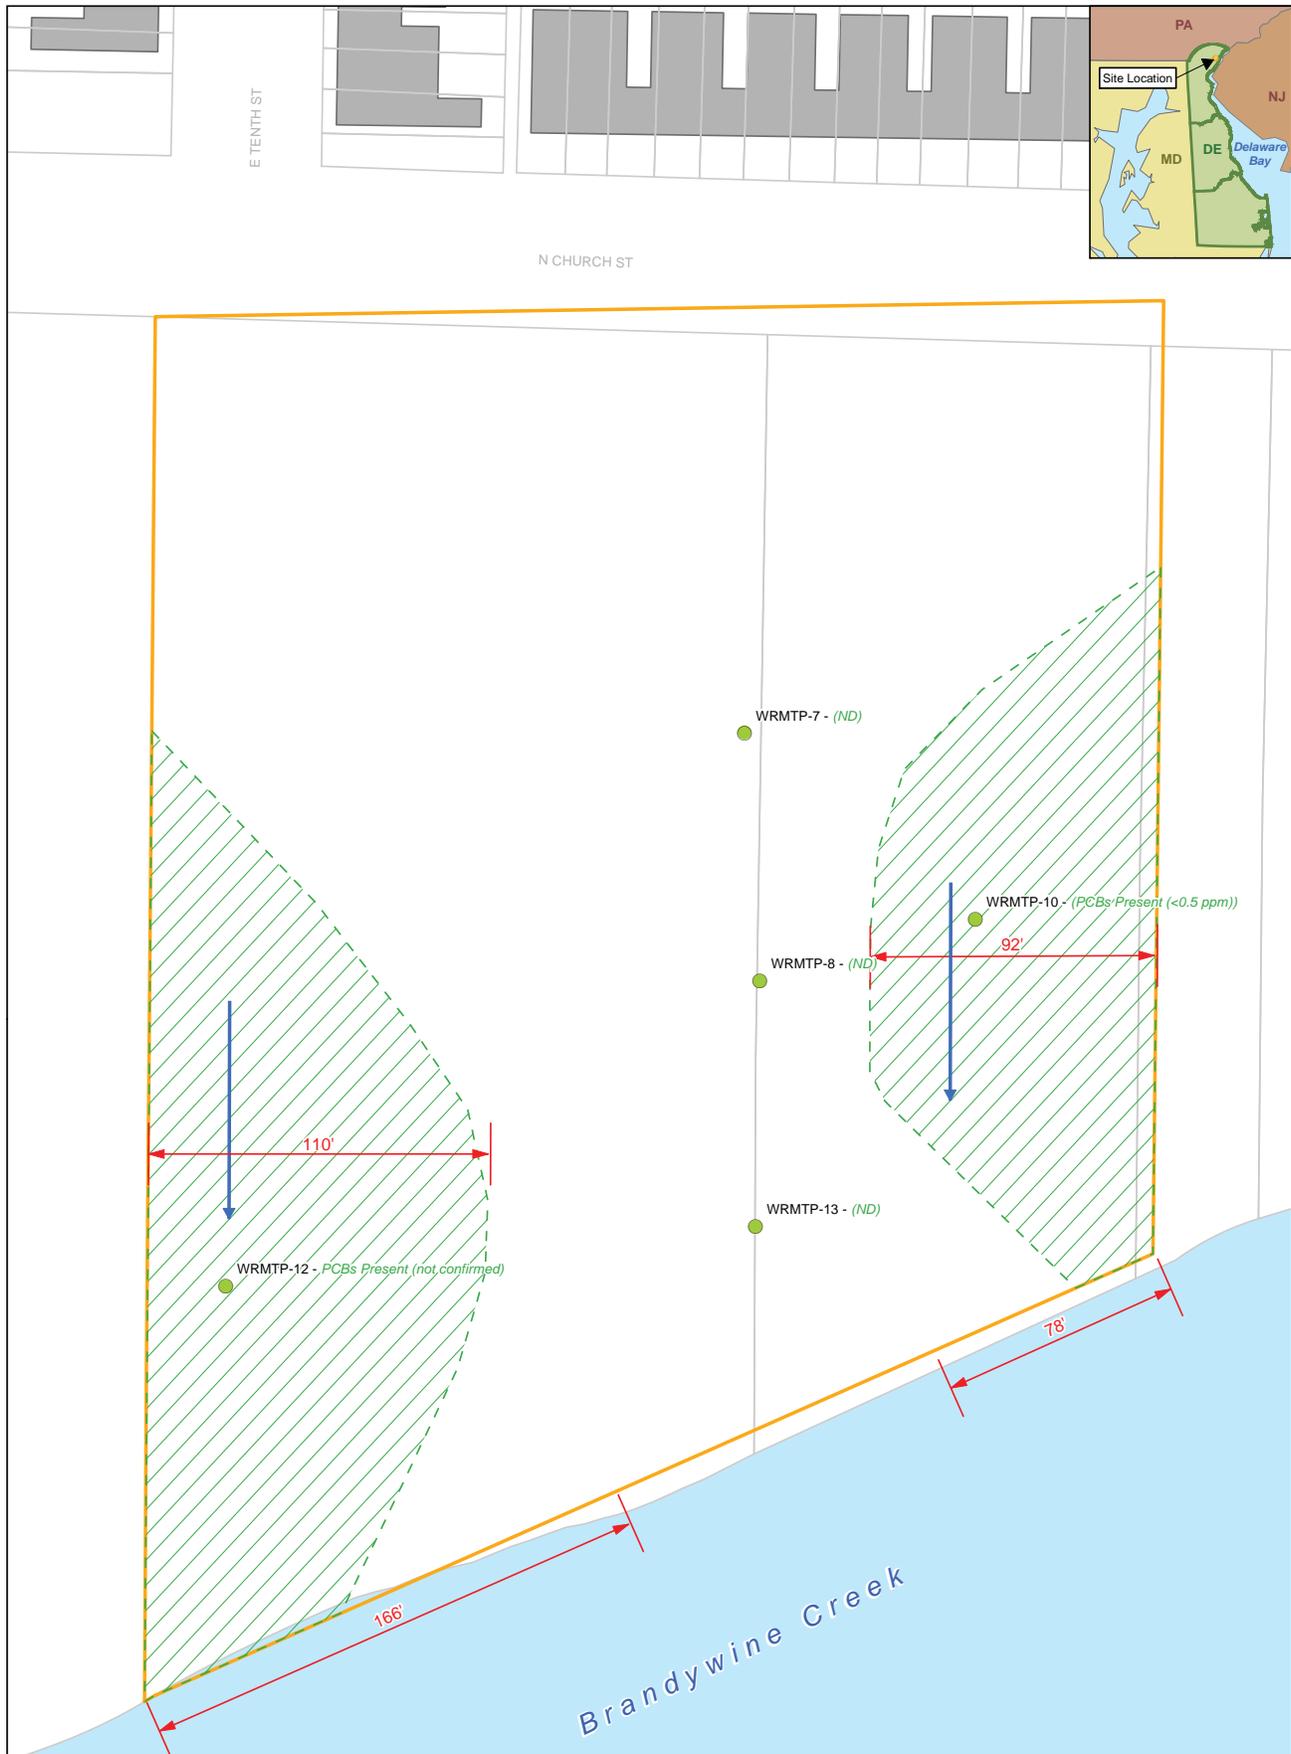
Drawn	By	Date	Scale	File Name:
ADS	ADS	12/17/2013	1:480	Fig7Discharge.mxd
Checked	Project #	Fig. No.	Figure 7	
JPR	0985.69.51	12/17/2013

- Soil Sample
- ↔ Groundwater Discharge Distance (feet)
- Groundwater Discharge Limit
- Groundwater Flow Direction
- ▨ Estimated PCB Distribution
- Wilmington Rolling Mill Site Boundary
- Tax Parcels
- Buildings
- Surface Water

Groundwater Discharge Map
 Wilmington Rolling Mill
 Wilmington, Delaware

Groundwater discharge is based on the hydraulic conductivity of the soil, the groundwater gradient, and the cross-sectional area of the aquifer. A breakdown of the individual factors used in the Darcy equation is presented below. A groundwater discharge map is included as Figure 7.

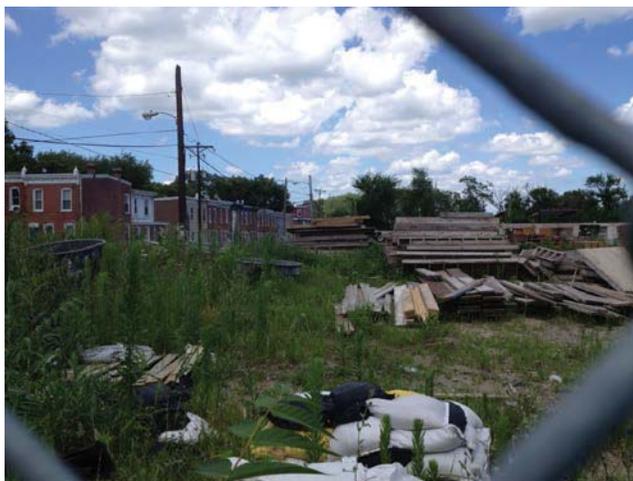
The western corner of the site along N Church Street with tall weeds and small saplings.

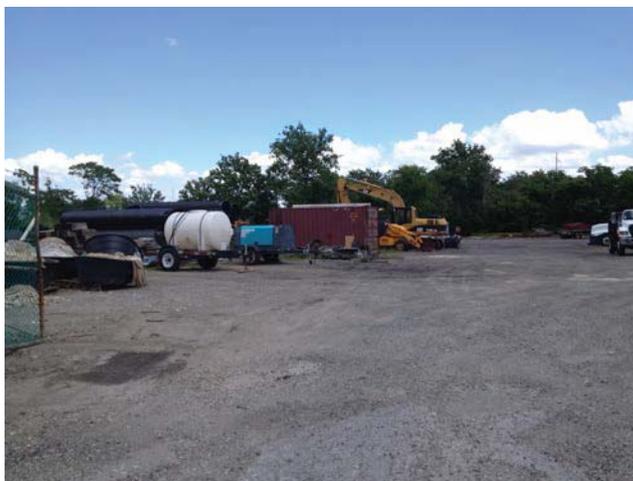
The entrance to the site on the southern boundary with gravel and limited vegetation.

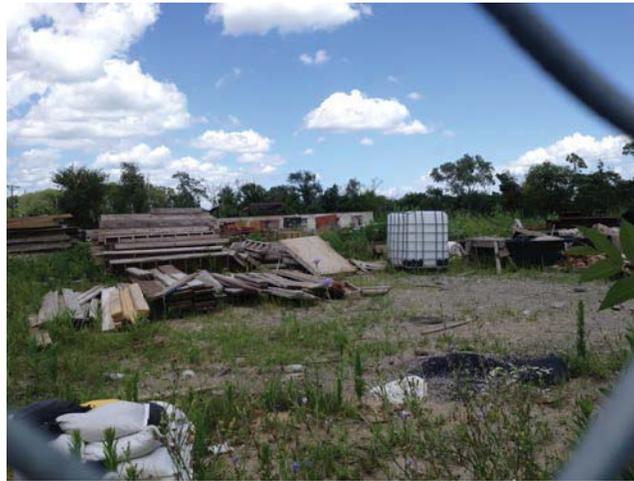
Looking north from the southern site boundary into debris piles and areas with patchy vegetation.
