PCB Mass Loading Phase II
Former Georgetown Substation
SIRS ID: DE-1286
Georgetown, Delaware

FORMER GEORGETOWN SUBSTATION GEORGETOWN, DELAWARE

SIRS ID: DE-1286

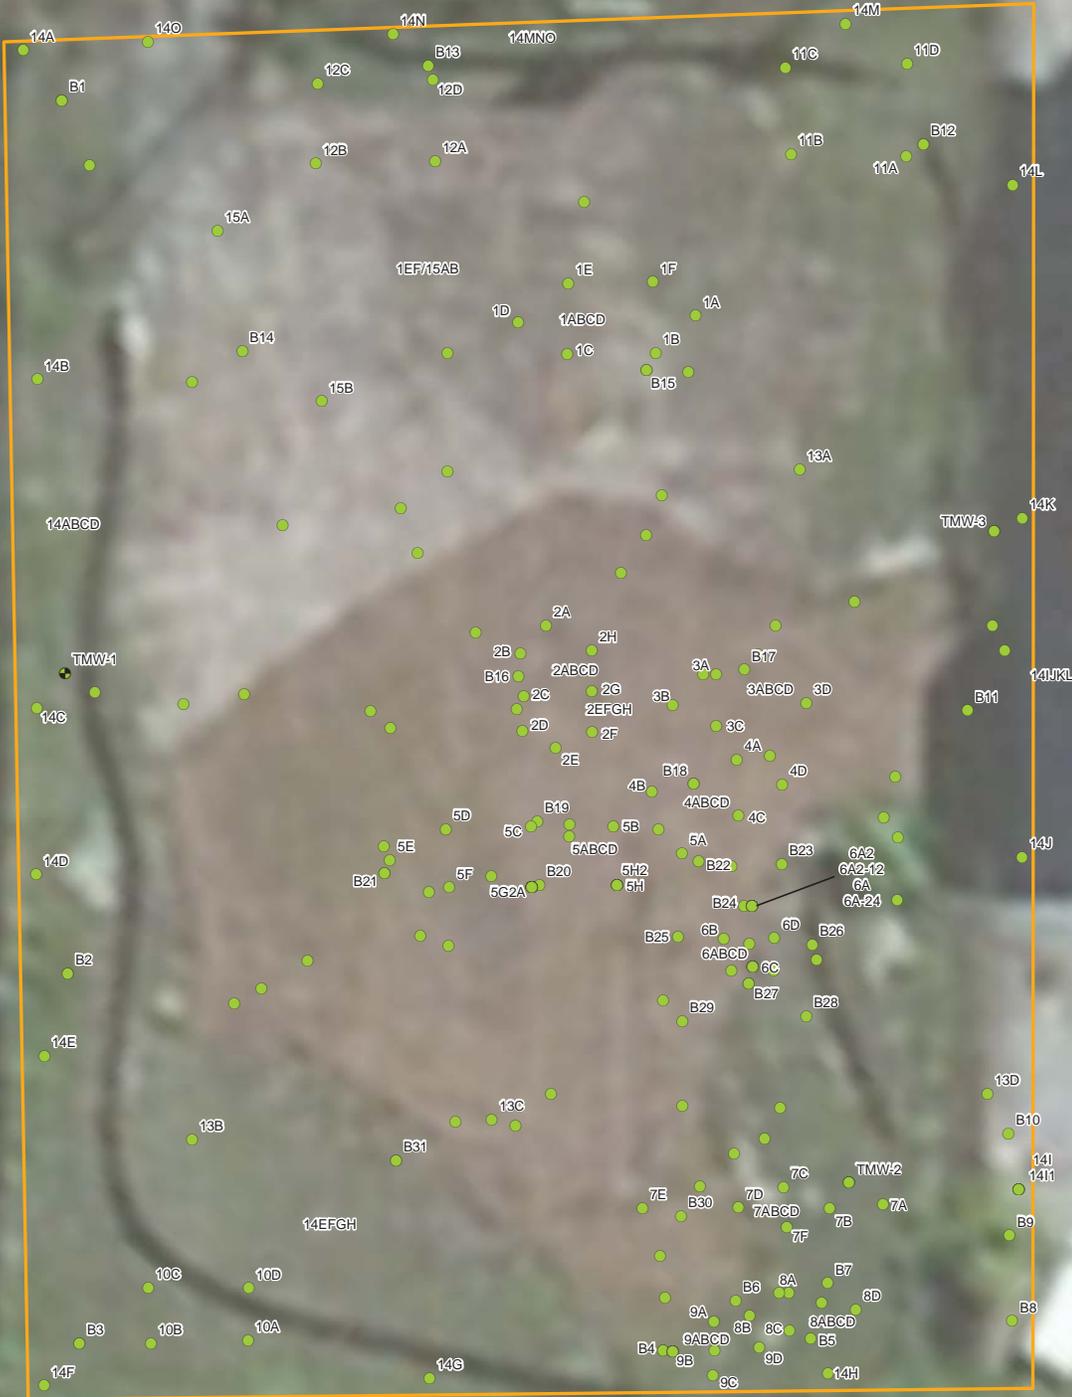
By	Date	Scale	File Name:
Drawn	ADS 6/19/2014	1:156	Fig1SiteLoc.mxd
Checked	JPR 6/19/2014	Fig. No.	Figure 1
Project #	0985.69.51	Figure 1

- Soil Sample
- Groundwater Sample
- Former Georgetown Substation Site Boundary (0.35 ac)

Historic Sample Locations
and Aerial Photograph (2012)
Former Georgetown Substation
Georgetown, Delaware

The former Georgetown Substation is located on the 200 block of North Race Street in Georgetown, Delaware between Depot Street and New Street (Figure 1). The site is approximately 0.35 acres in size and is comprised of one tax parcel (#135142012700). The property is bounded to the northwest by a daycare center; to the northeast by North Race Street, beyond which is a restaurant, community center, and vacant land; to the southeast by a commercial building; and to the southwest by residential properties. The surrounding land is generally residential, commercial, and some vacant properties.

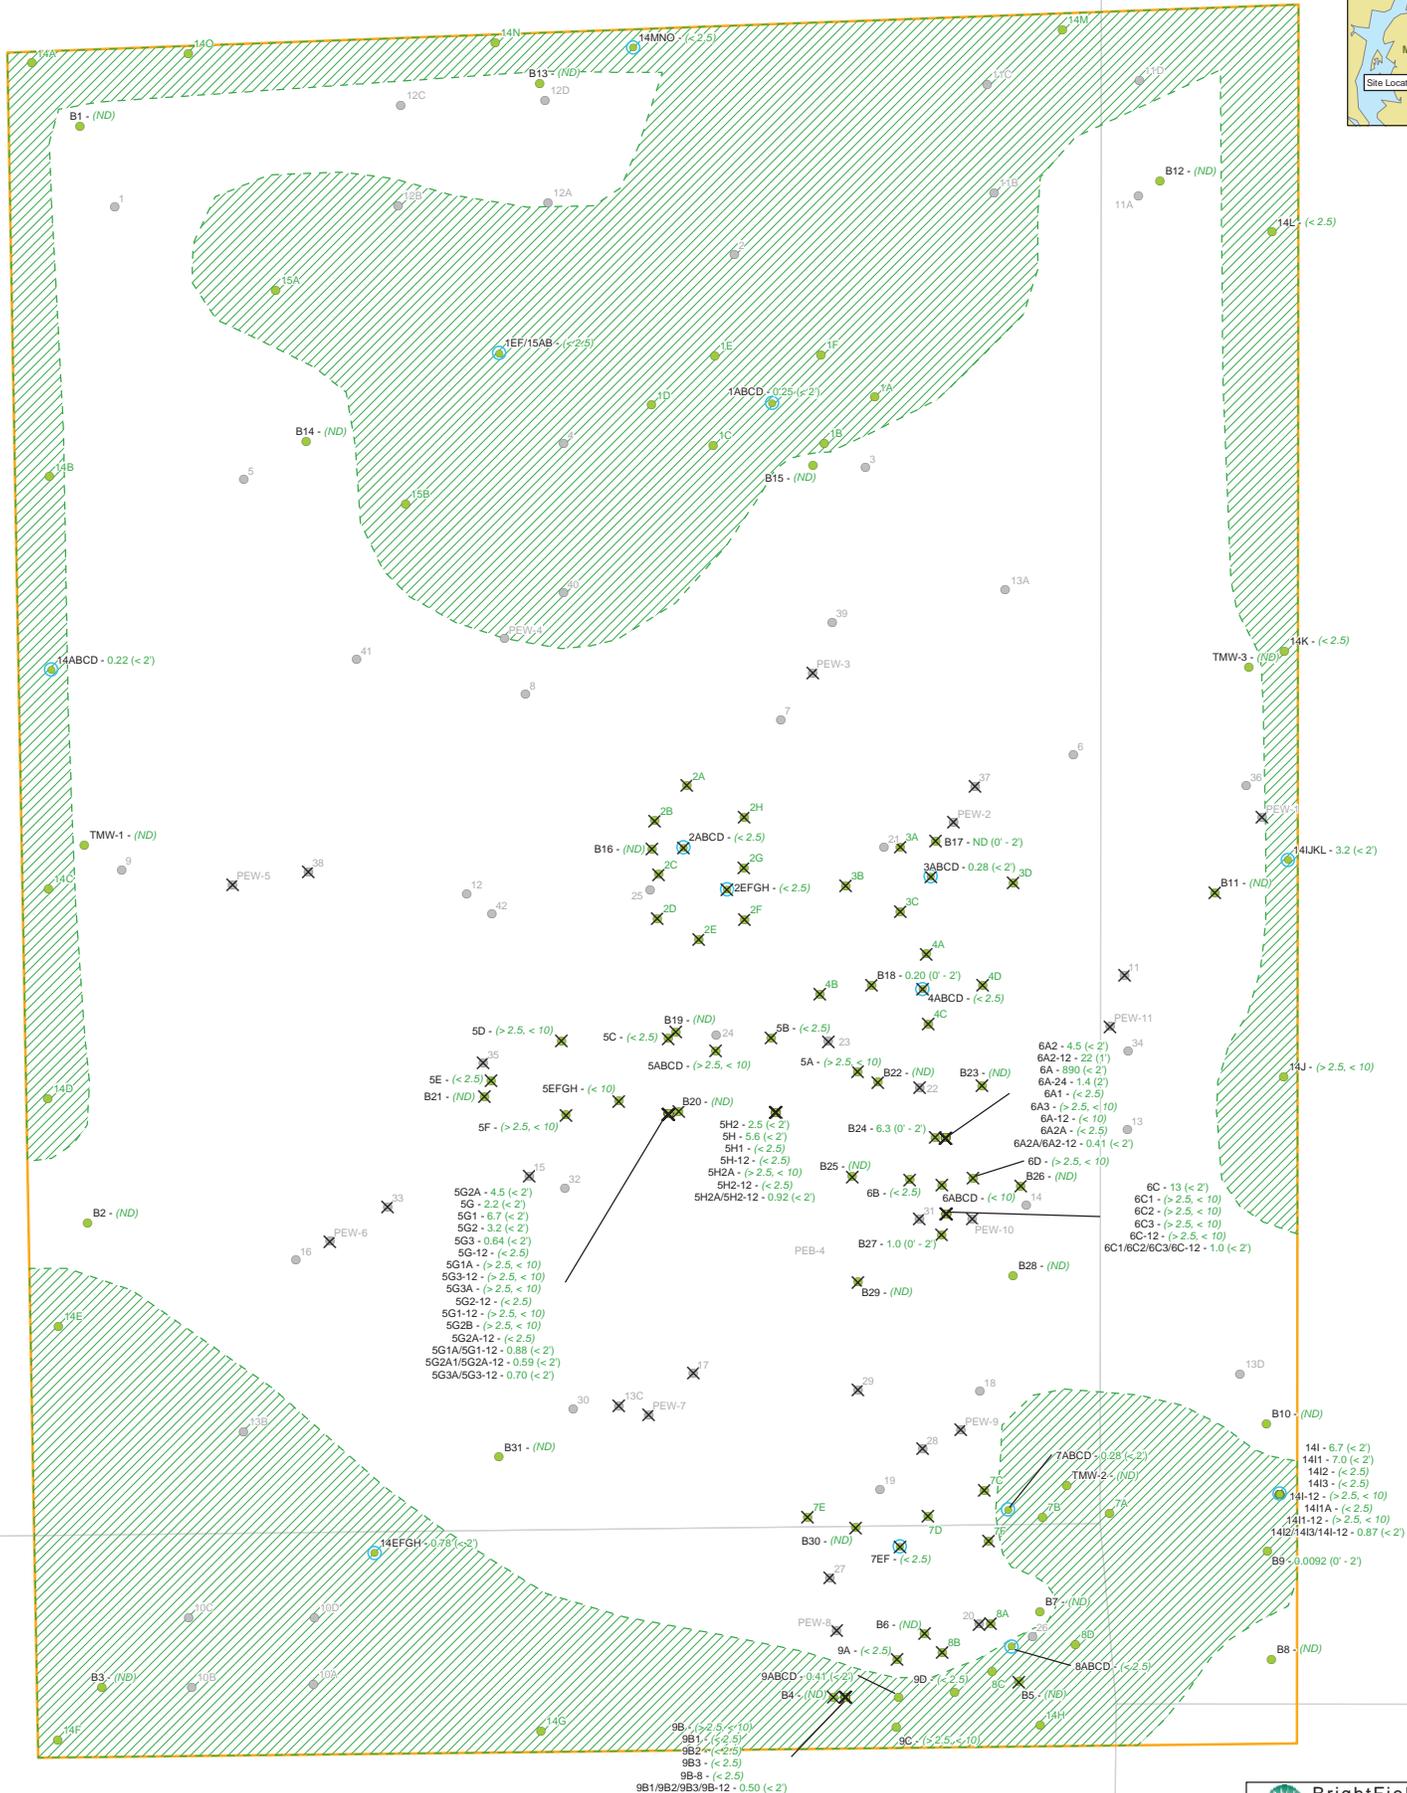
By	Date	Scale	File Name
Drawn ADS	6/19/2014	1:96	Fig2DistSurf.mxd
Checked JEH	6/19/2014		Fig. No.
Project # 0885.69.51			Figure 2

- ✕ Removed during Excavation
- Soil Sample, No PCB data available
- Soil Sample
- Composite Soil Sample
- ▨ Estimated PCB Distribution
- ▭ Former Georgetown Substation Site Boundary
- ▭ Tax Parcels

Notes:
 0.38 (0') - Total PCB Concentration (mg/kg) and Sample Depth.
 ND - Not Detected.
 Screening data is in parentheses and italicized.
 Composite Soil Samples are arbitrary locations to show PCB Concentrations.
 Source: Delaware DataMIL - Tax Parcels.

PCB Distribution in Surface Soil (0' - 2' bgs)
 Former Georgetown Substation
 Georgetown, Delaware

The estimated surface soil area impacted by PCBs is 0.13 acres (Figure 2). The estimated subsurface unsaturated soil area impacted by PCBs is 0.01 acres (Figure 3). Based on the data reviewed and analyzed by BrightFields, no saturated subsurface soil samples were analyzed for PCBs so the respective area impacted by PCBs cannot be determined. In addition, the available data showed that the dissolved groundwater is not impacted by PCBs.

The areas of elevated PCB detections (sample locations B-24 and B-27) have been excavated and backfilled to a depth varying between 2.5 feet and 3 feet bgs.

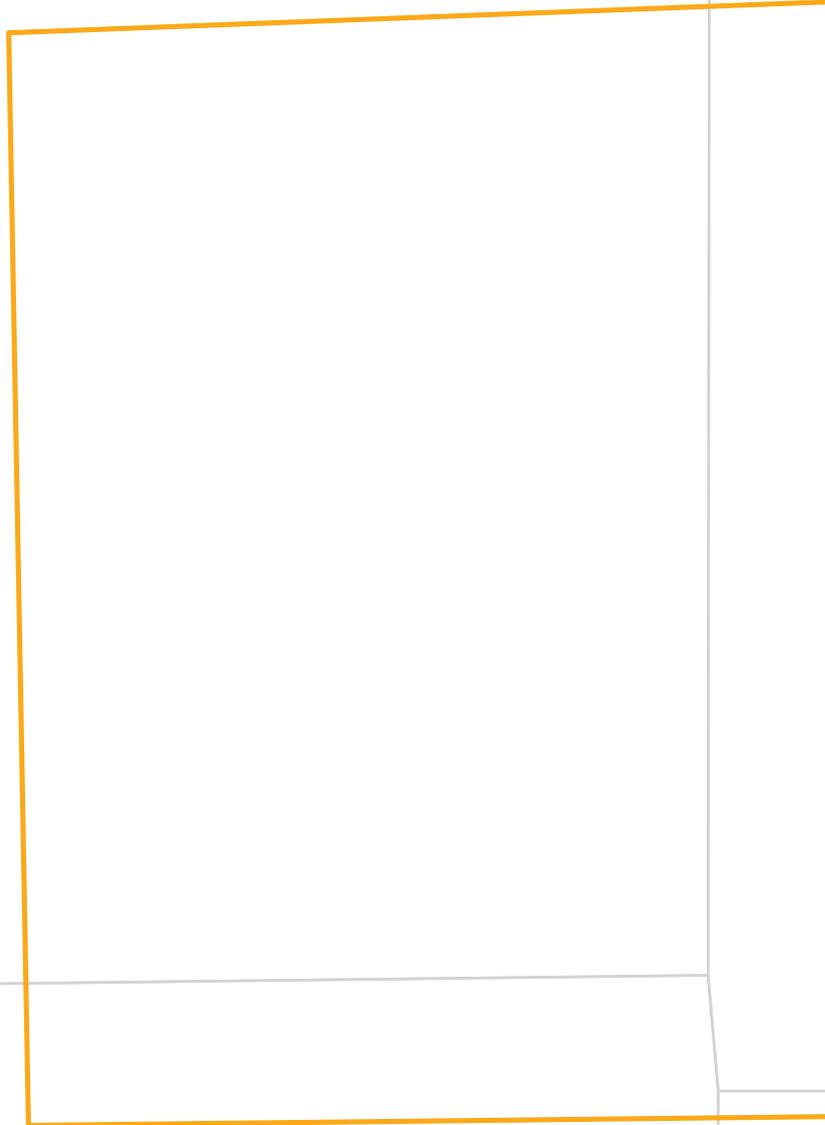
By	Date	Scale:	File Name:
Drawn	ADS	6/19/2014	1:300	Fig4SS_Sat.mxd
Checked	JPR	6/19/2014	Fig. No.	
Project #	0985.69.51	Figure 4

PCB Distribution in Subsurface Saturated Soil Former Georgetown Substation Georgetown, Delaware

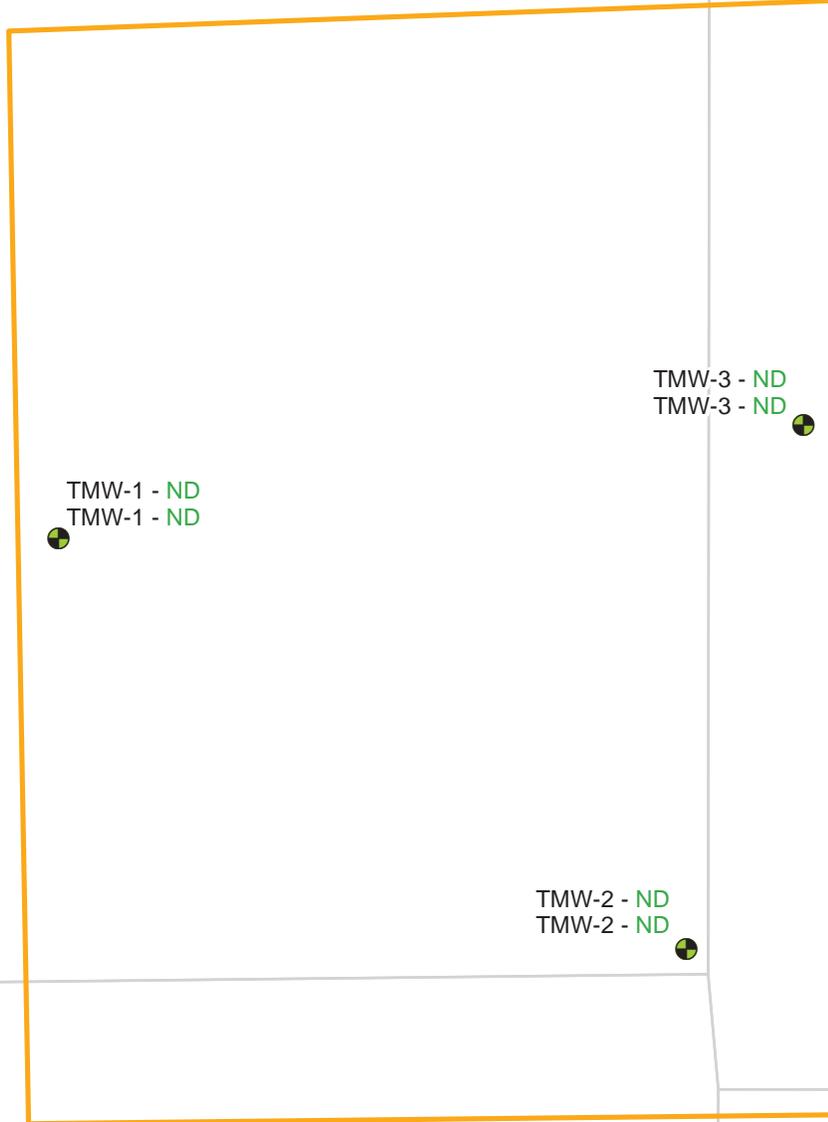
By	Date	Scale:	File Name:
Drawn	ADS	6/19/2014	1:300	Fig5GW.mxd
Checked	JEH	6/19/2014	Fig. No.	
Project #	0985.69.51		Figure 5

PCB Distribution in Groundwater
Former Georgetown Substation
Georgetown, Delaware

Note:
ND - Not Detected
Samples showing multiple concentrations
were filtered and not filtered.

Based on laboratory analysis of the samples, PCBs were not detected in groundwater.

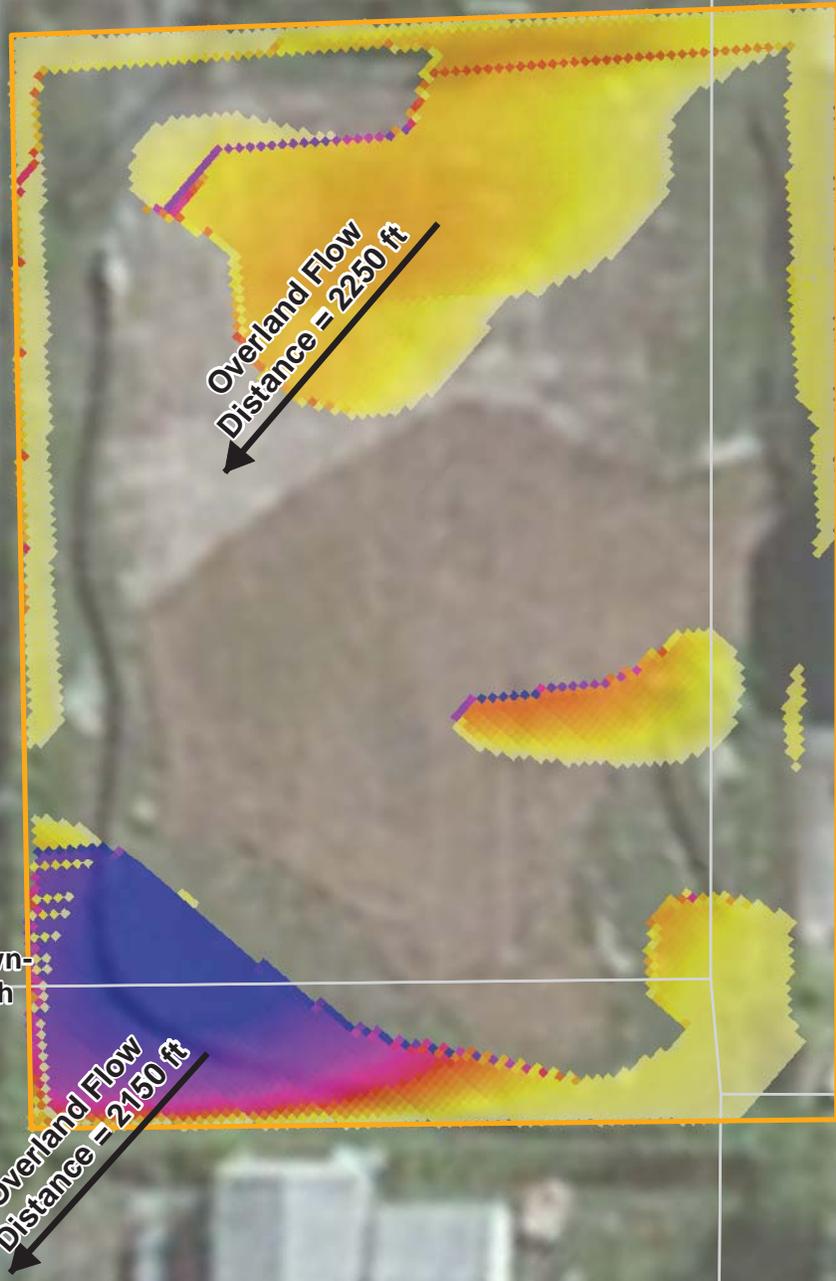
Drawn	By	Date	Scale:	File Name:
Checked	ADS	6/19/2014	1:300	Fig6SoilLoss.mxd
Project #	KEP	6/19/2014	Fig. No.	
	0985.69.51		Figure 6

Overland Flow Distance = 2250 ft

Overland Flow Distance = 2150 ft

Overland Flow
 Former Georgetown Substation Site Boundary
 Tax Parcels
 Tons/Year/Acre of Soil Loss Estimated
 High : 0.02
 Low : 0

Soil Loss Estimates
 Former Georgetown Substation
 Georgetown, Delaware

P = support practice factor (dimensionless)	1	No documentation was provided indicating that any sediment and erosion controls are in place.
A = average annual soil loss estimate (ton/ac-yr)	0.003	The average soil loss estimate was generated by ArcGIS using the input factors listed above.
Erodible Area (acres)	0.13	The erodible area was calculated based on the pervious surfaces within the area of concern polygon for surface soil (Figure 6).

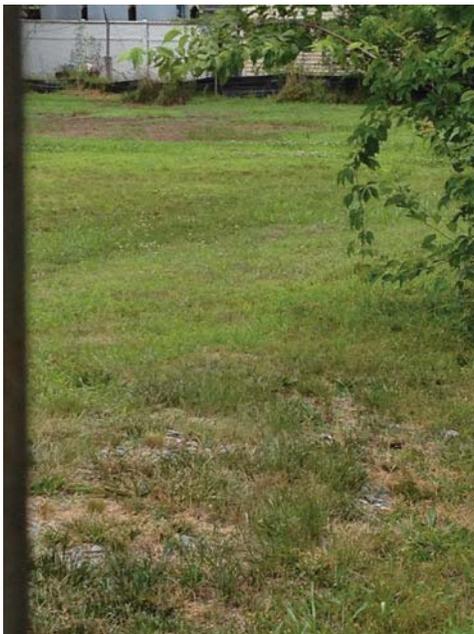
The middle of the site (taken from Race Street on the northeast boundary) which is mainly covered in short grass and has small elevation changes (<1 ft).

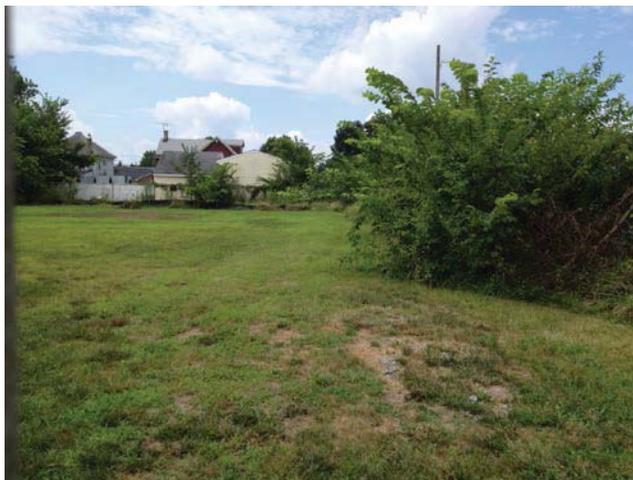
Some patchy areas and overgrown weeds along the northwestern border.

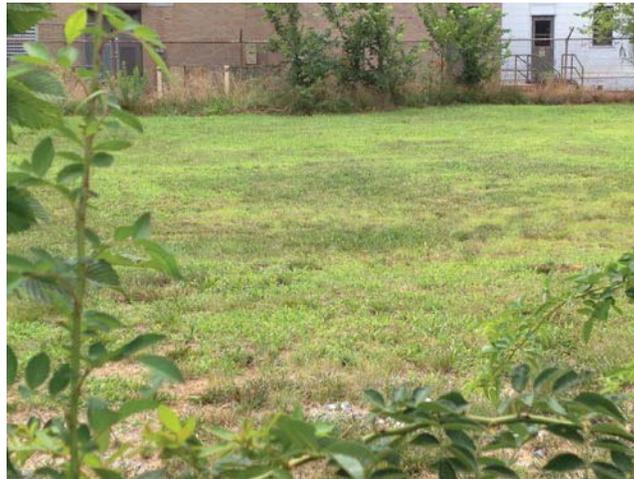
The southeast portion of the site where the site boundary cover ranges from short weeds to large trees in the south.

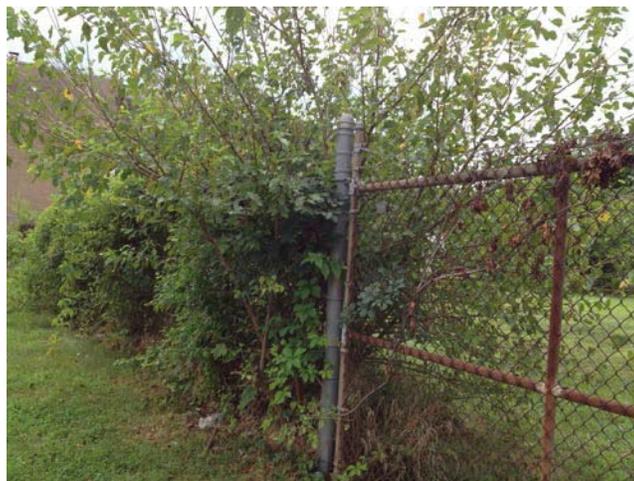
Looking towards the eastern corner of the site where the fence is covered in thick weeds and small trees.
