PCB Mass Loading Phase II  
1610/0 Bowers Street  
SIRS ID: DE-1440  
Wilmington, Delaware

## **Appendix 2**

**1610/0 BOWERS STREET  
(DIFFLEY PROPERTY)  
WILMINGTON, DELAWARE**

**SIRS ID: DE-1440**

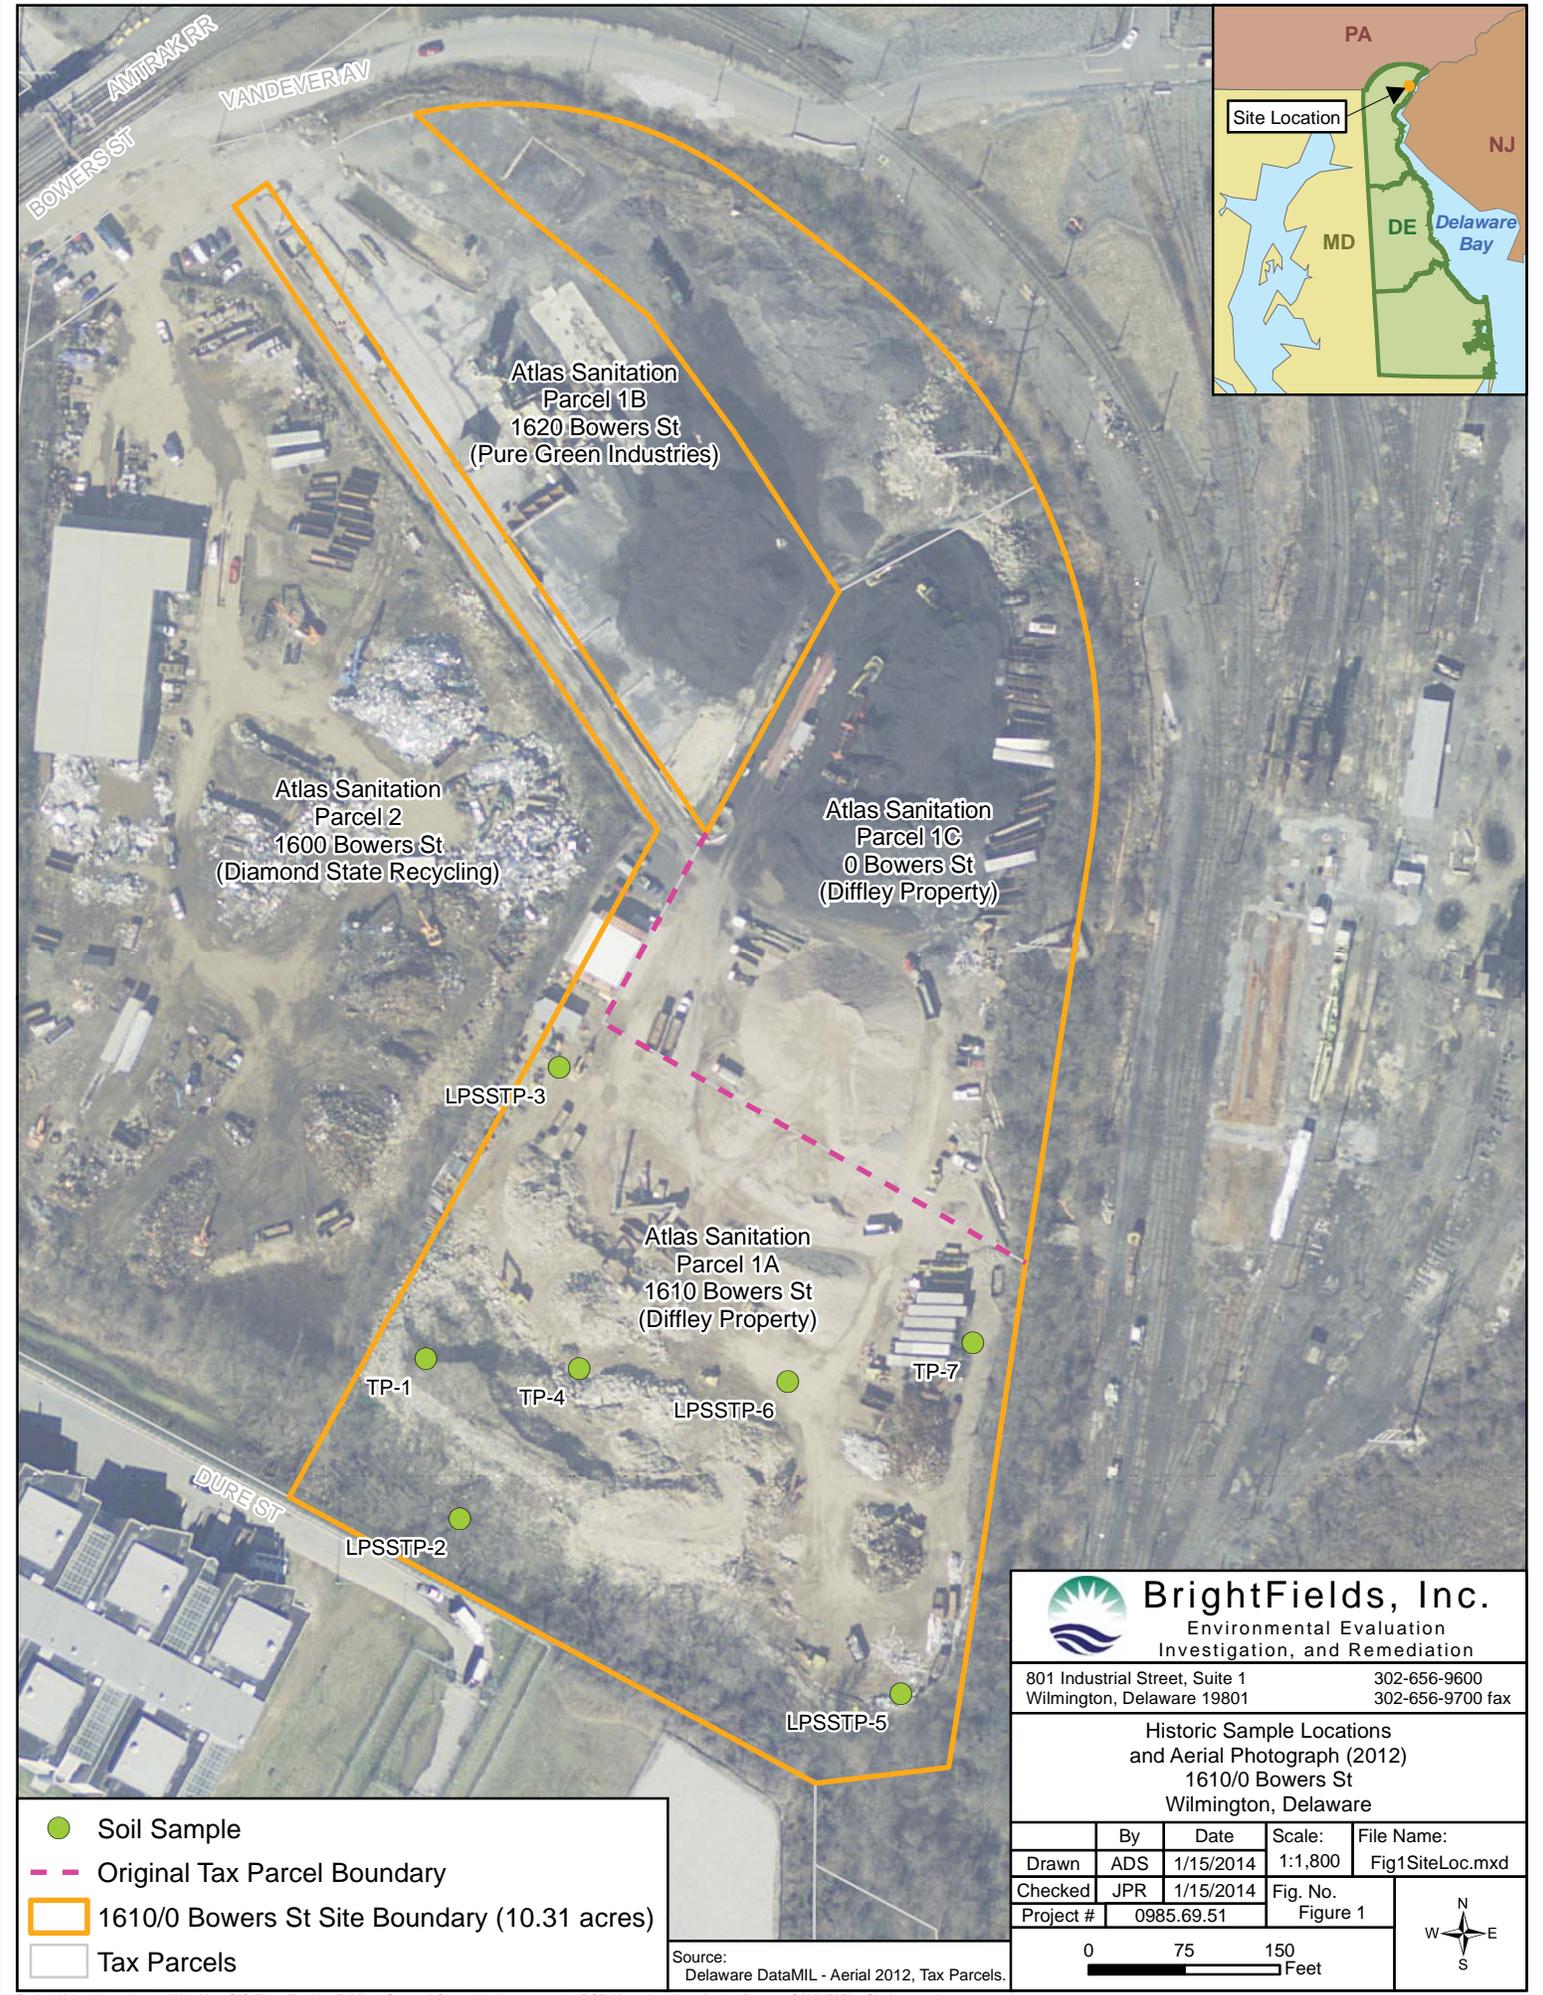
By	Date	Scale:	File Name:
Drawn	ADS	1/15/2014	1:1,800	Fig1SiteLoc.mxd
Checked	JPR	1/15/2014	Fig. No.	
Project #	0985.69.51		Figure 1

The site is located at 0 and 1610 Bowers Street in Wilmington, Delaware (Figure 1). The site is approximately 10.3 acres in size and is comprised of two tax parcels (#2603700006, and #2603700012), located southeast of the intersection of Bowers Street and Vandever Avenue in Wilmington. The property is bounded generally to the northwest by an asphalt plant (Pure Green Industries, Inc. DE-1054 and Wilmington Asphalt Plant DE-1448), to the west by a metal recycling plant (former Atlas Sanitation DE-0280); to the south by the Howard R. Young Correctional Facility (also known as Gander Hill Prison), and to the north and east by the Amtrak Refueling Facility (DE-0266).

- Soil Sample
- - - Original Tax Parcel Boundary
- 1610/0 Bowers St Site Boundary (10.31 acres)
- Tax Parcels

Historic Sample Locations  
and Aerial Photograph (2012)  
1610/0 Bowers St  
Wilmington, Delaware

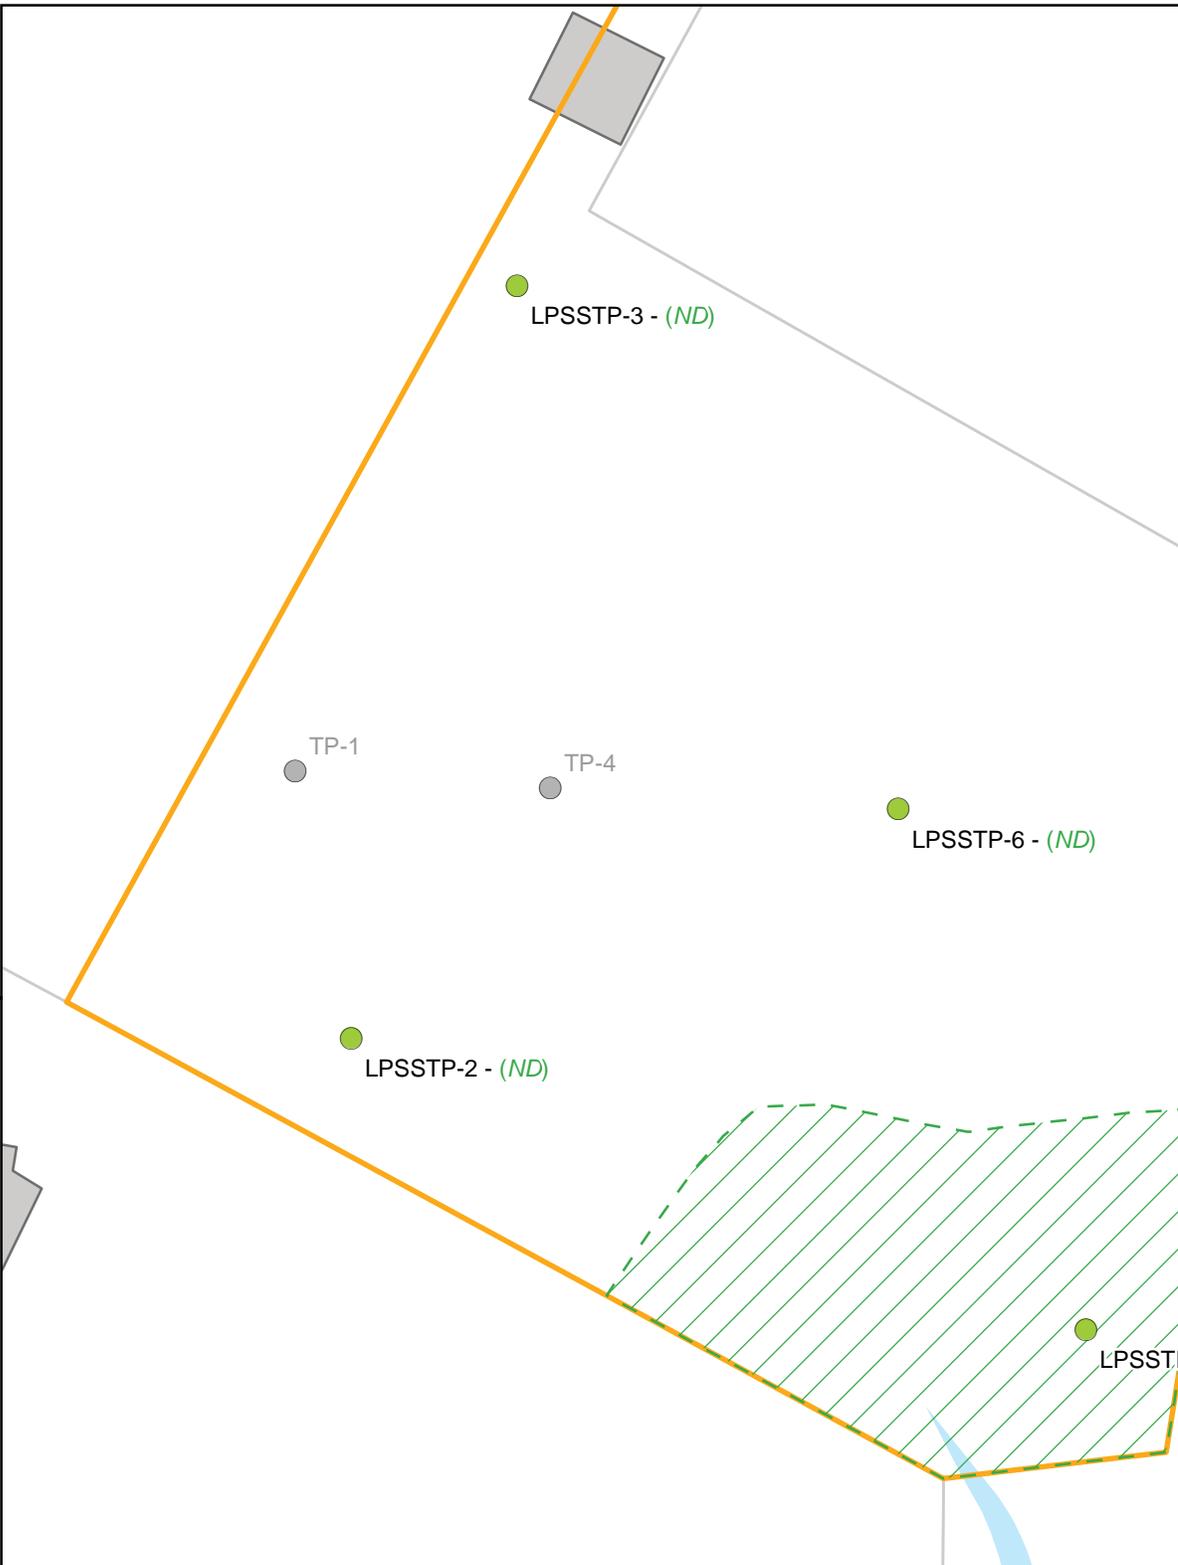
By	Date	Scale:	File Name:
Drawn	ADS	1/15/2014	1:1,080	Fig2DistSurf.mxd
Checked	JPR	1/15/2014	Fig. No.	
Project #	0985.69.51		Figure 2

The estimated surface soil area impacted by PCBs is 0.85 acres in the vicinity of LPSSTP-5 (Figure 2). According to the information available and reviewed by BrightFields, no subsurface saturated soil, subsurface unsaturated soil, or groundwater samples were analyzed for PCBs so the respective areas impacted by PCBs cannot be determined. Therefore, no groundwater loading estimates were prepared for the site.

- Soil Sample, No PCB data available
- Soil Sample
- Estimated PCB Distribution
- 1610/0 Bowers St Site Boundary
- Tax Parcels
- Buildings
- Surface Water

Notes:  
 ND - Not Detected  
 (1.4) - Screening data shown in mg/kg.  
 Source: Delaware DataMIL - Tax Parcels;  
 New Castle County - Buildings.

PCB Distribution in Surface Soil (0' - 2' bgs)  
 1610/0 Bowers St  
 Wilmington, Delaware

<b>Concentrations of PCBs on Site</b>			
<b>Sample Matrix</b>	<b>Corresponding Figure</b>	<b>Analytical Methods</b>	<b>Range of Total PCBs</b>
Surface Soil	Figure 2	Screening Data	Not detected to 1.4 mg/kg
Subsurface Soil (unsaturated)	Figure 3	Not Analyzed	Not Analyzed
Subsurface Soil (saturated)	Figure 4	Not Analyzed	Not Analyzed
Groundwater	Figure 5	Not Analyzed	Not Analyzed

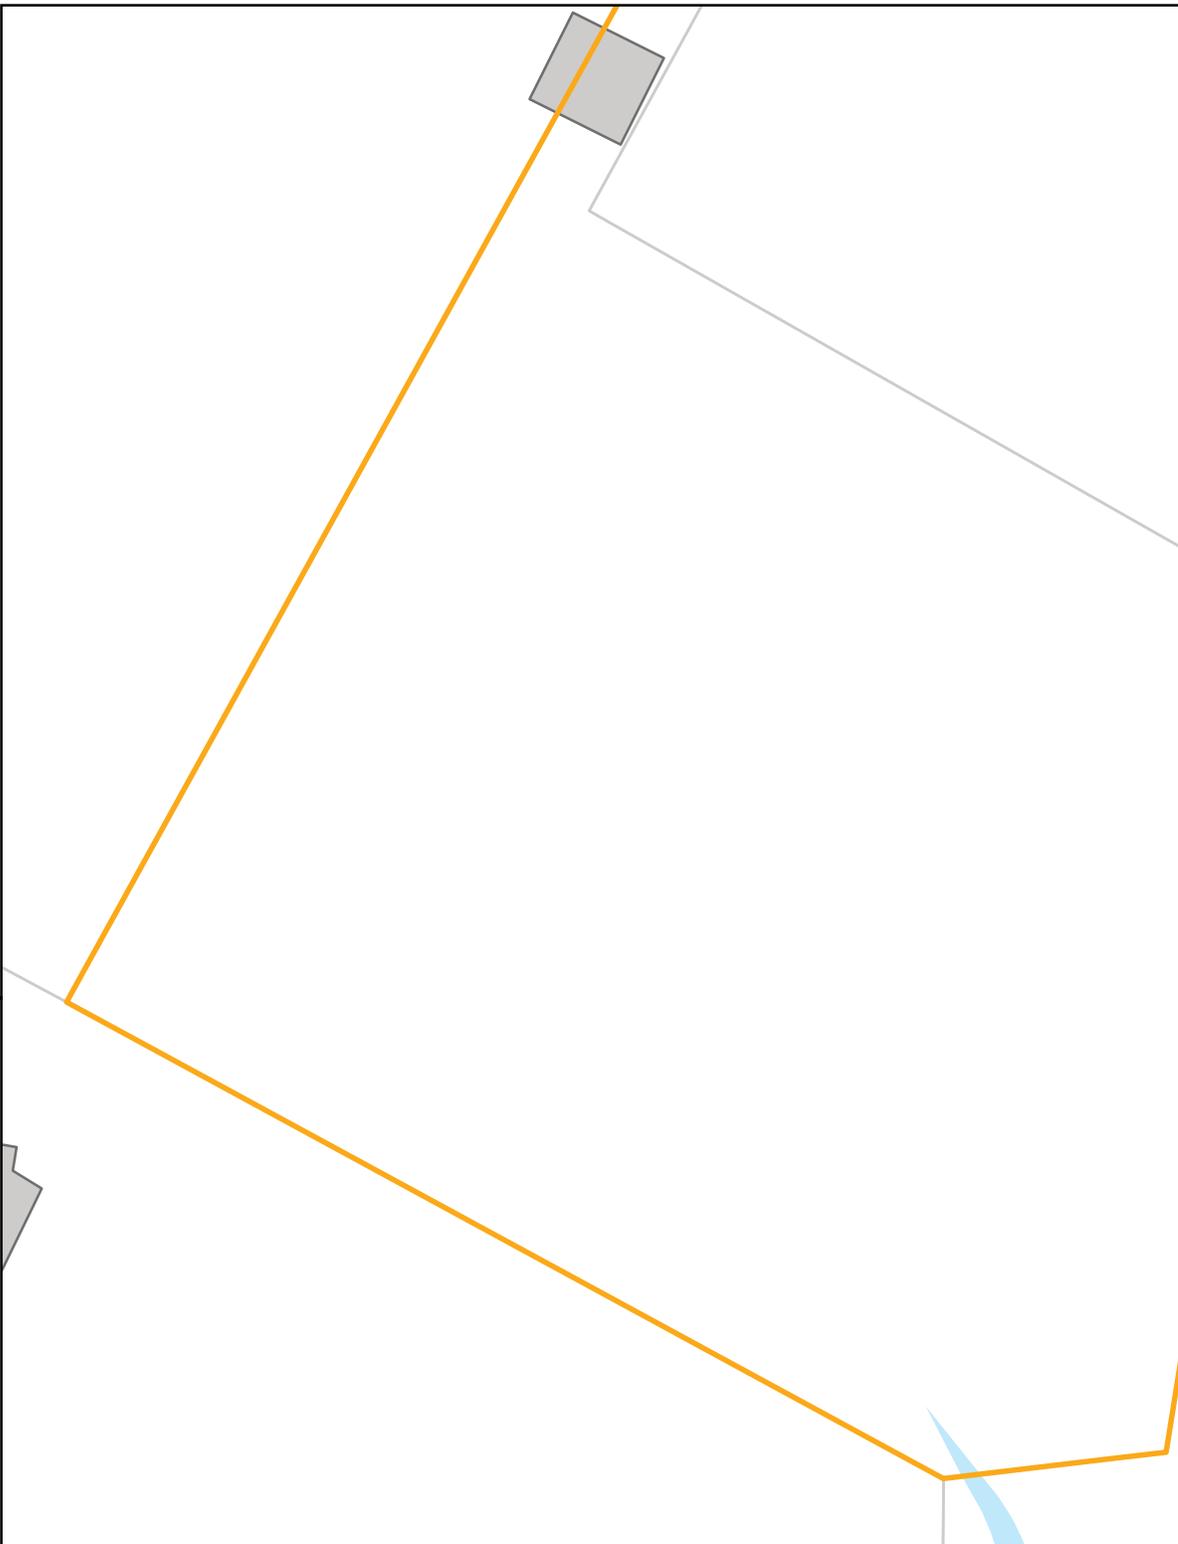
By	Date	Scale:	File Name:
Drawn	ADS	1/15/2014	1:1,080	Fig4SS_Sat.mxd
Checked	JPR	1/15/2014	Fig. No.	
Project #	0985.69.51		Figure 4

**PCB Distribution in Subsurface Saturated Soil**  
1610/0 Bowers St  
Wilmington, Delaware

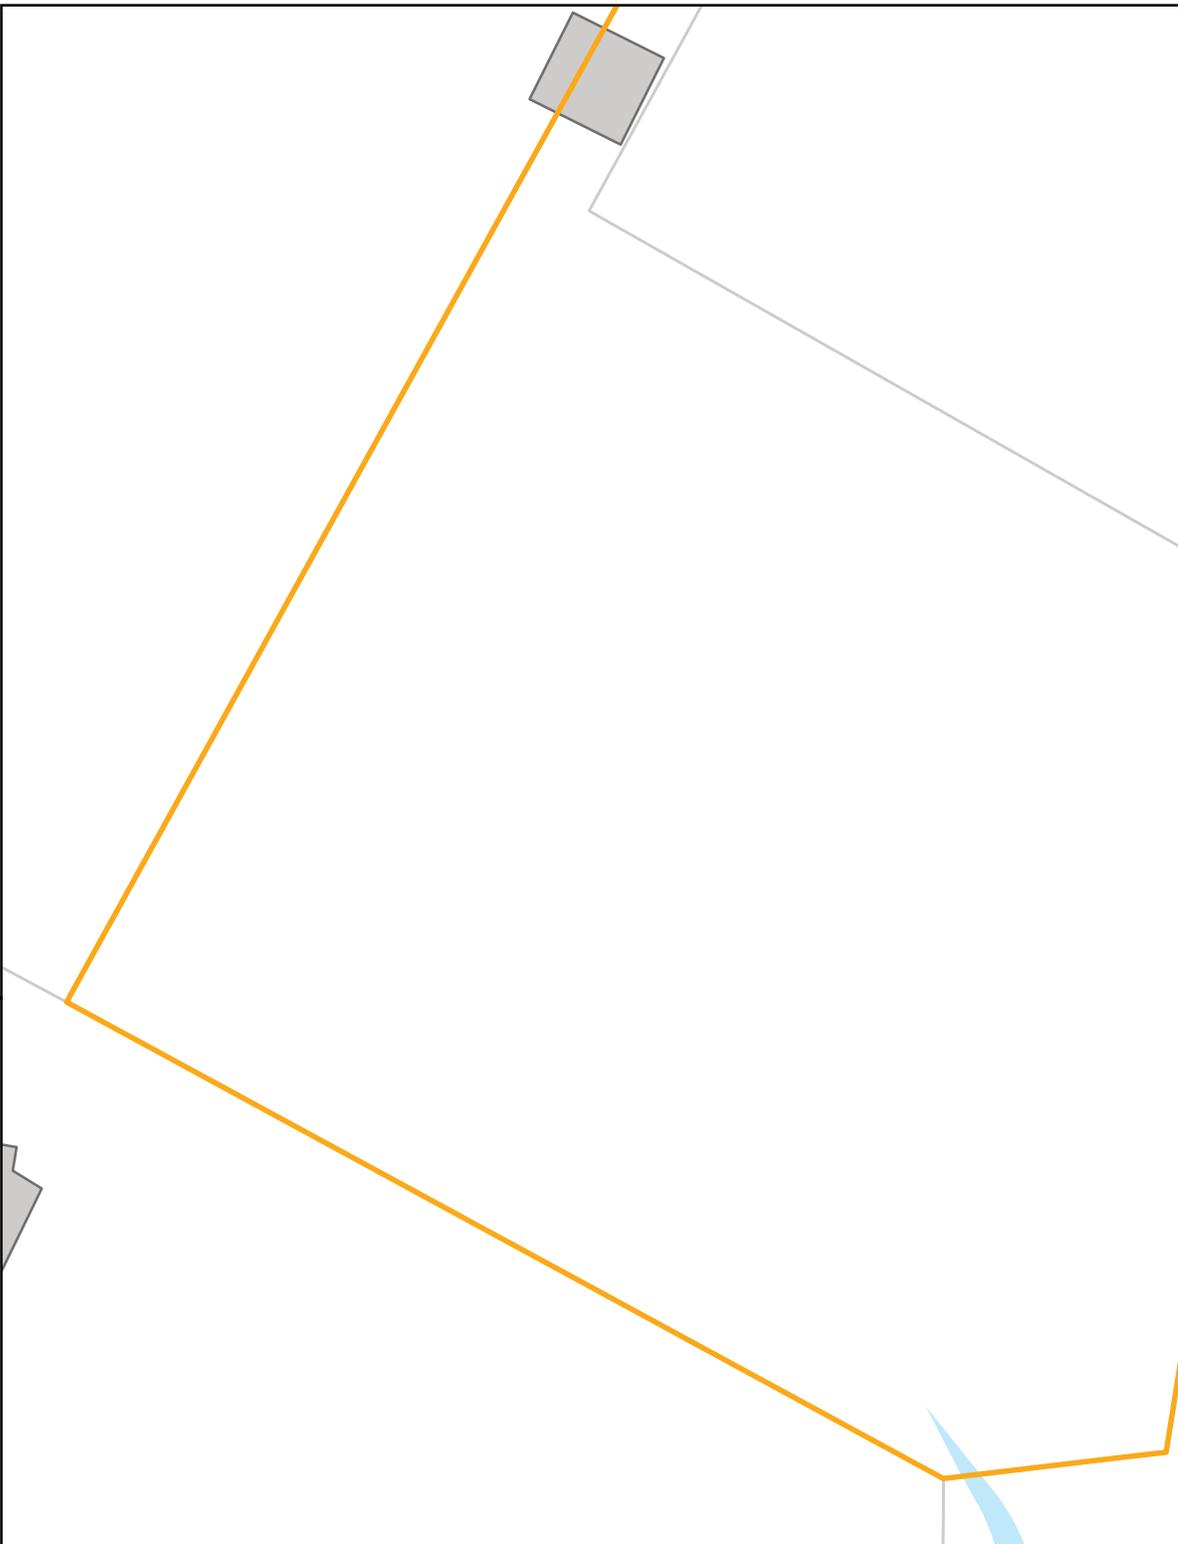
Note: No Groundwater data available.  
 Source: Delaware DataMIL - Tax Parcels;  
 New Castle County Buildings.

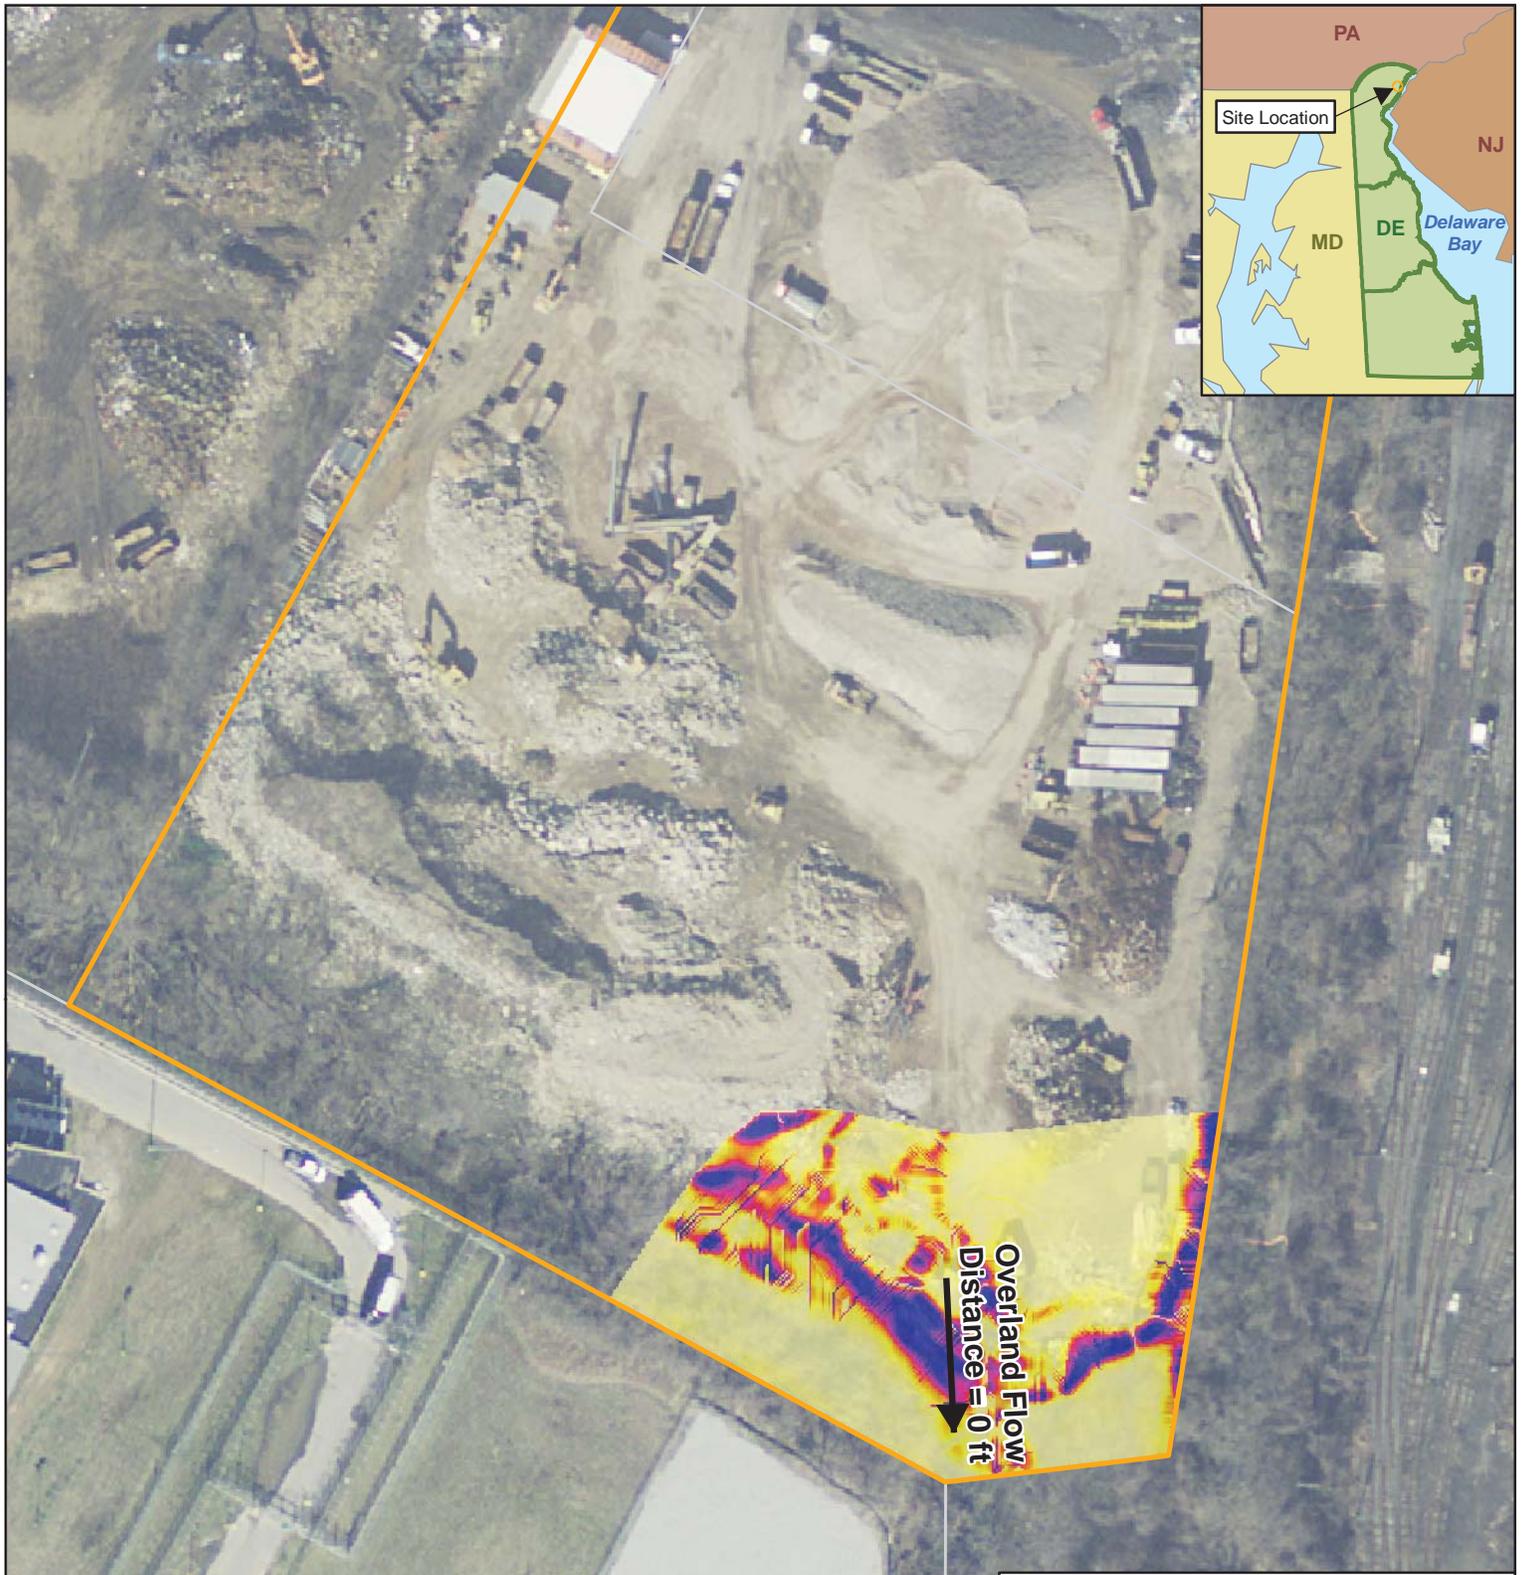
801 Industrial Street, Suite 1 Wilmington, Delaware 19801		302-656-9600 302-656-9700 fax		
Soil Loss Estimates 1610/0 Bowers St Wilmington, Delaware				
Drawn	By	Date	Scale:	File Name:
Checked	KEP	6/18/2014	1:1,080	Fig6SoilLoss.mxd
Project #	0985.69.51		Figure 6

P = support practice factor (dimensionless)	1	No documentation was provided indicating that any sediment and erosion controls are in place.
A = average annual soil loss estimate (ton/ac-yr)	24	The average soil loss estimate was generated by ArcGIS using the input factors listed above.
Erodible Area (acres)	0.85	The erodible area was calculated based on the pervious surfaces within the area of concern polygon for surface soil (Figure 6).

Overland Flow  
 1610/0 Bowers St Site Boundary  
 Tax Parcels  
 Tons/Year/Acre of Soil Loss Estimated  
 High : 587  
 Low : 0
