PCB Mass Loading  
American Tank Trailer Cleaning Co.  
SIRB ID: DE-1180  
Wilmington, Delaware

## **Appendix 1-C**

**AMERICAN TANK TRAILER CLEANING CO.  
WILMINGTON, DELAWARE**

**SIRB ID: DE-1180**

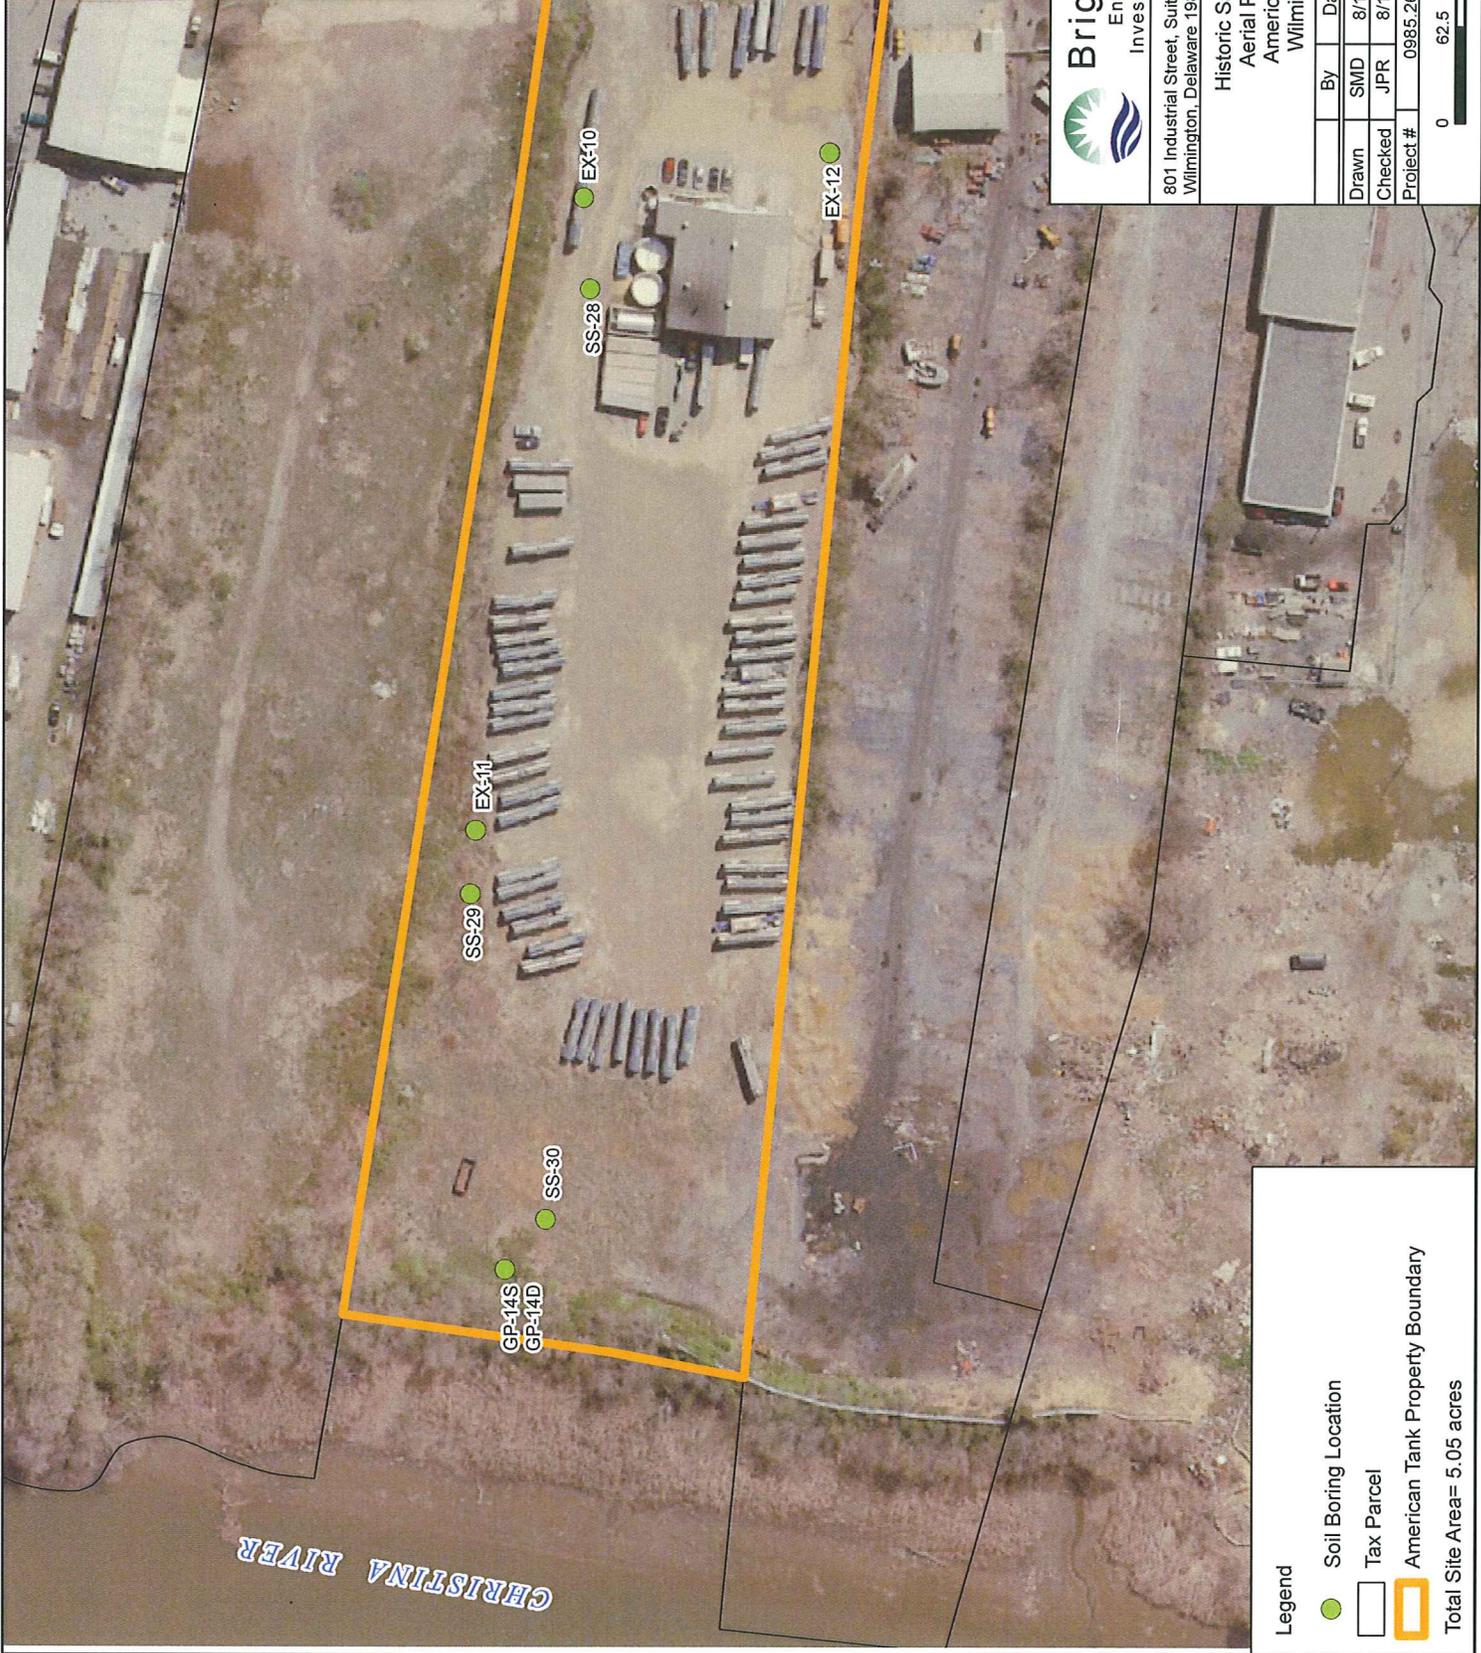
By	Date	Scale:	File Name:
Drawn	SMD	1:1500	am tank aerial.mxd
Checked	JPR	8/13/08	
Project #	0985.26.51	Fig. No.	Figure 1
0	62.5	125

Historic Sample Locations and  
Aerial Photograph (2007)  
American Tank Cleaning  
Wilmington, Delaware

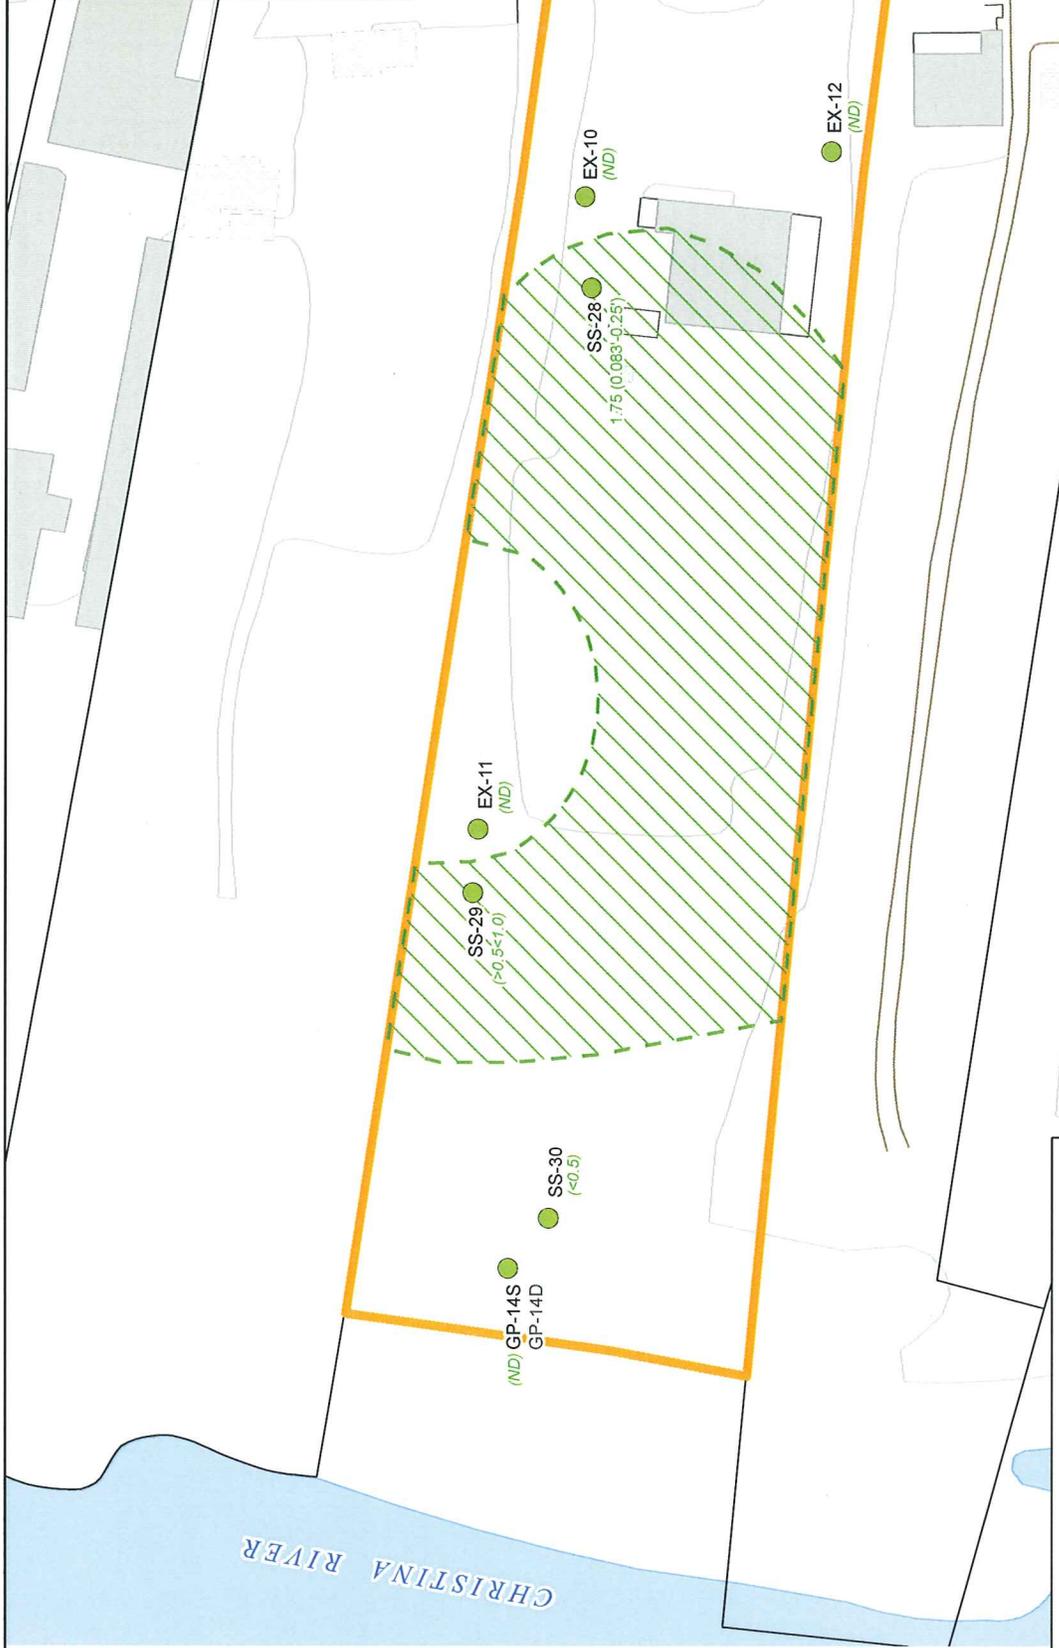
By	Date	Scale:	File Name:
Drawn	SMD 1/8/09	1:1500	am tank 0-2.mxd
Checked	JPR 1/8/09	Fig. No.	Figure 2
Project #	0985.26.51	Figure 2

The estimated surface soil area impacted by PCBs is 2.4 acres (Figure 2). There is no information indicating that the subsurface soil on the American Tank Trailer Cleaning property has been affected by PCBs.

PCB Distribution in Surface Soil (0'-2' bgs)  
 American Tank Cleaning  
 Wilmington, Delaware

Concentrations of PCBs on Site			
Sample Matrix	Corresponding Figure	Analytical Methods	Range of Total PCBs
Surface Soil	Figure 2	Immunoassay & Method 8082	1.75
Subsurface Soil (unsaturated)	Figure 3	Method 8082	Not Analyzed
Subsurface Soil (saturated)	Figure 4	Immunoassay Kits	Not Detected
Ground Water	Figure 5	Method 8082	Not detected

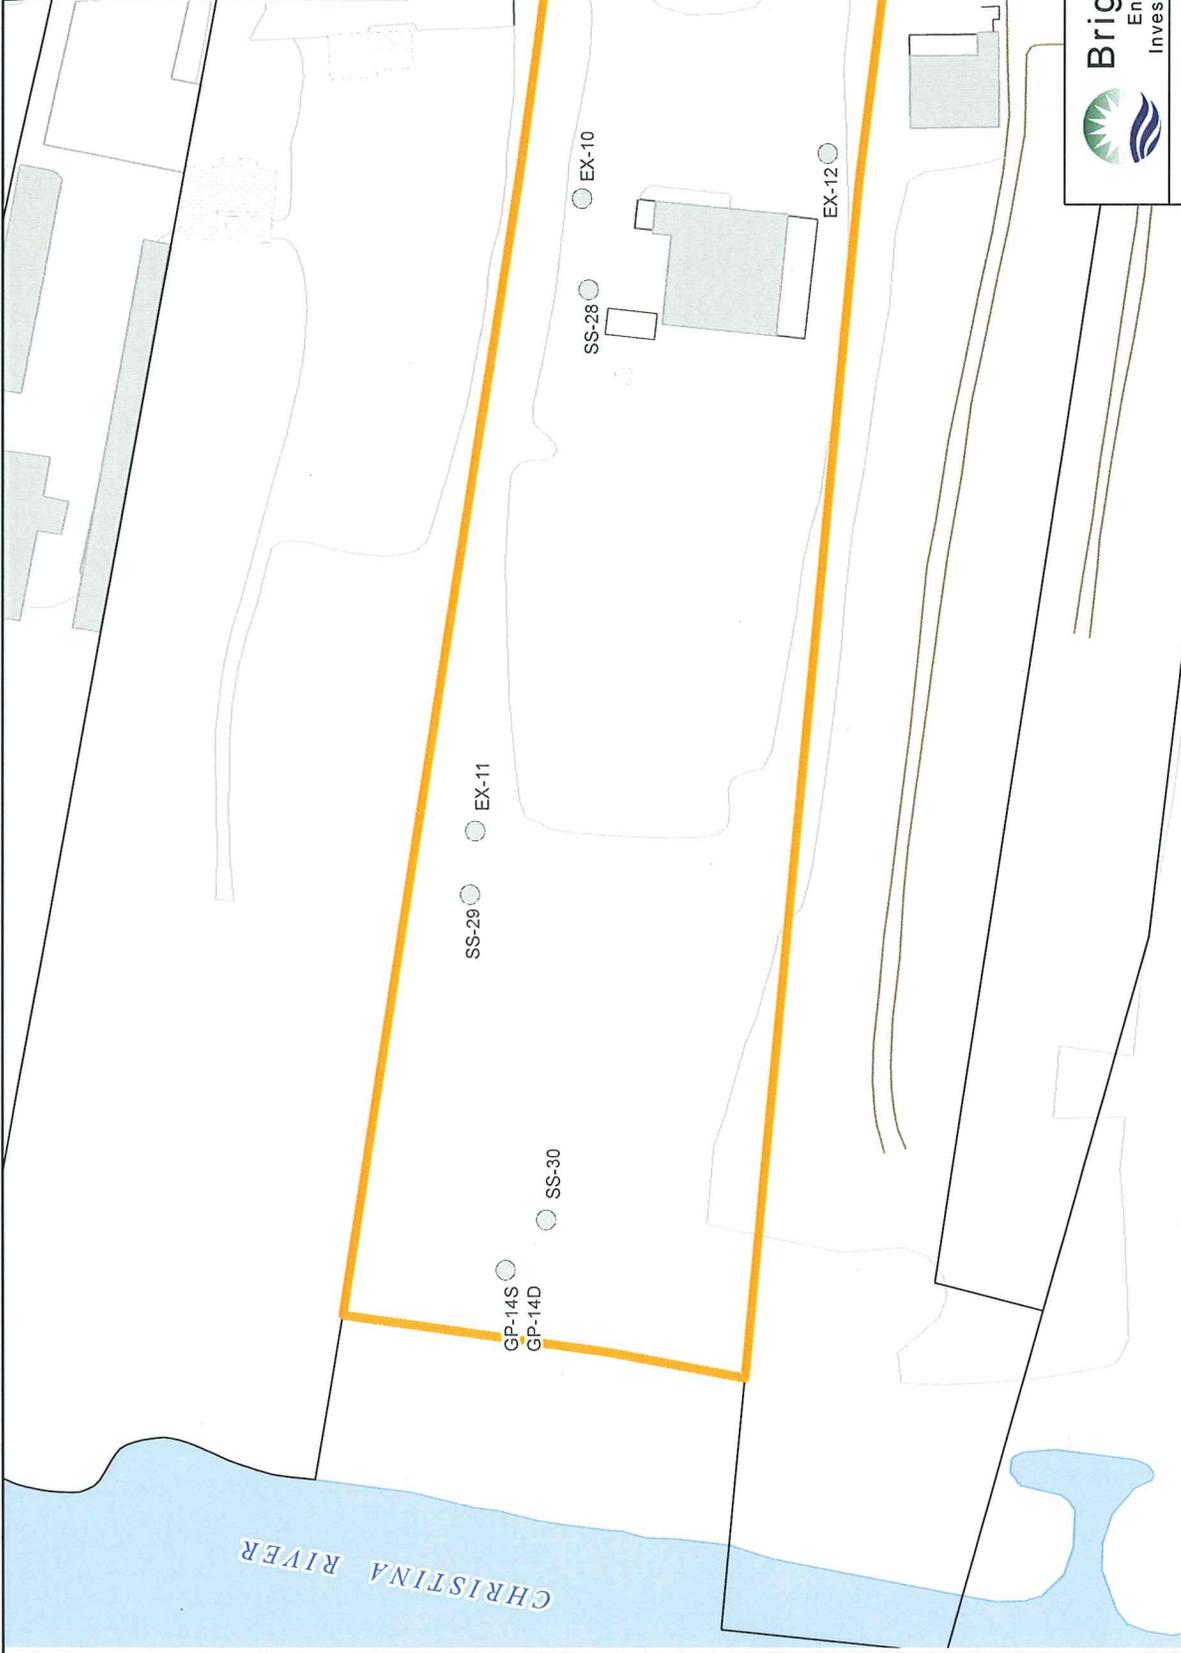
By	Date	Scale:	File Name:
Drawn SMD	8/13/08	1:1500	am tank unsat.mxd
Checked JPR	8/13/08	Fig. No.	Figure 3
Project #	0985.26.51		
0	62.5	125

PCB Distribution in Subsurface Unsaturated Soil  
 American Tank Cleaning  
 Wilmington, Delaware

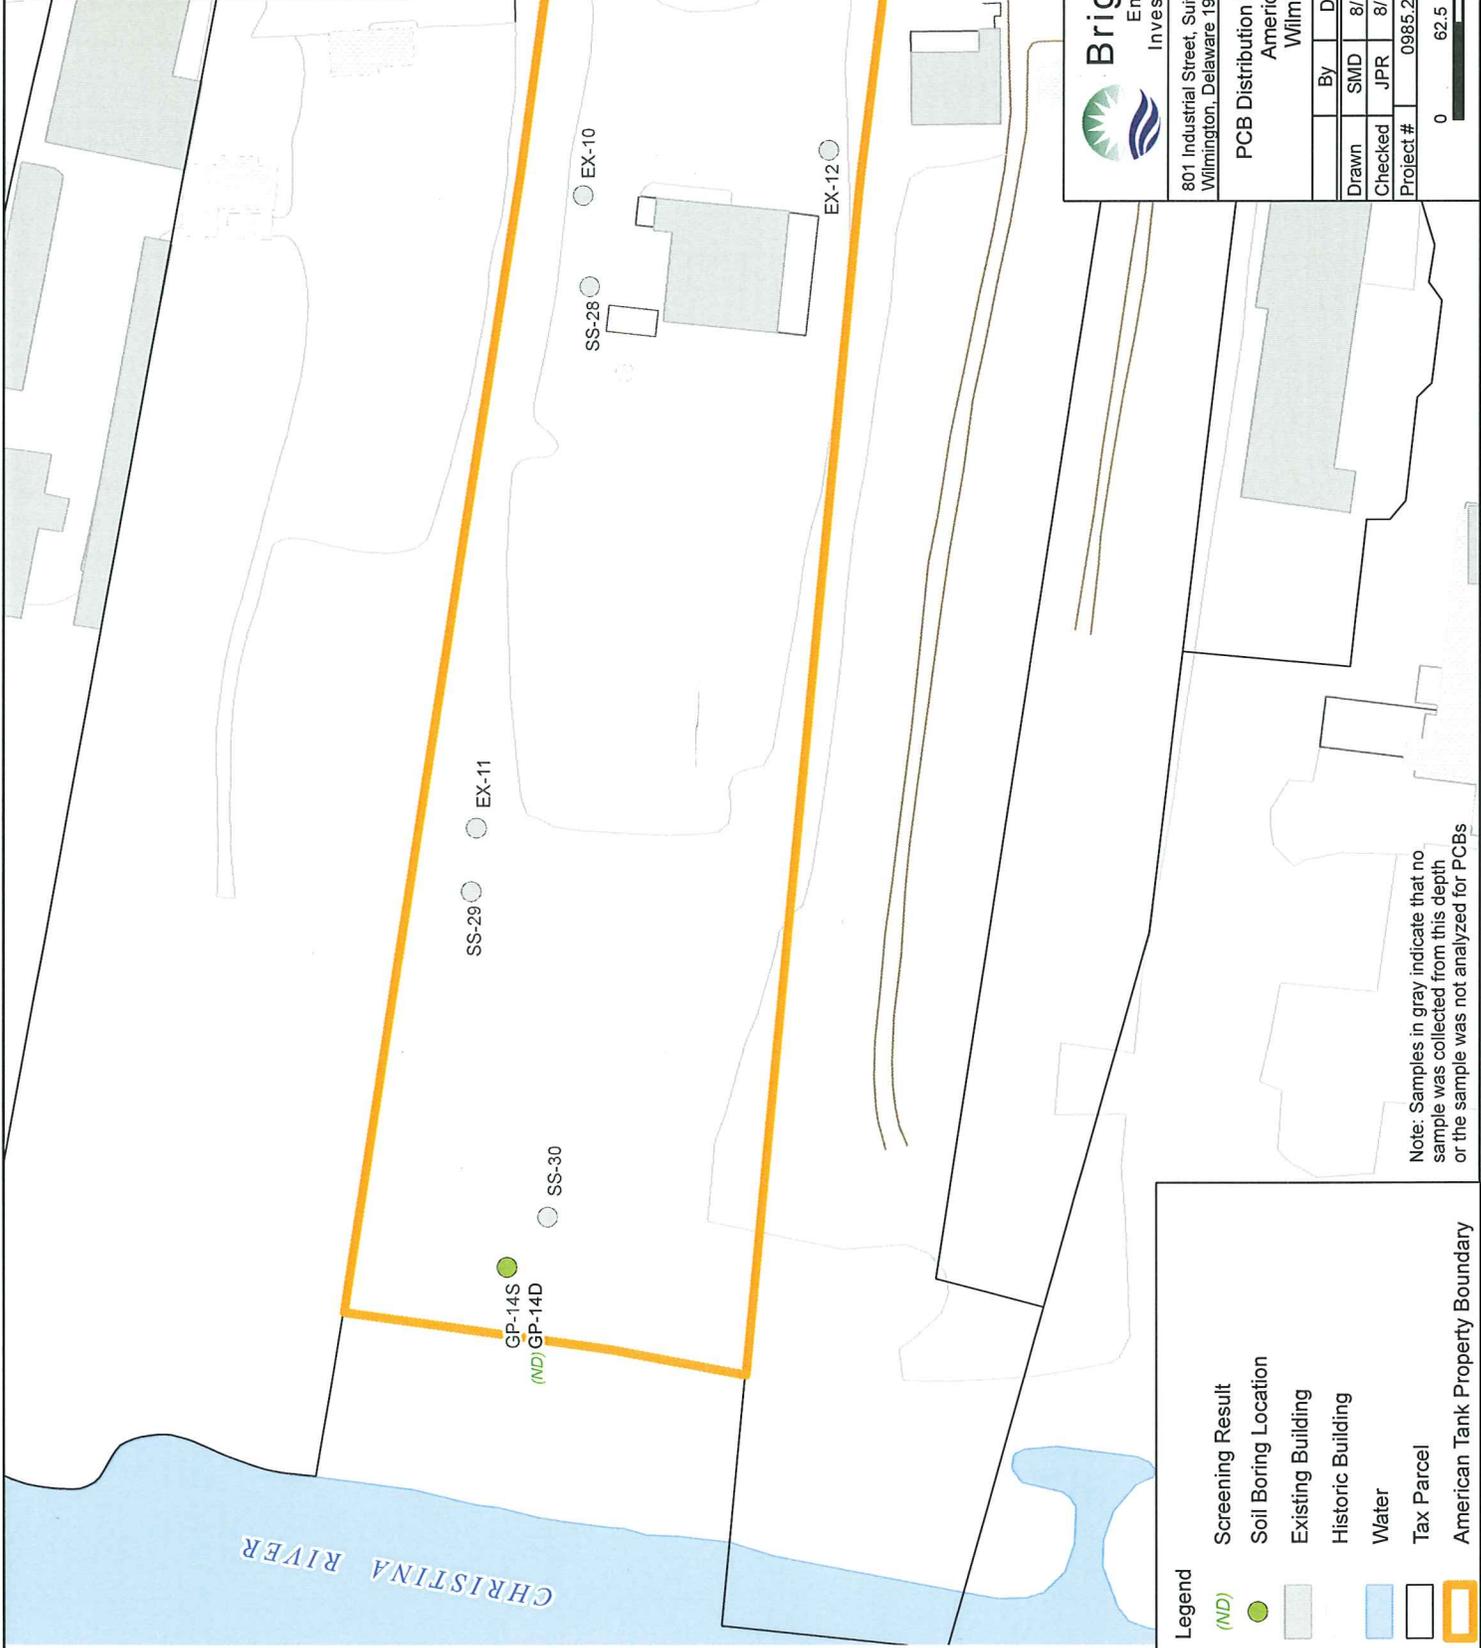
By	Date	Scale:	File Name:
Drawn	SMD 8/13/08	1:1500	am tank sat.mxd
Checked	JPR 8/13/08	Fig. No.	Figure 4
Project #	0985.26.51	0	62.5
		125	Feet

PCB Distribution in Subsurface Saturated Soil  
 American Tank Cleaning  
 Wilmington, Delaware

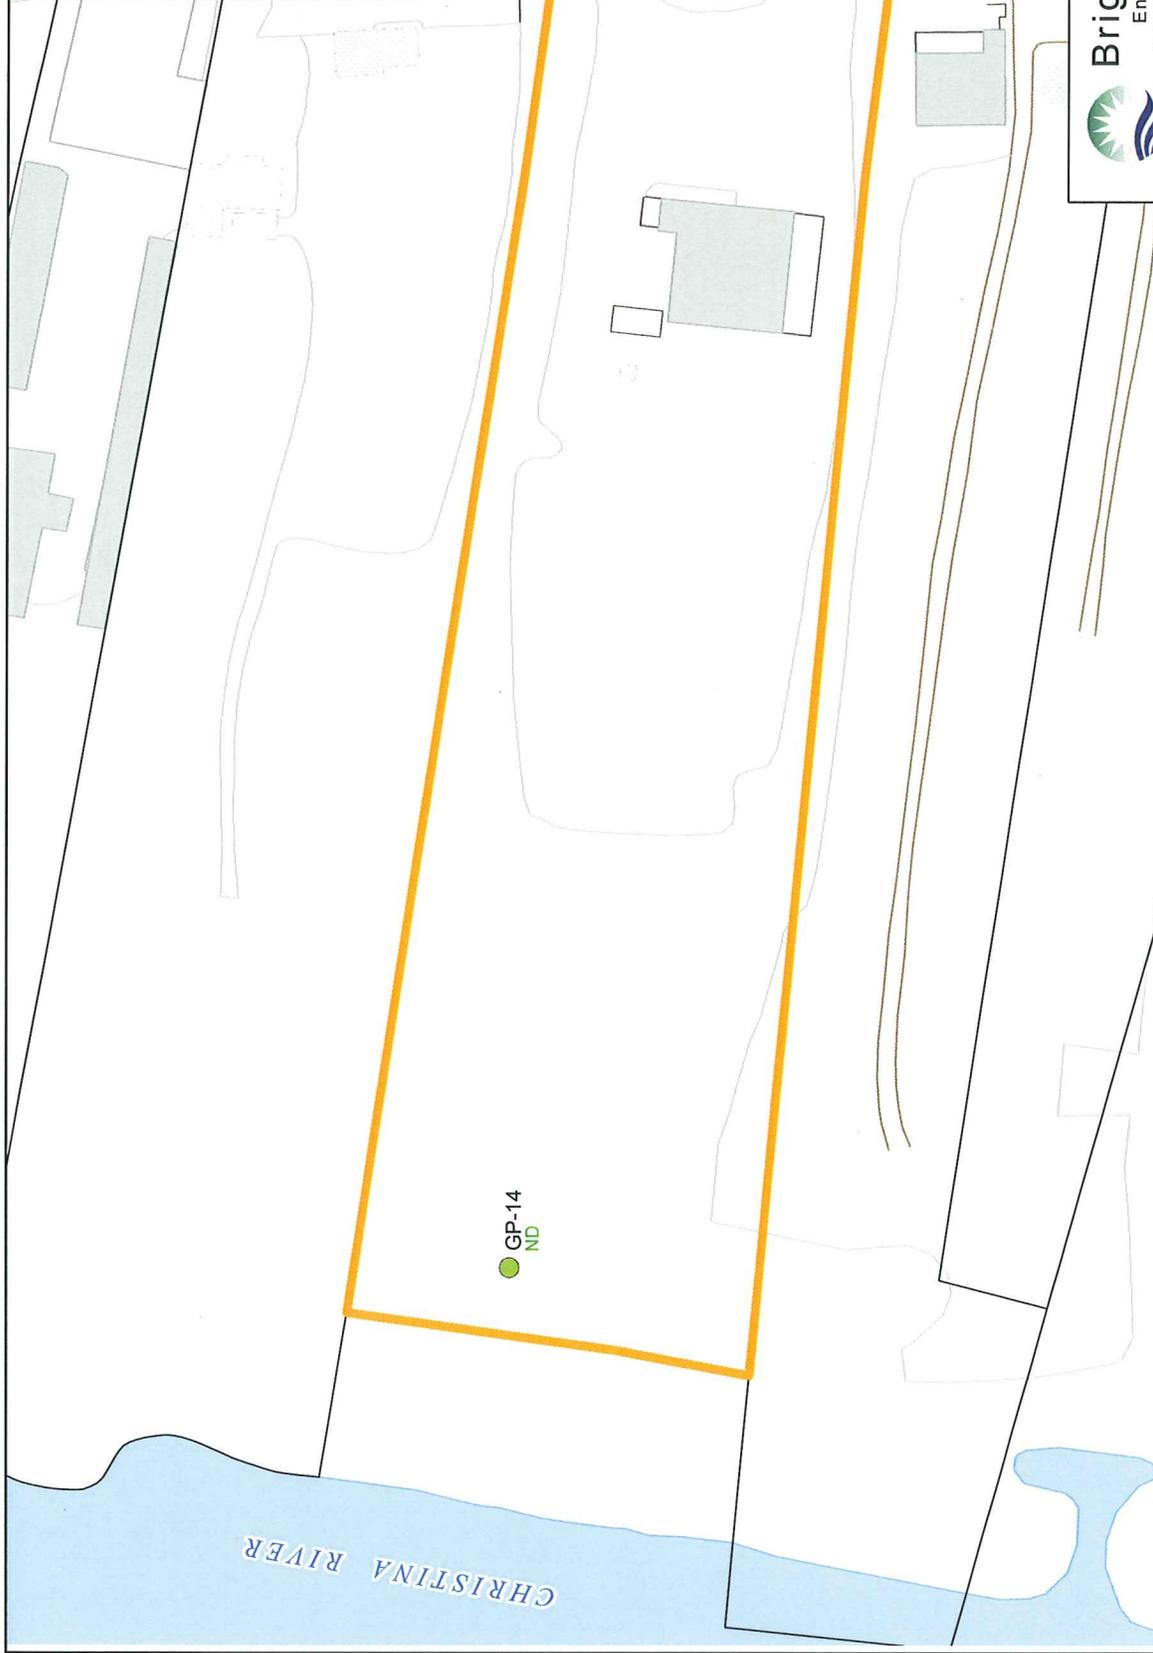
By	Date	Scale:	File Name:
Drawn SMD	8/13/08	1:1500	am tank gw.mxd
Checked JPR	8/13/08	Fig. No.	Figure 5
Project #	0985.26.51	0	62.5
		125	Feet

PCB Distribution in Groundwater  
American Tank Cleaning  
Wilmington, Delaware

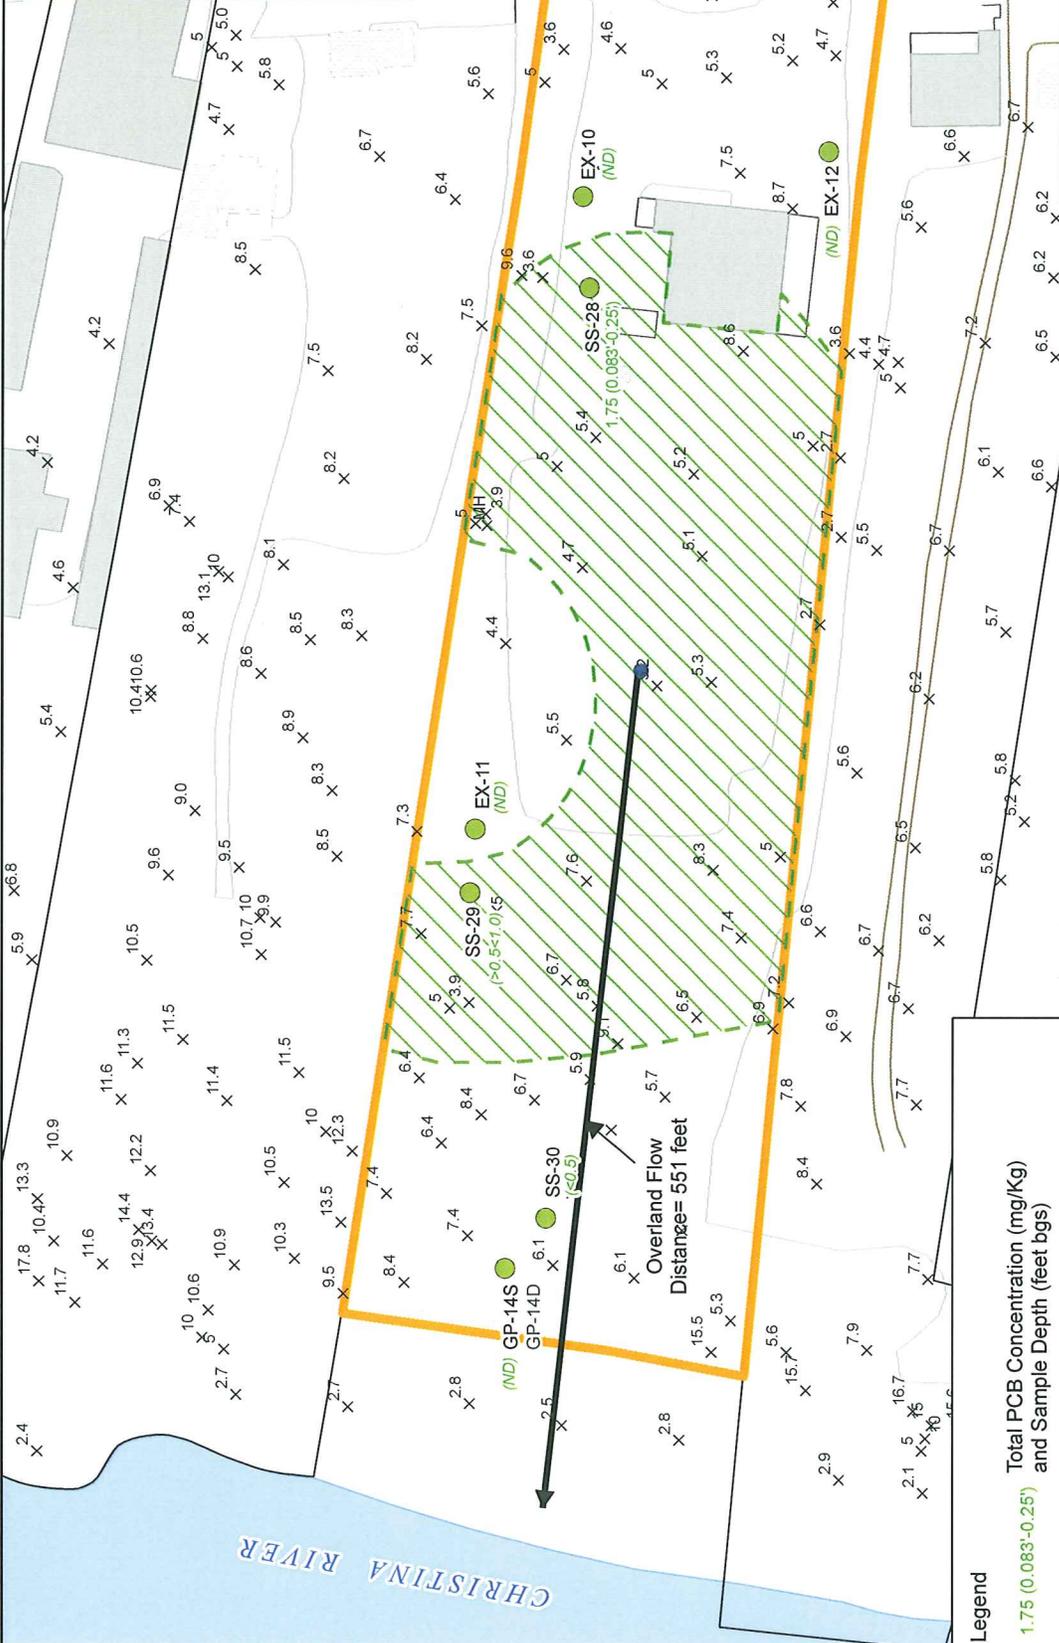
By	Date	Scale:	File Name:
Drawn	SMD 5/19/09	1:1500	am tank topo.mxd
Checked	JEC 5/19/09		
Project #	0985.26.51	Fig. No.	Figure 6
0	62.5	125	Feet

**Overland Flow Map**  
 American Tank Cleaning  
 Wilmington, Delaware
