PCB Mass Loading
Shuster Auto Salvage
SIRB ID: DE-1178
Wilmington, Delaware

Appendix 1-D

SHUSTER AUTO SALVAGE WILMINGTON, DELAWARE

SIRB ID: DE-1178

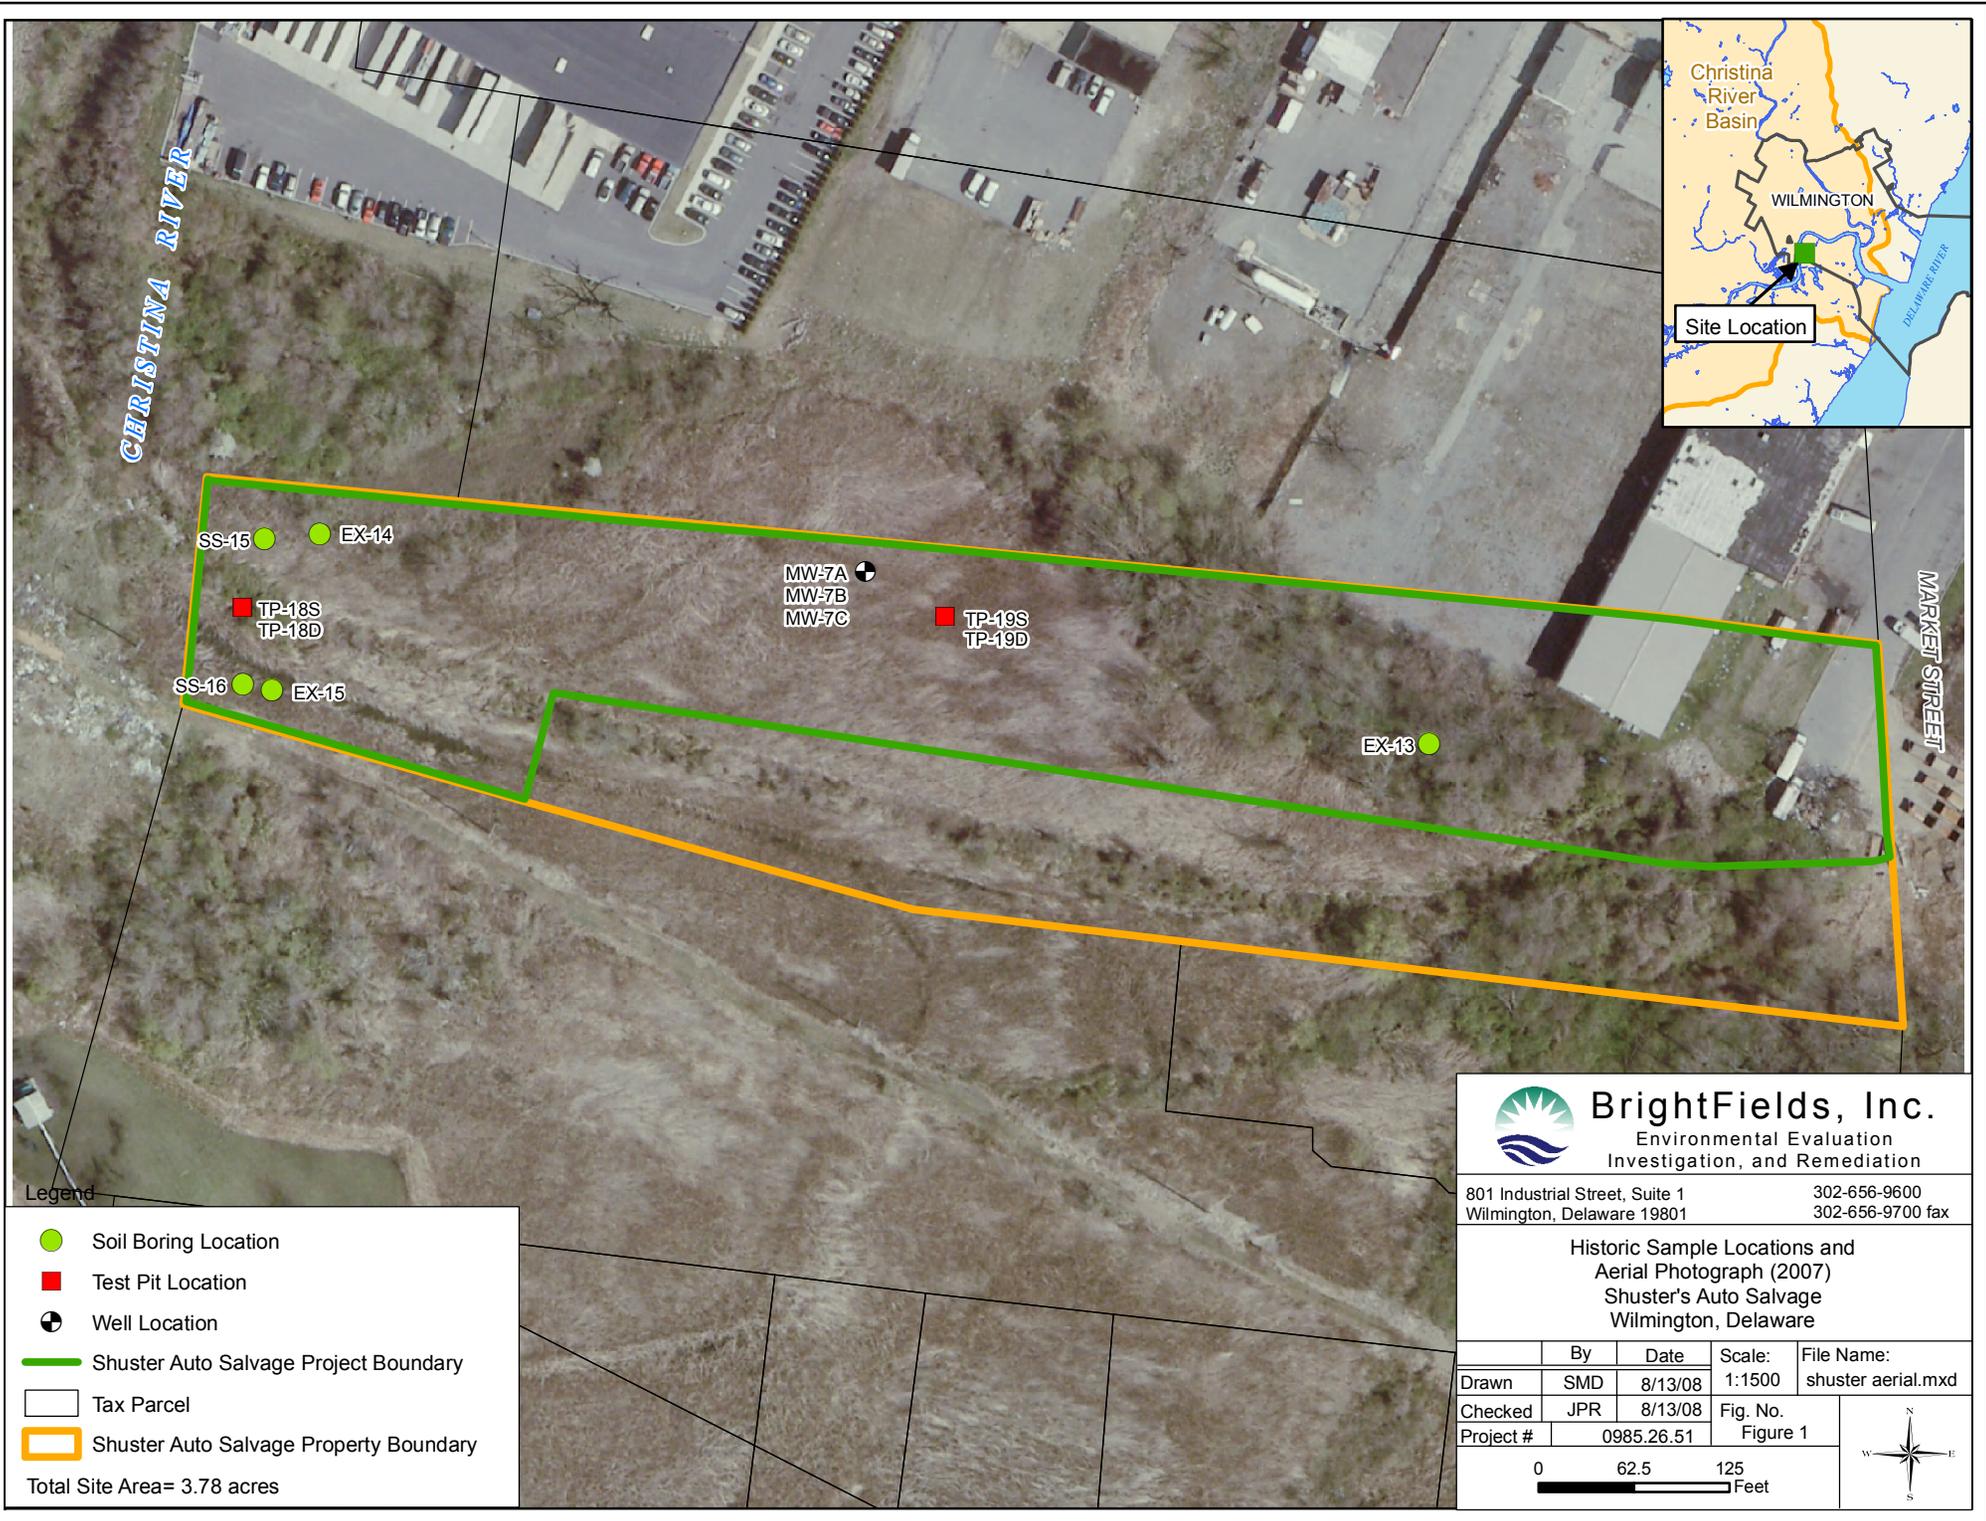
By	Date	Scale:	File Name:
Drawn	SMD	8/13/08	1:1500	shuster aerial.mxd
Checked	JPR	8/13/08	Fig. No.	Figure 1
Project #	0985.26.51

Historic Sample Locations and
Aerial Photograph (2007)
Shuster's Auto Salvage
Wilmington, Delaware

Site Location and Description: The Shuster Auto Salvage property is located in the vicinity of the south side of the Christina River in Wilmington, Delaware (Figure 1). The property has most recently been operated as a salvage yard and is bordered by commercial properties to the north and south, Christina River to the west, and Market Street to the east. Surrounding land is generally commercial and/or industrial. The Shuster Property is an approximately 6.0-acre property consisting of two tax parcels (Tax Parcel #26-057.00-048 and #26-057.00-001); however, during the collection of historical data for the assessment BrightFields only found data pertaining to tax parcel #26-057.00-048. In an effort to provide a more accurate report, BrightFields only completed the assessment on the tax parcel that was previously investigated.

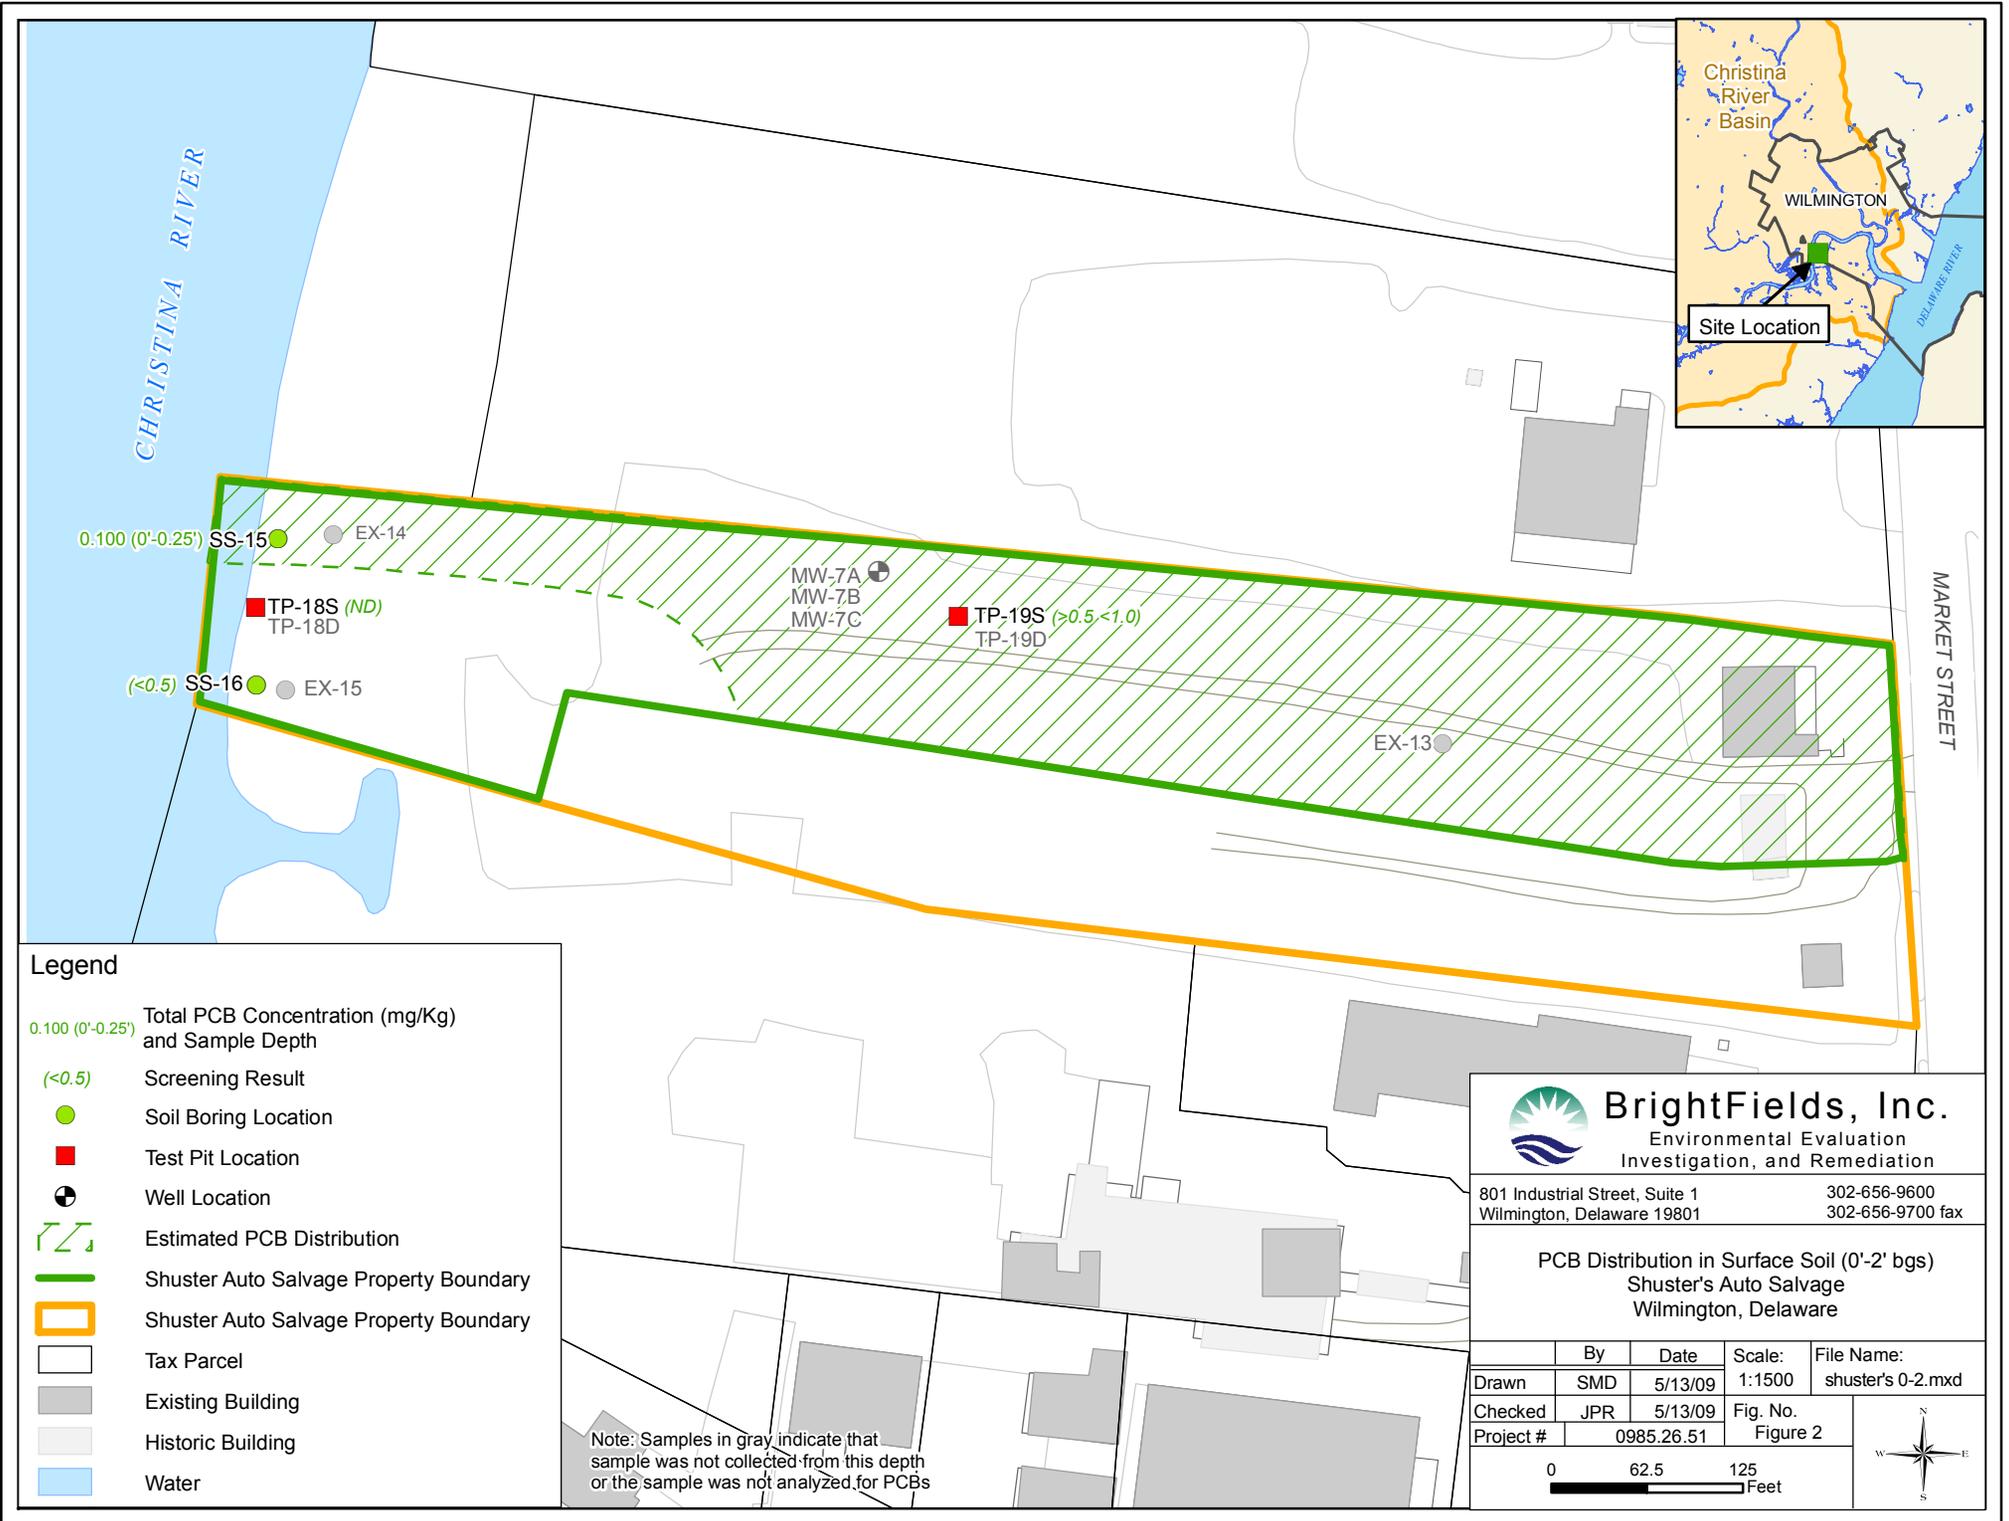
By	Date	Scale:	File Name:
Drawn	SMD	5/13/09	1:1500	shuster's 0-2.mxd
Checked	JPR	5/13/09	Fig. No.	Figure 2
Project #	0985.26.51

**PCB Distribution in Surface Soil (0'-2' bgs)
Shuster's Auto Salvage
Wilmington, Delaware**

Concentrations of PCBs on Site			
Sample Matrix	Corresponding Figure	Analytical Methods	Range of Total PCBs
Surface Soil	Figure 2	Method 8082	Not detected to 0.10 mg/kg
Subsurface Soil (unsaturated)	Figure 3	Immunoassay Kits	>0.5 mg/kg to <1.0 mg/kg
Subsurface Soil (saturated)	Figure 4	Method 8082	Not detected to 0.14 mg/kg
Ground Water	Figure 5	None	Not Analyzed

The estimated surface soil area impacted by PCBs is 2.92 acres (Figure 2). The estimated subsurface non-saturated area impacted by PCBs is 2.23 acres in the vicinity of TP19 (Figure 3). The estimated area of saturated soils impacted by PCBs is 0.95 acres in the vicinity of TP18 (Figure 4).

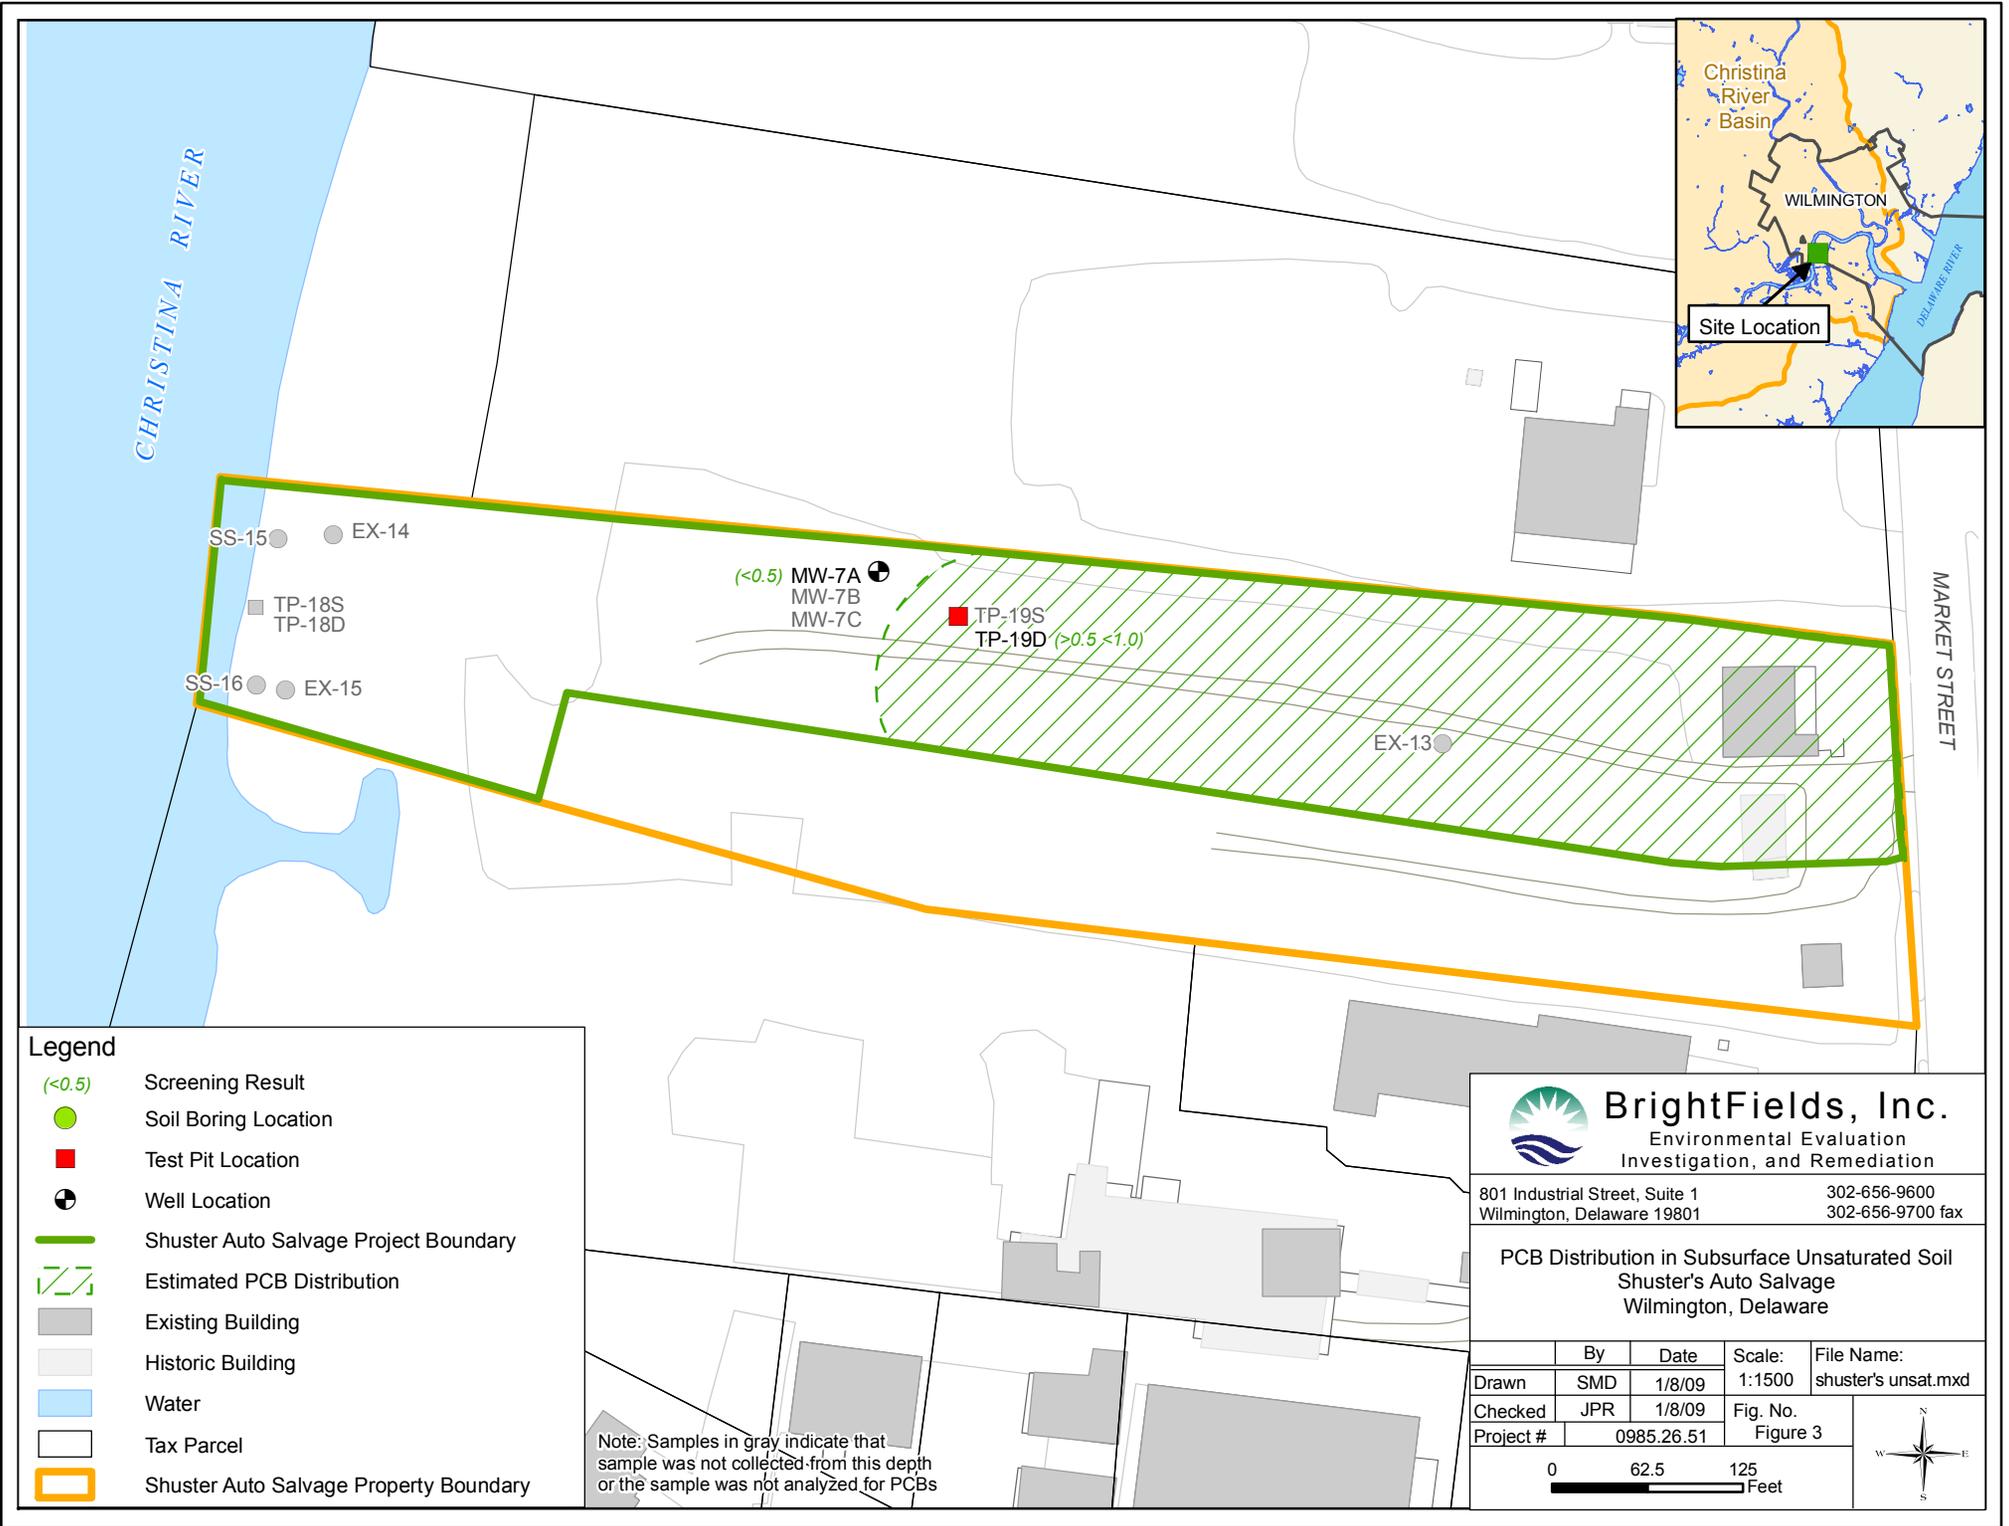
By	Date	Scale:	File Name:
Drawn	SMD	1/8/09	1:1500	shuster's unsat.mxd
Checked	JPR	1/8/09	Fig. No.	Figure 3
Project #	0985.26.51

**PCB Distribution in Subsurface Unsaturated Soil
 Shuster's Auto Salvage
 Wilmington, Delaware**

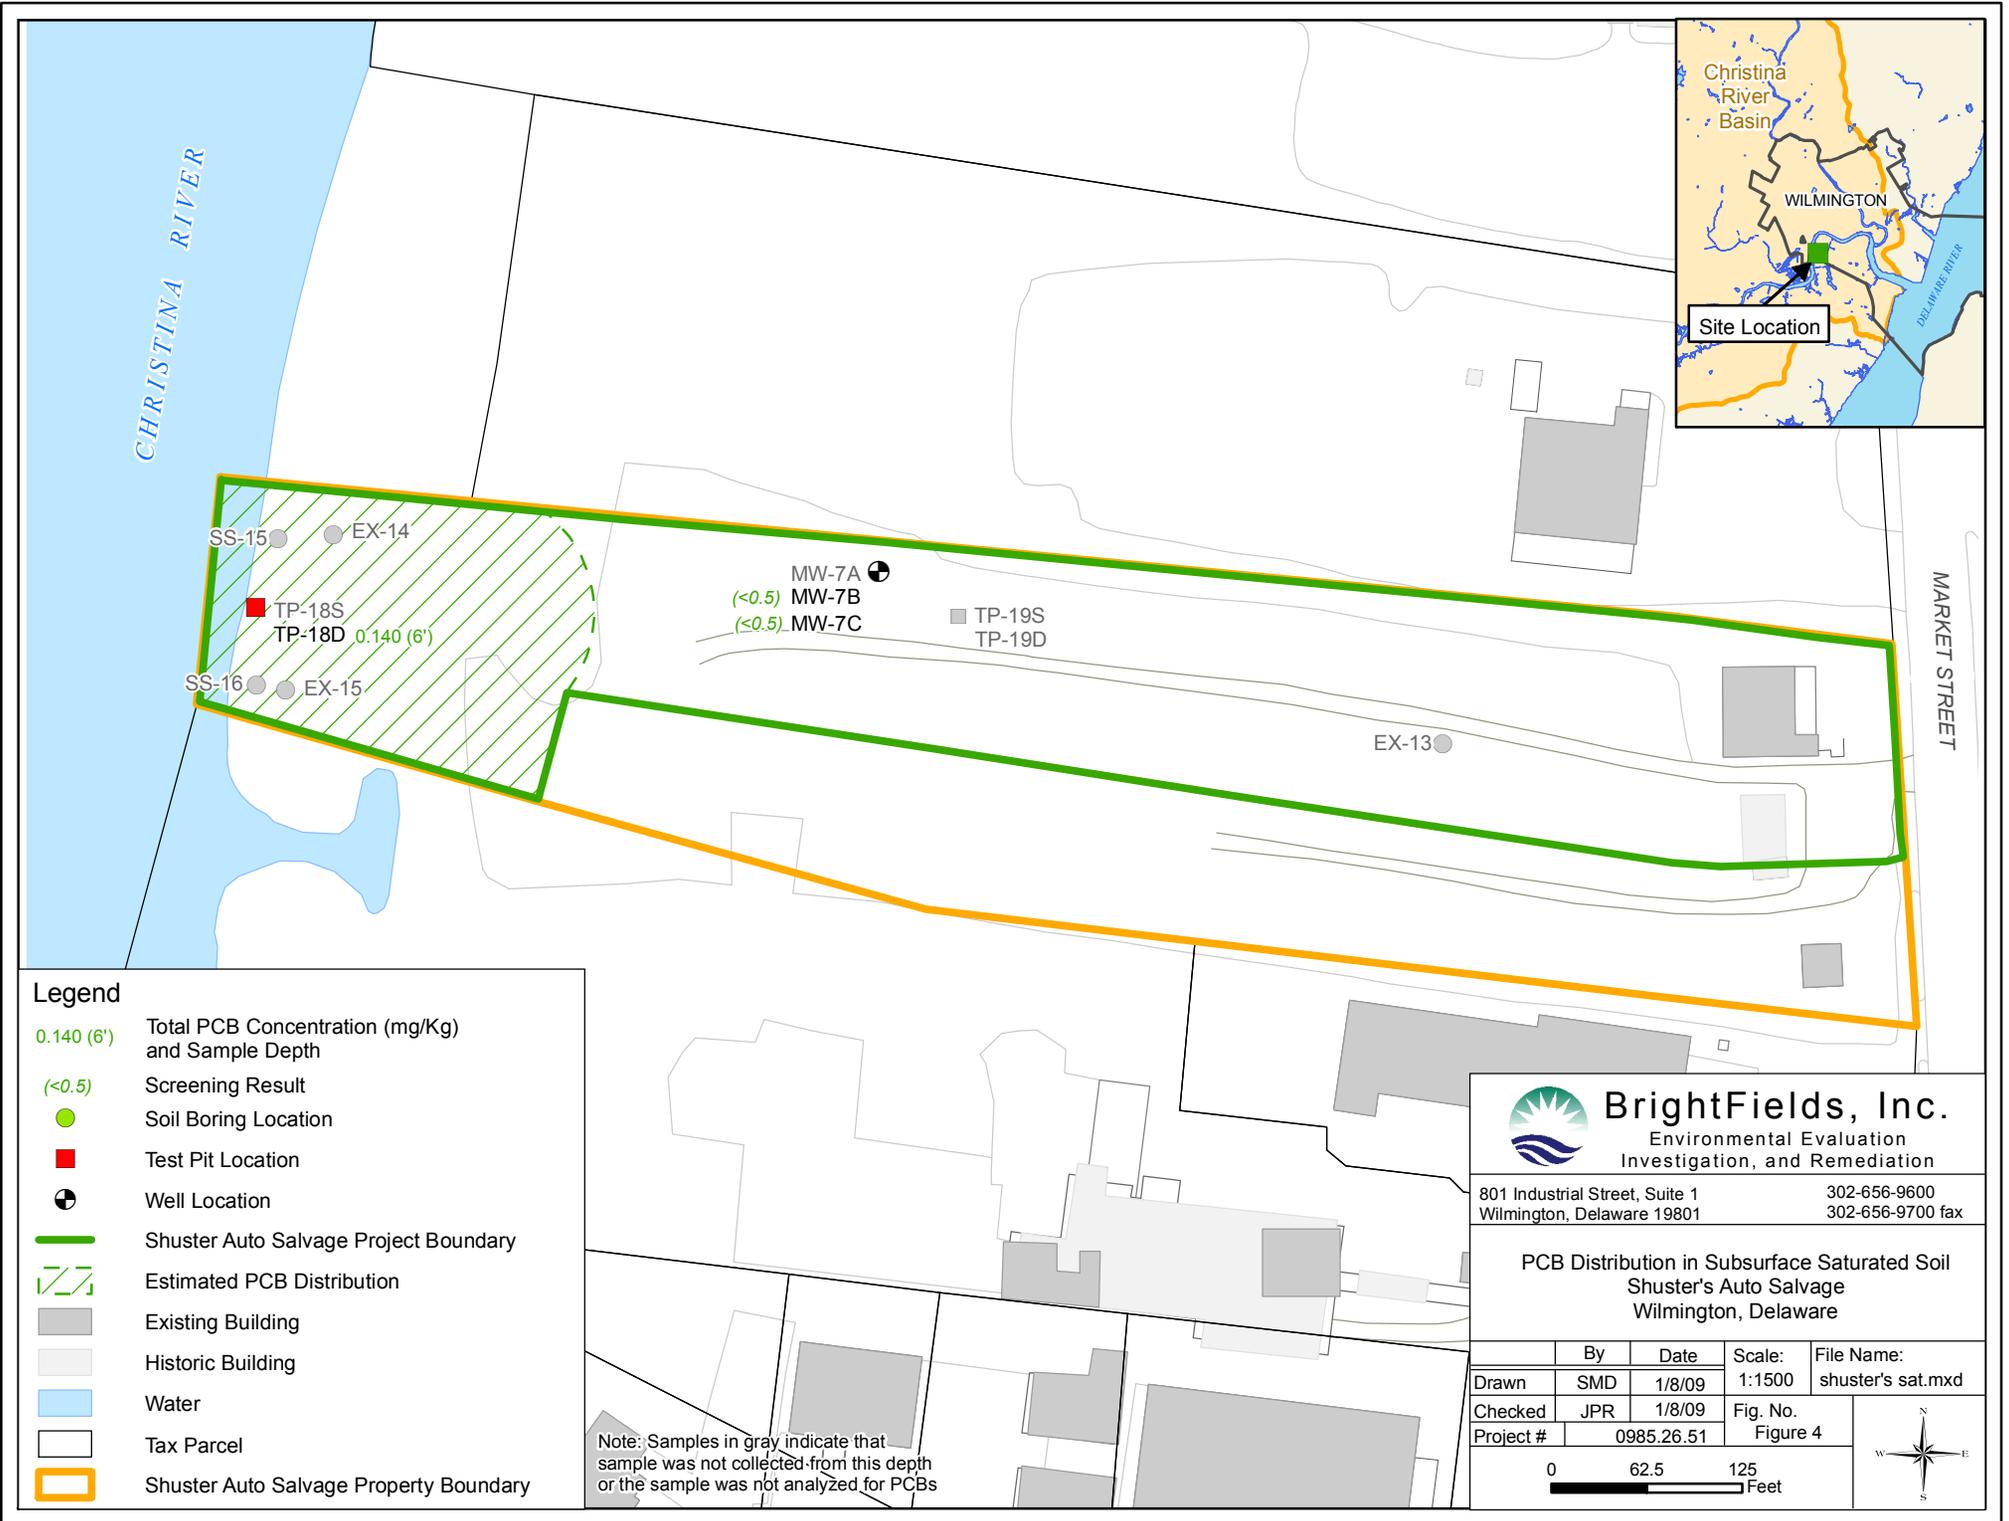
By	Date	Scale:	File Name:
Drawn	SMD	1/8/09	1:1500	shuster's sat.mxd
Checked	JPR	1/8/09	Fig. No.	Figure 4
Project #	0985.26.51

**PCB Distribution in Subsurface Saturated Soil
Shuster's Auto Salvage
Wilmington, Delaware**

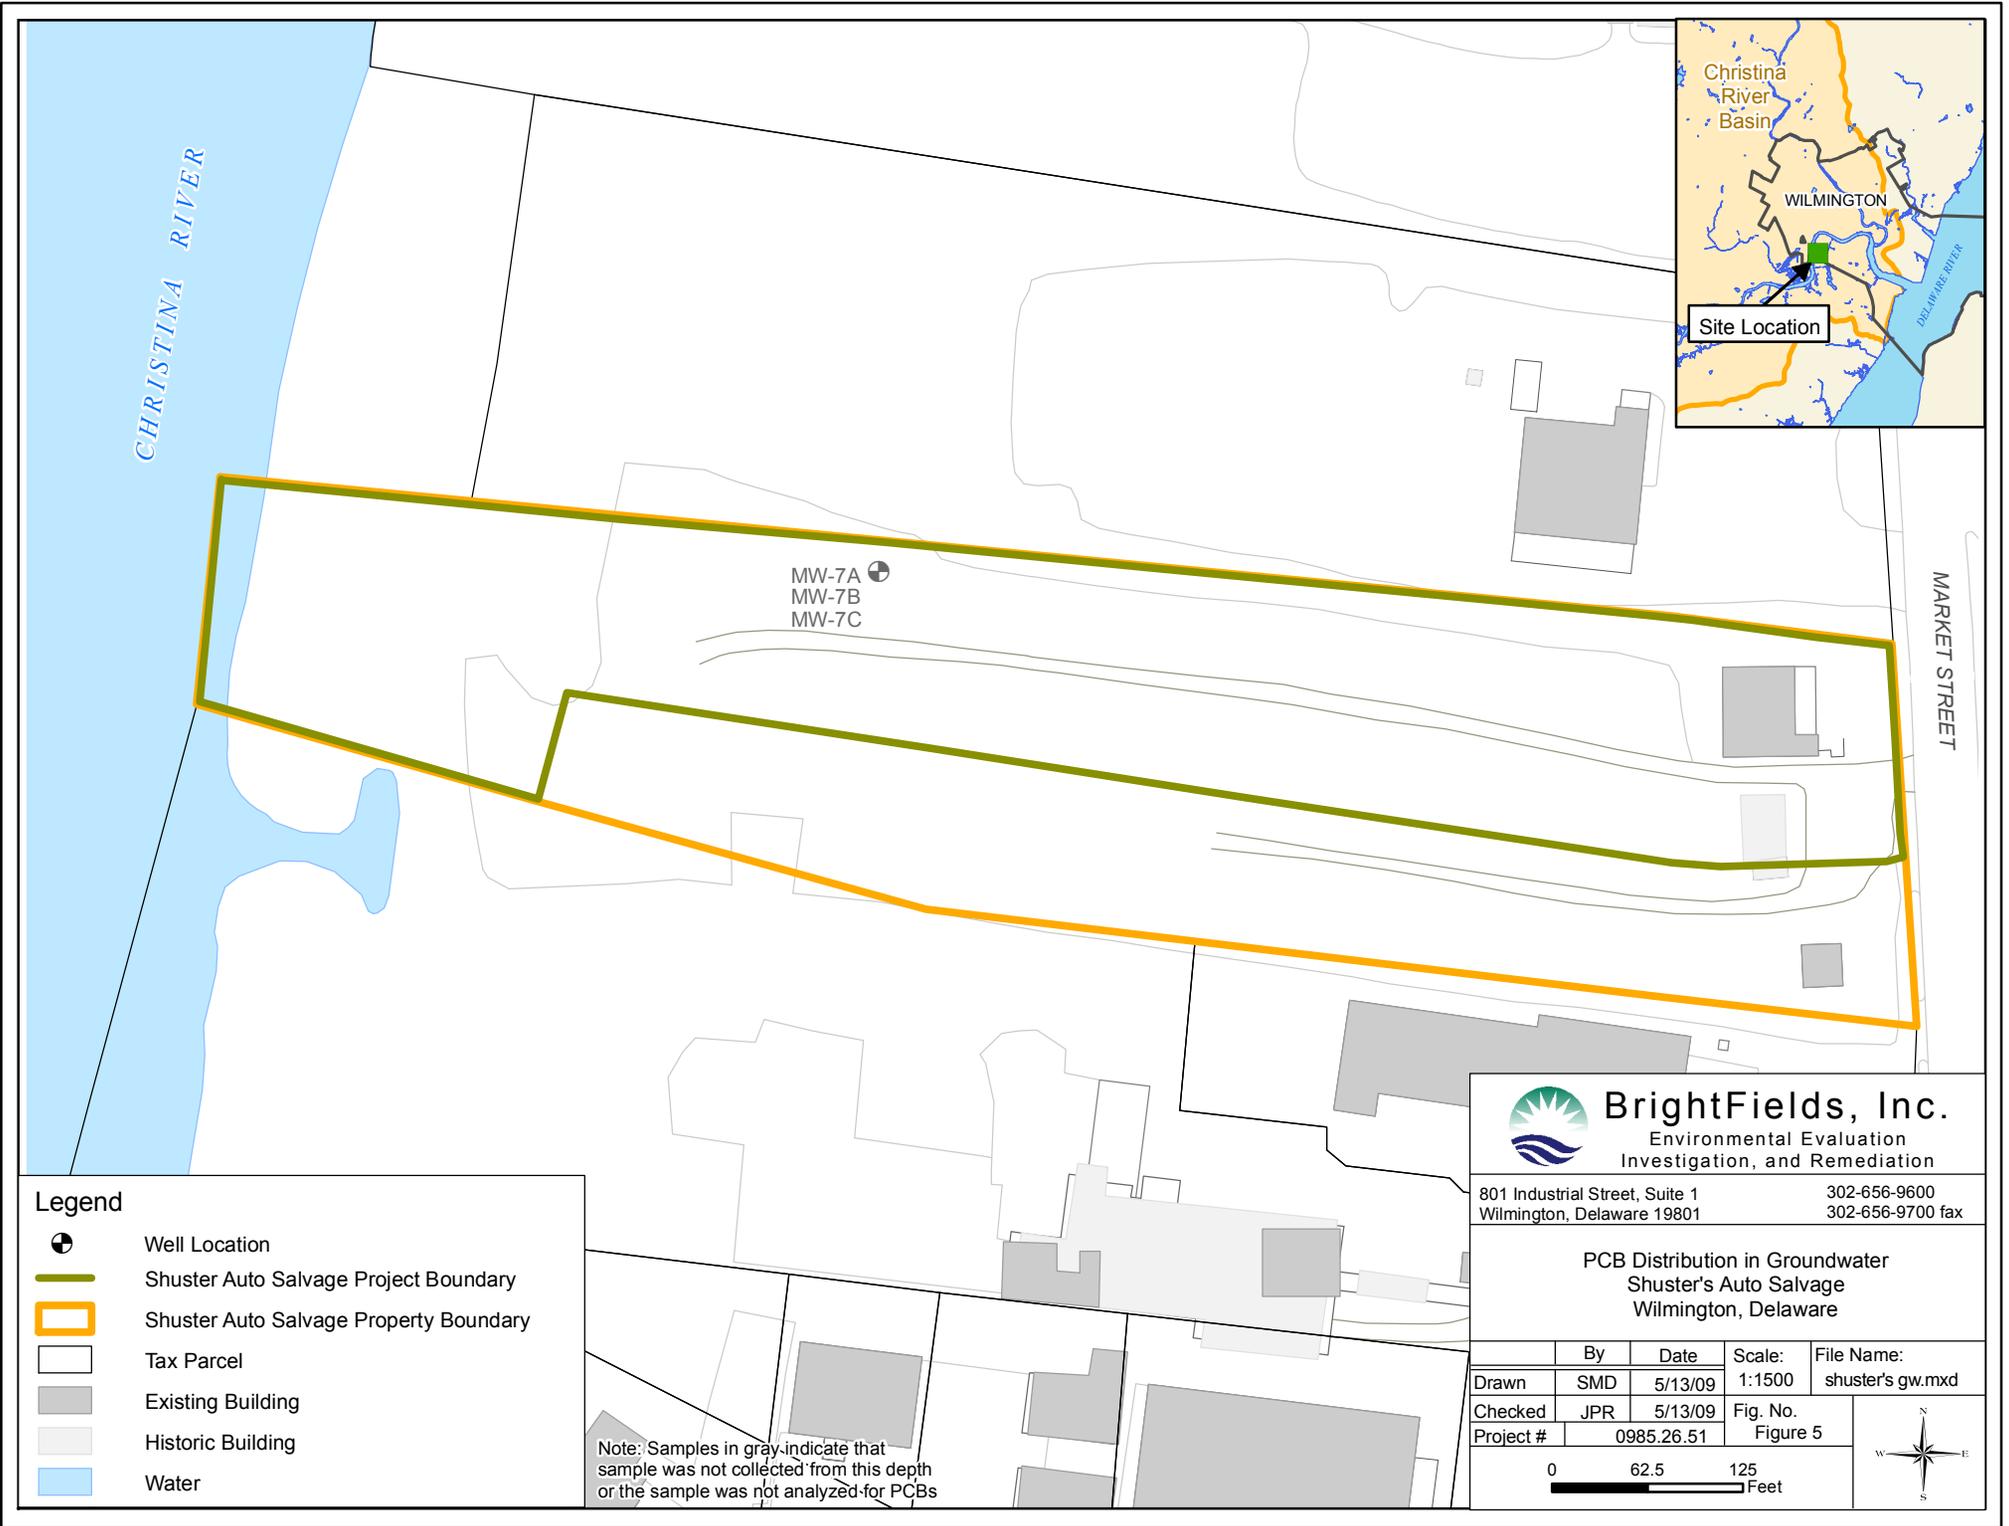
By	Date	Scale:	File Name:
Drawn	SMD	5/13/09	1:1500	shuster's gw.mxd
Checked	JPR	5/13/09	Fig. No.	Figure 5
Project #	0985.26.51

**PCB Distribution in Groundwater
Shuster's Auto Salvage
Wilmington, Delaware**

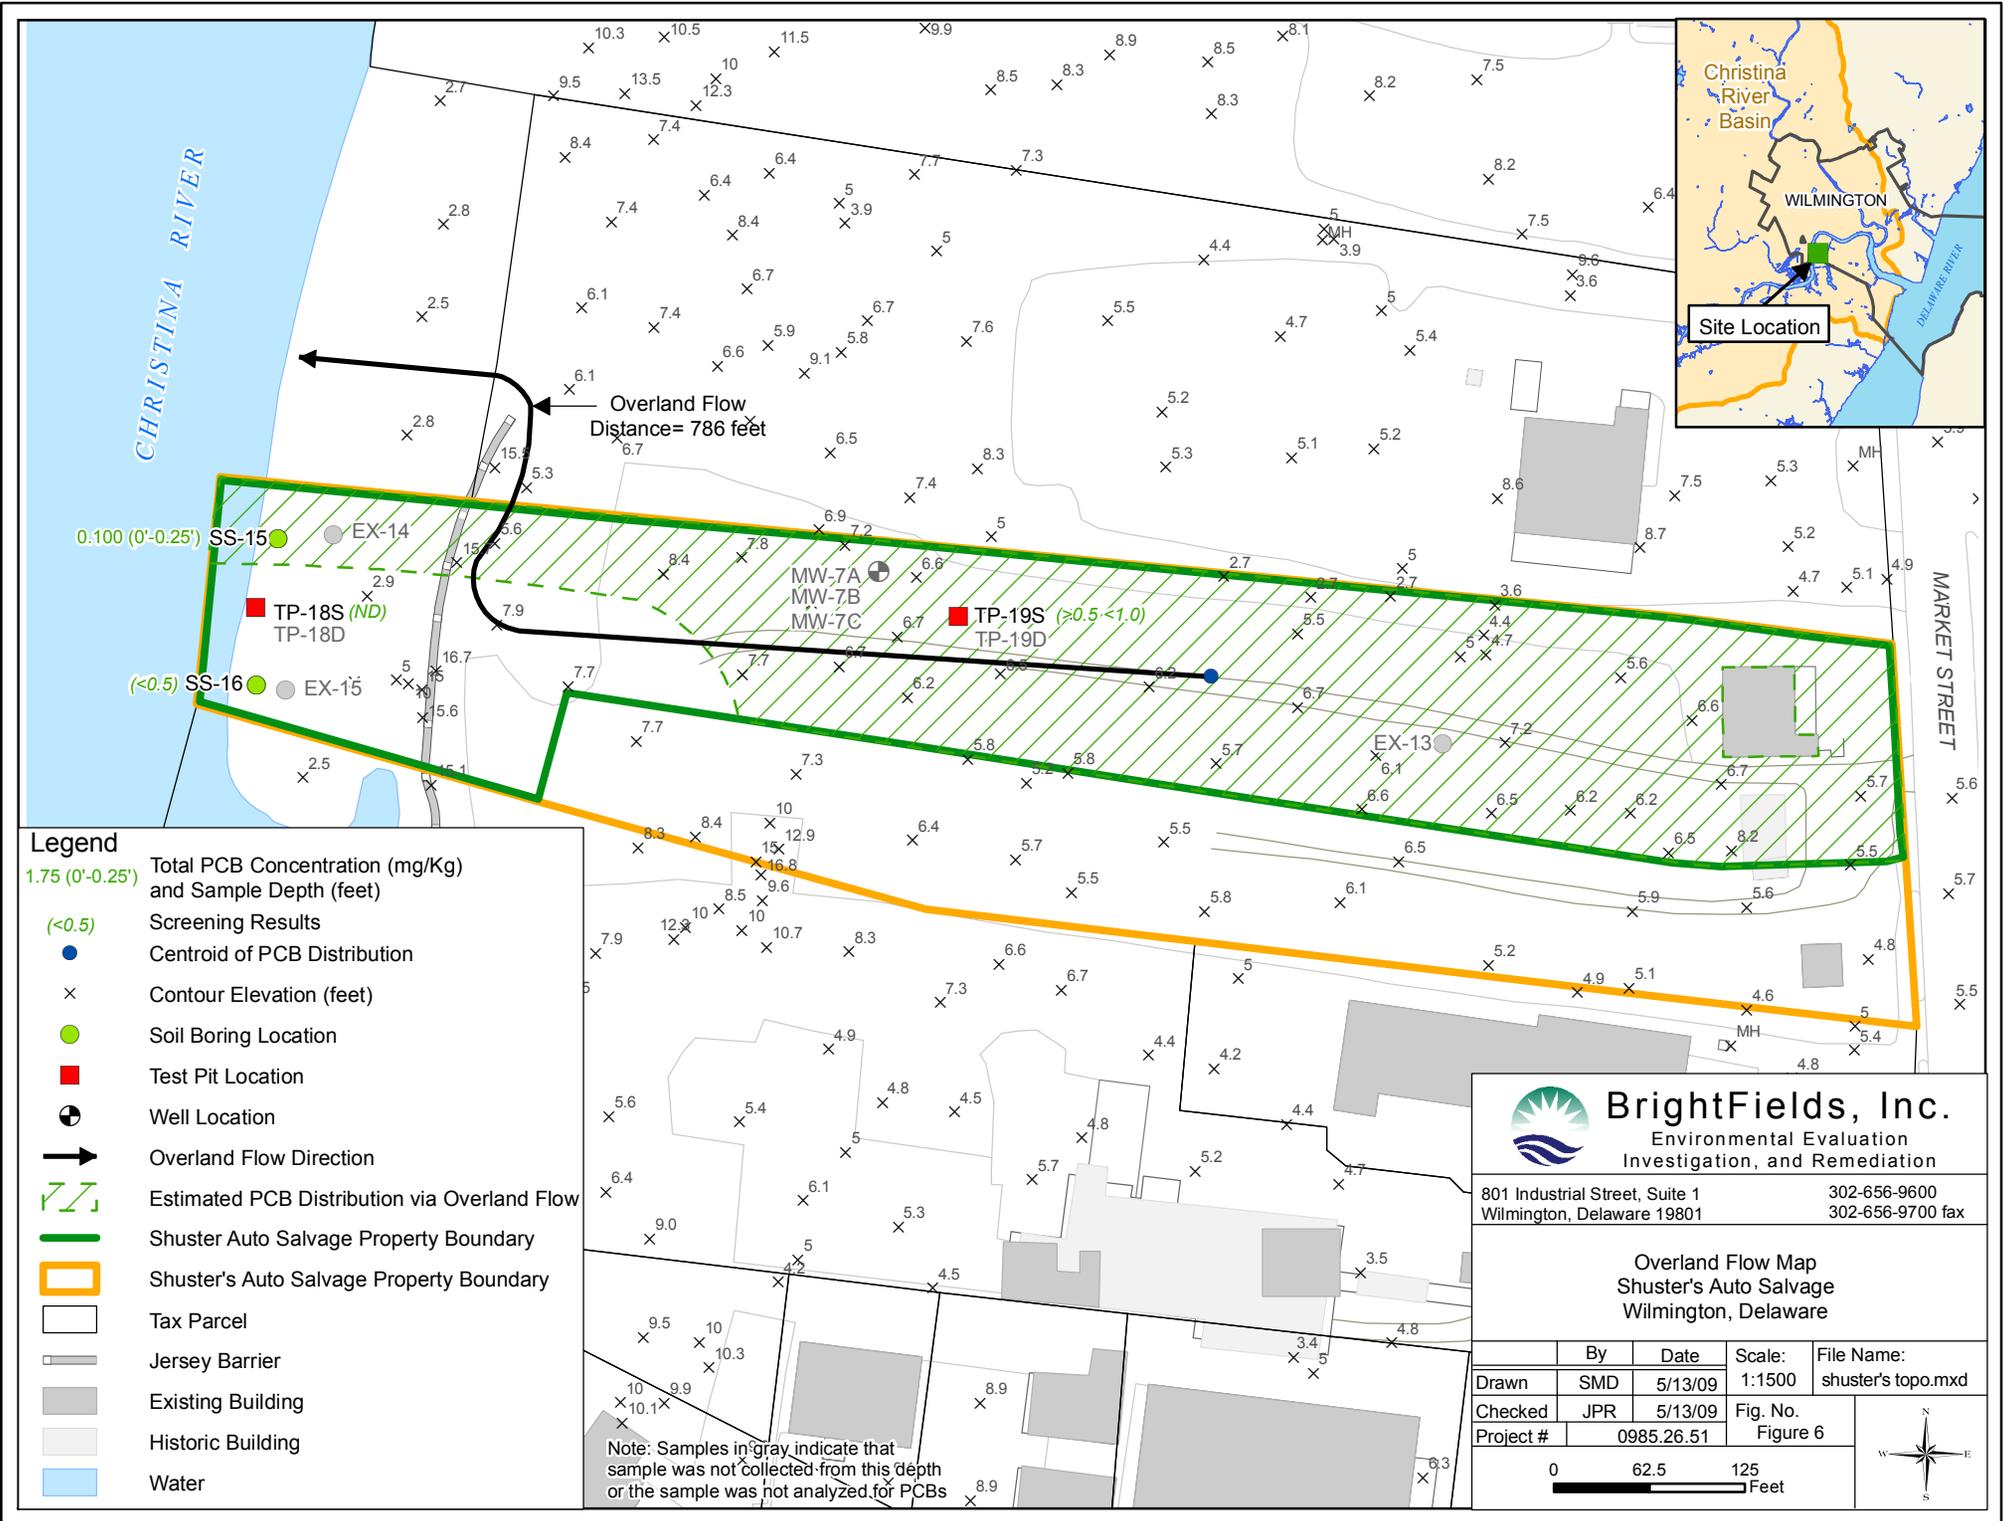
By	Date	Scale:	File Name:
Drawn SMD	5/13/09	1:1500	shuster's topo.mxd
Checked JPR	5/13/09	Fig. No.	Figure 6
Project #	0985.26.51

**Overland Flow Map
Shuster's Auto Salvage
Wilmington, Delaware**

RUSLE Factors	Values	Explanation of Selection
LS = topographic factor (dimensionless)	0.093	The slope length was estimated to be 786 feet, which is the distance between the centroid and the Christina River along the overland flow path. The assumed slope (0.5 %) and slope length were used to calculate a topographic factor of 0.093.
C = cover/management factor (dimensionless)	0.450	The cover/management factor C was assigned to the site and associated flow path by the USGS windows based application was 0.450, which corresponds to bare ground.
P = support practice factor (dimensionless)	1.0	There are currently no sediment and erosion controls in place at the Shuster's Auto Salvage property.

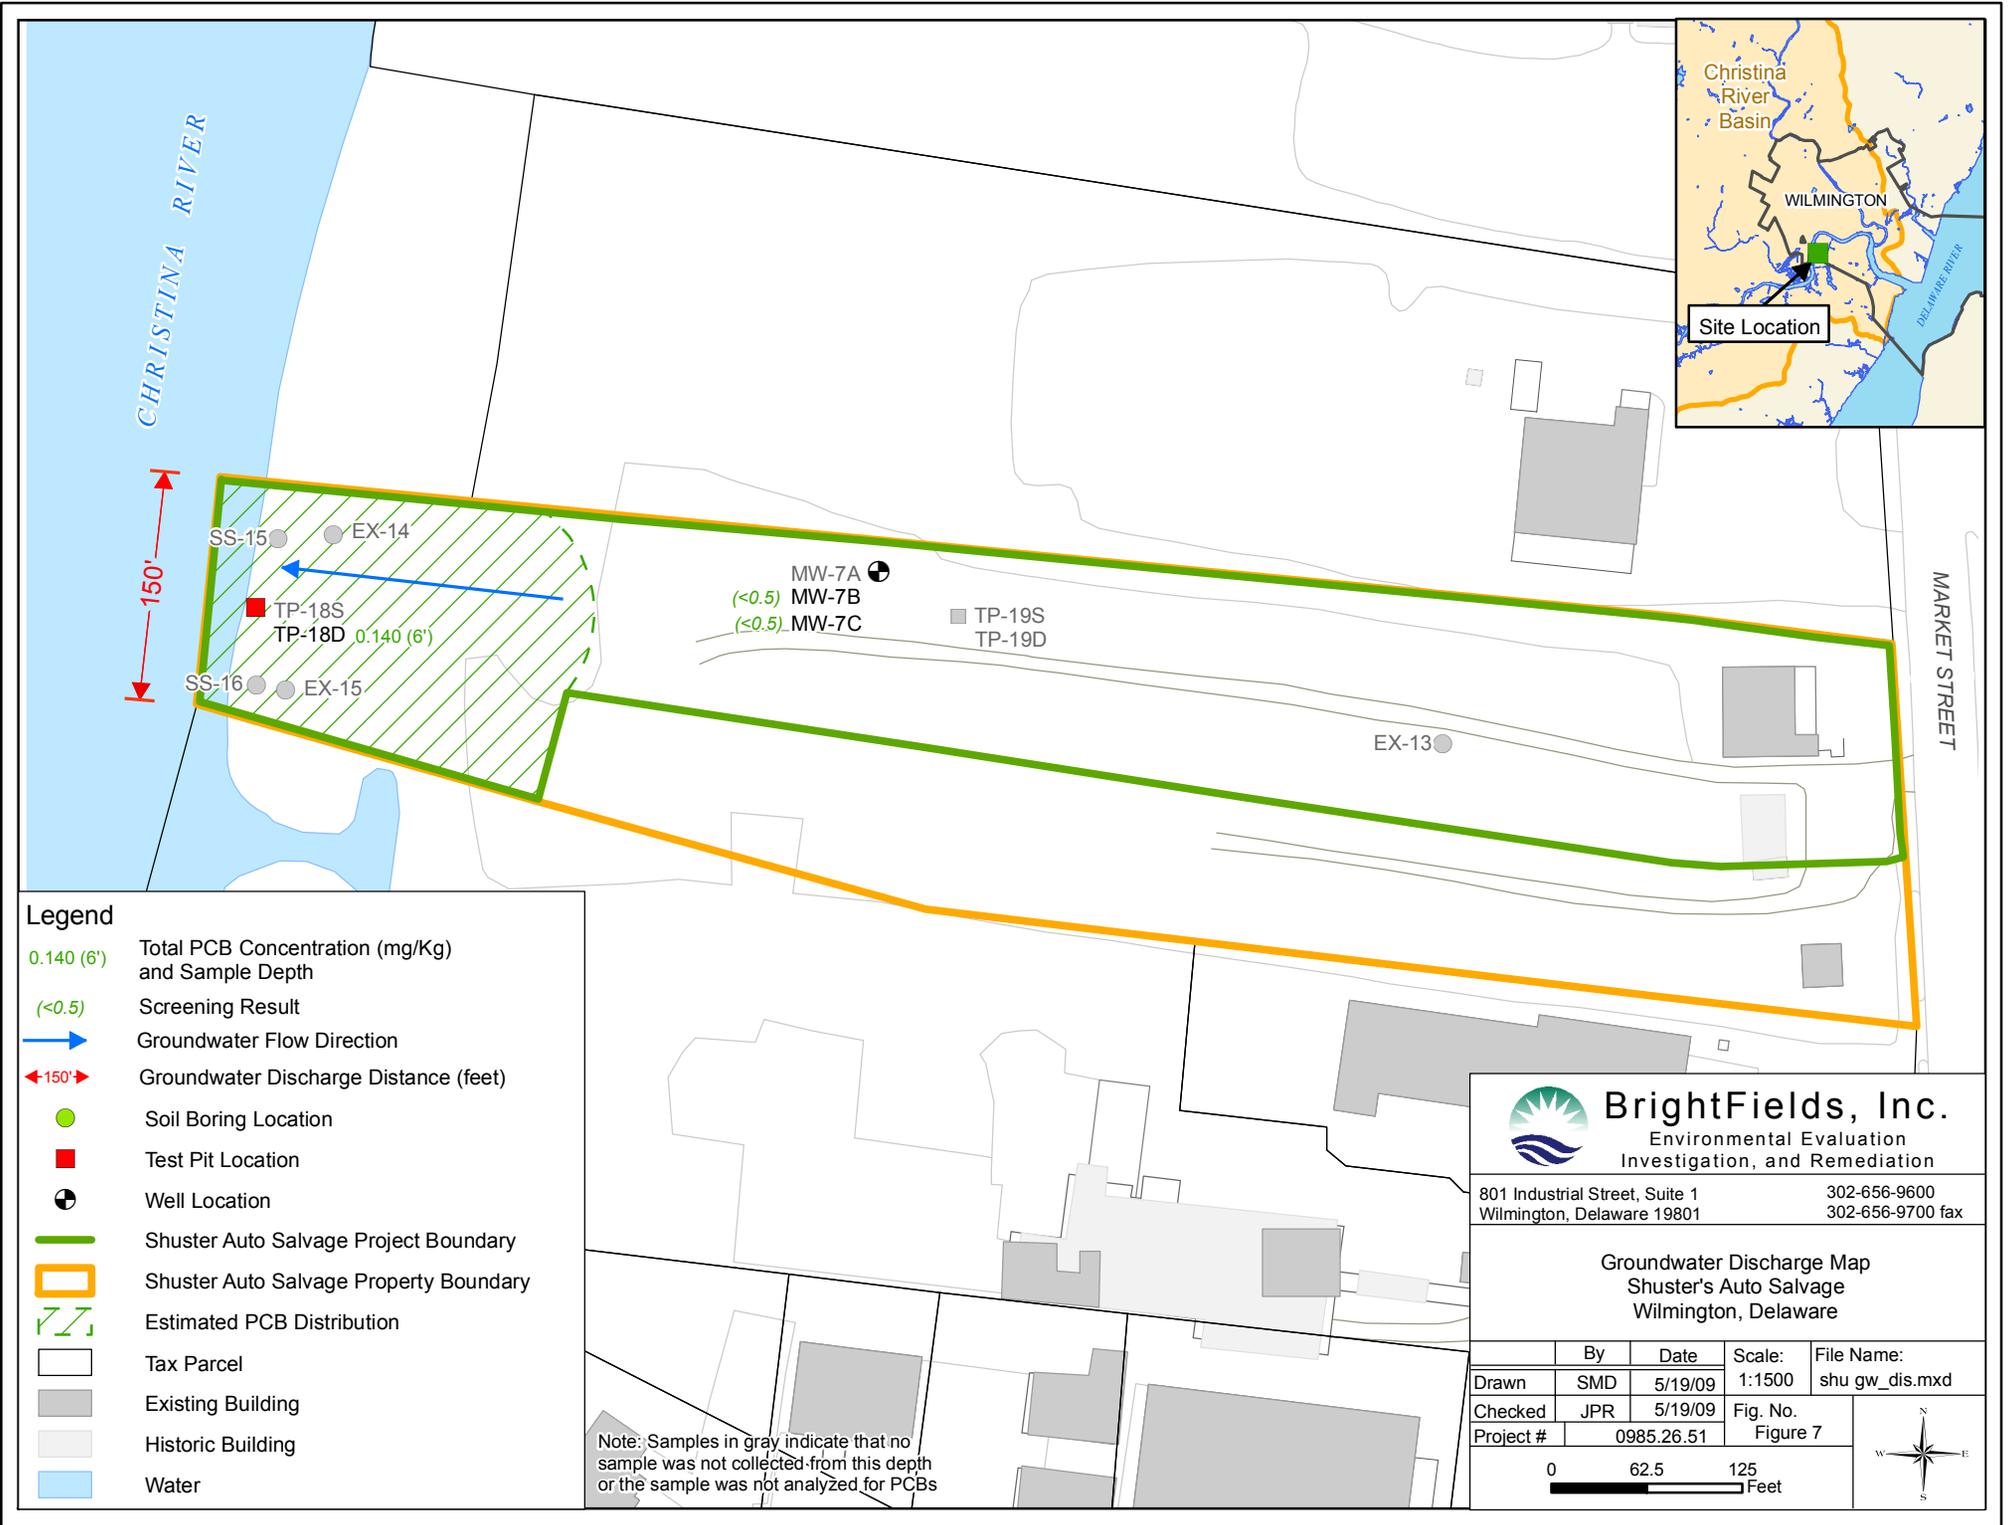
By	Date	Scale:	File Name:
Drawn	SMD	5/19/09	1:1500	shu_gw_dis.mxd
Checked	JPR	5/19/09	Fig. No.	Figure 7
Project #	0985.26.51

Groundwater Discharge Map
Shuster's Auto Salvage
Wilmington, Delaware

Saturated Thickness (ft)	1	3	Based on the logs, the saturated thickness was approximately 1 to at least 3 feet.
Lateral Discharge Distance (ft)	150	150	The lateral discharge distance was estimated to be equal to the length of the PCB impacted area (site width) measured perpendicular to the Christina River.
A = Cross-Sectional Area (ft ²)	150	450	Calculated from the saturated thickness and lateral discharge distance.
