PCB Mass Loading
Dravo Shipyard Property - Amer
SIRB ID: DE-1092
Wilmington, Delaware

Appendix 11-A

DRAVO SHIPYARD AMER INDUSTRIAL TECHNOLOGIES, INC. WILMINGTON, DELAWARE

SIRB ID: DE-1092

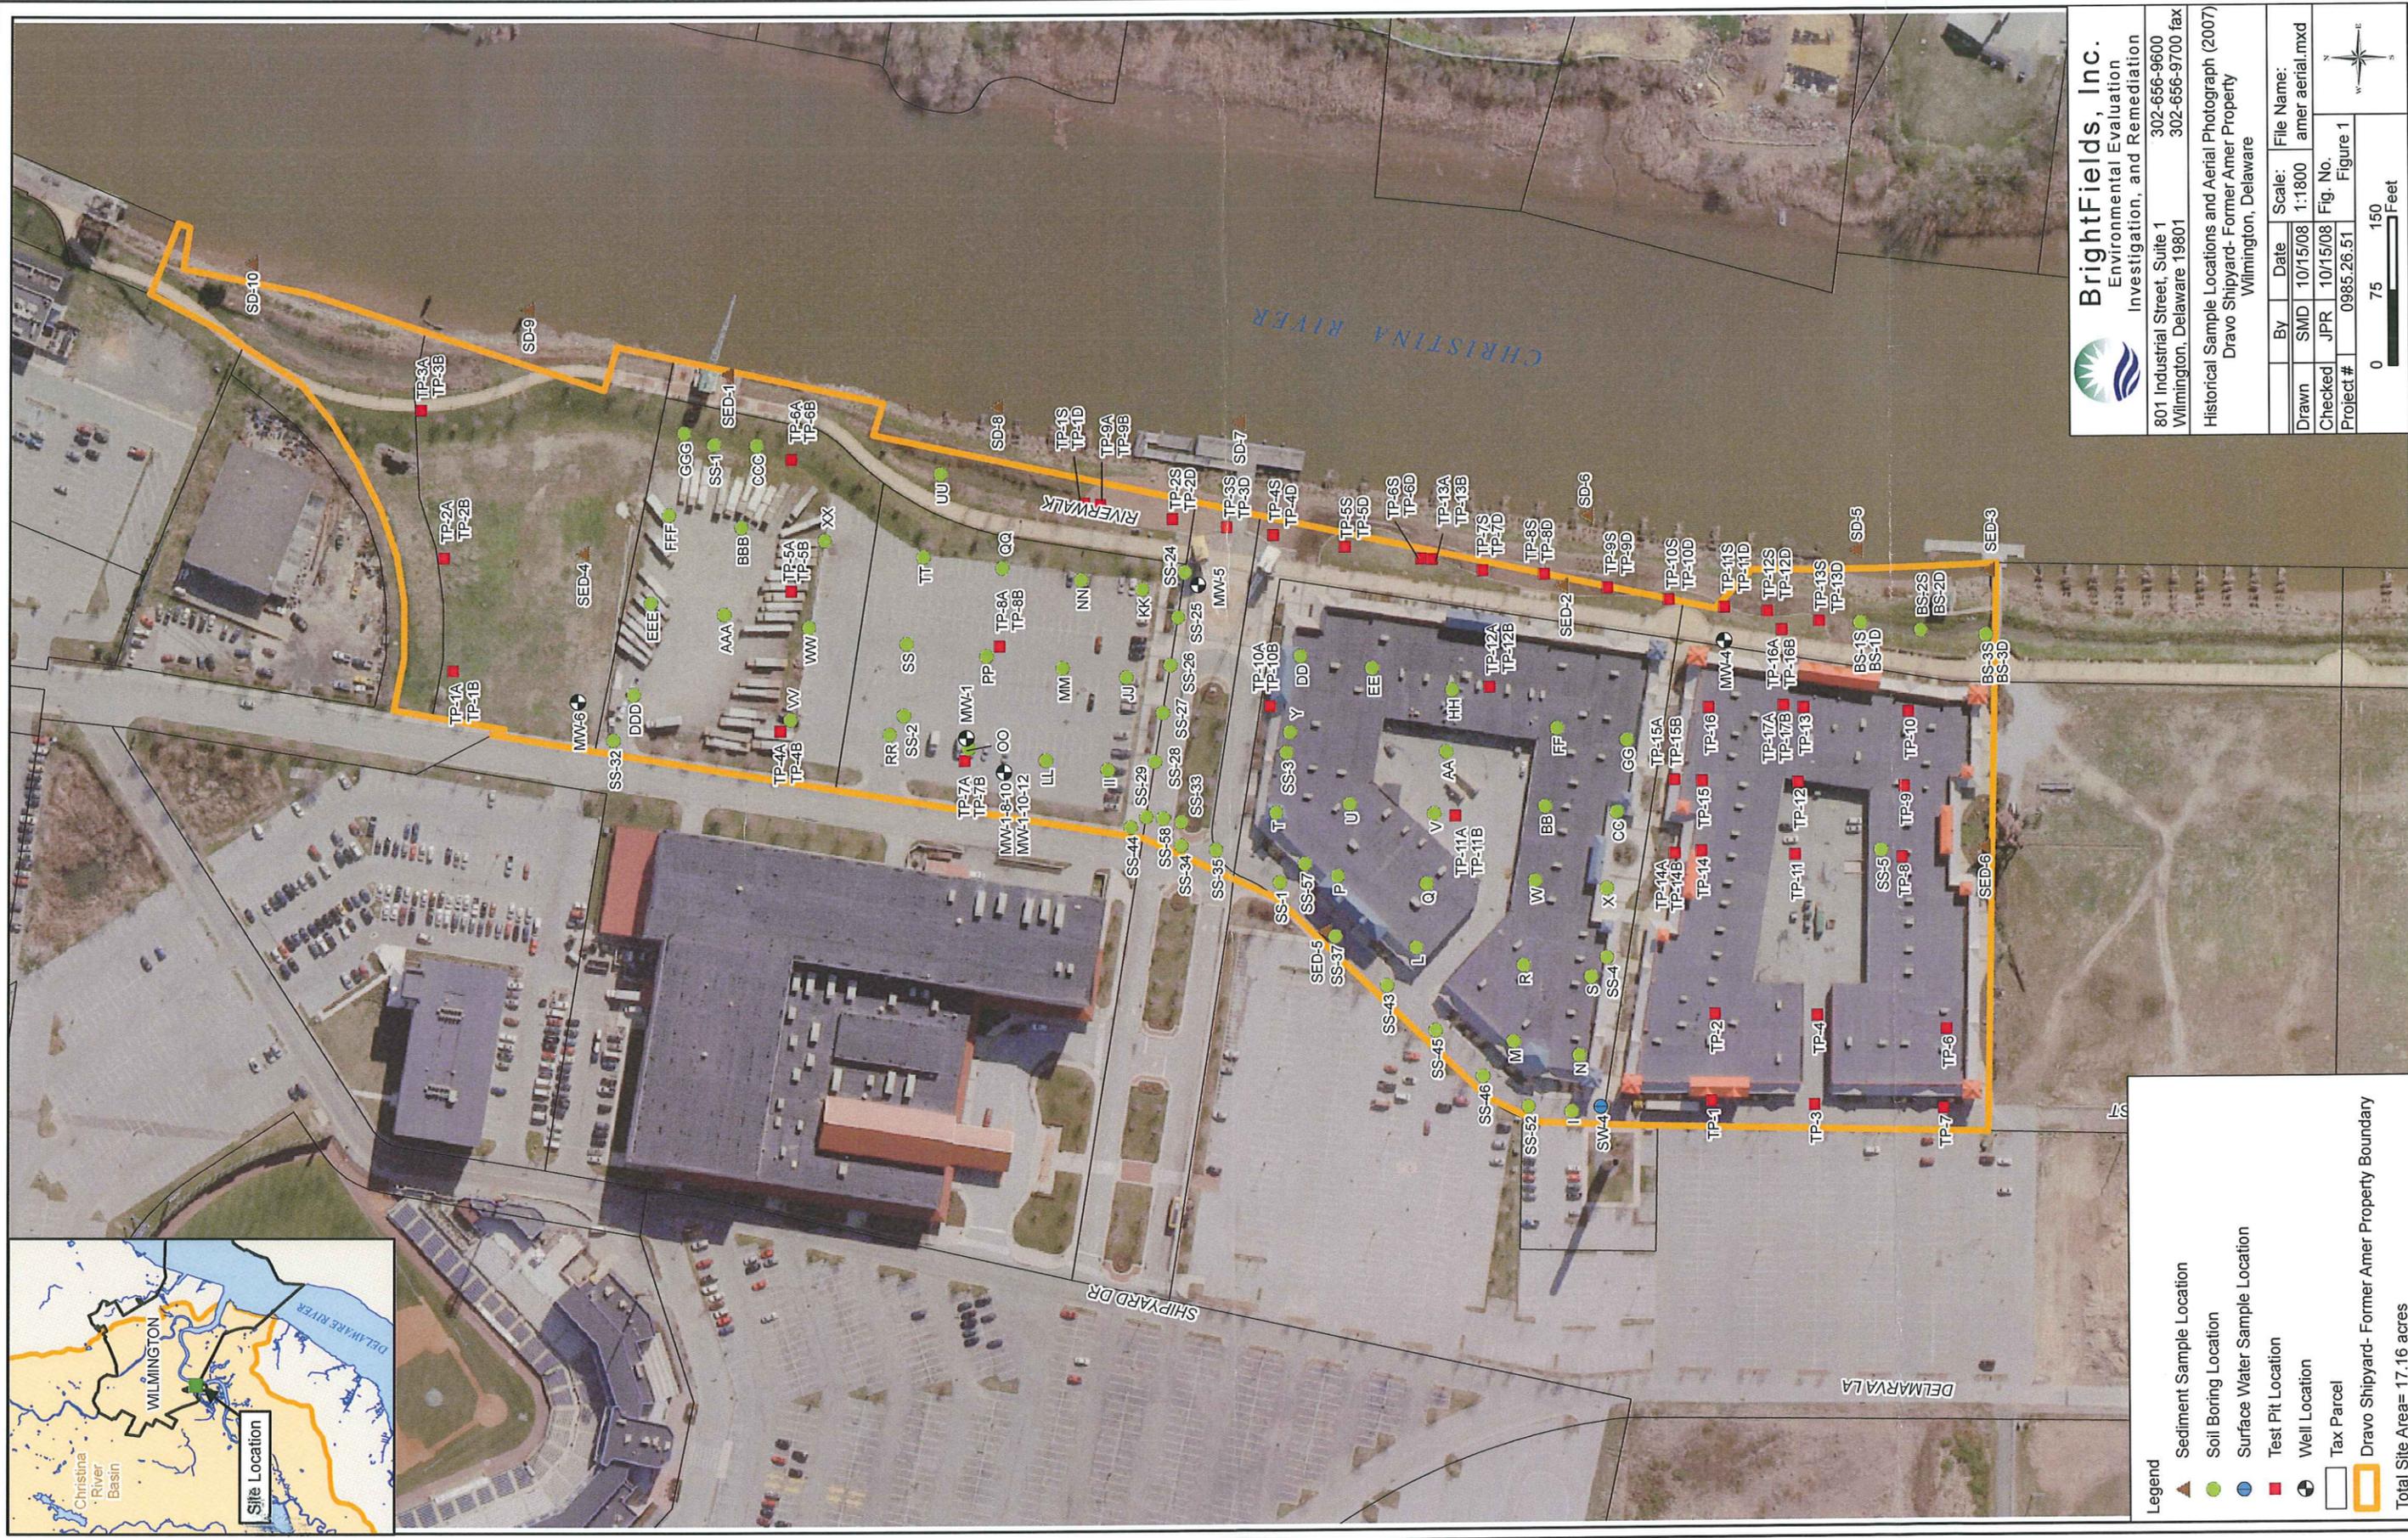
By	Date	Scale	File Name:
Drawn	SMD 10/15/08	1:1800	amer aerial.mxd
Checked	JPR 10/15/08	Fig. No.	
Project #	0985.26.51	Figure 1

Historical Sample Locations and Aerial Photograph (2007)
 Dravo Shipyard- Former Amer Property
 Wilmington, Delaware

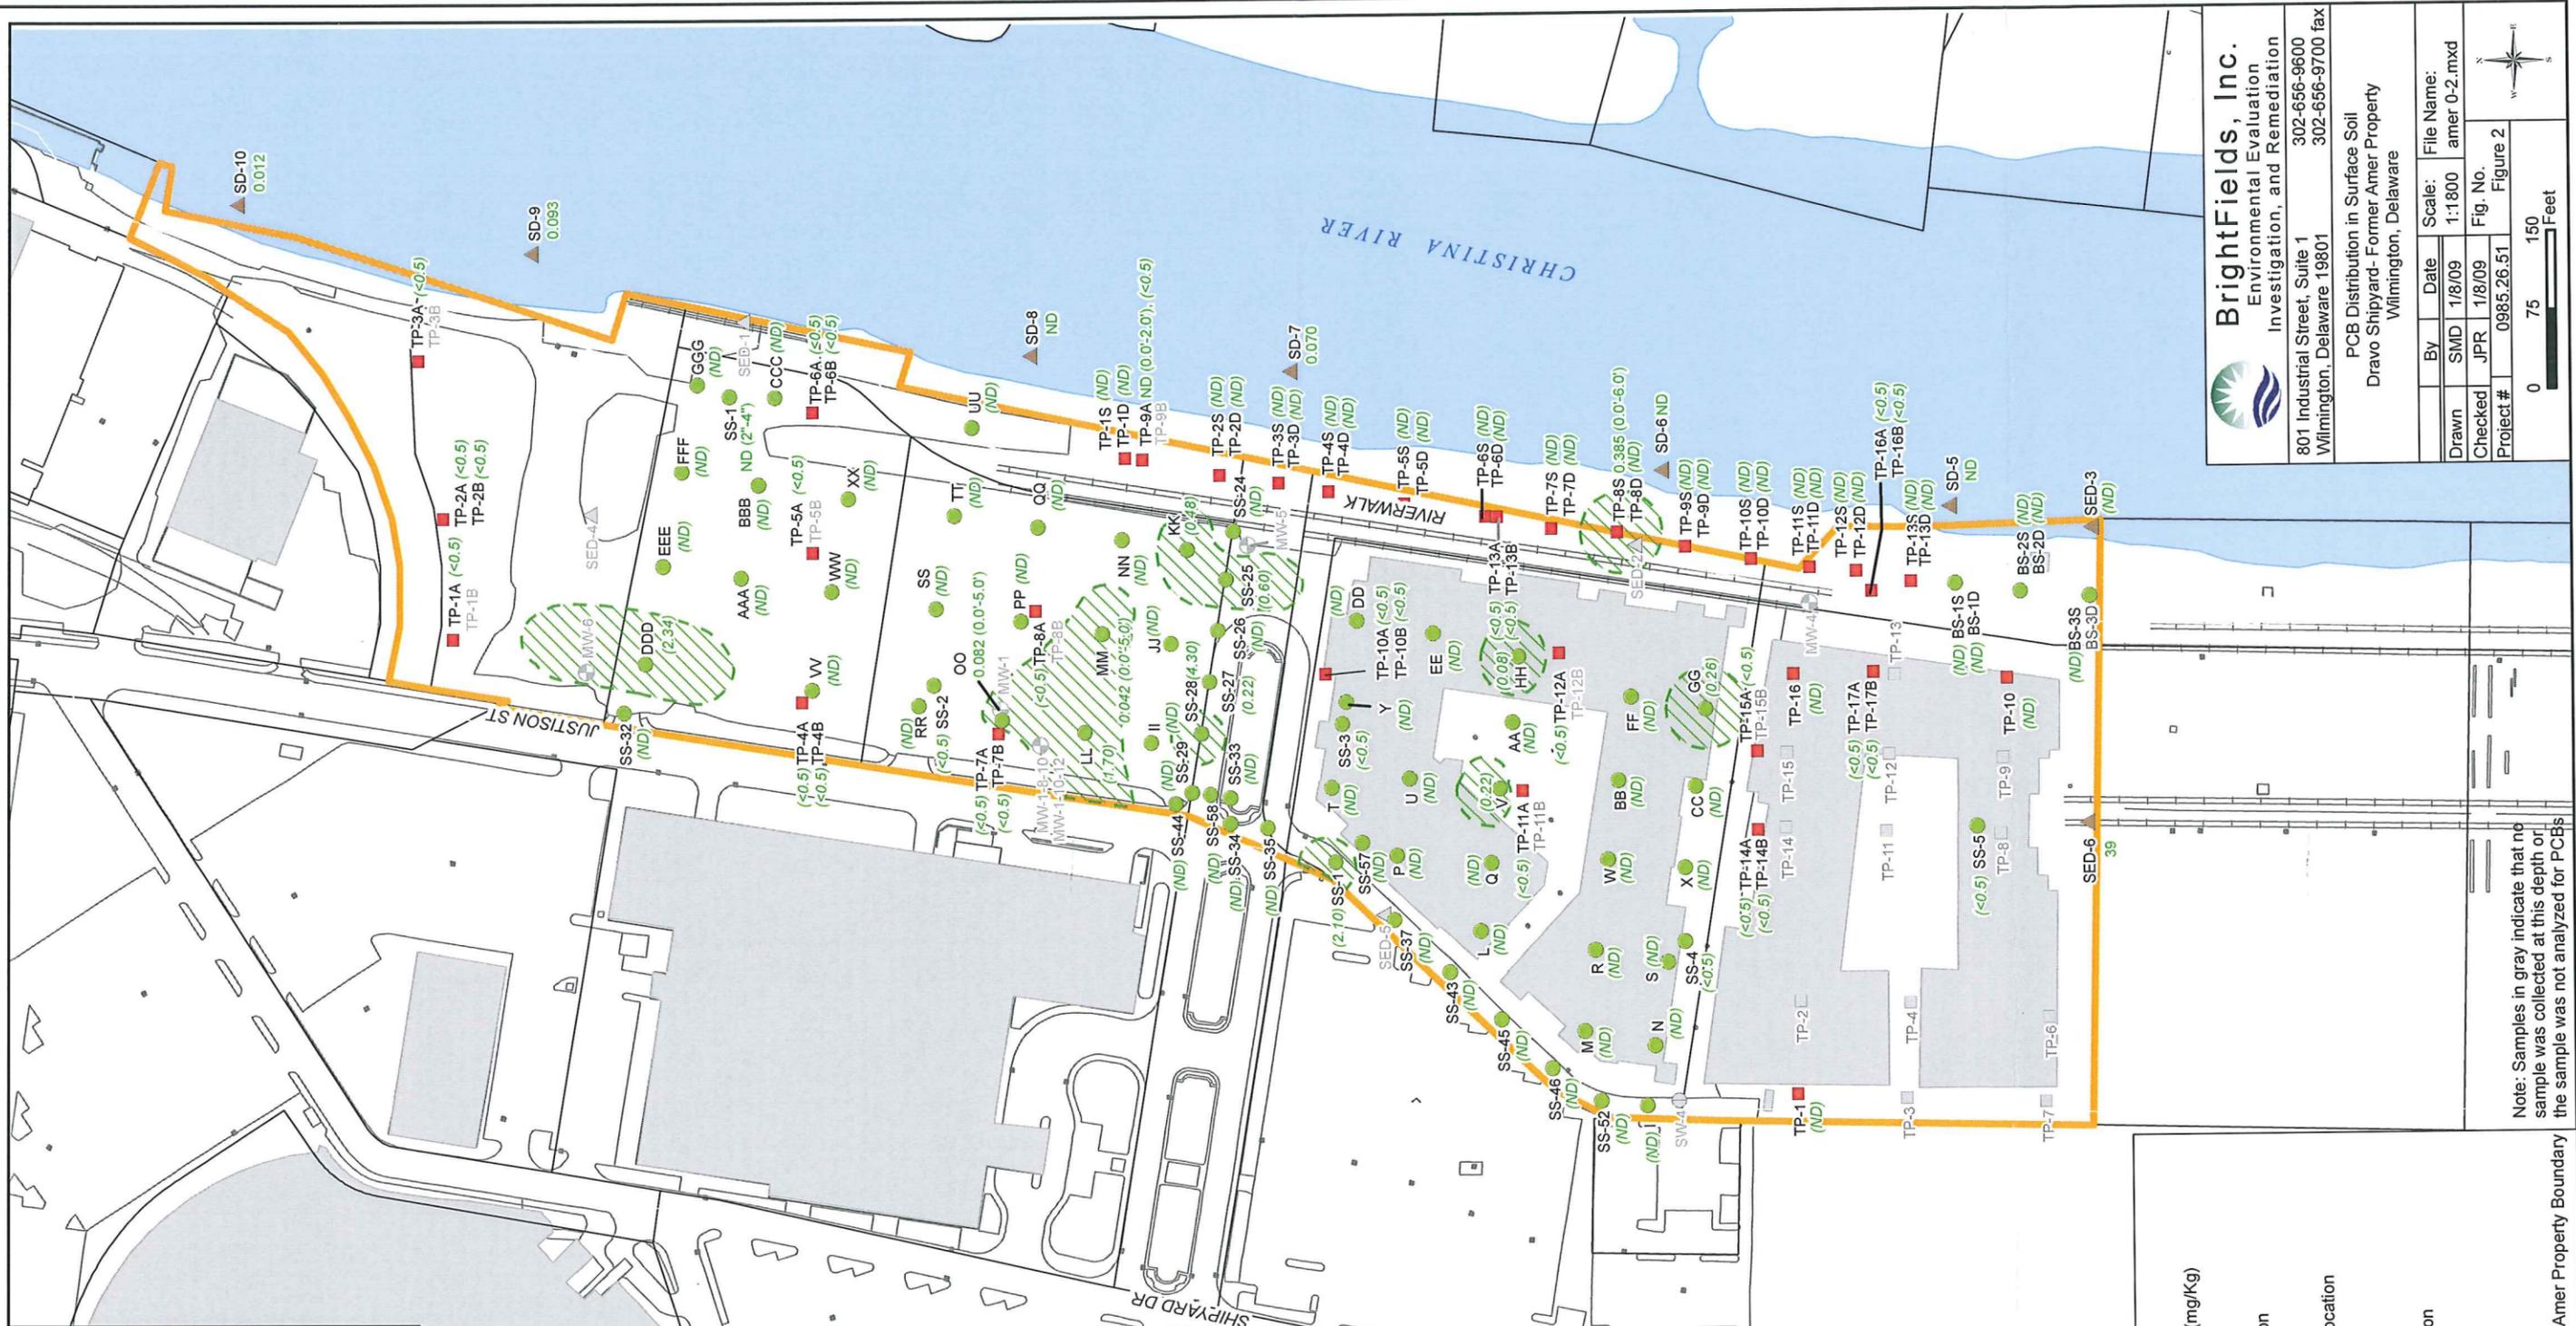
By	Date	Scale:	File Name:
Drawn	SMD 1/8/09	1:1800	amer 0-2.mxd
Checked	JPR 1/8/09	Fig. No.	Figure 2
Project #	0985.26.51

PCB Distribution in Surface Soil
 Dravo Shipyard- Former Amer Property
 Wilmington, Delaware

Total PCBs were detected in 13 surface soil sample locations at a concentrations ranging from 0.042 mg/kg to 4.3 mg/kg. Seven subsurface unsaturated samples were reported to have total PCBs ranging from 0.042 mg/kg to 2.34 mg/kg. There were no subsurface saturated samples reported to have concentrations above the detection limit for PCBs. Furthermore, no groundwater samples contained PCBs above their respective detection limits.

The estimated surface soil area impacted by PCBs is 1.38 acres (Figure 2) of which only 0.32 acres (Figure 6) may still be contributing to mass loading via overland flow. The other 1.06 acres is currently under an impervious surface. The estimated subsurface unsaturated soil that is impacted by PCBs is 1.29 acres (Figure 3). There were no PCBs detected in the groundwater or in the subsurface saturated zone.

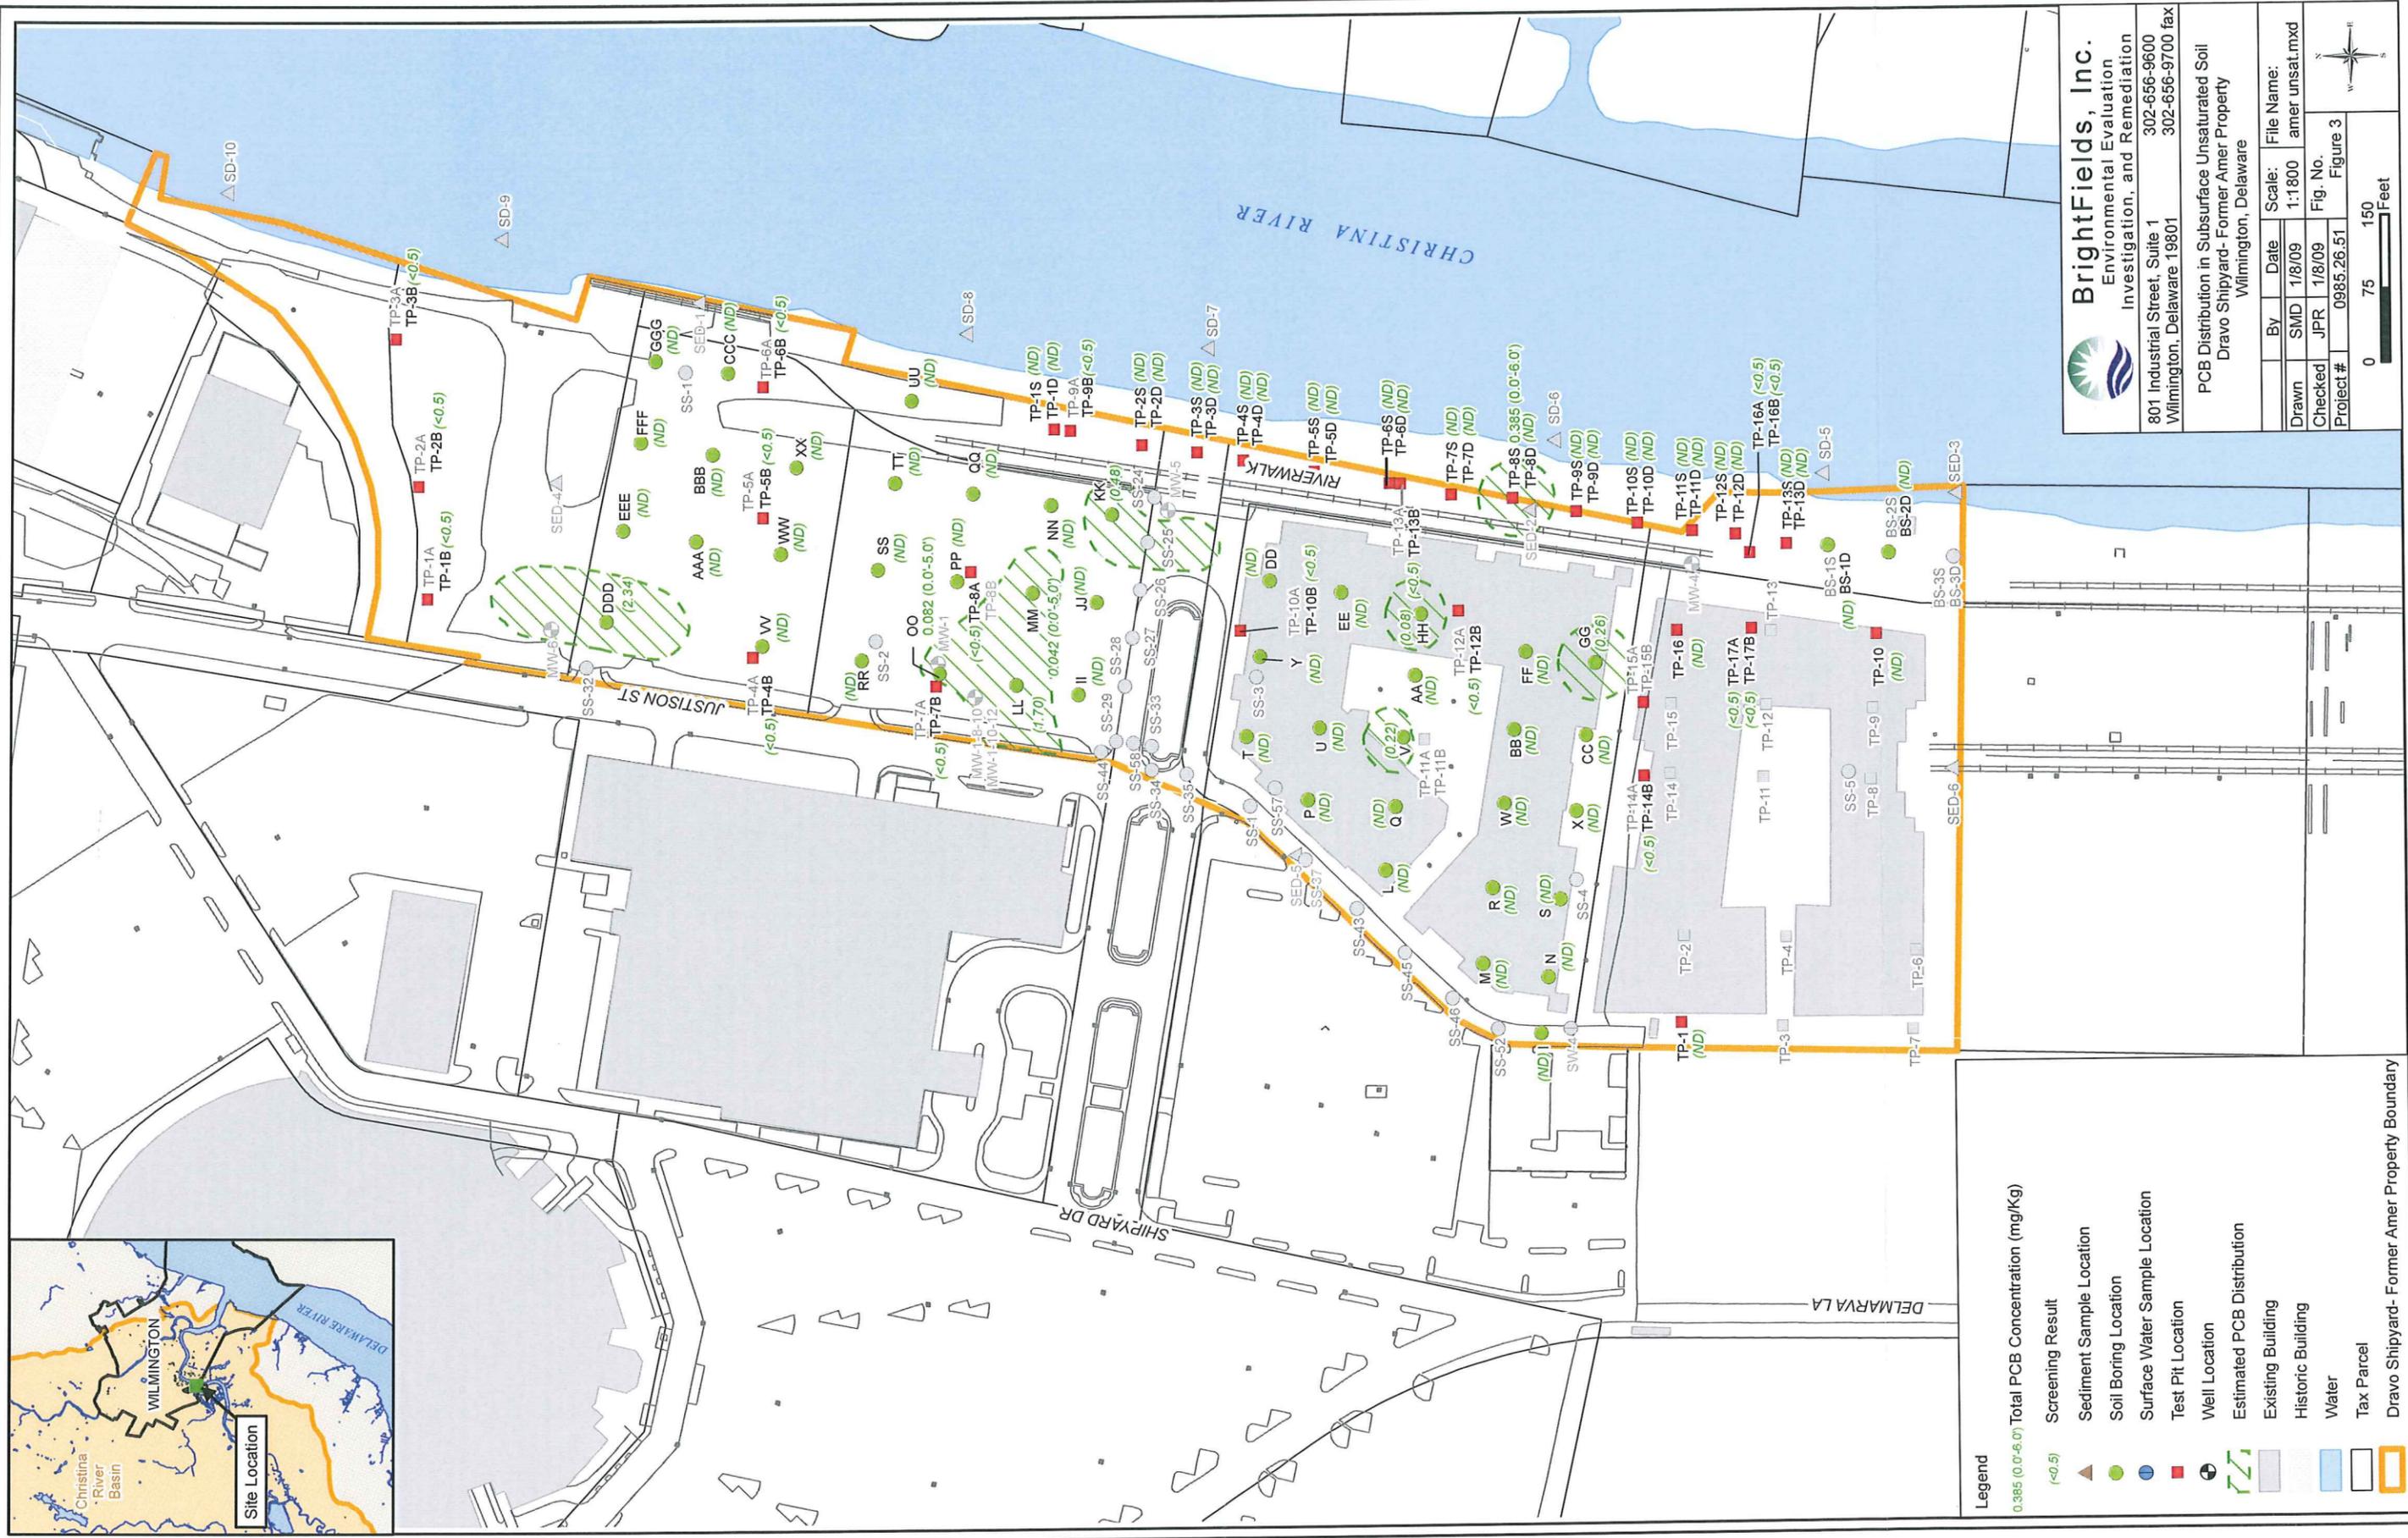
By	Date	Scale:	File Name:
Drawn	SMD 1/8/09	1:1800	amer unsat.mxd
Checked	JPR 1/8/09	Fig. No.	Figure 3
Project #	0985.26.51

PCB Distribution in Subsurface Unsaturated Soil
 Dravo Shipyard- Former Amer Property
 Wilmington, Delaware

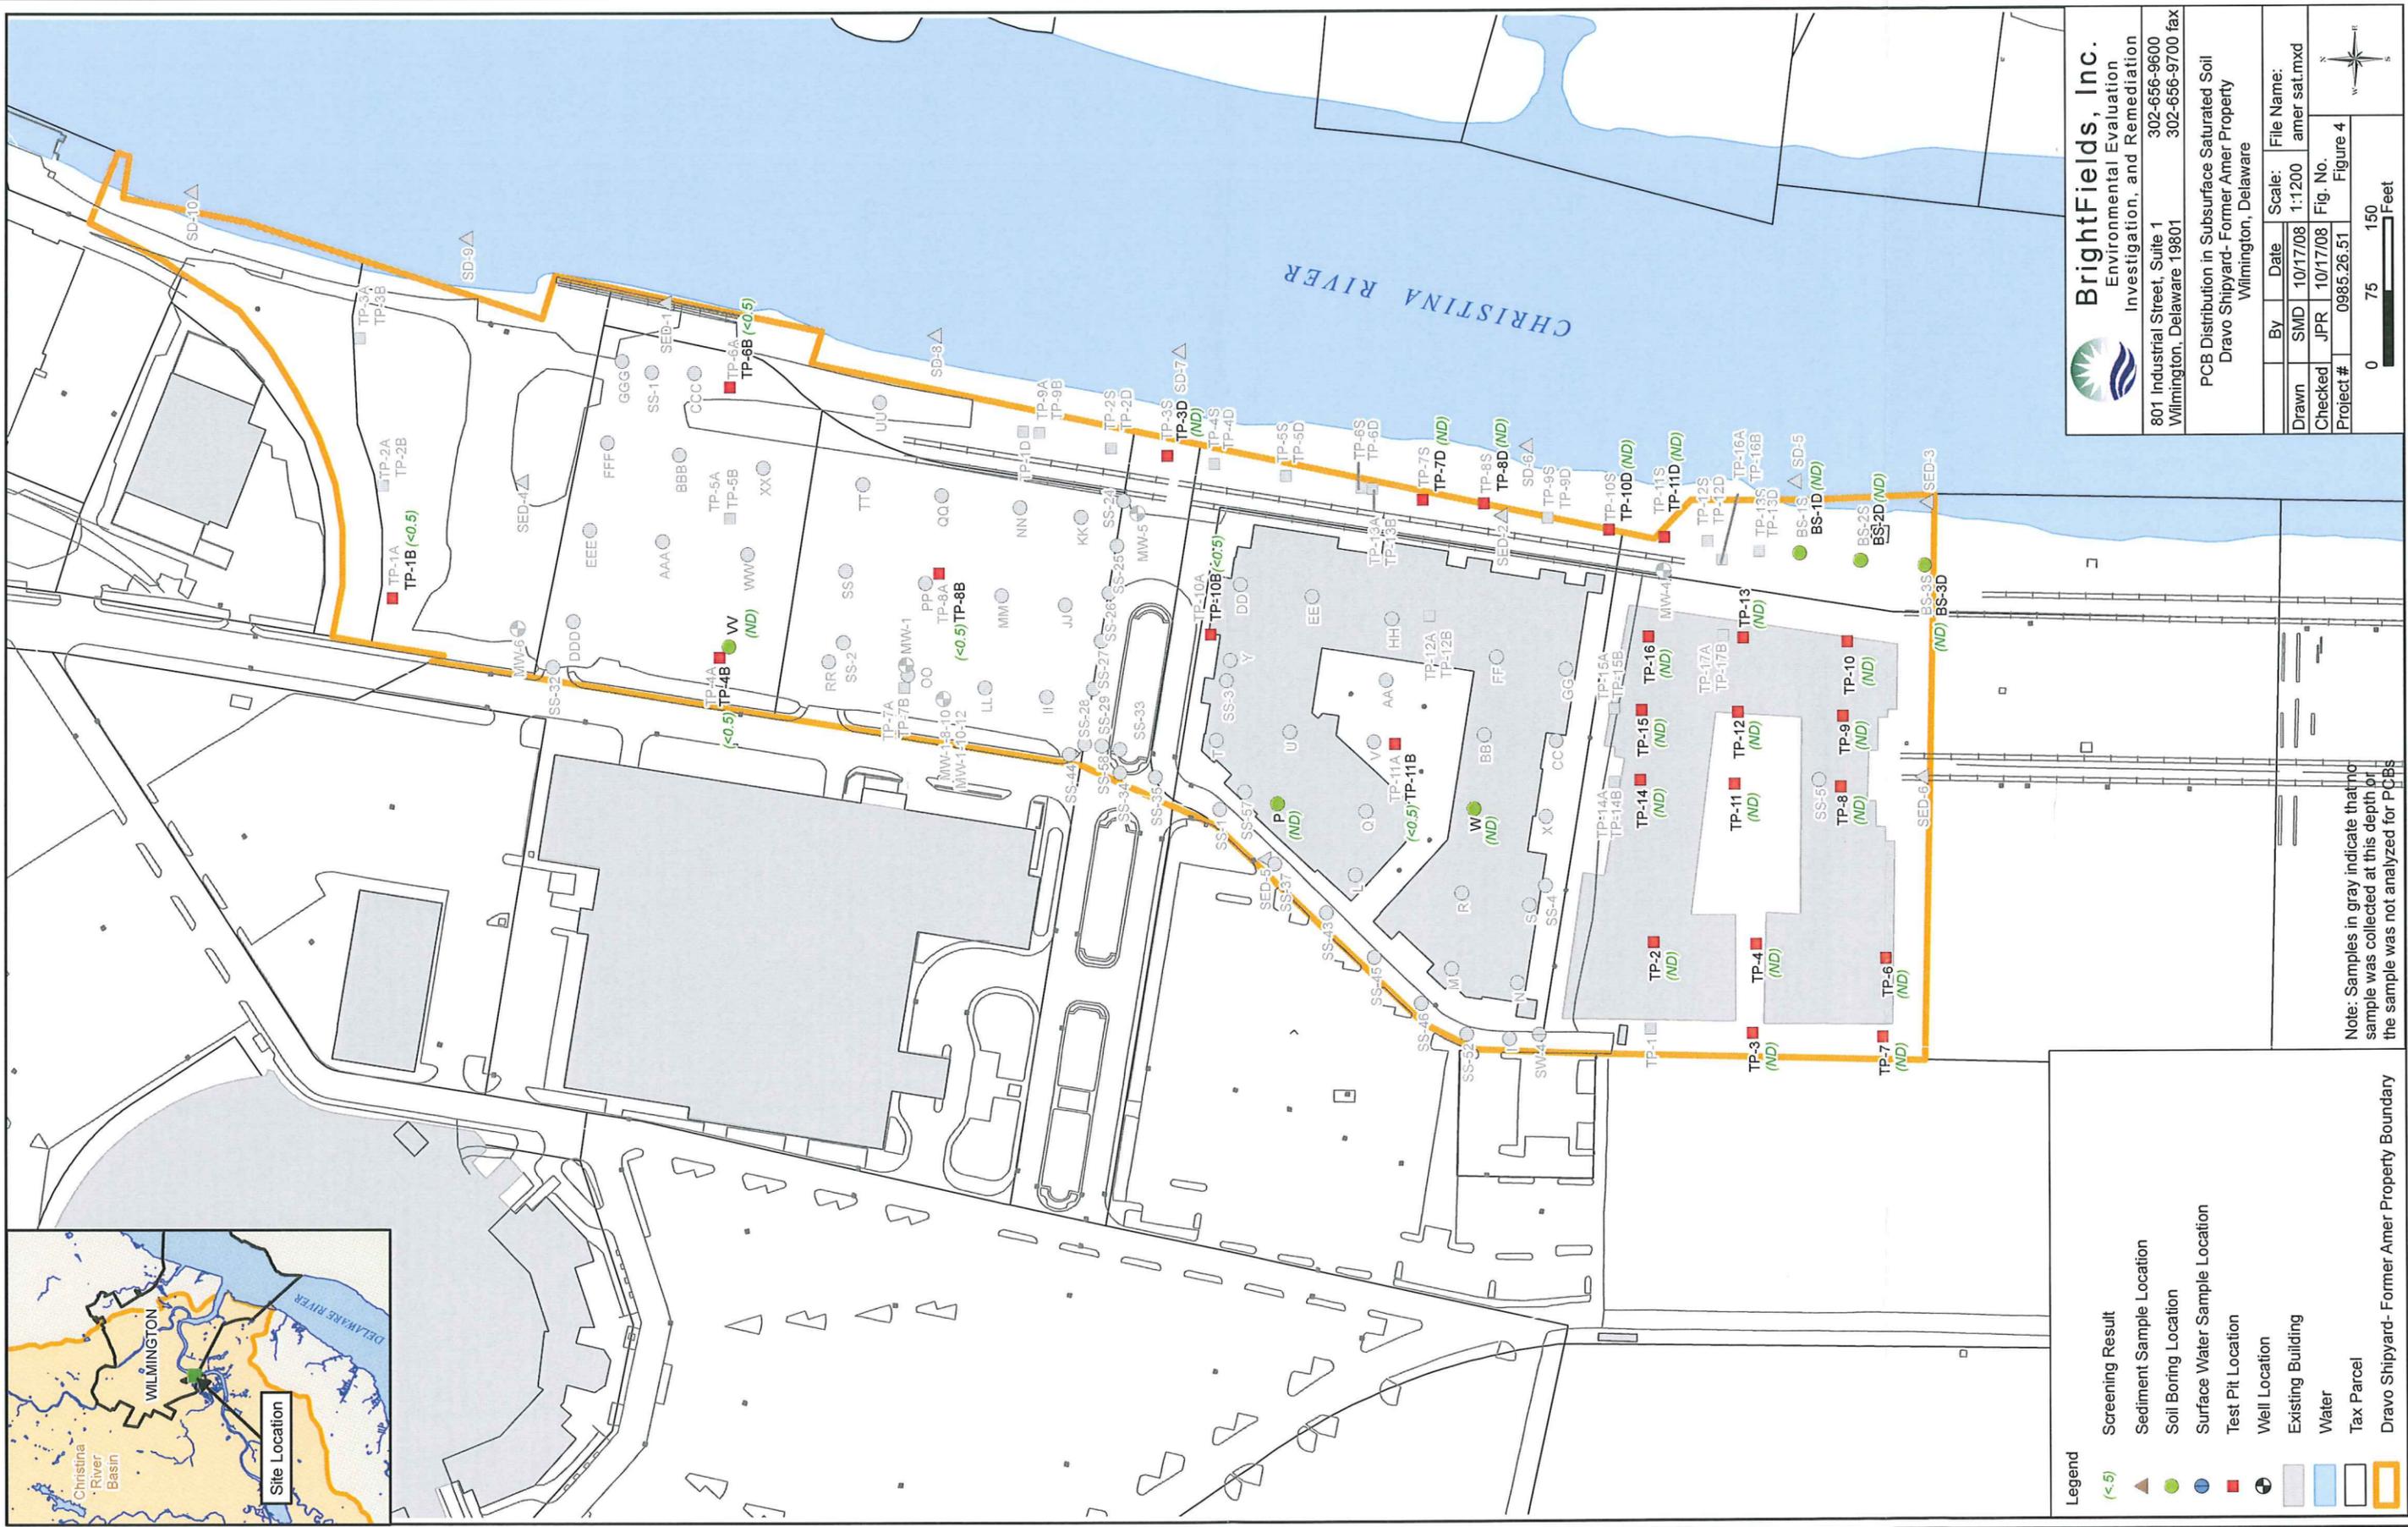
By	Date	Scale:	File Name:	
Drawn	SMD	10/17/08	1:1200	amer sat.mxd
Checked	JPR	10/17/08	Fig. No.	Figure 4
Project #	0985.26.51

PCB Distribution in Subsurface Saturated Soil
 Dravo Shipyard- Former Amer Property
 Wilmington, Delaware

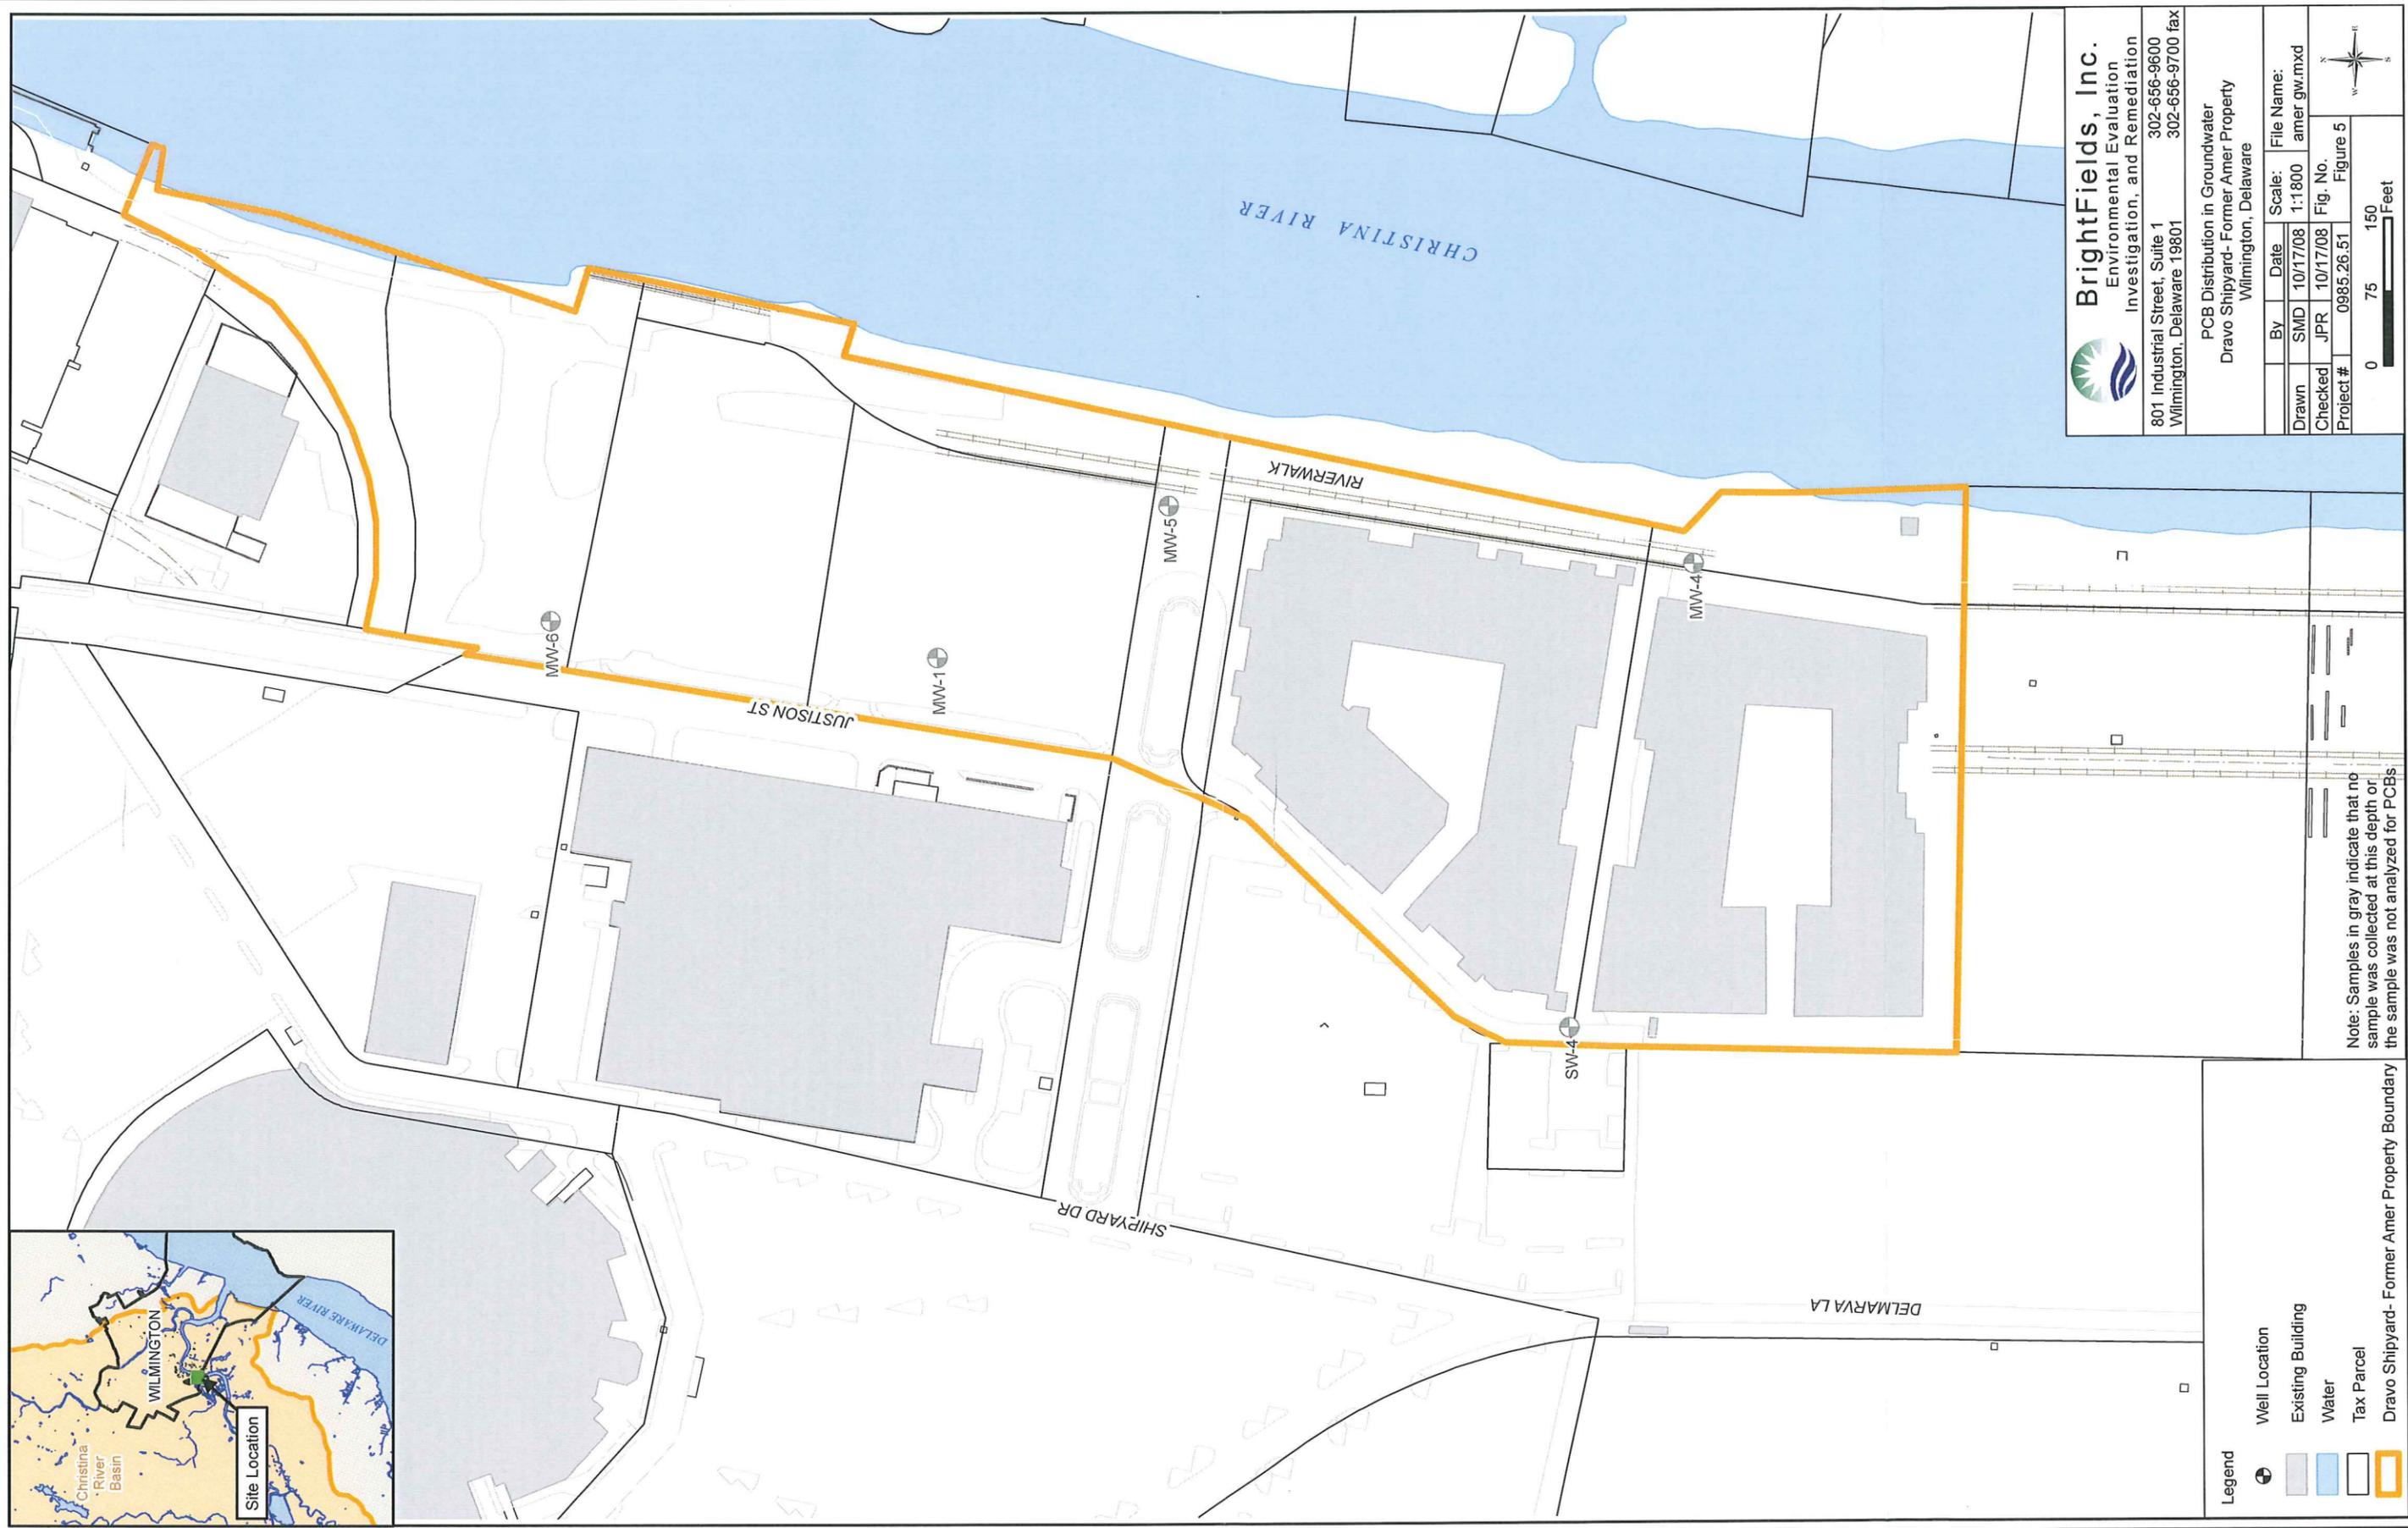
By	Date	Scale	File Name:
SMD	10/17/08	1:1800	amer gw.mxd
Checked	JPR	10/17/08	Fig. No.
Project #	0985.26.51		Figure 5

PCB Distribution in Groundwater
 Dravo Shipyard-Former Amer Property
 Wilmington, Delaware

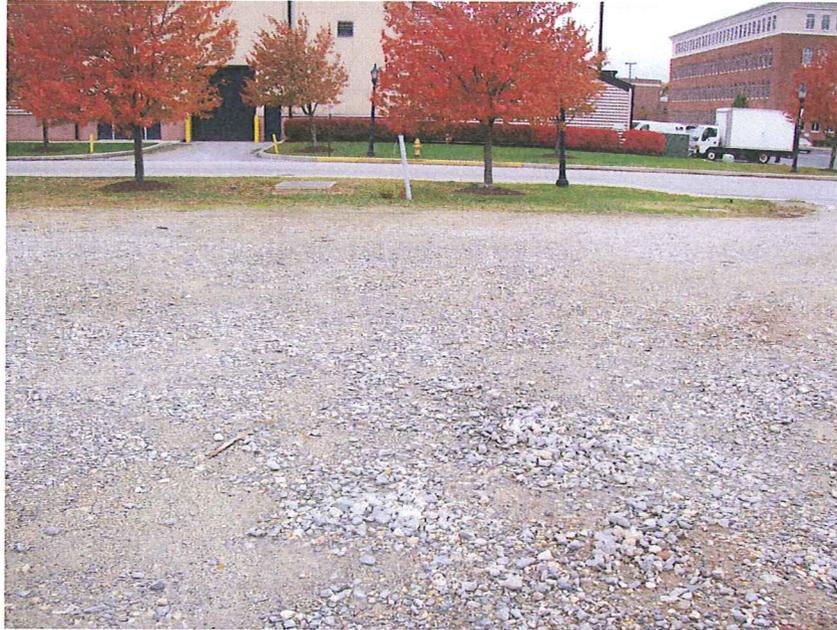
Stone mulch cover in the vicinity of boring DDD.

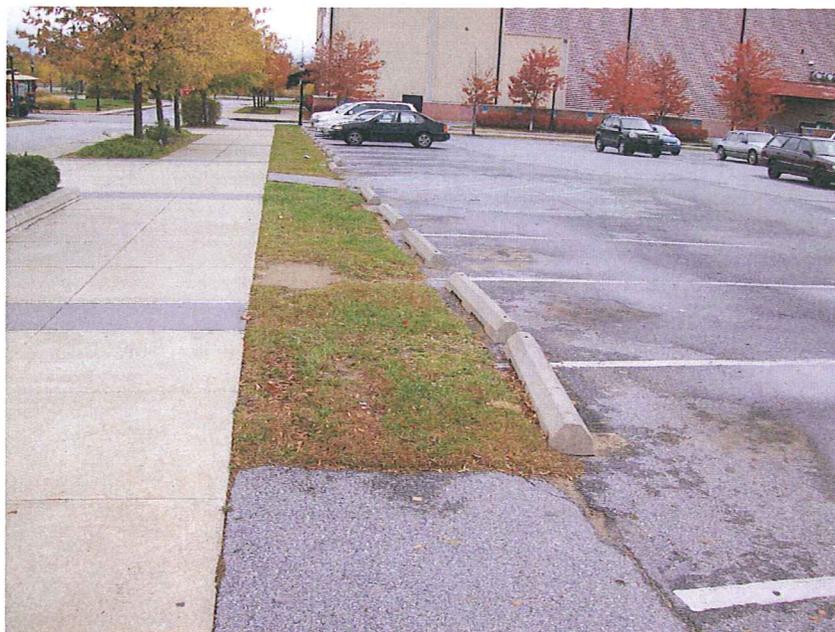
Landscaped areas and impervious surfaces associated with the site.

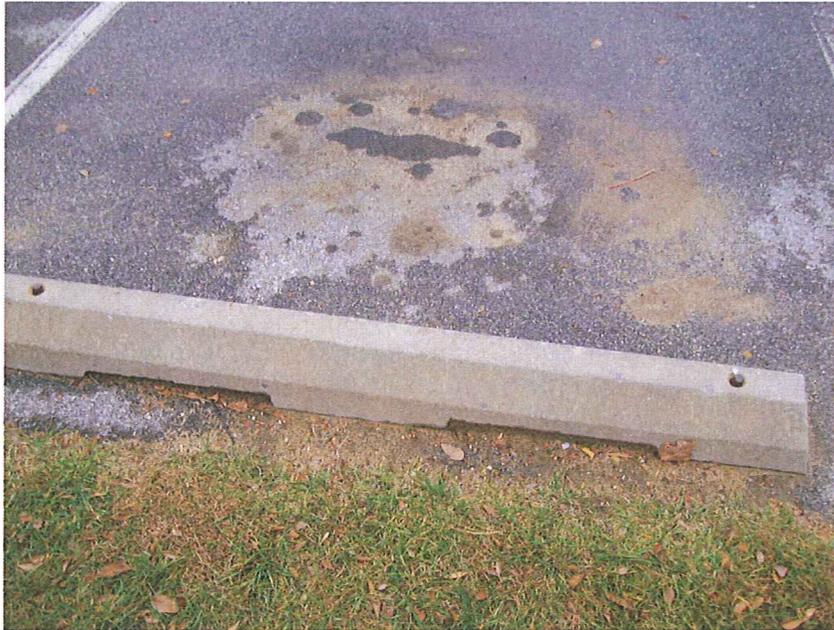
Some sediment migration in the landscaped areas.

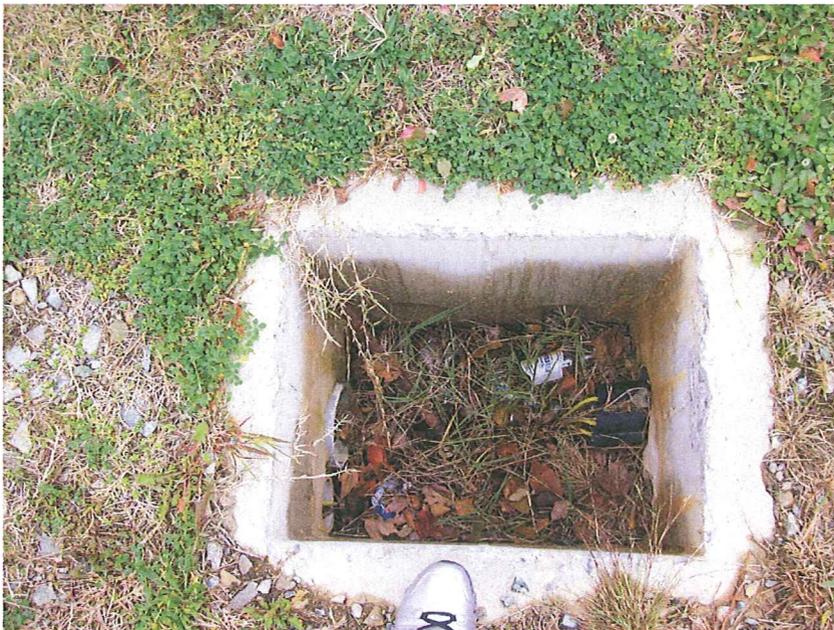
Catch Basin that is not covered.
