Appendix 18

KREIGER FINGER PROPERTY AND ADJACENT SITES WILMINGTON, DELAWARE

PCB MASS LOADING SUMMARY

PCB Mass Loading
Kreiger Finger Property and Adjacent Sites
SIRB ID: DE-1067, DE-0156, DE-1291, DE-1336, and DE-1337
Wilmington, Delaware

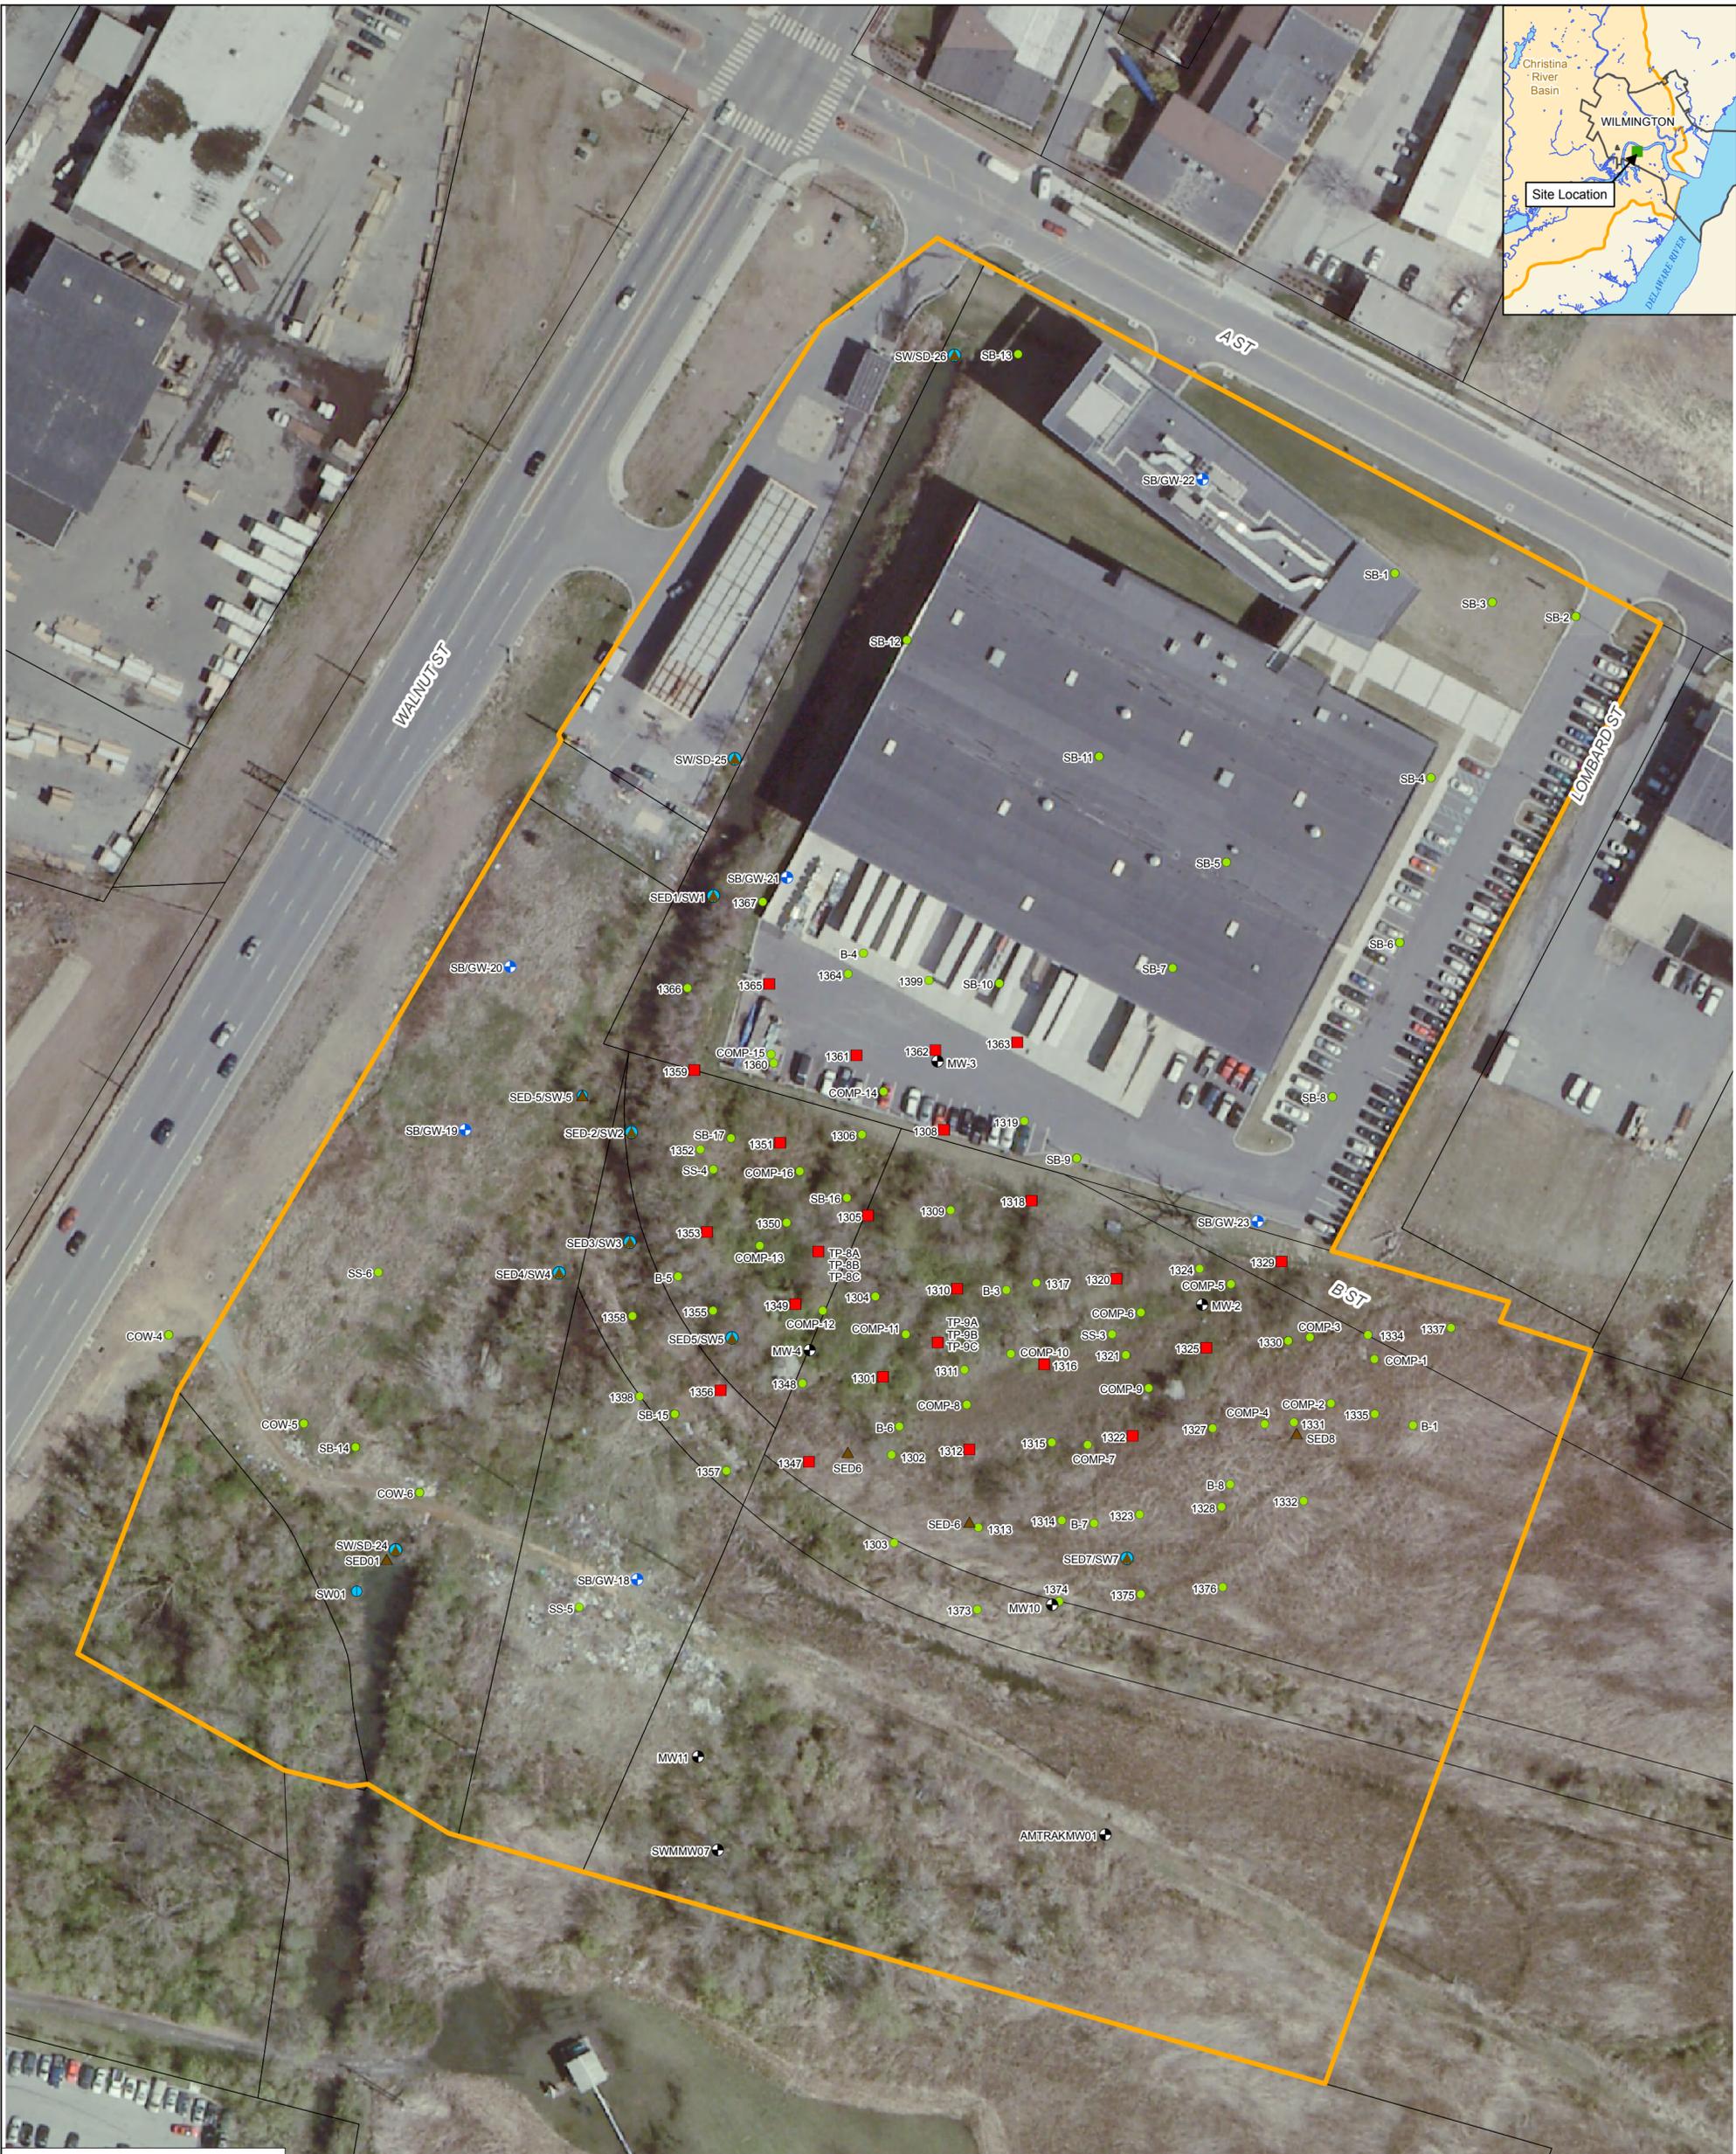
By	Date	Scale:	File Name:
Drawn	SMD	5/11/09	1:840	kreiger aerial.mxd
Checked	JPR	5/11/09	Fig. No.	
Project #	0985.26.51		Figure 1

Historic Sample Locations and Aerial Photograph (2007)
 Kreiger-Finger Property and Adjacent Sites
 Wilmington, Delaware

When evaluating the PCB data for this site, BrightFields identified areas within parcels that contained historical PCB data. In order to better spatially evaluate the actual concentrations of PCBs observed on the site, portions of some of the above mentioned parcels were removed from the evaluation. The parcel that was most reduced in size was 2605000058. The irregular shaped property boundary displayed in Figure 1 was considered to be the area of extent for this assessment.

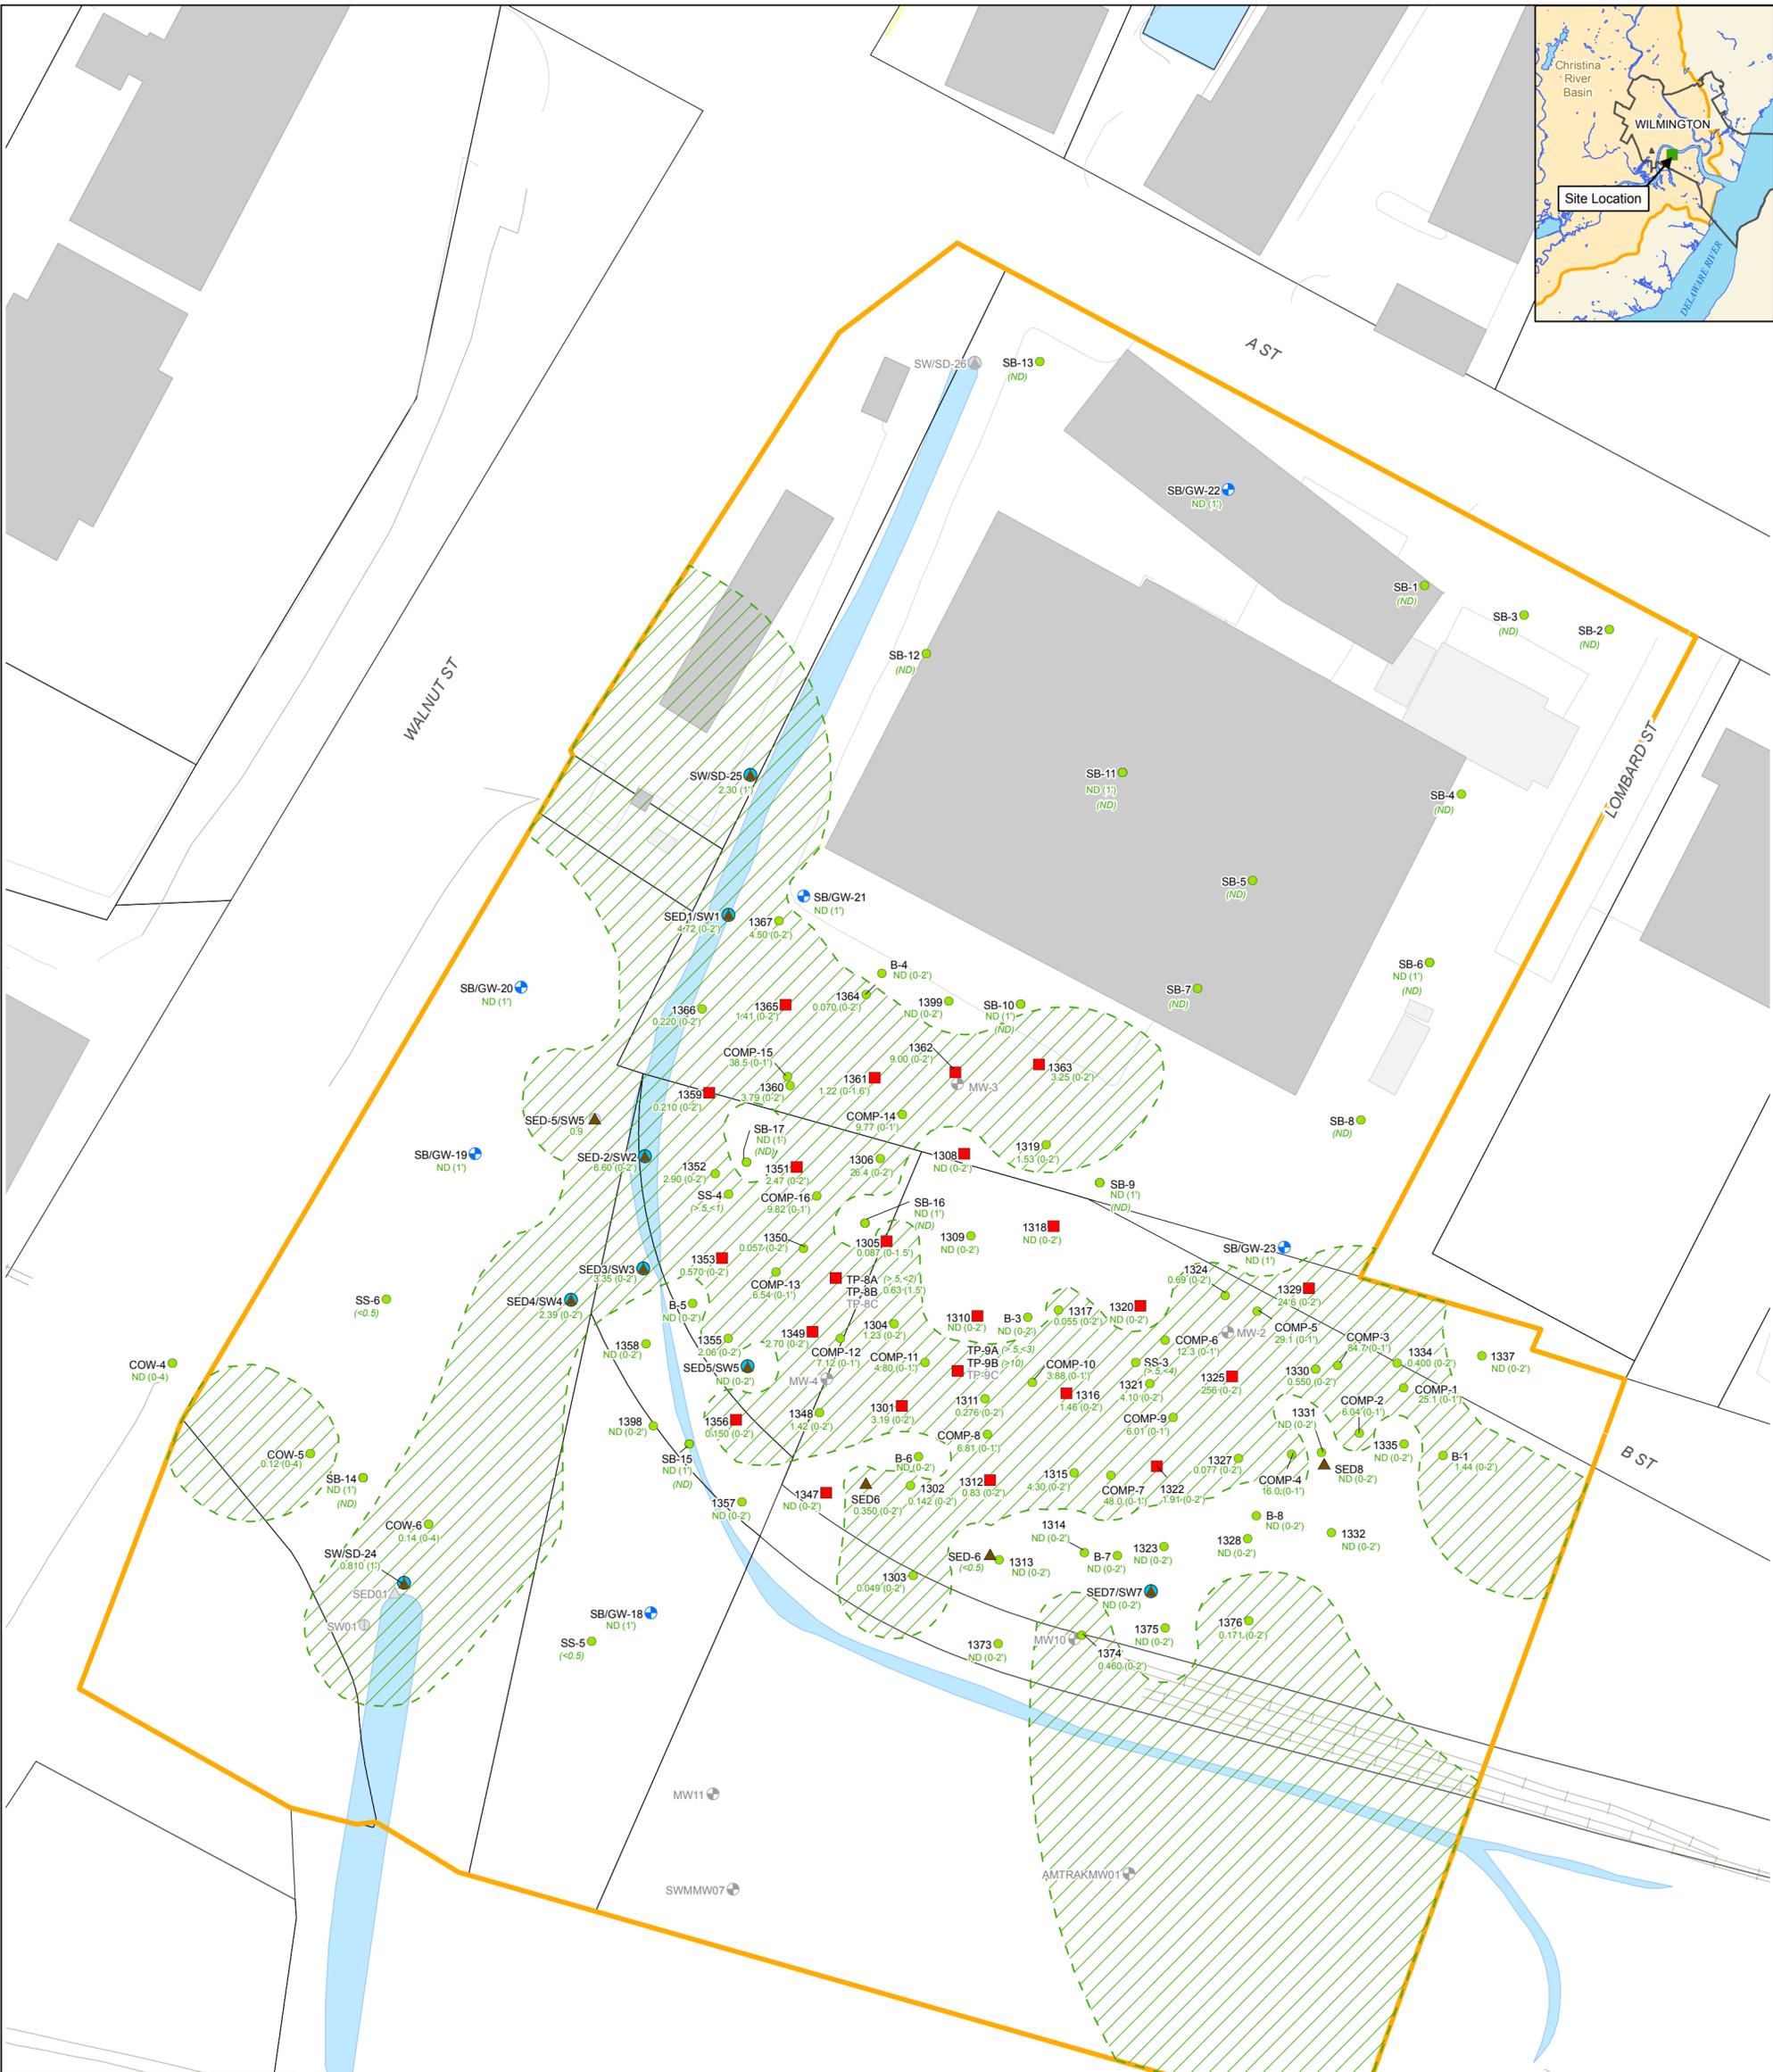
By	Date	Scale:	File Name:
Drawn	SMD	5/11/09	1:840	kreiger 0-2.mxd
Checked	JPR	5/11/09	Fig. No.	
Project #	0985.26.51		Figure 2

Note: Samples in gray indicate that no sample was collected from this depth or the sample was not analyzed for PCBs

PCB Distribution in Surface Soil (0'-2' bgs)
 Kreiger-Finger Property and Adjacent Sites
 Wilmington, Delaware

Concentrations of PCBs on Site			
Sample Matrix	Corresponding Figure	Analytical Methods	Range of Total PCBs
Surface Soil	Figure 2	Method 8082	Not detected to 256 mg/kg
Subsurface Soil (unsaturated)	Figure 3	Method 8082	Not detected to 31 mg/kg
Subsurface Soil (saturated)	Figure 4	Method 8082	Not detected to 140 mg/kg
Groundwater	Figure 5	Method 8082	Not detected

The estimated surface soil area impacted by PCBs is 5.5 acres (Figure 2); however the area that may still be contributing to overland flow is 4.7 acres (Figure 6). The estimated subsurface unsaturated soil that is impacted by PCBs is 2.5 acres (Figure 3). The estimated subsurface saturated soil impacted by PCBs is 2.5 acres.

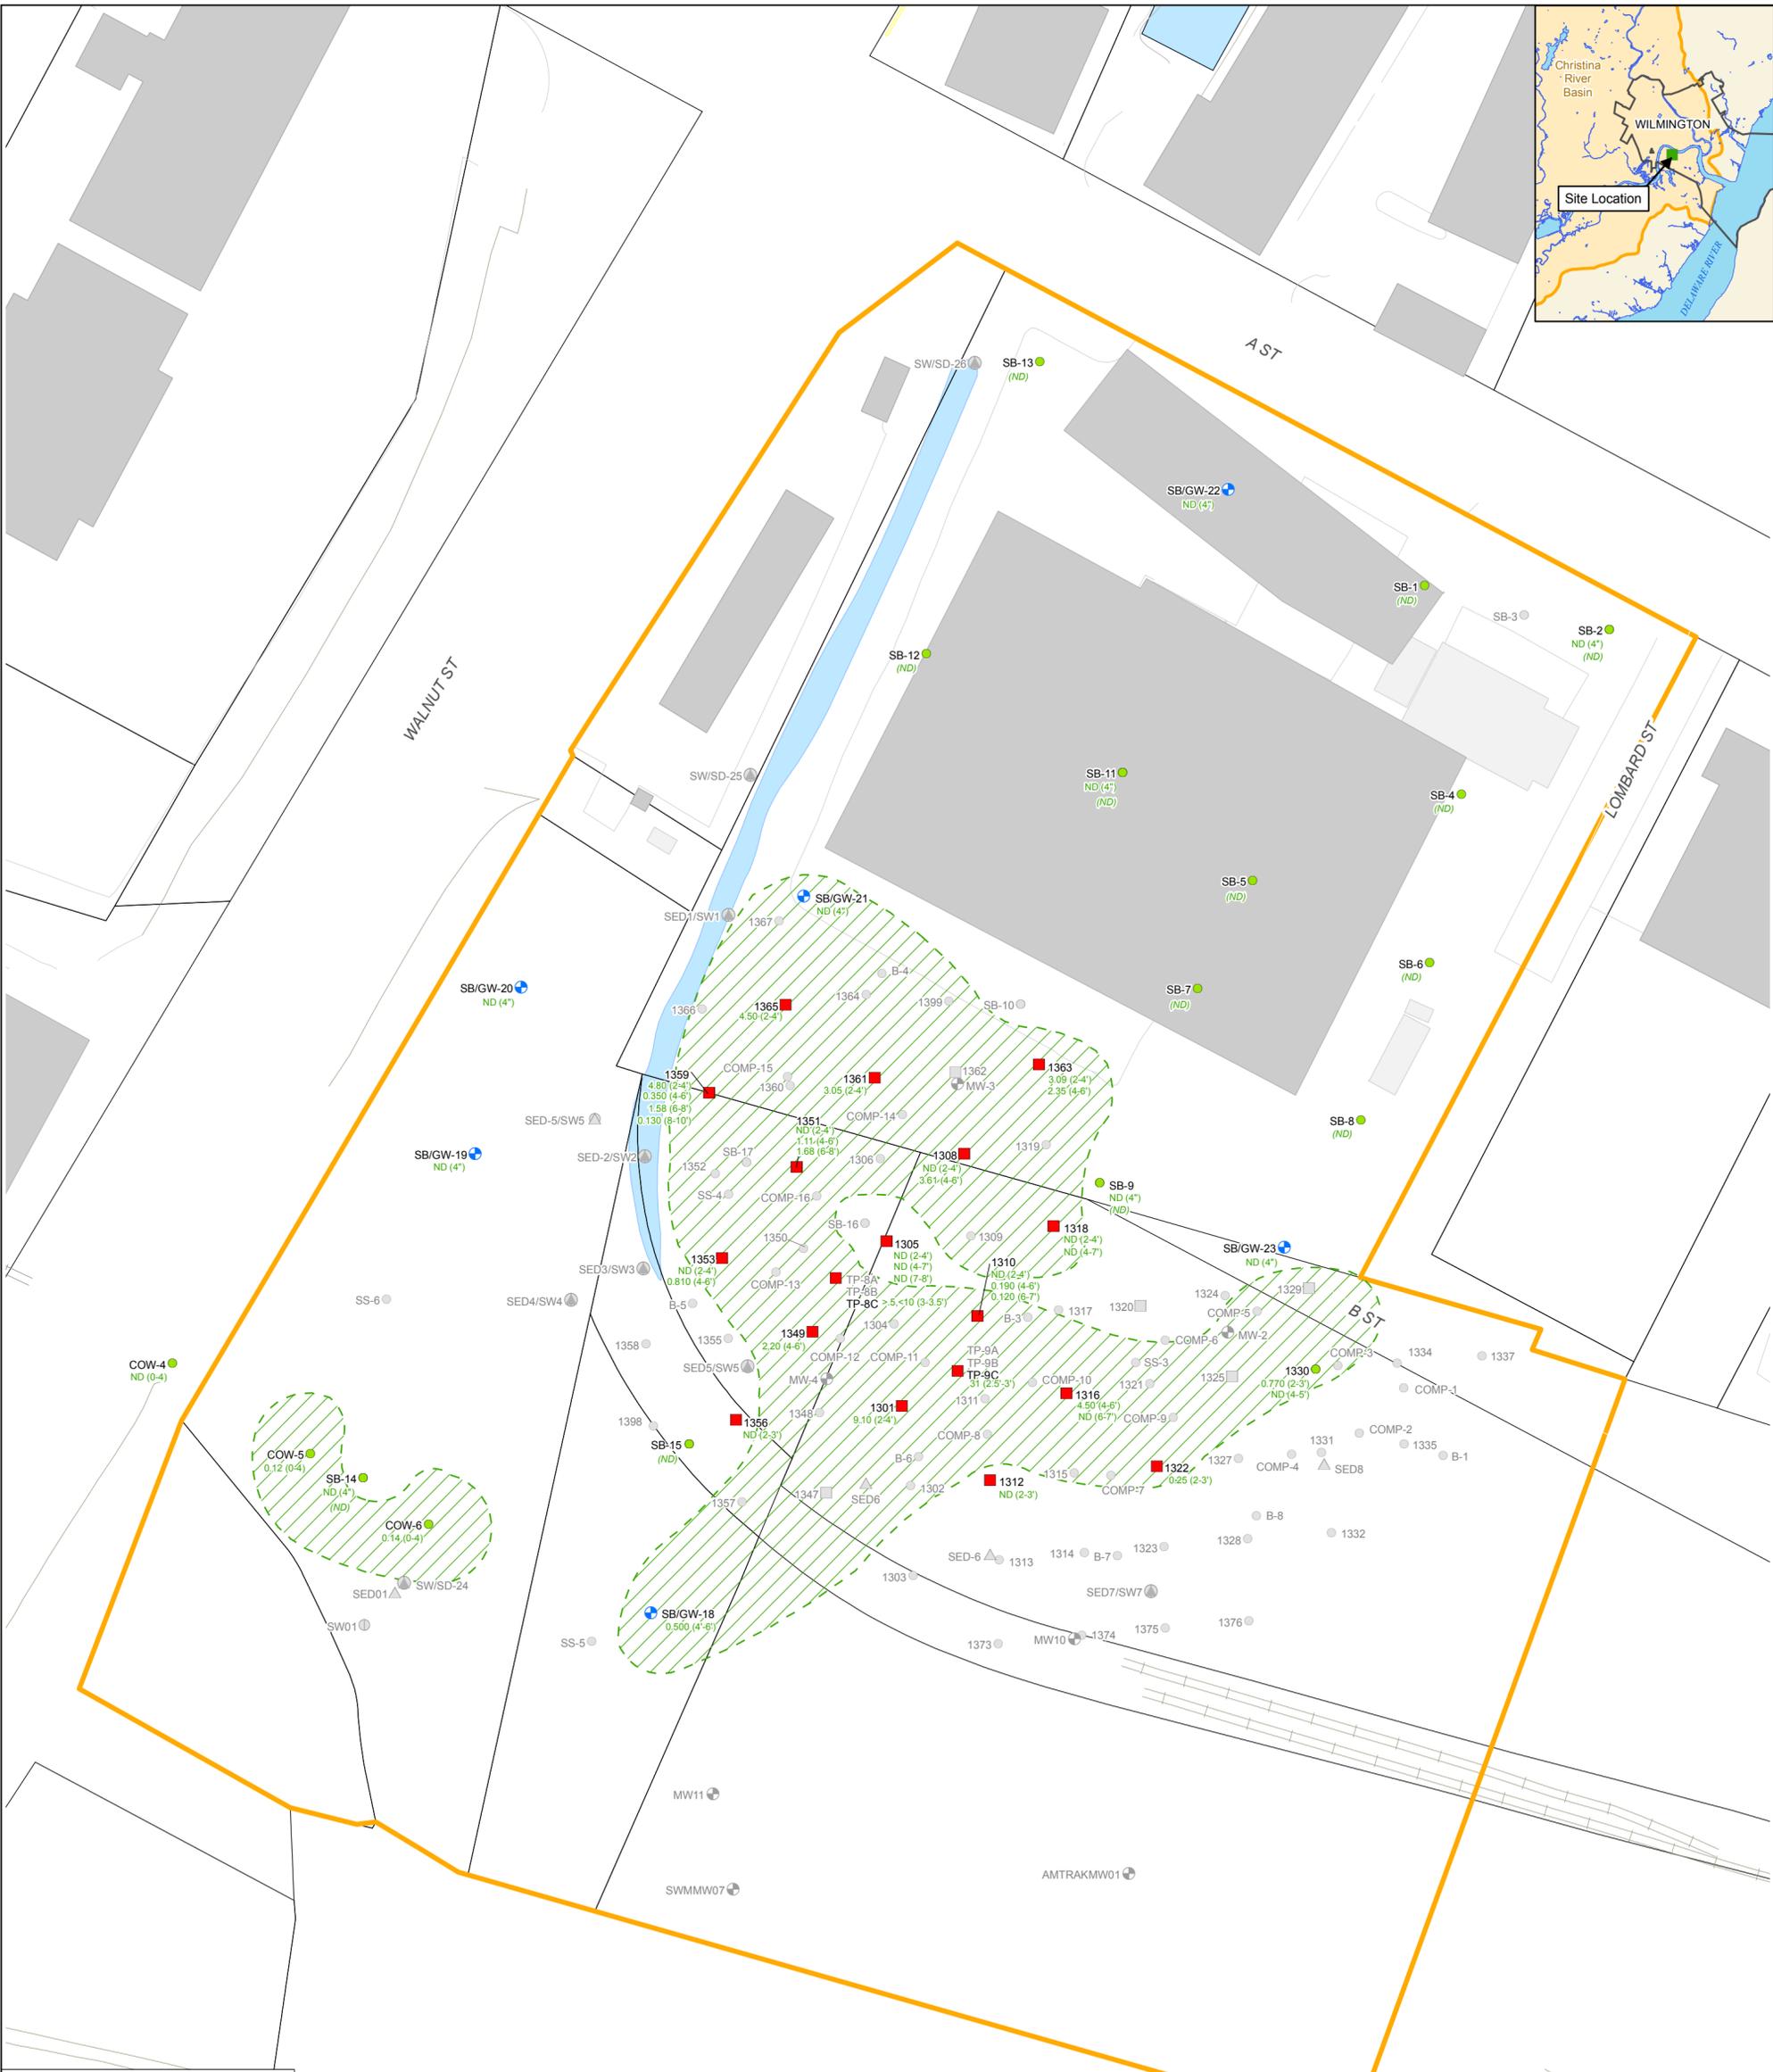
By	Date	Scale:	File Name:
Drawn	SMD 5/11/09	1:840	kreiger_unsat.mxd
Checked	Date	Fig. No.	
JPR	5/11/09	Figure 3	
Project #	0985.26.51

Note: Samples in gray indicate that no sample was collected from this depth or the sample was not analyzed for PCBs. PCB polygon was created based on the assessment from the South Wilmington Wetlands Assessment, 2009.

PCB Distribution in Subsurface Unsaturated Soil
 Kreiger-Finger Property and Adjacent Sites
 Wilmington, Delaware

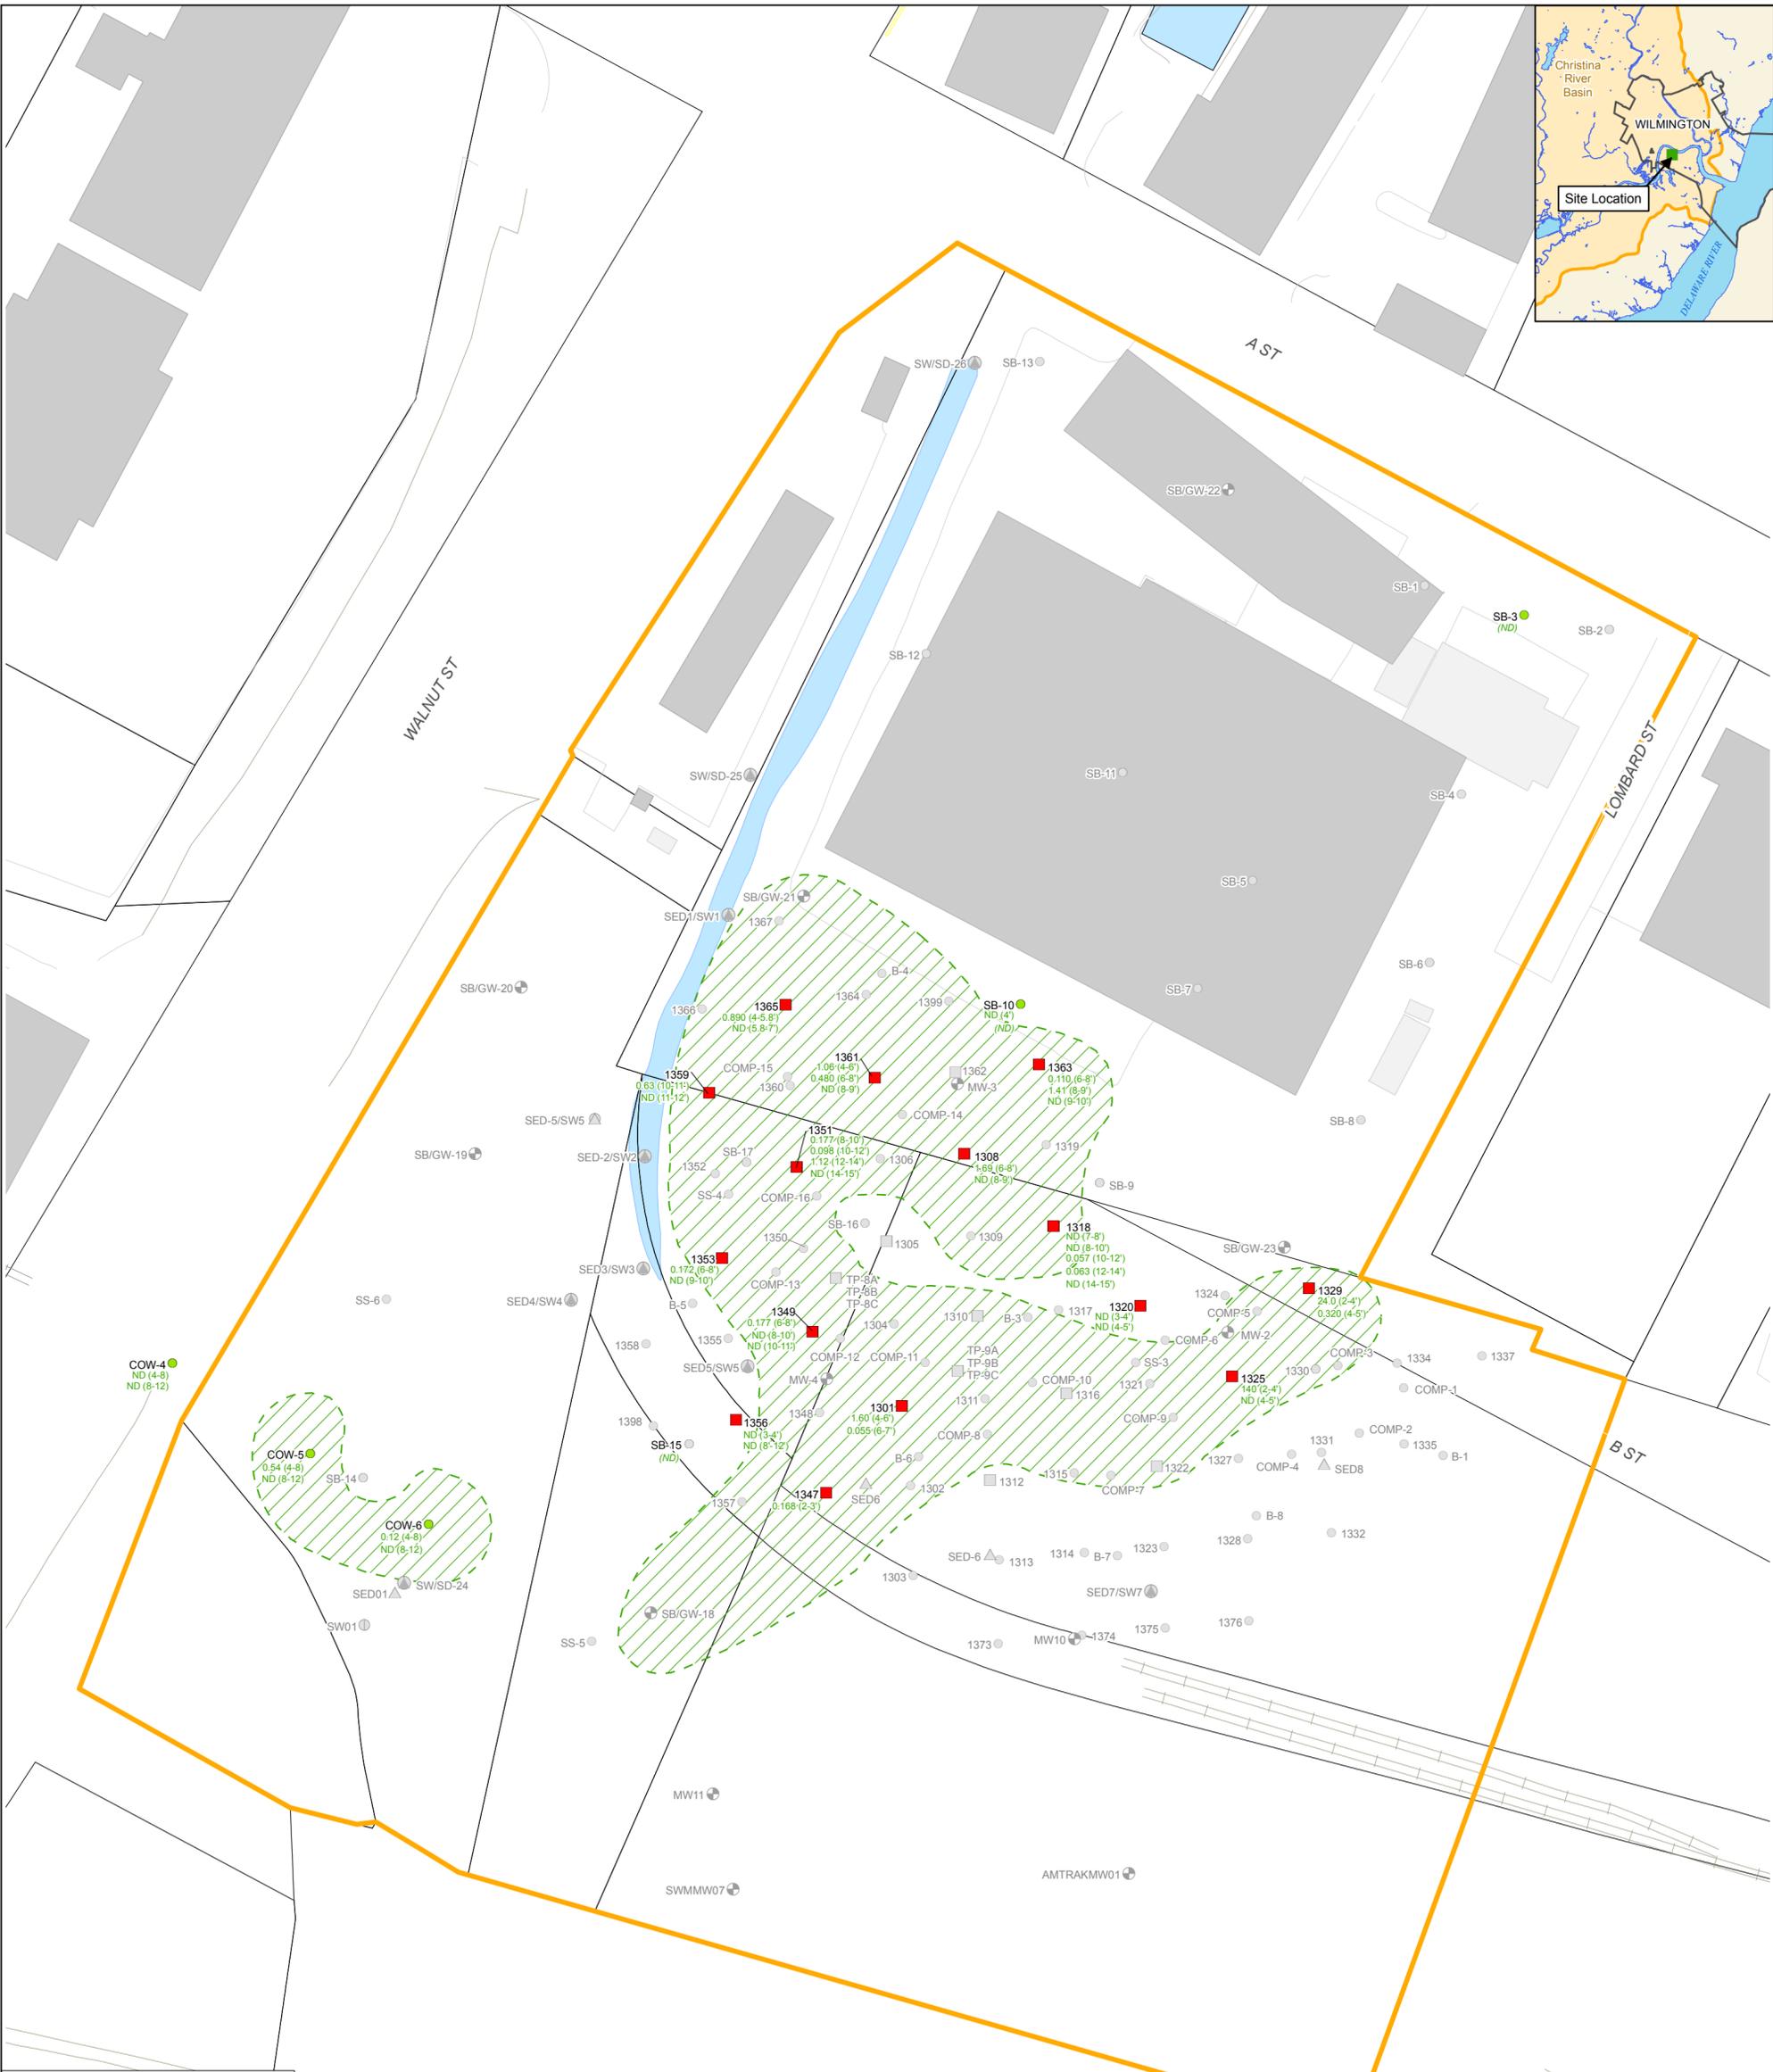
By	Date	Scale:	File Name:
Drawn	SMD 5/11/09	1:840	kreiger sat.mxd
Checked	JPR 5/11/09	Fig. No.	
Project #	0985.26.51	Figure 4

Note: Samples in gray indicate that no sample was collected from this depth or the sample was not analyzed for PCBs. PCB polygon was created based on the assessment from the South Wilmington Wetlands Assessment, 2009.

PCB Distribution in Subsurface Saturated Soil
 Kreiger-Finger Property and Adjacent Sites
 Wilmington, Delaware

The concentrations of PCBs in subsurface saturated soils ranged from non-detect to 140 mg/kg. The subsurface saturated soils were evaluated as three distinct areas. Within these areas, average concentrations of PCBs were determined. These average concentrations were used in the groundwater partitioning equation to estimate pore water concentration.

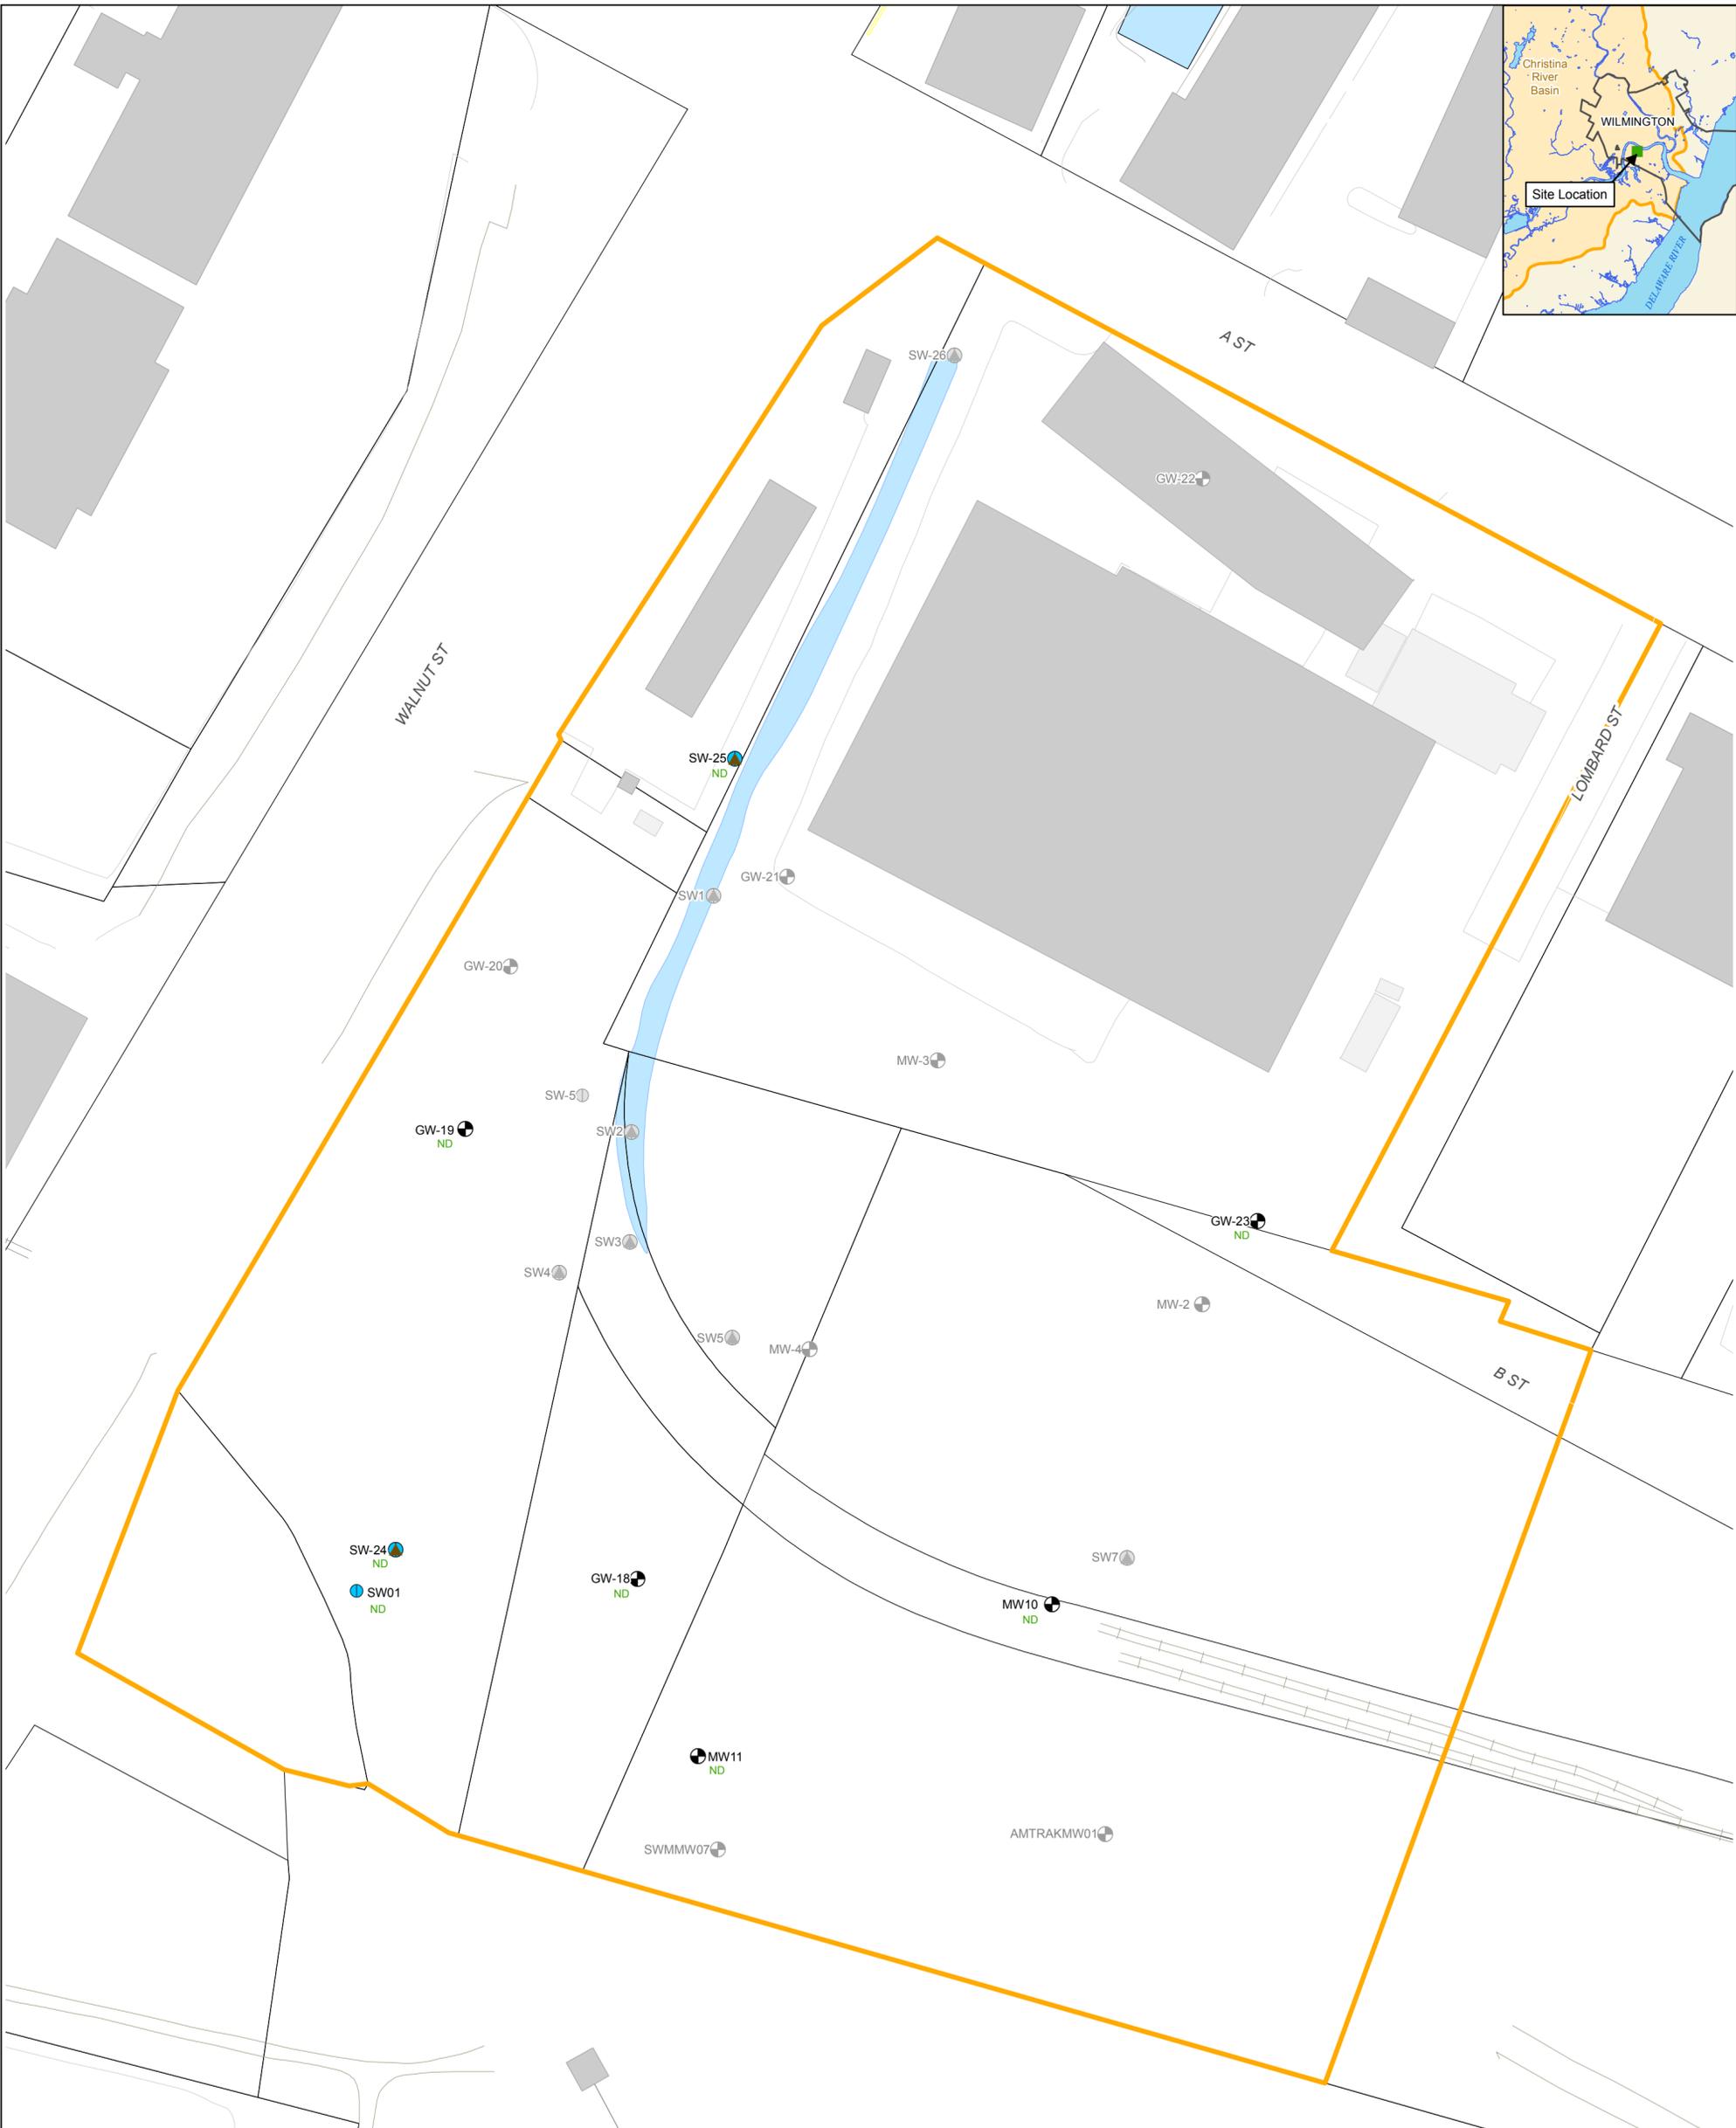
By	Date	Scale:	File Name:
Drawn	SMD	11/10/08	1:840	kreiger gw.mxd
Checked	JPR	11/10/08	Fig. No.	
Project #	0985.26.51		Figure 5

Note: Samples in gray indicate that no sample was collected from this depth or the sample was not analyzed for PCBs

PCB Distribution in Groundwater
 Kreiger-Finger Property and Adjacent Sites
 Wilmington, Delaware
