Appendix 18

KREIGER FINGER PROPERTY AND ADJACENT SITES WILMINGTON, DELAWARE

PCB MASS LOADING SUMMARY

PCB Mass Loading
Kreiger Finger Property and Adjacent Sites
SIRB ID: DE-1067, DE-0156, DE-1291, DE-1336, and DE-1337
Wilmington, Delaware

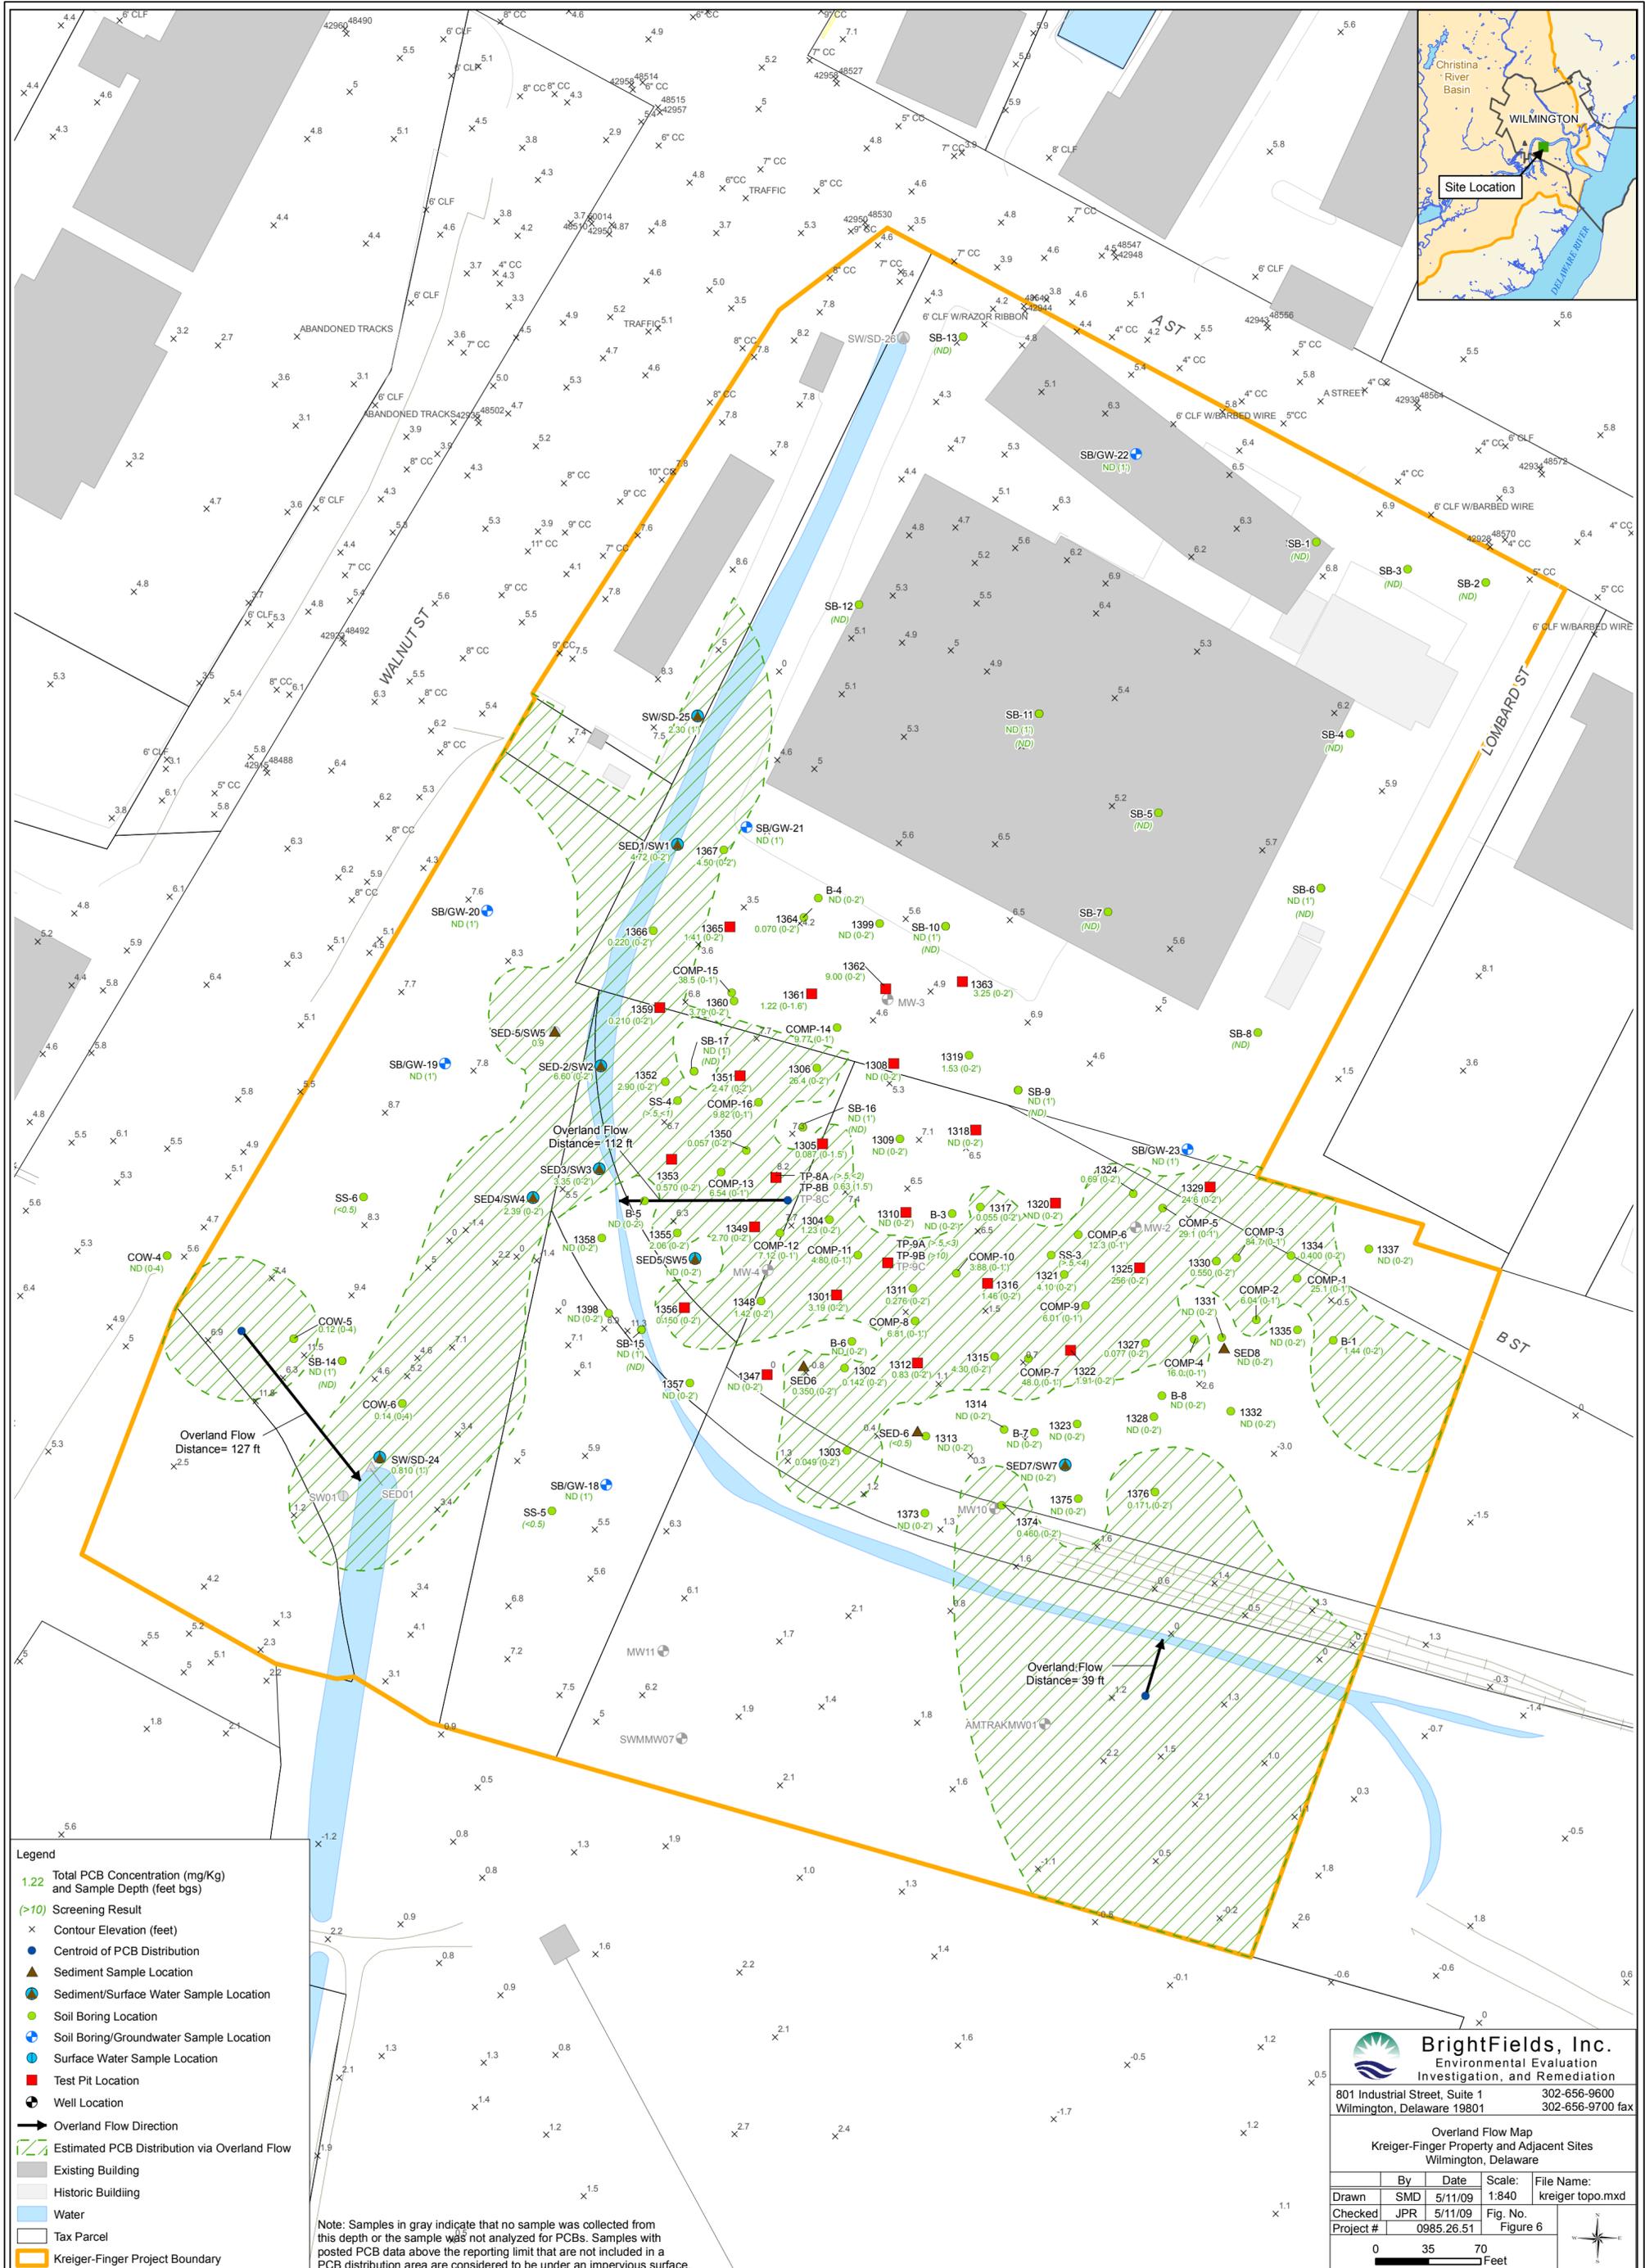
By	Date	Scale	File Name
Drawn	SMD 5/11/09	1:840	kreiger topo.mxd
Checked	JPR 5/11/09	Fig. No.	
Project #	0985.26.51	Figure 6

Note: Samples in gray indicate that no sample was collected from this depth or the sample was not analyzed for PCBs. Samples with posted PCB data above the reporting limit that are not included in a PCB distribution area are considered to be under an impervious surface.

Overland Flow Map
 Kreiger-Finger Property and Adjacent Sites
 Wilmington, Delaware

The estimated surface soil area impacted by PCBs is 5.5 acres (Figure 2); however the area that may still be contributing to overland flow is 4.7 acres (Figure 6). The estimated subsurface unsaturated soil that is impacted by PCBs is 2.5 acres (Figure 3). The estimated subsurface saturated soil impacted by PCBs is 2.5 acres.

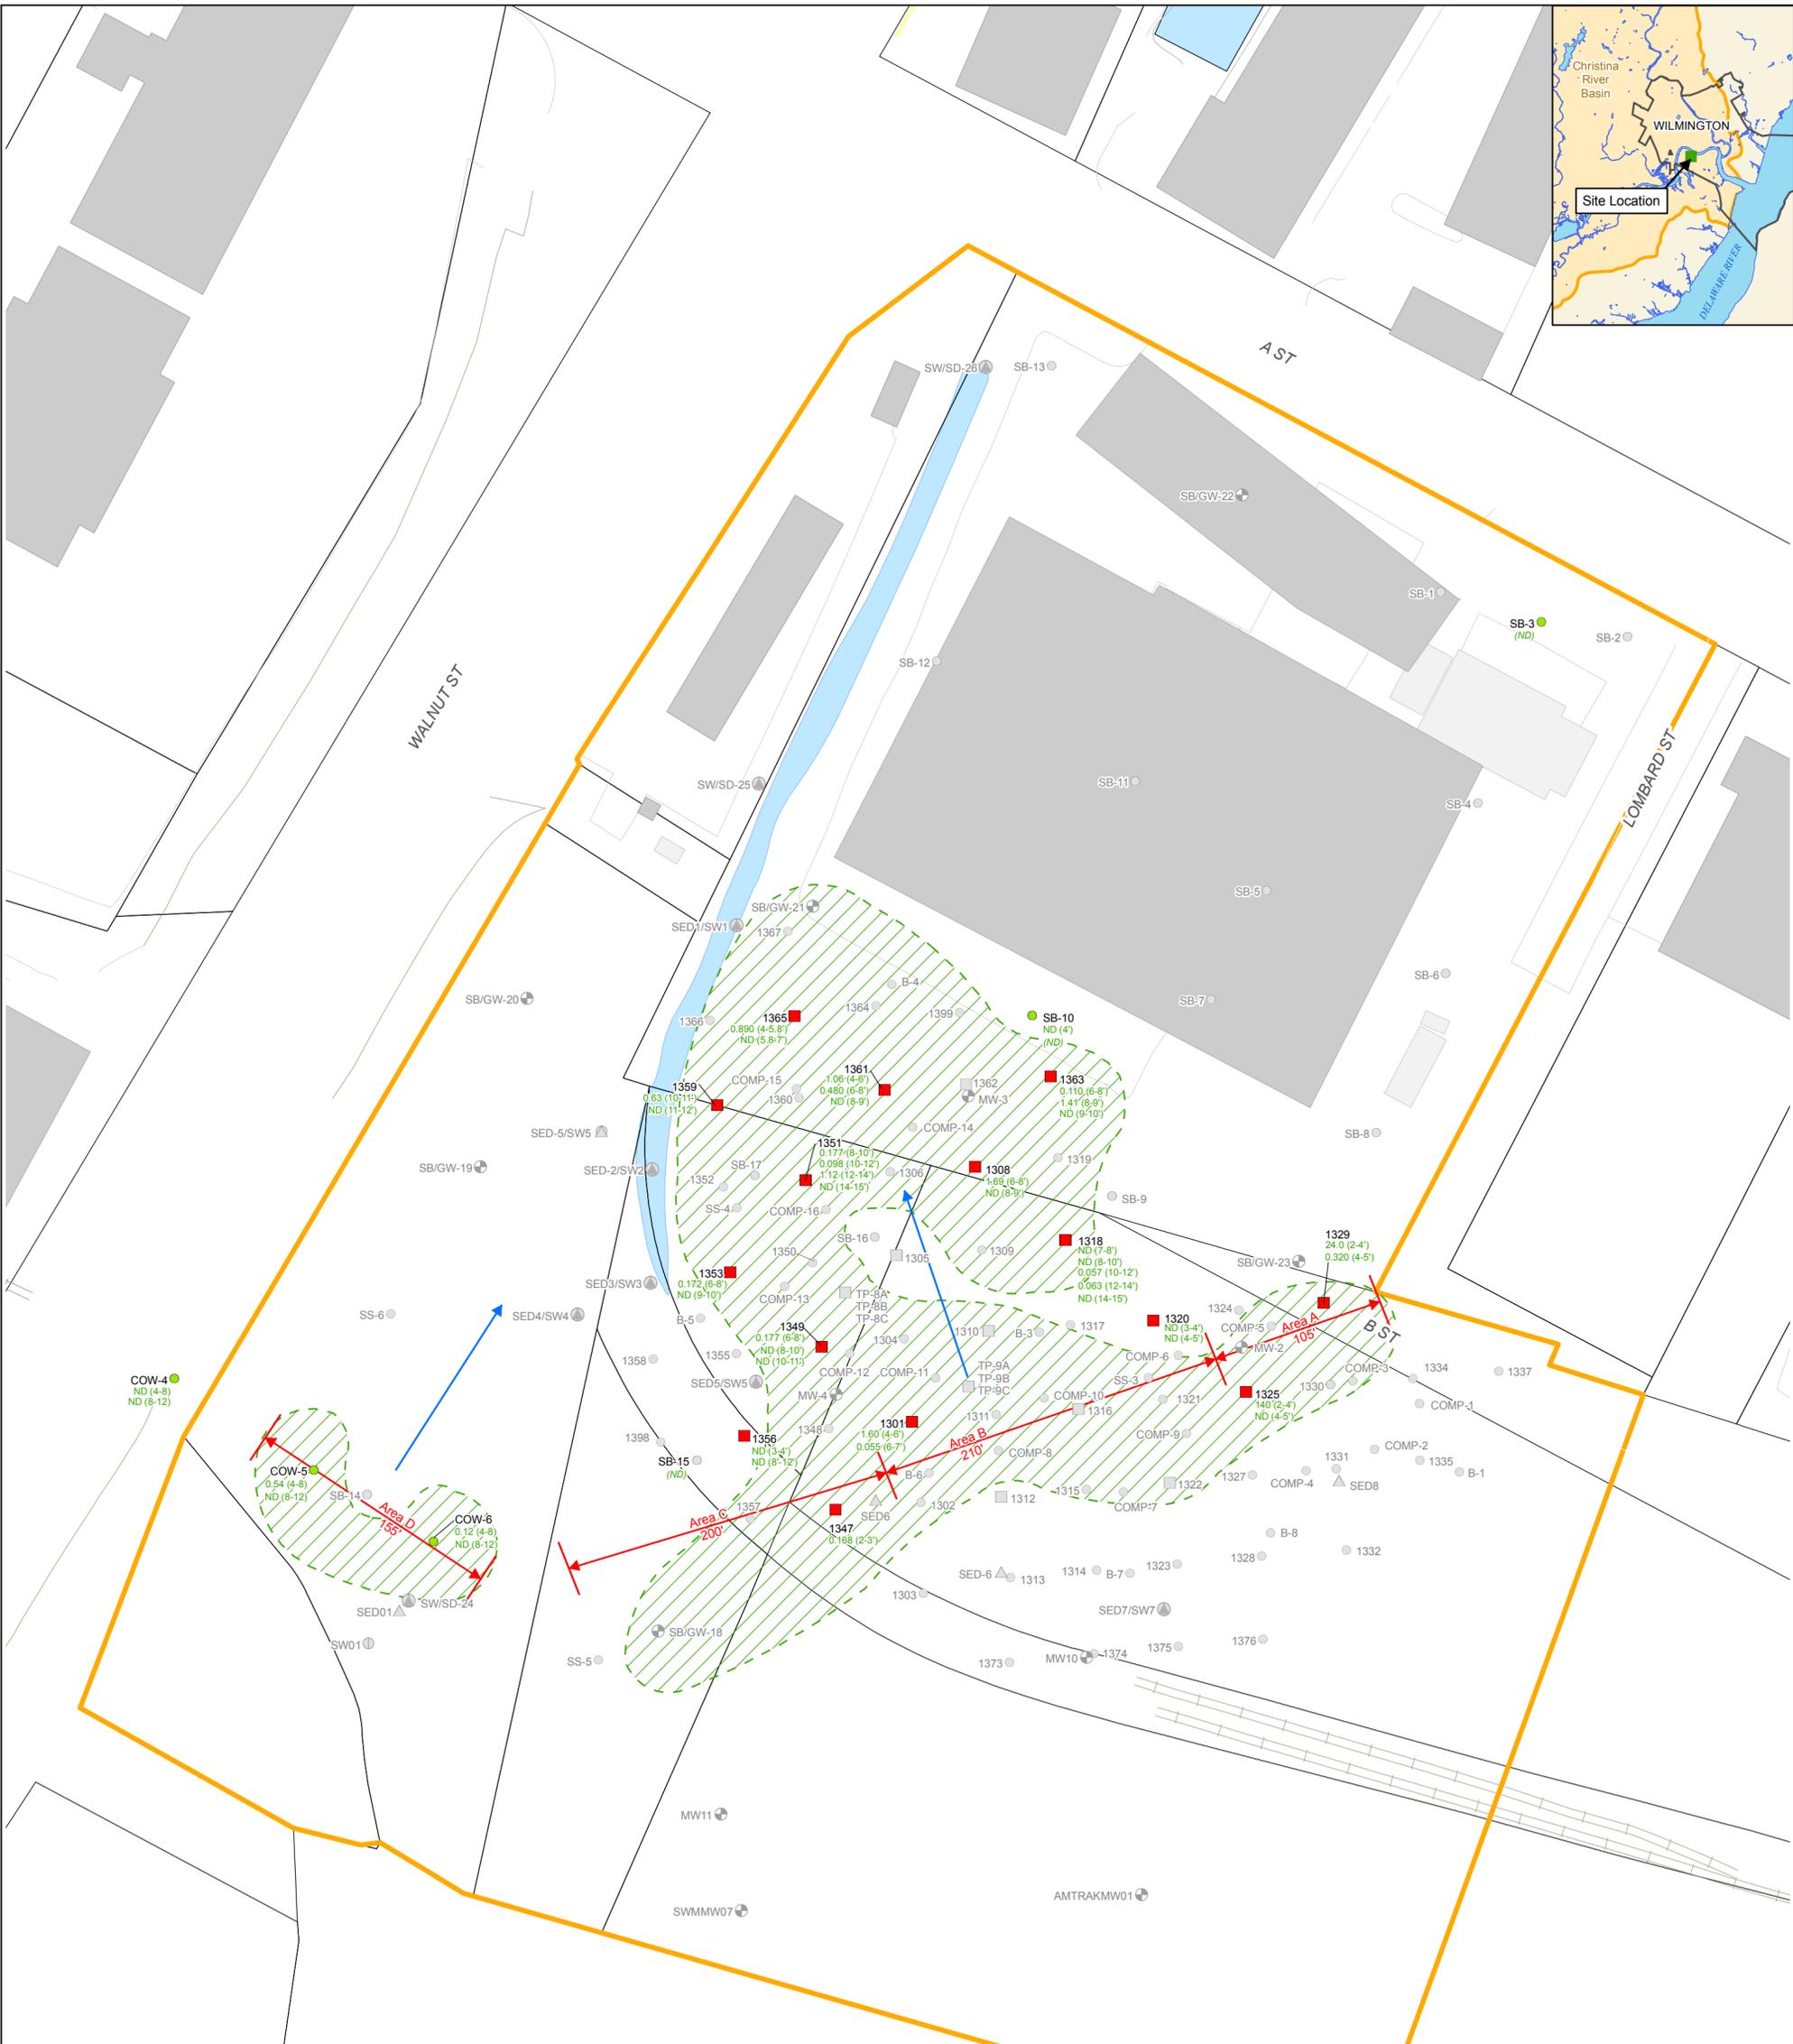
By	Date	Scale:	File Name:	
Drawn	SMD	5/19/09	1:840	kreiger gw dis.mxd
Checked	JPR	5/19/09	Fig. No.	
Project #	0985.26.51		Figure 7

Note: Samples in gray indicate that no sample was collected from this depth or the sample was not analyzed for PCBs. PCB polygon was created based on the assessment from the South Wilmington Wetlands Assessment, 2009.

Groundwater Discharge Map
 Kreiger-Finger Property and Adjacent Sites
 Wilmington, Delaware

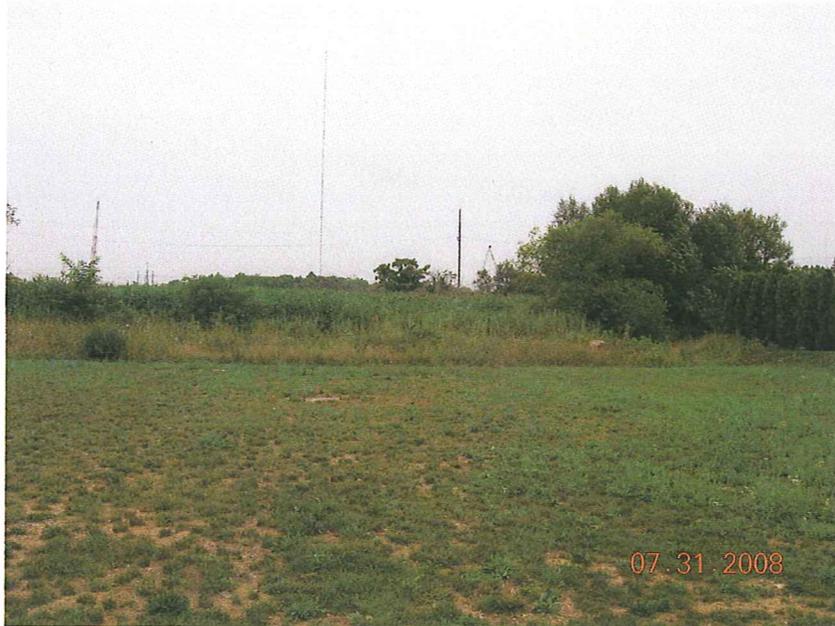
Site cover and canopy associated with Kreiger Finger/Landfill.

A site inspection was performed on July 30, 2008 to estimate the current site ground cover and canopy. The cover/management factor (C) assigned to the site and associated flow path is 0.11, which corresponds to areas that have a vegetative cover consisting of 75% groundcover of tall weeds or short brush, with the cover at the surface being grass, grass-like plants, decaying compacted duff, or litter at least 2 inches deep. Photographs of the site ground cover and canopy are attached.

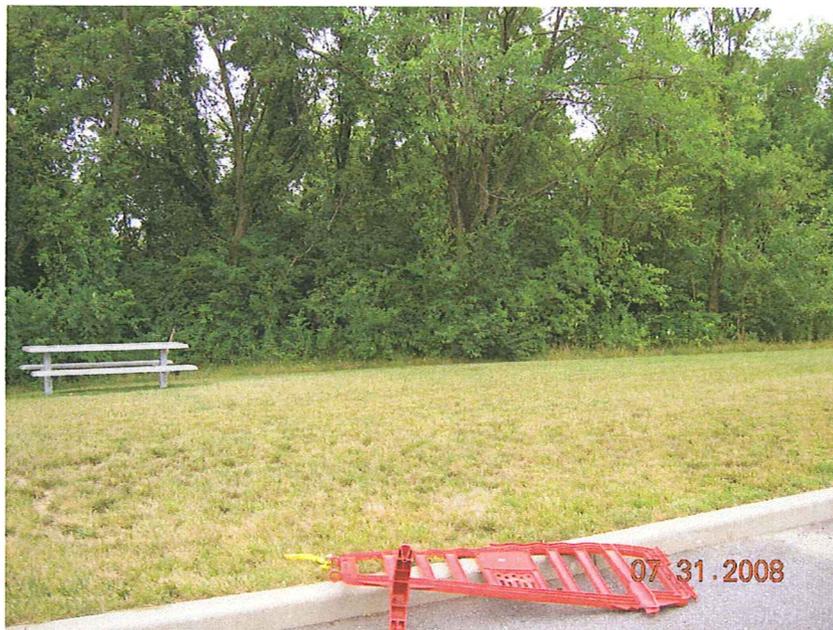
Vast amount of vegetation associated with northeast portion of the site.
