PCB Mass Loading
Former NVF Facility
SIRB ID: DE-1374
Wilmington, Delaware

Appendix 20

FORMER NVF FACILITY WILMINGTON, DELAWARE

SIRB ID: DE-1374

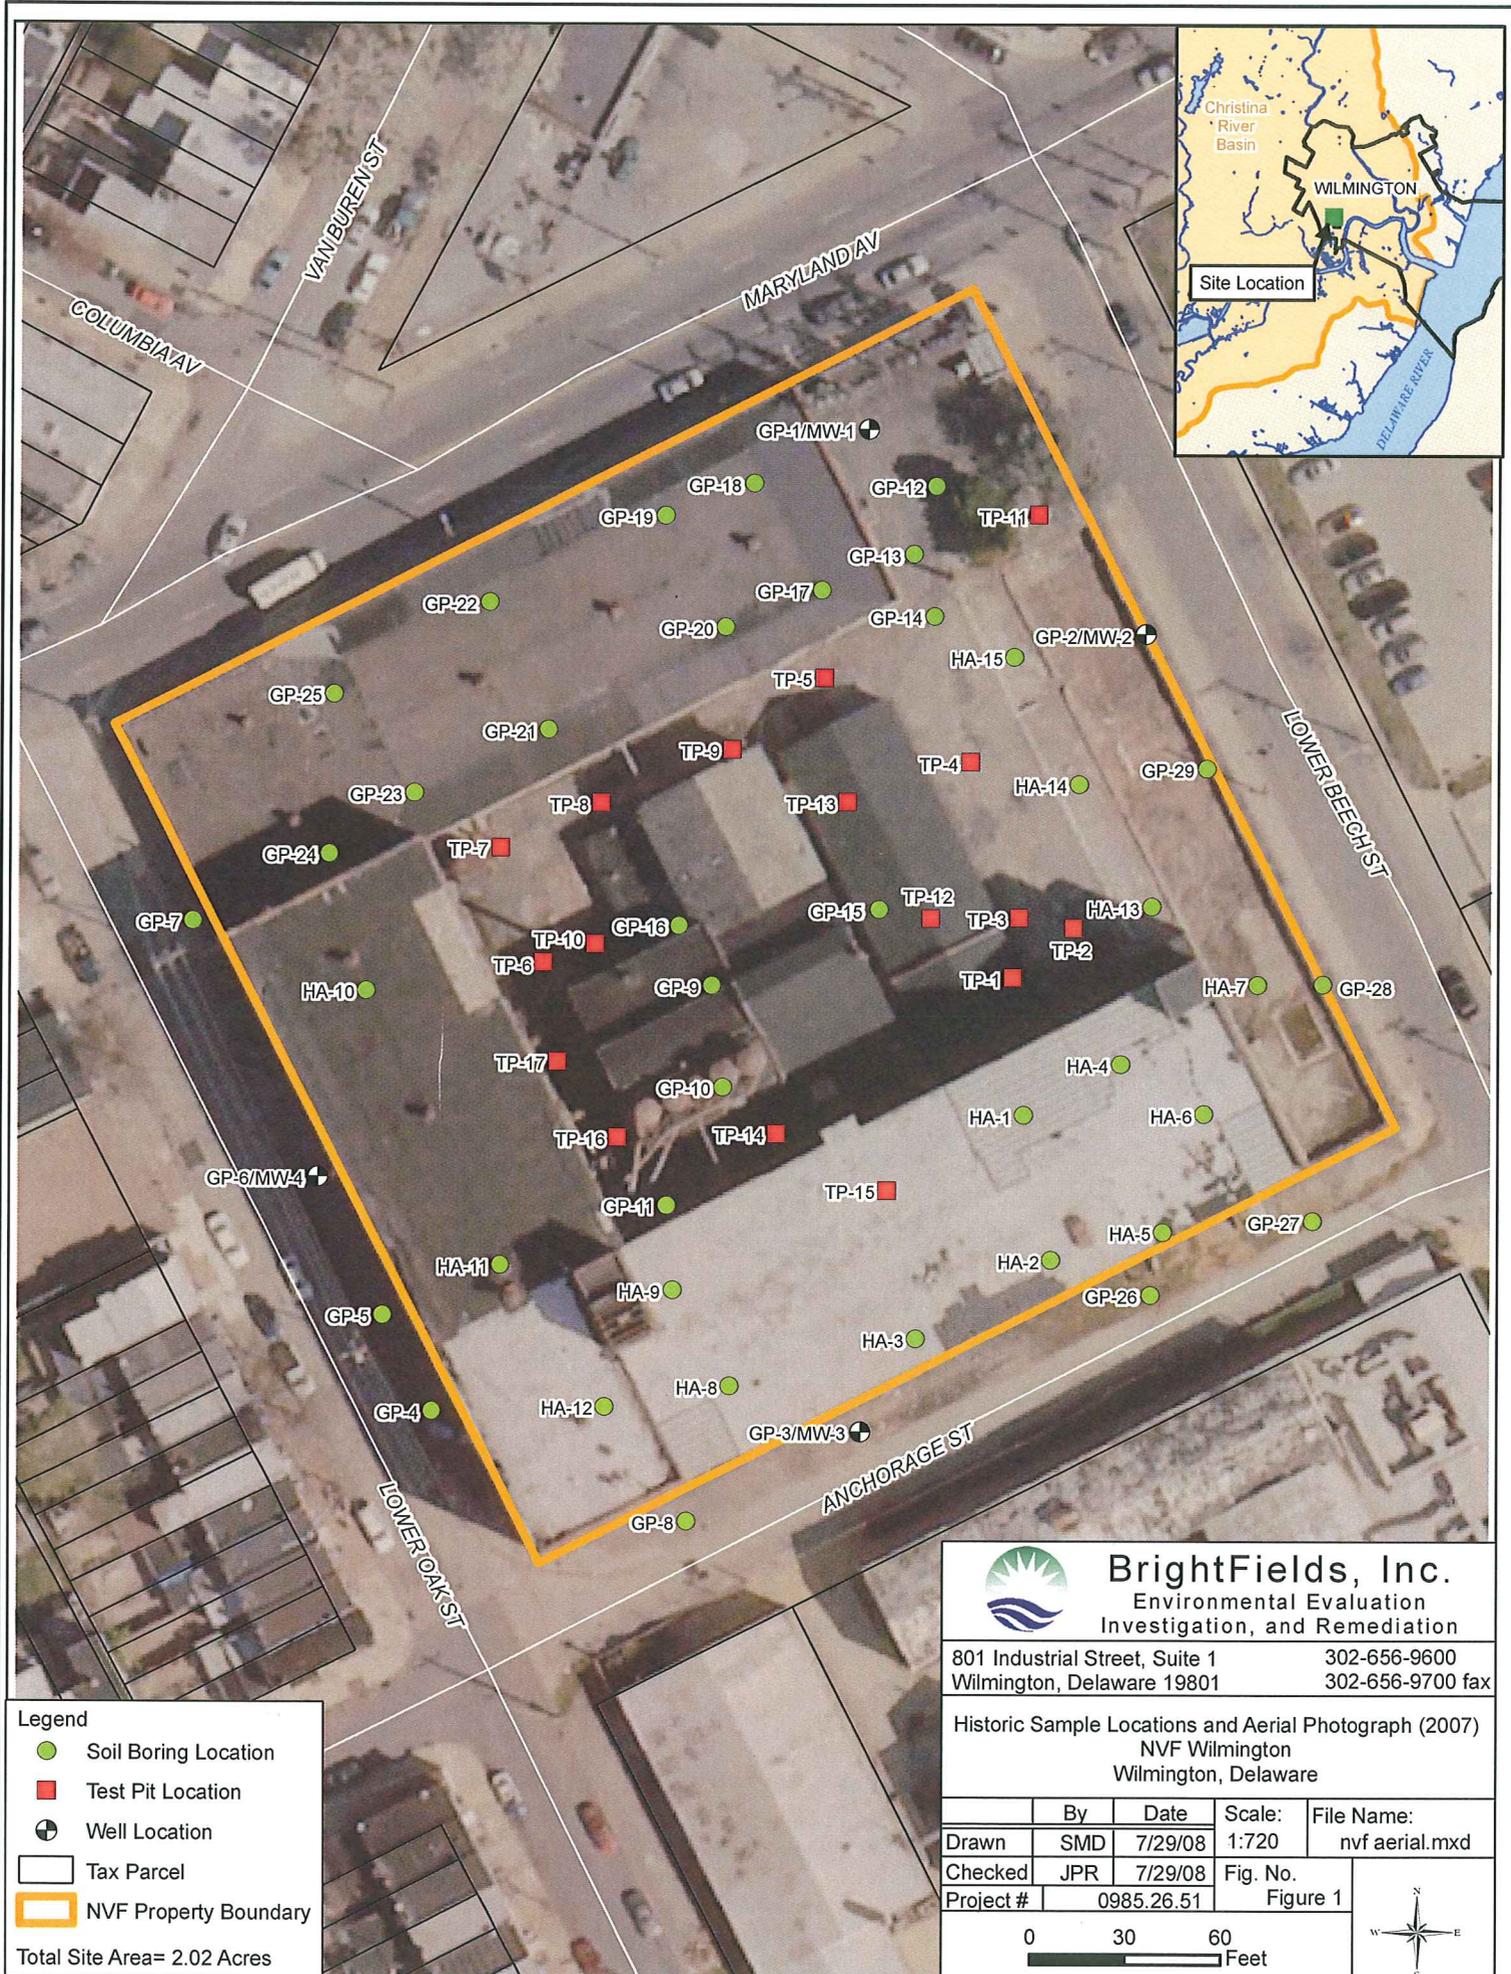
By	Date	Scale:	File Name:
Drawn	SMD	7/29/08	1:720	nvf aerial.mxd
Checked	JPR	7/29/08	Fig. No.	
Project #	0985.26.51		Figure 1

Historic Sample Locations and Aerial Photograph (2007)
NVF Wilmington
Wilmington, Delaware

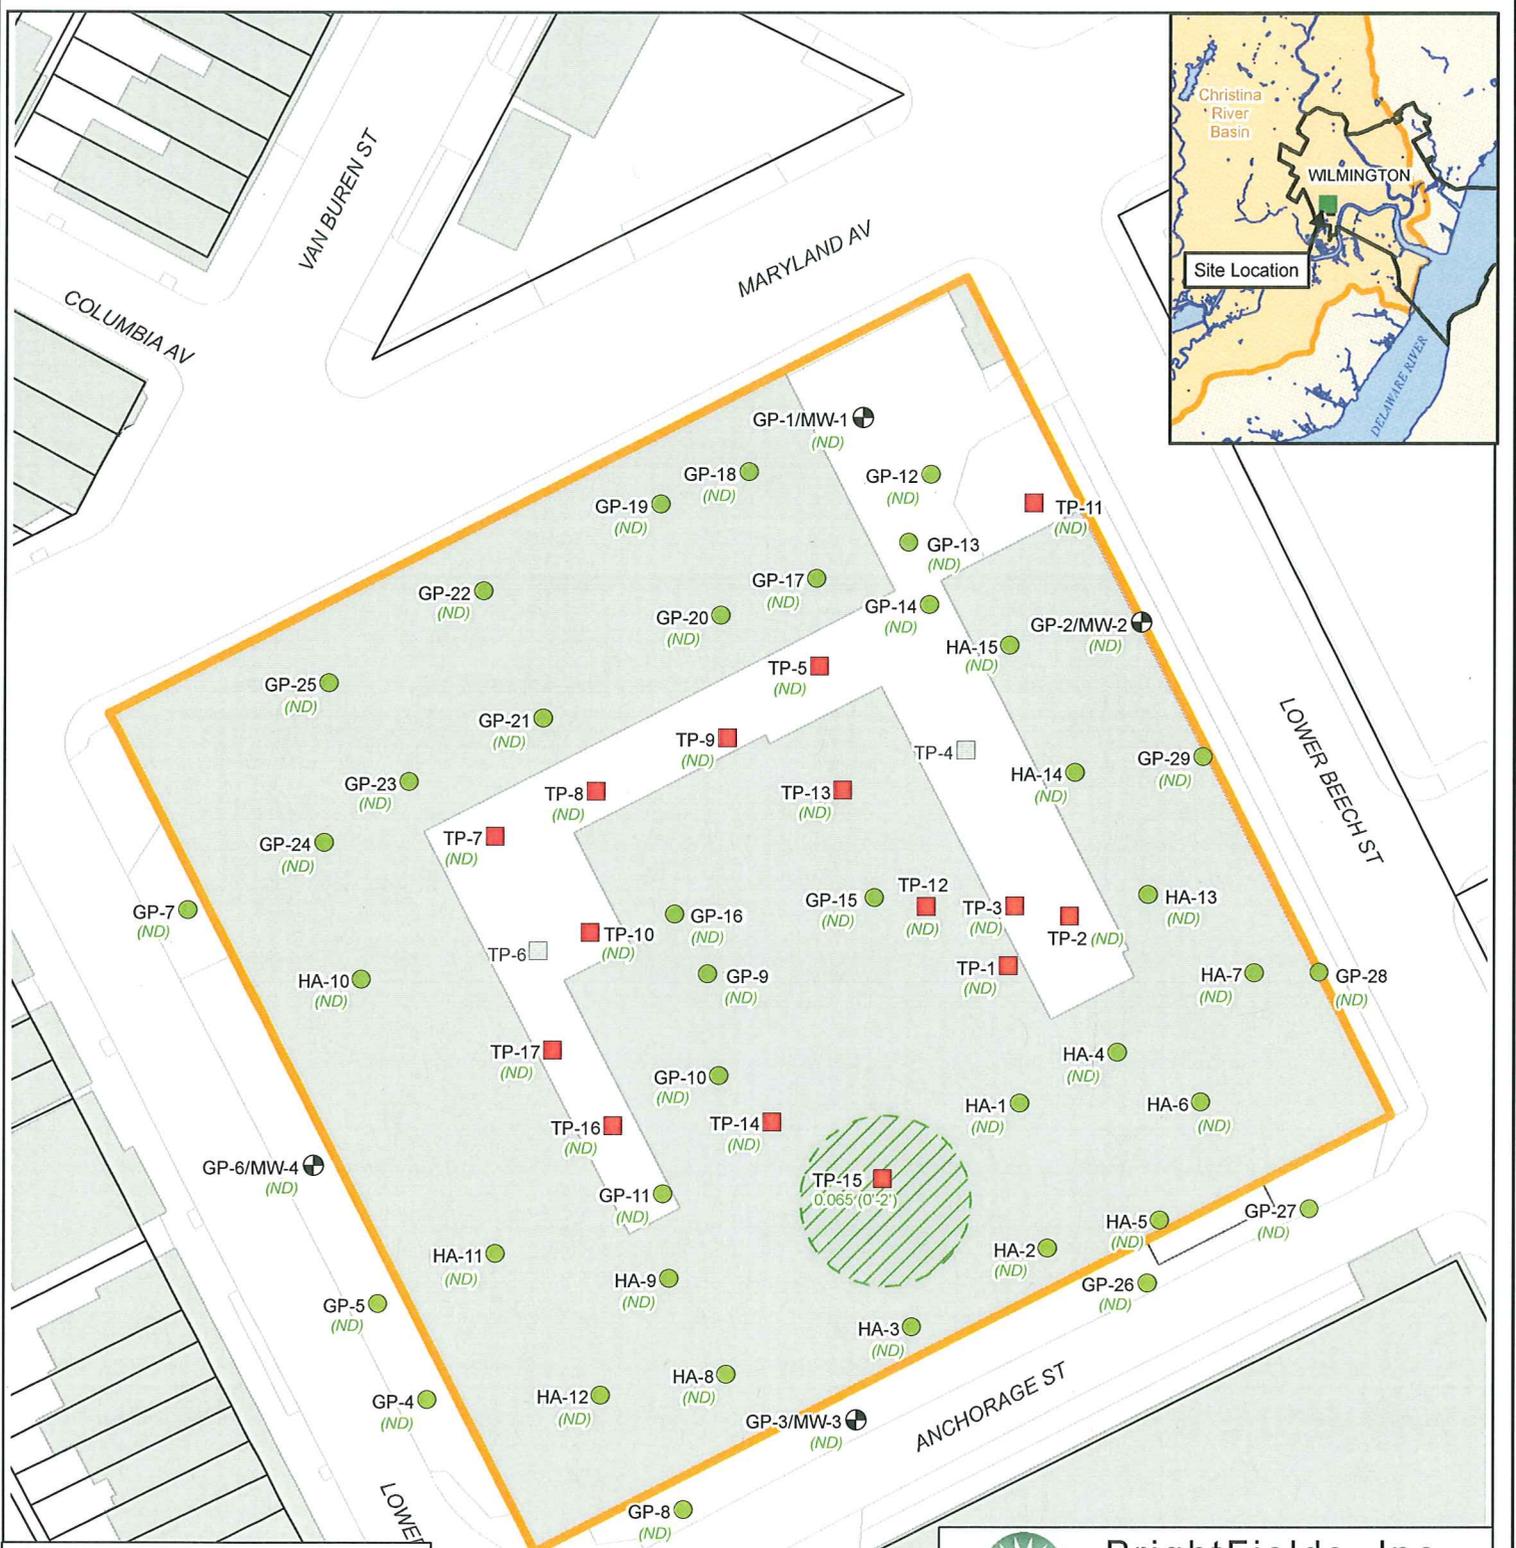
By	Date	Scale:	File Name:
Drawn	SMD	7/29/08	1:720	nvf 0-2.mxd
Checked	JPR	7/29/08	Fig. No.	
Project #	0985.26.51		Figure 2

PCB Distribution in Surface Soil (0'-2' bgs)
NVF Wilmington
Wilmington, Delaware

Concentrations of PCBs on Site			
Sample Matrix	Corresponding Figure	Analytical Methods	Range of Total PCBs
Surface Soil	Figure 2	Immunoassay and Method 8082	Not detected to 0.065 mg/kg
Subsurface Soil (unsaturated)	Figure 3	Immunoassay	Not detected
Subsurface Soil (saturated)	Figure 4	Immunoassay and Method 8082	Not detected to 0.061 mg/kg
Groundwater	Figure 5	Method 8082	Not detected

The estimated surface soil area impacted by PCBs is 0.05 acres in the vicinity of the TP15 sample location (Figure 2). The estimated subsurface saturated soil area impacted by PCBs is 0.18 acres in the vicinity of TP15 sample location (Figure 4).

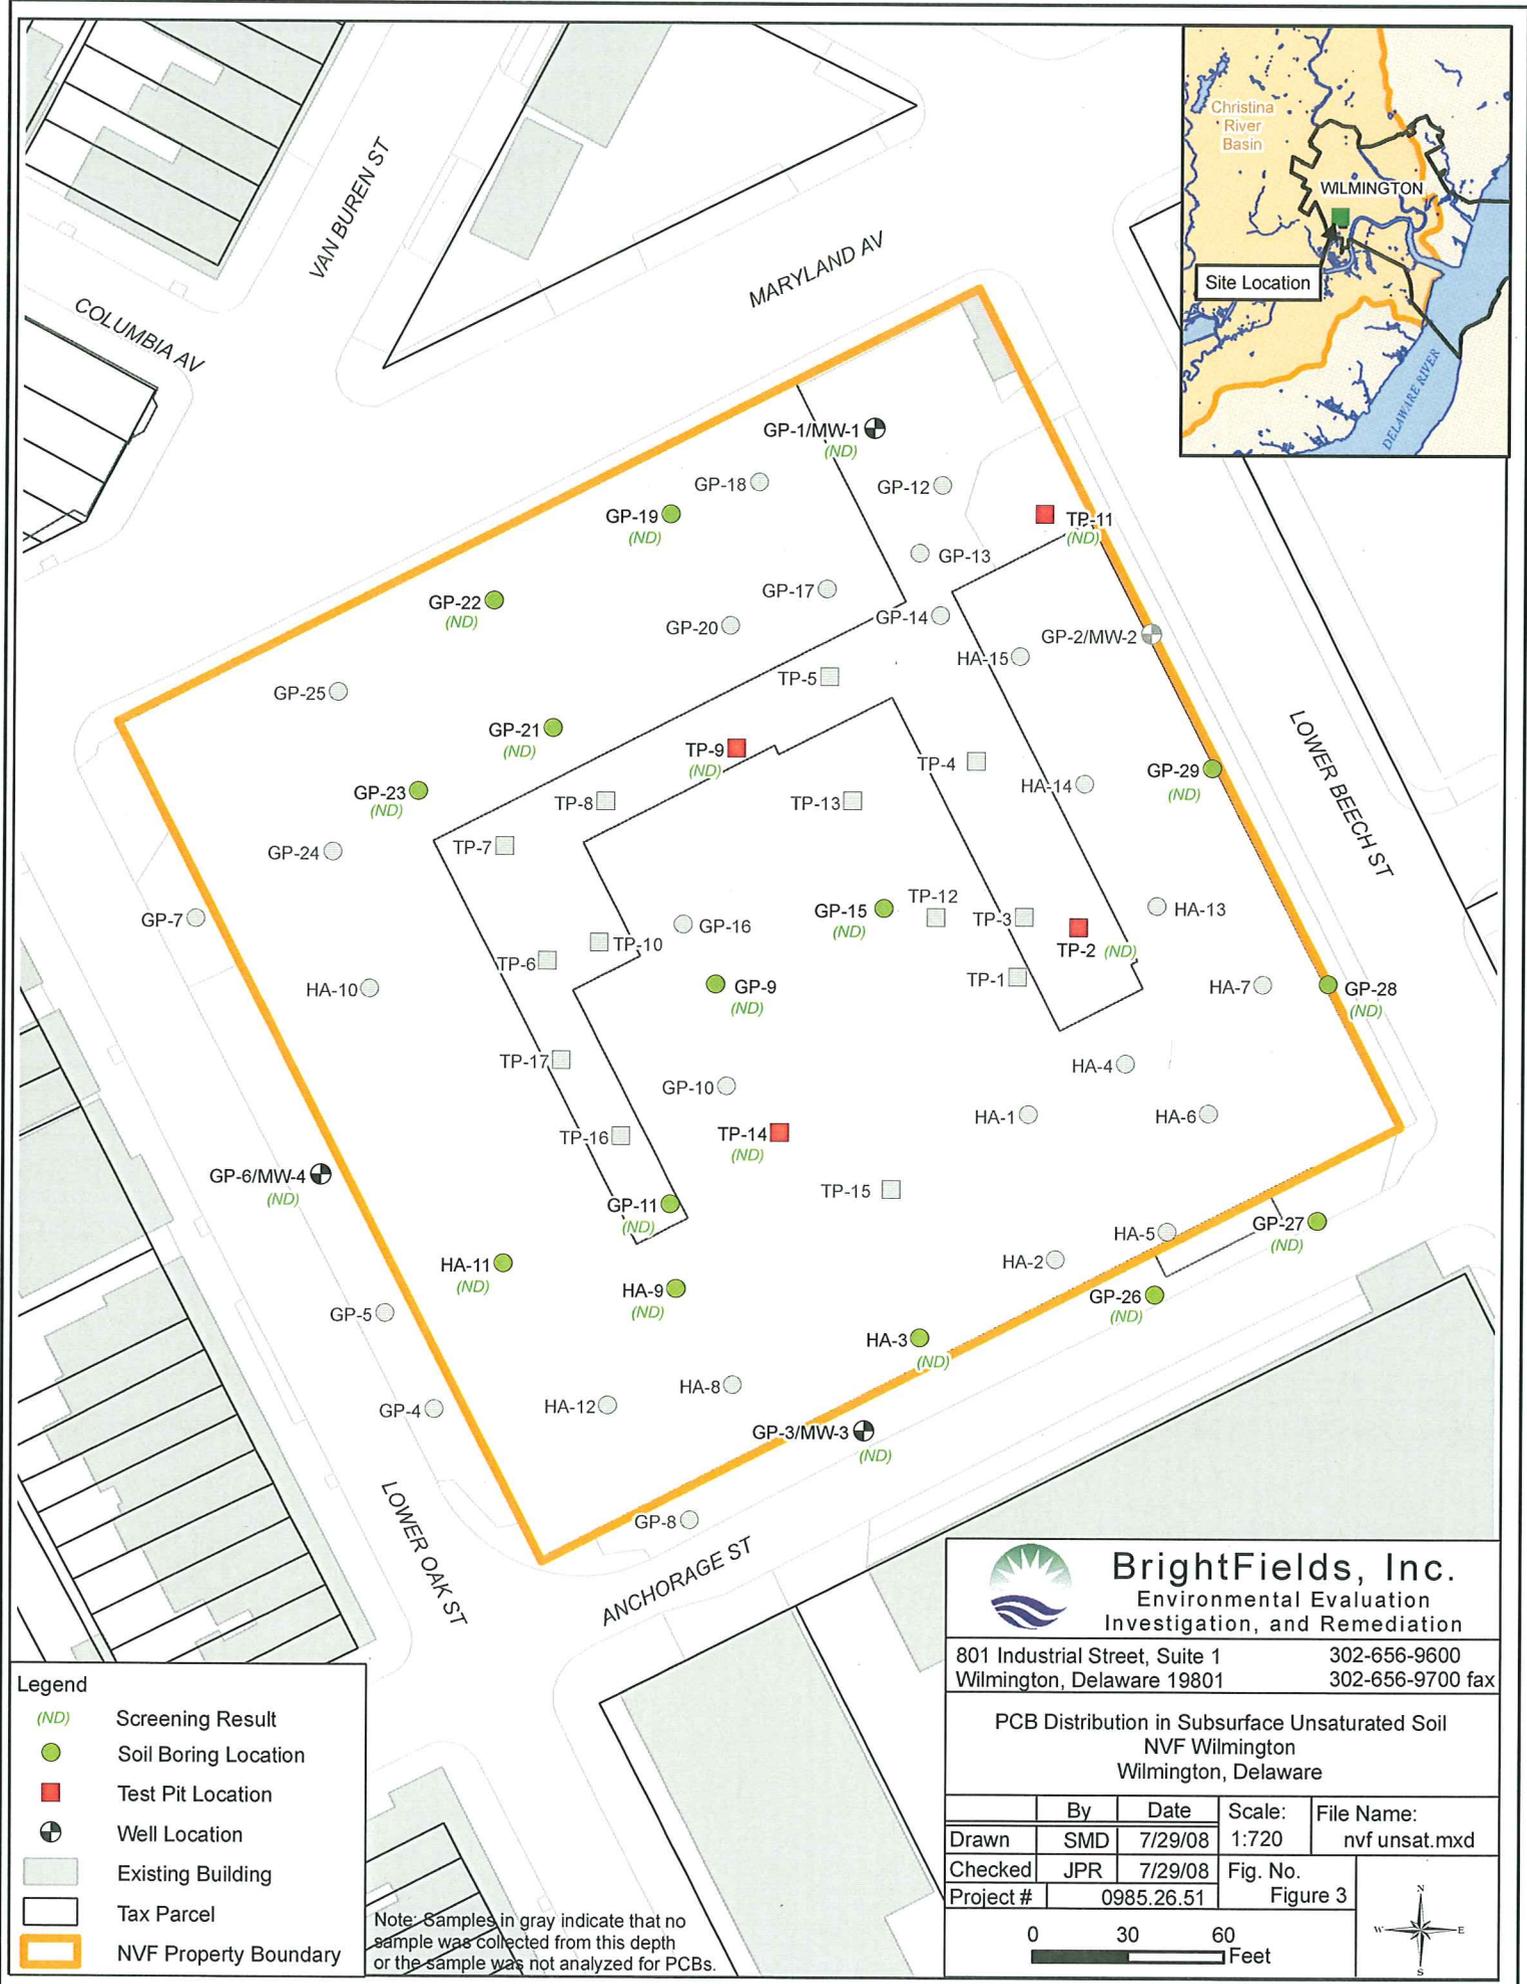
801 Industrial Street, Suite 1 Wilmington, Delaware 19801		302-656-9600 302-656-9700 fax		
PCB Distribution in Subsurface Unsaturated Soil NVF Wilmington Wilmington, Delaware				
	By	Date	Scale:	File Name:
Drawn	SMD	7/29/08	1:720	nvf unsat.mxd
Checked	JPR	7/29/08	Fig. No.	
Project #	0985.26.51		Figure 3

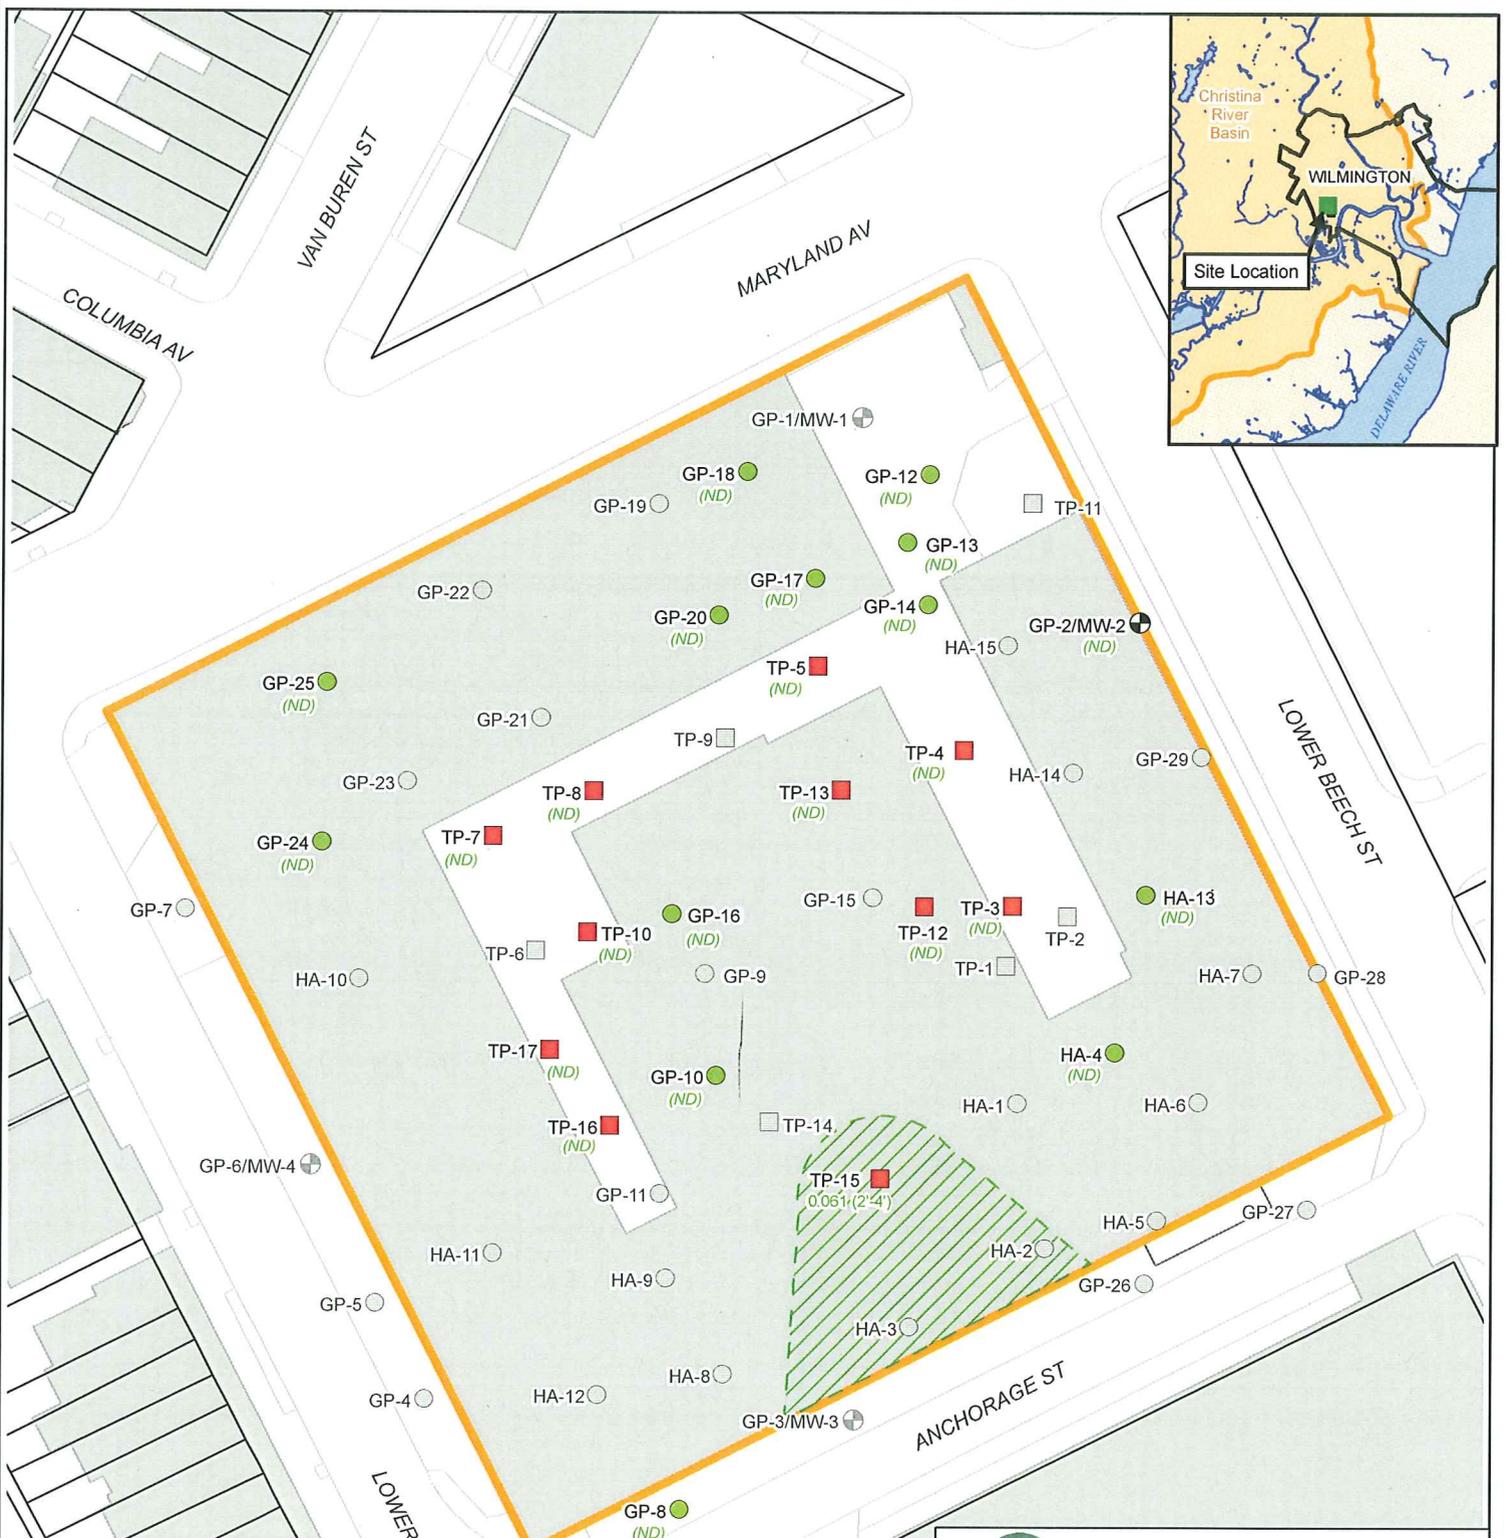
By	Date	Scale:	File Name:
Drawn	SMD	7/29/08	1:720	nvf sat.mxd
Checked	JPR	7/29/08	Fig. No.	Figure 4
Project #	0985.26.51

PCB Distribution in Subsurface Saturated Soil
NVF Wilmington
Wilmington, Delaware

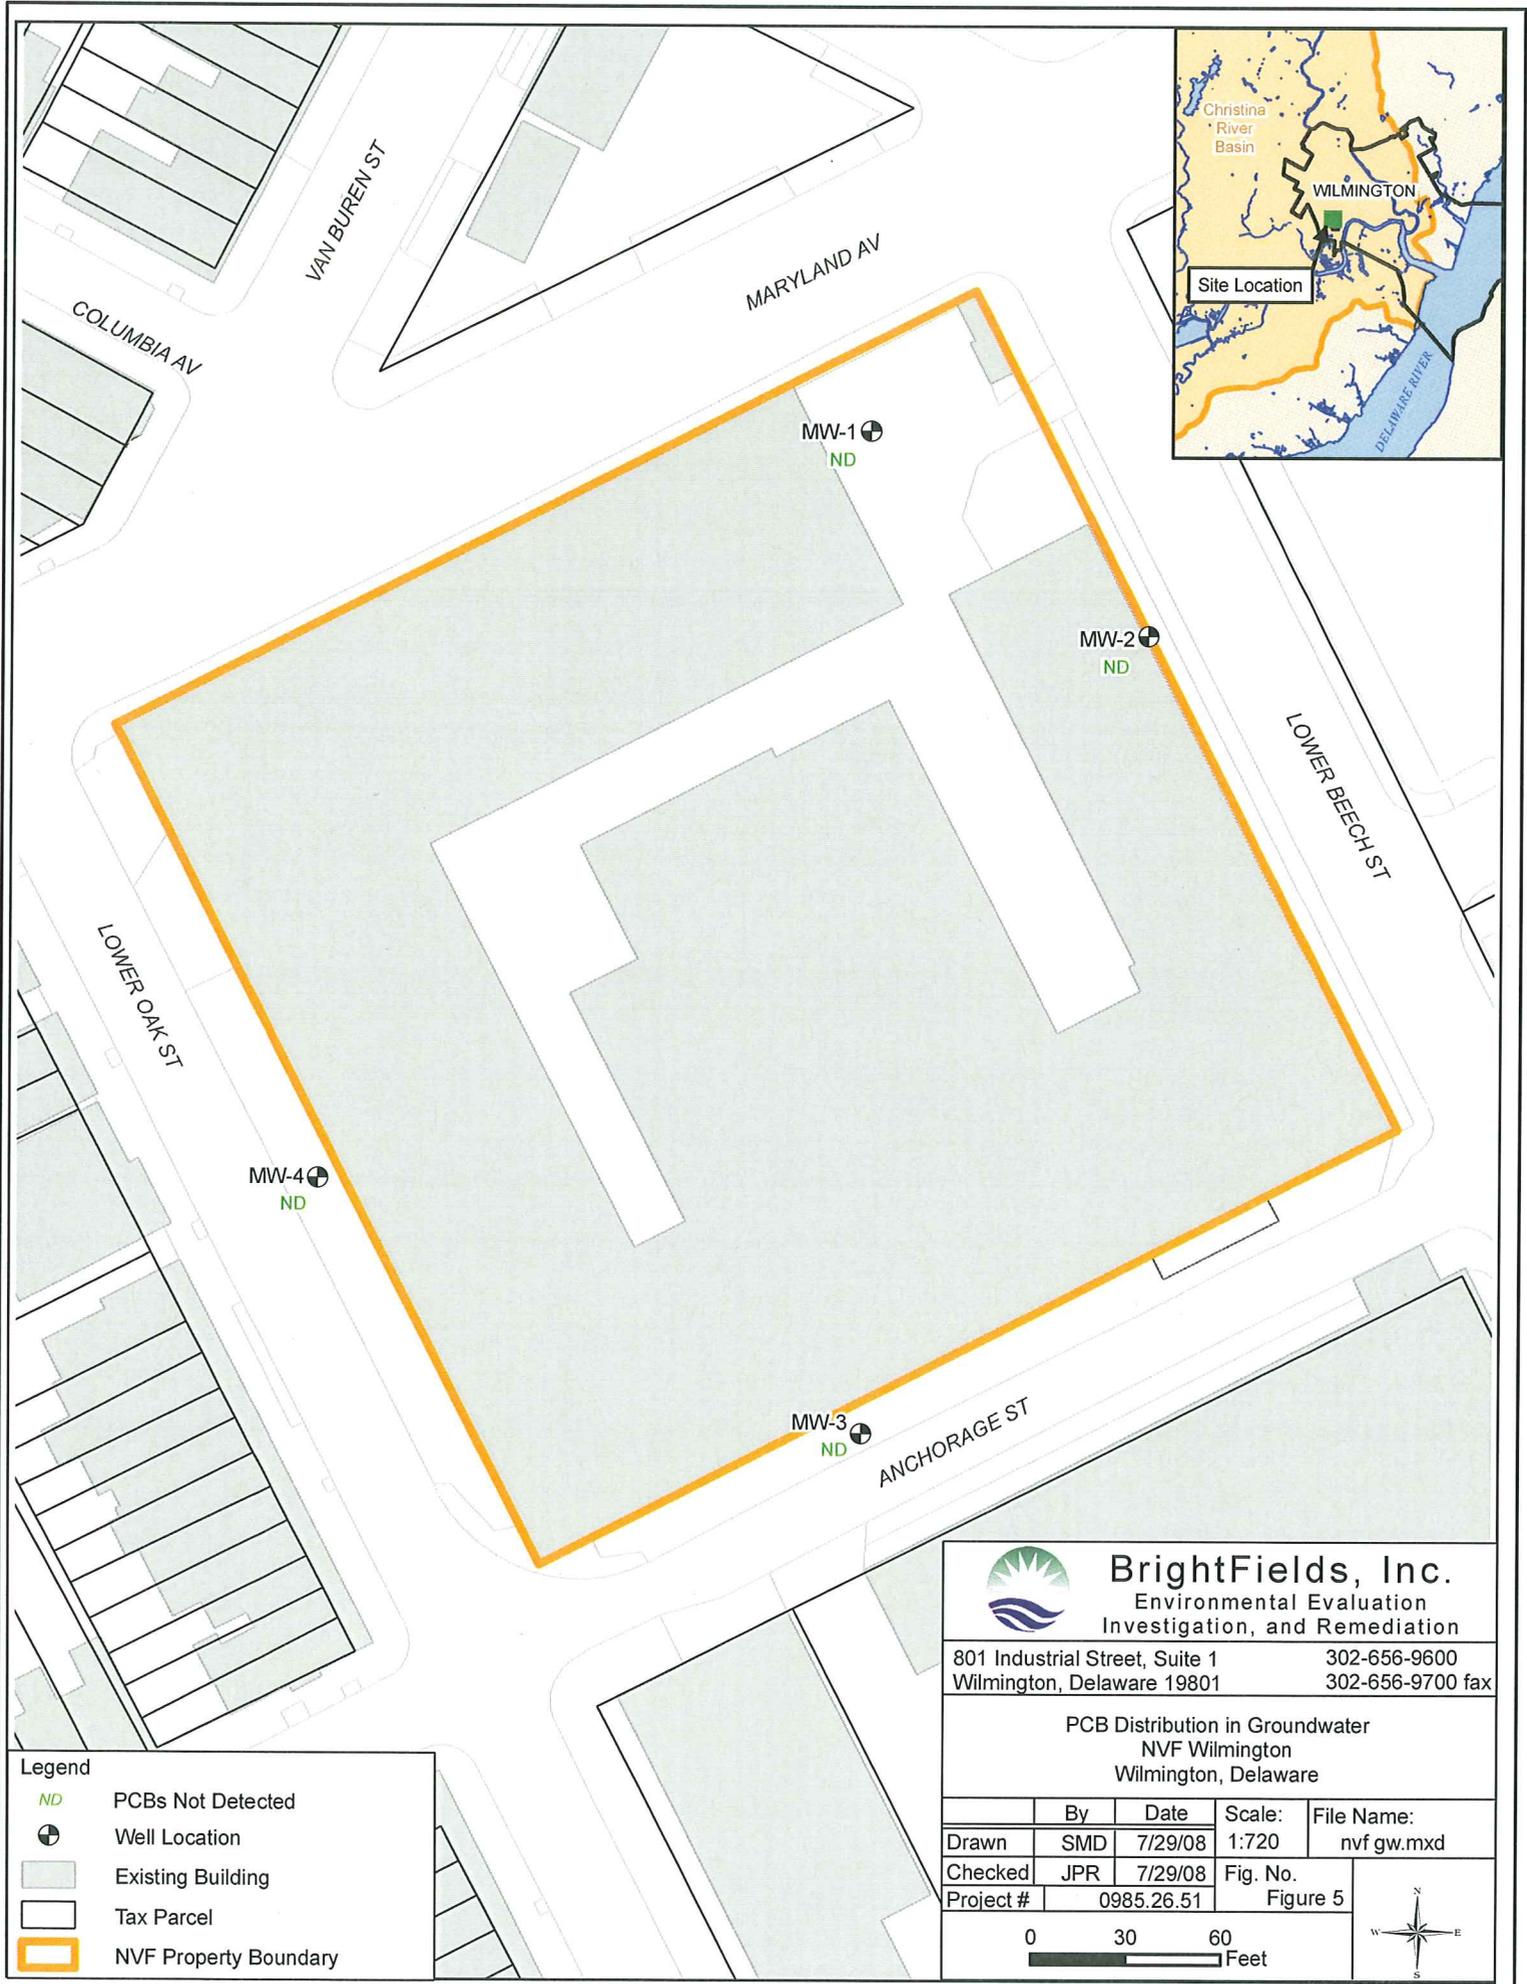
801 Industrial Street, Suite 1 Wilmington, Delaware 19801		302-656-9600 302-656-9700 fax		
PCB Distribution in Groundwater NVF Wilmington Wilmington, Delaware				
	By	Date	Scale:	File Name:
Drawn	SMD	7/29/08	1:720	nvf gw.mxd
Checked	JPR	7/29/08	Fig. No.	
Project #	0985.26.51		Figure 5

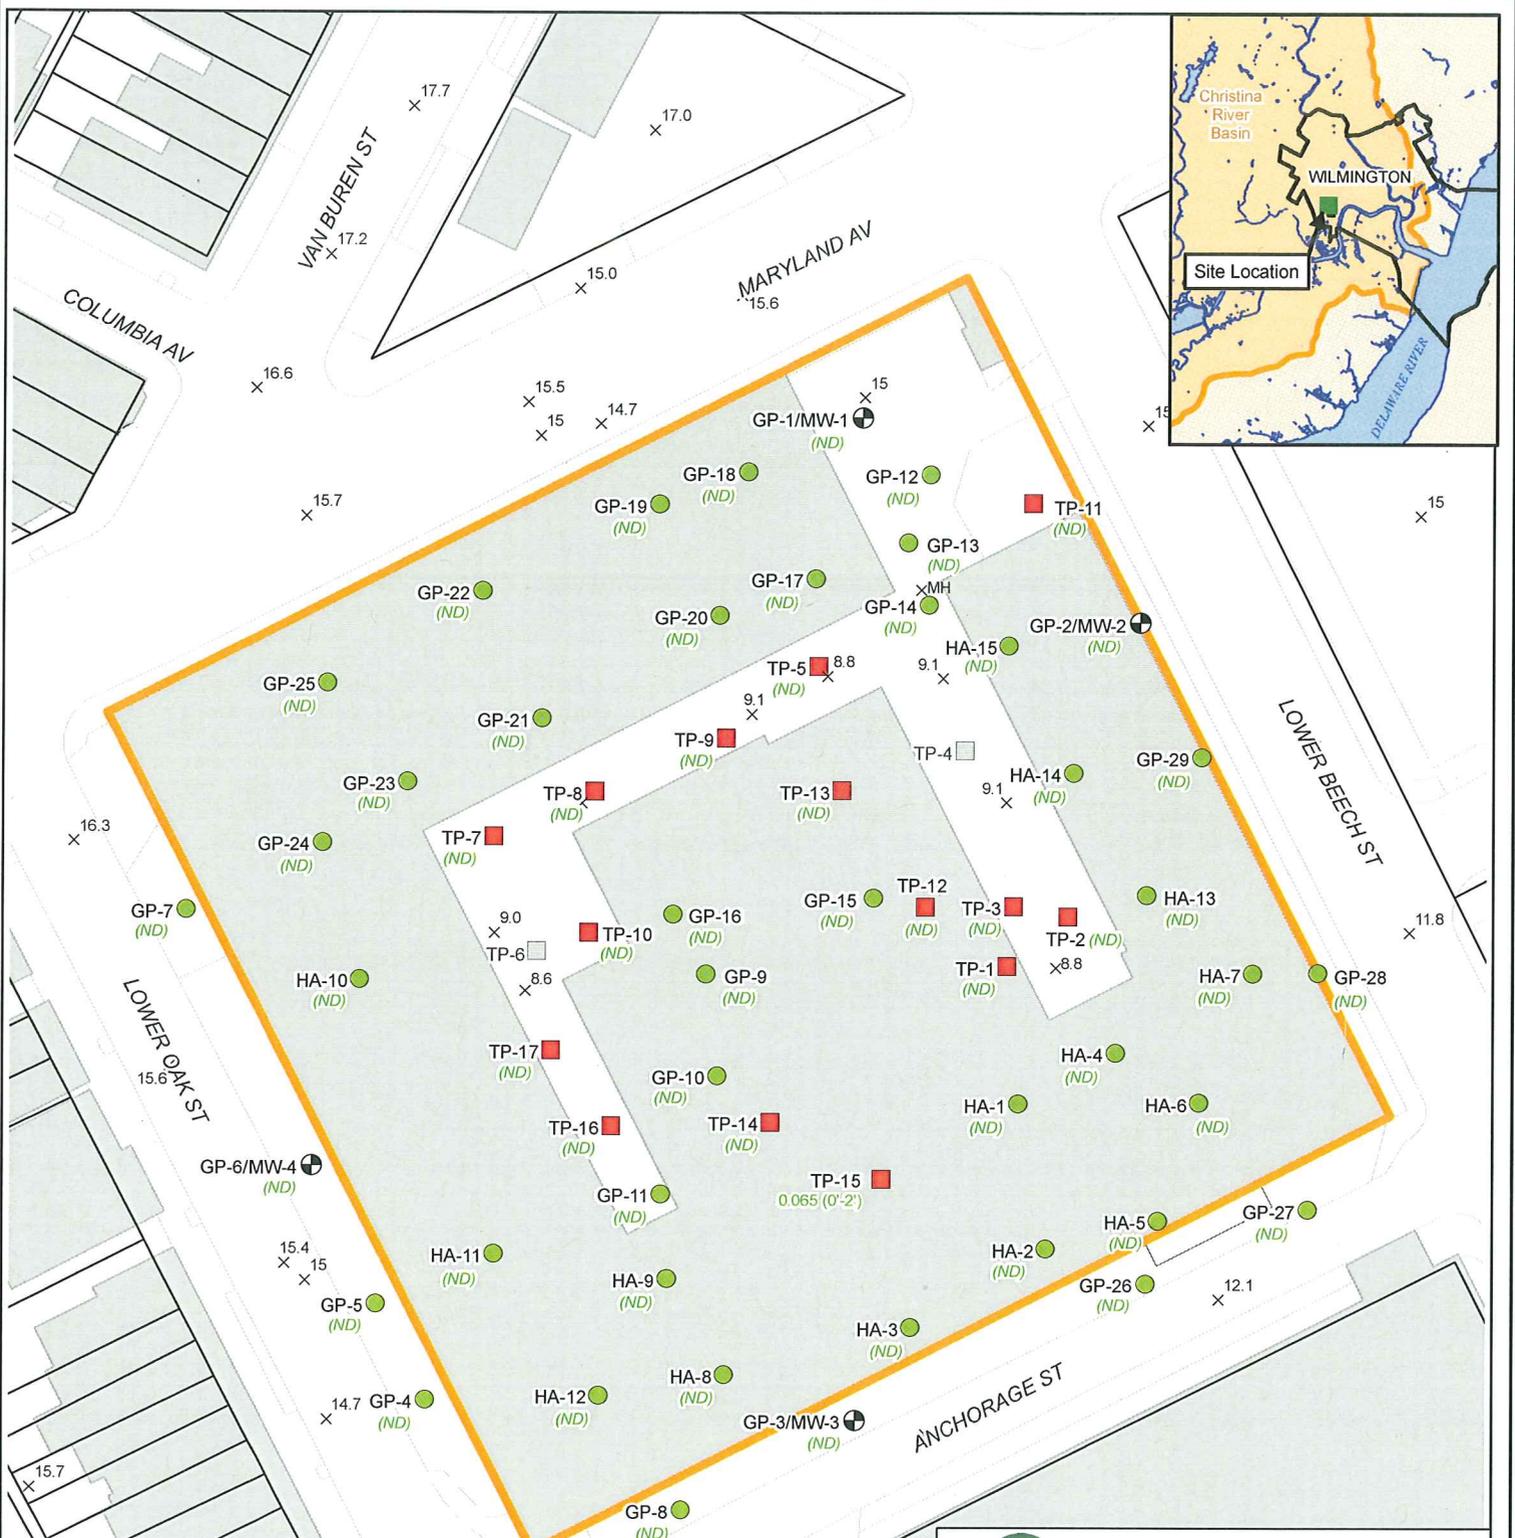
By	Date	Scale:	File Name:
Drawn	SMD	7/29/08	1:720	nvf topo.mxd
Checked	JPR	7/29/08	Fig. No.	Figure 6
Project #	0985.26.51

Overland Flow Map
NVF Wilmington
Wilmington, Delaware

One surface concentration was observed at NVF Wilmington at TP15 sample location. At the time of the inspection conducted by BrightFields on July 31, 2008 there was no access to inside of the facility. Interpretation of the aerial photograph led BrightFields to reason that the sample was either collected from inside the building footprint or directly adjacent to the building in the courtyard areas. Areas of the courtyard visible during the site visit consisted of impervious surfaces. No overland flow calculations were performed for this site because the sample location was interpreted as being under an impervious surface where little to no surface erosion could occur.

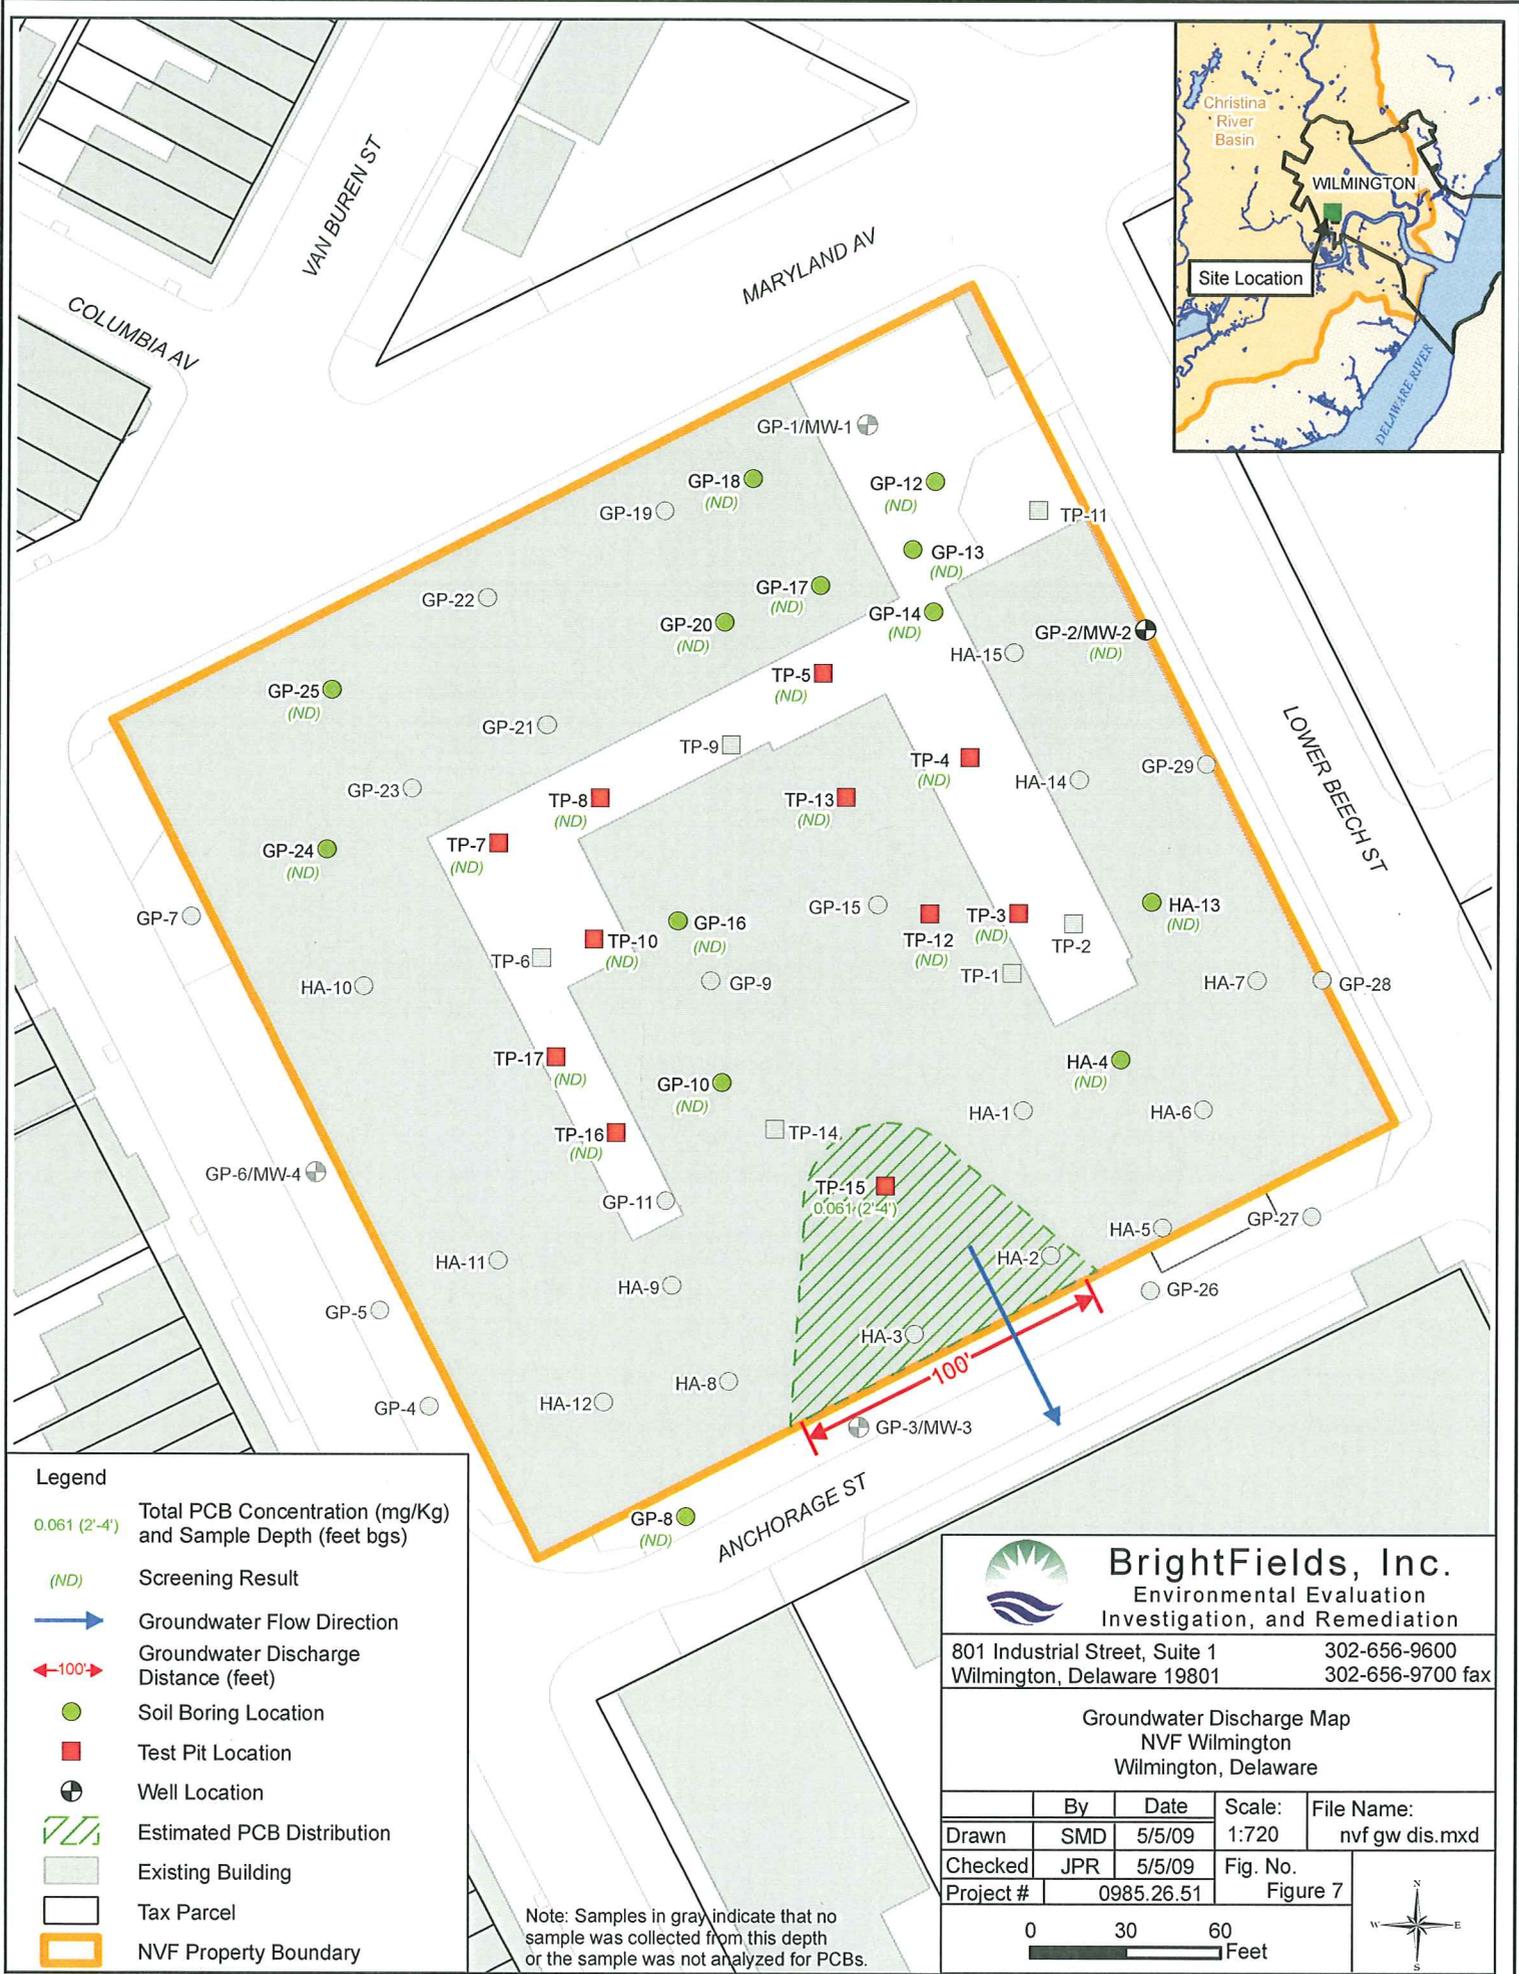
By	Date	Scale:	File Name:
Drawn	SMD	5/5/09	1:720	nvf gw dis.mxd
Checked	JPR	5/5/09	Fig. No.	Figure 7
Project #	0985.26.51

Groundwater Discharge Map
 NVF Wilmington
 Wilmington, Delaware

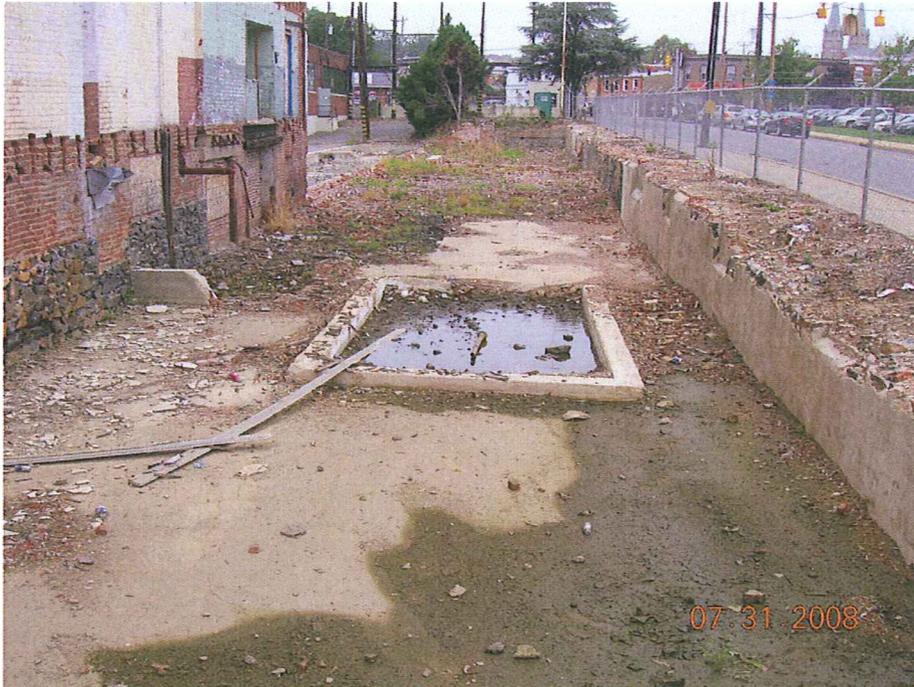
Basement slab remaining from demolition of building along Beech St.

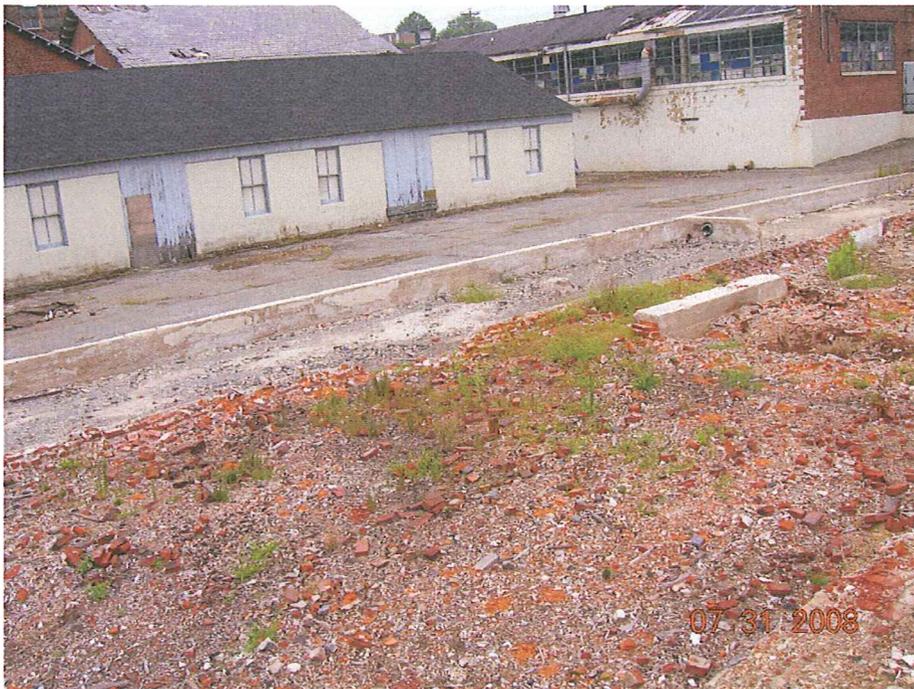
Crushed brick and gravel placed on site from building demolition.

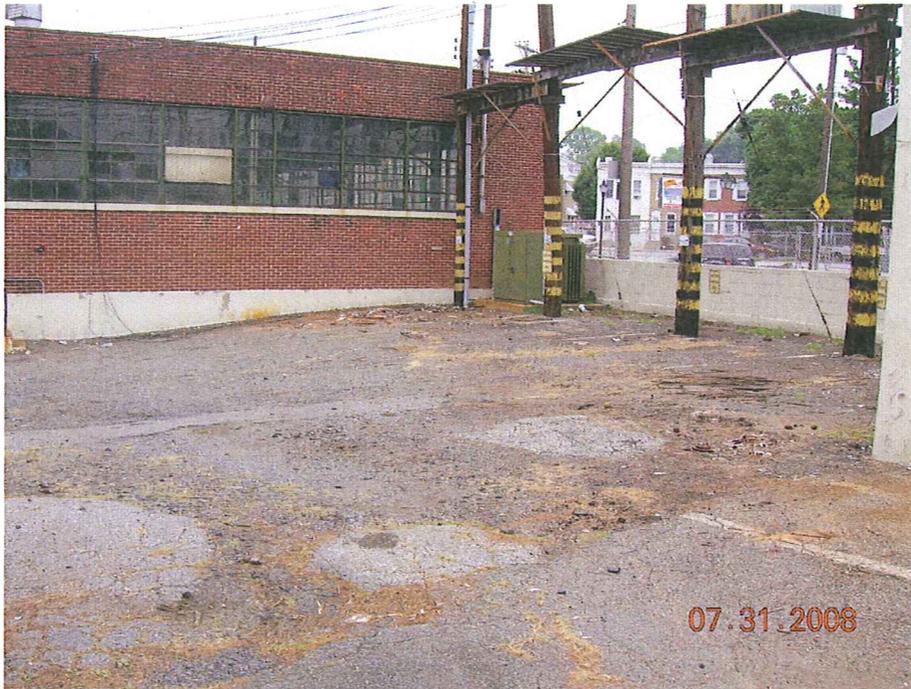
Area under capacitors.

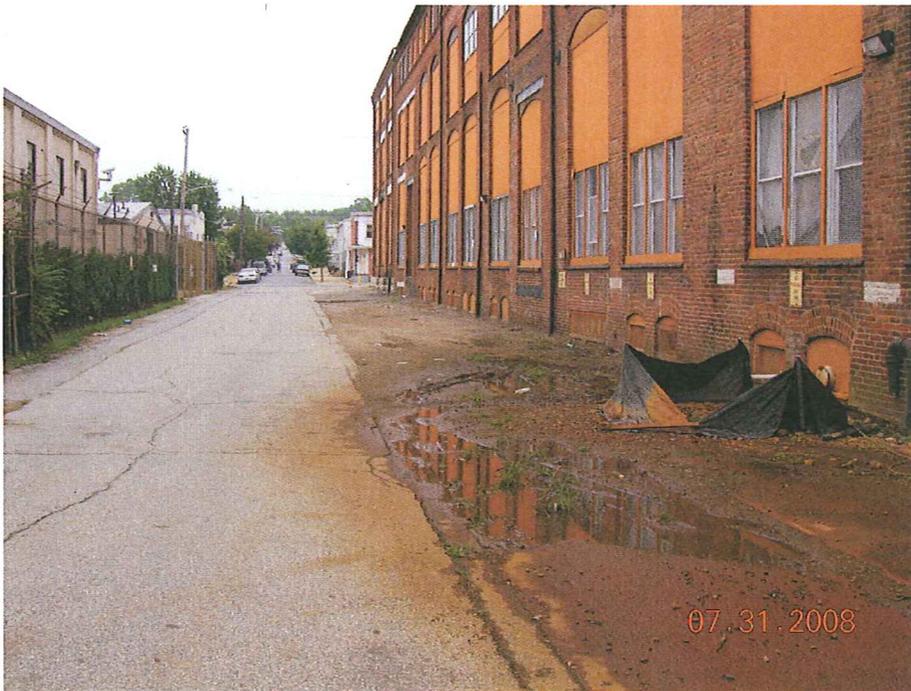
Anchorage Street side of NVF - Wilmington building.

At the time of the inspection the only sediment and erosion control on site included a physically damaged silt fence surrounding a catch basin directly adjacent to the NVF-Wilmington building on Anchorage Street.

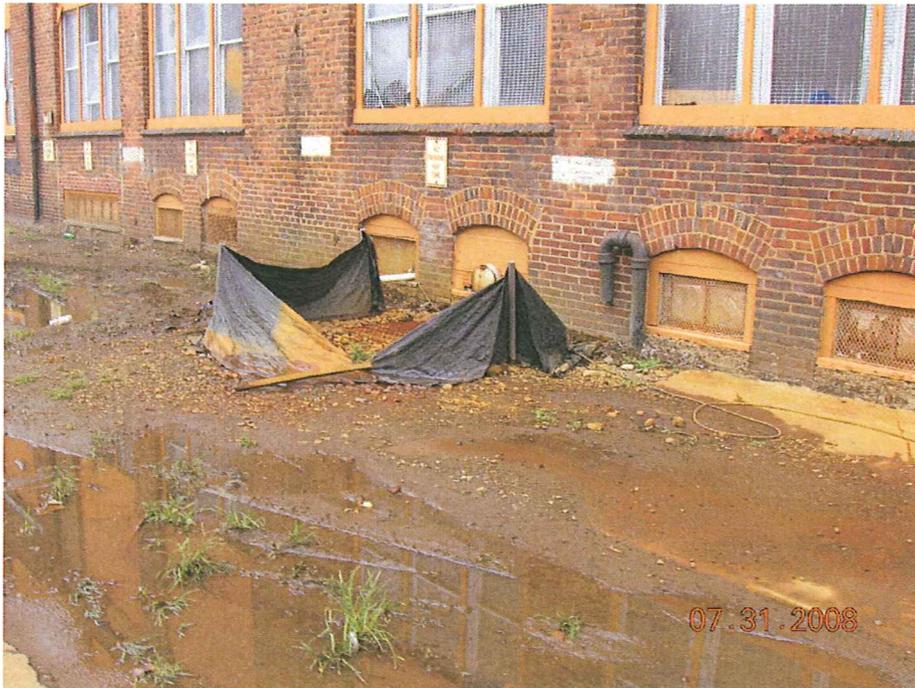
Likely overland flow discharge point for TP15, if sample location is not under an impervious surface.
