PCB Mass Loading
Salvation Army Property
SIRB ID: DE-1370
Wilmington, Delaware

Appendix 23

SALVATION ARMY PROPERTY WILMINGTON, DELAWARE

SIRB ID: DE-1370

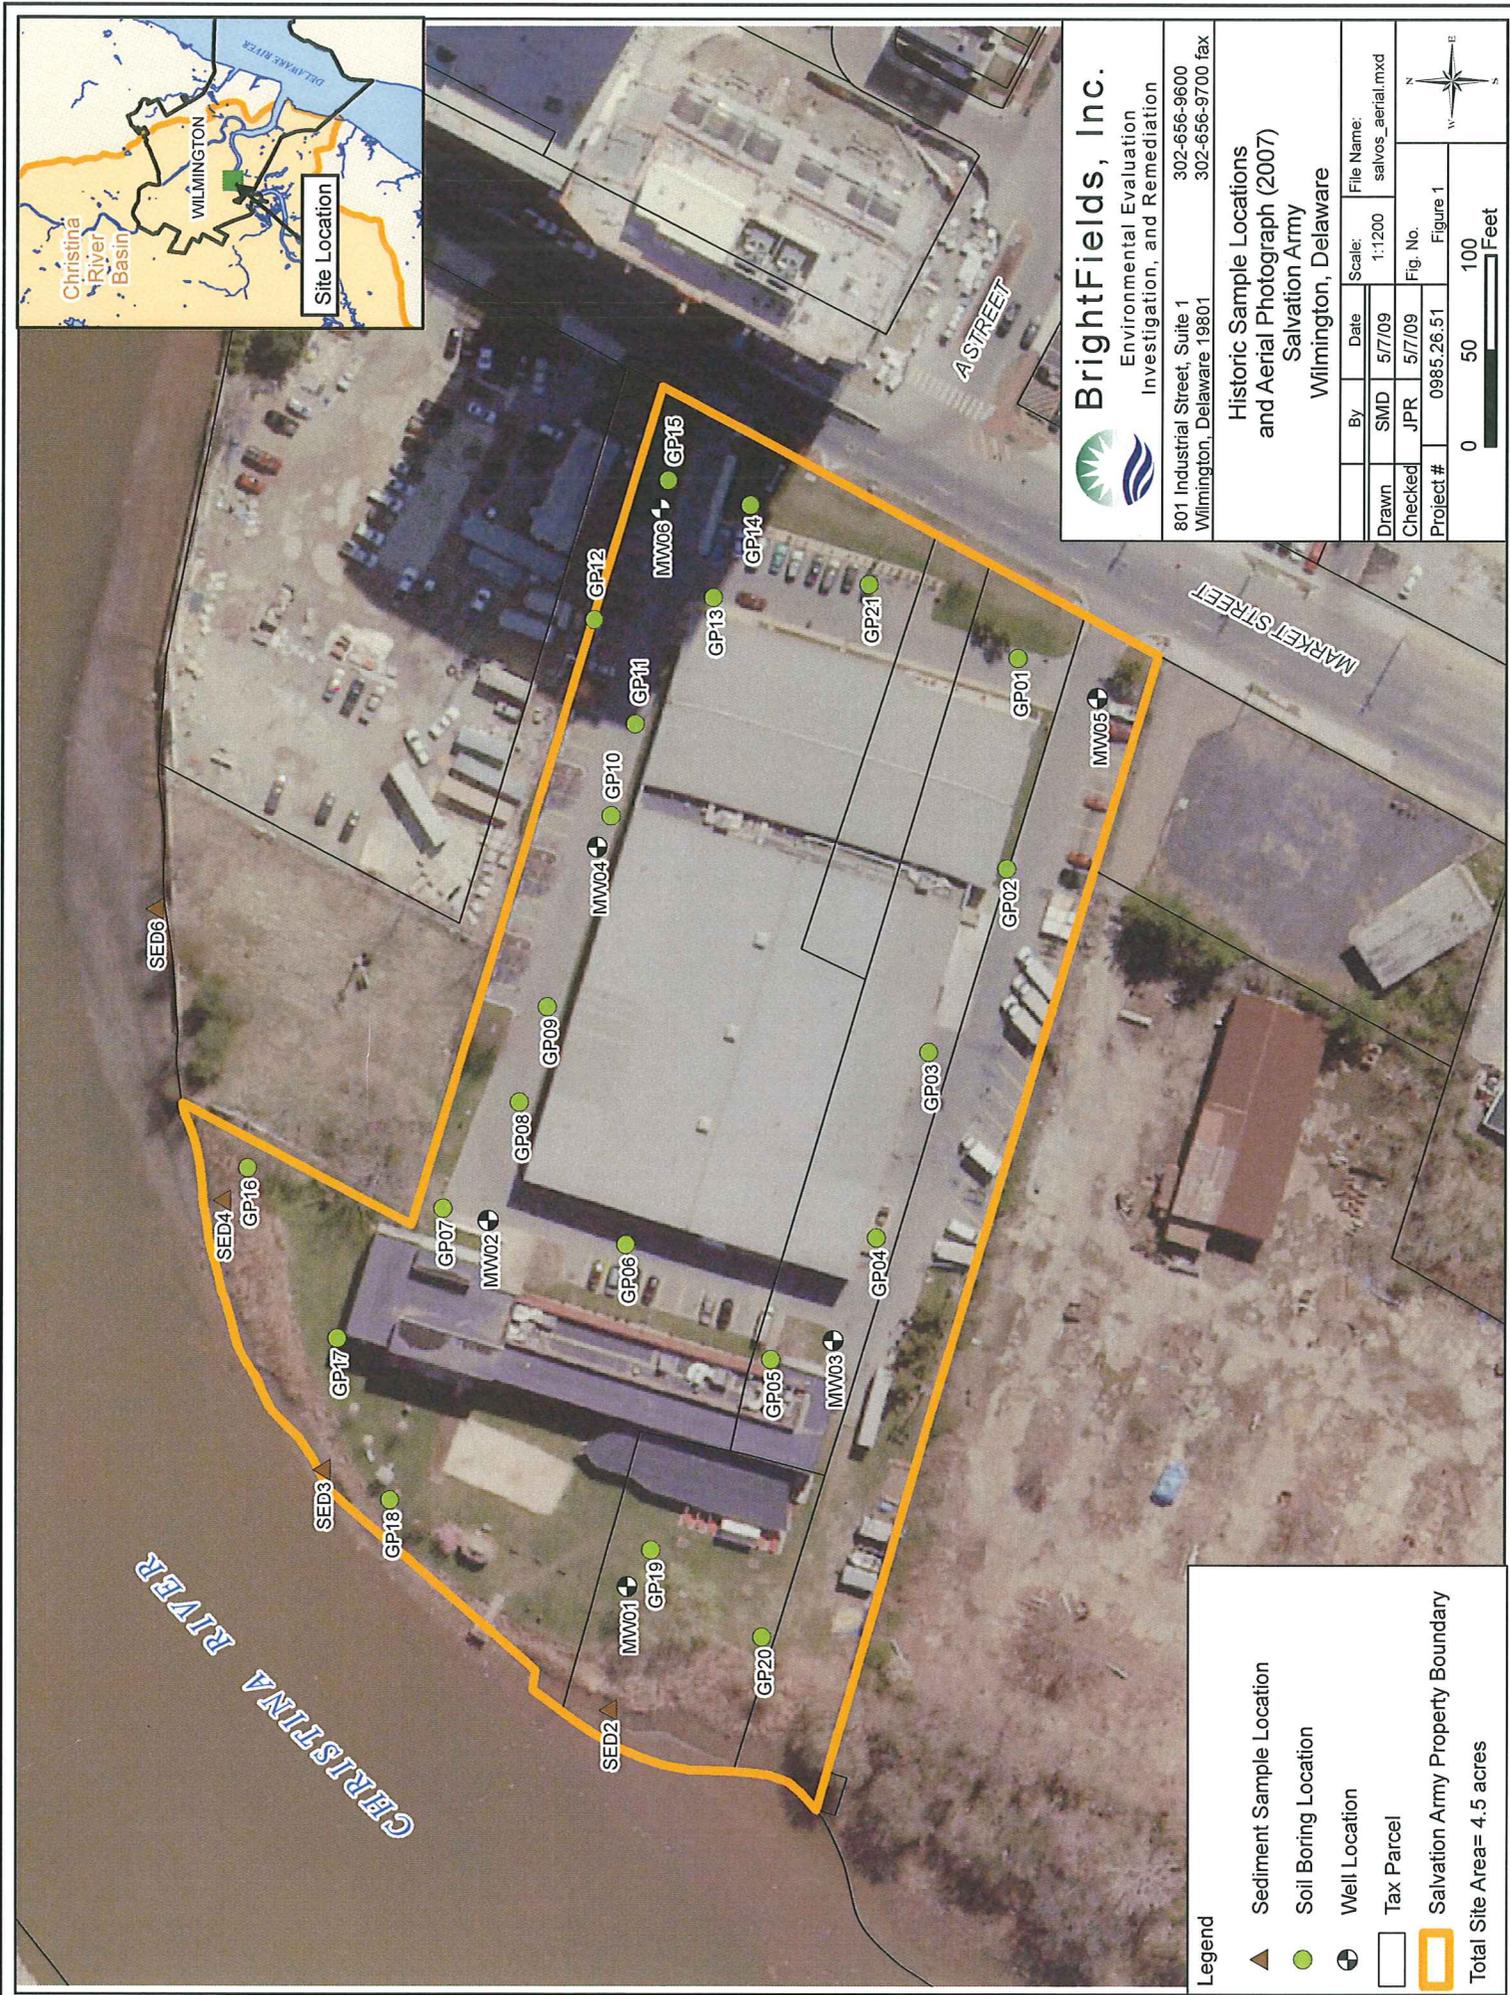
By	Date	Scale:	File Name:
Drawn	SMD	5/7/09	1:1200
Checked	JPR	5/7/09	salvos_aerial.mxd
Project #	0985.26.51		Figure 1

Historic Sample Locations
 and Aerial Photograph (2007)
 Salvation Army
 Wilmington, Delaware

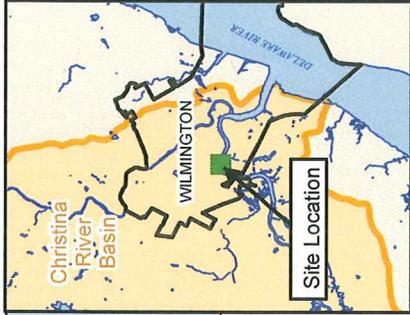
By	Date	Scale:	File Name:
Drawn	SMD	8/1/08	1:1200
Checked	JPR	8/1/08	salvos_0-2.mxd
Project #	0985.26.51		Figure 2

PCB Distribution in Surface Soil (0'-2' bgs)

Salvation Army
Wilmington, Delaware

Note: Samples in gray indicate that no sample was collected from this depth or the sample was not analyzed for PCBs.

Concentrations of PCBs on Site			
Sample Matrix	Corresponding Figure	Analytical Methods	Range of Total PCBs
Surface Soil	Figure 2	Method 8082 and Screening Data	Not detected
Subsurface Soil (unsaturated)	Figure 3	Method 8082 and Screening Data	Not detected
Subsurface Soil (saturated)	Figure 4	Method 8082 and Screening Data	Not detected to 0.45 mg/kg
Ground Water	Figure 5	Method 8082	Not detected

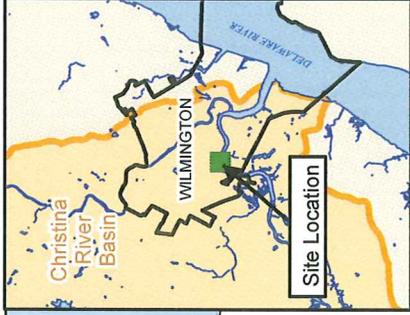
By	Date	Scale	File Name:
SMD	8/1/08	1:1200	salvos_unsat.mxd
Checked	JPR	8/1/08	Fig. No.
Project #	0985.26.51	Figure 3

PCB Distribution in Subsurface Unsaturated Soil Salvation Army Wilmington, Delaware

Note: Samples in gray indicate that no sample was collected from this depth or the sample was not analyzed for PCBs.

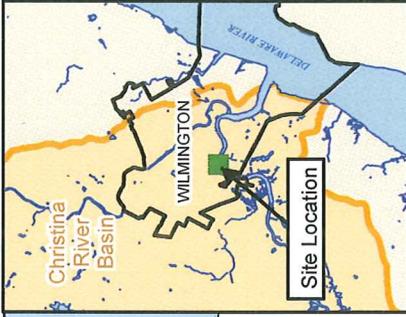
- 0.45 (7'-8') [Green hatched box]
- (ND) [Green circle]
- ND (6'-8') [Green circle]
- Sediment Sample Location [Green triangle]
- Soil Boring Location [Green circle]
- Well Location [Black circle with crosshair]
- Estimated PCB Distribution [Green hatched box]
- Existing Building [Gray rectangle]
- Historic Building [Light gray rectangle]
- Water [Blue area]
- Tax Parcel [Black outline]
- Salvation Army Property Boundary [Orange outline]

Note: Samples in gray indicate that no sample was collected from this depth or the sample was not analyzed for PCBs.

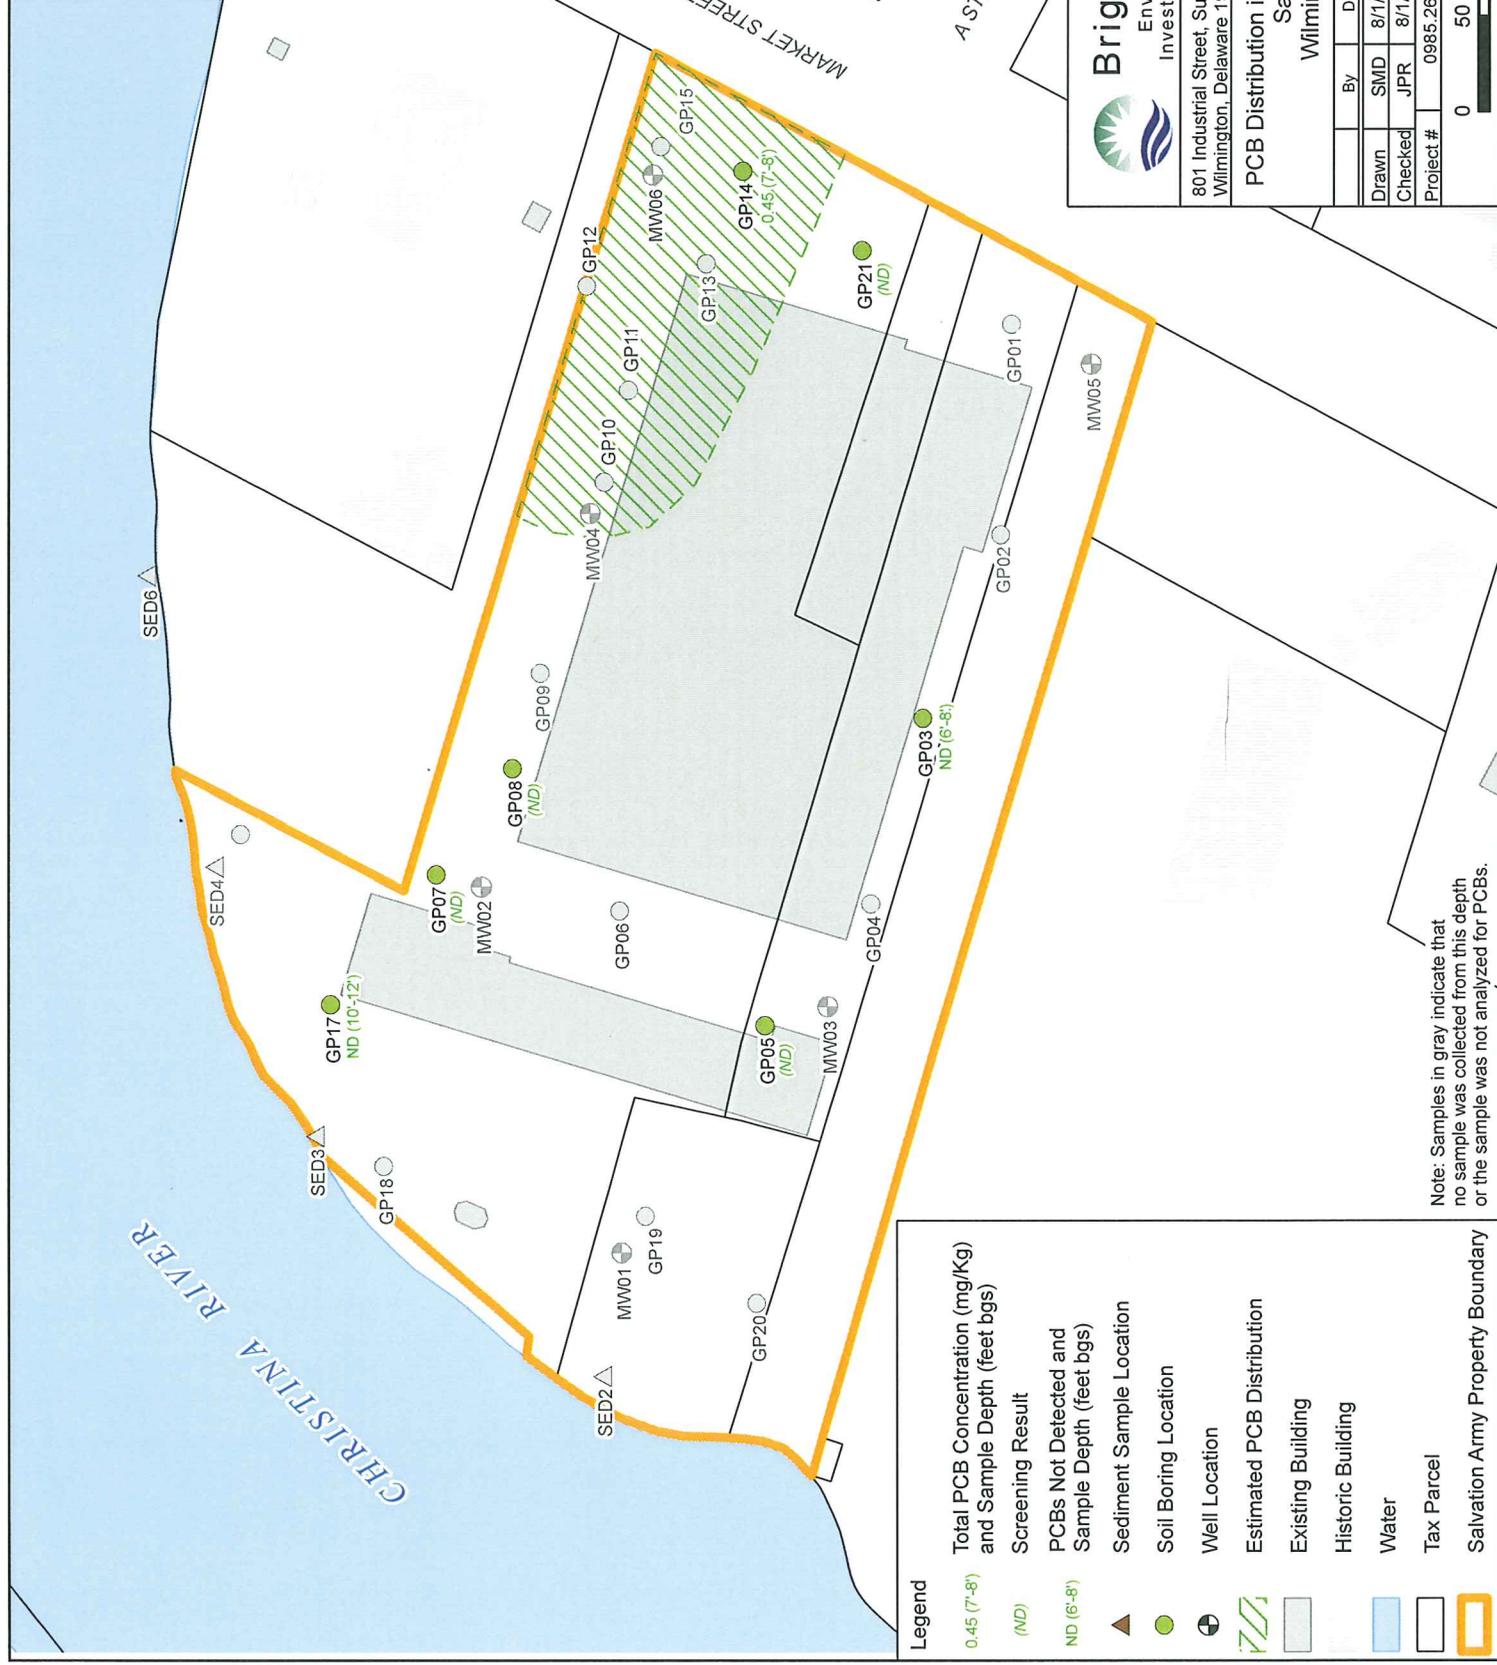
By	Date	Scale	File Name:
Drawn	SMD	1:1200	salvos_sat.mxd
Checked	JPR	8/1/08	
Project #	0985.26.51	Fig. No.	Figure 4

PCB Distribution in Subsurface Saturated Soil

PCBs (Aroclor-1254) were detected in subsurface saturated soil at one location, GP14-S002 (7.0 to 8.0 feet below ground surface (bgs)) at a concentration of 0.450 mg/kg, which is below the restricted use Uniform Risk-Based Remediation Standard (URS) value for human health for Aroclor-1254. The surface soil and unsaturated subsurface soil did not contain any PCBs.

There are no surface or subsurface unsaturated soil areas that are impacted by PCBs. The estimated subsurface saturated soil area impacted by PCBs is 0.53 acres in the vicinity of GP14 (Figure 4).

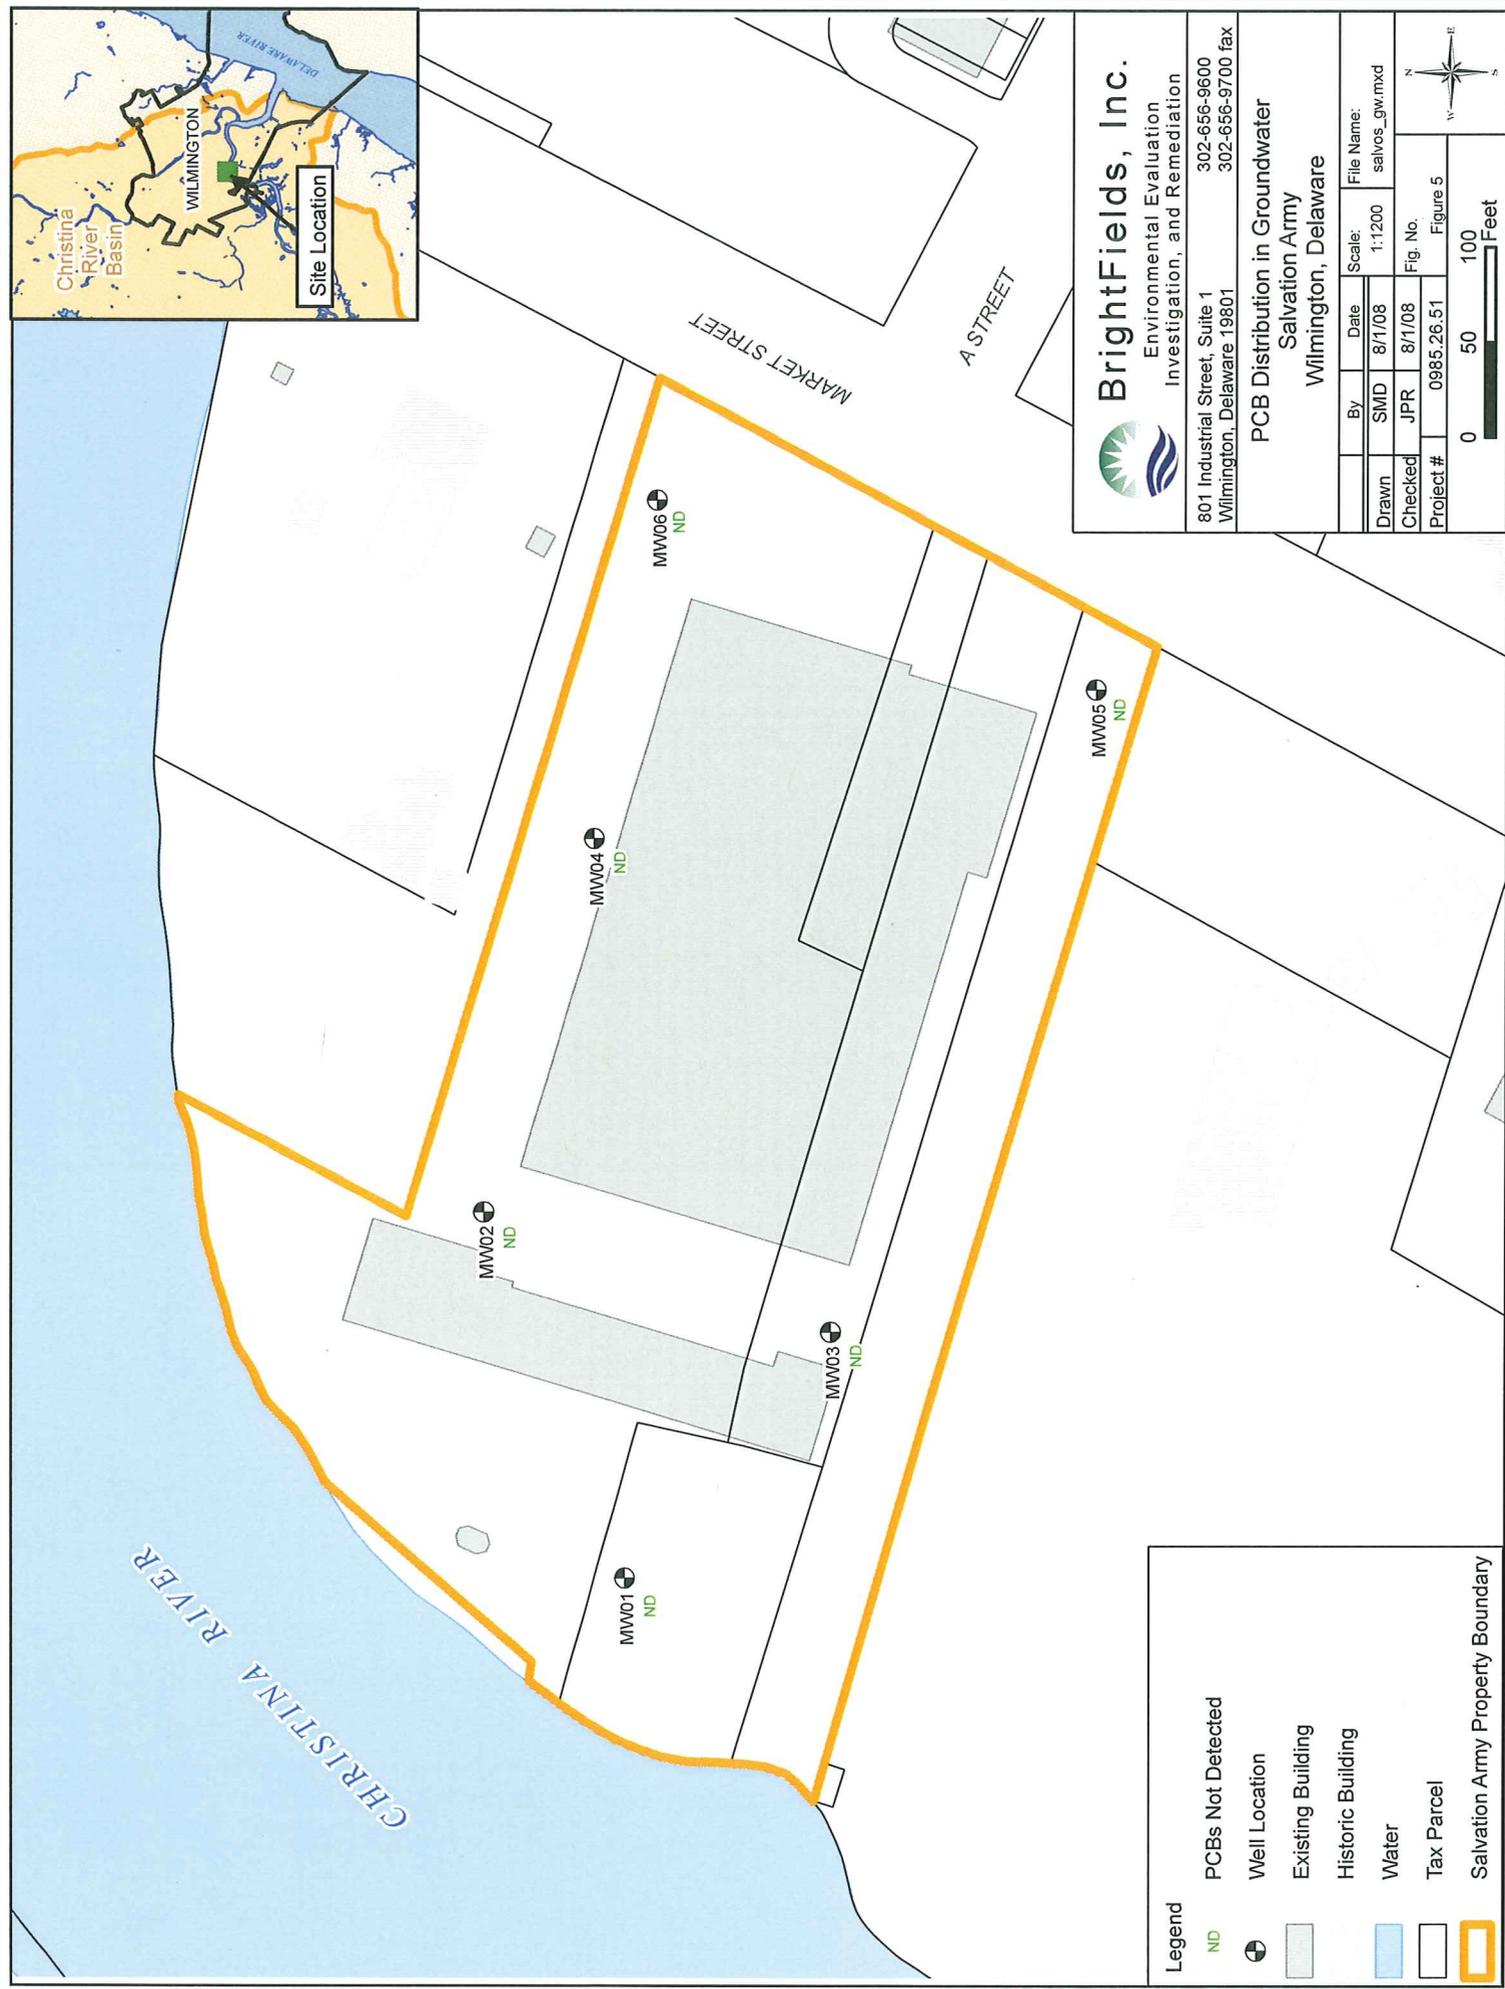
By	Date	Scale:	File Name:
Drawn	SMD 8/1/08	1:1200	salvos_gw.mxd
Checked	JPR 8/1/08		
Project #	0985.26.51	Fig. No.	Figure 5

PCB Distribution in Groundwater
Salvation Army
Wilmington, Delaware

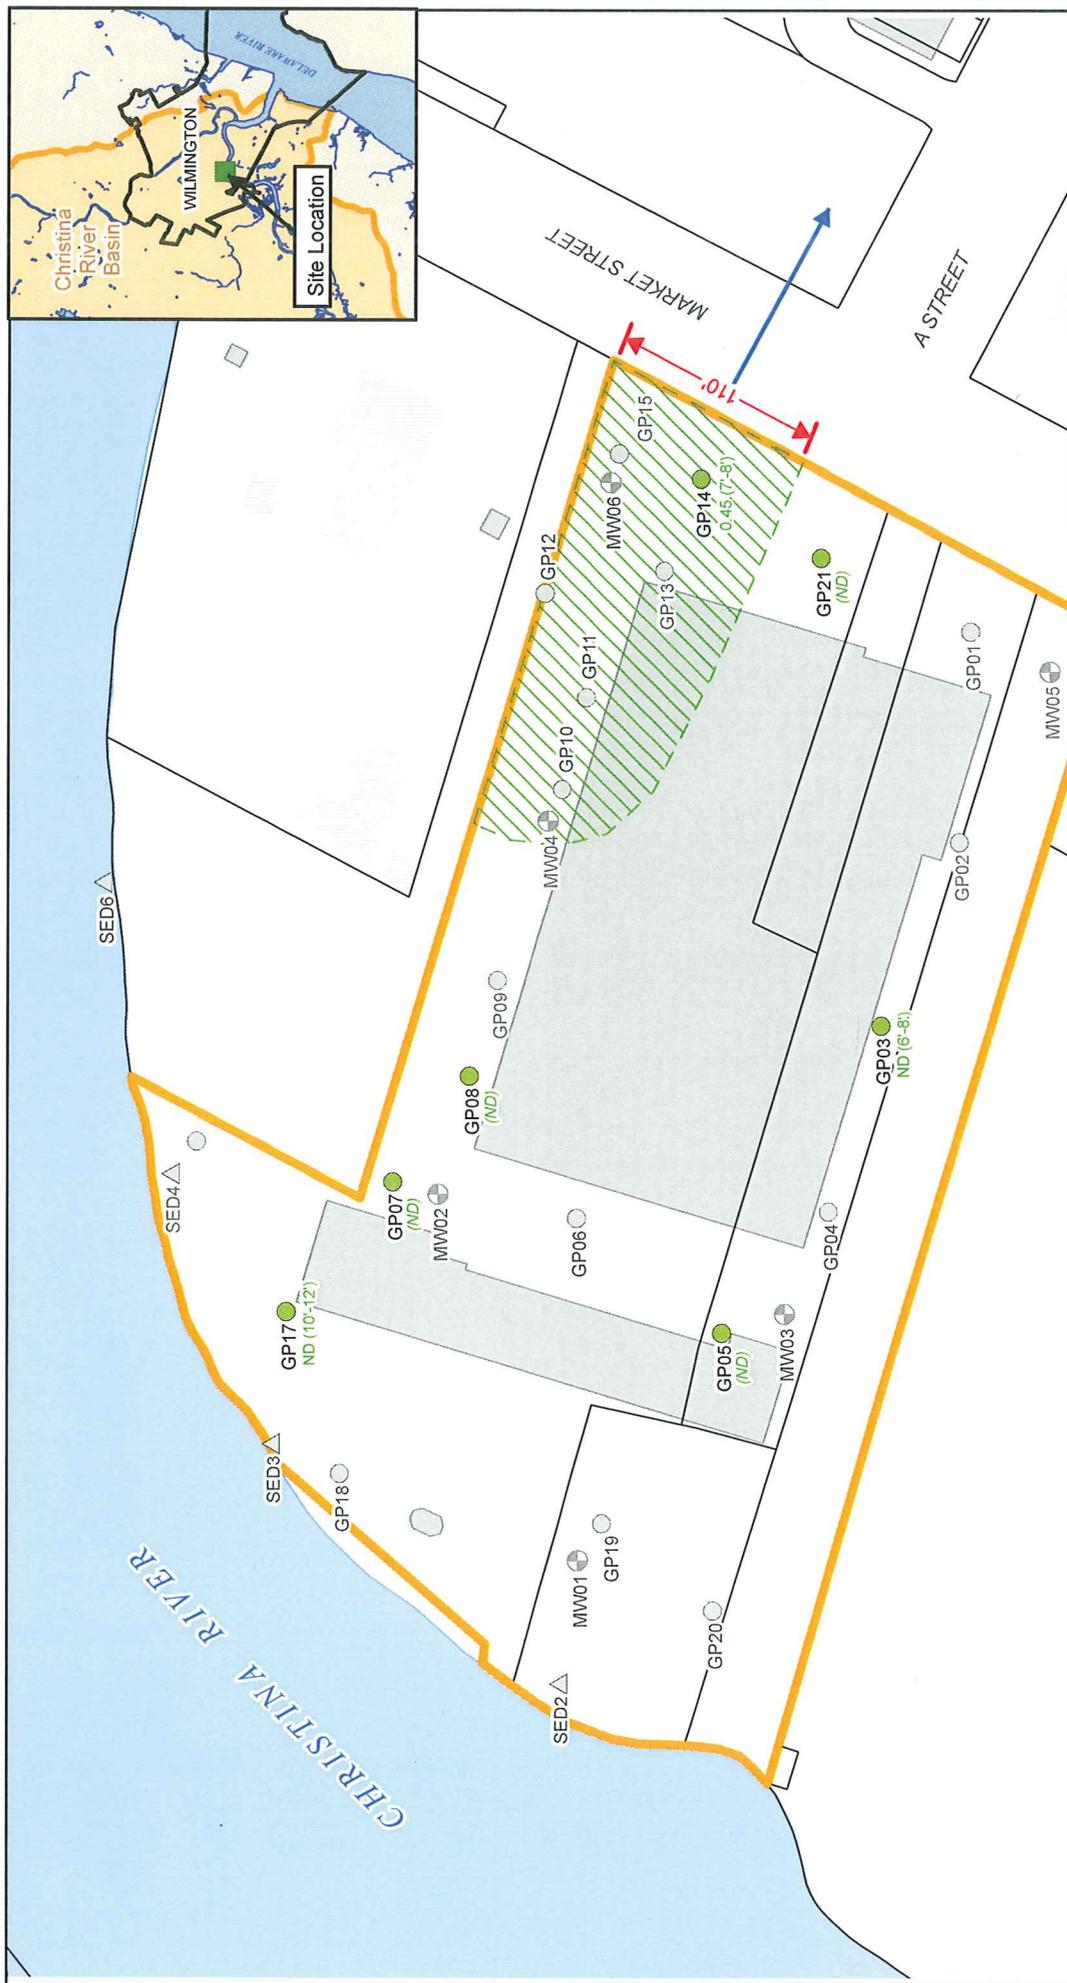
By	Date	Scale	File Name:
SMD	5/19/09	1:1200	salvos_sat.mxd
Checked	JPR	5/19/09	Fig. No.
Project #	0985.26.51		Figure 6

Groundwater Discharge Map
 Salvation Army
 Wilmington, Delaware

- ▲ 0.45 (7'-8')
- ND (6'-8')
- ND (10'-12')
- ▲ Sediment Sample Location
- Soil Boring Location
- ⊕ Well Location
- Groundwater Flow Direction
- ↔ 110' Groundwater Discharge Distance (feet)
- ▨ Estimated PCB Distribution
- ▭ Existing Building
- ▭ Historic Building
- ▭ Water
- ▭ Tax Parcel
- ▭ Salvation Army Property Boundary

Saturated Thickness (ft)	8.3	8.3	Based on the borings logs, the saturated thickness averaged 8.3 feet.
Lateral Discharge Distance (ft)	110	110	The lateral discharge distance was estimated to be equal to the length of the PCB impacted area measured perpendicular to the Christina River.
A= Cross-Sectional Area (ft ²)	913	913	Calculated from the saturated thickness and lateral discharge distance.
Groundwater PCB Concentration (ug/L)	0.10	0.49	The maximum concentration observed in the saturated subsurface soil (0.450 mg/kg) was used to determine the estimated concentration in groundwater.
Distance to Discharge point (ft)	Directly adjacent		Approximate distance from property boundary to closest surface water location.

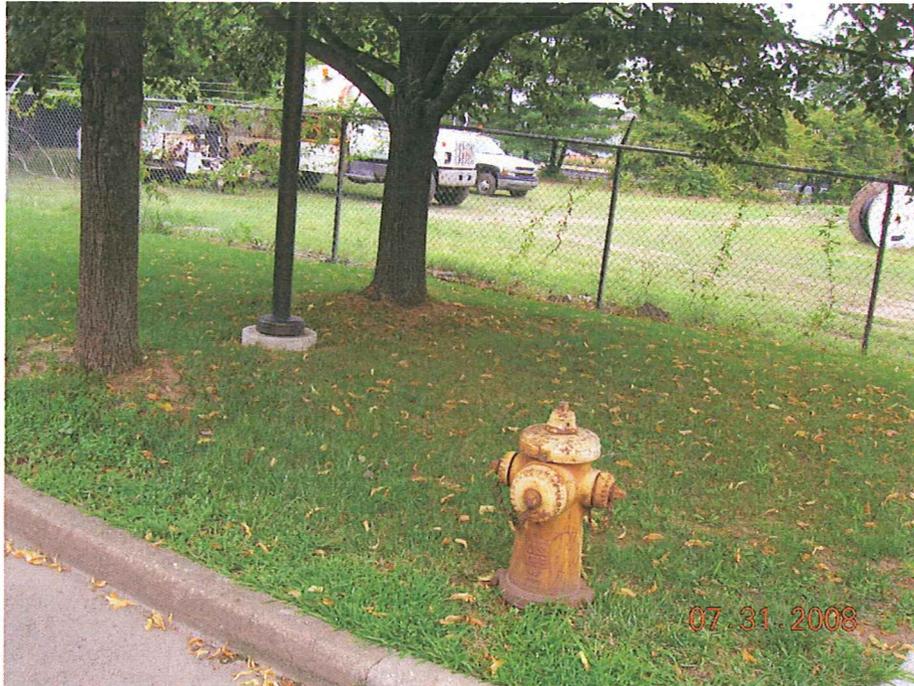
Landscaped areas associated with the Salvation Army building.

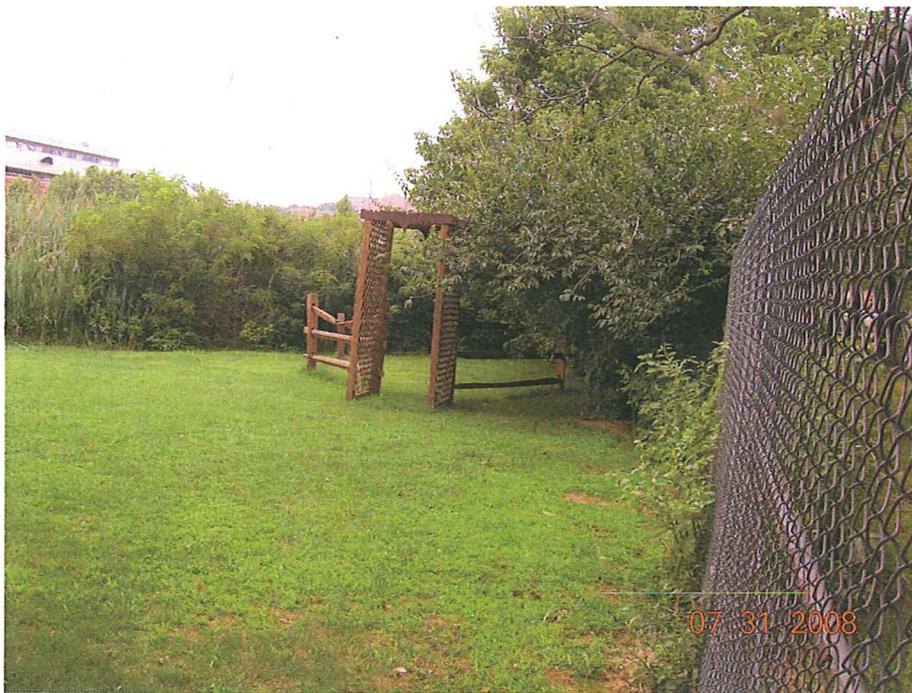
Cover in the northwest portion of the site.

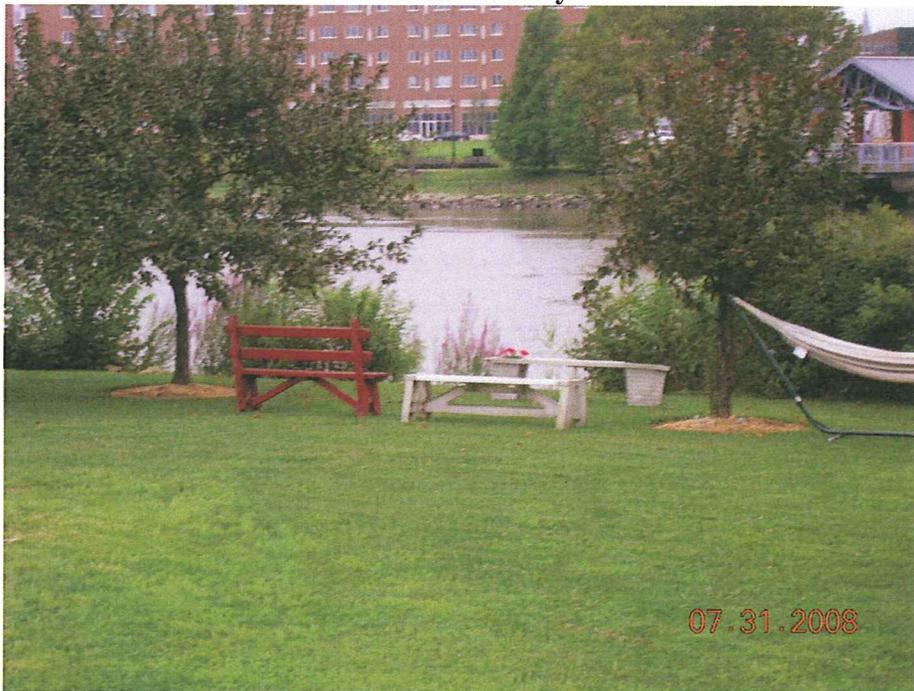
Cover behind the rehabilitation facility. Slopes directly into river with very little riparian buffer.

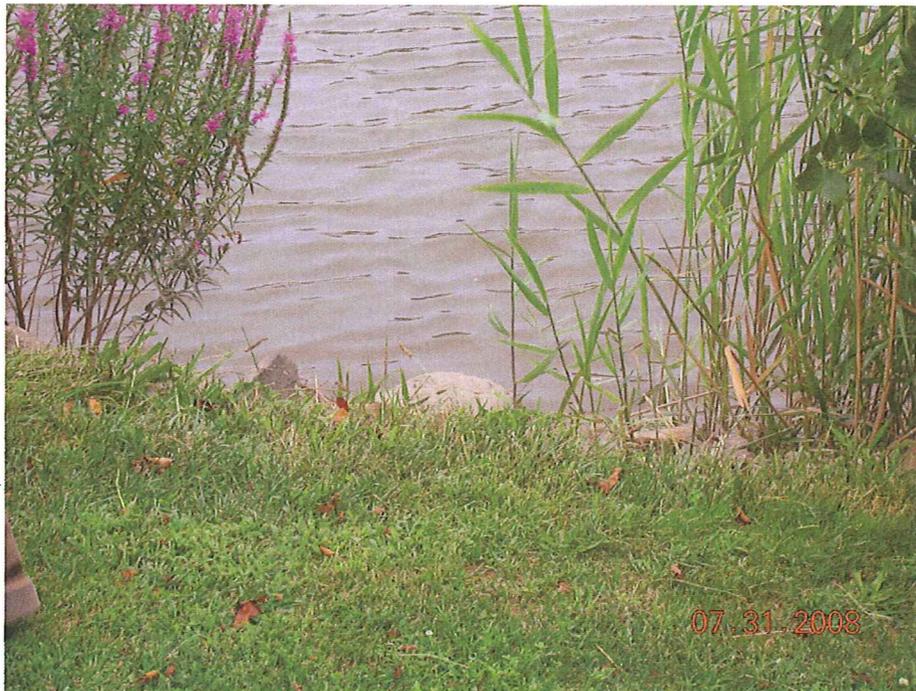
Grass cut all the way up to river bank.

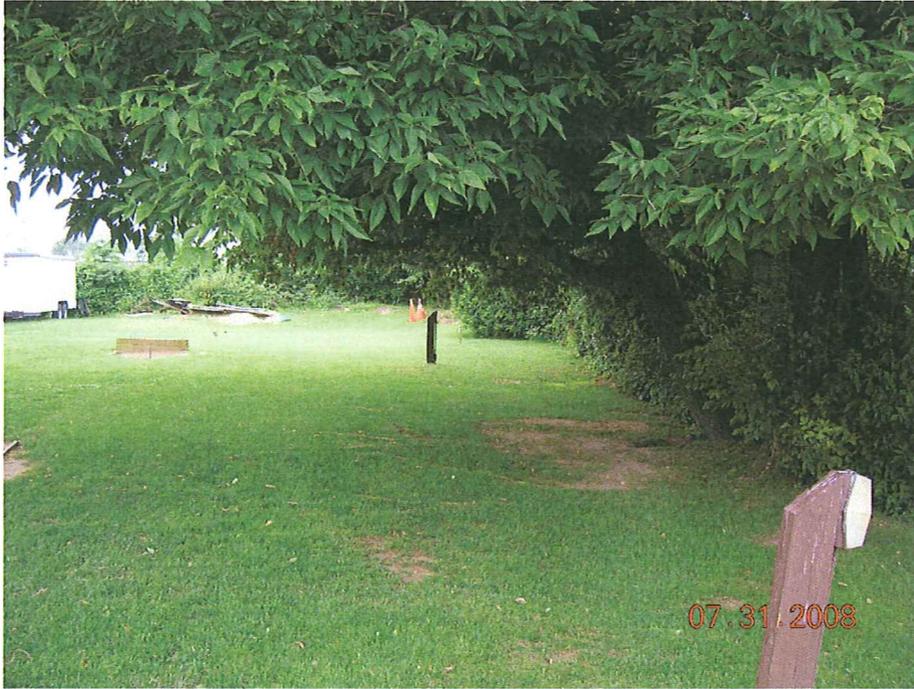
Cover in the southwest portion of the site with larger riparian buffer.
