PRELIMINARY ASSESSMENT OF
WILMINGTON AMTRAK RAILYARD - MAINTENANCE FACILITY
PREPARED UNDER

TDD NO. F3-8808-54
EPA NO. DE-170
CONTRACT NO. 68-01-7346

FEBRUARY 23, 1989

Site Inspection Report
Amtrak Wilmington Refueling Facility
December, 1994

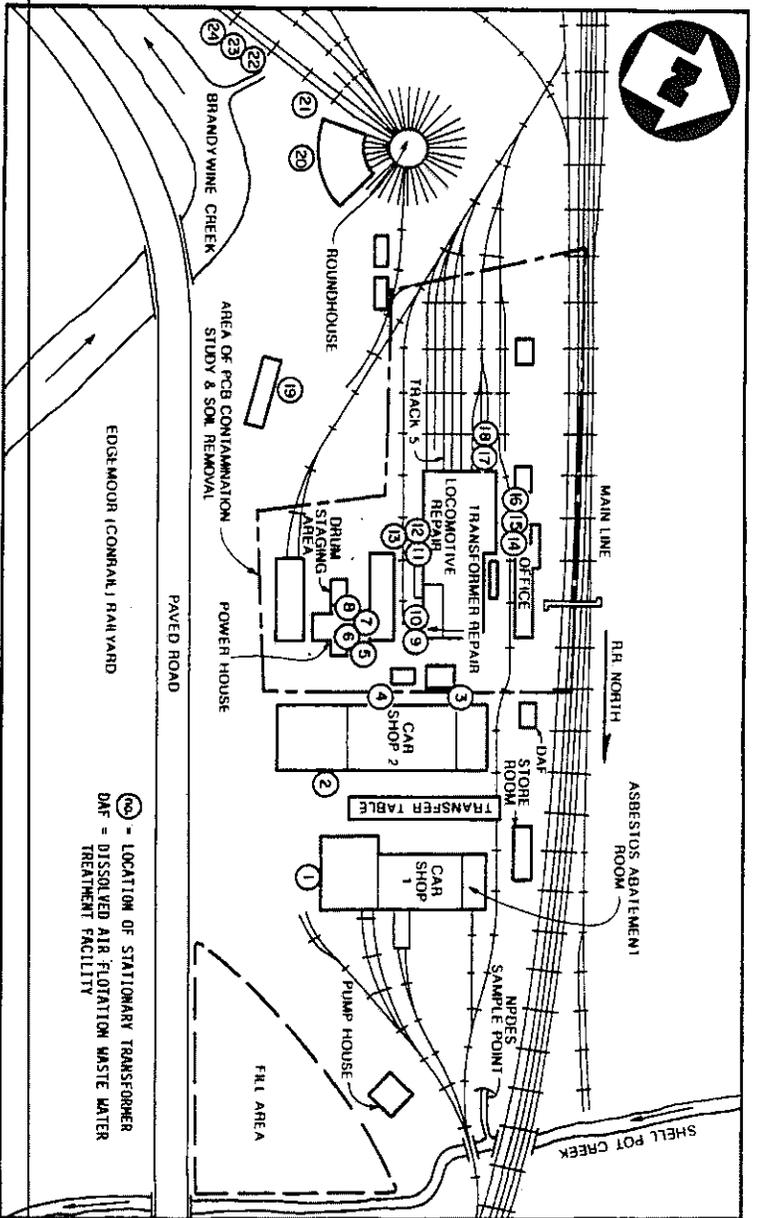
SITE SKETCH
 WILMINGTON AMTRAK RAILYARD MAINTENANCE FACILITY
 (NO SCALE)

(1) = LOCATION OF STATIONARY TRANSFORMER
 DAF = DISSOLVED AIR FLUTATION WASTE WATER TREATMENT FACILITY

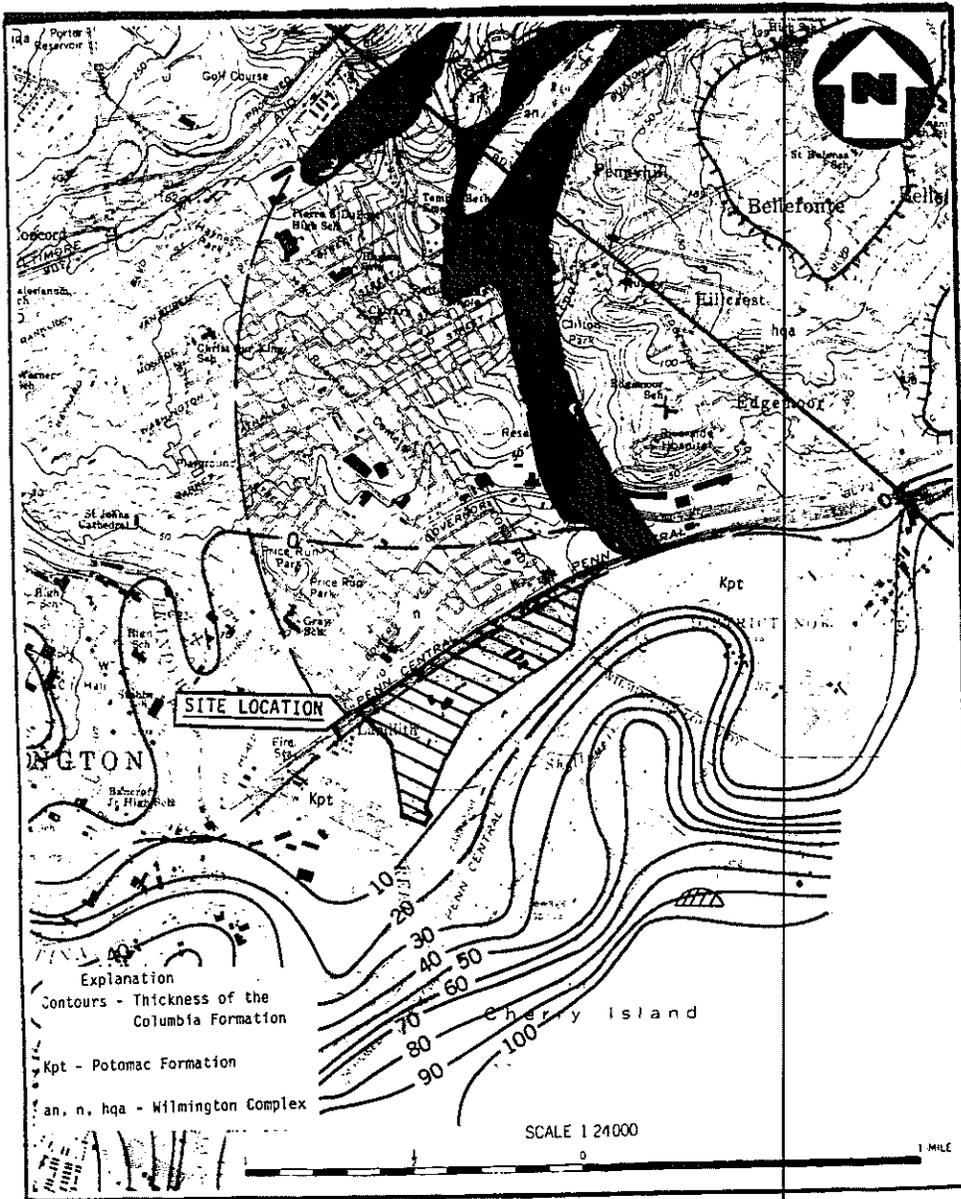
Geologic Map: Wilmington Amtrak Railyard Maintenance Facility
New Castle County, Delaware

The Cretaceous age Potomac Formation underlies the Columbia Formation and consists of variegated red, gray, purple, yellow, and white silts and clays. These silts and clays contain interbeds of white, gray, and rust brown quartz sands and gravels. The Potomac Formation pinches out along the northwestern edge of the site, so the thickness of the Potomac Formation is expected to be thin beneath the site.^{18,19}

The Precambrian age Wilmington Complex subcrops beneath the Columbia Formation along the northwestern border of the site and crops out approximately 0.1 mile north of the site. In the site area, the Wilmington Complex consists of norite, hypersthene-quartz-andesine gneiss, noritic anthrosite, and anorthosite. These crystalline basement rocks are often weathered to a depth of several tens of feet. The resulting regolith is as much as 70 feet thick in some areas.^{18,19}

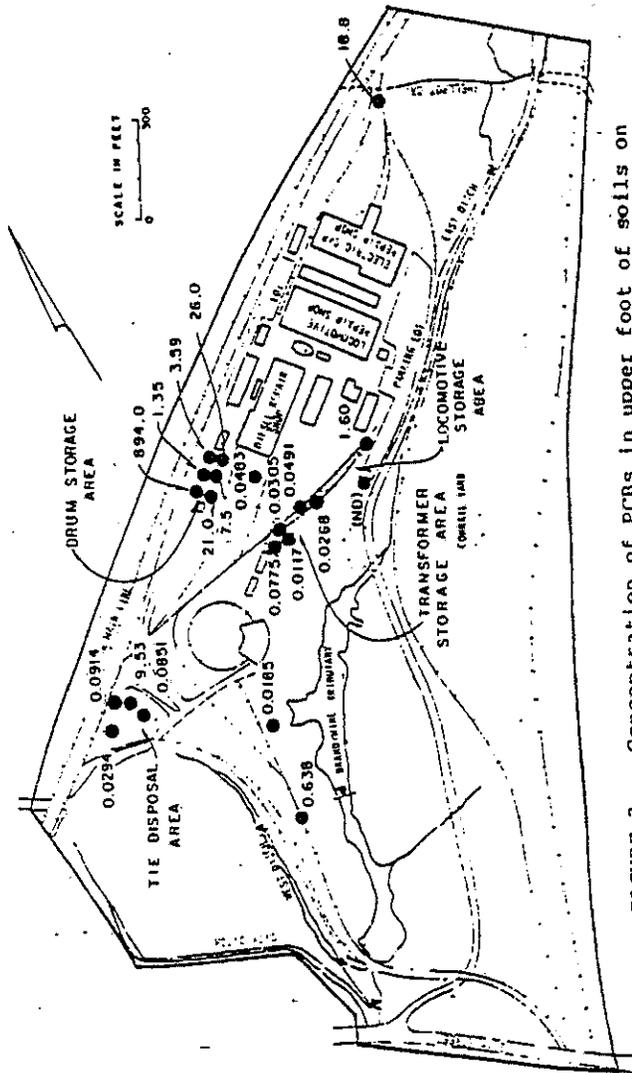
FIGURE 2 - Concentration of PCBs in upper foot of soils on roadways and mainline tracks. Concentration expressed in mg/kg.

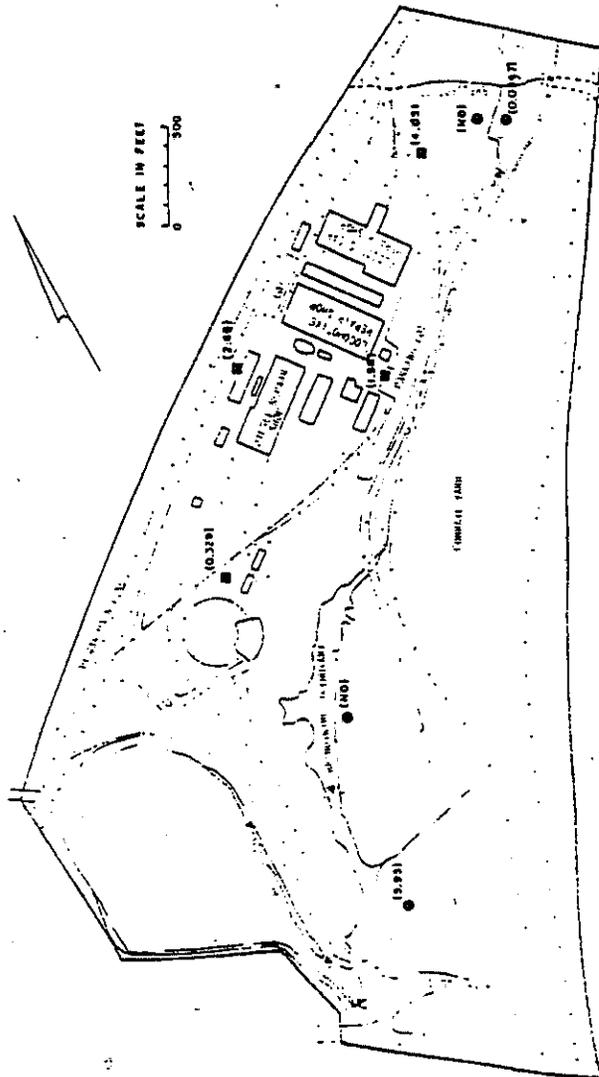
FIGURE 4 - Concentration of PCBs in soil samples collected from soils in marshes and puddles at the Wilmington Maintenance Facility. Values are expressed in mg/kg. ND means not detectable. Locations of marsh samples are shown with circles, and puddle locations are shown with squares.

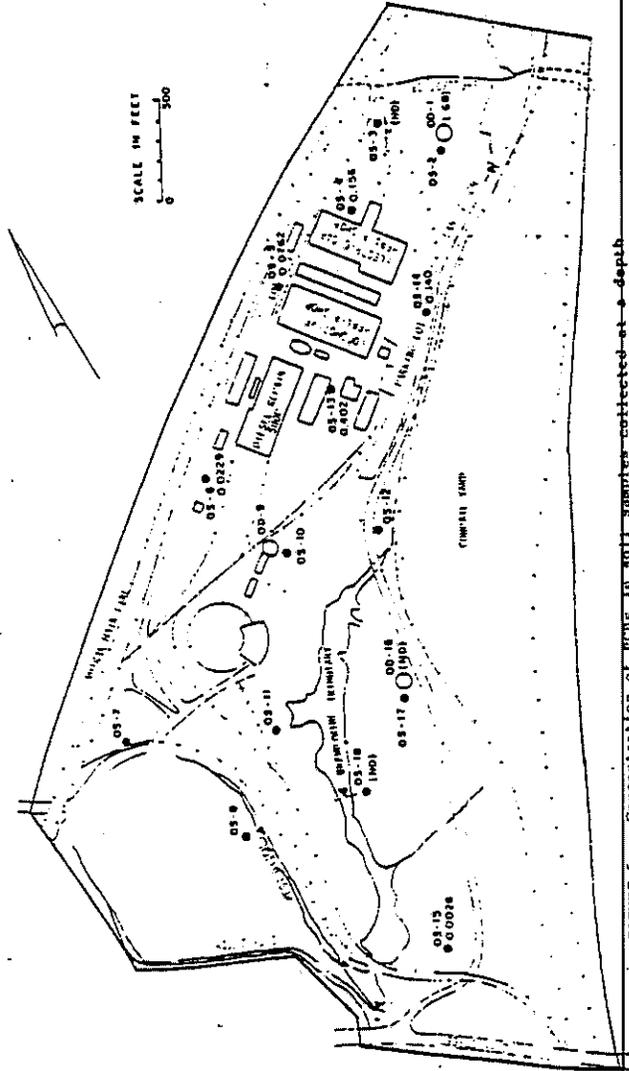
FIGURE 5 - Concentration of PCBs in soil samples collected at a depth of 5.0 to 6.5 feet below the surface at monitoring wells. Values are expressed in mg/kg. ND means not detected. Wells with no values means sample was not analyzed for PCBs.

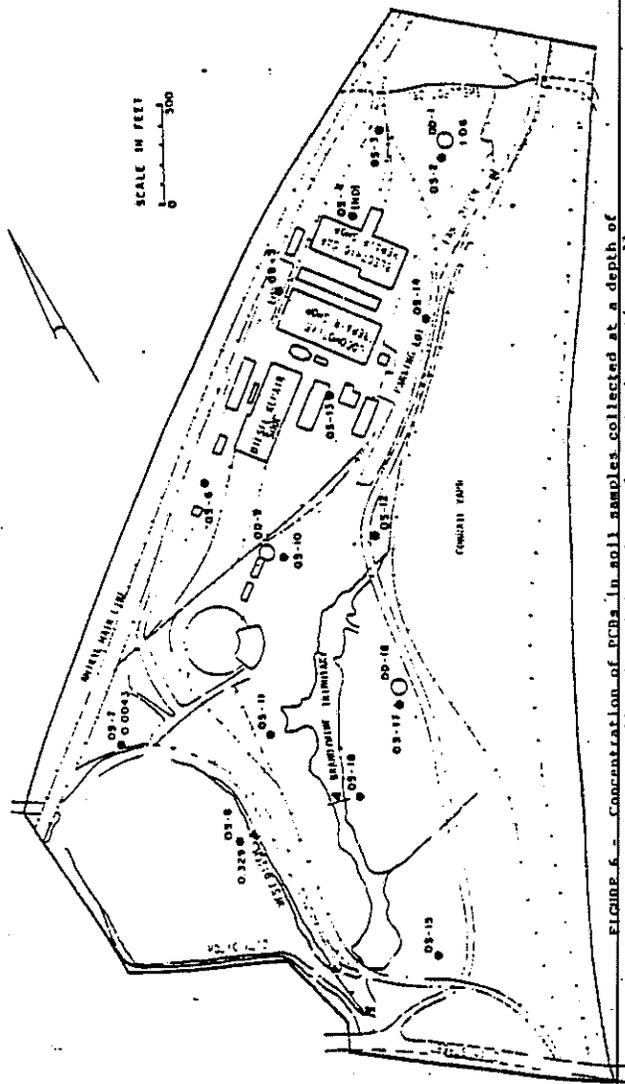
FIGURE 6 - Concentration of PCBs in soil samples collected at a depth of 10.0 to 11.5 feet below the surface at observation wells. Values are expressed in mg/kg. ND means not detected. Wells with no values means sample was not analyzed for PCBs.

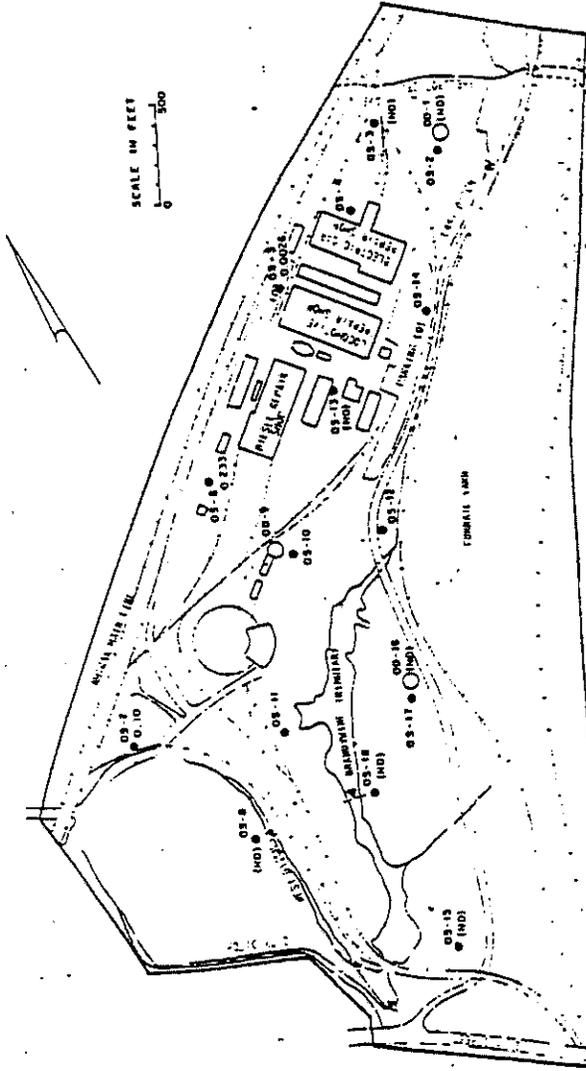
FIGURE 7 - Concentration of PCBs in soil samples collected at a depth of 15.0 to 16.5 feet below the surface at observation wells. Values are expressed in mg/kg. ND means not detected. Wells with no values means sample was not analyzed for PCBs.

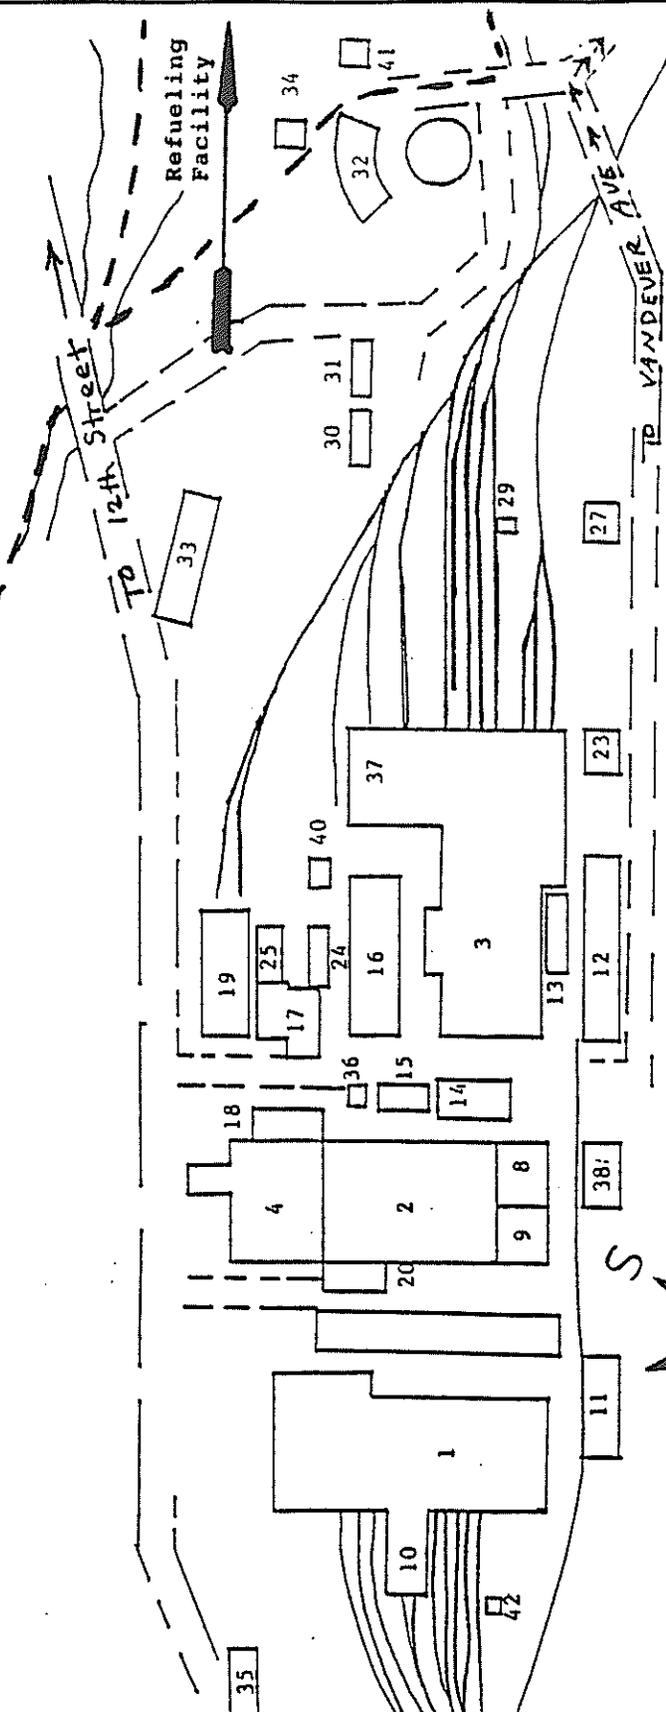
Figure 5.

- 1. Car Shop I
- 2. Car Shop II
- 3. Locomotive Shop
- 4. Electric Shop
- 8. Maintenance Shop
- 9. Tin Shop
- 10. Car Shop I / Asbestos Abatement
- 11. Battery House
- 12. Main Office Building
- 13. Old Bake Ovens
- 14. Main Locker Room
- 15. Supervisors Locker Room
- 16. Blacksmith / Brake Shop
- 17. Powerhouse
- 18. Electric Shop / Receiving
- 19. Air Brake Shop
- 20. Material Control / Receiving
- 23. Material Control / Storage
- 24. Waste Oil Storage
- 25. Used Drum Storage Area
- 27. Material Control / Oil House
- 29. Locomotive Shop / Inspection Shanty
- 30. B & B Shop
- 31. B & B Shop
- 32. Roundhouse
- 33. C&S / E.T. / Track Office
- 34. Foam House
- 35. Fire Pump House
- 36. Oxygen & Acetylene Tank Storage
- 37. Wheel Shop
- 38. DAF Pollution Building
- 40. PCB Distillery
- 41. Enginehouse / Crew Sign-up
- 42. Oxygen & Acetylene Tank Storage

Area of Previous Investigations/Assessments
Amtrak Wilmington Maintenance Facility

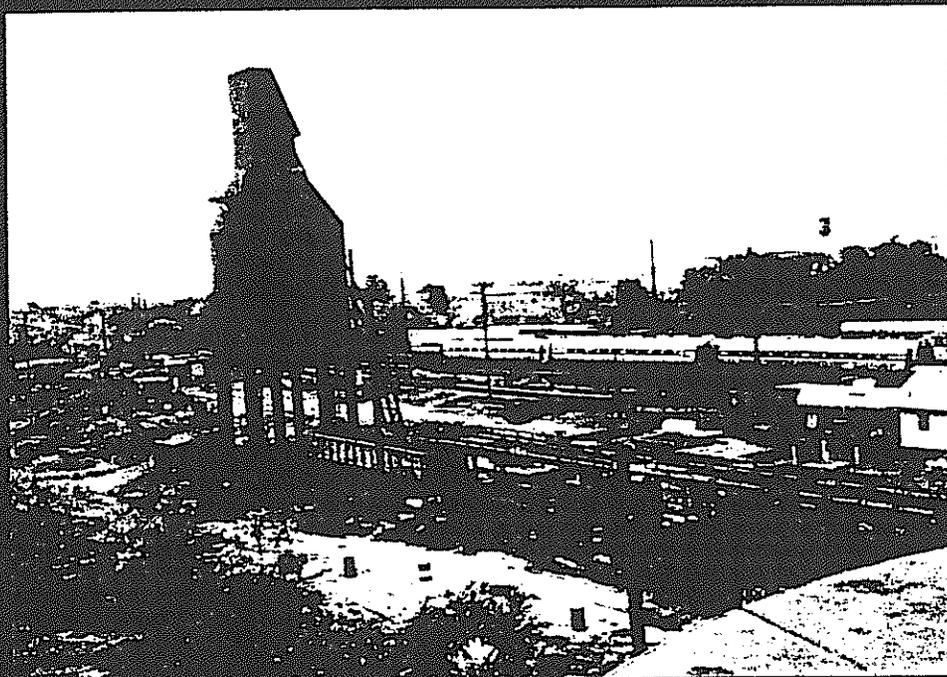
PHOTO 4. View of abandoned coal dock
from top of 250K oil tank. Note oil
seep area at lower left.
