PCB Mass Loading  
Former Christina Marina  
SIRB ID: DE-1293  
Wilmington, Delaware

## **Appendix 8**

# **FORMER CHRISTINA MARINA PROPERTY WILMINGTON, DELAWARE**

**SIRB ID: DE-1293**

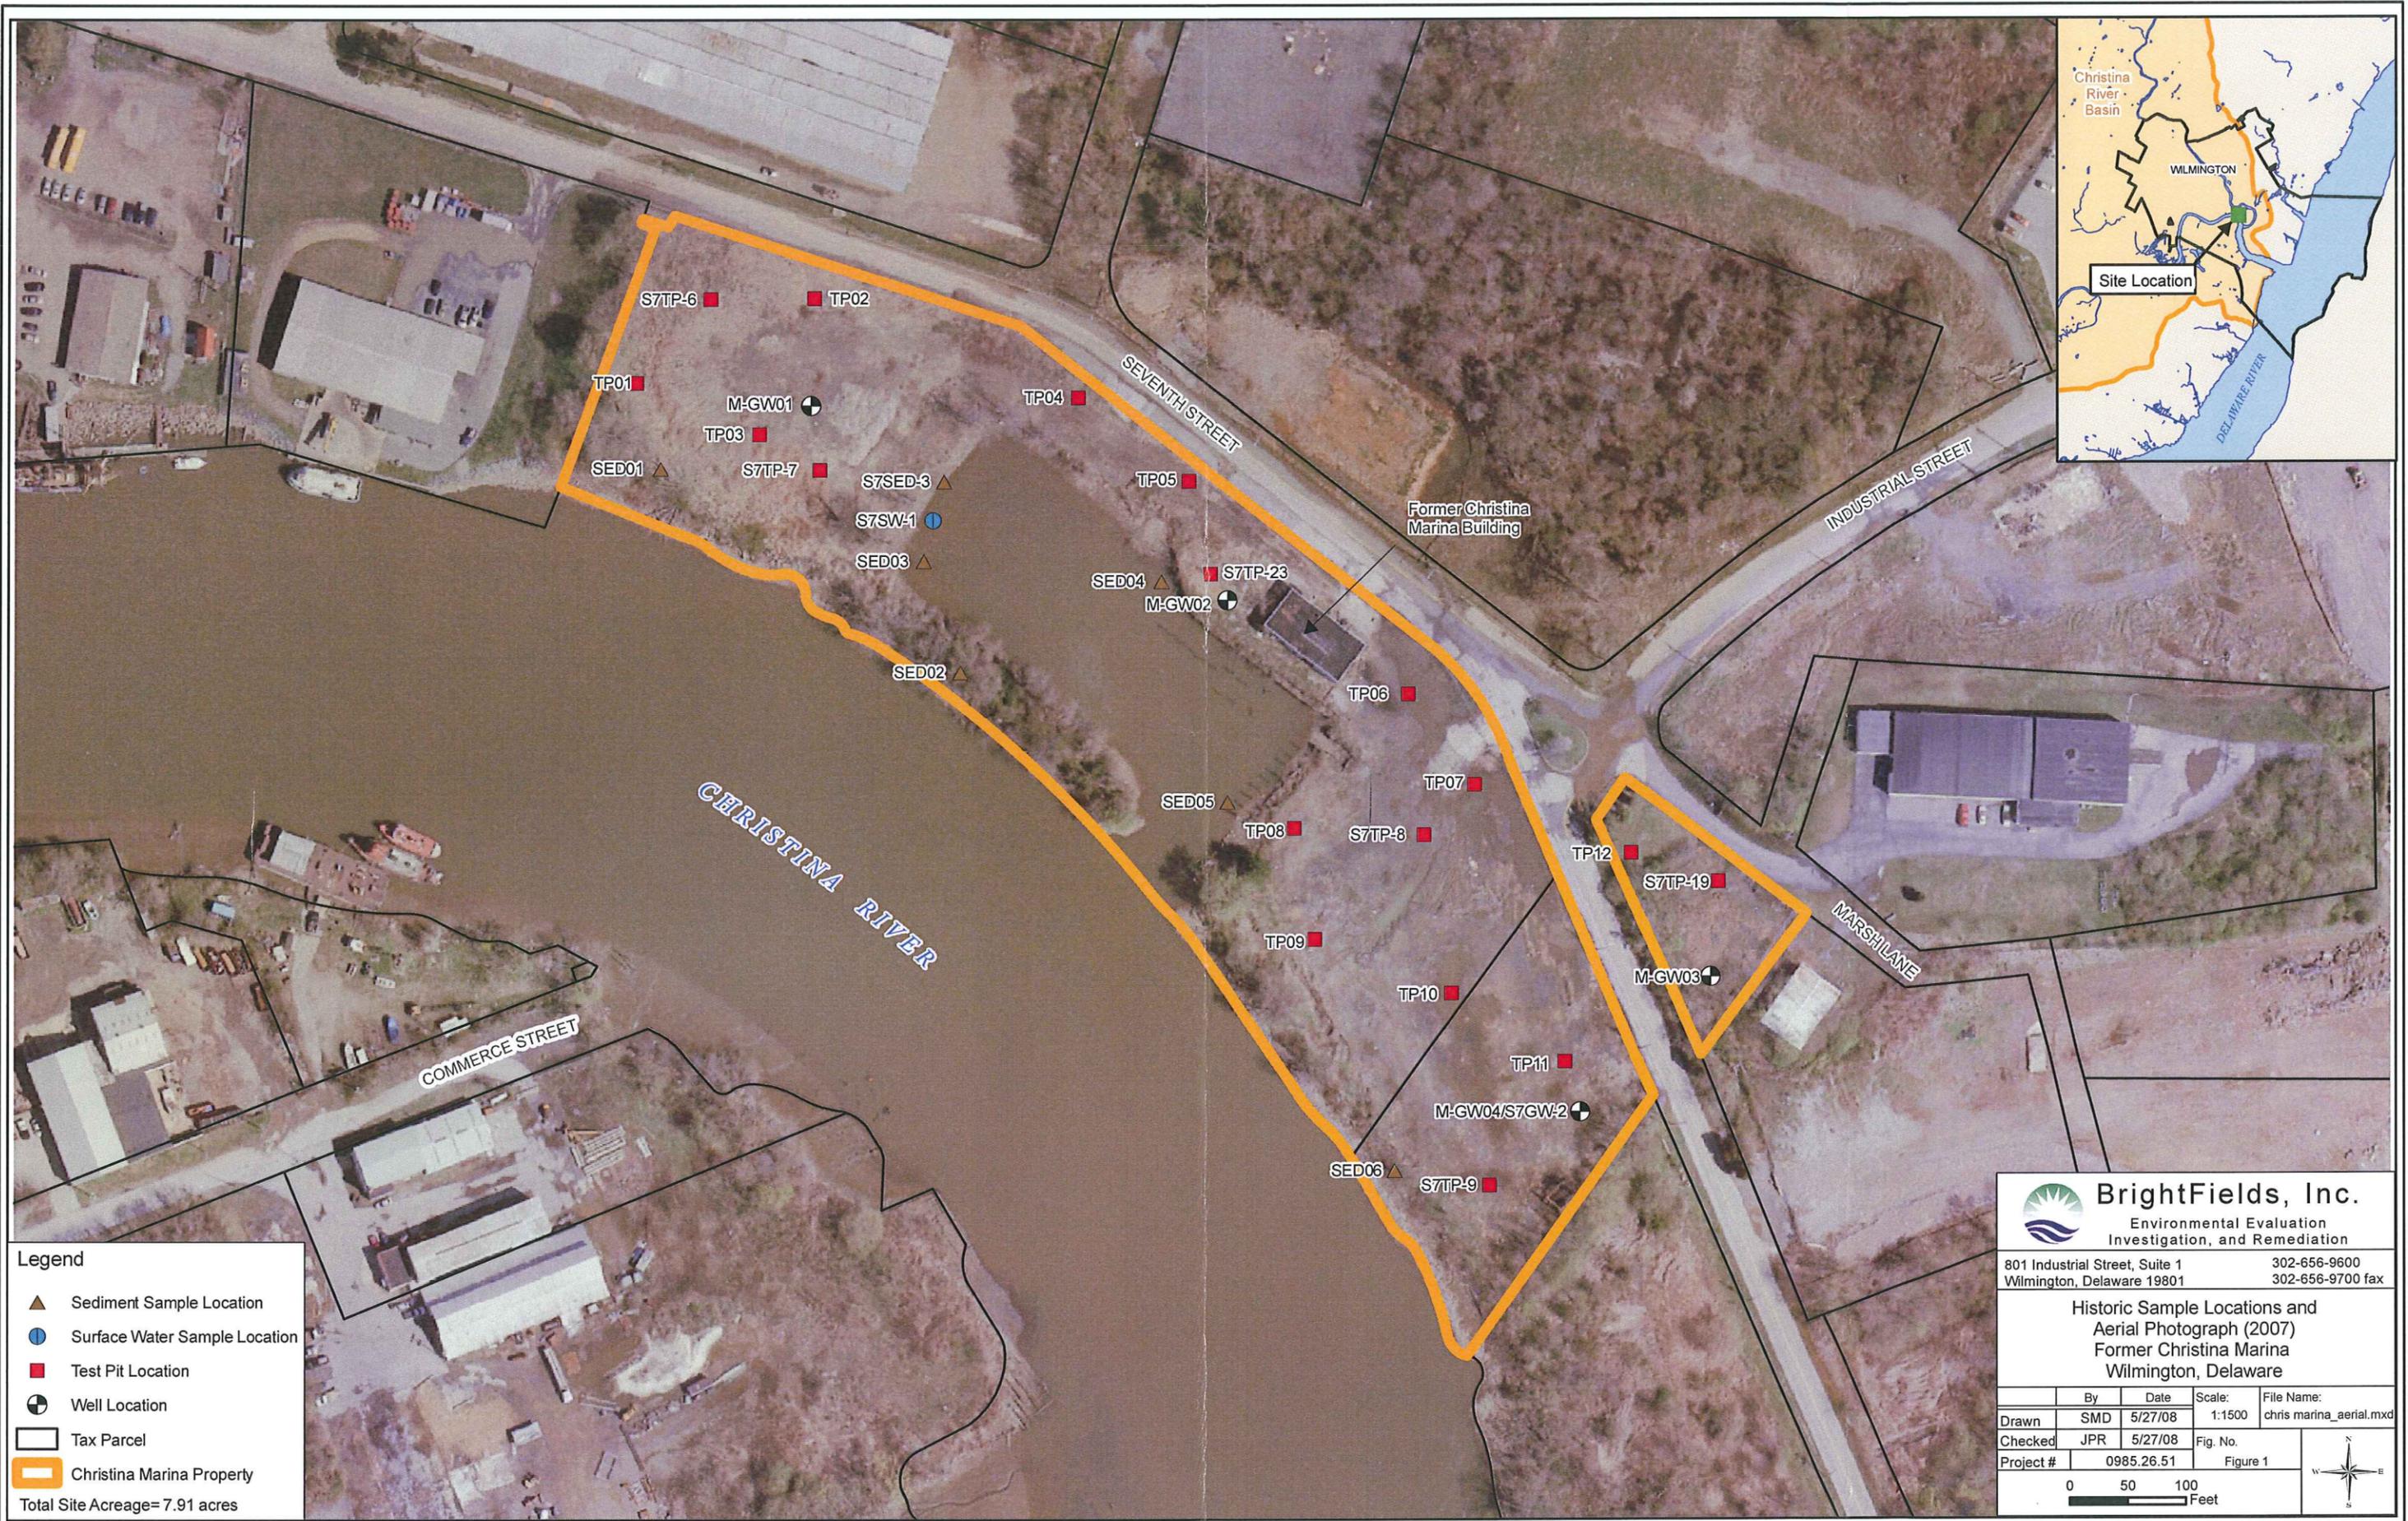
By	Date	Scale:	File Name:
SMD	5/27/08	1:1500	chris marina_aerial.mxd
Checked	JPR	5/27/08	Fig. No.
Project #	0985.26.51	Figure 1

**Historic Sample Locations and  
 Aerial Photograph (2007)  
 Former Christina Marina  
 Wilmington, Delaware**

**Site Location and Description:** The Former Christina Marina is located on the E. 7<sup>th</sup> Street Peninsula at 1126 E. 7<sup>th</sup> Street in Wilmington (Figure 1). The property is bordered to the north by various commercial properties, to the south by the Christina River, to the east by the E. 7<sup>th</sup> Street Park, and to the west by Marine Lubricants. The nearest intersecting street is Industrial Street. There are currently no structures on the property.

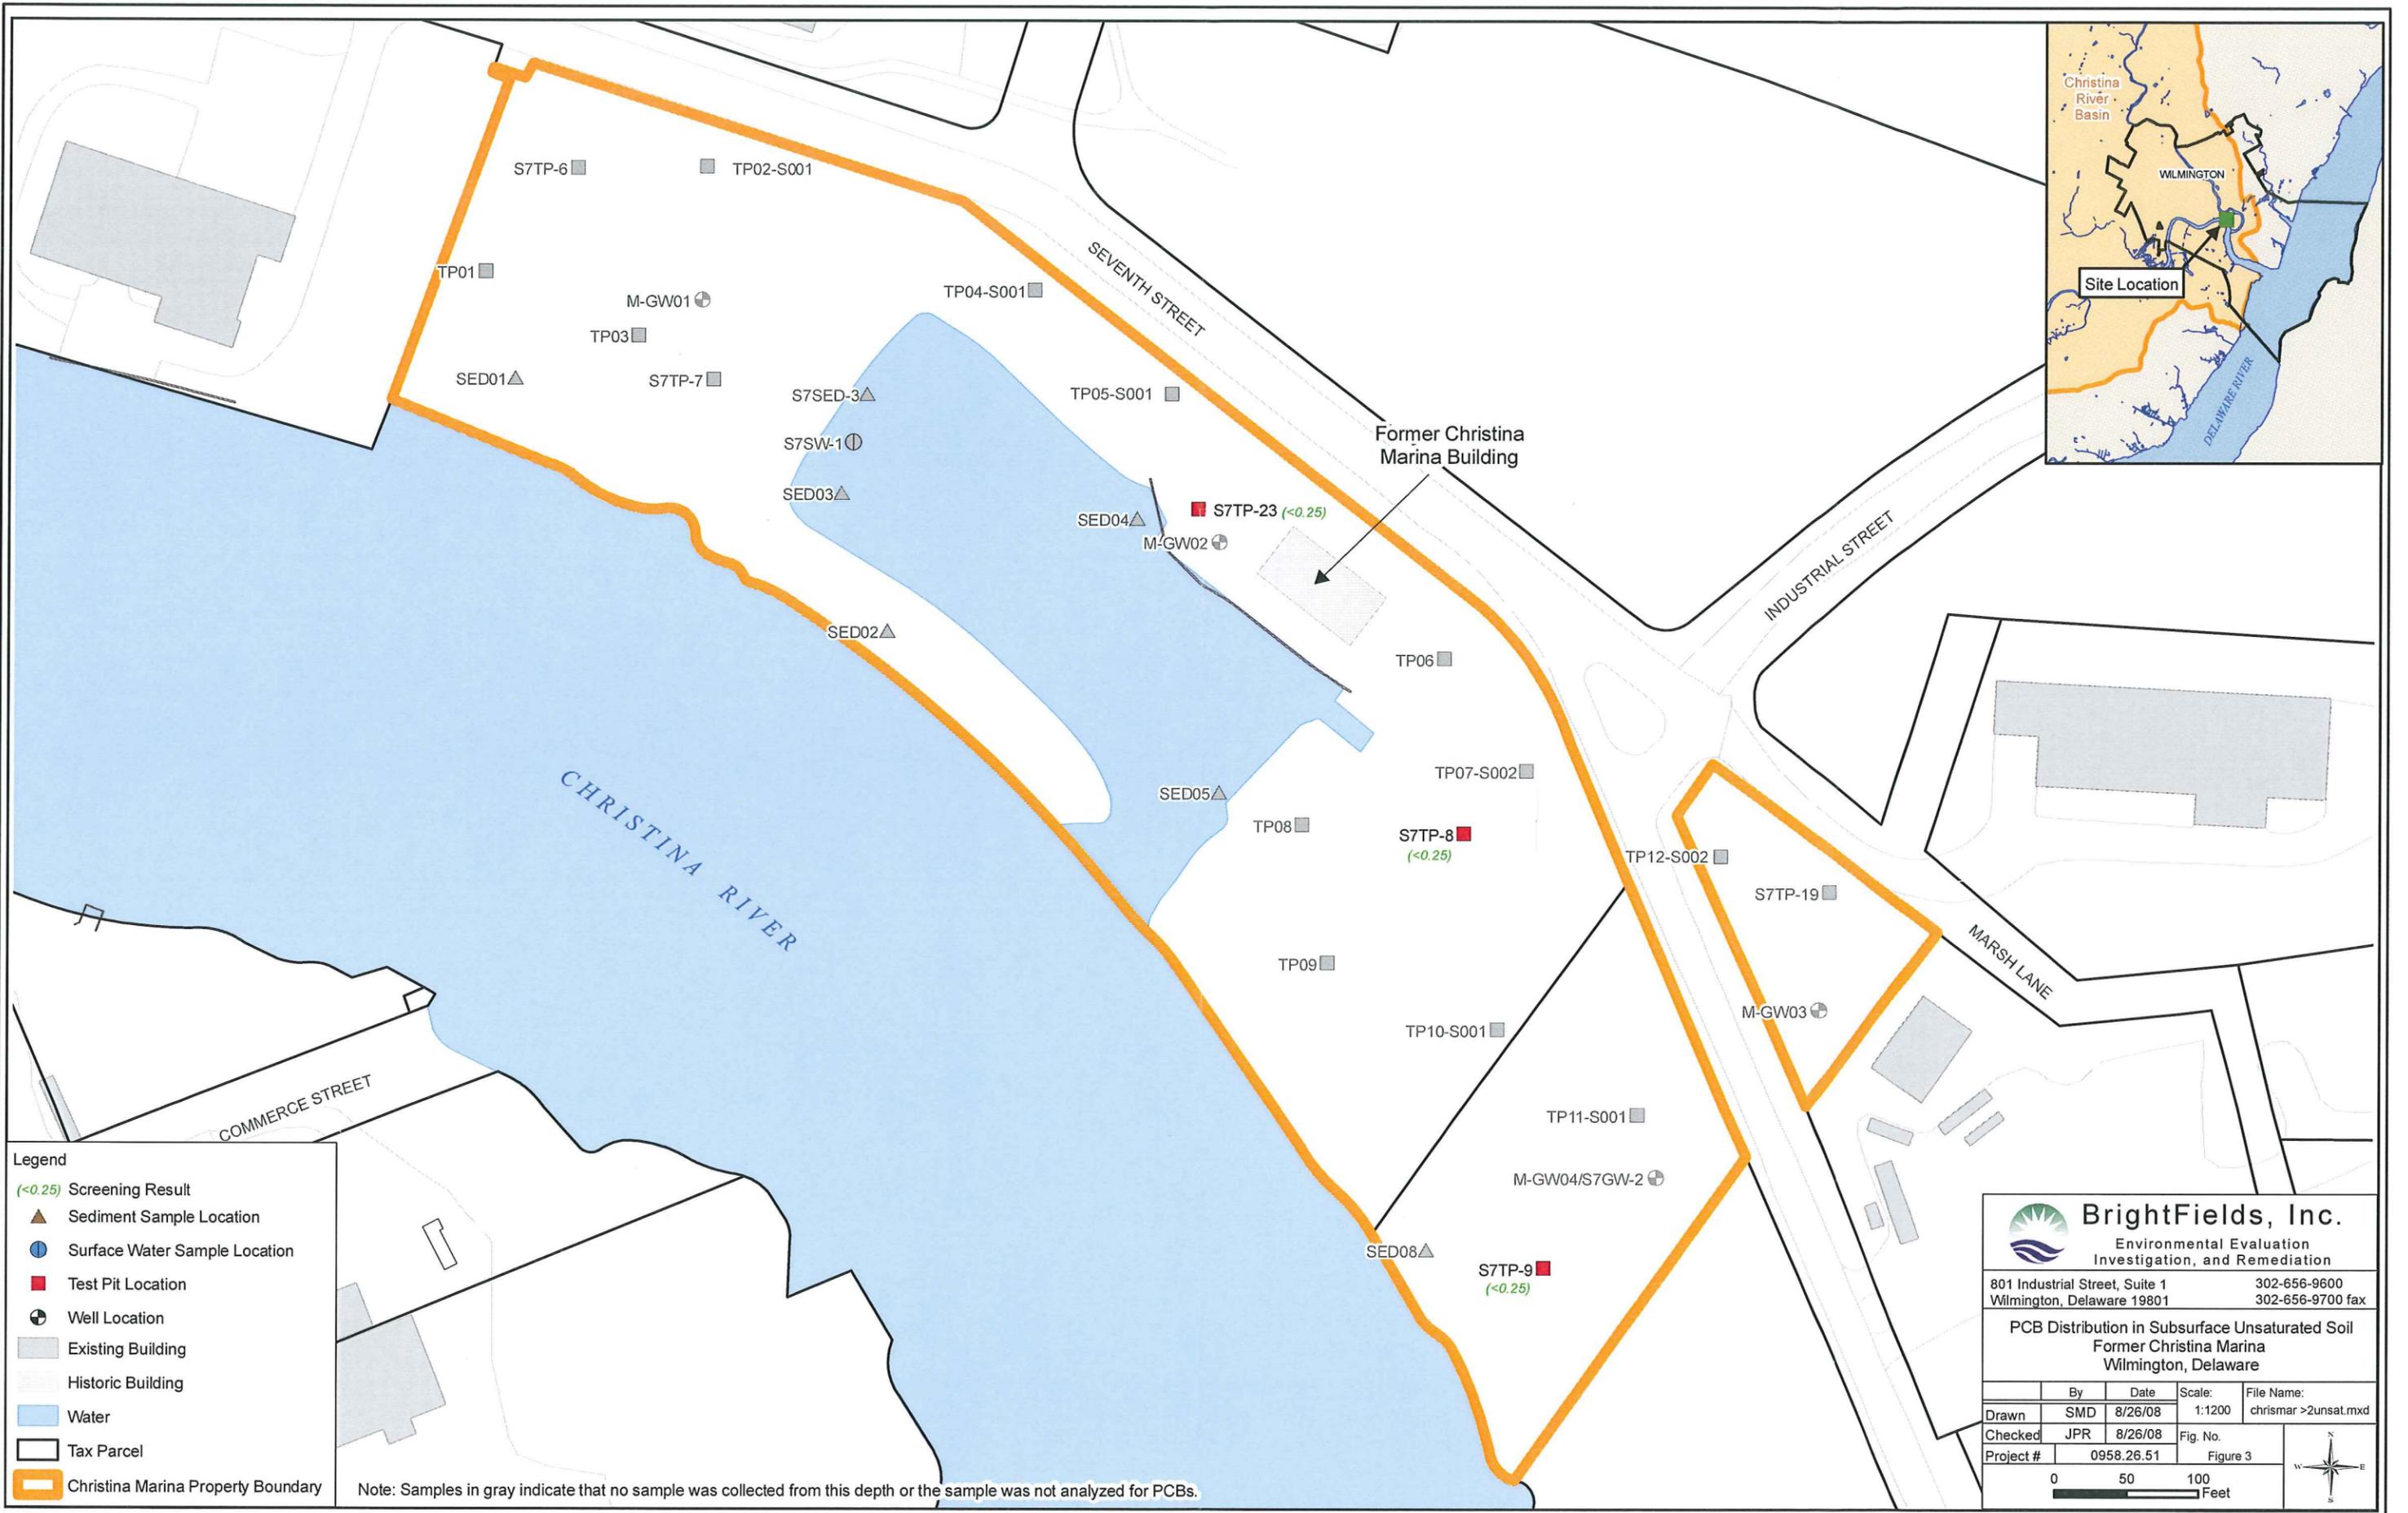
By	Date	Scale:	File Name:
Drawn	SMD	8/26/08	1:1200	chrismar >2unsat.mxd
Checked	JPR	8/26/08	Fig. No.	
Project #	0958.26.51		Figure 3

PCB Distribution in Subsurface Unsaturated Soil  
 Former Christina Marina  
 Wilmington, Delaware

The estimated surface soil area impacted by PCBs is 0.45 acres in the vicinity of TP11 (Figure 2). There were no reported concentrations of PCBs in the subsurface unsaturated soil. The

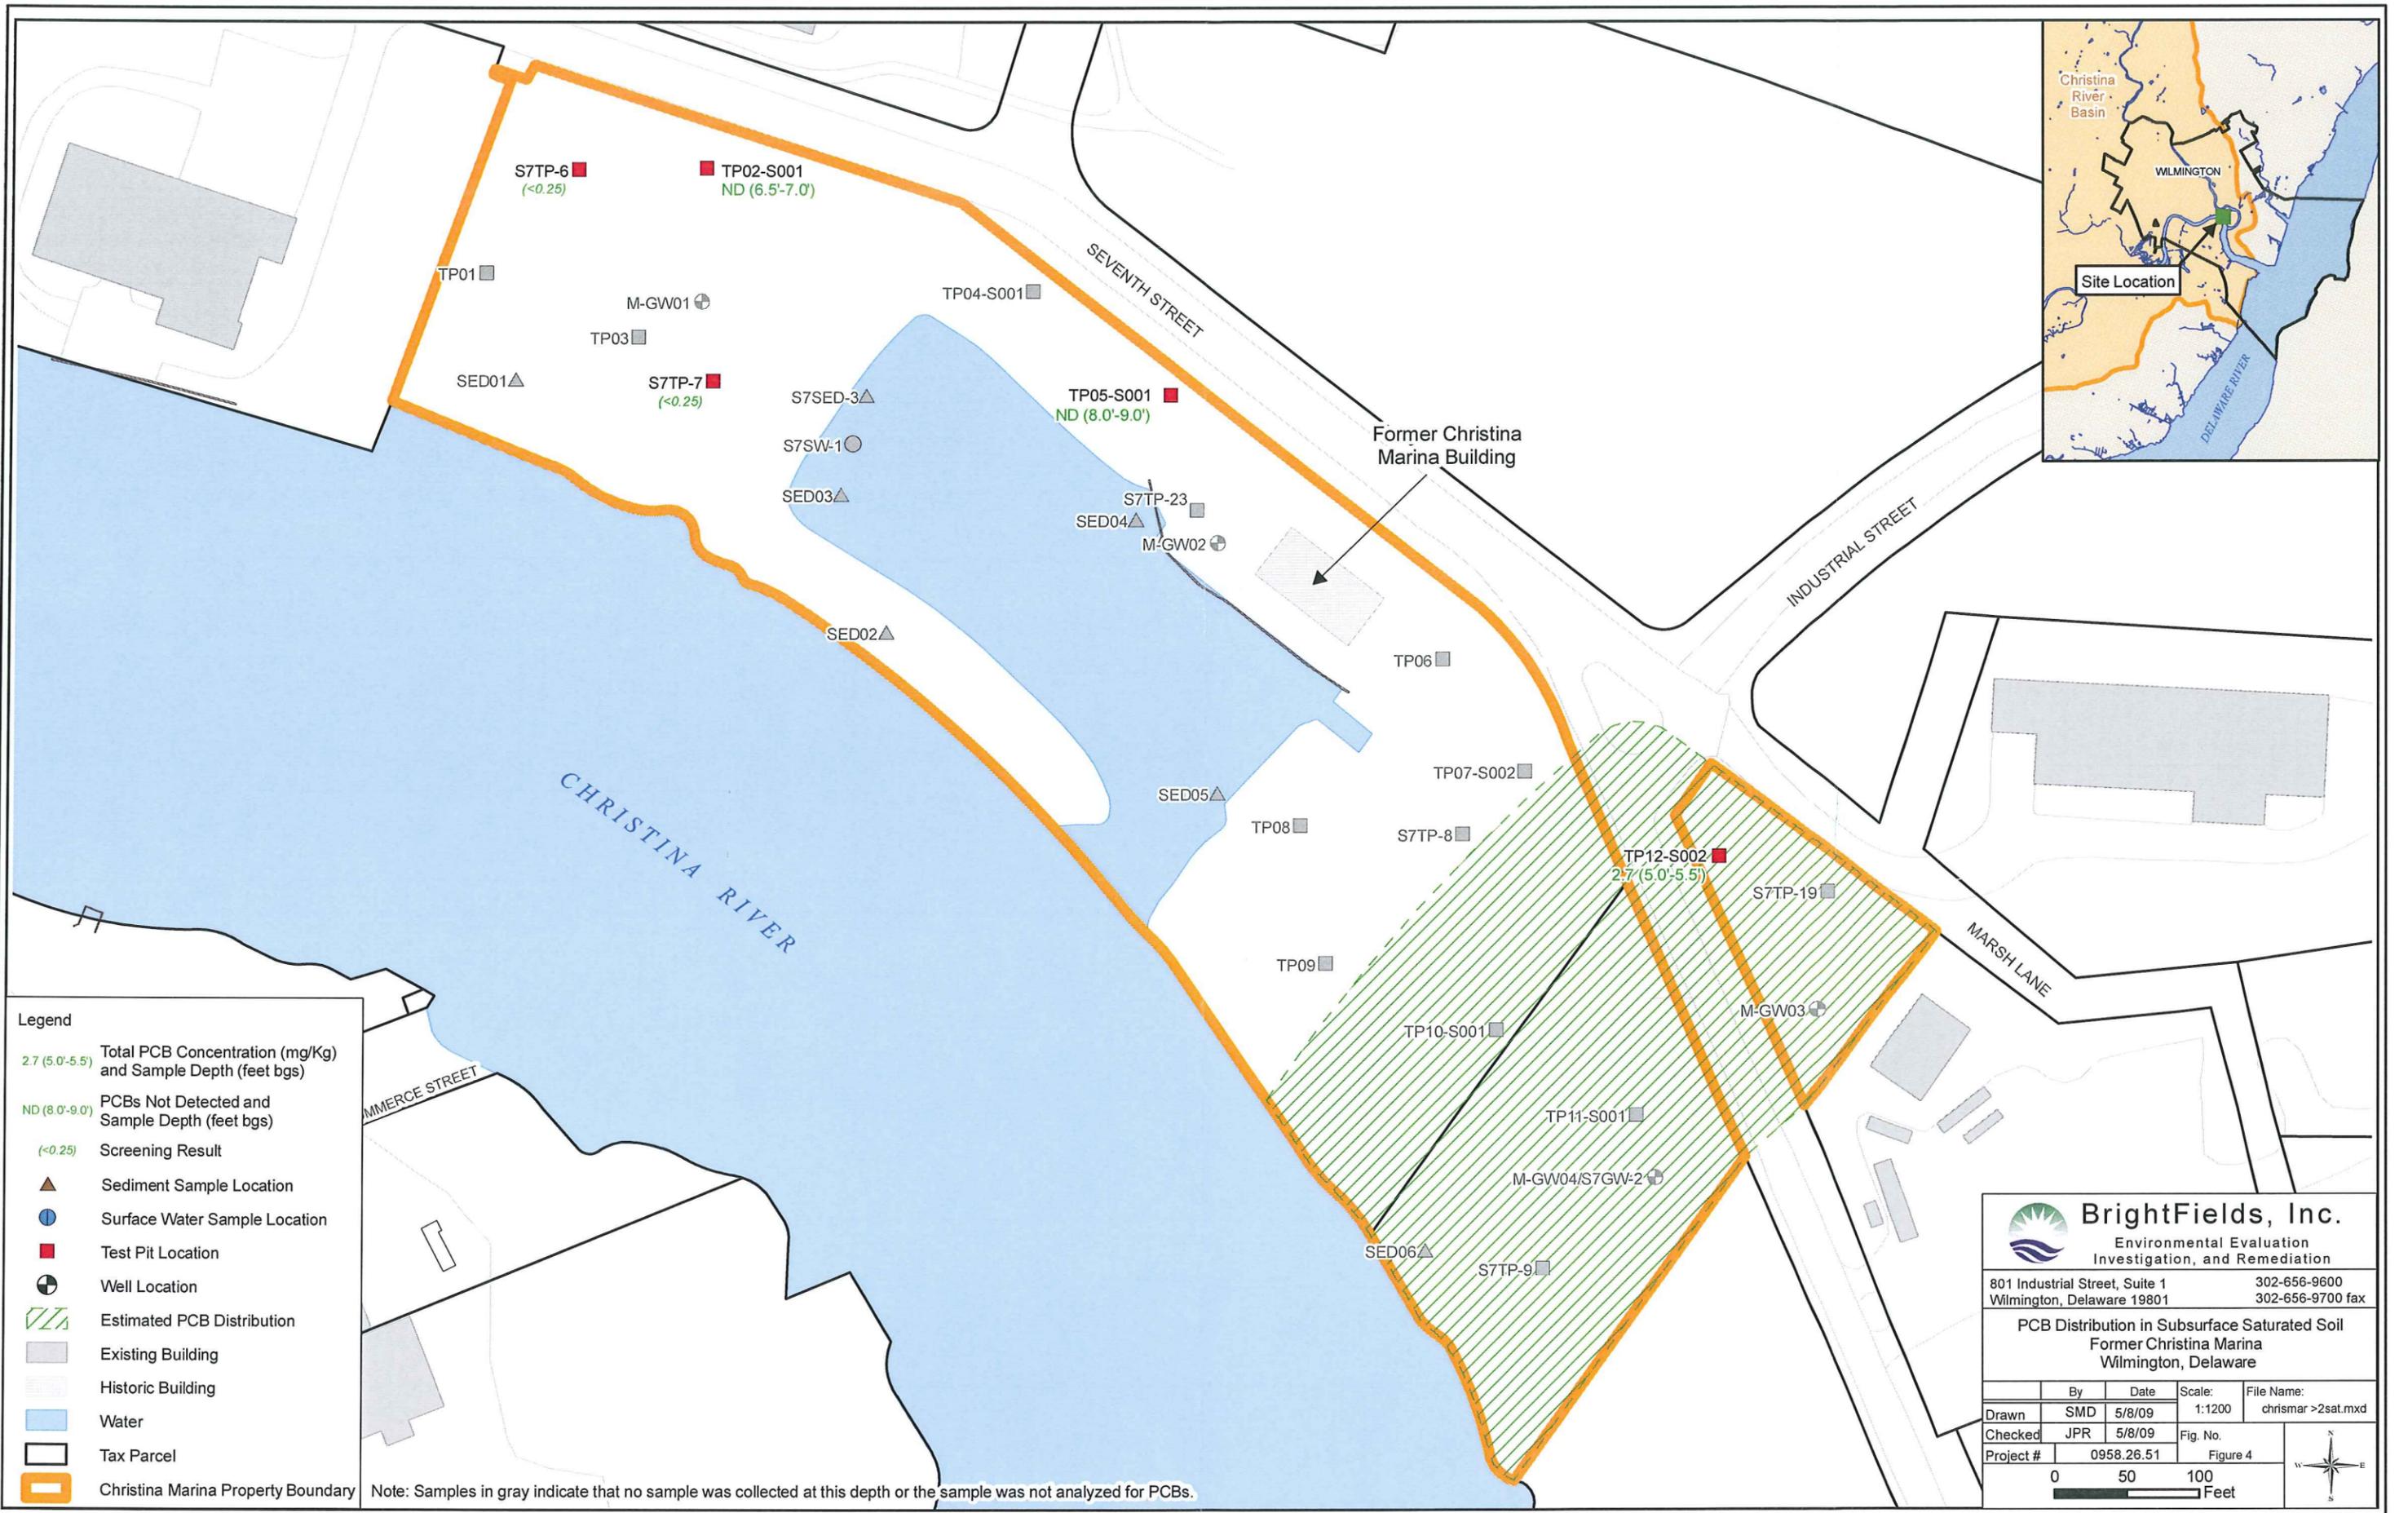
By	Date	Scale:	File Name:
SMD	5/8/09	1:1200	chrismar >2sat.mxd
Checked	JPR	5/8/09	Fig. No.
Project #	0958.26.51	Figure 4

- Legend**
- 2.7 (5.0'-5.5') Total PCB Concentration (mg/Kg) and Sample Depth (feet bgs)
  - ND (8.0'-9.0') PCBs Not Detected and Sample Depth (feet bgs)
  - <0.25 Screening Result
  - ▲ Sediment Sample Location
  - Surface Water Sample Location
  - Test Pit Location
  - ⊕ Well Location
  - ▨ Estimated PCB Distribution
  - ▭ Existing Building
  - ▭ Historic Building
  - Water
  - ▭ Tax Parcel
  - ▭ Christina Marina Property Boundary

**PCB Distribution in Subsurface Saturated Soil  
 Former Christina Marina  
 Wilmington, Delaware**

estimated subsurface saturated soil area impacted by PCBs is 3.9 acres in the vicinity of TP12 (Figure 4).

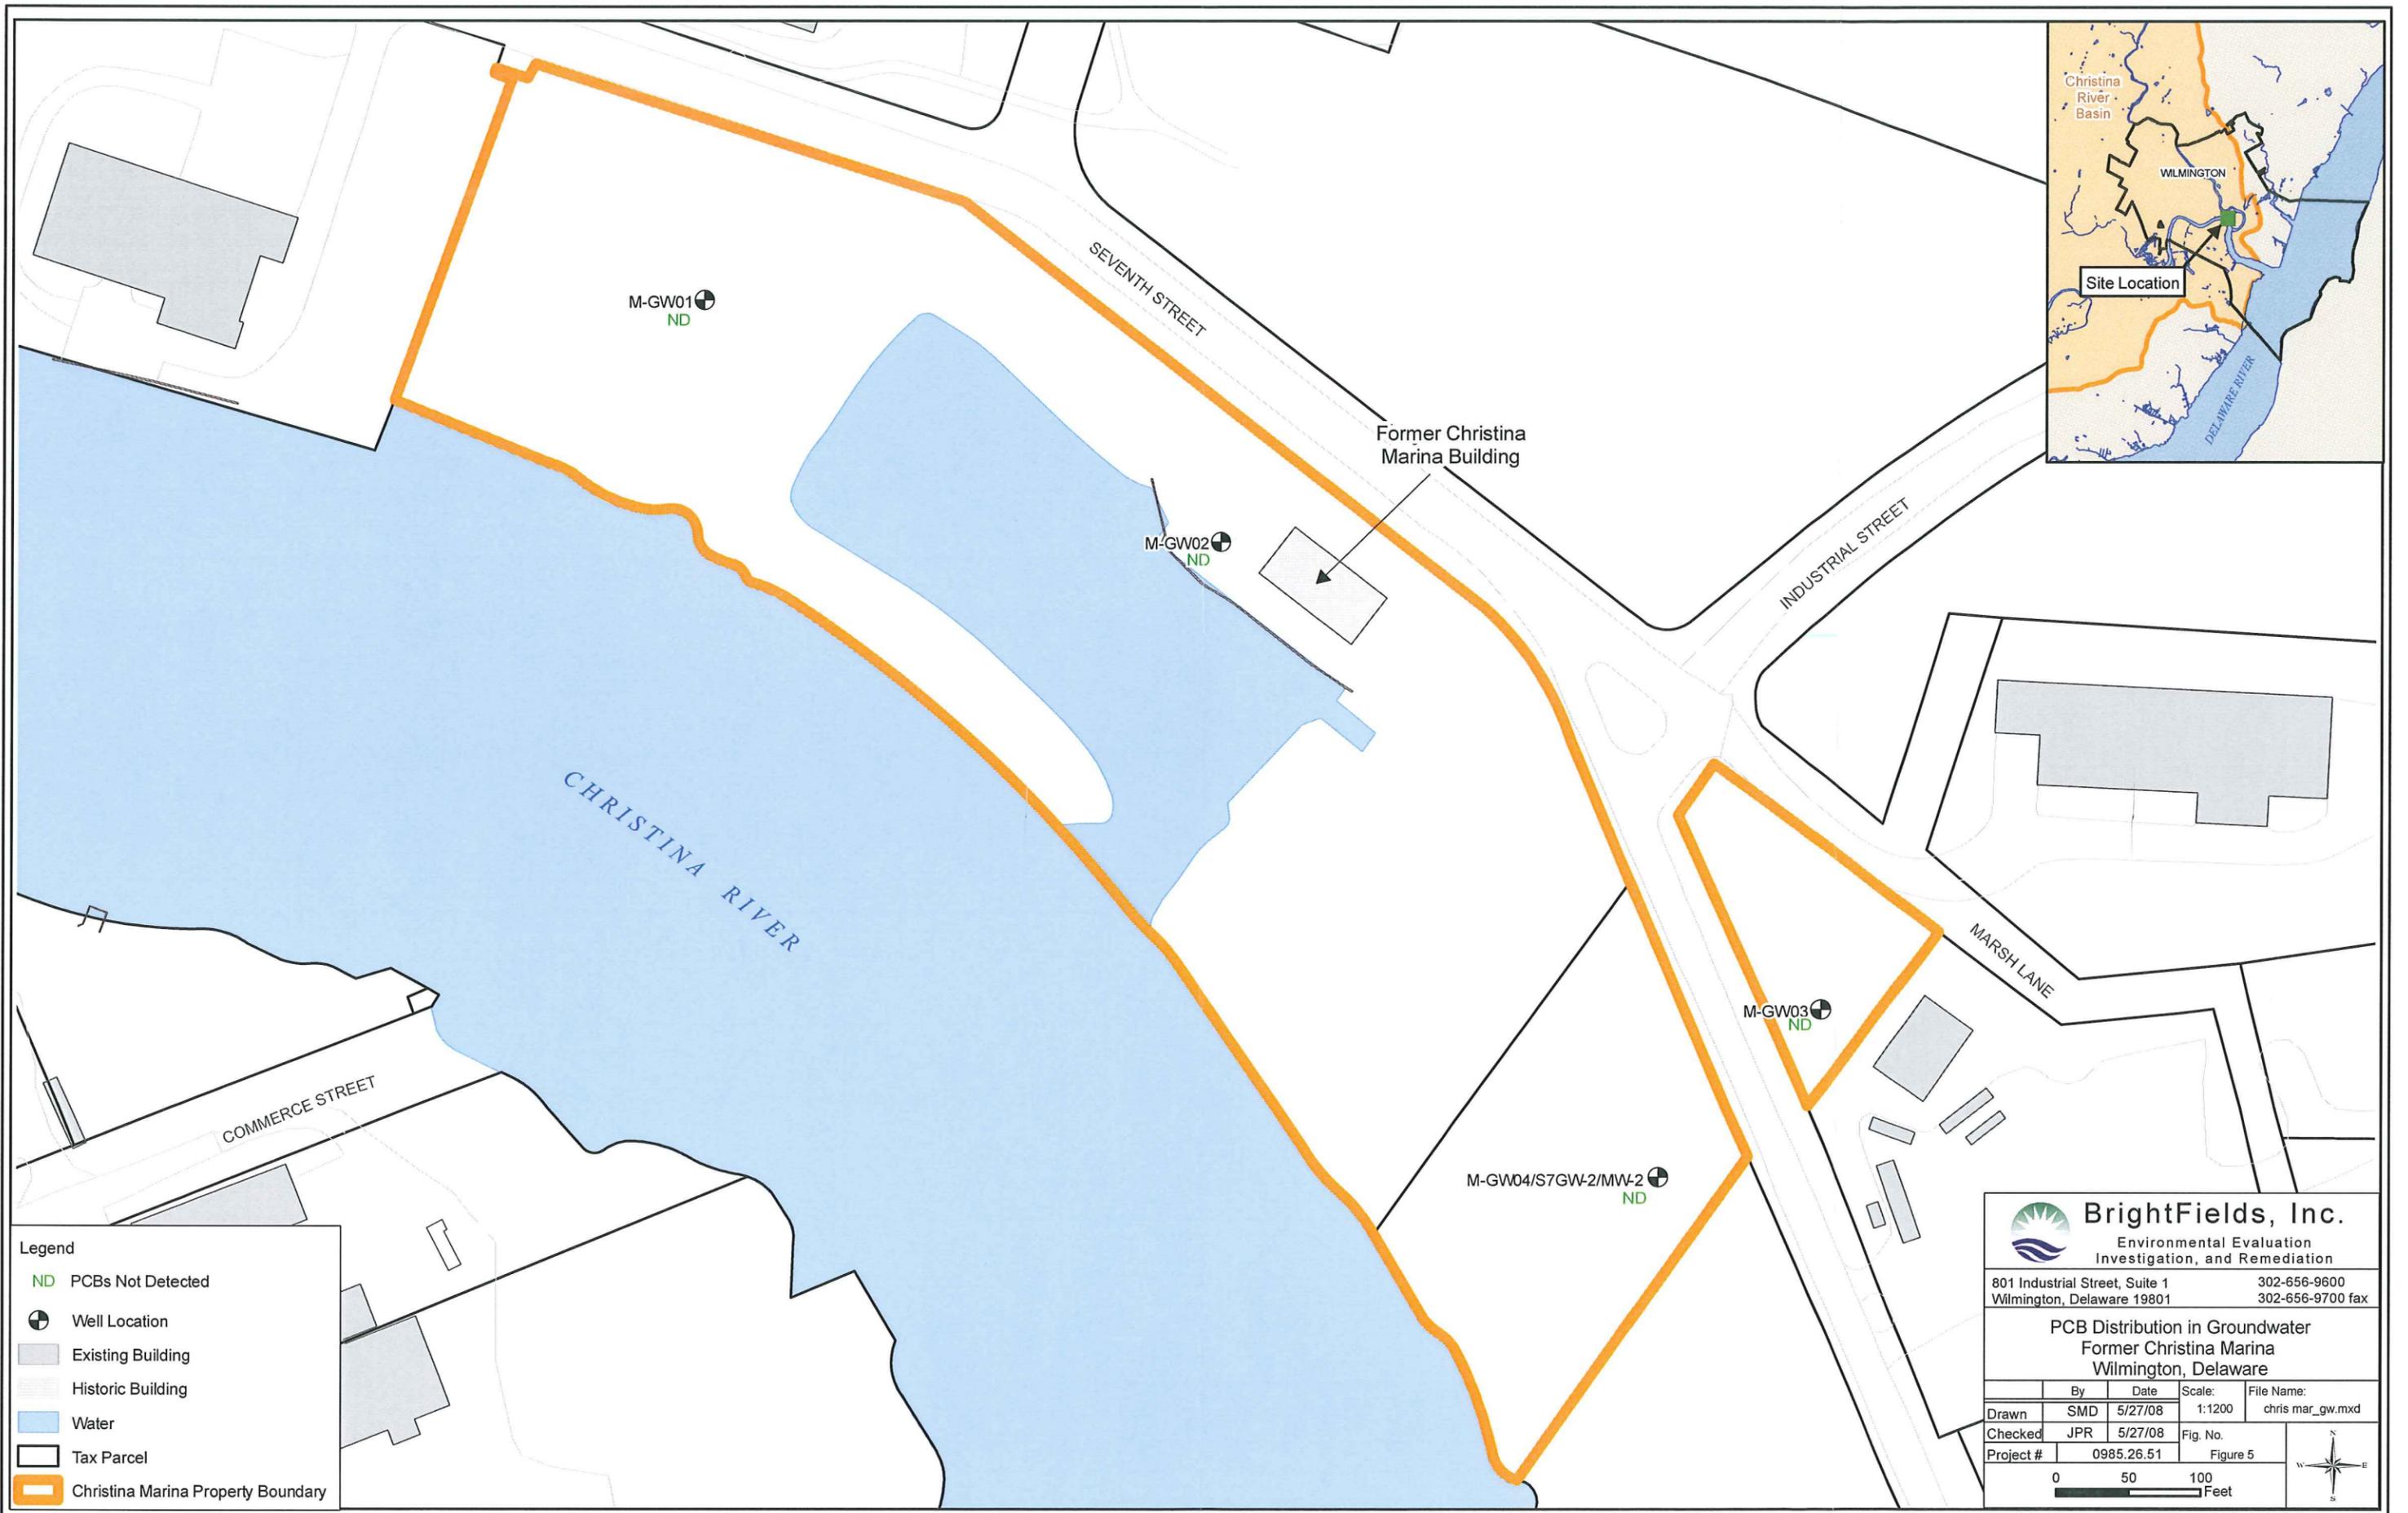
By	Date	Scale:	File Name:
SMD	5/27/08	1:1200	chris_mar_gw.mxd
Checked	JPR	5/27/08	Fig. No.
Project #	0985.26.51	Figure 5

**PCB Distribution in Groundwater  
 Former Christina Marina  
 Wilmington, Delaware**

<b>Concentrations of PCBs on Site</b>			
<b>Sample Matrix</b>	<b>Corresponding Figure</b>	<b>Analytical Methods</b>	<b>Range of Total PCBs</b>
Surface Soil	Figure 2	Method 8082 and Immunoassay Kits	Not detected to 0.16 mg/kg
Subsurface Soil (unsaturated)	Figure 3	Method 8082 and Immunoassay Kits	Not detected
Subsurface Soil (saturated)	Figure 4	Method 8082 and Immunoassay Kits	Not detected to 2.7 mg/kg
Groundwater	Figure 5	Method 8082 and Immunoassay Kits	Not detected

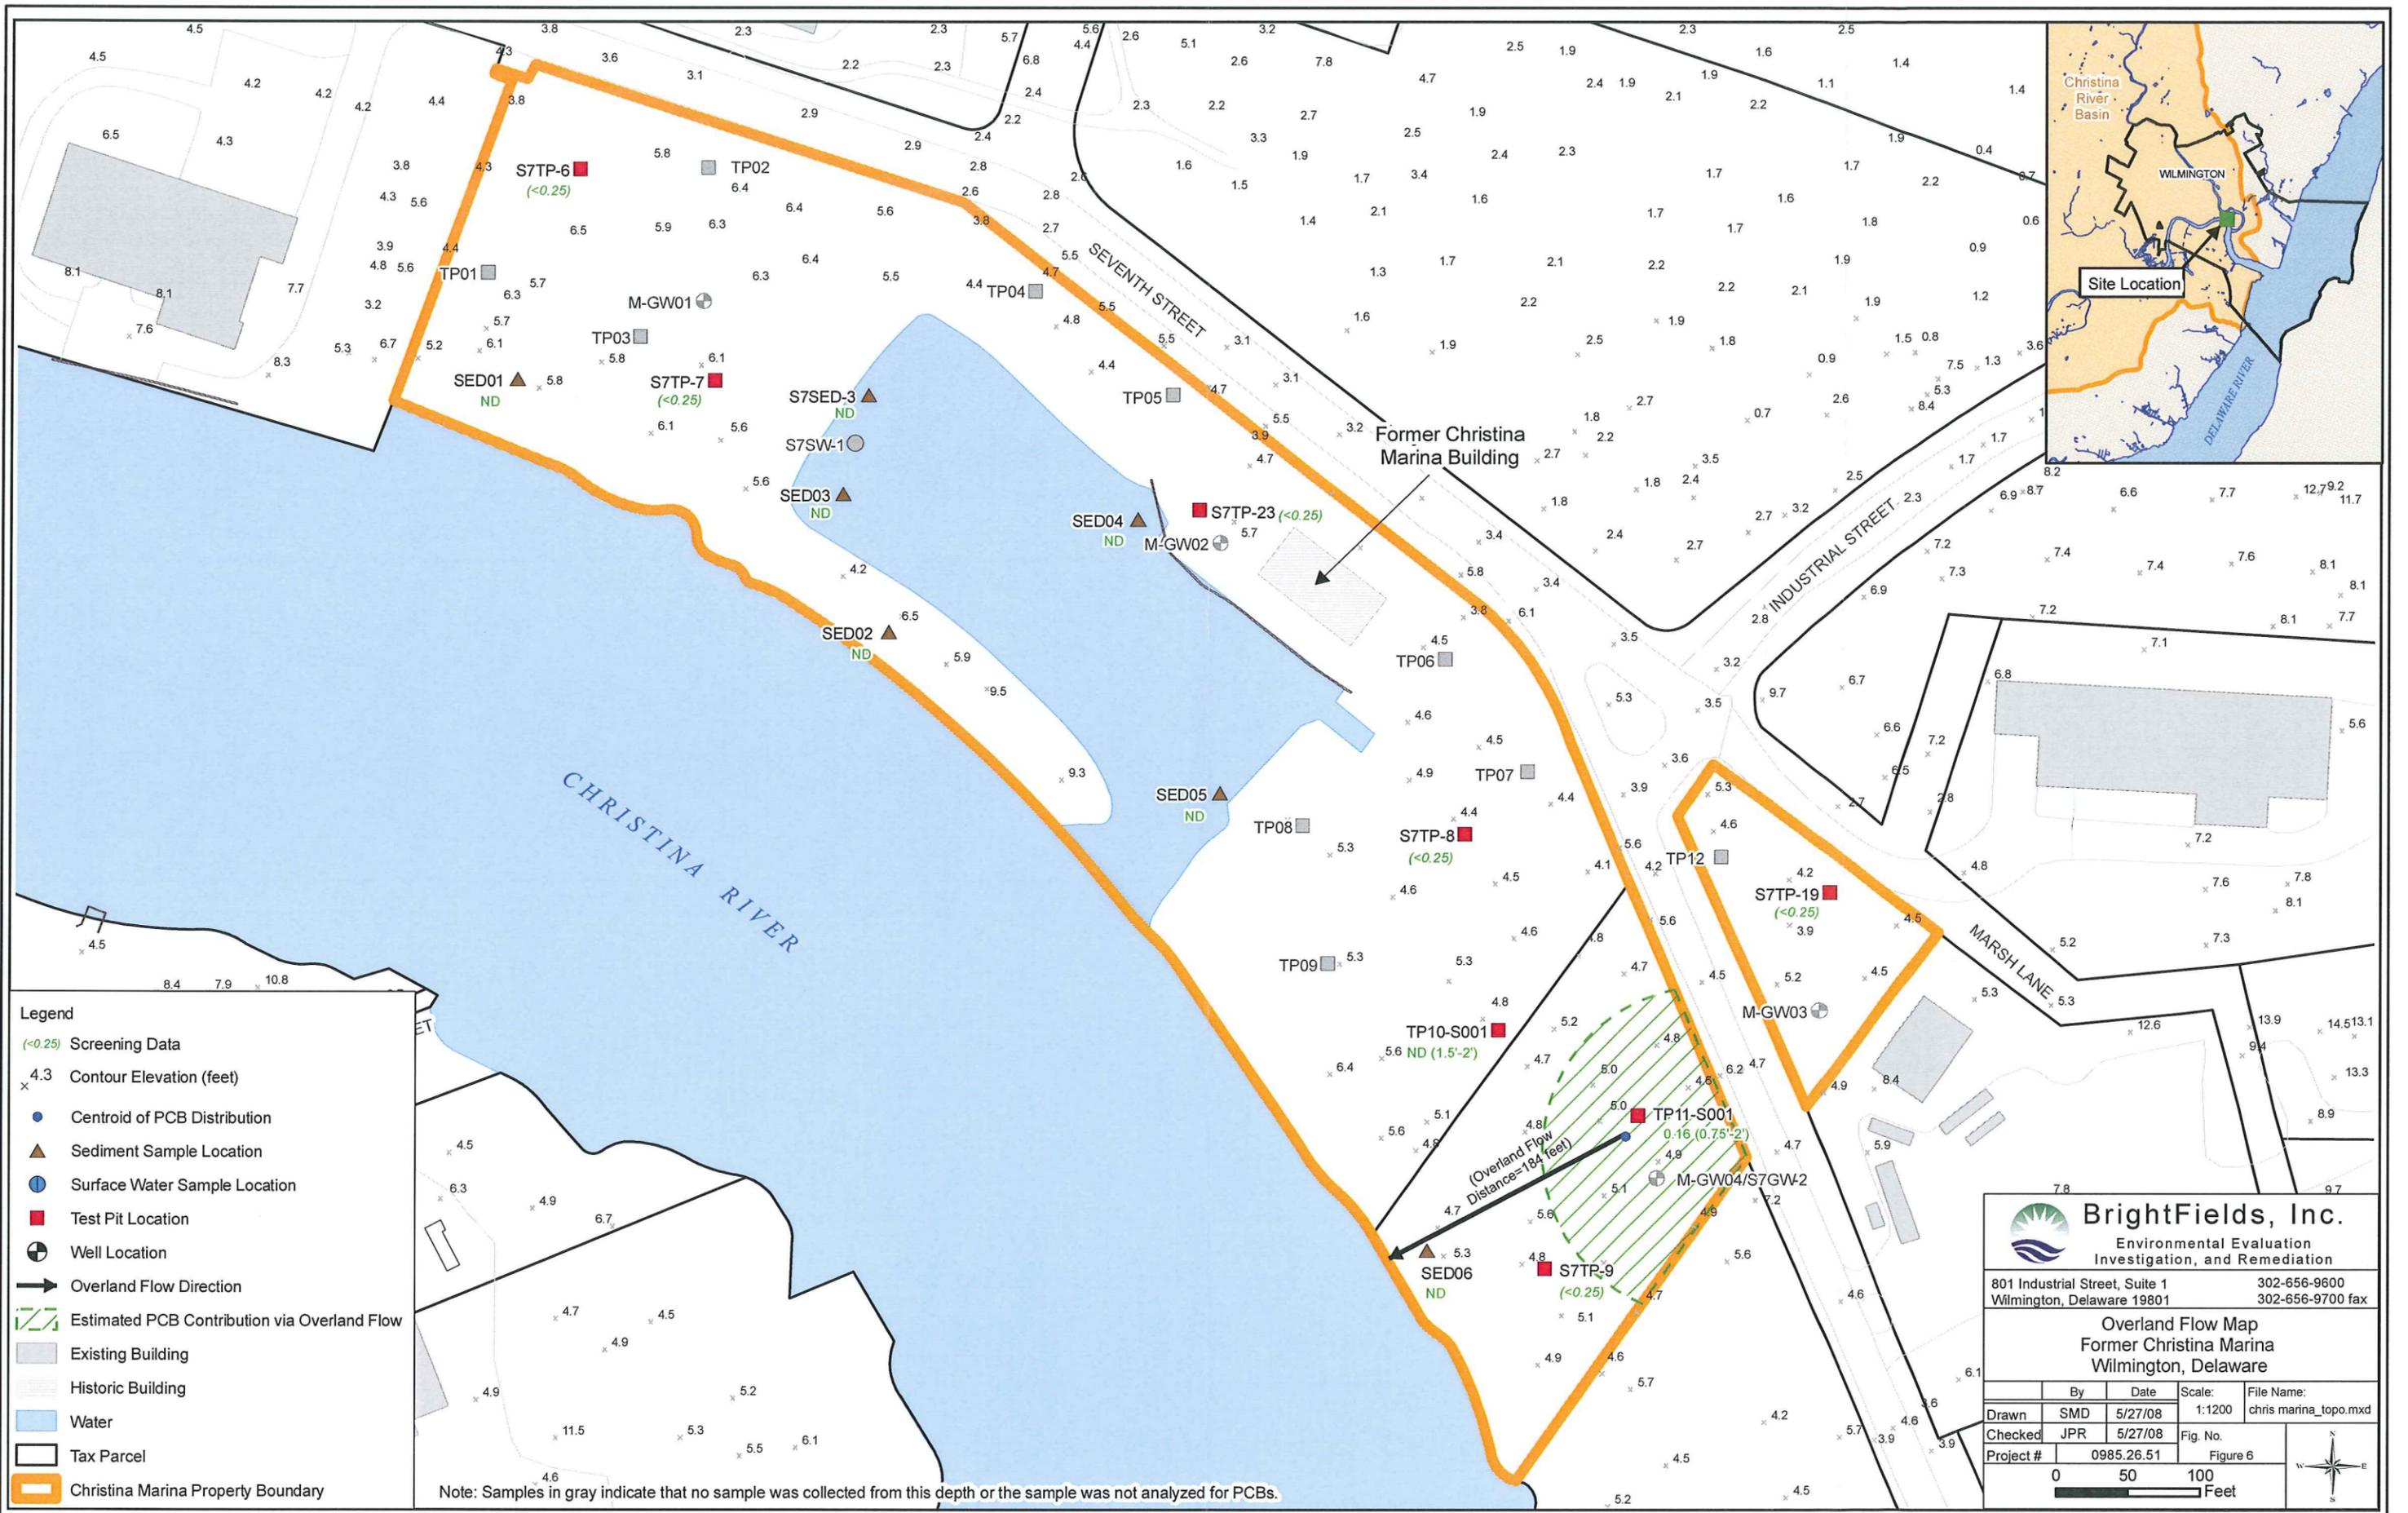
By	Date	Scale:	File Name:
SMD	5/27/08	1:1200	chris_marina_topo.mxd
Checked	JPR	5/27/08	Fig. No.
Project #	0985.26.51		Figure 6

**Overland Flow Map**  
 Former Christina Marina  
 Wilmington, Delaware

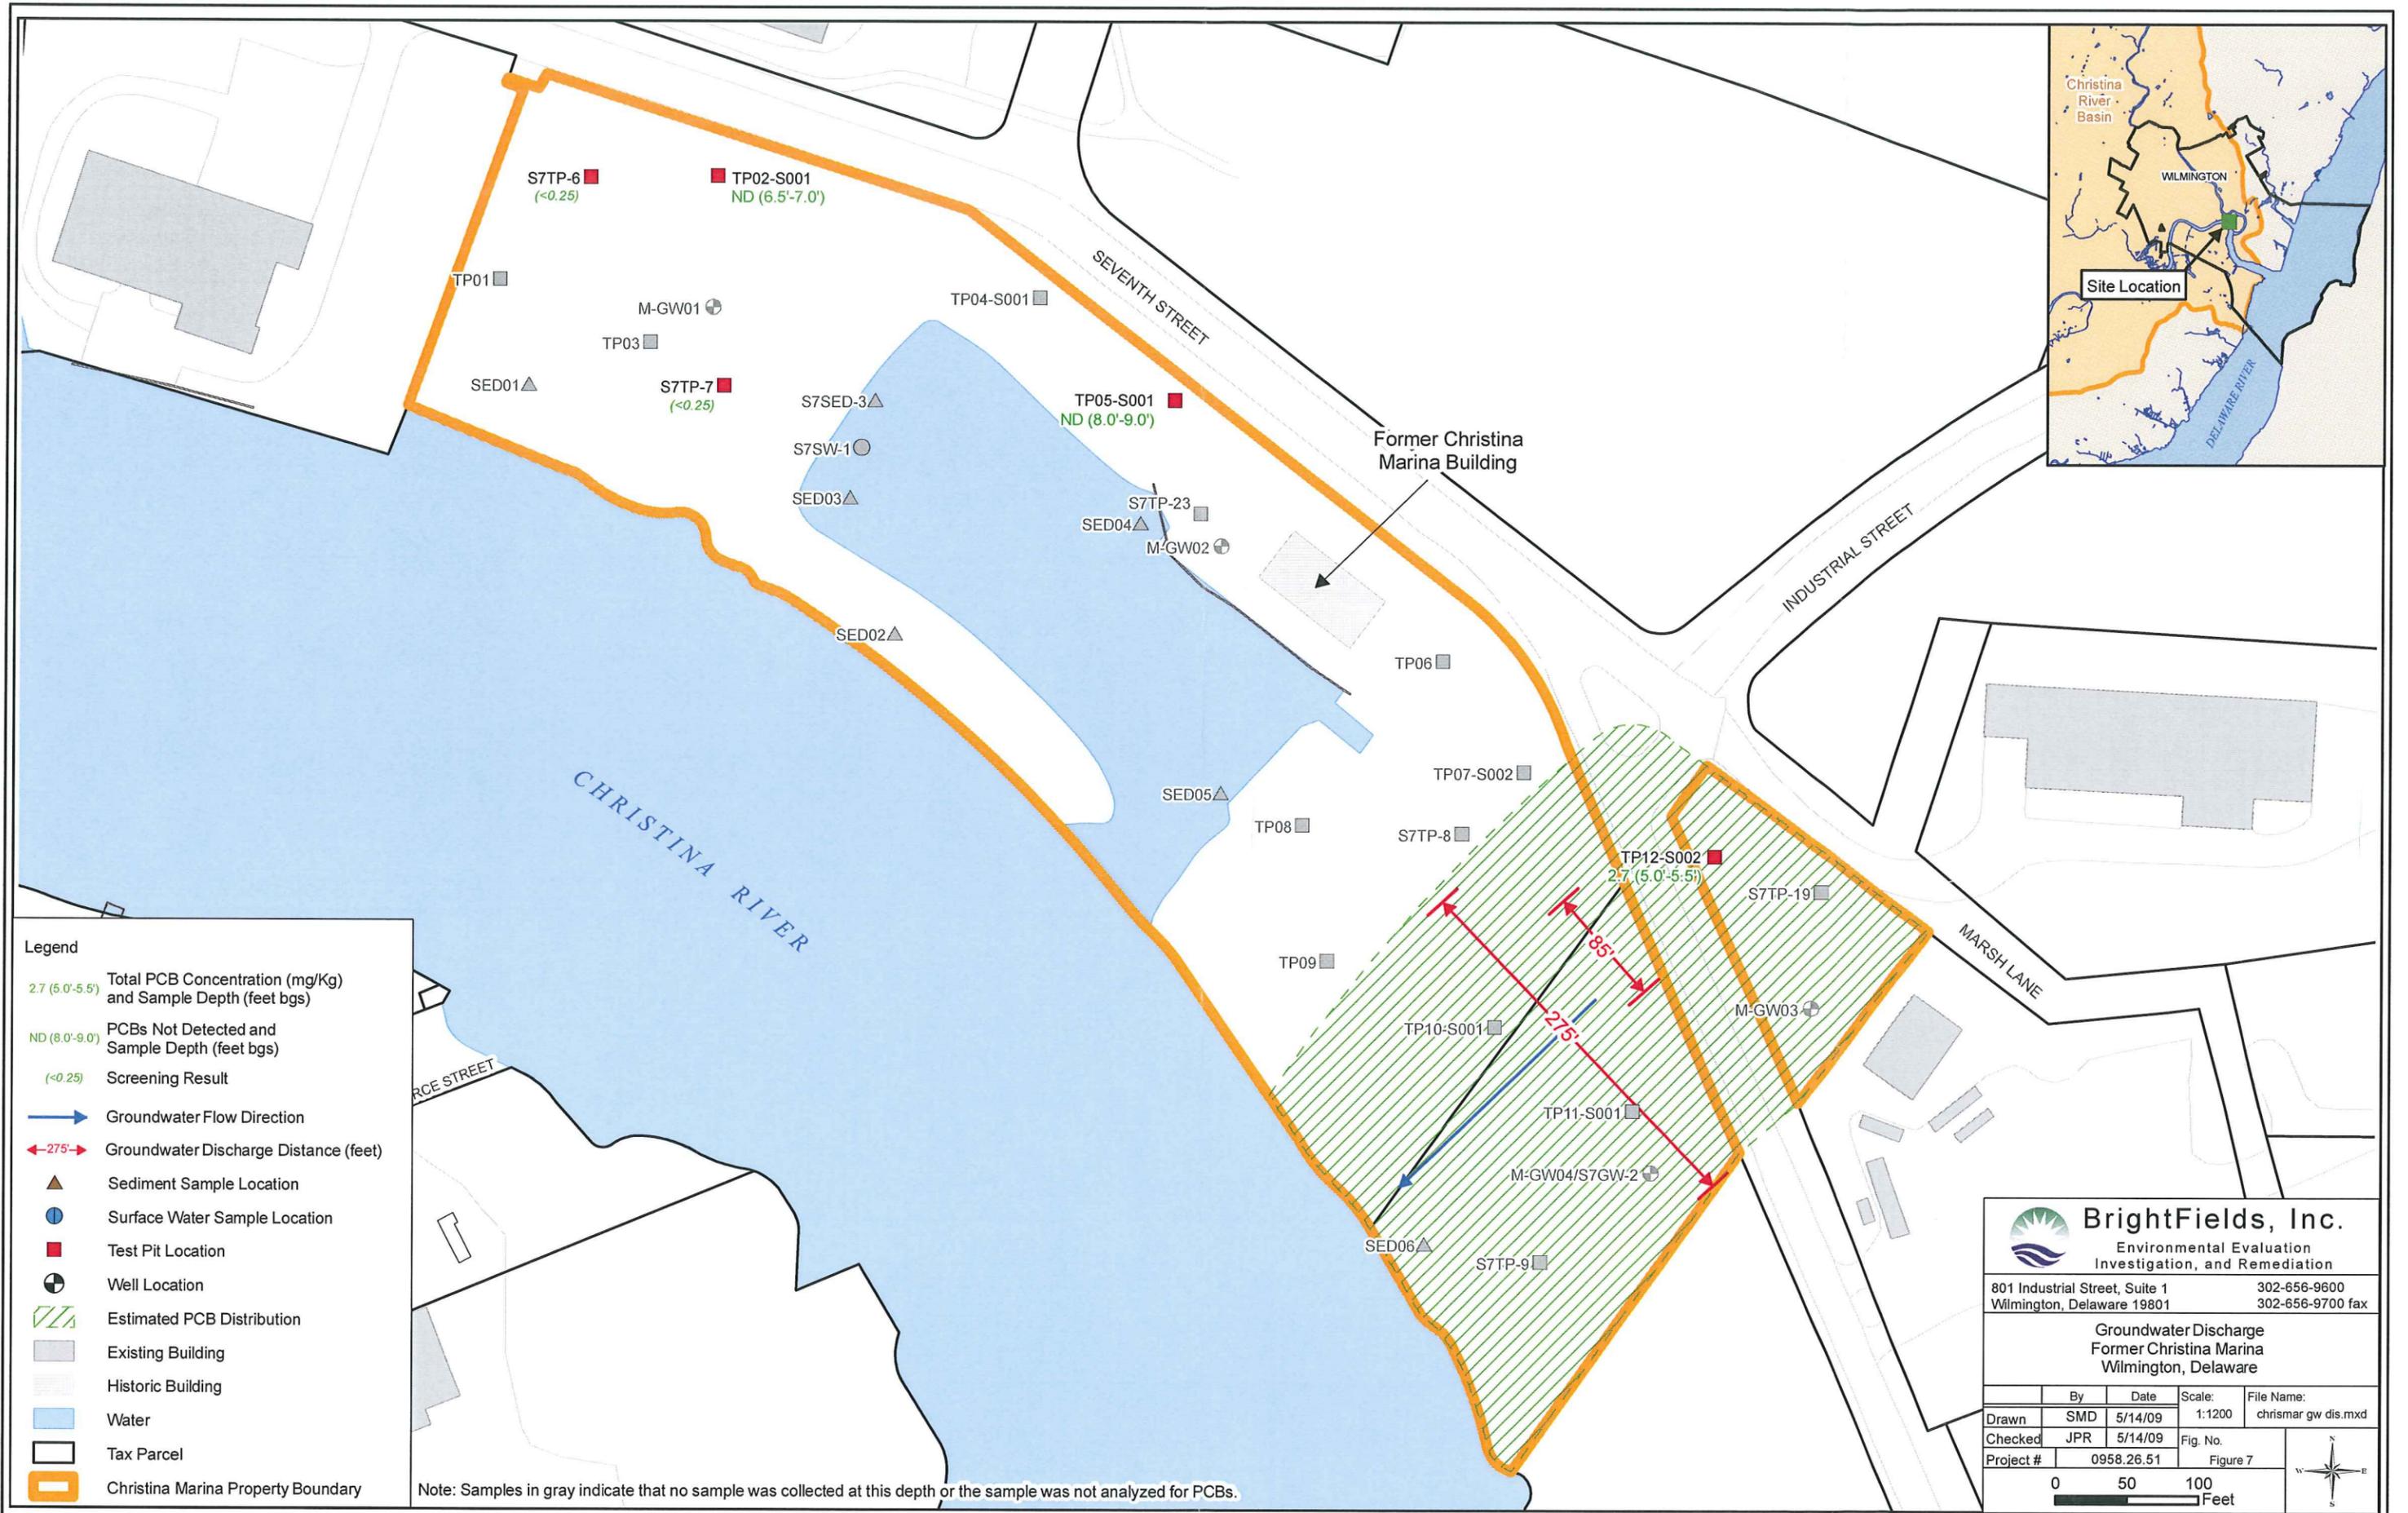
By	Date	Scale:	File Name:
SMD	5/14/09	1:1200	chrismar gw dis.mxd
Checked	JPR	5/14/09	Fig. No.
Project #	0958.26.51	Figure 7

**Groundwater Discharge  
 Former Christina Marina  
 Wilmington, Delaware**
