PCB Mass Loading  
Former Christina Marina  
SIRB ID: DE-1293  
Wilmington, Delaware

## **Appendix 8**

# **FORMER CHRISTINA MARINA PROPERTY WILMINGTON, DELAWARE**

**SIRB ID: DE-1293**

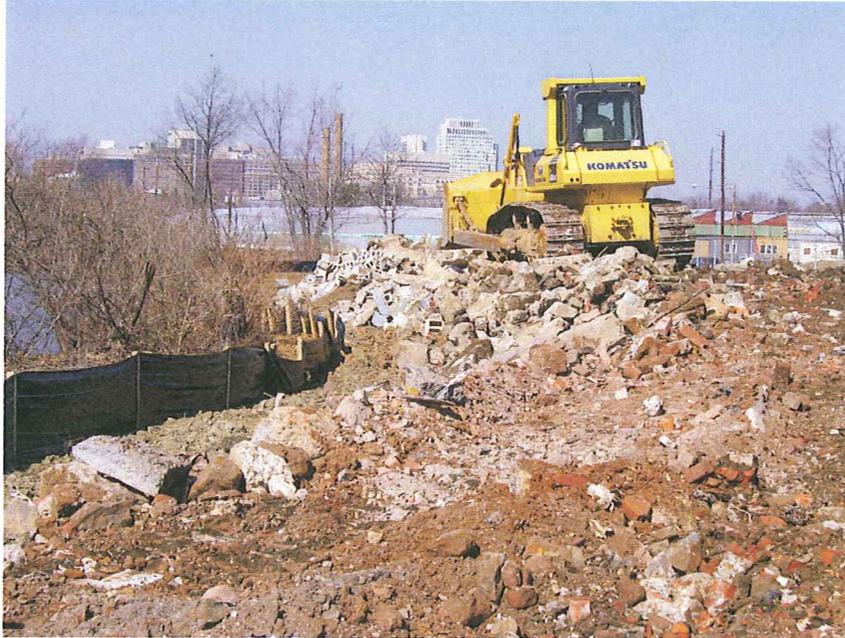
Partial site cover (emplacing brick and block for berm installation).

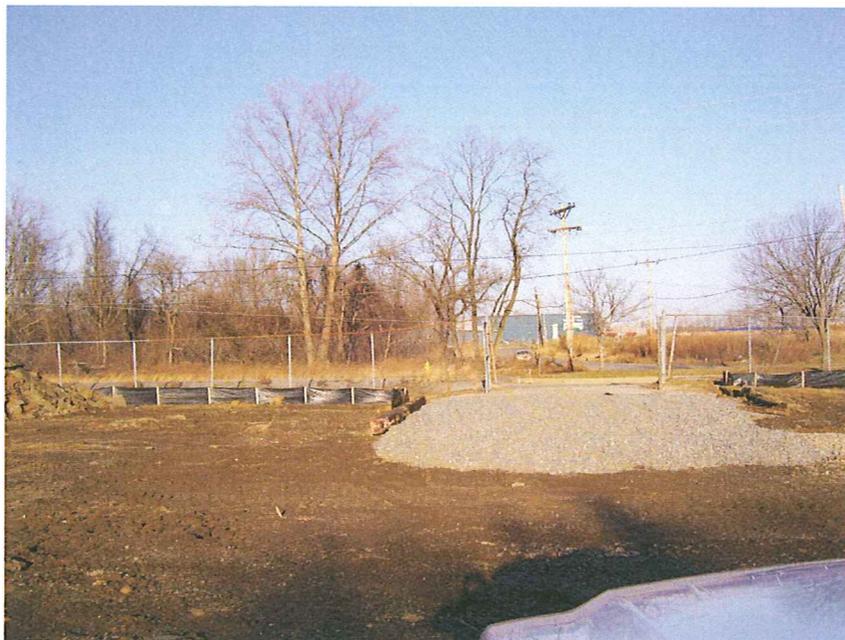
Site entrance displaying erosion and sediment controls and stone access ramp.

At the time of the inspection the site contained silt fence around the perimeter of the property to help prevent the off site migration of soil. The site also contained a stone construction entrance to minimize the amount of soil migrating off site during the site capping. Photographs of these sediment and erosion control techniques in use at the site are attached.

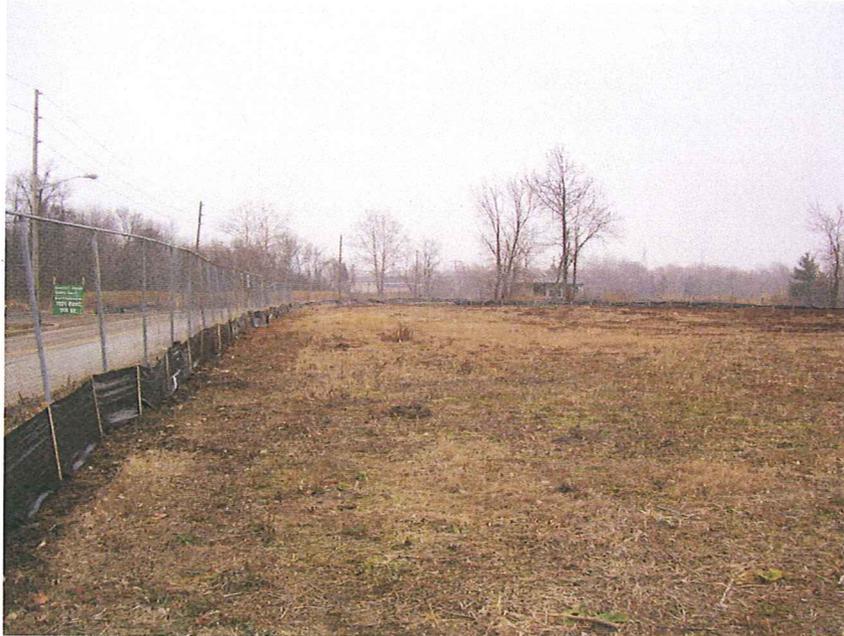
Site cover on western side of the property consisting of primarily little vegetation scrub.  
Erosion and sediment controls are in place around the complete perimeter.

A site inspection was performed on August 26, 2008 to estimate the current site ground cover and canopy. The cover/management factor (C) assigned to the site and associated flow path is 0.244, which corresponds to idle land with no appreciable shrub or tree canopy (77%), little crushed stone mulch (15%), and little wood mulch (8%). Photographs of the site ground cover and canopy are attached.
