PCB Mass Loading
Peninsula Park
SIRB ID: DE-1147
Wilmington, Delaware

PENINSULA PARK WILMINGTON, DELAWARE

SIRB ID: DE-1147

PCB MASS LOADING SUMMARY

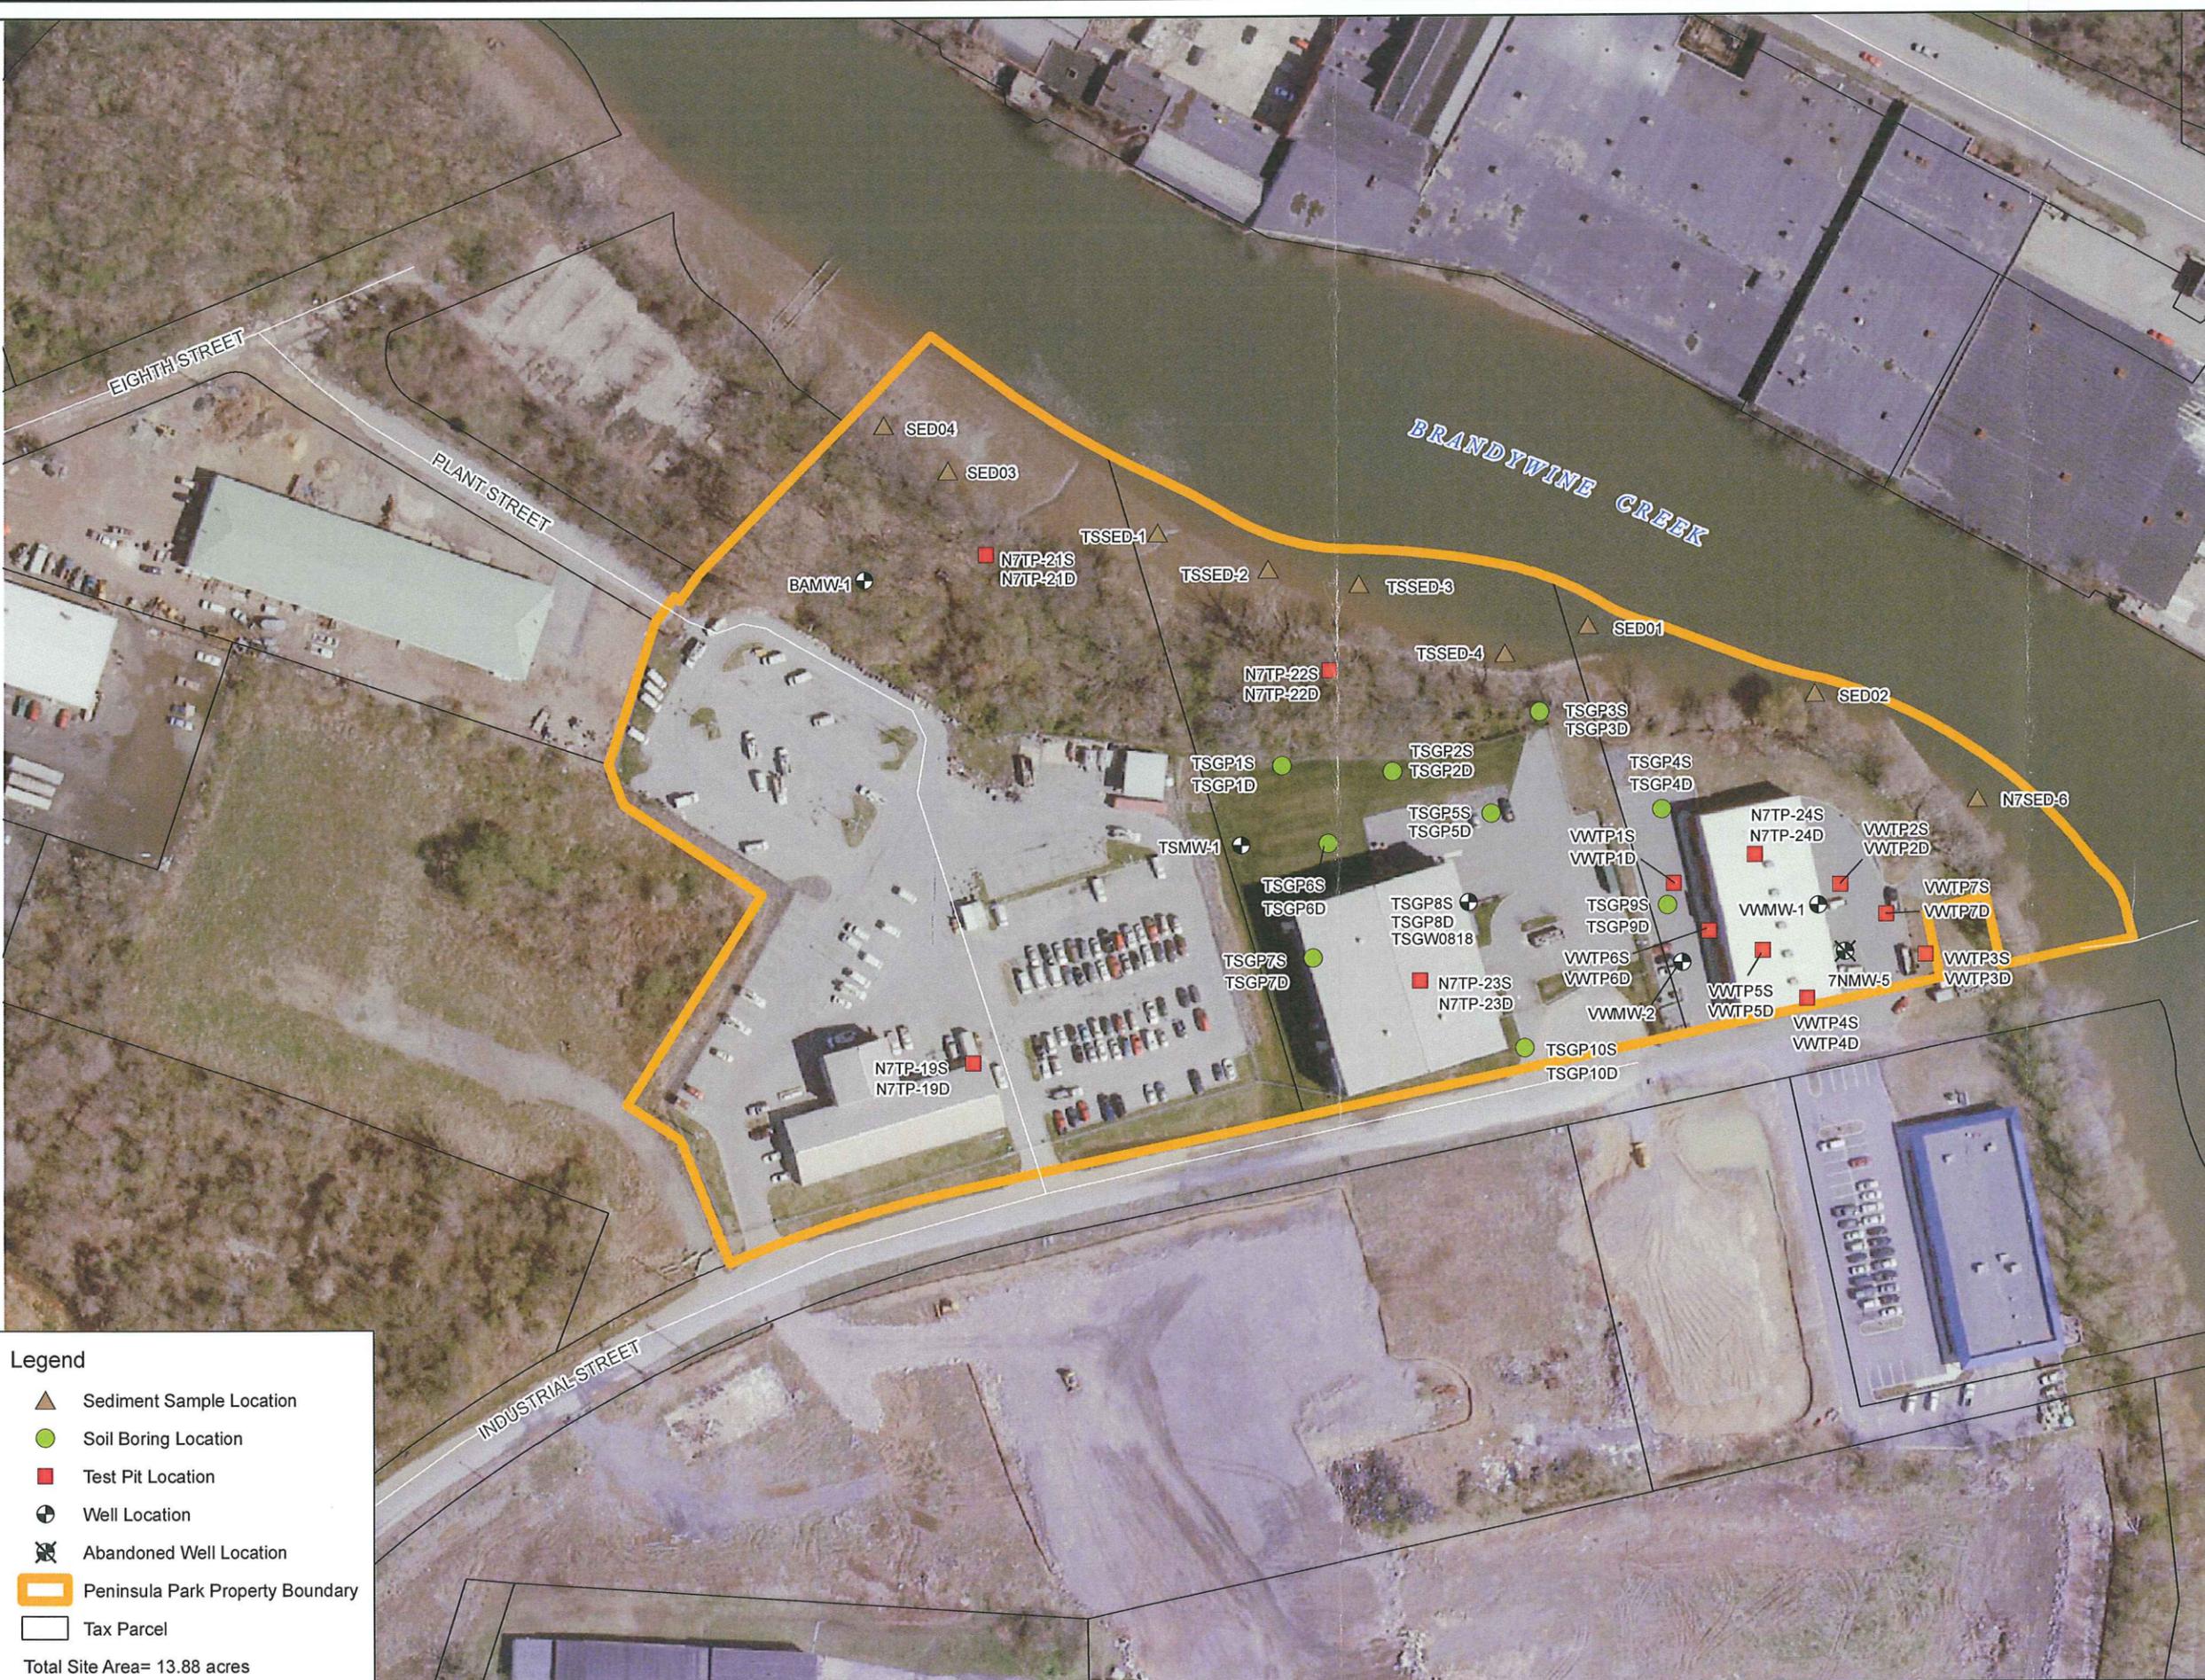
By	Date	Scale:	File Name:
Drawn SMD	5/1/09	1:1500	pp_aerial.mxd
Checked JPR	5/1/09	Fig. No.	
Project #	0985.26.51	Figure 1

Historic Sample Locations and
 Aerial Photograph (2007)
 Peninsula Park Property
 Wilmington, Delaware

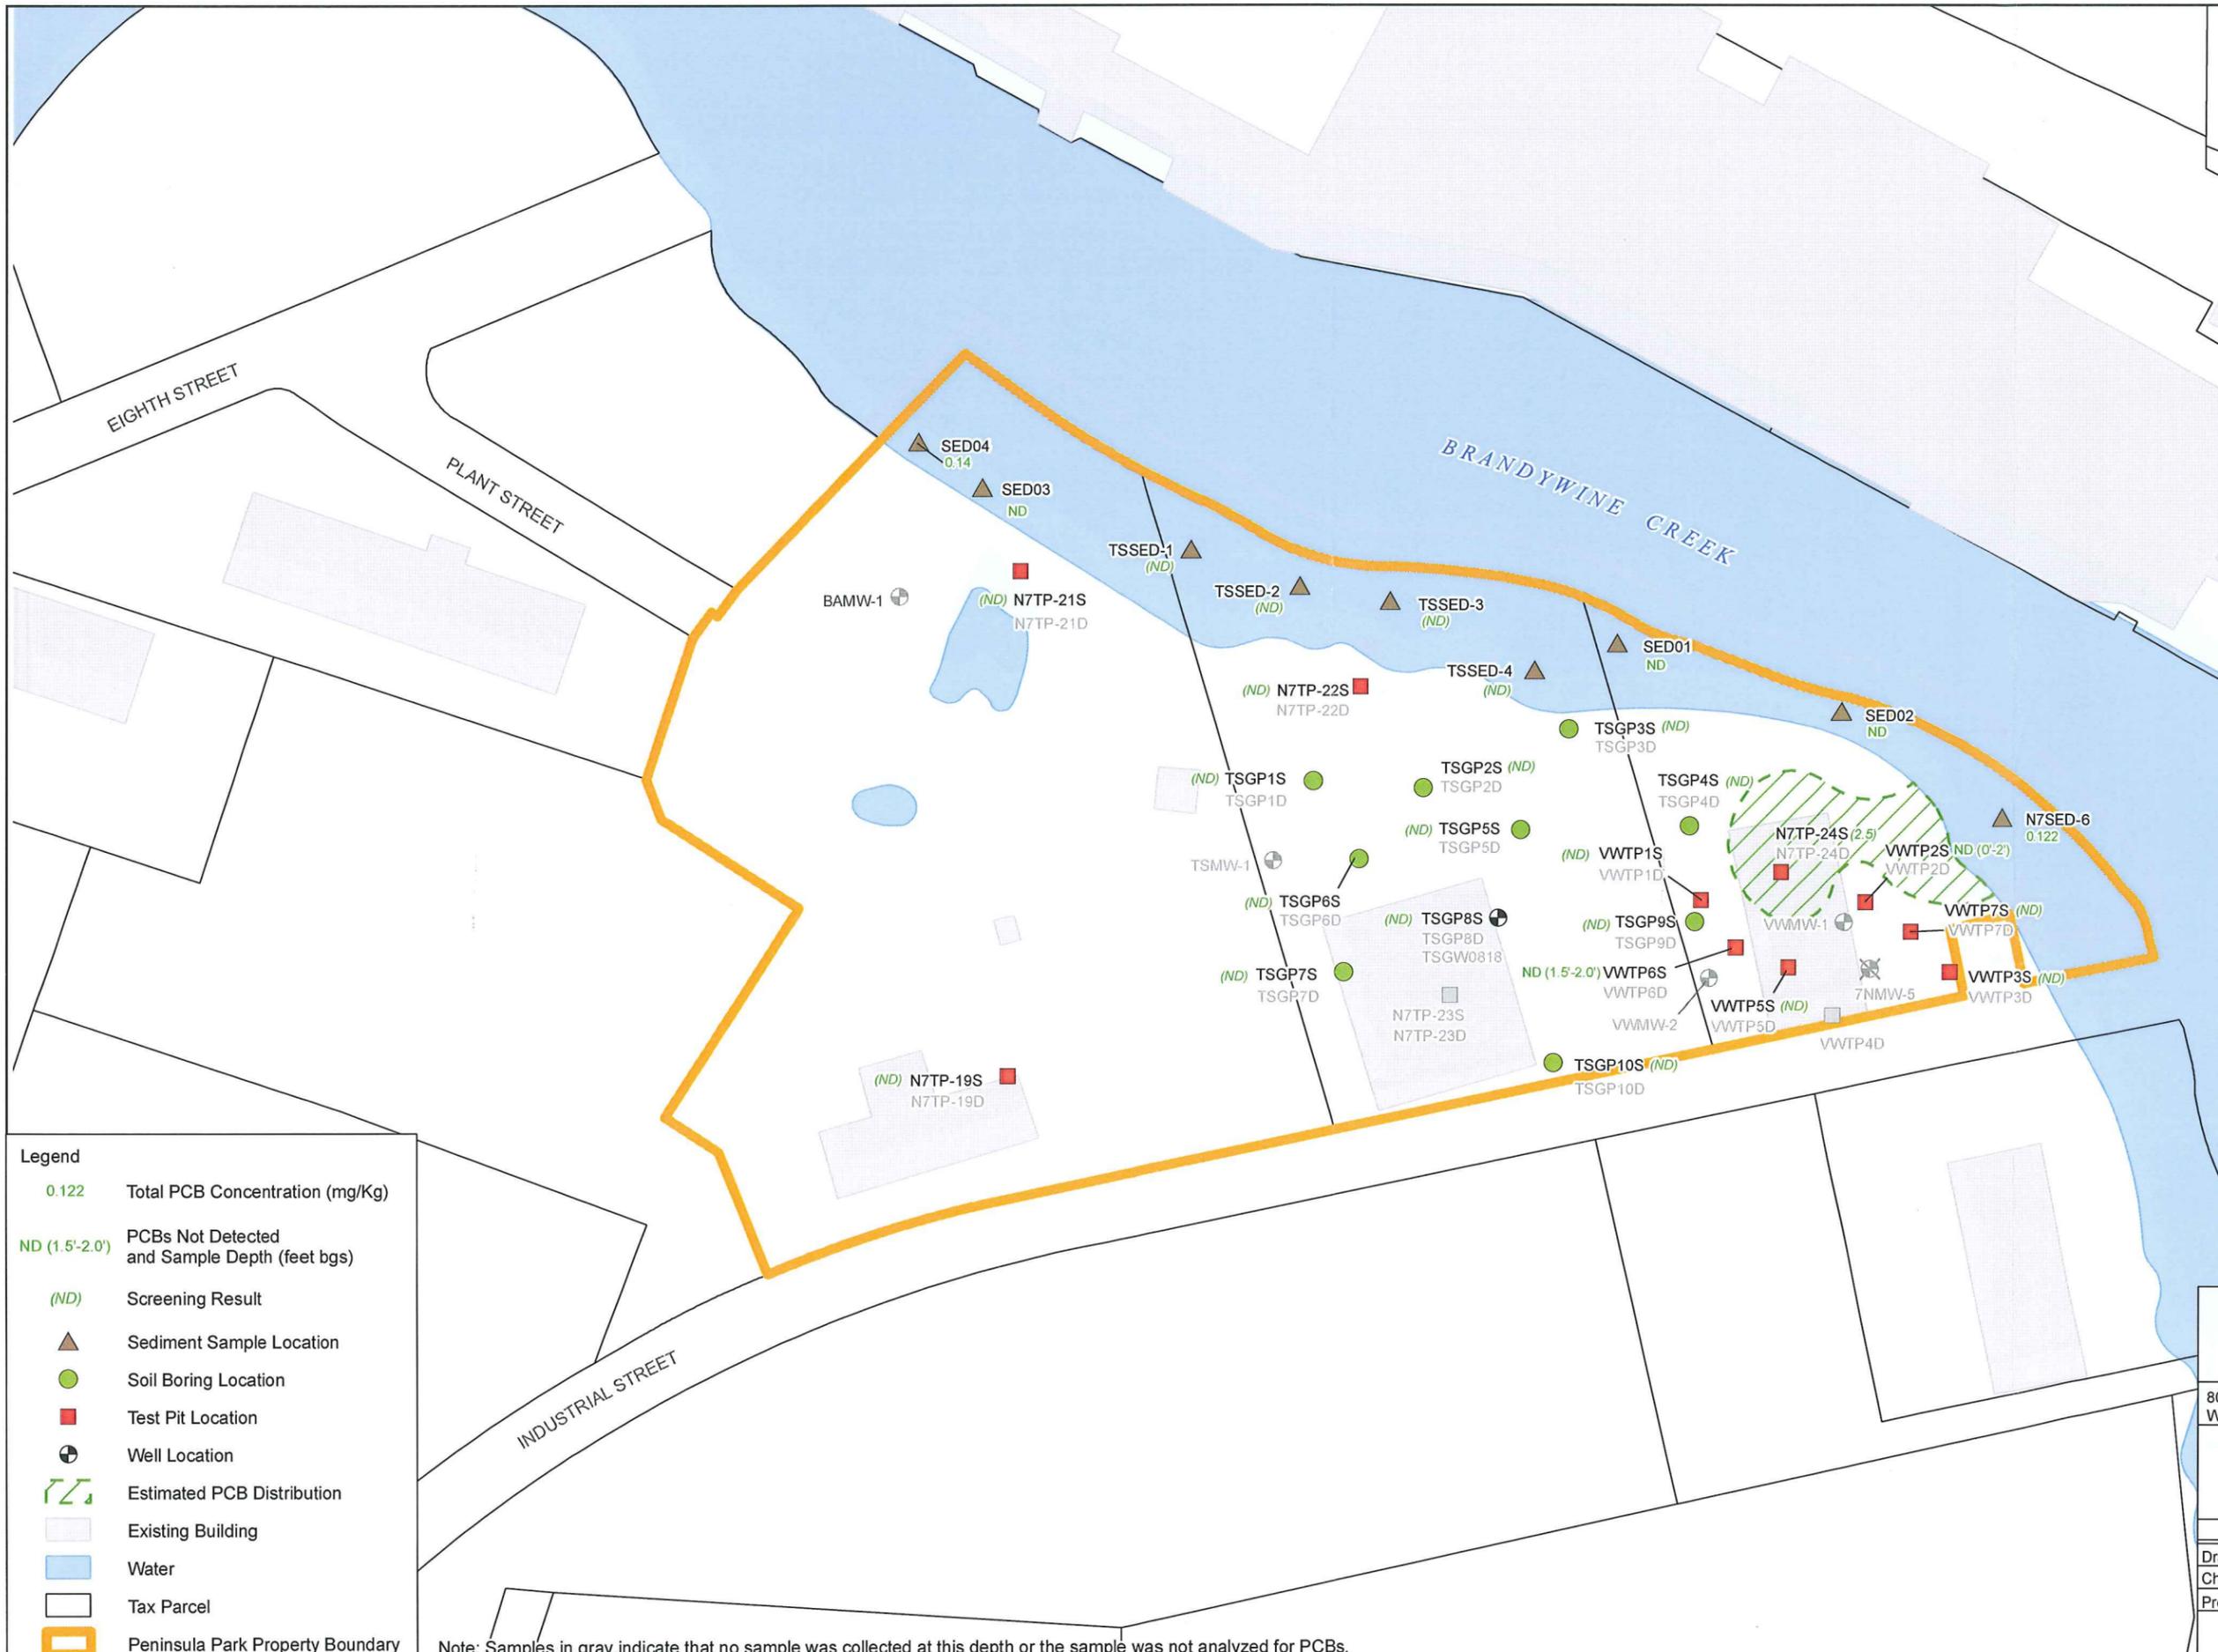
By	Date	Scale:	File Name:
SMD	5/1/09	1:1500	pp_0-2.mxd
Checked	JPR	5/1/09	Fig. No.
Project #	0985.26.51	Figure 2

**PCB Distribution in Surface Soil
 Peninsula Park Property
 Wilmington, Delaware**

Concentrations of PCBs on Site			
Sample Matrix	Corresponding Figure	Analytical Methods	Range of Total PCBs
Surface Soil	Figure 2	Method 8082 and Immunoassay	Not detected to 2.5 mg/kg
Subsurface Soil (unsaturated)	Figure 3	Method 8082 and Immunoassay	Not detected to 7.4 mg/kg
Subsurface Soil (saturated)	Figure 4	Method 8082 and Immunoassay	Not detected
Groundwater	Figure 5	Method 8082	Not detected

Estimated surface soil area impacted by PCBs is 2.14 acres (Figure 2). Estimated subsurface non-saturated area impacted by PCBs is 2.71 acres (Figure 4). The review of historical reports did not indicate that there were any subsurface saturated soils or groundwater impacted by PCBs.

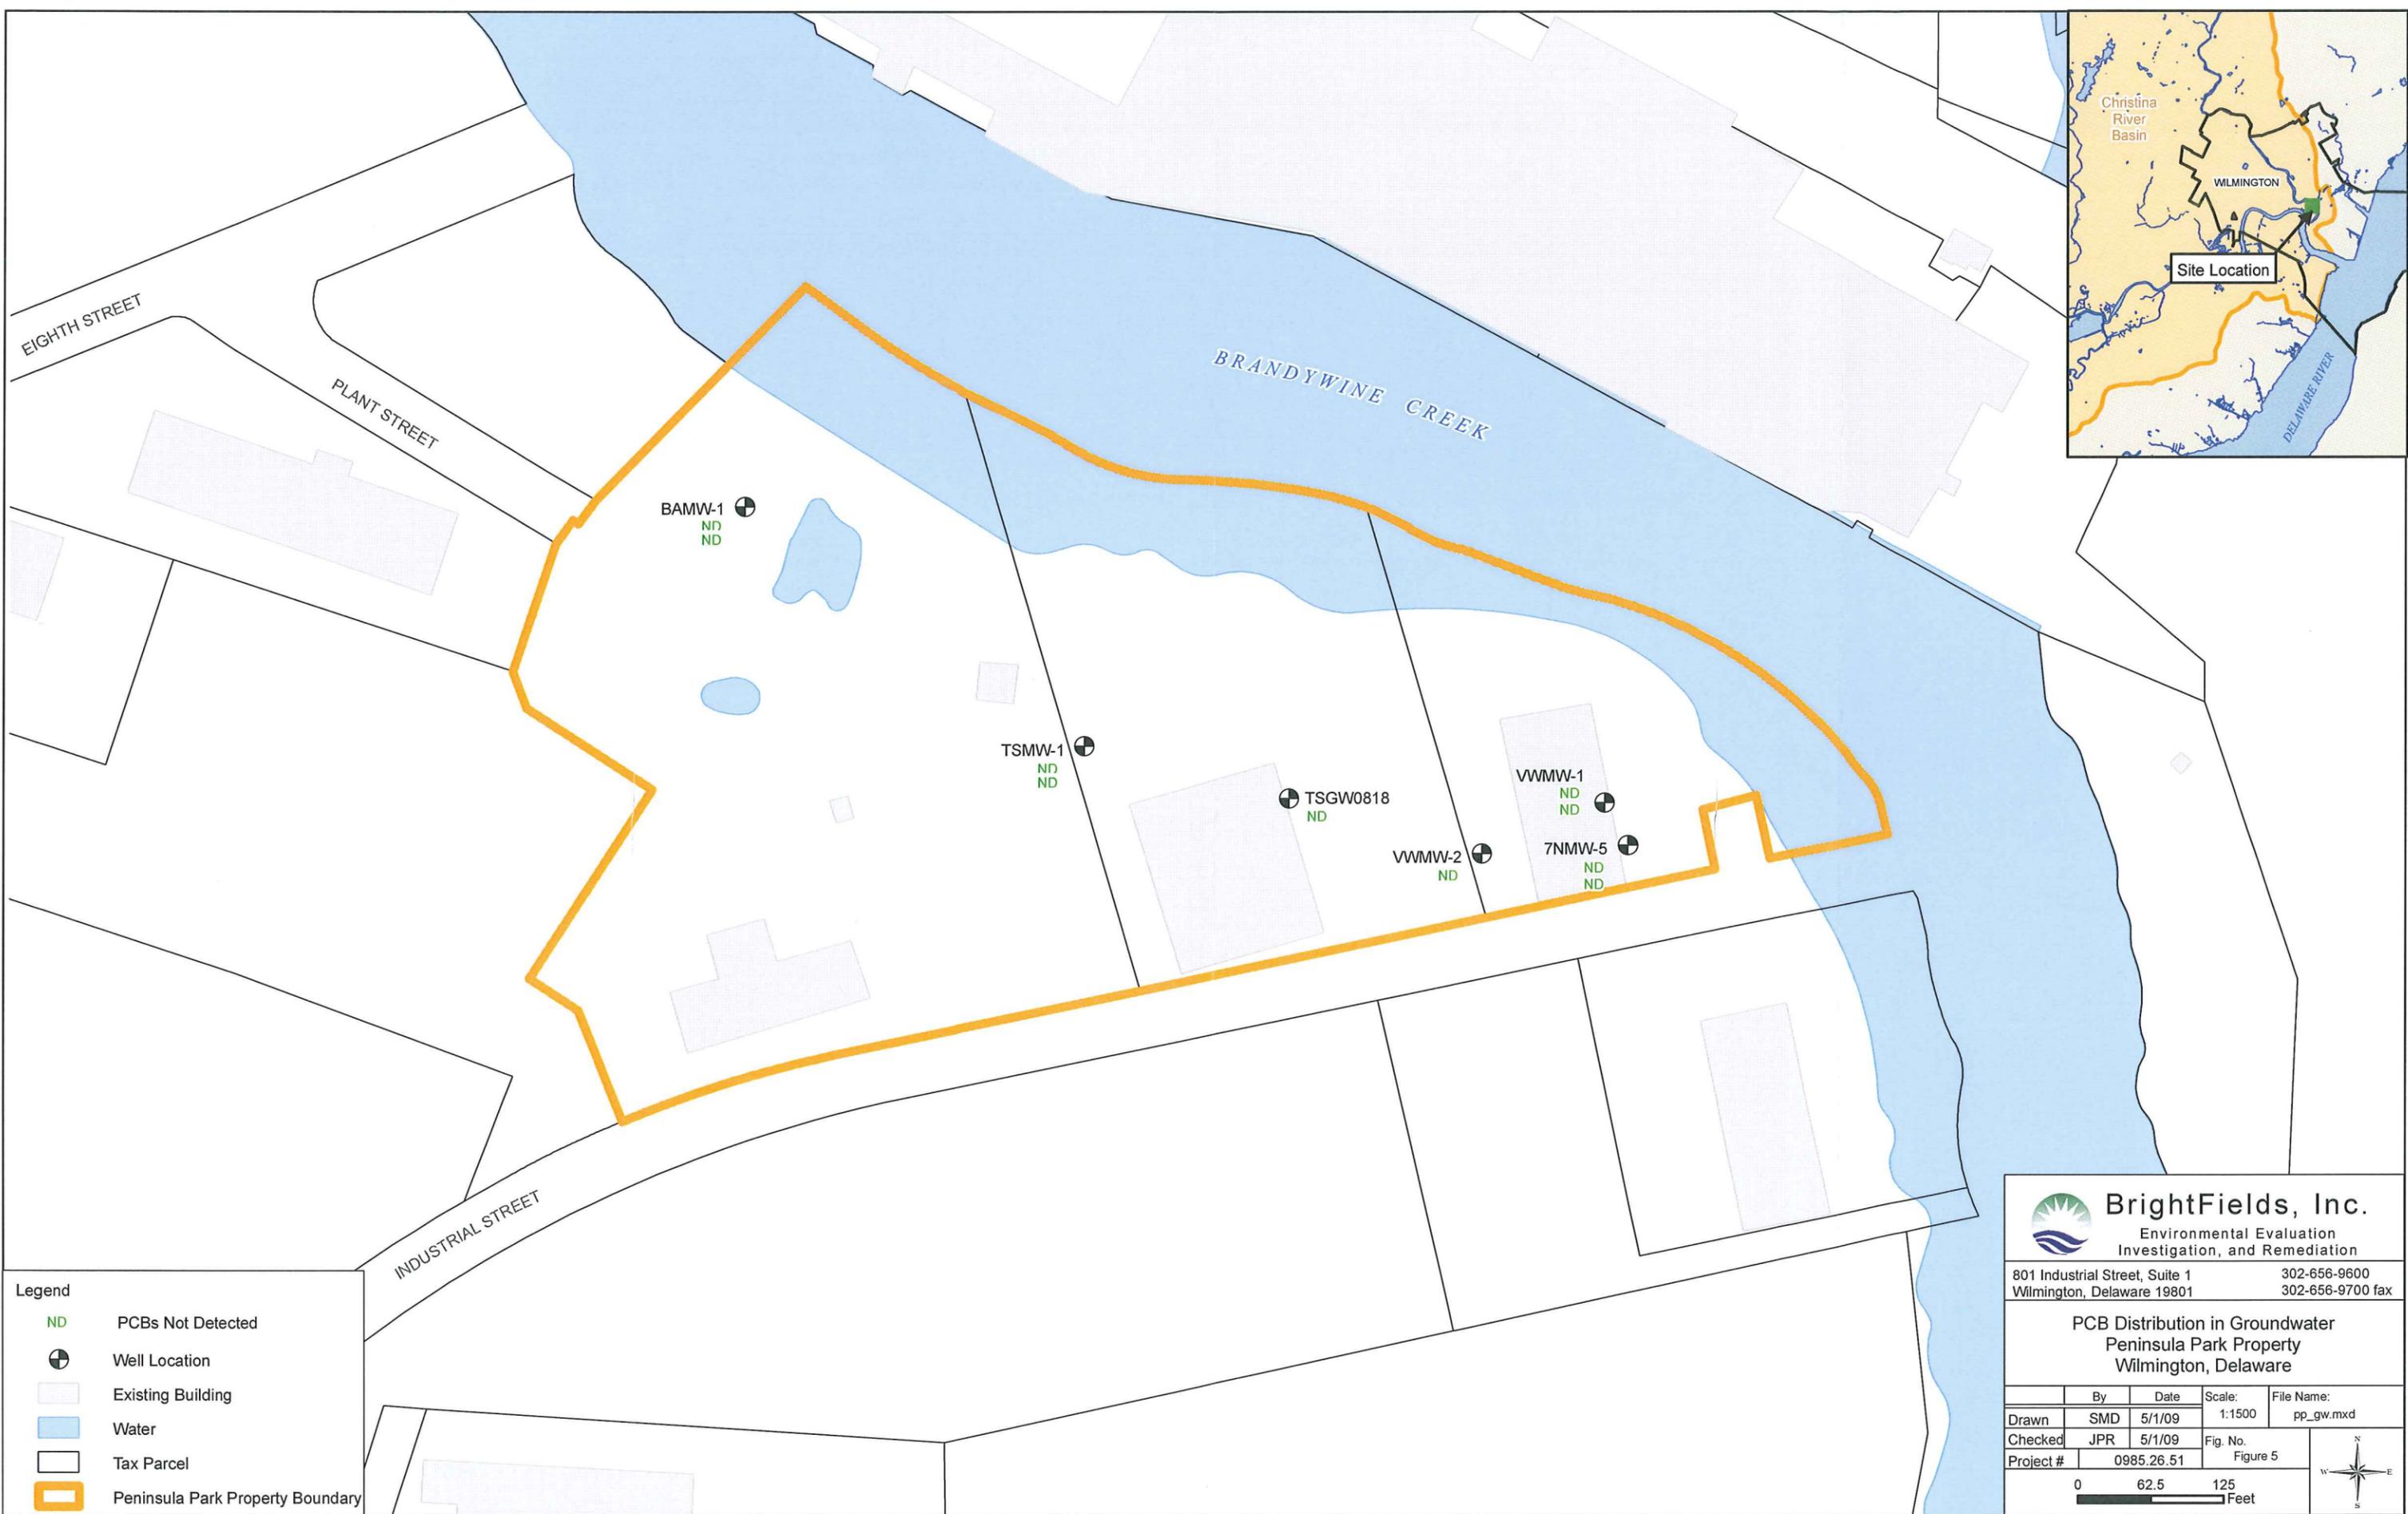
By	Date	Scale:	File Name:
Drawn	SMD	5/1/09	1:1500	pp_gw.mxd
Checked	JPR	5/1/09	Fig. No.	
Project #	0985.26.51		Figure 5

**PCB Distribution in Groundwater
 Peninsula Park Property
 Wilmington, Delaware**

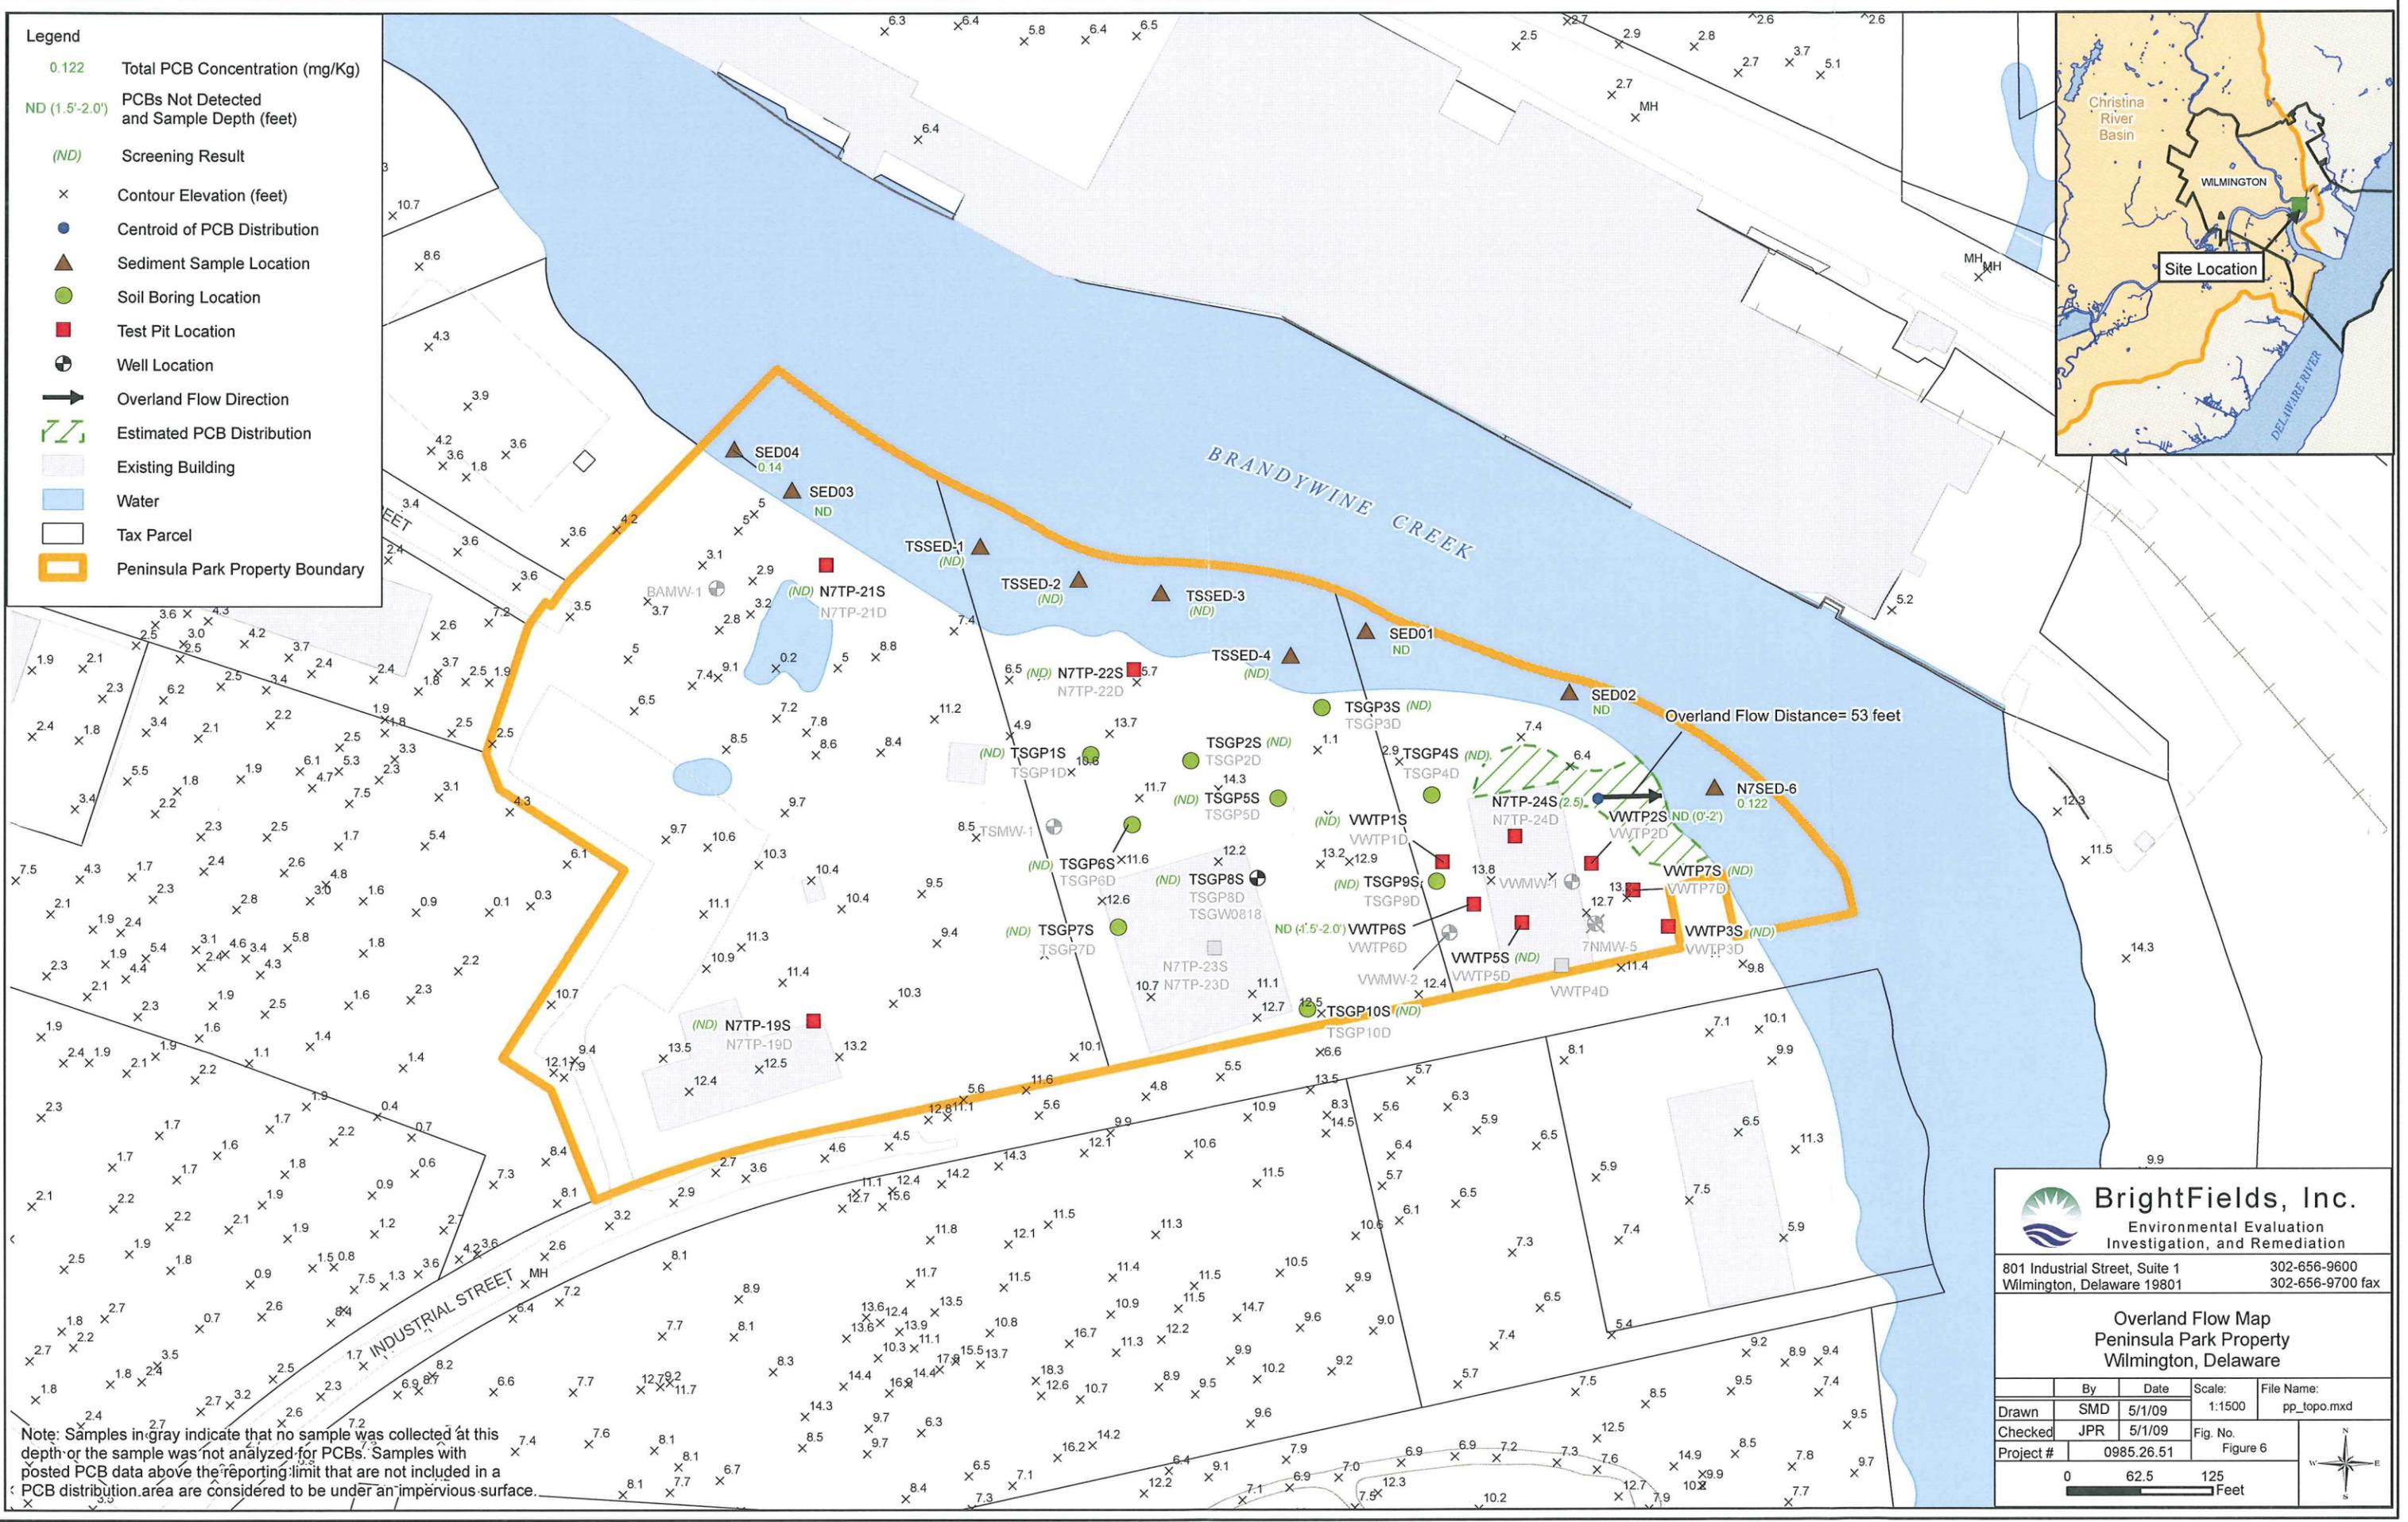
By	Date	Scale:	File Name:
Drawn SMD	5/1/09	1:1500	pp_topo.mxd
Checked JPR	5/1/09	Fig. No.	Figure 6
Project #	0985.26.51

Note: Samples in gray indicate that no sample was collected at this depth or the sample was not analyzed for PCBs. Samples with posted PCB data above the reporting limit that are not included in a PCB distribution area are considered to be under an impervious surface.

**Overland Flow Map
 Peninsula Park Property
 Wilmington, Delaware**

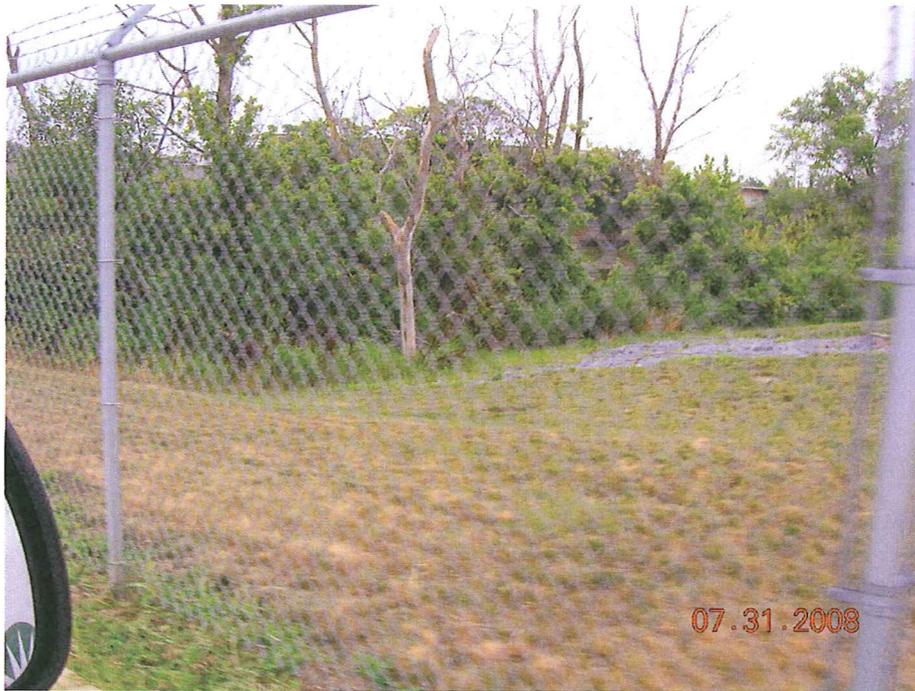
Sloping area down to river associated erosion.

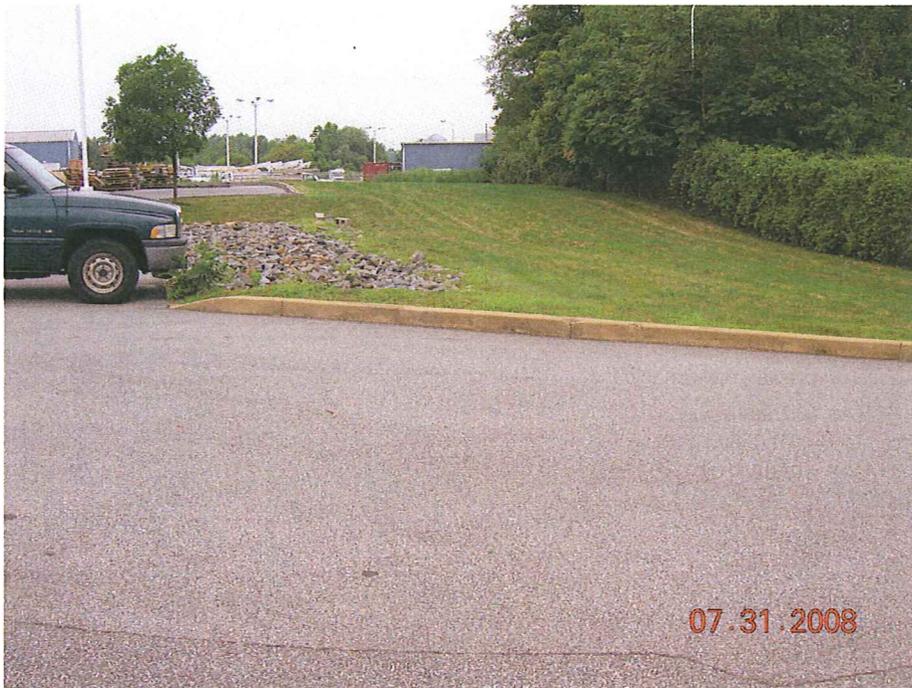
Cover behind carpet distributor along industrial street.
Area is implementing two feet clean fill.

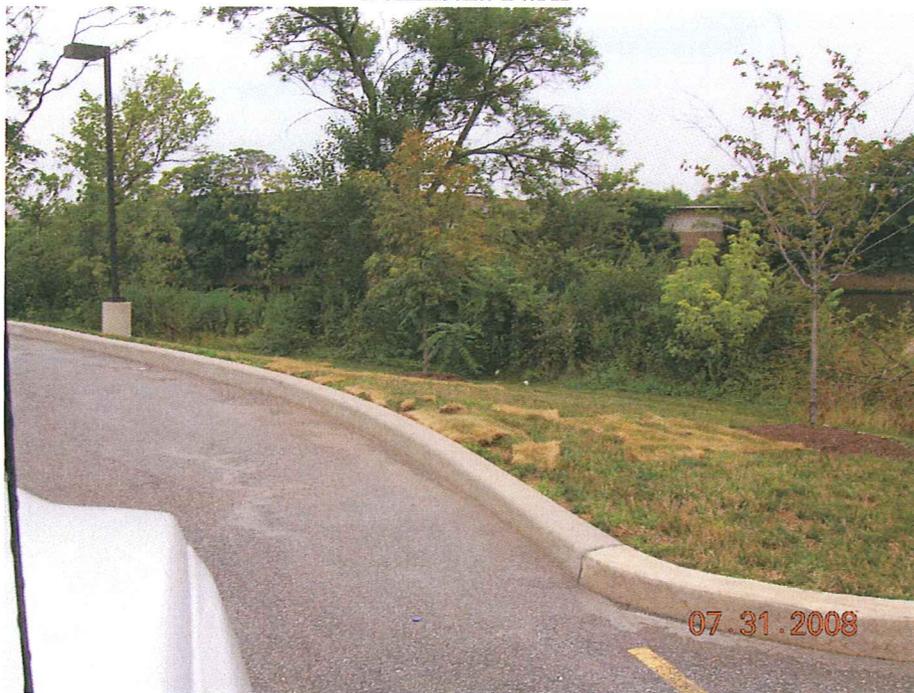
Cover factors associated with eastern portion of the site.

A site inspection was performed to estimate the current site ground cover and canopy on July 31, 2008. The evaluation incorporated the use of aerial photography as well as the site visit due to the limited access to the site. A specific cover/management factor (C) was assigned to the area in vicinity of S7TP-24. This area was assigned a value of 0.016, which corresponds to 80% surface cover with the cover at the surface consisting primarily of grass, grass-like plants, decaying compacted duff, or litter at least 2 inches deep.

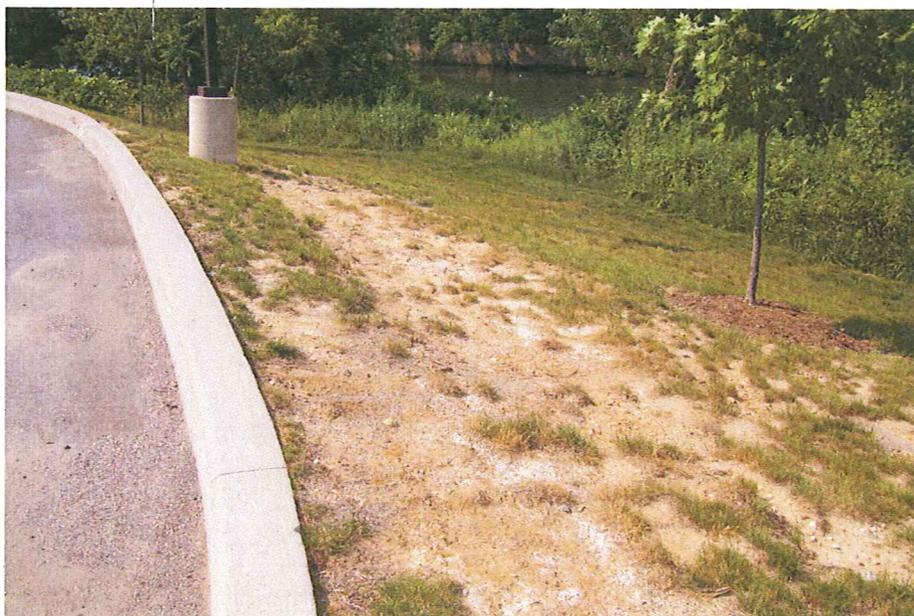
Signs of erosion on eastern portion of the site.
