PCB Mass Loading  
Amtrak Refueling Yard  
SIRB ID: DE-0266  
Wilmington, Delaware

**Subject: Draft Phase II RI/FFS Report  
AMTRAK Former Fueling Facility (DE 266), Wilmington, Delaware**

DRAFT PHASE II REMEDIAL INVESTIGATION AND  
FOCUSED FEASIBILITY STUDY REPORT  
AMTRAK FORMER FUELING FACILITY  
VANDEVER AVENUE  
WILMINGTON, DELAWARE

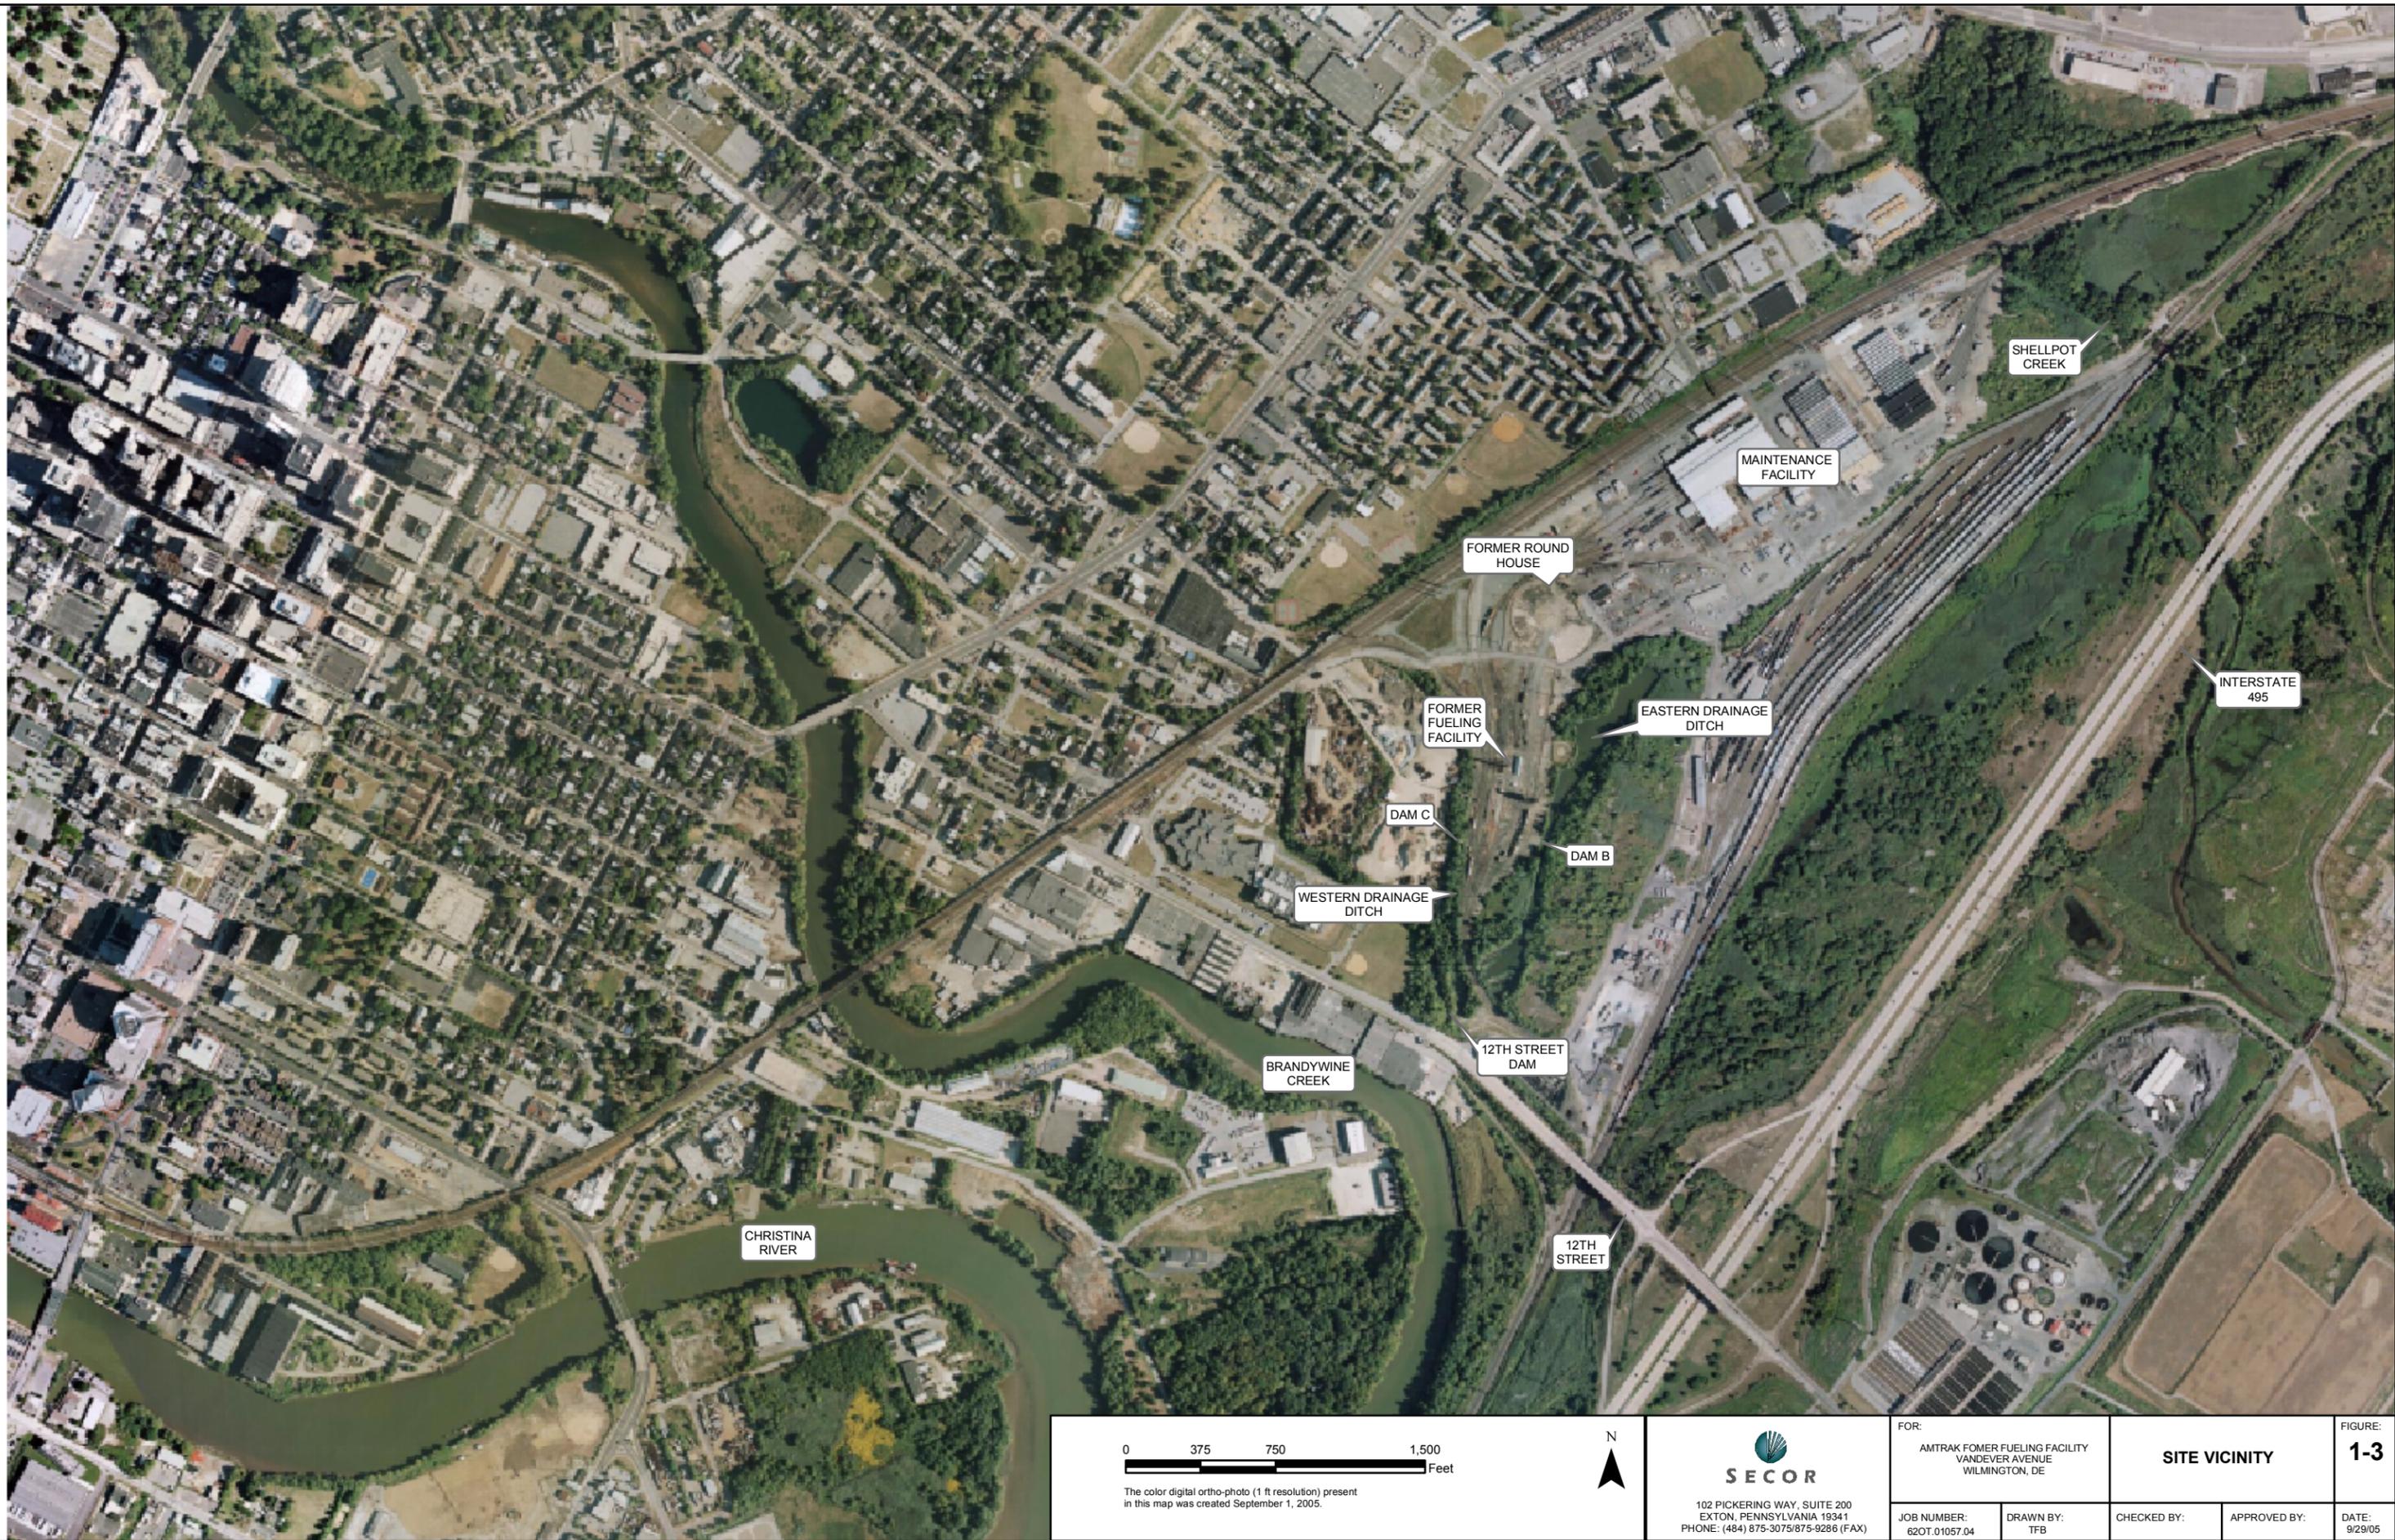
<p><b>SECOR</b>          100 PROCEEDING WAY, SUITE 200          FARMINGTON, CT 06031          PHONE: 860.634.1100          FAX: 860.634.1101          WWW.SECOR.COM</p>	PROJECT: AMTRAK FORMER FUELING FACILITY	SHEET: SITE PLAN	DATE: 1-2
	JOB NUMBER: WILMINGTON DELAWARE	DRAWN BY: 587	CHECKED BY: 58

The color digital ortho-photo (1 ft resolution) present in this map was created September 1, 2005.

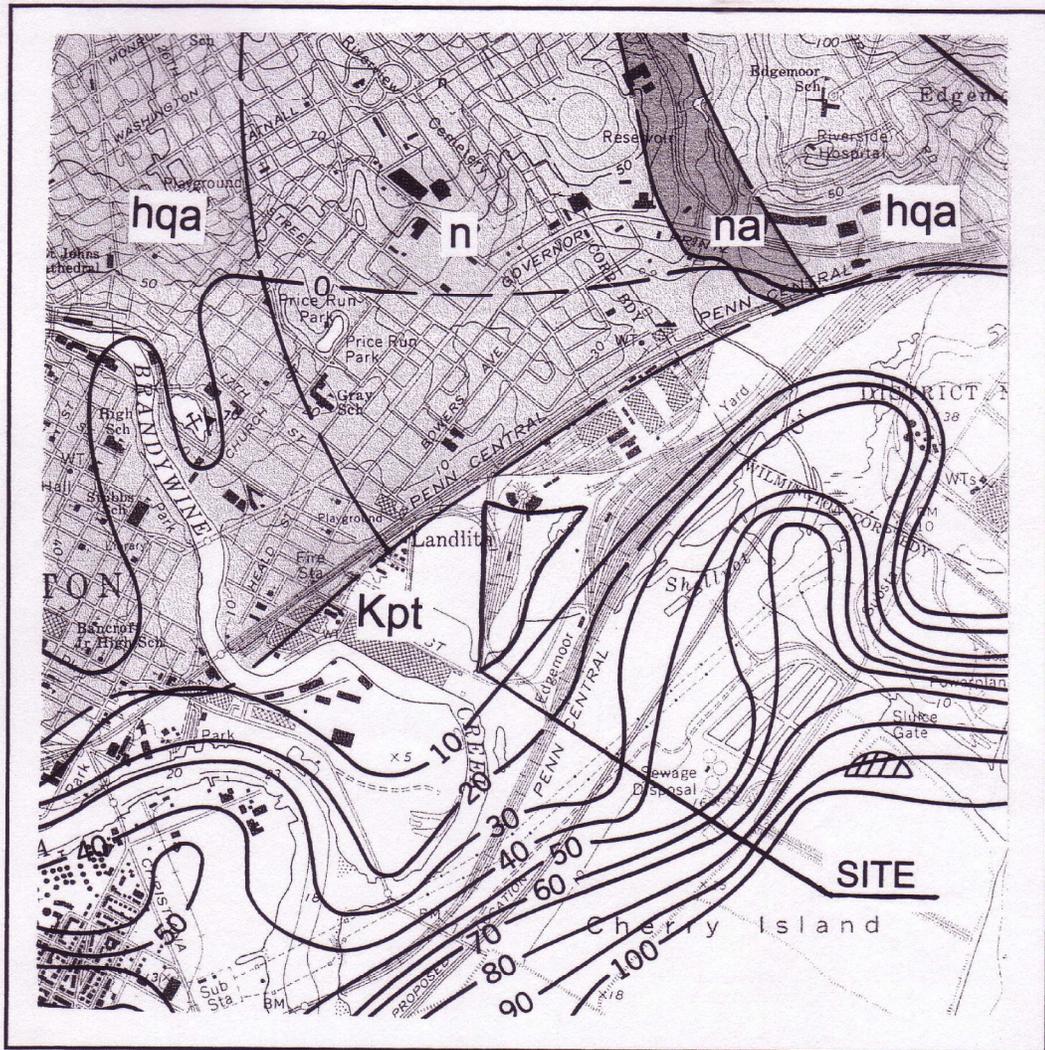
FIGURE 2-1

# GEOLOGIC MAP

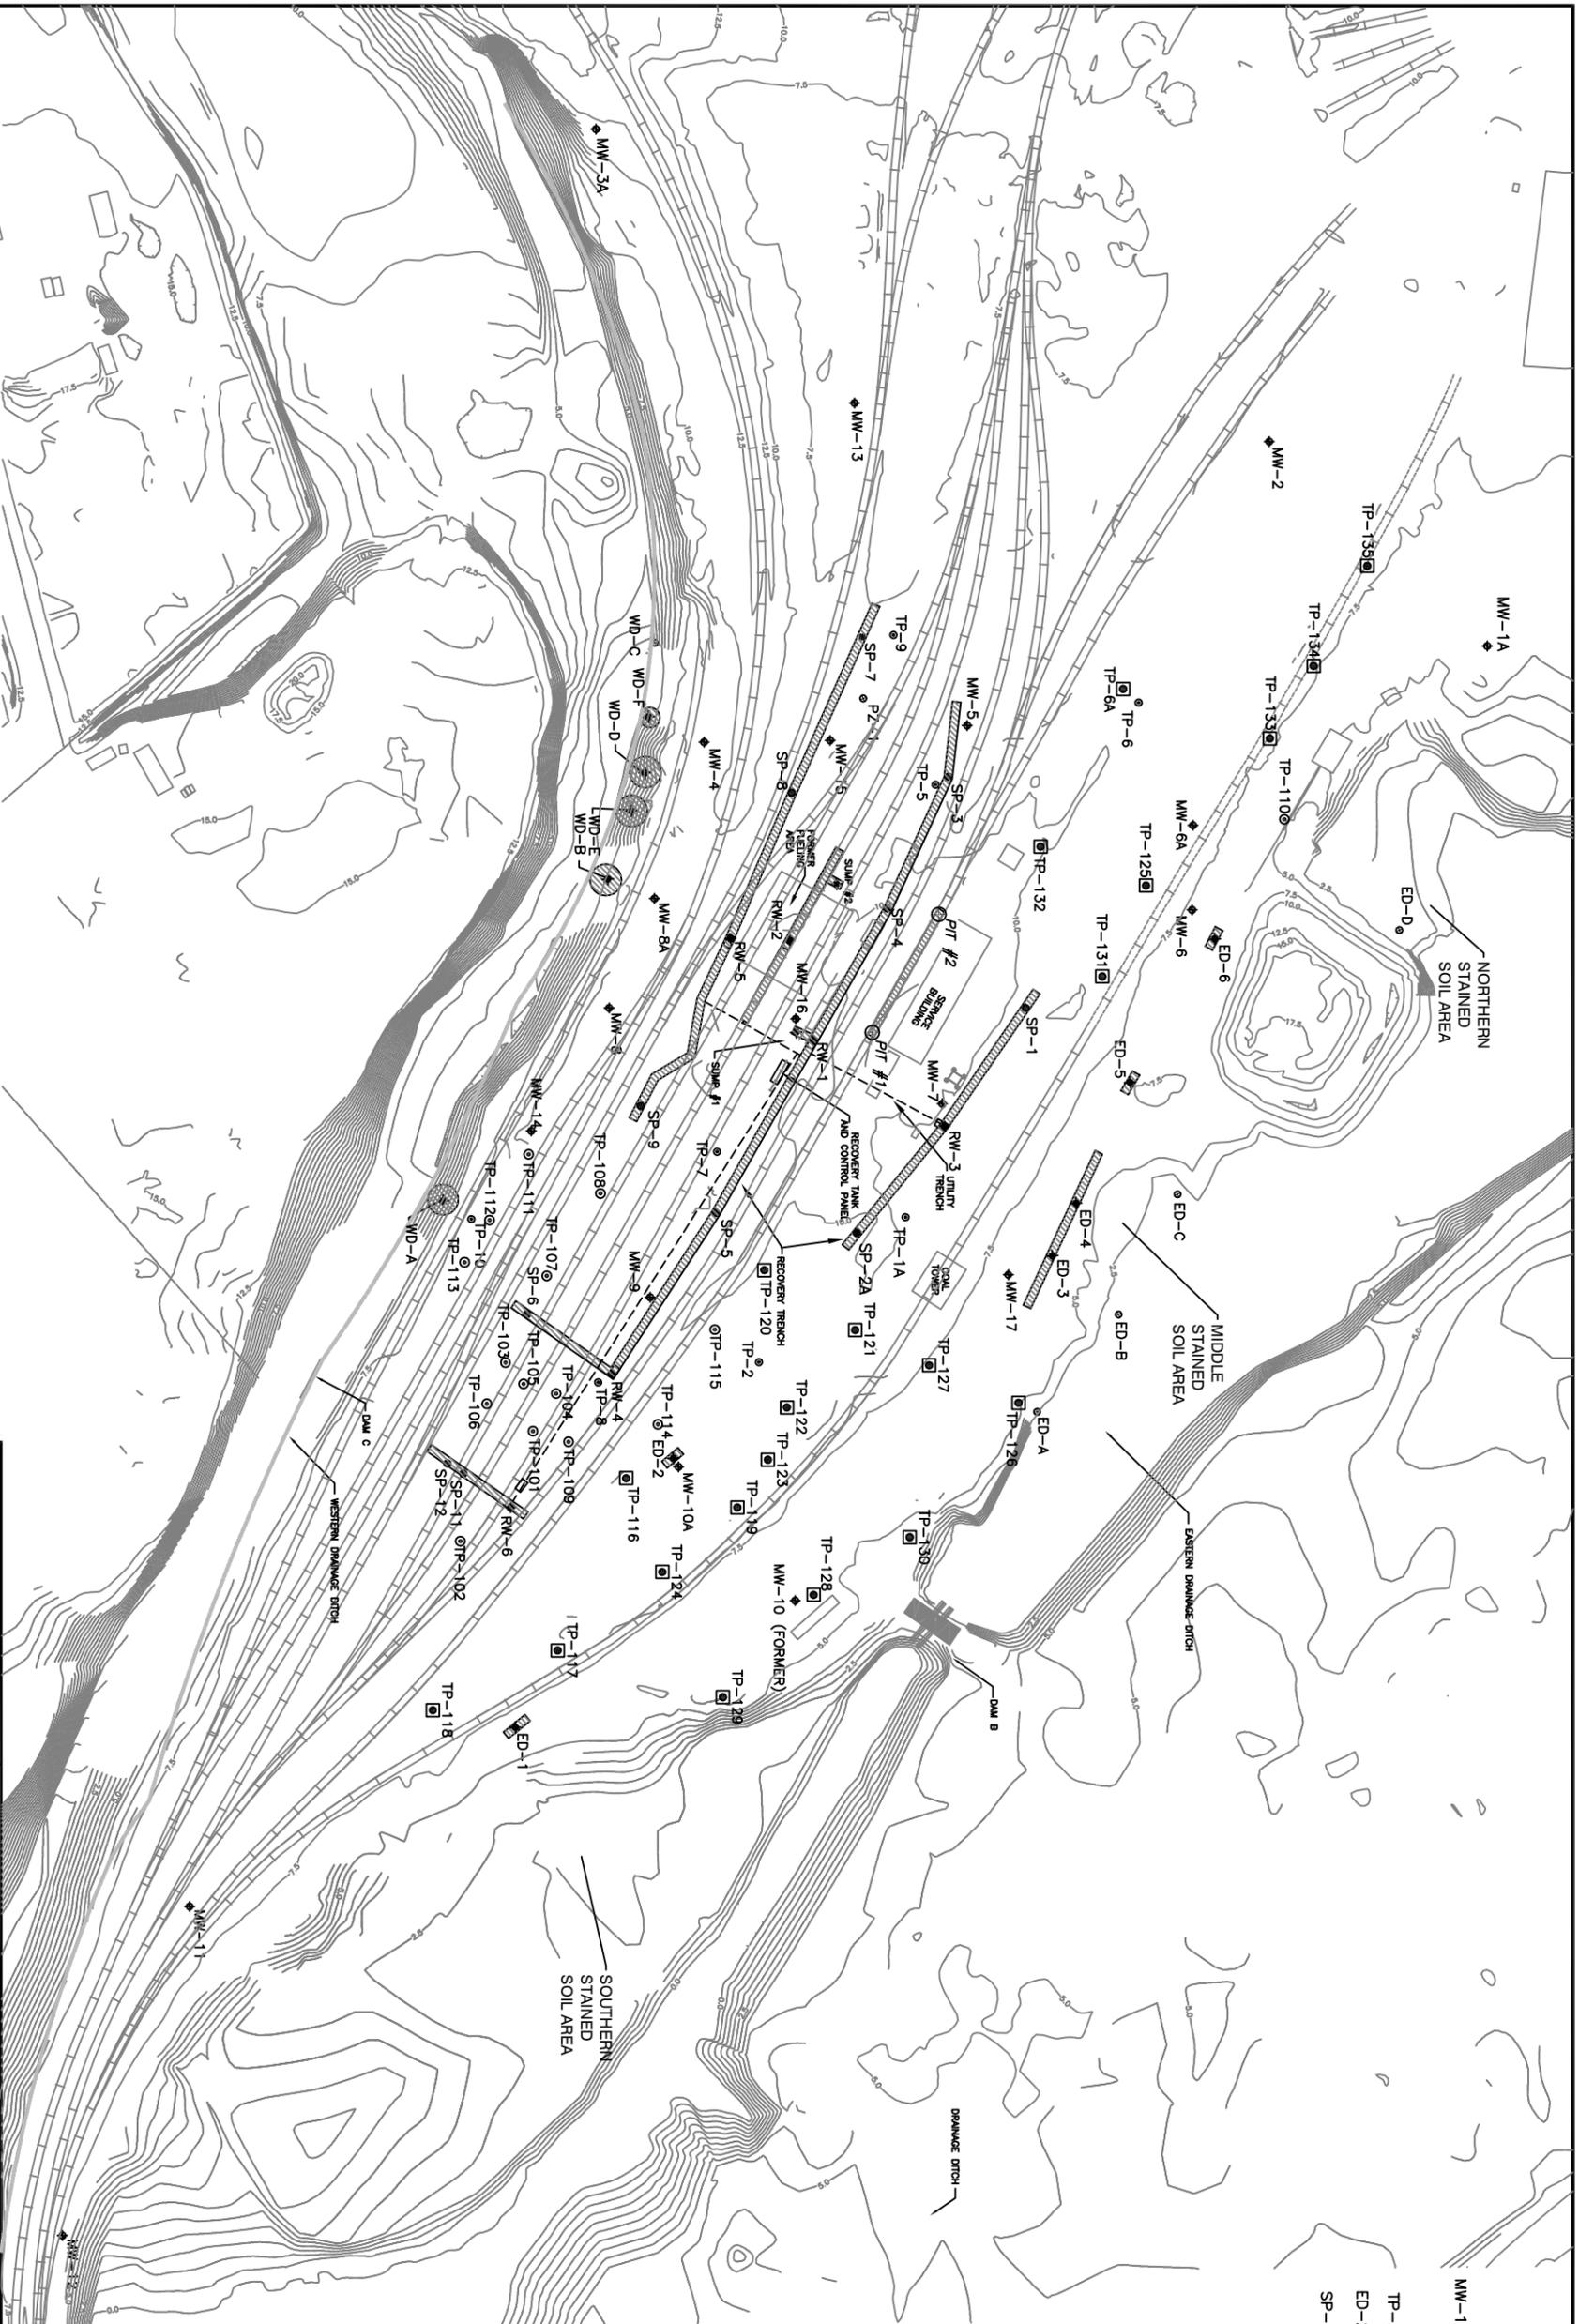
**2-1**

NOTE:  
THE LOCATIONS OF WELLS MW-1A, MW-3A,  
SP-2A AND TP-1A ARE APPROXIMATE.

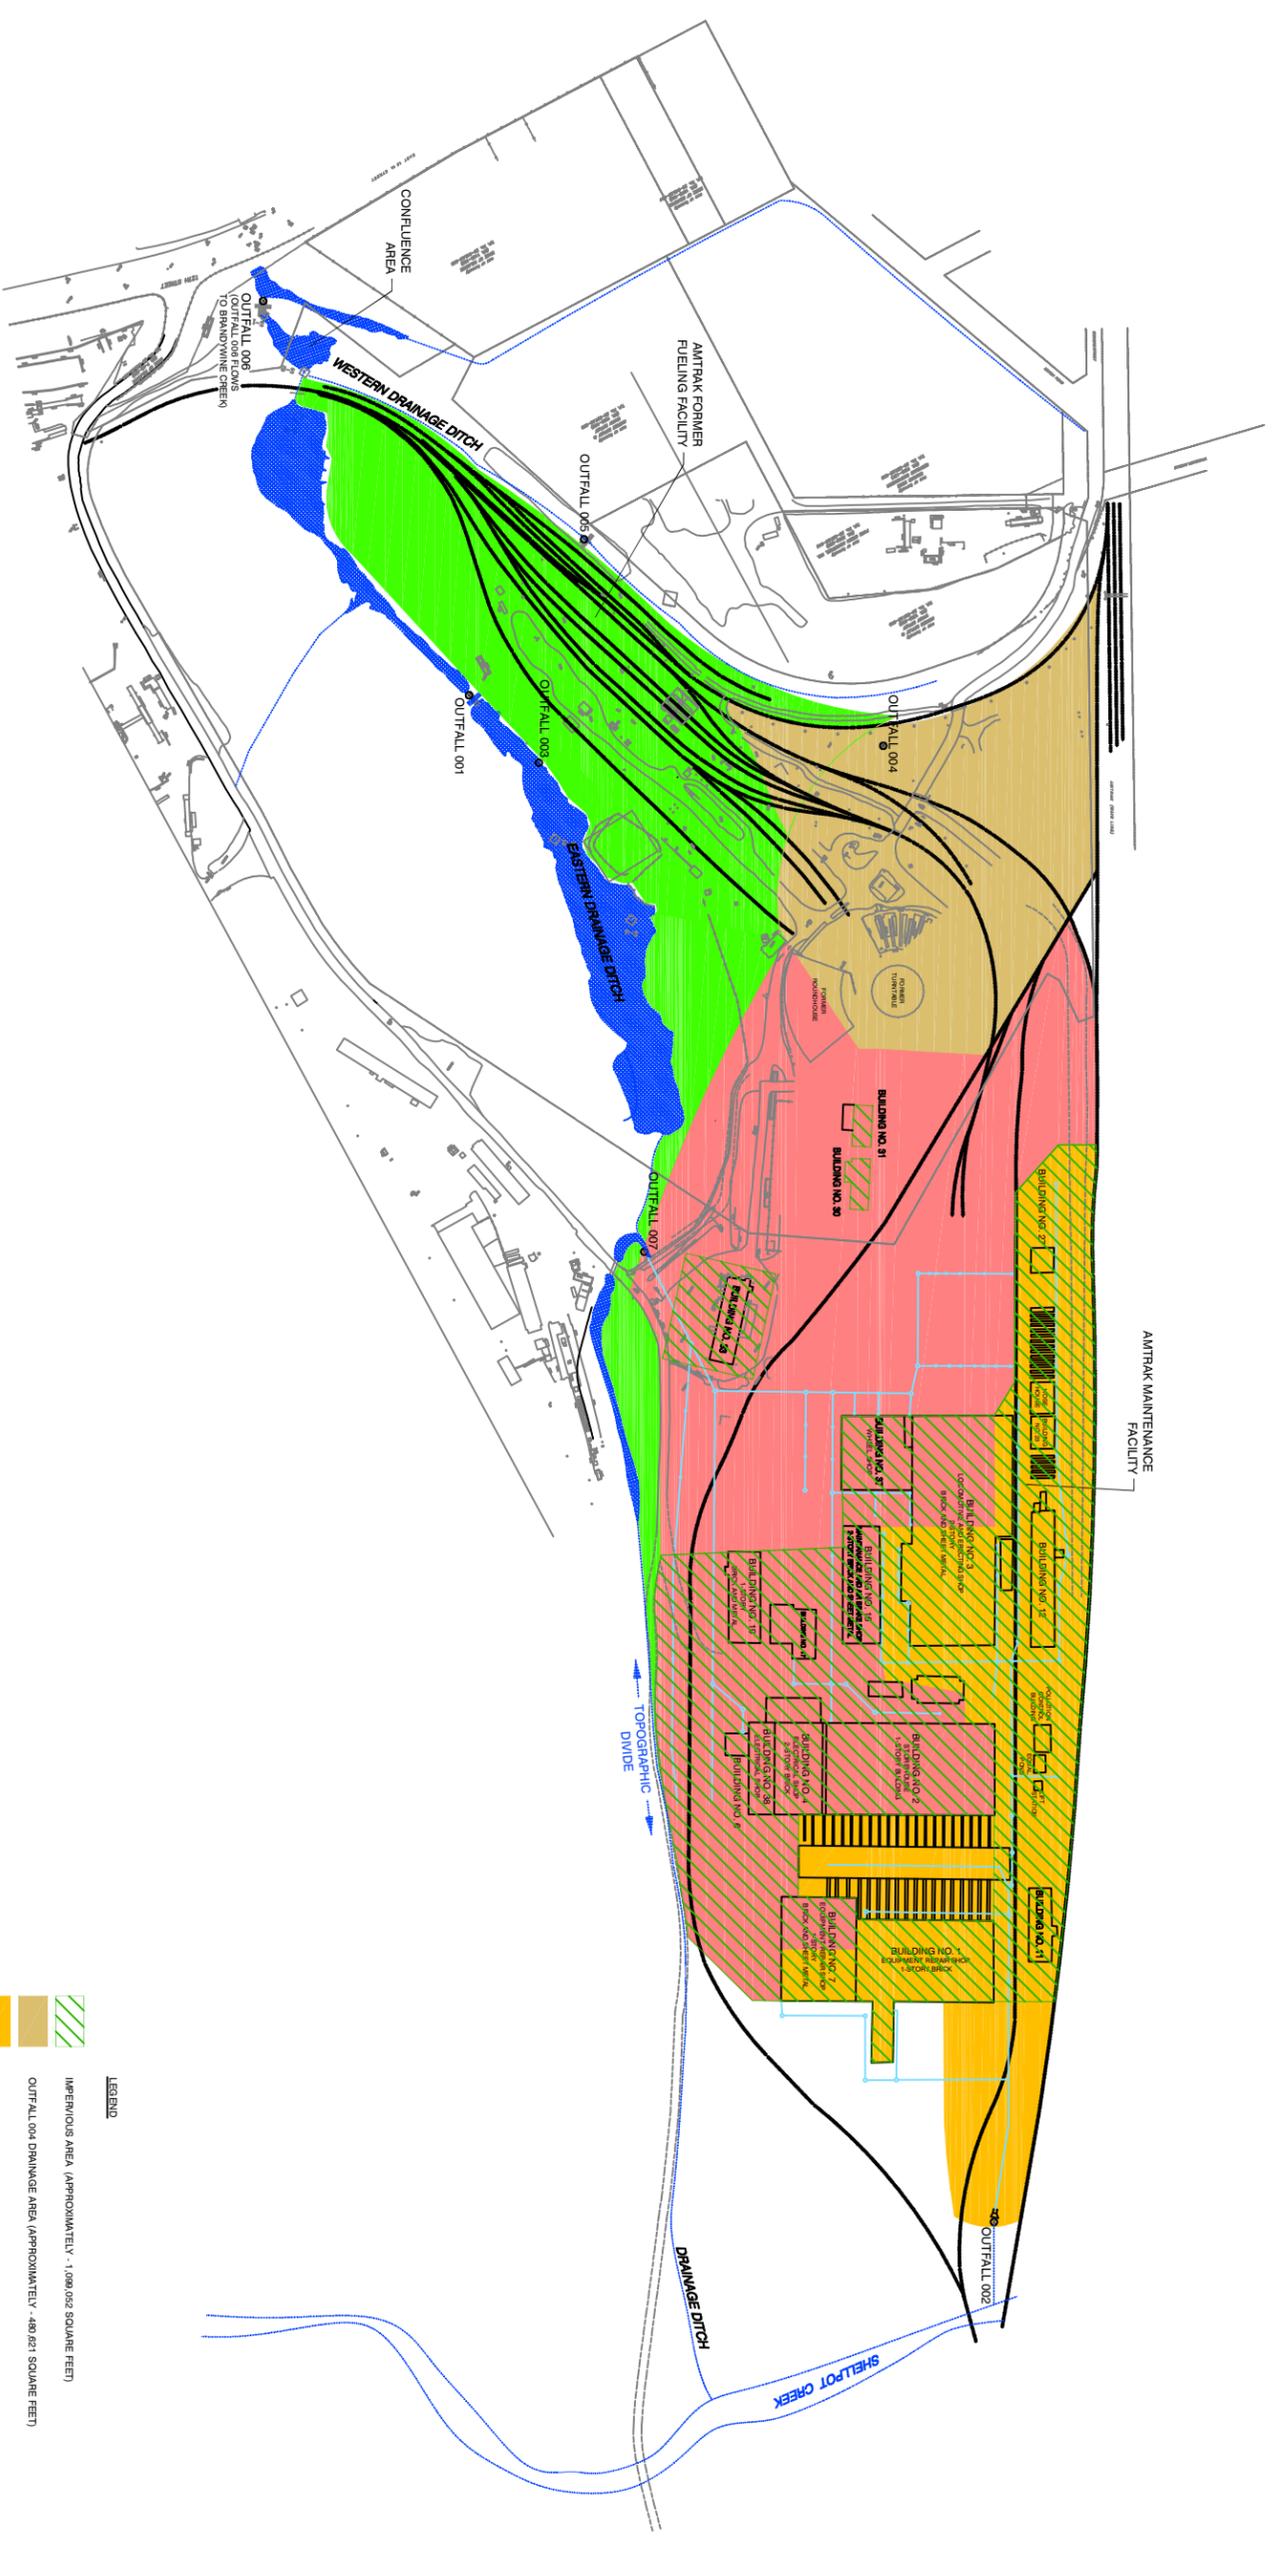
IMPERVIOUS AREA (APPROXIMATELY - 1,098,052 SQUARE FEET)
	OUTFALL 004 DRAINAGE AREA (APPROXIMATELY - 480,621 SQUARE FEET)
	OUTFALL 002 DRAINAGE AREA (APPROXIMATELY - 689,803 SQUARE FEET)
	OUTFALL 007 DRAINAGE AREA (APPROXIMATELY - 1,389,724 SQUARE FEET)
	OUTFALL 001, 003, 005 AND 006 DRAINAGE AREAS (APPROXIMATELY - 659,337 SQUARE FEET PLUS UPSTREAM AND OFF-SITE AREAS)

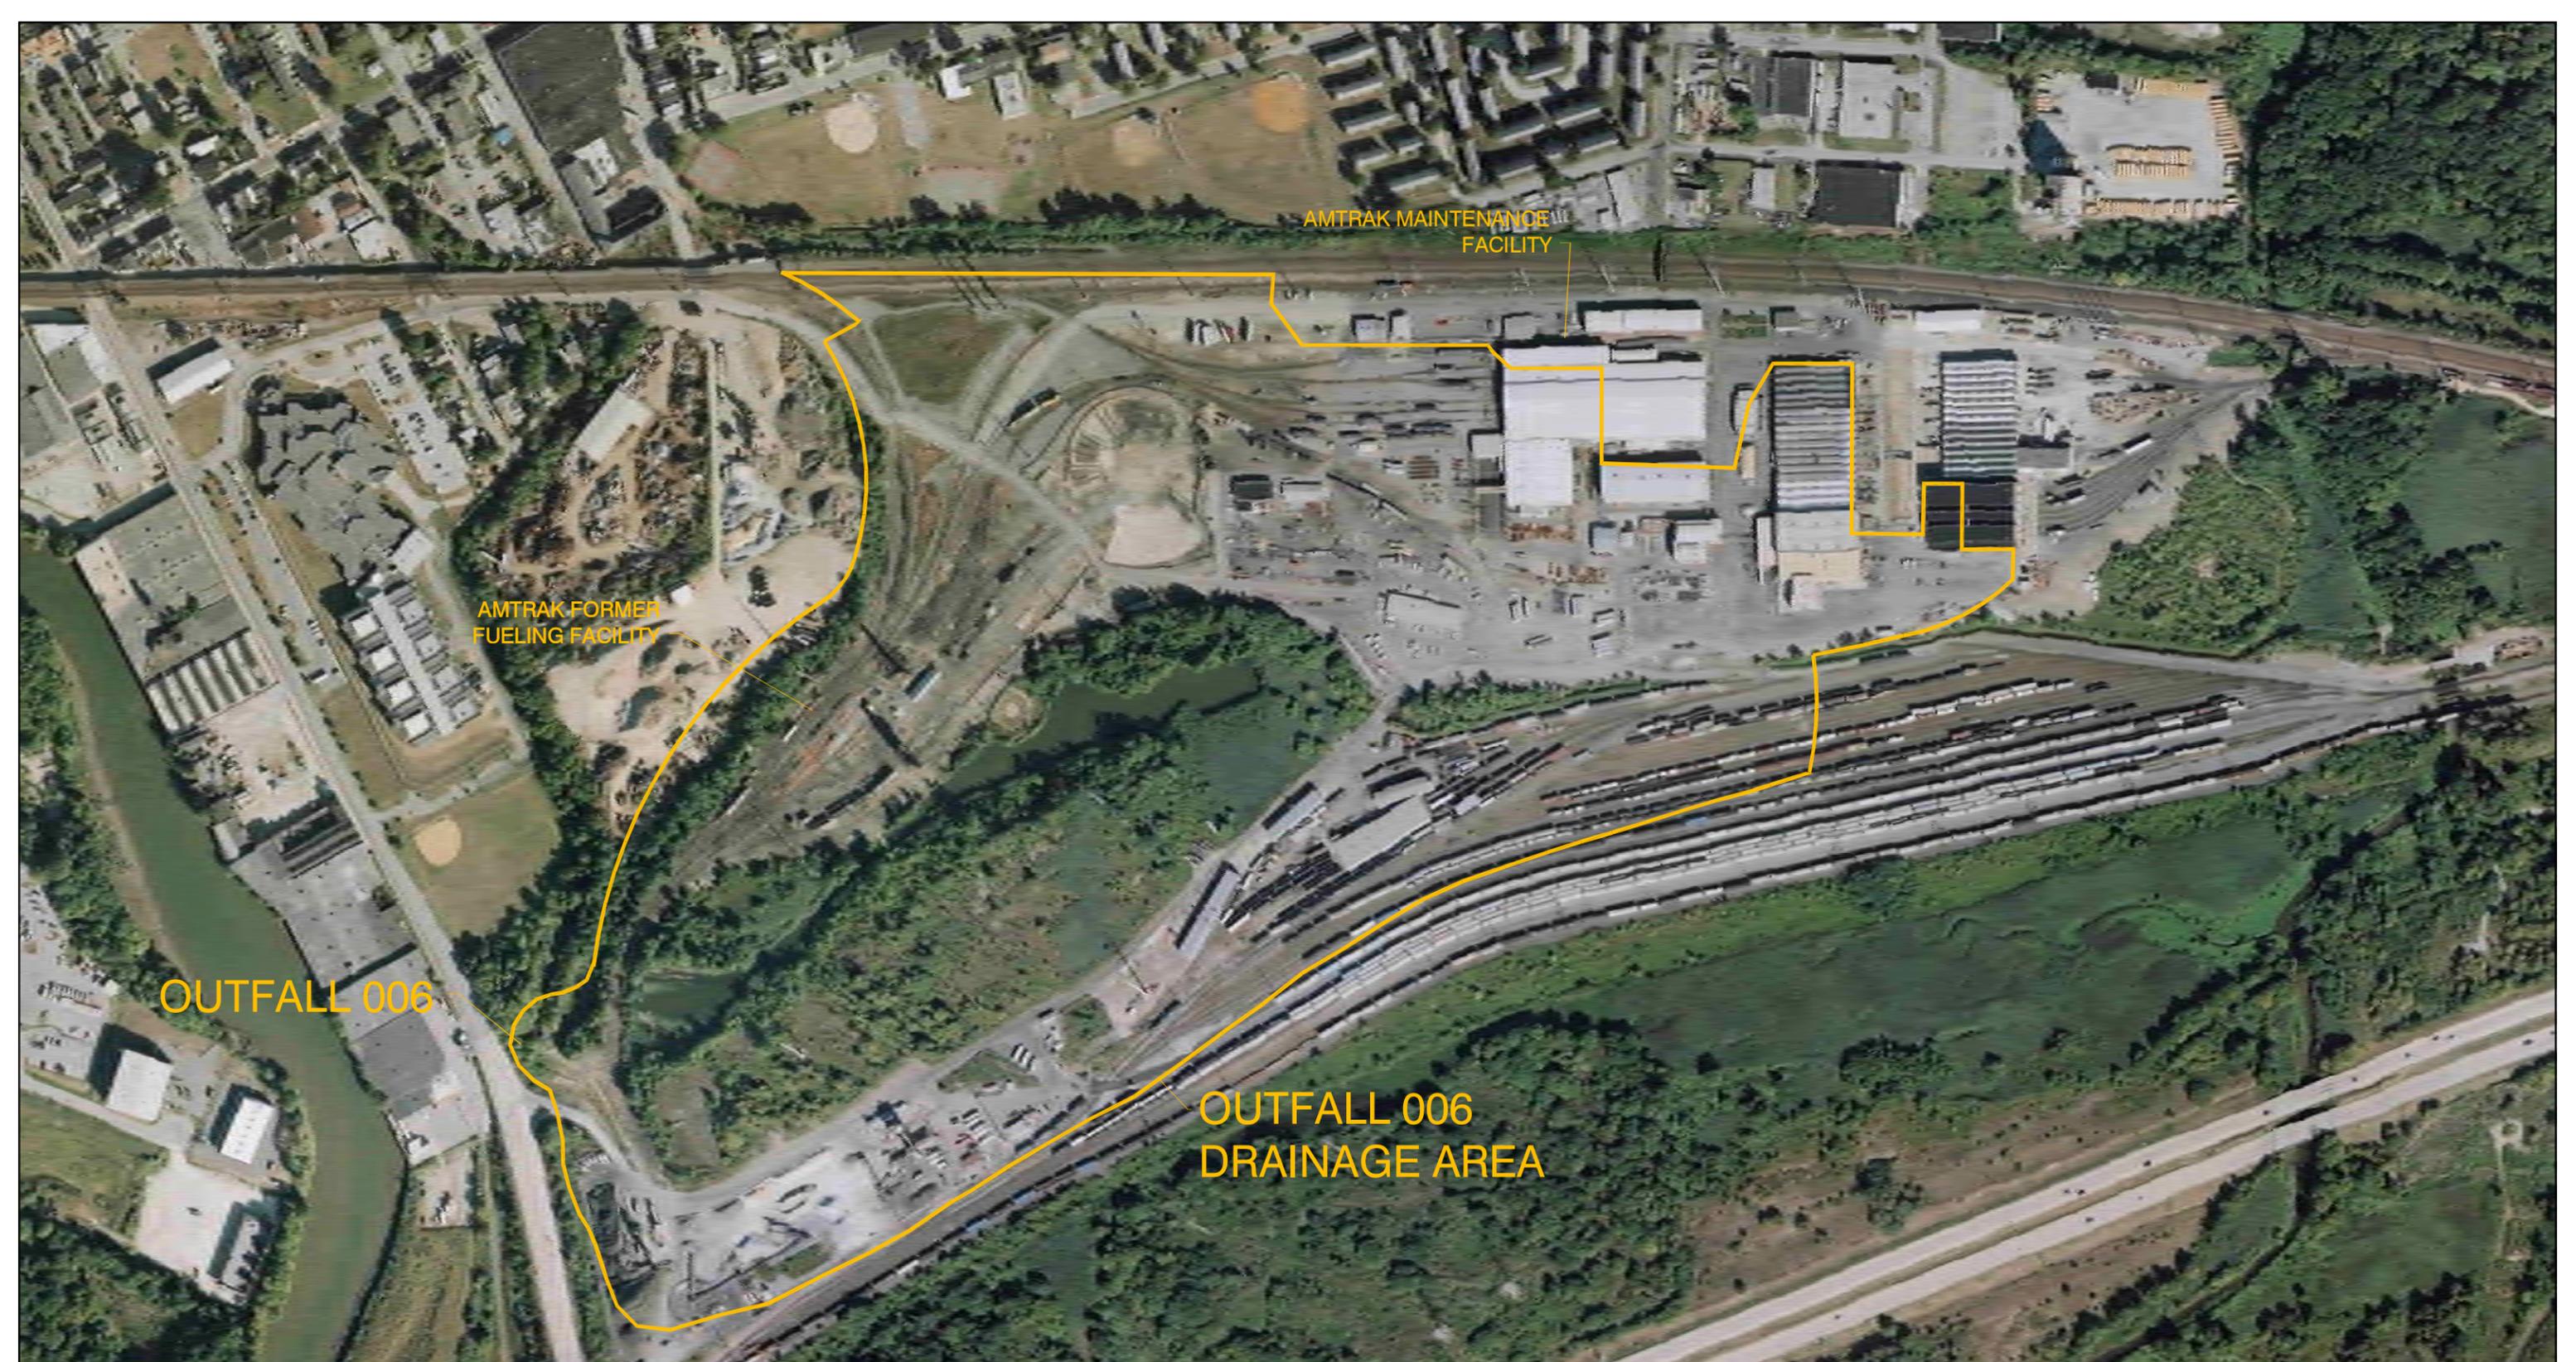
**NOTE:**  
006 DRAINAGE AREA = 5,160,407 SQUARE FEET

112 PICKERING WAY, SUITE 200	FOR:	AMTRAK FORMER FUELING FACILITY VANDEVER AVENUE WILMINGTON, DELAWARE	OUTFALL 006 DRAINAGE AREA	PLATE: 2-5
