National Register of Historic Places  
Inventory—Nomination Form

historic (1) Joseph Bancroft & Sons Cotton Mills or Rockford Cotton Mills, and  
(2) Brandywine Cotton Mills or James Riddle & Son Mills

and or common The Bancroft Mills

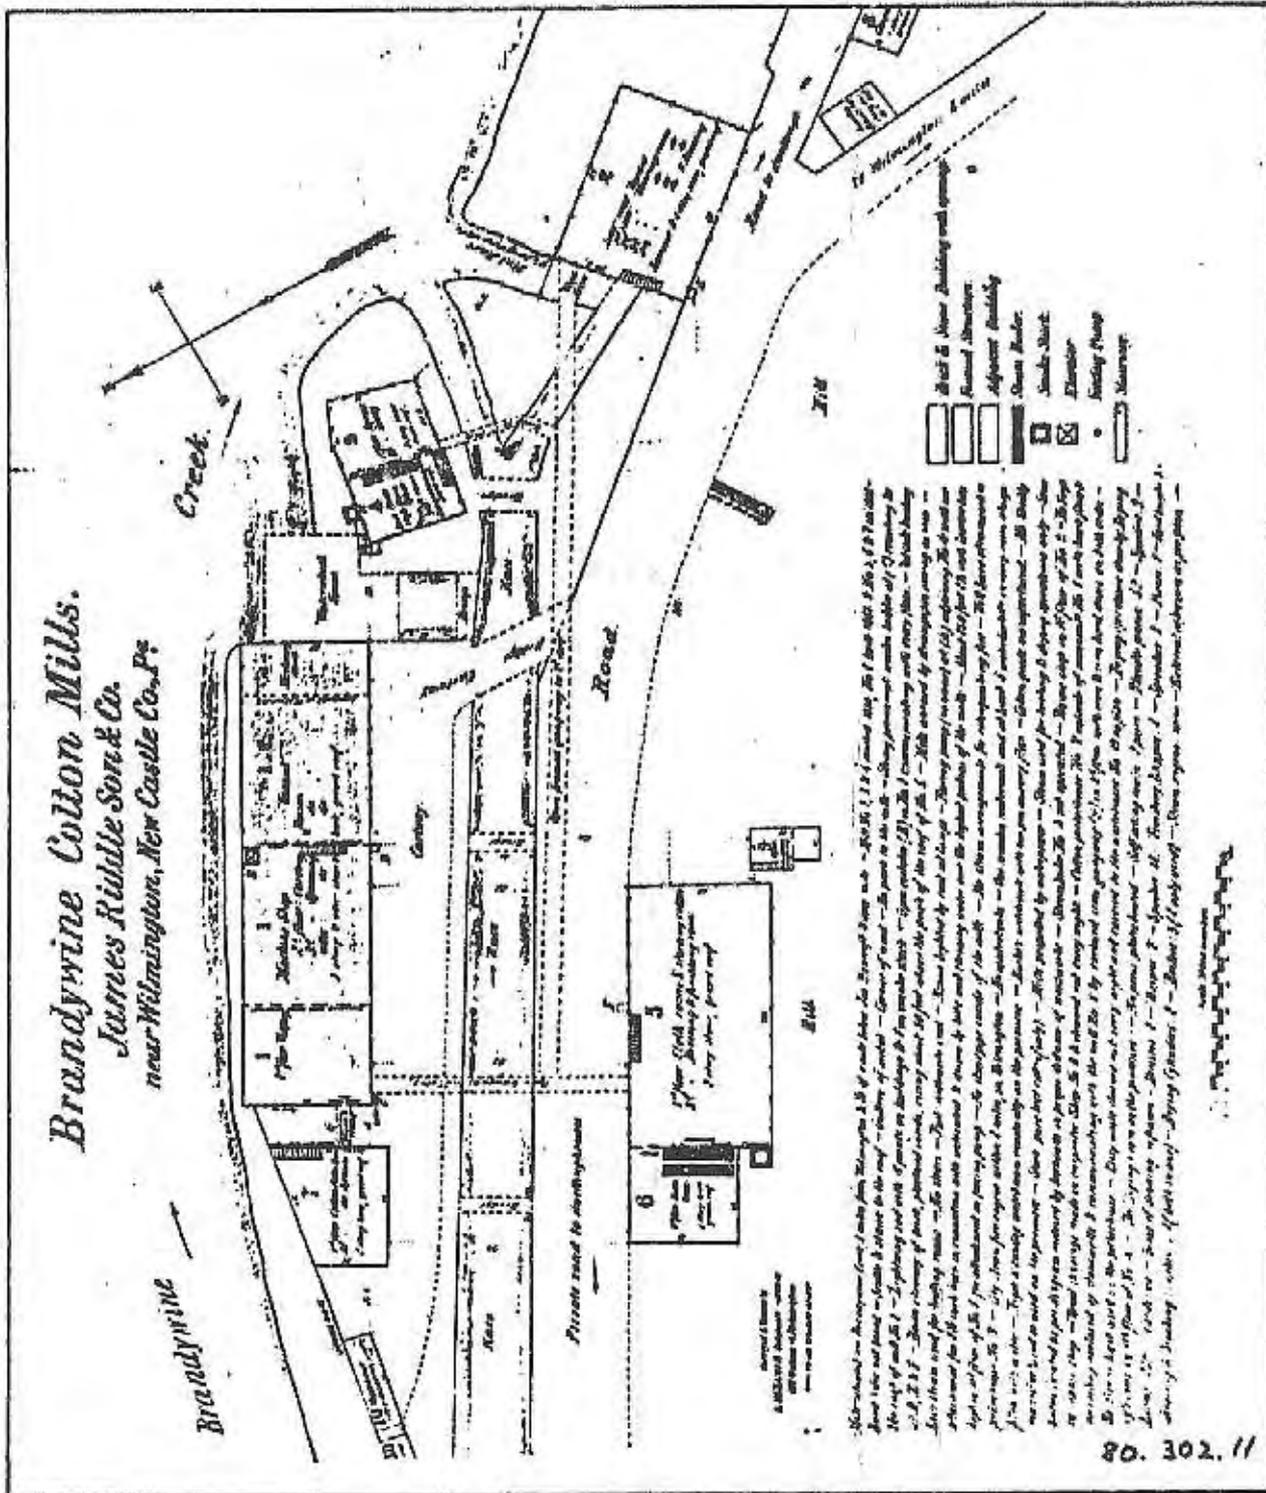
Figure 2

**Brandywine Cotton Mills.**  
*James Riddle Son & Co.*  
 near Wilmington, New Castle Co., Pa.

Hexamer Survey, Brandywine Mills, 1856

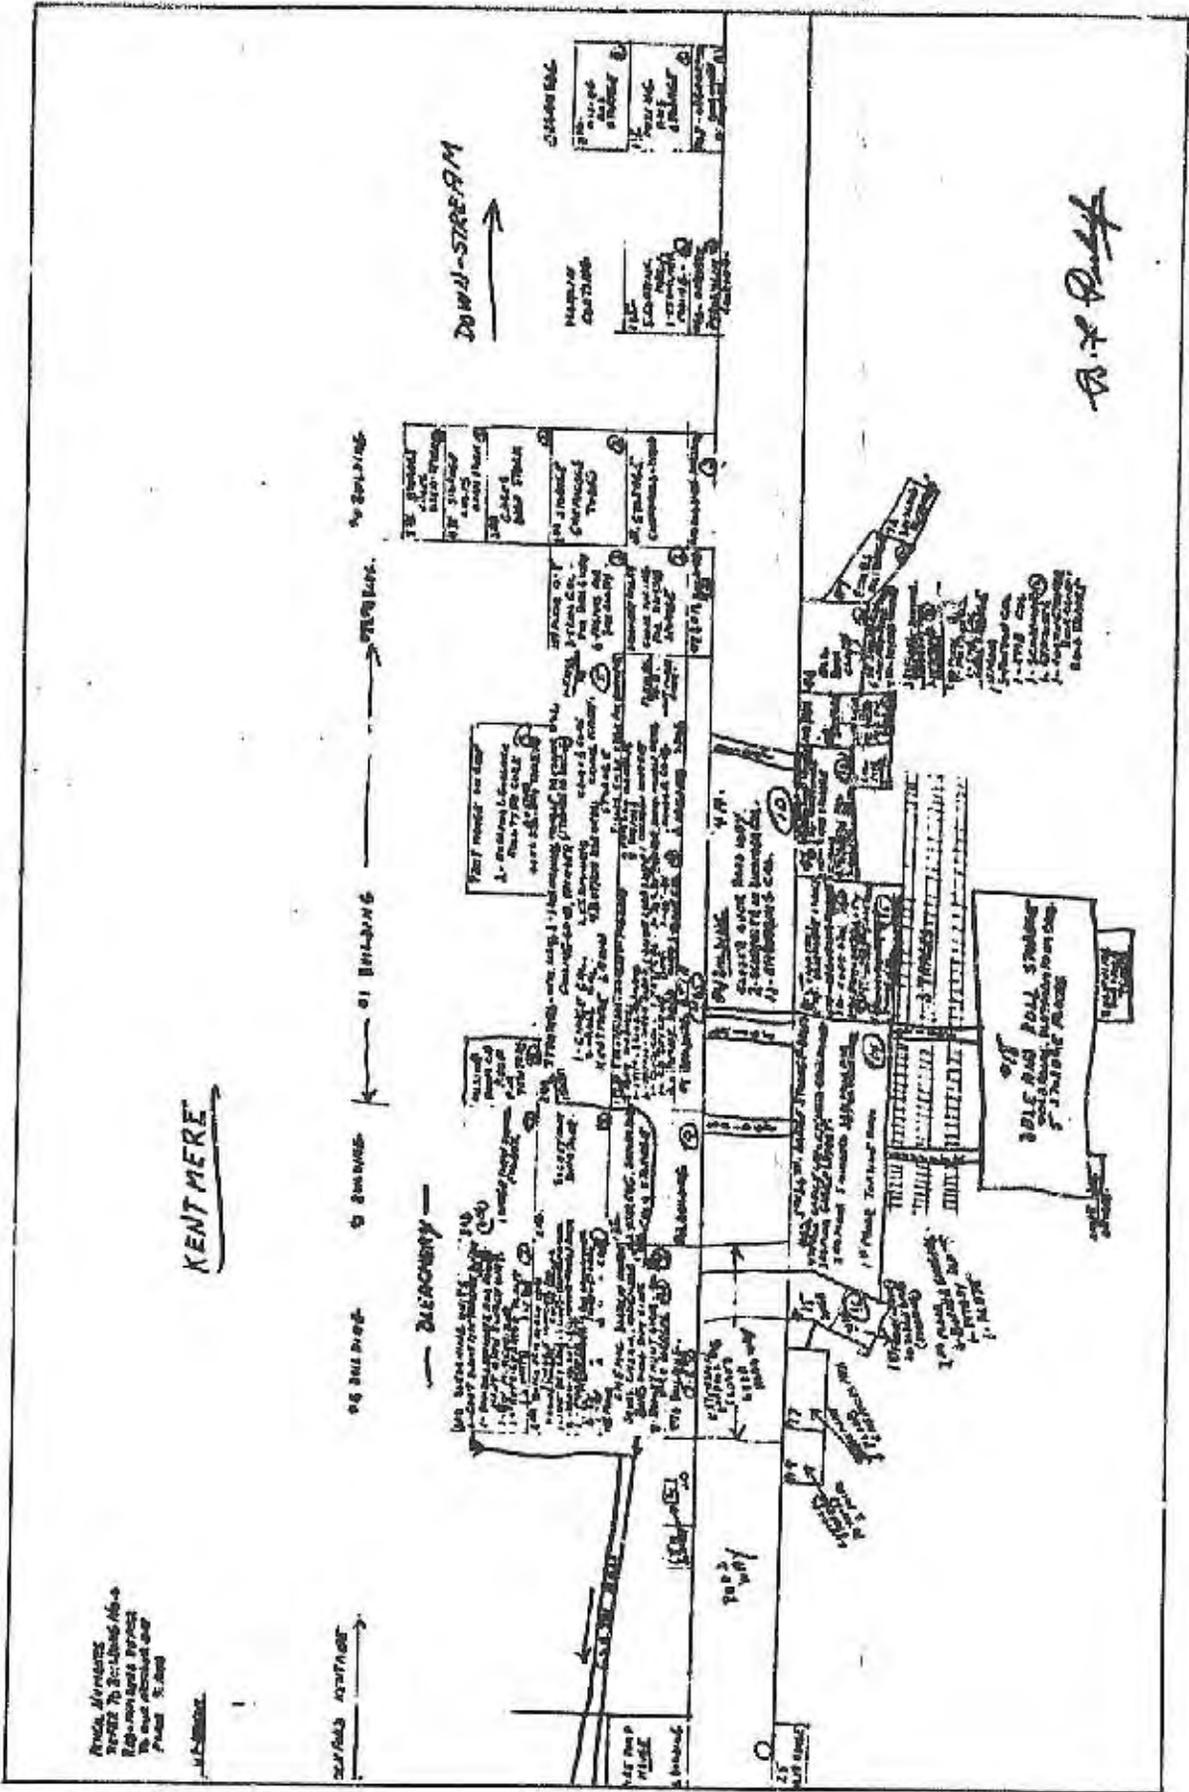
Figure 3

Pulstifer Survey, Kentmere, 1961

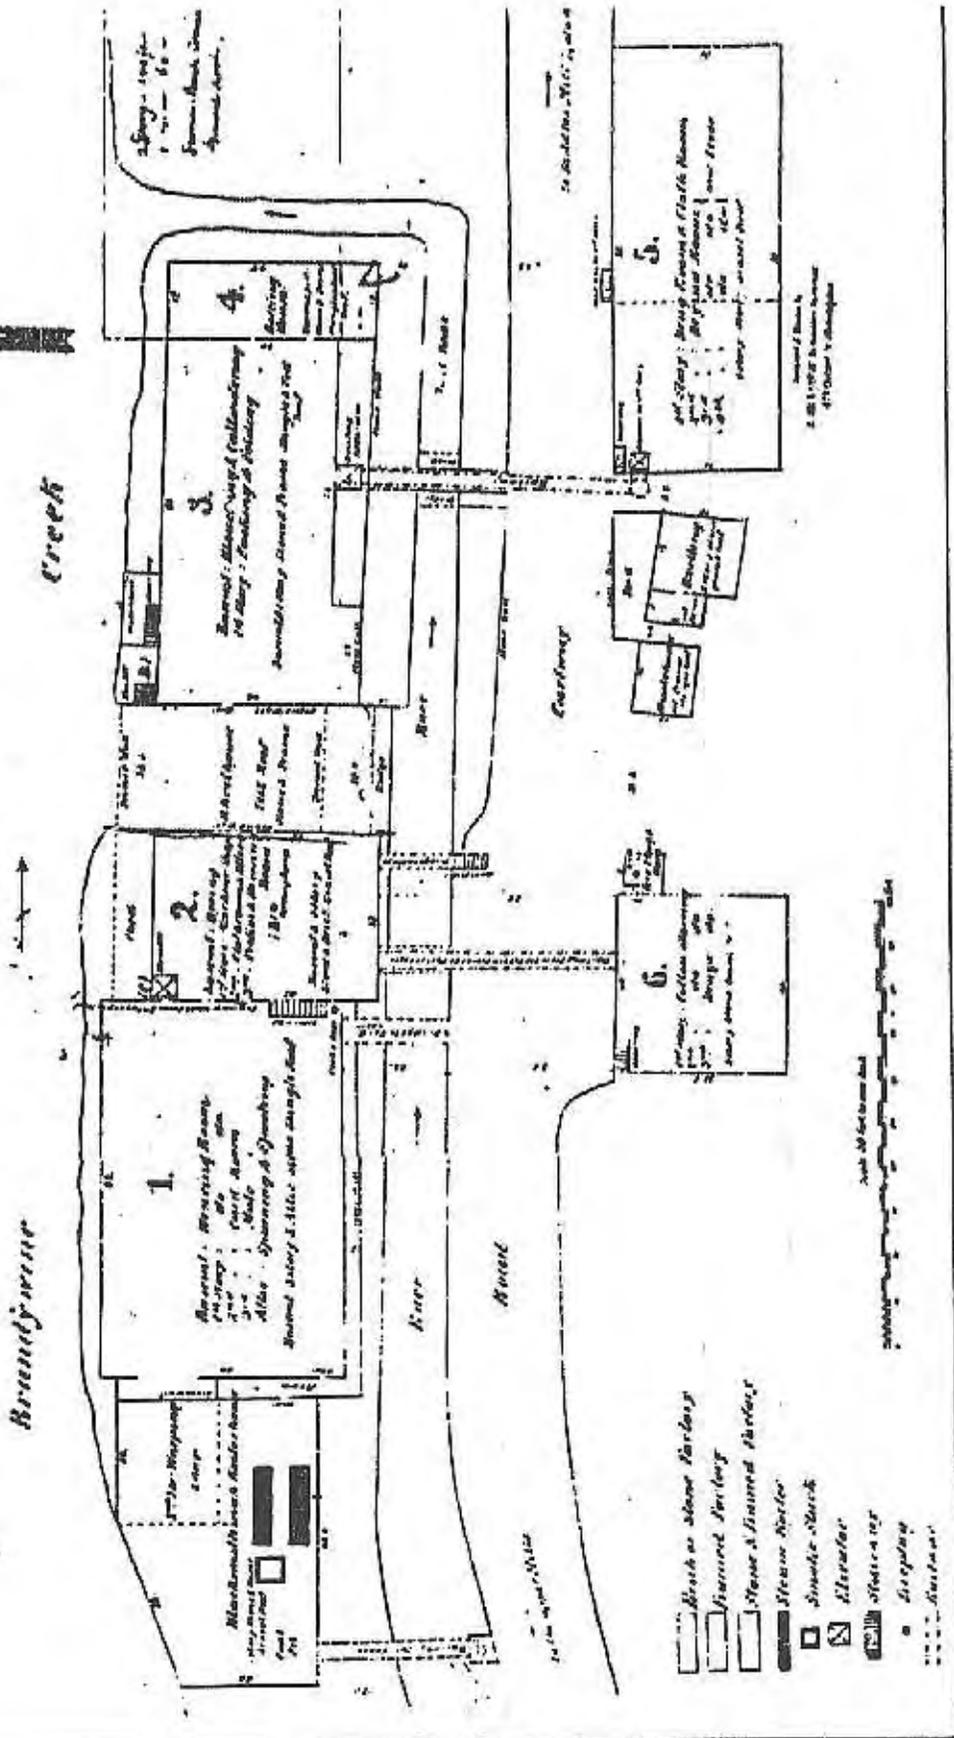
Figure 1

# Joseph Bancroft & Sons Cotton Mills.

near Wilmington, New Castle Co. Del.

Hexamer Survey, Bancroft Mills, 1866
