Appendix B
Community Maps with Location of Drainage Concerns and Proposed Solutions

Appendix D
Field Reconnaissance Photographs

**Oak Orchard – Coastal Drainage Engineering Study
Field Data Form**

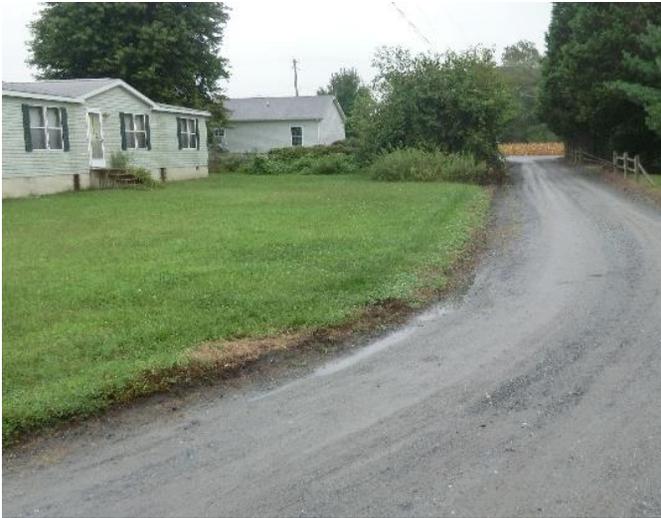
Figure D.1: Standing water in front of 29222 Honeysuckle Knoll (OO_01)

Solution ID ¹	Questionnaire ID	Proposed Project Location	Source of Flooding	Existing Site Conditions	Recommendation Summary	Recommendation	Notes (constraints, effectiveness)	Property Ownership ²	Agency
OO_01	102	29222 Honeysuckle Knoll	Localized runoff	The ditch in front of 29222 Honeysuckle Knoll floods 2 to 3 times a year.	Improve ditch, create infiltration zone	Increase the size of the existing ditch west of Honeysuckle Knoll, and extend to the 90° bend in the road. Install culvert under Honeysuckle Knoll to existing low area. Create a well-defined infiltration area.	This solution has the potential to decrease the frequency and duration of flooding from localized runoff.	Primarily public ownership (road), although one drainage easement through private property would be required.	DNREC
OO_02	104.1	Road in front of 31346 River Rd.	Localized runoff	Road in front of 31346 River Rd. floods during heavy rain (yearly).	Regrade road shoulder, replace storm drain pipe cap	Mill existing road shoulder to provide positive drainage to the existing catch basin. Replace the existing 4-inch perforated PVC end cap (Barguard by Agri drain or similar) to maximize discharge.	This solution has the potential to decrease the frequency and duration of flooding from localized runoff.	Primarily public ownership (road), although a portion of the roadway shoulder may be on private property.	DNREC

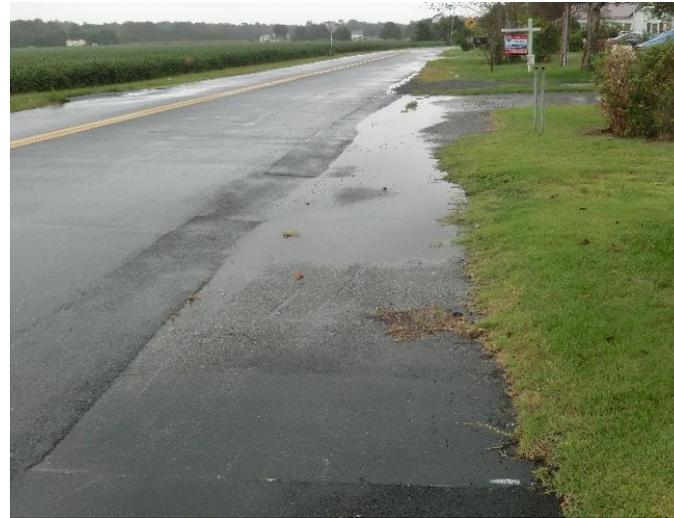
Figure D.2: Road in front of 31346 River Road with standing water (OO_02)

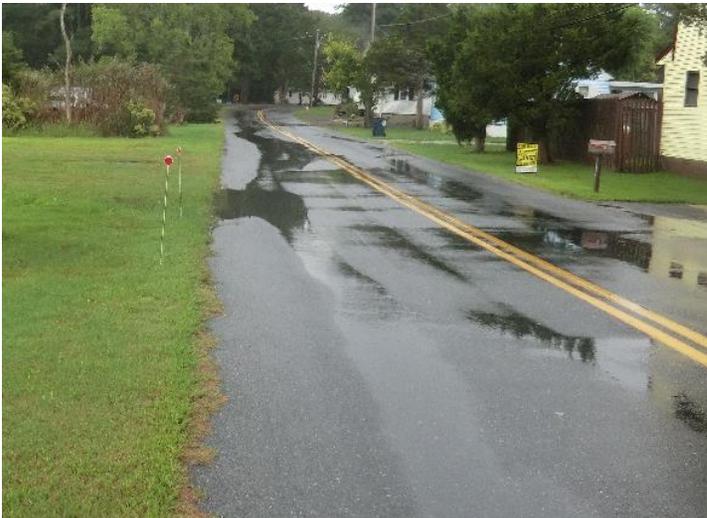
Figure D.3: River Road approximately 2,000 feet west of Chief Road (OO_04)

OO_04A	201.1, 202.1, 203.1, 205.1, 207.1, 501.4	River Rd., approximately 2,000 feet west of Chief Rd.	Localized runoff and tidal flooding	A low area in River Rd. floods several times a year. An existing culvert that crosses River Rd. at this location is currently covered by collapsed concrete. Water was observed flowing upstream from Indian River Bay.	Upgrade storm drain, raise road	Raise approximately 400 feet of River Rd. from elevation 2 feet NAVD88 to a finished elevation of 3 to 4 feet NAVD88 (an increase of 1 to 2 feet) from 32026 River Rd. to 31362 River Road. Install ditch north of River Rd. if needed that connects to existing ditch system. Replace existing pipe, and install backflow prevention on the bay side of the pipe. A tide gate may be required if the marsh north of River Rd. is a salt water marsh to provide saltwater flow to maintain environmental functions.	This solution has the potential to decrease the frequency and duration of flooding from localized runoff and bay tidal events.	Primarily public ownership (road), although an easement through private property would be required to replace the storm drain pipe.	DelDOT

OO_04B	201.1, 202.1, 203.1, 205.1, 207.1, 501.4	River Rd., approximately 2,000 feet west of Chief Rd.	Localized runoff and tidal flooding	A low area in River Rd. floods several times a year. An existing culvert that crosses River Rd. at this location is currently covered by collapsed concrete. Water was observed flowing upstream from Indian River Bay.	Upgrade storm drain, install bulkhead	Install approximately 400 feet of bulkhead north of River Rd. from the existing culvert to an elevation of 4 feet NAVD88, and regrade road to provide positive drainage toward the marsh. Install ditch north of River Rd., if needed, that connects to existing ditch system. Replace existing pipe, and install backflow prevention on the bay side of the pipe. A tide gate may be required if the marsh north of River Rd. is a saltwater marsh to provide saltwater flow to maintain environmental functions.	Environmental permitting would be required to construct a bulkhead in the marsh. This solution has the potential to decrease the frequency and duration of flooding from localized runoff and bay tidal events.	5 to 10 easements through private property would be required.	DNREC - High Priority

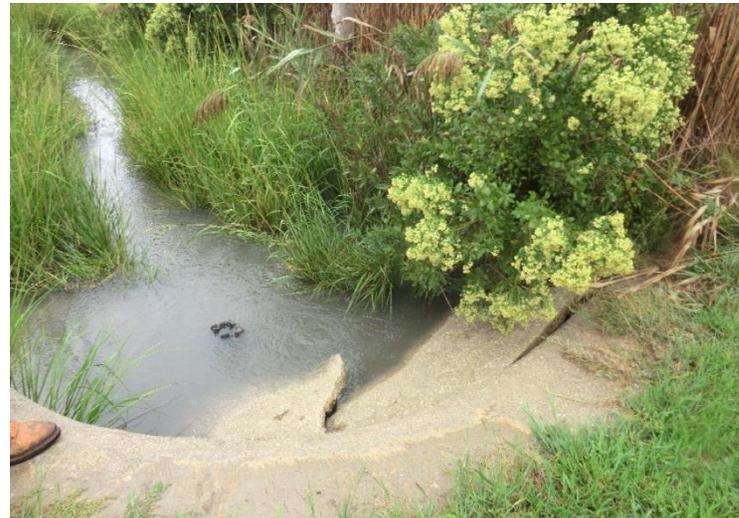
Figure D.4: Culvert with collapsed headwall crossing River Road approximately 2,000 feet west of Chief Road (OO_04)

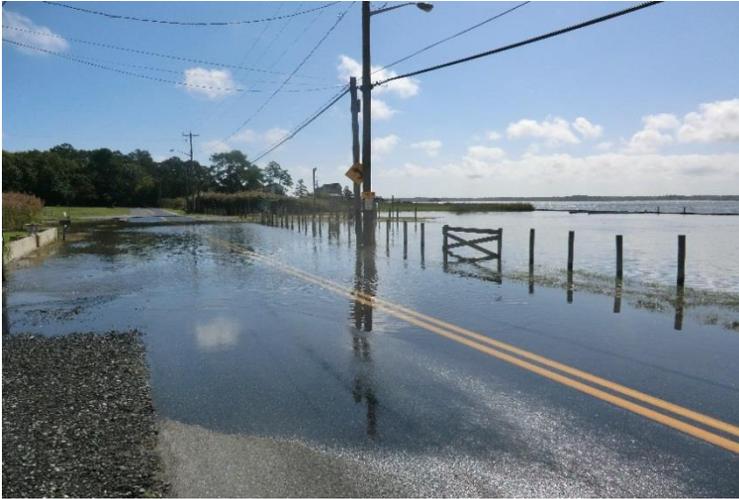
Figure D.5: The intersection of River Road and Chief Road flooded during an abnormally high tide (OO_06)

OO_06	203.2, 205.2, 206.1, 207.2, 208.1, 209, 209.1, 210, 210.1, 211, 211.1, 213.1, 218.1, 406.1	Intersection of Chief Rd. and River Rd.	Localized runoff and tidal flooding	River Rd. and nearby properties flood frequently (flooding observed during 2 days of field work). The existing storm drain pipe could not be identified during field investigation.	Raise road, extend bulkhead, and upgrade storm drain	Raise approximately 500 feet of River Rd. from elevation 2 feet NAVD88 to a finished elevation of 4 feet NAVD88 (an increase of 1 to 2 feet) from 400 feet west of the intersection of River Rd. and Chief Rd., to 100 feet east of the intersection. Install approximately 300 feet of bulkhead to tie existing bulkhead south of existing parking lot to elevation of 4 feet NAVD88. Regrade boat ramp to keep it from flooding the parking lot. Possibly resize and replace existing storm drain pipe with backflow prevention on the bay side of pipe. A tide gate may be required if the marsh north of River Rd. is a saltwater marsh to provide saltwater flow to maintain environmental functions.	This solution has the potential to decrease the frequency and duration of flooding from localized runoff and bay tidal events.	Primarily public ownership (road), although two easements through private property would be required.	DelDOT

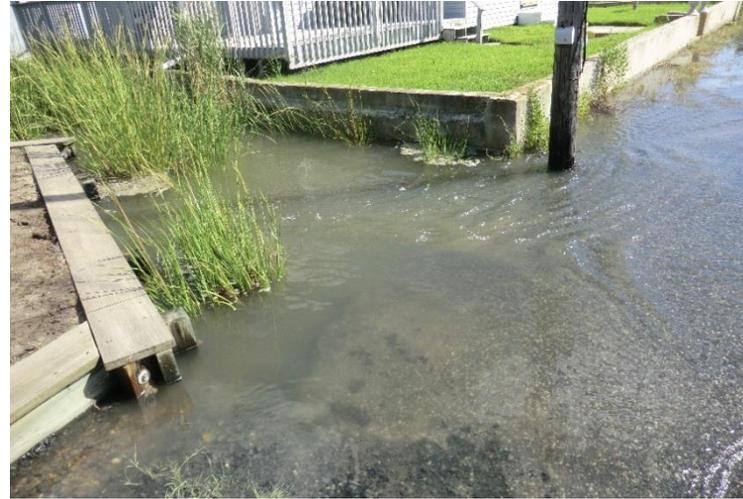
Figure D.6: Marsh near the intersection of River Road and Chief Road flooded during an abnormally high tide (OO_06)

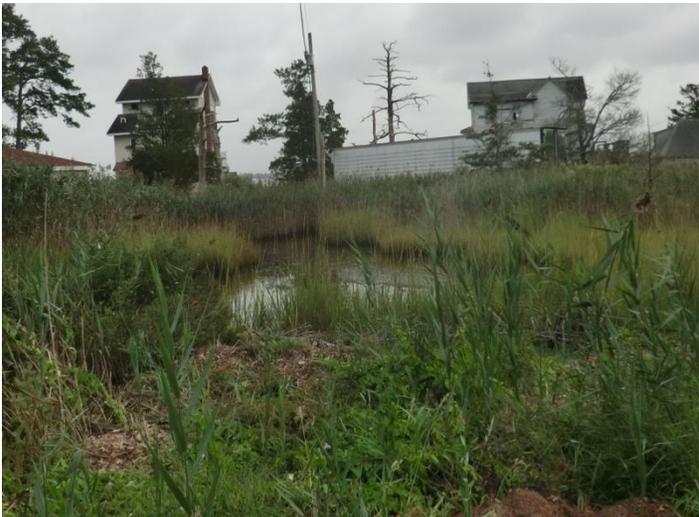
Figure D.7: Tidal pond near 32280 River Road (OO_07)

OO_07	212.1	Property to the right of 32280 River Rd.	Tidal flooding	There is a tidal ponding area adjacent to the property of 32280 River Rd. that often holds water. No flooding outside of pond has been observed.	Regrade private yard	Raise yard to keep water from the tidal ponding area from impacting the property.	Environmental permitting would be required to grade near the tidal wetland. This solution has the potential to decrease the frequency and duration of flooding from bay tidal events.	Entirely private ownership.	Homeowner Implementation/ Technical Assistance

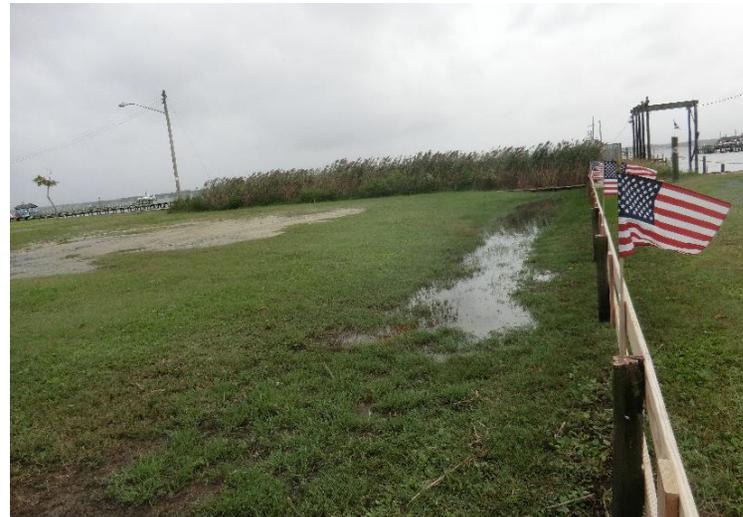
Figure D.8: Flooded area south of the intersection of Nanticoke Avenue and River Road (OO_08)

Solution ID ¹	Questionnaire ID	Proposed Project Location	Source of Flooding	Existing Site Conditions	Recommendation Summary	Recommendation	Notes (constraints, effectiveness)	Property Ownership ²	Agency
OO_08	214.1, 214.2, 215.1, 215.2, 216, 216.1, 217, 501.6	Intersection of River Rd. with Nanticoke Ave. and Cherokee Ave.	Localized runoff and tidal flooding	River Rd. and nearby properties flood 4 to 8 times per year. Existing catch basins contained standing water and large debris (e.g., a horseshoe crab). There is a gap between the existing bulkheads on the bayside of River Rd., which allows tidal water to drain toward River Rd. There is a boat ramp at this site. Several driveways and Nanticoke Avenue are at the same elevation as the roadway.	Install bulkhead, install backflow prevention	Install approximately 200 feet of bulkhead to tie existing bulkhead to elevation 2 feet NAVD88 on the Indian River Water Sport Club property. Regrade boat ramp to tie in to bulkhead elevation. Install backflow prevention on bayside of storm drain pipe.	This solution has the potential to decrease the frequency and duration of flooding from bay tidal events.	Construction would be entirely private property.	DNREC

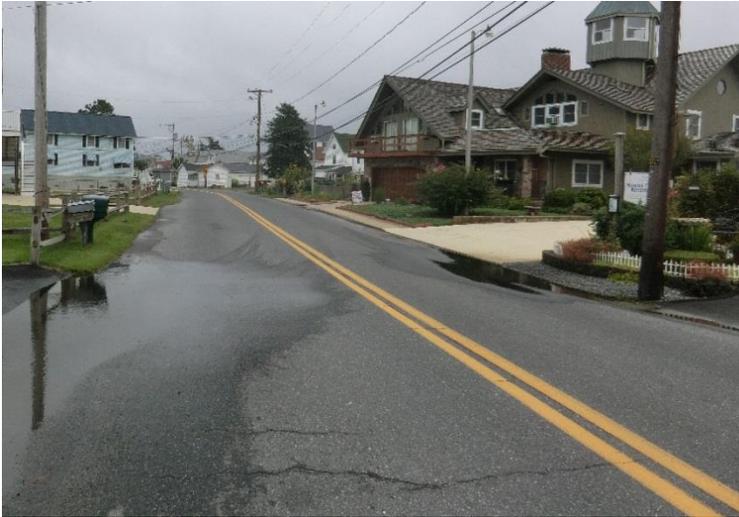
Figure D.9: River Road near the intersection of Cerise Avenue with standing water (OO_09)

OO_09A	207.3, 213.2, 219, 220, 220.1, 501.5	Intersection of Cerise Ave. and River Rd., and Roberta Ln.	Localized runoff and tidal flooding	There is flooding by the existing drainage ditch that typically occurs during abnormally high tides (monthly) and drains slowly. Flooding due to localized runoff has also been observed. The existing culvert is a 30-inch pipe that was submerged during the field investigation (plans provided by DNREC indicate that the material is either PVC or RCP). Roadway flooding was observed during the field investigation. Flooding extends to Roberta Ln. several times a year.	Raise road, upgrade existing storm drain	Raise approximately 600 feet of River Rd. from elevation 2 feet NAVD88 to a finished elevation of 3 feet NAVD88 (an increase of 6 inches to 1 foot). Resize the existing 30-inch storm drain pipe and provide backflow prevention on the bayside of the pipe. A tide gate may be required if the marsh north of River Rd. is a saltwater marsh to provide saltwater flow to maintain environmental functions.	This solution has the potential to decrease the frequency and duration of flooding from localized runoff and bay tidal events.	An easement through private property would be required to replace the existing storm drain pipe. An existing fence would need to be removed and replaced.	DeIDOT

OO_09B	207.3, 213.2, 219, 220, 220.1, 501.5	Intersection of Cerise Ave. and River Rd., and Roberta Ln.	Localized Runoff and Tidal Flooding	There is flooding by the existing drainage ditch that typically occurs during abnormally high tides (monthly) and drains slowly. Flooding due to localized runoff has also been observed. The existing culvert is a 30-inch pipe that was submerged during the field investigation (plans provided by DNREC indicate that the material is either PVC or RCP). Roadway flooding was observed during the field investigation. Flooding extends to Roberta Ln. several times a year.	Levee/bulkhead	Install bulkhead on either side of the existing ditch to provide additional storage for water and to prevent flooding of roadway and nearby properties. Resize the existing 30-inch storm drain pipe and provide backflow prevention on the bayside of the pipe. A tide gate may be required if the marsh north of River Rd. is a saltwater marsh to allow enough saltwater flow to maintain environmental functions.	This solution has the potential to decrease the frequency and duration of flooding from localized runoff and bay tidal events. Construction would occur in the existing marsh.	5 to 10 easements through private property would be required. An existing fence would need to be removed and replaced.	DNREC - High Priority

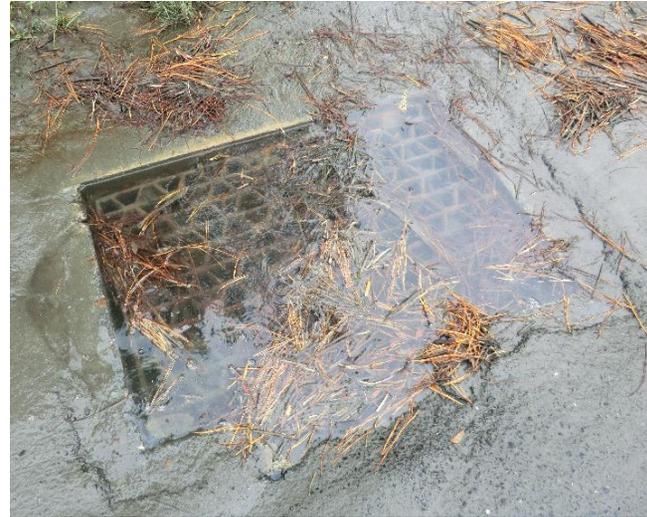
Figure D.10: Surcharging catch basin at River Road near the intersection of Cerise Avenue (OO_09)

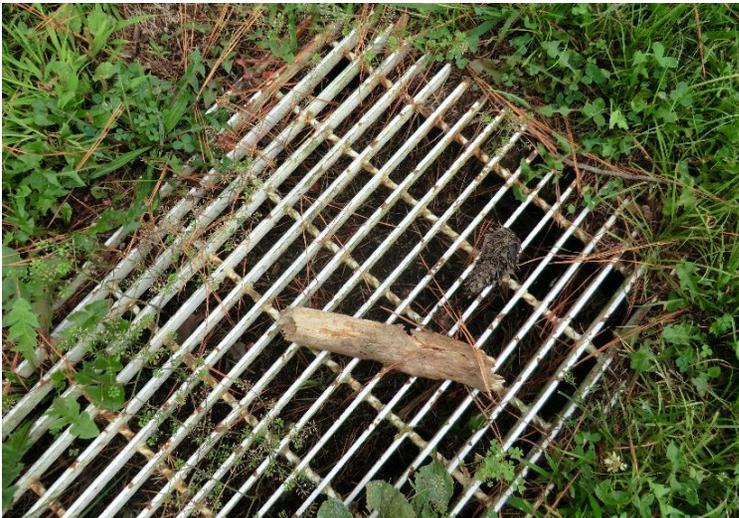
Figure D.11: Existing catch basin full of debris at Cerise Avenue (OO_10)

OO_10	222, 220.2	Intersection of Cerise Ave. and Oak Orchard Rd.	Localized runoff	Cerise Ln. floods several times a year as a result of localized runoff. Runoff from Oak Orchard Rd. drains onto Cerise Ave., exceeding the capacity of the existing storm drain system. Several of the observed catch basins are full of debris and standing water.	Upgrade existing storm drain	Clean all existing catch basins, and resize existing storm drain pipes as necessary. Add tide gate to existing outfall located at the existing tidal pond West of Cerise Ave.	This solution has the potential to reduce the frequency and duration of flooding. Flooding from the tidal pond would not be impacted by this proposed solution.	Construction would be entirely on a single private property within the mobile home park.	DNREC
OO_11	207.4, 219.1, 221.1, 223.1, 501.2	Intersection of Oak Orchard Rd. and River Rd.	Localized runoff and tidal flooding	The intersection of Oak Orchard Rd. and River Rd. floods monthly as a result of backwater from the bay flowing through the existing storm drain system that is exacerbated by local runoff.	NA, DeIDOT has a proposed design.	DeIDOT is planning to replace the existing storm drain and to add a tide gate at the intersection of Oak Orchard Rd. and River Rd.	NA	NA	DeIDOT

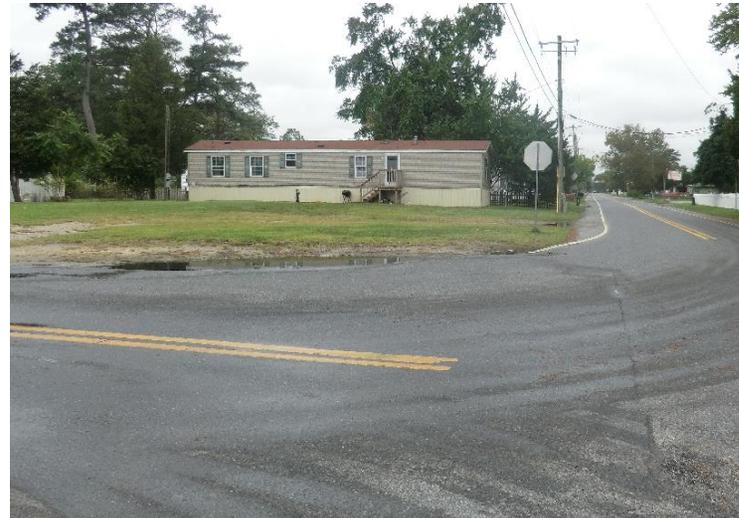
Figure D.12: The intersection of Oak Orchard Road and River Road with standing water (OO_11)

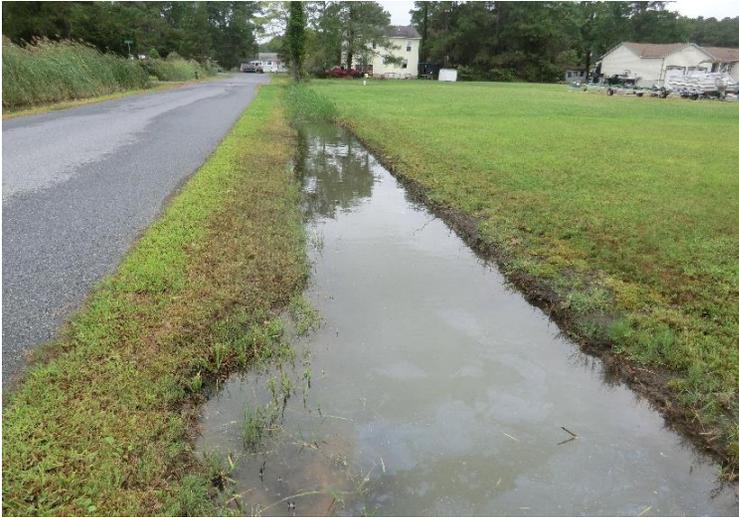
Figure D.13: Mercer Avenue ditch with standing water (OO_12)

Solution ID ¹	Questionnaire ID	Proposed Project Location	Source of Flooding	Existing Site Conditions	Recommendation Summary	Recommendation	Notes (constraints, effectiveness)	Property Ownership ²	Agency
OO_12	223.2, 223.3, 223.4, 223.5, 223.6, 224.1, 225.1, 226, 226.1, 226.2, 227.1, 227.2, 228.1, 229.1, 501.7	Delaware St. & Mercer Ave	Localized runoff and tidal flooding	The roadside ditches and catch basins on Mercer Ave. and Delaware St. are receiving coastal water during high tide, but cannot drain during low tide. The existing outlet pipe is covered by sediment during high tide (observed covered by sediment during the field investigation) and only drains when the sand is cleared by local residents. The ditches and catch basins were observed to have 1 to 2 feet of standing water during the field investigation.	Clean existing ditch, upgrade storm drain	Clean existing ditch along Mercer Ave. and Delaware St. and replace existing storm drain system. Extend pipe into the bay and install backflow prevention. A sediment transport study would be required to verify the extent of the deposition zone and length of pipe required. Install dock over the proposed pipe to provide maintenance access.	This solution has the potential to decrease the frequency and duration of flooding from localized runoff and bay tidal events.	Primarily public ownership (road), although an easement through a single private property would be required to replace the pipe that extends to the bay.	DNREC - High Priority

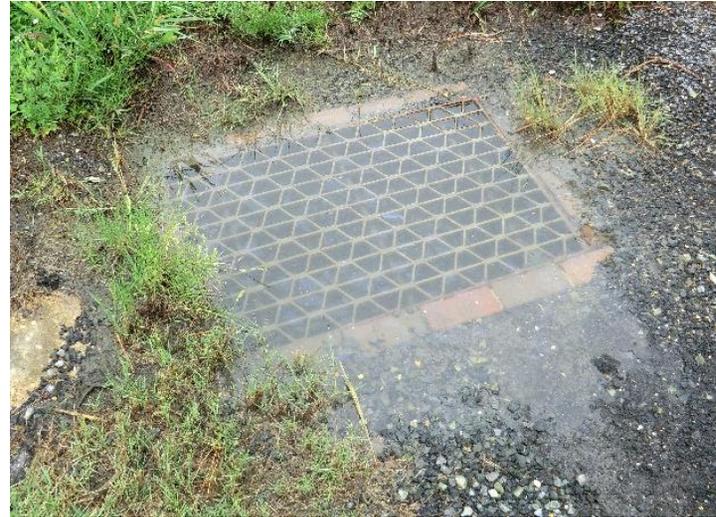
Figure D.14: Catch basin adjacent to Mercer Avenue full of standing water (OO_12)

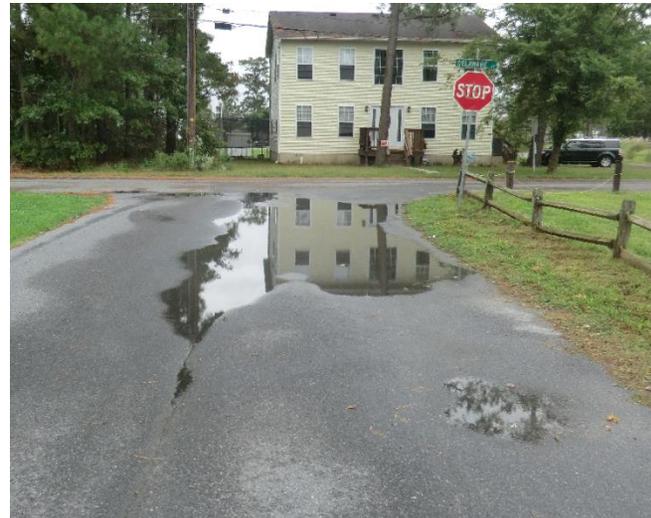
Figure D.16: Intersection of Delaware Avenue and Forest Drive with standing water (OO_13)

OO_13	230.1, 231.1, 231.2, 501.8	Forest Dr.	Localized runoff	Forest Dr. floods several times a year. Water was observed ponding at a localized low area at the intersection of Delaware St. and Forest Ave. during the field investigation.	Install storm drain	Install catch basin at the center of the west bound lane of Forest Ave. 10 feet from the intersection with Delaware St. and route to the existing roadside ditch on the east side of Mercer Ave.	This solution has the potential to reduce the frequency and duration of flooding. The proposed storm drain would need to cross water and sewer lines.	Public ownership (road).	DNREC - High Priority
OO_16	302.1	Northwest corner of Circle Dr.	Localized runoff	Circle Dr. floods following large rain events. An existing catch basin with a 12-inch corrugated metal pipe may not be adequate for the existing drainage area. The pipe connects to the Vera Ln. stormwater system before releasing to the existing ditch system.	Upgrade existing storm drain	Replace approximately 700 feet of storm drain pipe from Circle Dr. down Vera Ln. to the existing outfall.	This solution has the potential to reduce the frequency and duration of flooding at Circle Dr. from localized runoff. The proposed storm drain would need to cross water and sewer lines.	Public ownership (road) and private ownership. Two to seven easements through private property would be required.	DNREC

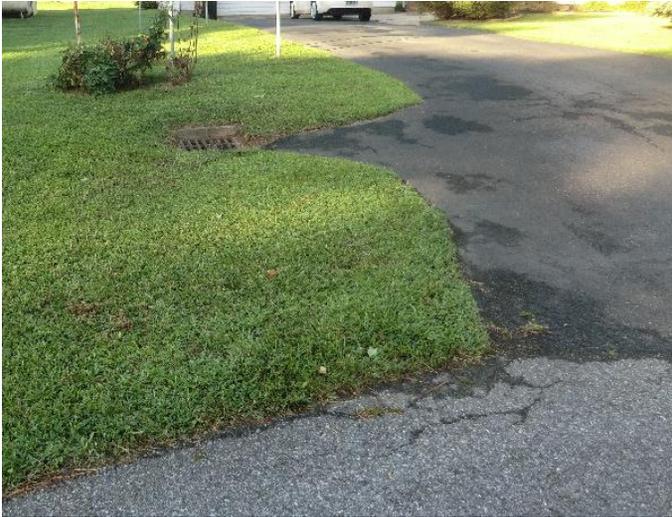
Figure D.17: Existing catch basin at Circle Drive cul-de-sac (OO_16)

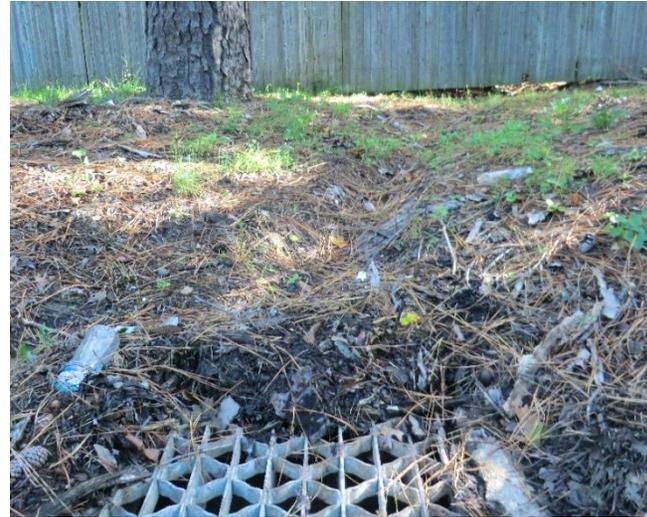
Figure D.18: Existing catch basin full of debris west of Captains Grant wet pond (OO_18)

OO_18	307.1, 308, 308.1, 308.2, 309, 309.1, 310, 310.1,	W. Fairfax Ct. and W. James Ct. (southwest corner of Captains Grant), and Oak Orchard Rd. west of Captains Grant	Localized runoff	Water collects at the western end of W. Fairfax Ct. and W. James Ct. as a result of the lack of an outlet toward Oak Orchard Rd. causing flooding several times a year. Clogging of existing 3:1 V-ditches and 12-inch CMP and PVC culverts on both W. Fairfax Ct. and W. James Ct. from sediment and debris was observed in the field. Oak Orchard Rd. also floods near this location as a result of the lack of conveyance system.	Install ditch, implement sediment control	Install ditch east of Oak Orchard Rd. from approximately 200 feet southwest of W. James Court to existing 24-inch CMP culvert that crosses Captains Way and flows to the existing wet pond. Install ditch from W. Fairfax Ct. and W. James Ct. to proposed Oak Orchard Rd. ditch. Remove sediment and debris from the existing storm drain pipe that crosses Oak Orchard Rd. and from around the grate inlets. Resize stormdrain pipe if necessary. Install 6- to 12-inch risers over the existing grate inlets or install sediment basins to reduce sedimentation at the storm drain.	This solution has the potential to reduce the frequency and duration of flooding at Fairfax Ct. and W. James Ct., and Oak Orchard Rd. from localized runoff. The sewer line in the western lane of Oak Orchard Rd. should not impact the proposed design. Several existing trees south of W. James Ct. and W. Fairfax Ct. may impact the proposed ditch system.	Public (road) and private ownership. Private ownership is primarily homeowner association, with one to two additional easements through private property required.	DNREC - High Priority

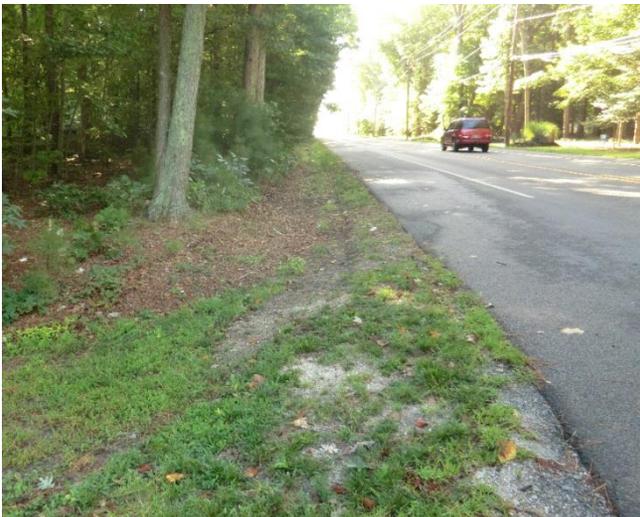
Figure D.19: Shoulder of Oak Orchard Road southwest of Captains Way (OO_17)

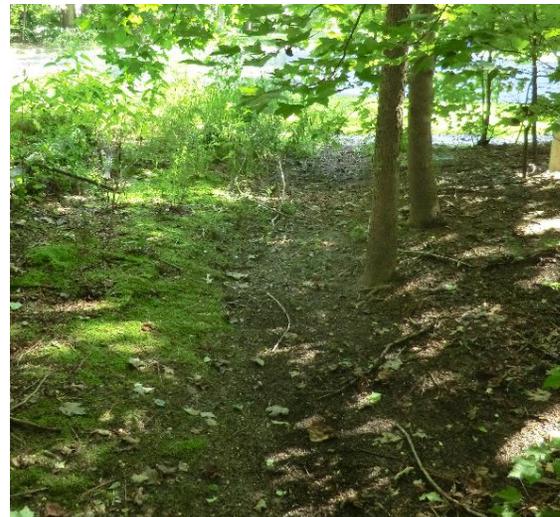
Figure D.20: Poorly defined ditch west of Fairfax Court (OO_18)

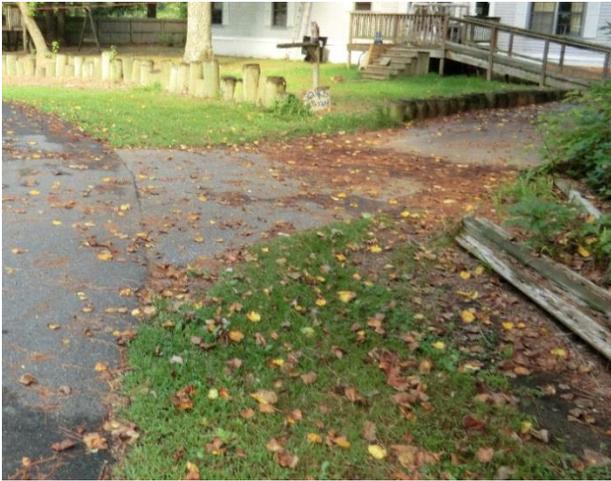
Figure D.21: Driveway of 32405 West Penn Court with a sag at approximately the same elevation as the v-ditch upstream and downstream (OO_19)

OO_19	314	32405 W Penn Ct.	Localized runoff	The driveway of 32405 W. Penn Ct. floods during large rain events. A sag in the driveway is at approximately the same elevation of the V-ditch on either side. The elevation of the driveway increases rapidly toward the homeowner's garage.	Regrade private driveway	Raise private driveway to provide positive drainage toward road, and install a driveway entrance culvert to hydraulically connect the ditch north of the driveway to the ditch to the south.	This solution has the potential to reduce the frequency and duration of flooding of the driveway.	Primarily private ownership (driveway), although some construction would be in the road right-of-way.	Homeowner Implementation/ Technical Assistance
OO_20	317.1	Swale in front of 32545 Captains Way	Localized runoff	The ditch in front of 32545 Captains Way floods several times a year, impacting the roadway and driveways. The existing culverts are up to 80% full of sediment, and the ditch appears to be at the same level as the driveway.	Raise driveway, replace existing storm drain	Raise driveway (north and south sections) of 32545 Captains Way, and replace existing culverts at a higher elevation with enough of a slope to avoid sedimentation. Clear the existing ditches as needed to provide positive conveyance toward the southwest.	This solution has the potential to reduce the frequency and duration of flooding.	Primarily private ownership (driveway), although some construction would be in the road right-of-way.	Homeowner Implementation/ Technical Assistance

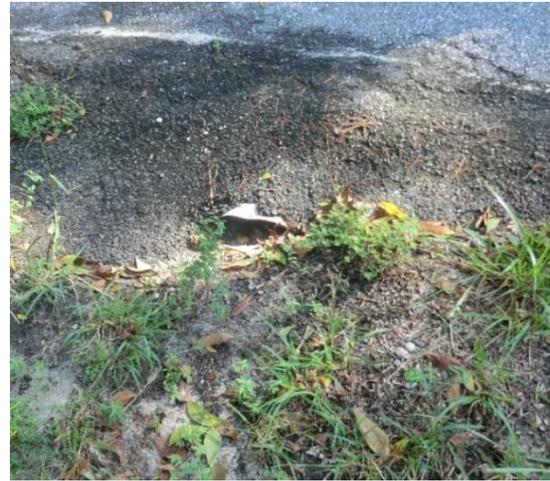
Figure D.22: Ditch and culvert through 32545 Captains Way driveway full of sediment (OO_20)

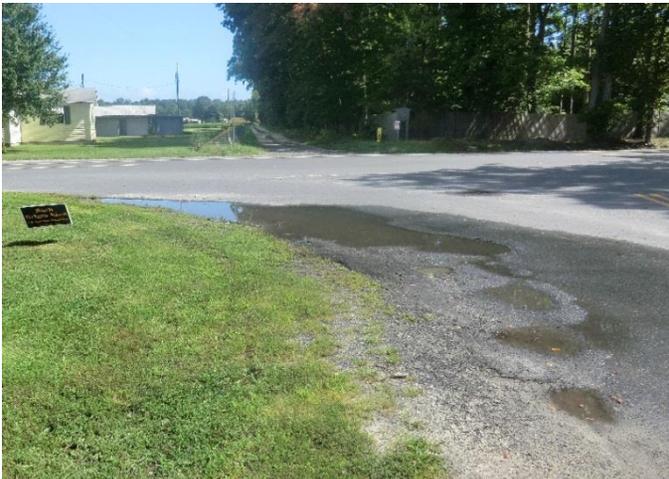
Figure D.23: The intersection of Oak Orchard Road and Chief Road/Norwood Lane (OO_22)

Solution ID ¹	Questionnaire ID	Proposed Project Location	Source of Flooding	Existing Site Conditions	Recommendation Summary	Recommendation	Notes (constraints, effectiveness)	Property Ownership ²	Agency
OO_22	401, 401.1, 401.2, 401.3, 402, 402.1, 403.1, 404.1, 404.2, 404.3, 404.4, 407, 407.1, 408, 408.1	Oak Meadow Dr. adjacent to Norwood Ln. (southeast corner of Oak Meadows)	Localized runoff	The southeastern corner of Oak Meadow Dr. floods several times a year. Thistle Ln., Clover Ln., and Briar Ln. also flood near existing catch basins. The existing storm drain system comprises 12- to 18-inch pipes, catch basins, and roadside ditches. Several of the inlet pipes are at lower elevations than outlet pipes and it appears the system is head driven.	Install/upgrade ditch, upgrade existing storm drain	Resize and replace existing storm drain pipes, and replace with a gravity driven storm drain system. Pipes should be replaced from Briar Ln. to the outlet into the Amber Drive wet pond. Install/upgrade ditches as needed, including from the driveway of 27706 Oak Meadows Dr. to the existing catch basin.	Resizing the existing storm drain system and upgrading it to a gravity driven system has the potential to reduce the frequency and duration of nuisance flooding.	Public (road) and private ownership. Easements through five to 10 properties would be required.	DNREC - High Priority

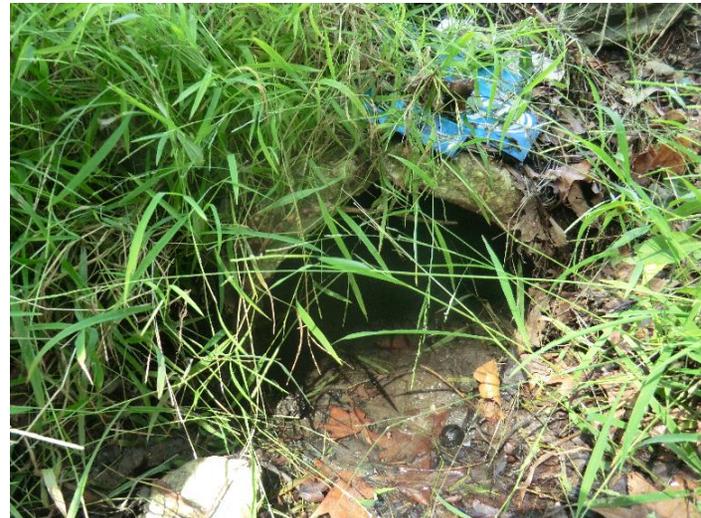
Figure D.24: Culvert crossing Chief Road partially filled with sediment (OO_22)

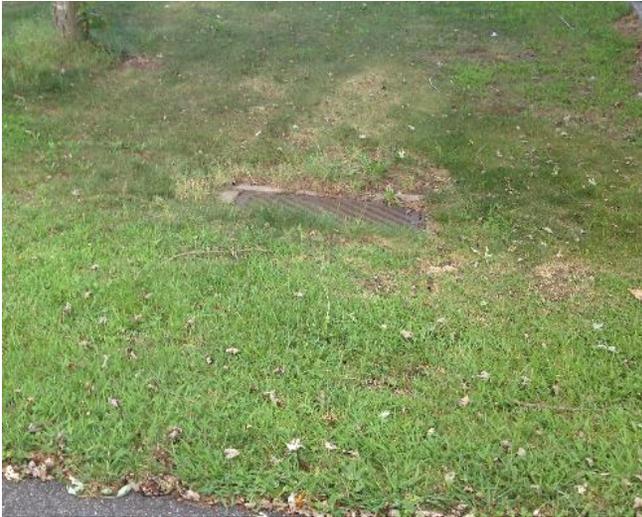
Figure D.25: Existing catch basin south of Oak Meadows Drive (OO_22)

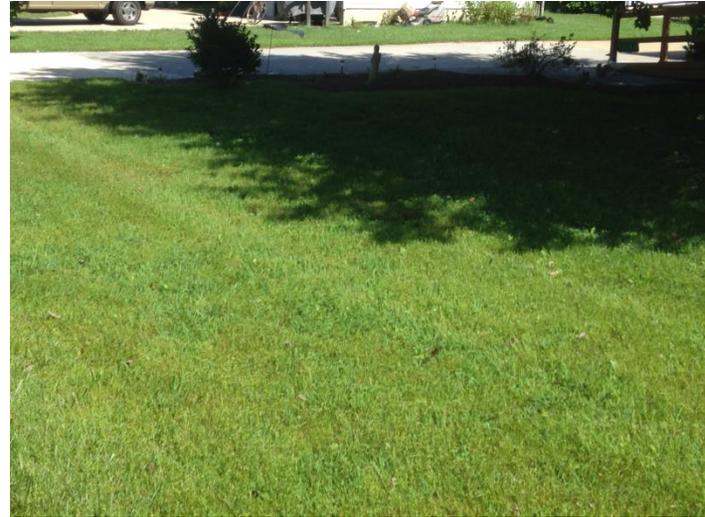
Figure D.26: Yard of 27465 Oak Meadow Drive (OO_27)

OO_27	411	27465 Oak Meadow Dr.	Localized runoff	The yard and driveway of 27465 Oak Meadows Dr. flood monthly. The driveway and yard are a local low point.	Install rain garden, raise private driveway	Install a rain garden or biofiltration to create a controlled local low point with infiltration capacity. Raise existing driveway to the maximum extent possible based on the garage elevation (approximately 6 inches) to provide positive conveyance to roadway and proposed rain garden.	This solution has the potential to reduce the frequency and duration of flooding.	Private ownership.	Homeowner Implementation/ Technical Assistance
OO_28	412	27843 Oak Meadow Dr.	Localized runoff	The driveway, yard, and roadway of 27843 Oak Meadows Dr. floods monthly. There is no drainage at this location, so water ponds and infiltrates slowly.	Install ditch	Install a ditch north of Briar Ln. from the intersection of Oak Meadow Dr. and Briar Ln. to the existing catch basin. Install storm drain pipes under driveways as needed.	This solution has the potential to reduce the frequency and duration of flooding.	Public ownership (road).	DNREC - High Priority

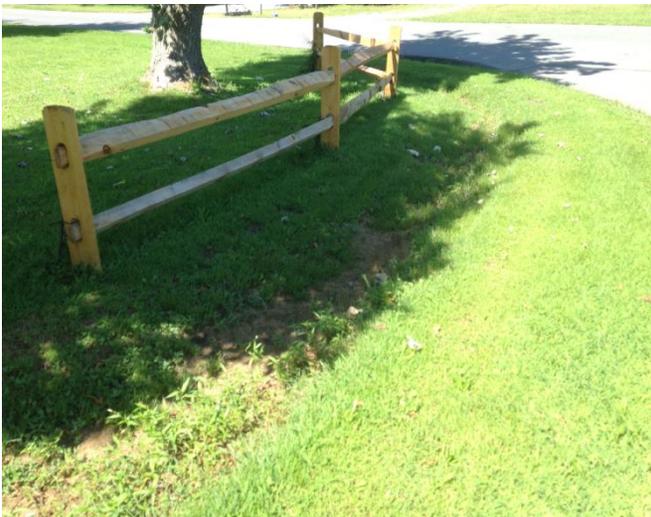
Figure D.27: Ponding/infiltration area near 27843 Oak Meadows Drive (OO_28)

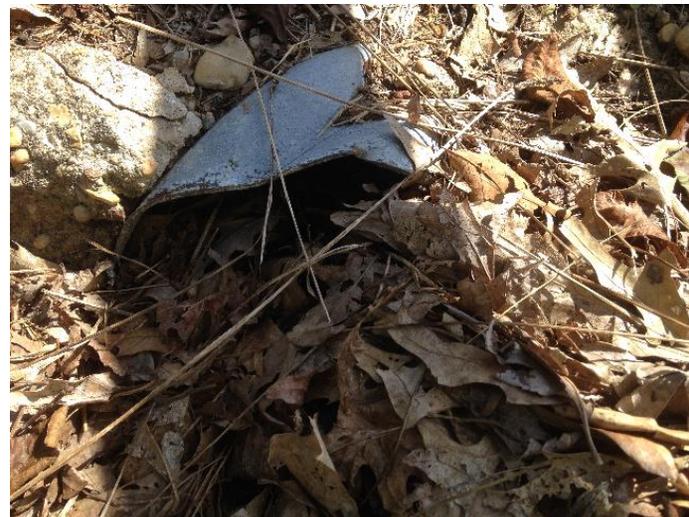
Figure D.28: 31913 Schooner Drive culvert full of leaf litter (OO_29)

OO_29	413	31913 Schooner Dr.	Localized runoff	The driveway and yard of 31913 Schooner Dr. flood several times a year. The existing storm drain pipe under the driveway is covered by tall grass at the inlet and leaves at the outlet. A storm drain pipe from the existing ditch to a stormwater management facility south of the property also has debris and vegetation blocking flow.	Maintenance	Remove debris impeding flow into existing storm drain pipe and ditches as needed to convey runoff to the existing stormwater management facility.	This solution has the potential to reduce the frequency and duration of flooding.	Private ownership (River Village homeowners association).	Homeowner Association/ Technical Assistance
OO_30	414, 414.1	27223 Clipper Dr. and road in front of property	Localized runoff	The driveway and yard of 27223 Clipper Dr. flood several times a year. There does not appear to be an engineered drainage solution at this property (there may have been a ditch that has filled in over time).	Install ditch	Install ditch east of Clipper Dr. from 27223 Clipper Dr. around corner past the driveway of 27237 Clipper Dr. to connect with the existing ditch. Install a storm drain pipe under the driveway of 27237 Clipper Dr. or a valley gutter.	This solution has the potential to reduce the frequency and duration of flooding. There is a light post and electric box east of Clipper Dr. that could impact construction. Sewer lines are located within the roadway and would not be expected to impact construction.	Private ownership. Primarily River Village homeowners association, although an additional easement through private property may be required.	Homeowner Association/ Technical Assistance

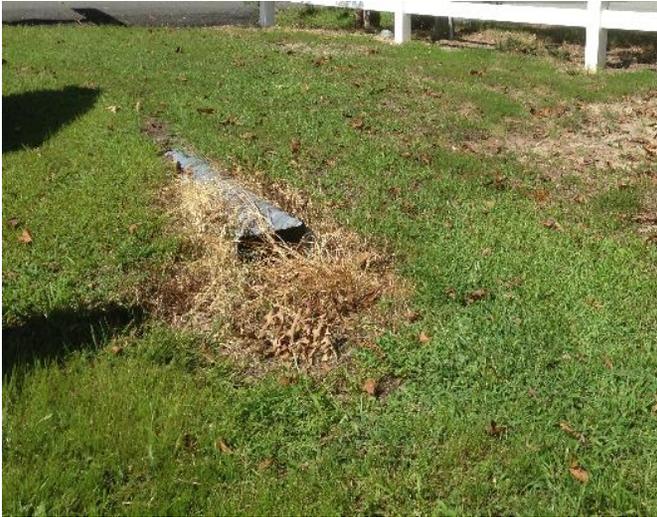
Figure D.29: Schooner Drive Dry Pond inlet pipe partially covered by vegetation and leaf litter (OO_29)

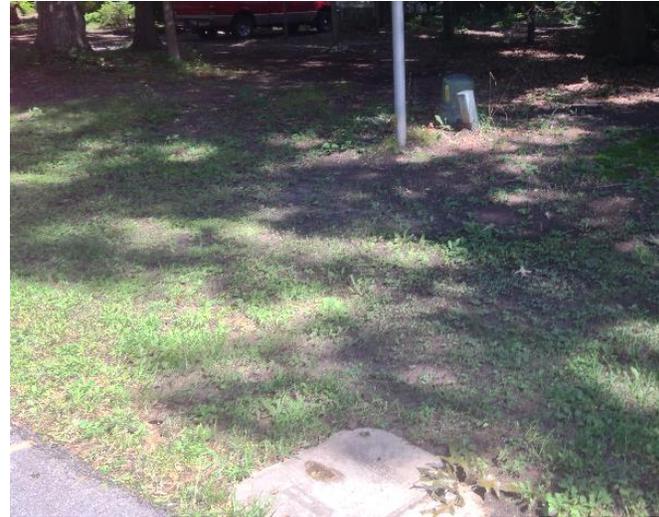
Figure D.30: Yard of 27223 Clipper Drive (OO_30)

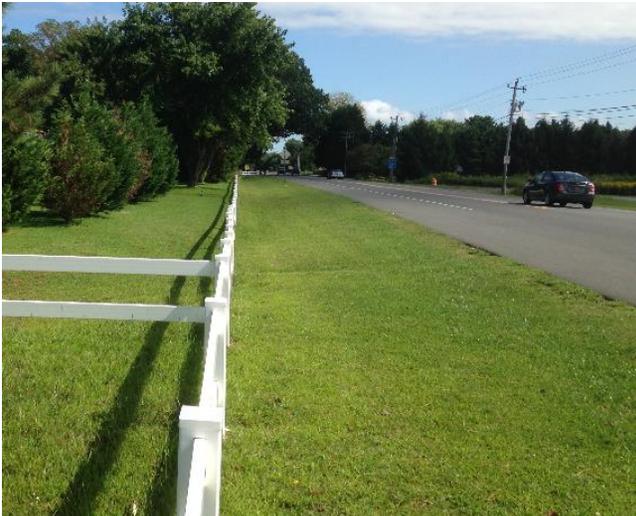
Figure D.31: Oak Orchard Road between Caravel Drive and Driftwood Village (OO_31)

OO_31	None (DNREC noted concern from community meeting)	Driftwood Stormwater Management facility to Caravel Dr.	Localized runoff	Oak Orchard Rd. floods from the Driftwood Stormwater Management facility to Caravel Dr. as a result of the lack of conveyance system.	Install storm drain, retrofit stormwater management ponds	Install approximately 700 feet of closed storm drain with catch basins as needed northwest of Oak Orchard Rd. from the existing stormwater management facility southeast of Schooner Dr. to 300 feet south of Caravel Drive. Connect proposed storm drain system to the existing stormwater management facility and retrofit as needed to store additional flow. Install approximately 1,200 feet of closed storm drain with catch basins as needed northwest of Oak Orchard Rd. from the existing stormwater management facility south of Driftwood Blvd. to 400 feet south of Schooner Dr. Connect proposed storm drain system to the existing stormwater management facility and retrofit as needed to store additional flow.	This solution has the potential to reduce the frequency and duration of flooding. Sewer and water lines along Oak Orchard Rd. may be impacted.	Primarily public ownership (road), with two easements through homeowner association property required.	DNREC

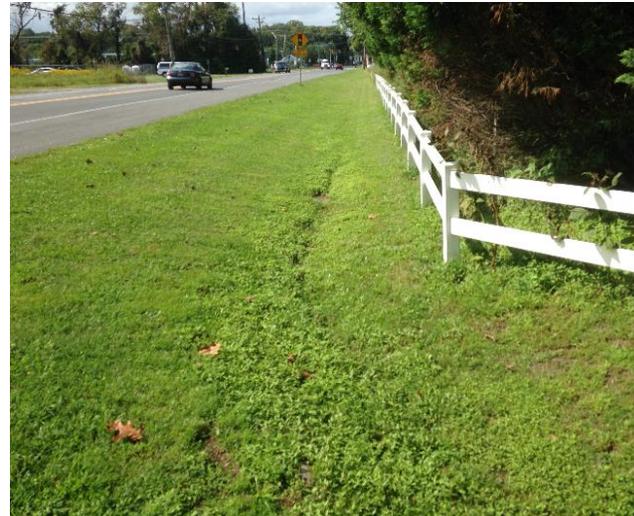
Figure D.32: Existing ditch at the corner of Oak Orchard Road and Caravel Drive (OO_32)

OO_32	416.1	Intersection of Caravel Dr. and Oak Orchard Rd.	Localized runoff	The intersection of Caravel Dr. and Oak Orchard Rd. flood several times a year. Currently, water ponds in the grass area (which resembles a ditch) on the corner of Caravel Dr. and Oak Orchard Rd. and infiltrates.	Improve existing ditch	Improve the existing ditch so runoff flows from Caravel Dr. to the existing stormwater management facility to the north.	This solution has the potential to reduce the frequency and duration of flooding. Sewer and water lines along Oak Orchard Rd. should not be impacted by the proposed design.	Primarily public ownership (road), although an easement will be required to work on the existing stormwater management facility (homeowner association).	DNREC

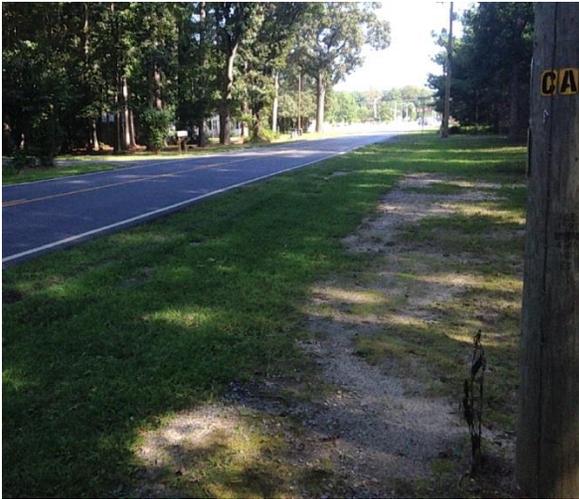
Figure D.33: Roadway shoulder in front of 30772 Mount Joy Road (OO_33)

Solution ID ¹	Questionnaire ID	Proposed Project Location	Source of Flooding	Existing Site Conditions	Recommendation Summary	Recommendation	Notes (constraints, effectiveness)	Property Ownership ²	Agency
OO_33	417.1	Road in front of 30772 Mount Joy Rd.	Localized runoff	The right of way along Mount Joy Rd. floods in front of 30772 Mount Joy Rd. several times a year. The flooding does not impact the road.	Regrade private lot	Regrade private lot to provide positive drainage to roadway.	This solution has the potential to reduce the frequency and duration of flooding. Sewer lines on the northbound lane of Mount Joy Rd. should not be impacted.	Private property.	Homeowner Implementation/ Technical Assistance
OO_34	410, S_22, S_21, S_10, S_09	Commercial property north of Route 24 / Route 5 intersection	Localized runoff	There is flooding at 27522 Oak Meadow Dr. and the commercial property north of the intersection of Route 24 and Oak Orchard Road. The runoff appears to be generated north of Route 24. Currently, there is no storage or conveyance for this runoff as it travels through the Oak Meadows neighborhood, Chief Rd. ditch / storm drain, and the existing ditch parallel to Oak Meadows Rd. to the existing 30-inch storm drain pipe to the Indian River Bay.	Implement regional stormwater management facility	Implement a regional stormwater management facility (such as a dry pond) in the vacant lot between Route 24 and Oak Meadow Dr. to retain upland waters. Design facility to include storage for potential future development of the vacant lot. Install storm drain system and ditches as needed to capture runoff from Mount Joy Rd. and Route 24 (and potentially Caravel Dr.).	This solution has the potential to reduce the frequency of flooding for the Oak Meadows neighborhood, Chief Rd., and River Rd. near the Cerise Ave. intersection. The lot is primarily composed of grasses, but some wetland vegetation may be present. Sewer lines run parallel to Route 24 south of the road and should not impact the proposed design.	Private ownership (undeveloped lot owned by a single property owner).	DNREC

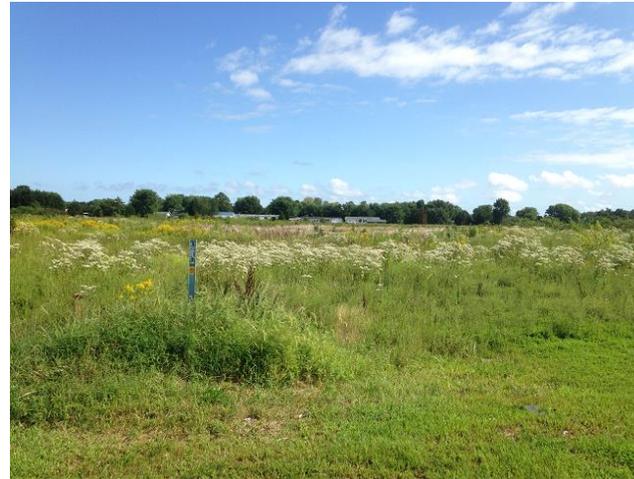
Figure D.34: Open space between Oak Meadow Drive and John J Williams Highway (OO_34)

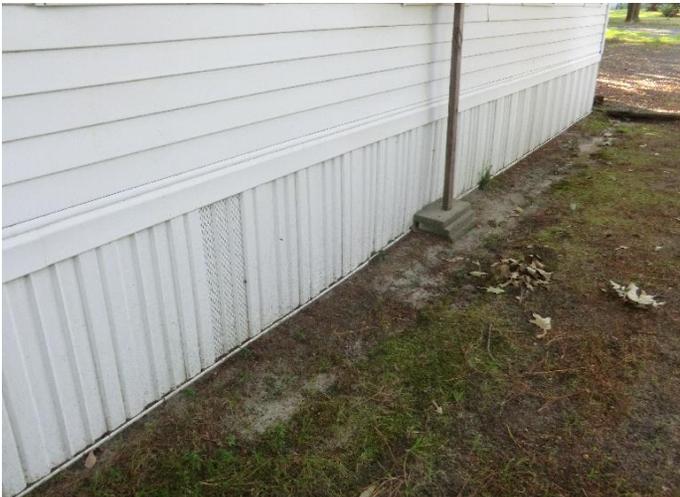
Figure D.35: Yard and residential structure of 33002 Circle Drive (OO_35)

OO_35	303	33002 Circle Dr.	Localized runoff	The yard and the basement of 33002 Circle Dr. flood because the house is at a local low point.	Regrade private lot	Raise property to allow positive drainage to road.	This solution has the potential to reduce the frequency and duration of flooding. The mobile home is sitting on a frame so raising the lot may be cost prohibitive.	Private ownership.	Homeowner Implementation/ Technical Assistance
OO_36	223.3	Intersection of Myrtle Ave. and Delaware St.	Localized runoff	There is a relative low point at the intersection of Myrtle Ave. and Delaware St. where water ponds frequently. Ponding water was observed in the field.	Install valley gutter	Install valley gutter at the intersection of Myrtle Ave. and Delaware St. parallel to Delaware St. from the northern roadway fillet curve of Myrtle Ave. to the southern roadway fillet curve.	This solution has the potential to reduce the frequency and duration of flooding. The proposed valley gutter would cross sewer and water lines, but neither should be impacted by the design.	Public ownership (road).	DNREC

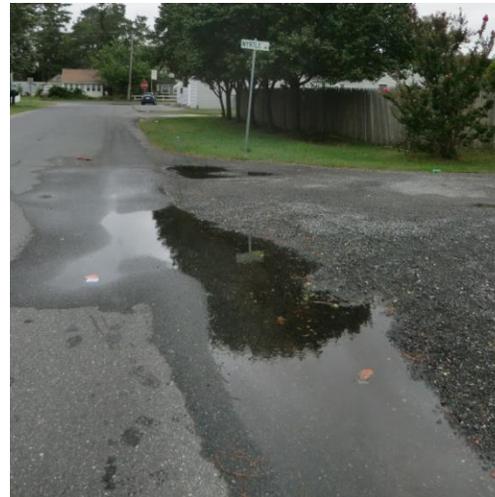
Figure D.36: Intersection of Myrtle Avenue and Delaware Street (OO_36)

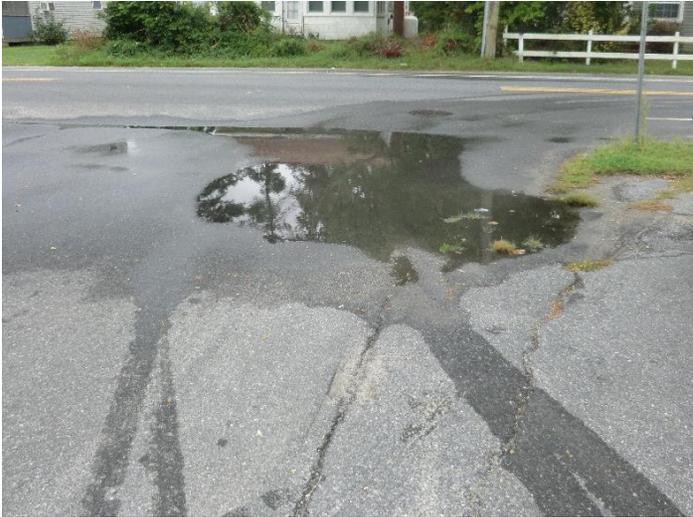
Figure D.37: Intersection of Oak Orchard Road and Delaware Street (OO_37)

OO_37	223.2	Delaware St. and Oak Orchard Rd.	Localized runoff	There is a relative low point at the intersection of Delaware St. and Oak Orchard Rd. where water ponds frequently. Ponding water was observed in the field.	Install valley gutter	Install valley gutter at the intersection of Oak Orchard Rd. and Delaware St. parallel to Oak Orchard Rd. from the northern roadway fillet curve of Delaware St. to the southern roadway fillet curve.	This solution has the potential to reduce the frequency and duration of flooding at the intersection. Flooding may still occur on the roadway shoulder south of the intersection. The proposed valley gutter would cross sewer and water lines, but neither should be impacted by the design.	Public ownership (road).	DNREC
OO_38	None (DNREC noted concern from community meeting)	River View Ave.	Tidal flooding	The existing stormdrain system on the west side of River View Ave. drains to the Indian River Bay. The stormdrain pipe extends into the bay. The existing catch basin closest to Mercer Ave. is substantially lower than the local grade and is partially covered by sediment and debris.	Upgrade existing storm drain	Remove and replace the catch basin closest to Mercer Ave. and reconnect to existing stormdrain pipe. Install backflow prevention on the bay side of the pipe extending into the Indian River Bay and replace the pipe if leaks are present.	This solution has the potential to reduce the frequency and duration of flooding on the street. There are water and sewer lines in the vicinity of the existing storm drain system.	Entirely private ownership (private road).	DNREC

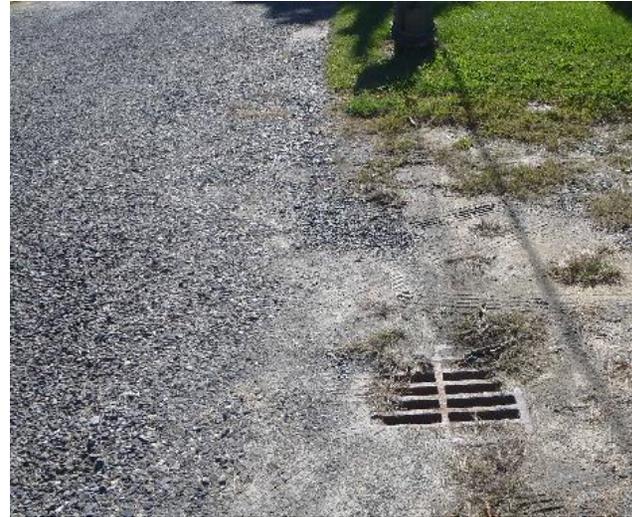
Figure D.38: Catch basin partially filled with debris at River View Avenue (OO_38)

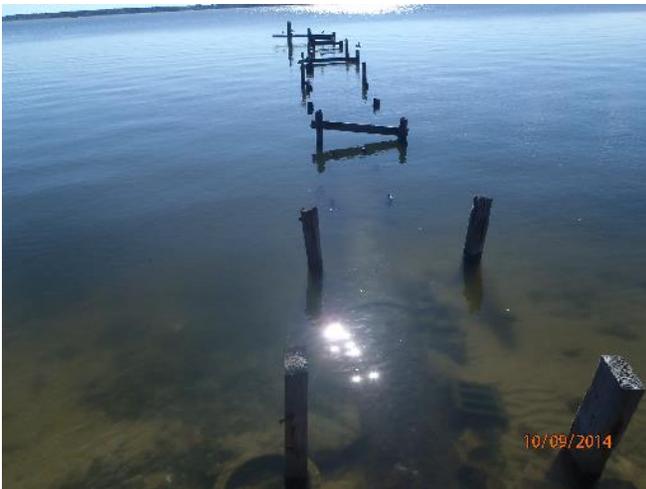
Figure D.39: Pipe extending out to the Indian River Bay from River View Avenue (OO_38)
