Appendix B
Community Maps with Location of Drainage Concerns and Proposed Solutions

Appendix D
Field Reconnaissance Photographs

**Oak Orchard – Coastal Drainage Engineering Study
Field Data Form**

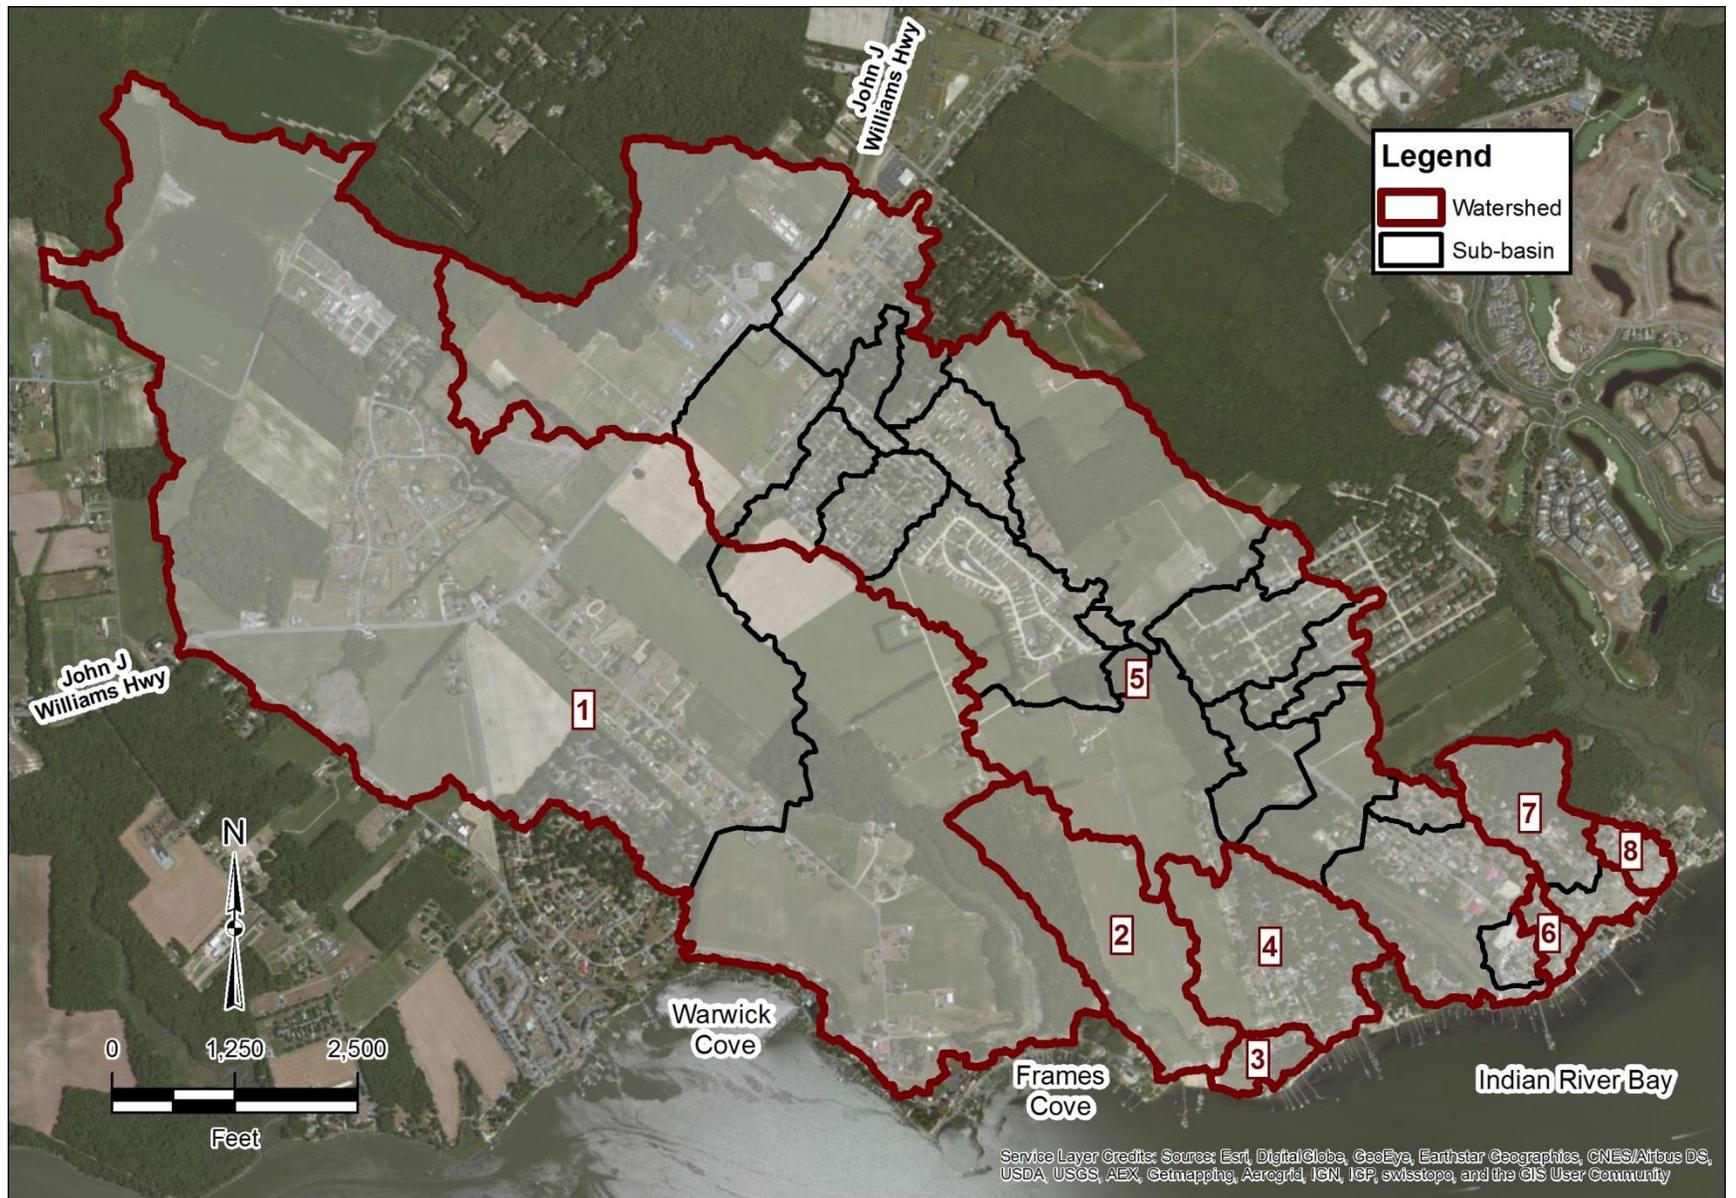
Figure F-1: Oak Orchard Drainage Divide Map

URS developed the hydrologic model using HEC-HMS 4.0 (USACE, 2010). URS developed the elevation preprocessing, watershed delineation, and attribute management using ArcGIS 10.1 (ESRI, 2012). Figure F-1 displays the 8 watersheds and 31 sub-basins included in the hydrologic analysis. Figure F-2 display the 31 sub-basins, 24 junctions, 8 outfalls, and the routing reaches modeled using HEC-HMS. The sub-basins were selected based on the locations of existing drainage concerns and hydrologic considerations.
