Writing the CCR Report

Application for
Sediment and Stormwater Management
CERTIFIED CONSTRUCTION REVIEWER

YOUR COMPANY LOGO
(Post Rain Event Review)

Project Site/Name: Sweetbriar High School 2014-001

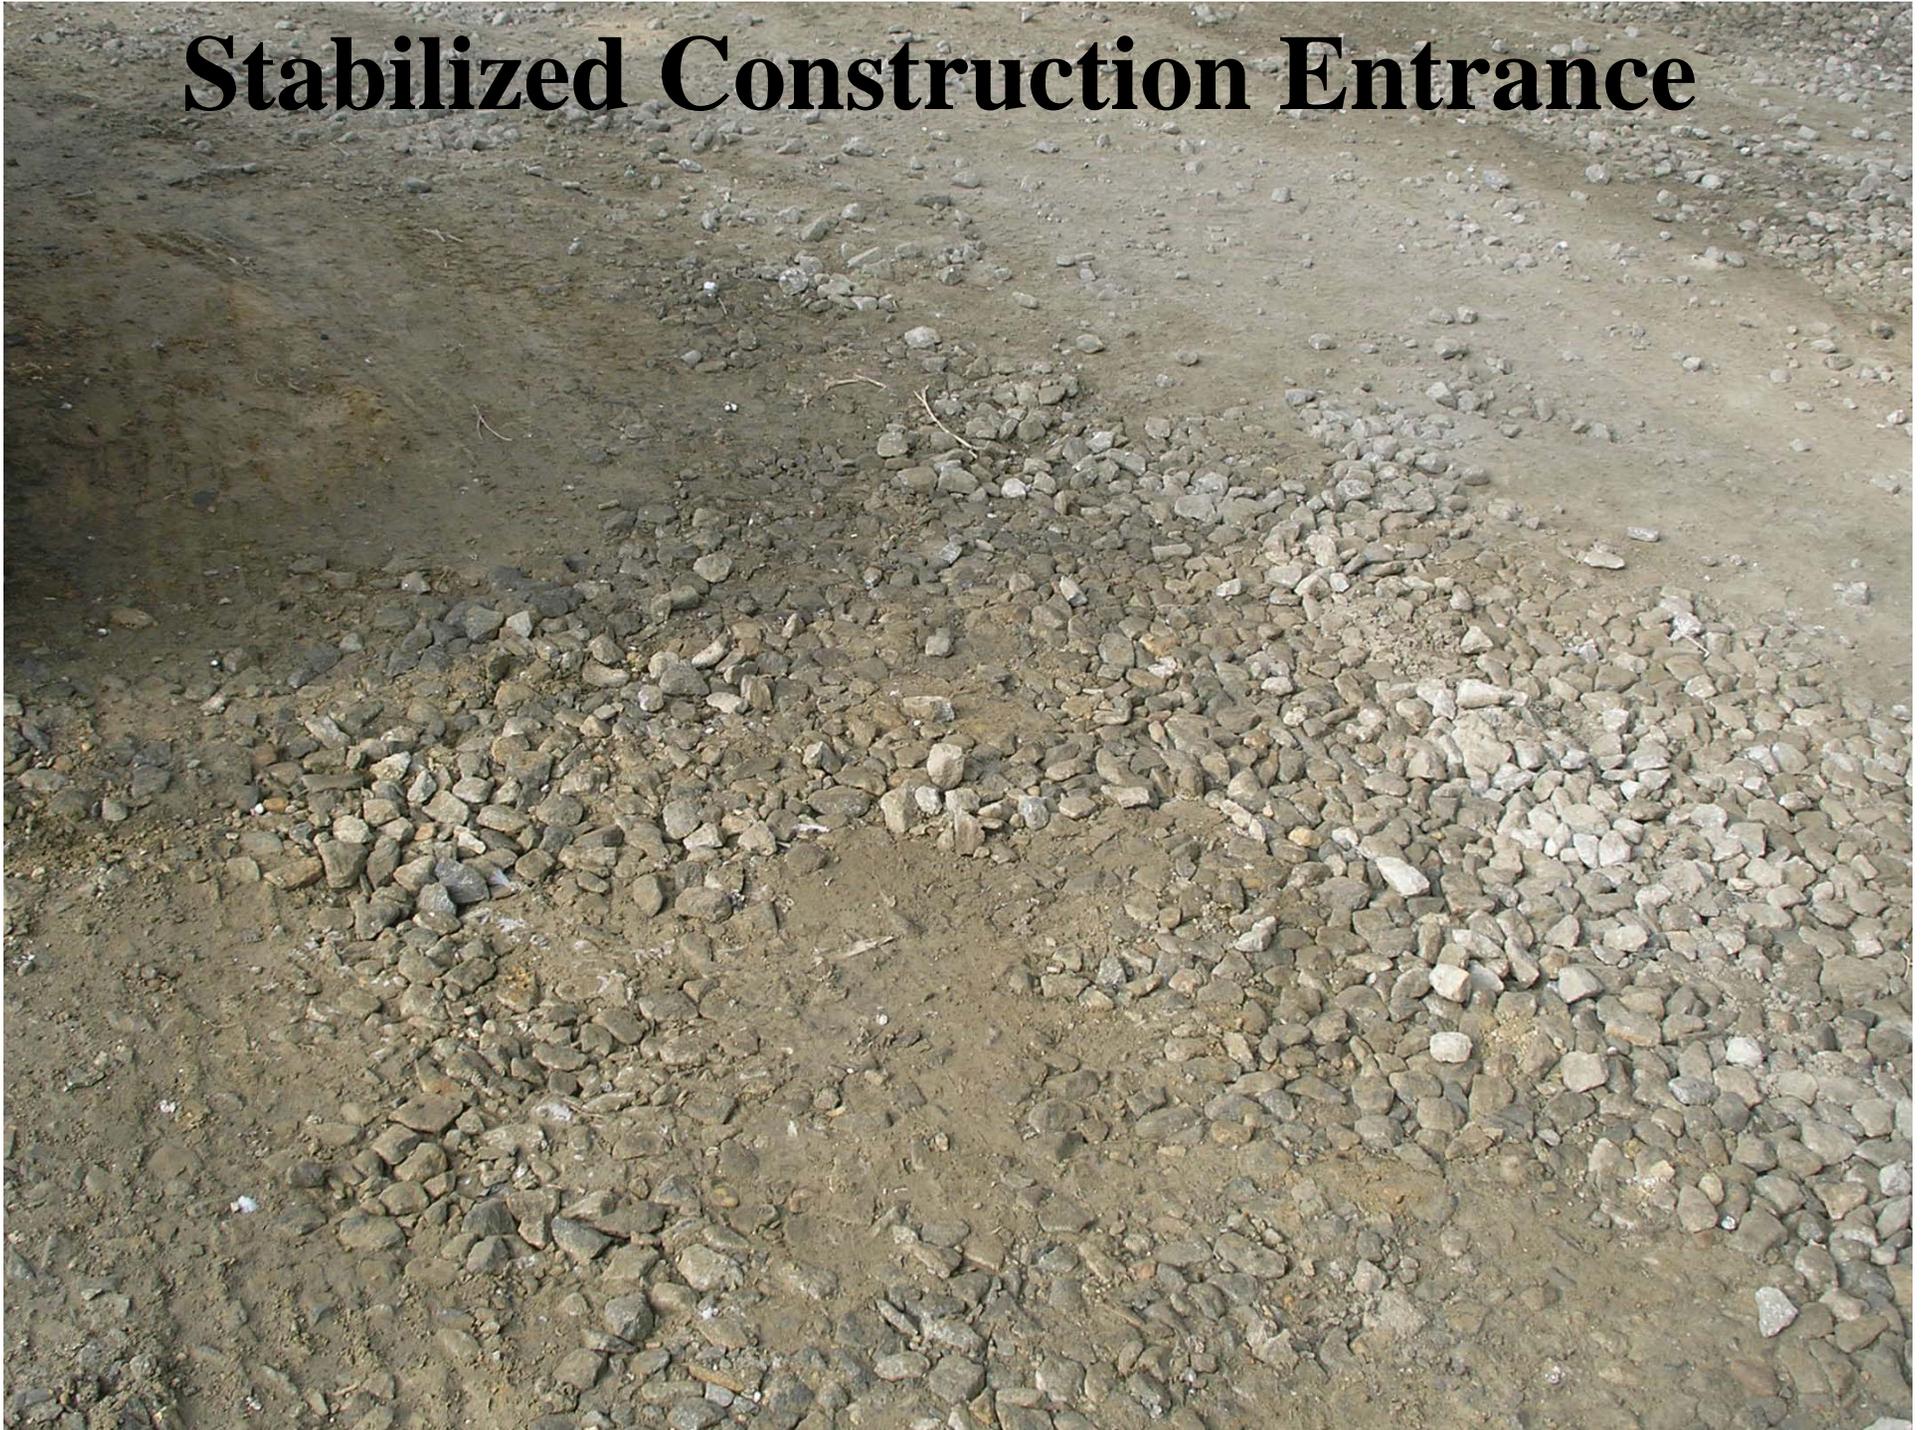
Stabilized Construction Entrance

1.0 Stabilized Construction Entrance:

a. The stabilized construction entrance is laden with sediment and there is tracking out onto the roadway.

[Corrective Action] Rough the existing stone to loosen the sediment and refresh the entrance with more DE #3 stone. Sweep the sediment off the roadway and return the sediment to the site. Maintain the roadway with regular street sweeping.

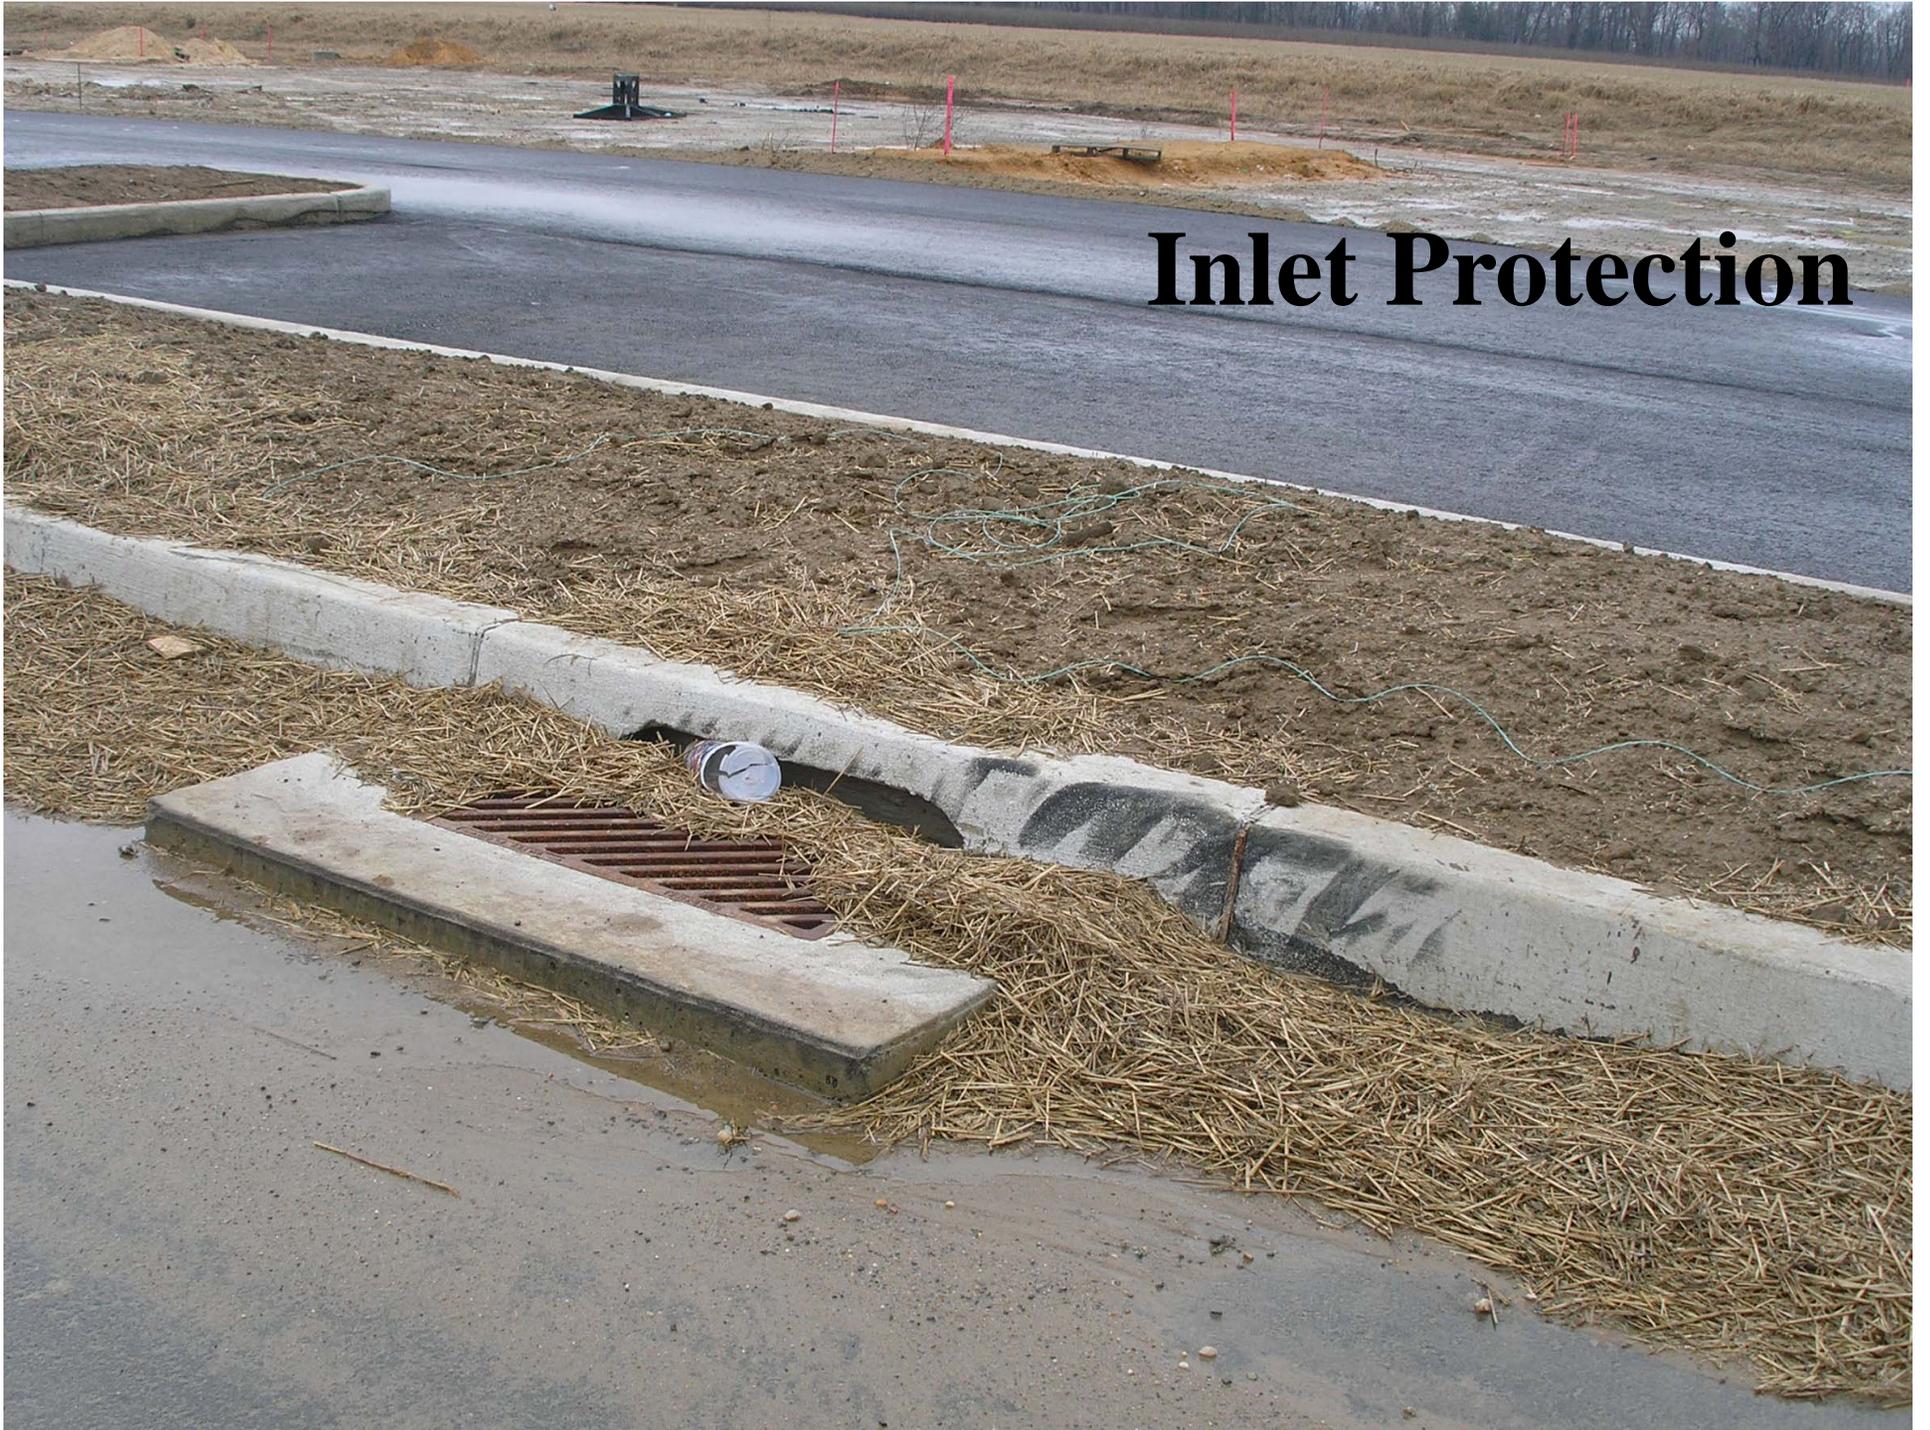
Inlet Protection

3. Inlet Protection:

- a. The inlets are inundated with straw from the stabilizing efforts and they are threatened with sediment. Inlet protection has been removed without approval from the delegated agency. **[Corrective Action]** Remove all straw and sediment from the inlet boxes. Install the silt bags in the inlets and continue to maintain the silt bags. Removal of the inlet protection is only permitted upon the approval of the delegated agency.

- a. The inlets are inundated with straw from the stabilizing efforts and are threatened with sediment. Inlet protection has been removed without approval from the delegated agency. **[Corrective Action]** Remove all straw and sediment from the inlet boxes. Install the silt bags in the inlets and continue to maintain the silt bags. Removal of the inlet protection is only permitted upon the approval of the delegated agency.

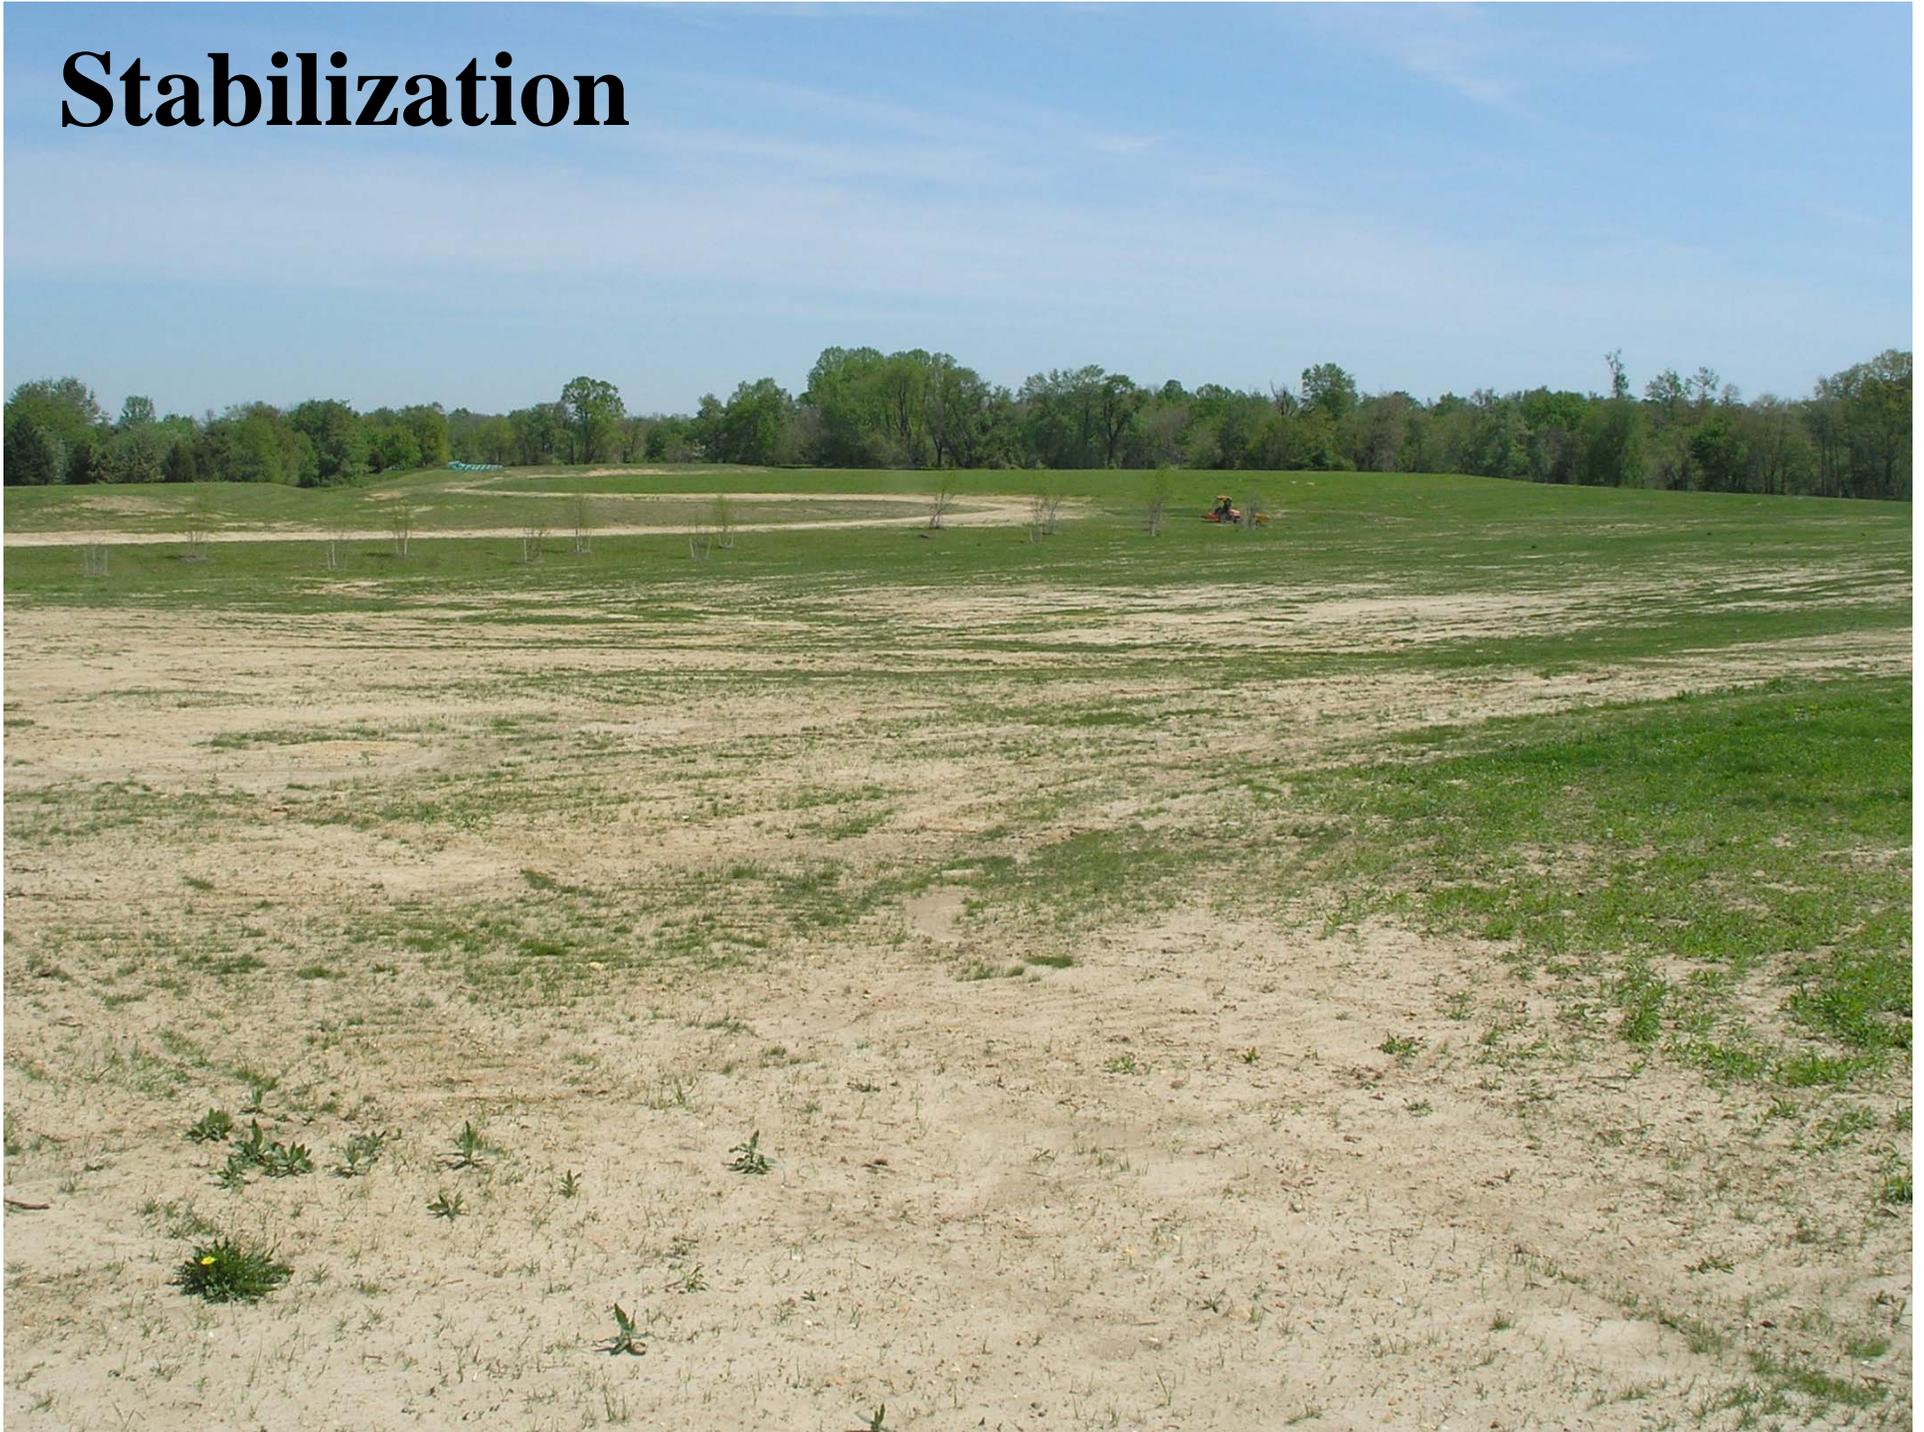
Stabilization

4. Vegetative Stabilization:

- a. The stabilization that was applied back in November 2014 has taken well in some locations. There are some significant areas that will require additional stabilizing to achieve the 70% uniform cover. **[Corrective Action]**
Loosen compacted areas of the soil and apply stabilization as per the vegetative specifications on the approved plan, page C-5.

- a. The stabilization that was applied back in November 2014 has taken well in some locations. There are some significant areas that will require additional stabilizing to achieve the 70% uniform cover. **[Corrective Action]** Loosen compacted areas of the soil and apply stabilization as per the vegetative specifications on the approved plan, page C-5.

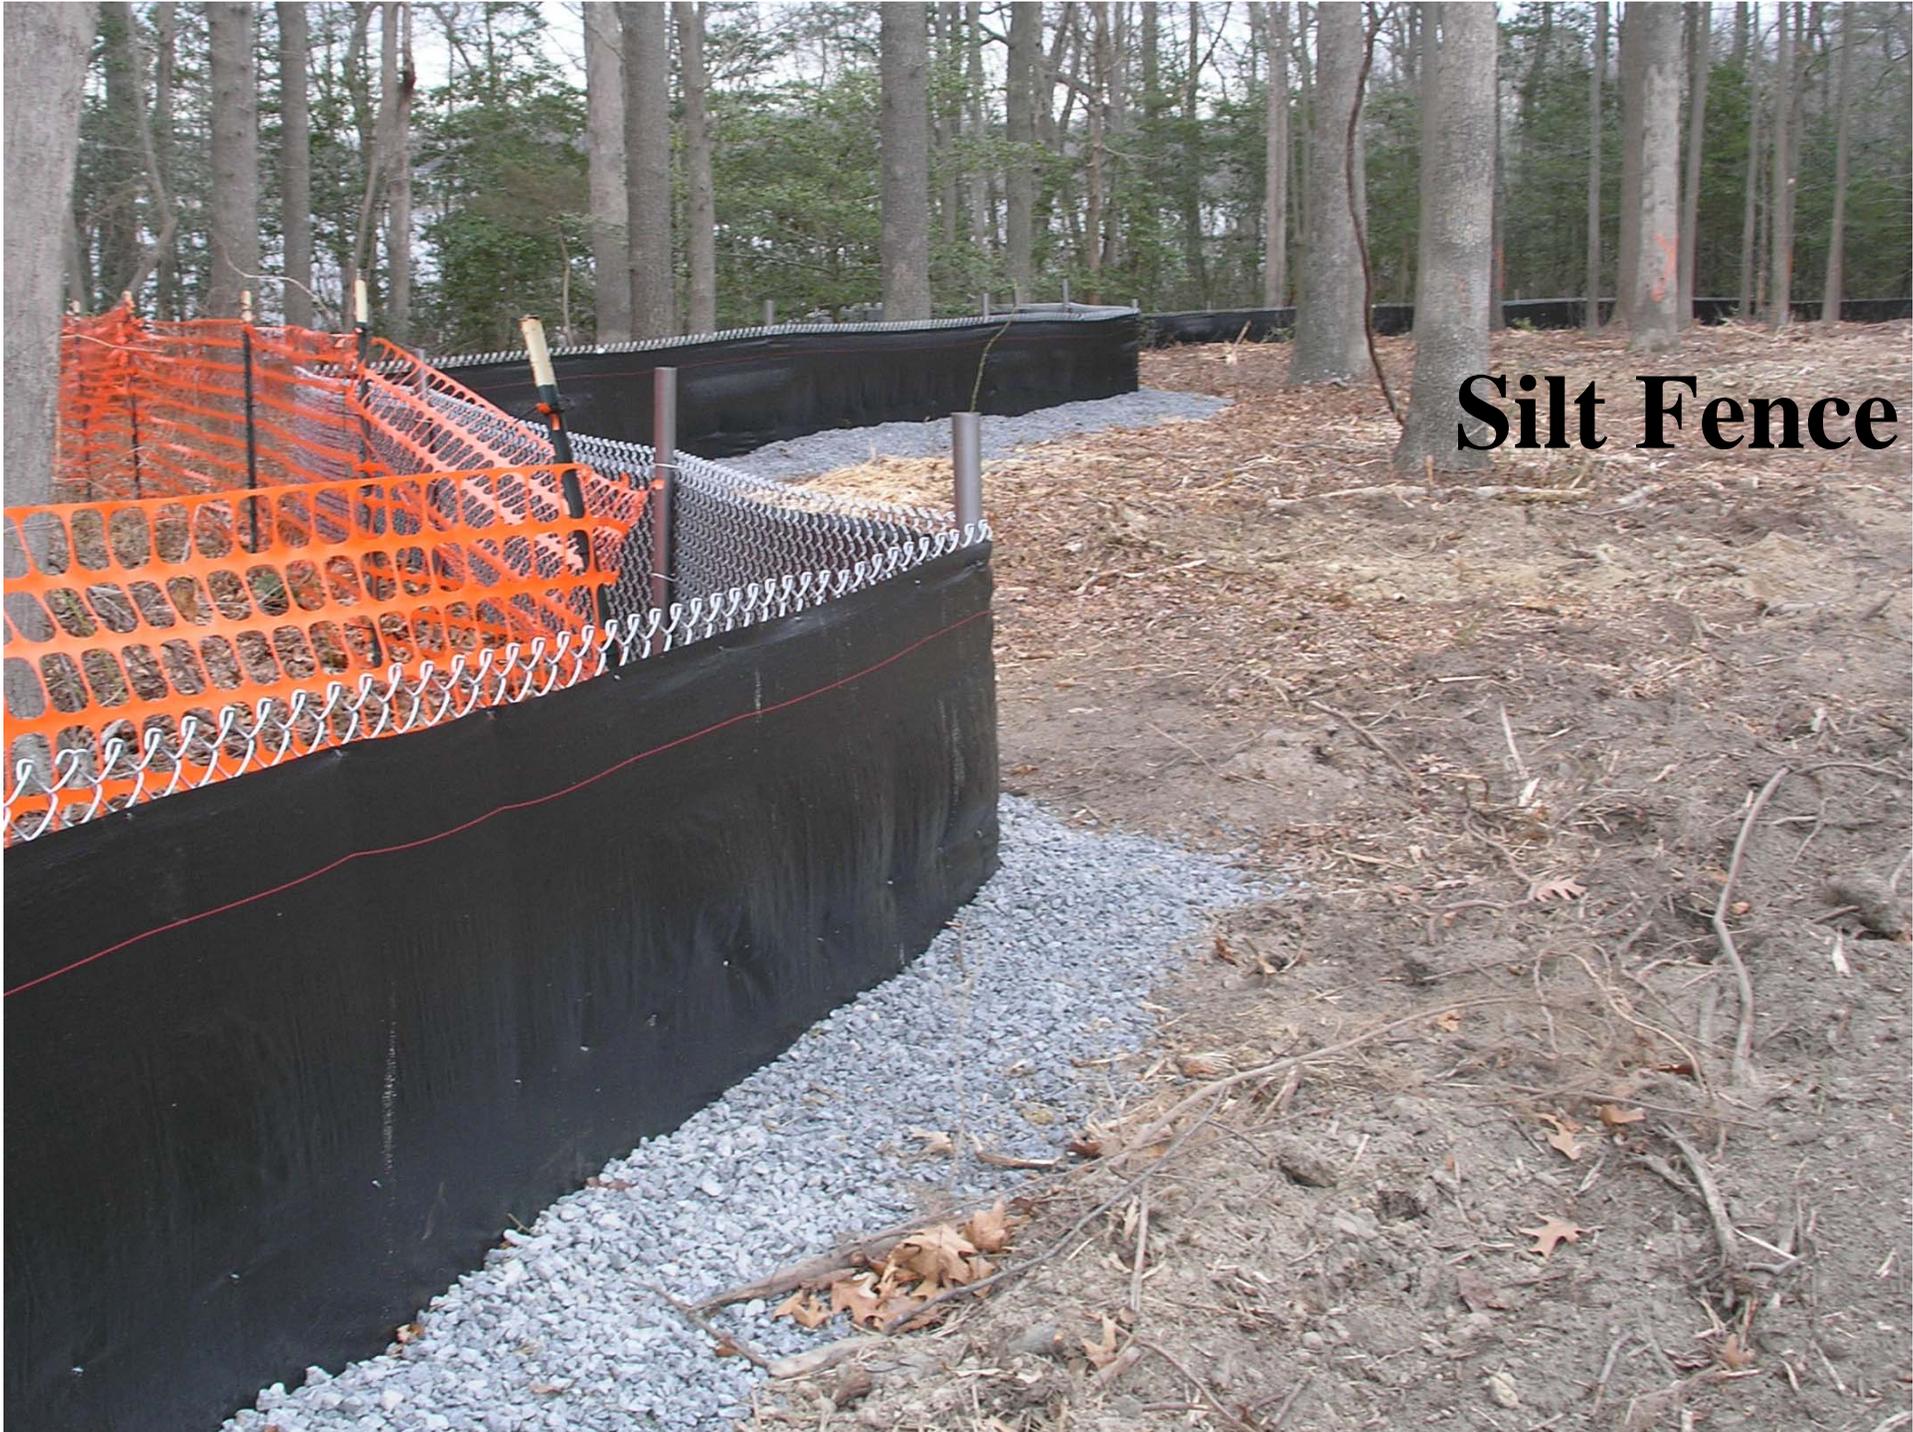
Silt Fence

6. Silt Fence:

- a. The super silt fence along the east side of the site is properly installed and functioning well. The addition of the stone at the base of the fence has resolved the previous scour problem. **[No Action]**

- a. The super silt fence along the east side of the site is properly installed and functioning well. The addition of the stone at the base of the fence has resolved the previous scour problem. **[No Action]**

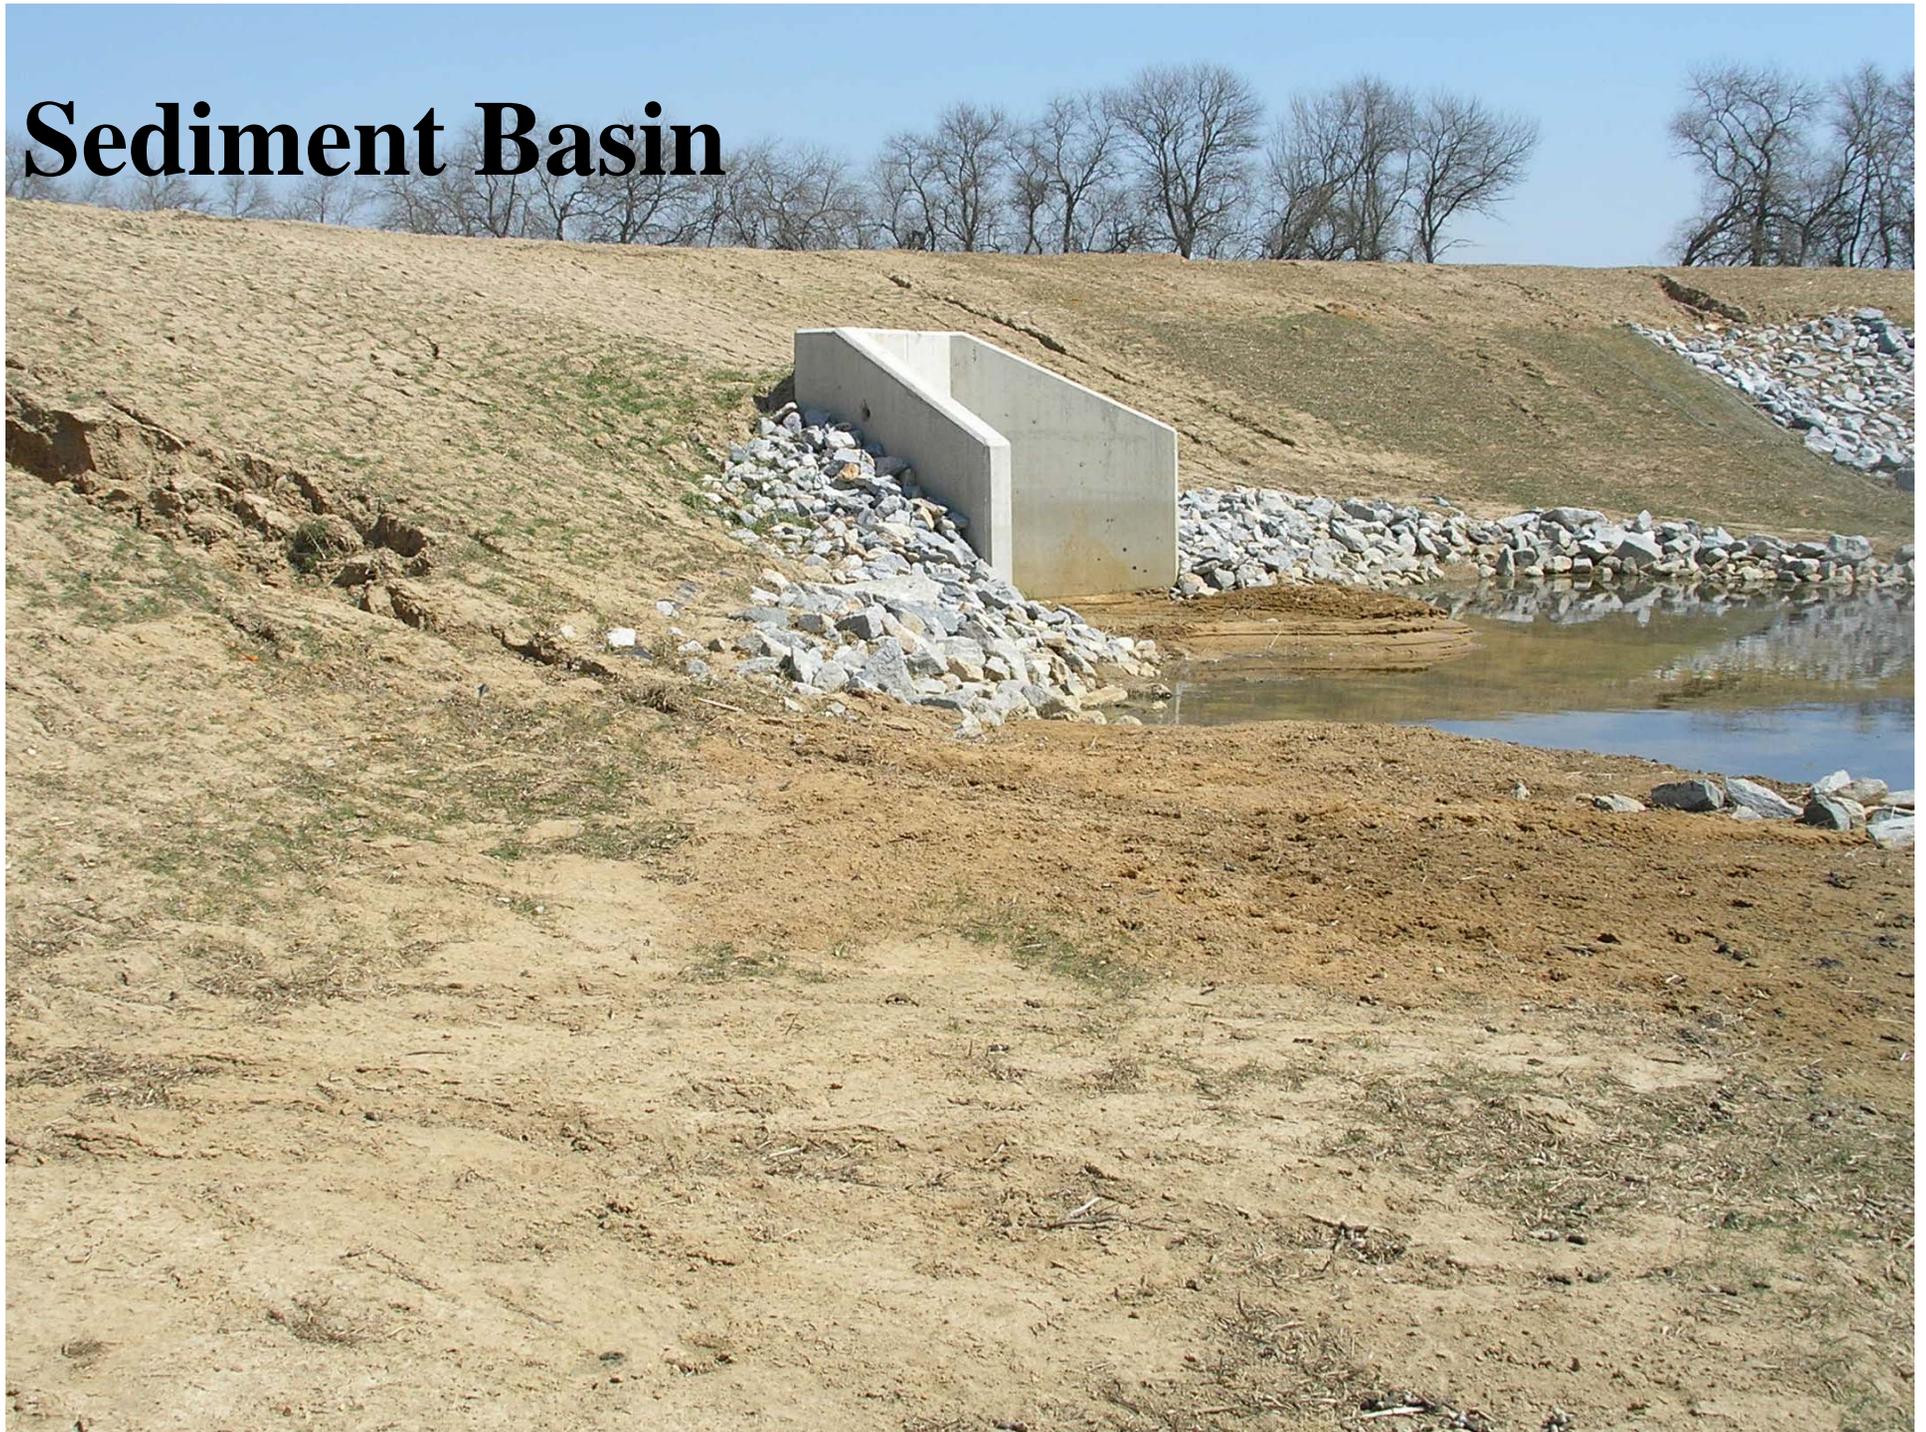
Sediment Basin

7. Sediment Traps/Basins:

[Repeat Observation] There is significant gullying near the basin headwall. The gullying has worsened since this observation was first reported. The initial stabilization applied to the basin banks has not become established. **[Corrective Action]** Repair the gullies by filling and compacting the base soils. Leave the top 6" of soil loose and well fertilized. Apply erosion blanket and seed to these critical areas to allow the grass to establish. Reduce the concentrated flow at the top of the basin bank by applying a straw wattle, turned upward toward the stormwater flow to avoid abrupt ends, until the soil is stabilized.

- a. **[Repeat Observation]** There is significant gullying near the basin headwall. The gullying has worsened since this observation was first reported. The initial stabilization applied to the basin banks has not become established. **[Corrective Action]** Repair the gullies by filling and compacting the base soils. Leave the top 6" of soil loose and well fertilized. Apply erosion blanket and seed to these critical areas to allow the grass to establish. Reduce the concentrated flow at the top of the basin bank by applying a straw wattle, turned upward toward the stormwater flow to avoid abrupt ends, until the soil is stabilized.

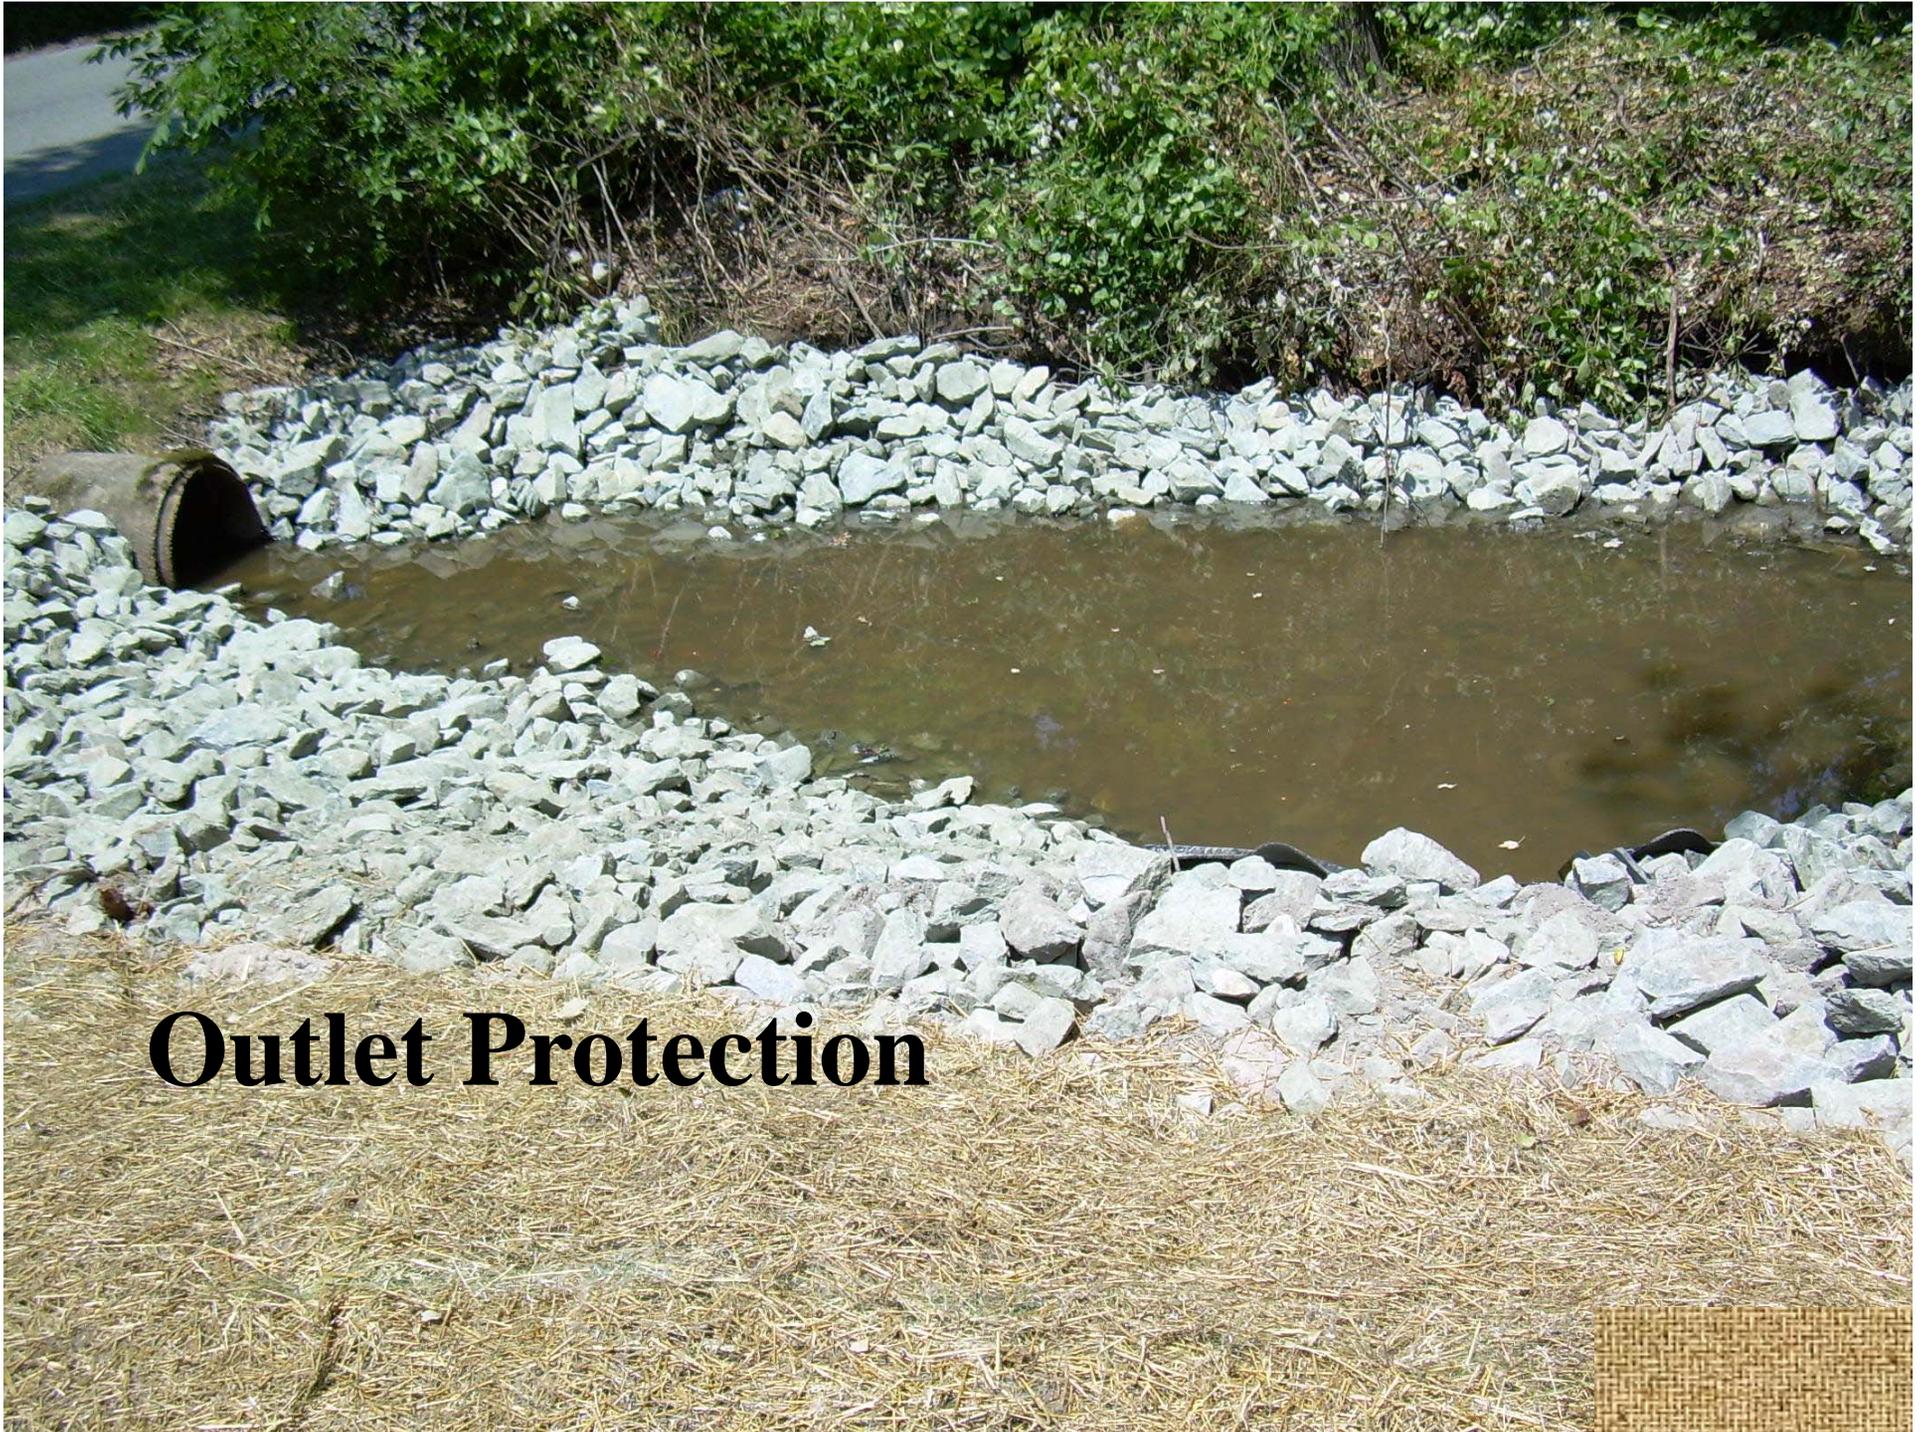
Outlet Protection

8. Outlet Protection:

- a. The outfall protection has been installed as per the approved plan and the 6” rip rap has been underlain with the Mirafi 600X fabric. The area around the outlet has been seeded and the ECSC-2B erosion blanket has been installed. **[No Action]**

- a. The outfall protection has been installed as per the approved plan and the 6" rip rap has been underlain with the Mirafi 600X fabric. The area around the outlet has been seeded and the ECSC-2B erosion blanket has been installed. **[No Action]**

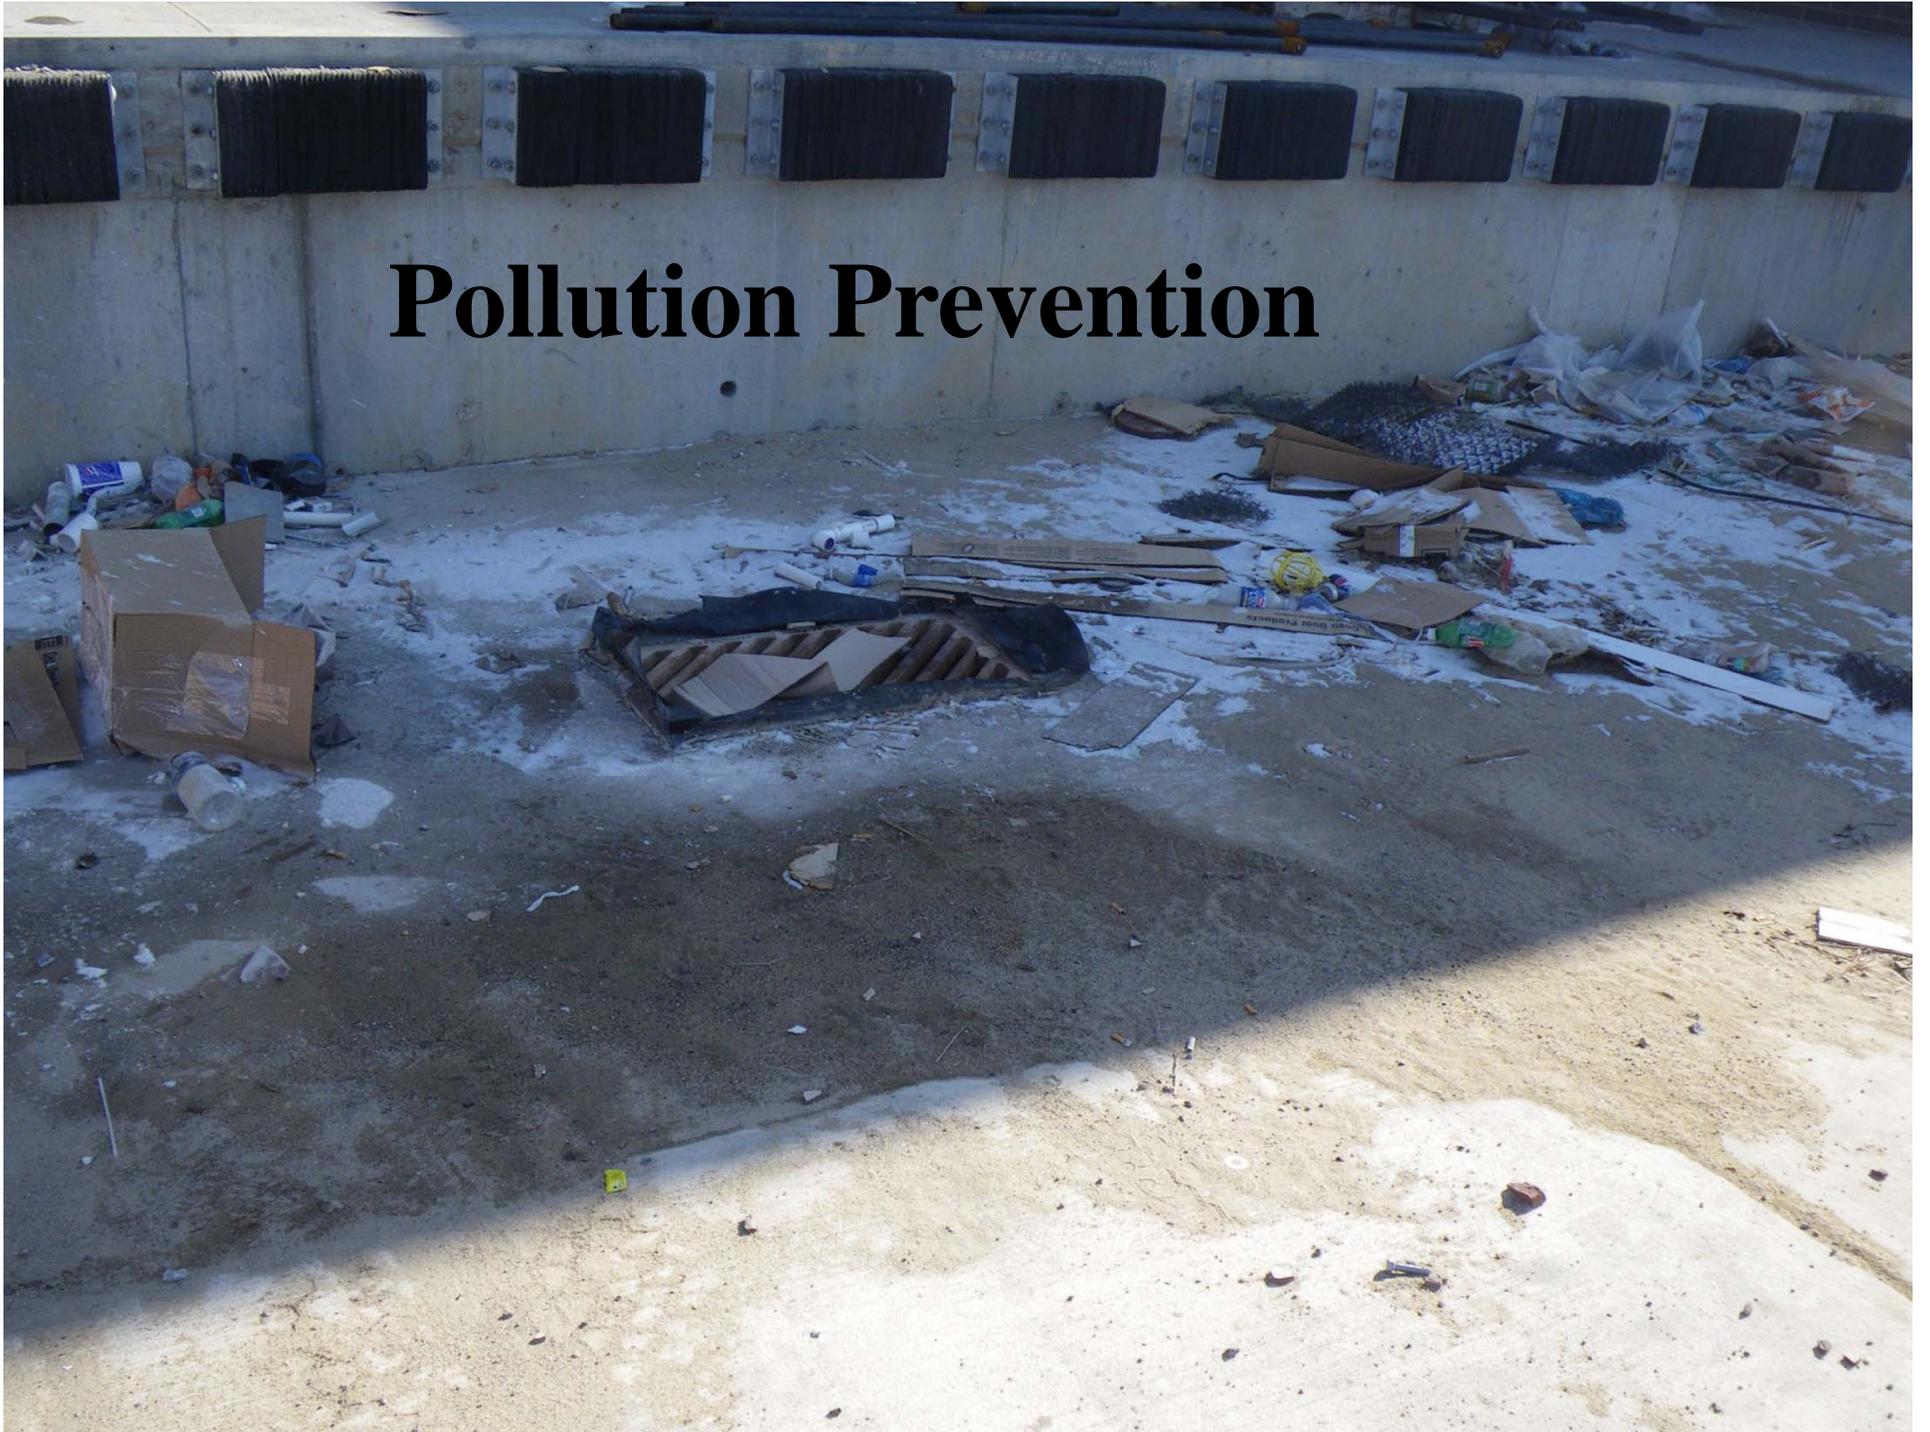
Pollution Prevention

10. Pollution Prevention:

- a. It appears that the painting trades are washing their equipment in the loading dock area by the catch basin. **[Corrective Action]** This is a violation to wash hazardous substances into a catch basin. I spoke with the site superintendent and directed him to stop the tradesmen from washing in this area and we discussed another location on site where the wash water can be captured.
- b. The loading dock area is inundated with trash and sediment. **[Corrective Action]** Remove the trash from this area and provide trash receptacles. Flat shovel the sediment and return it to a controlled area.
- c. All fueling operations are within controlled areas and containers are properly stored. **[No Action]**

- a. It appears that the painting trades are washing their equipment in the loading dock area by the catch basin. **[Corrective Action]** This is a violation to wash hazardous substances into a catch basin. I spoke with the site superintendent and directed him to stop the tradesmen from washing in this area and we discussed another location on site where the wash water can be captured.
- b. The loading dock area is inundated with trash and sediment. **[Corrective Action]** Remove the trash from this area and provide trash receptacles. Flat shovel the sediment and return it to a controlled area.
- c. All fueling operations are within controlled areas and containers are properly stored. **[No Action]**
