# South Bethany, Delaware

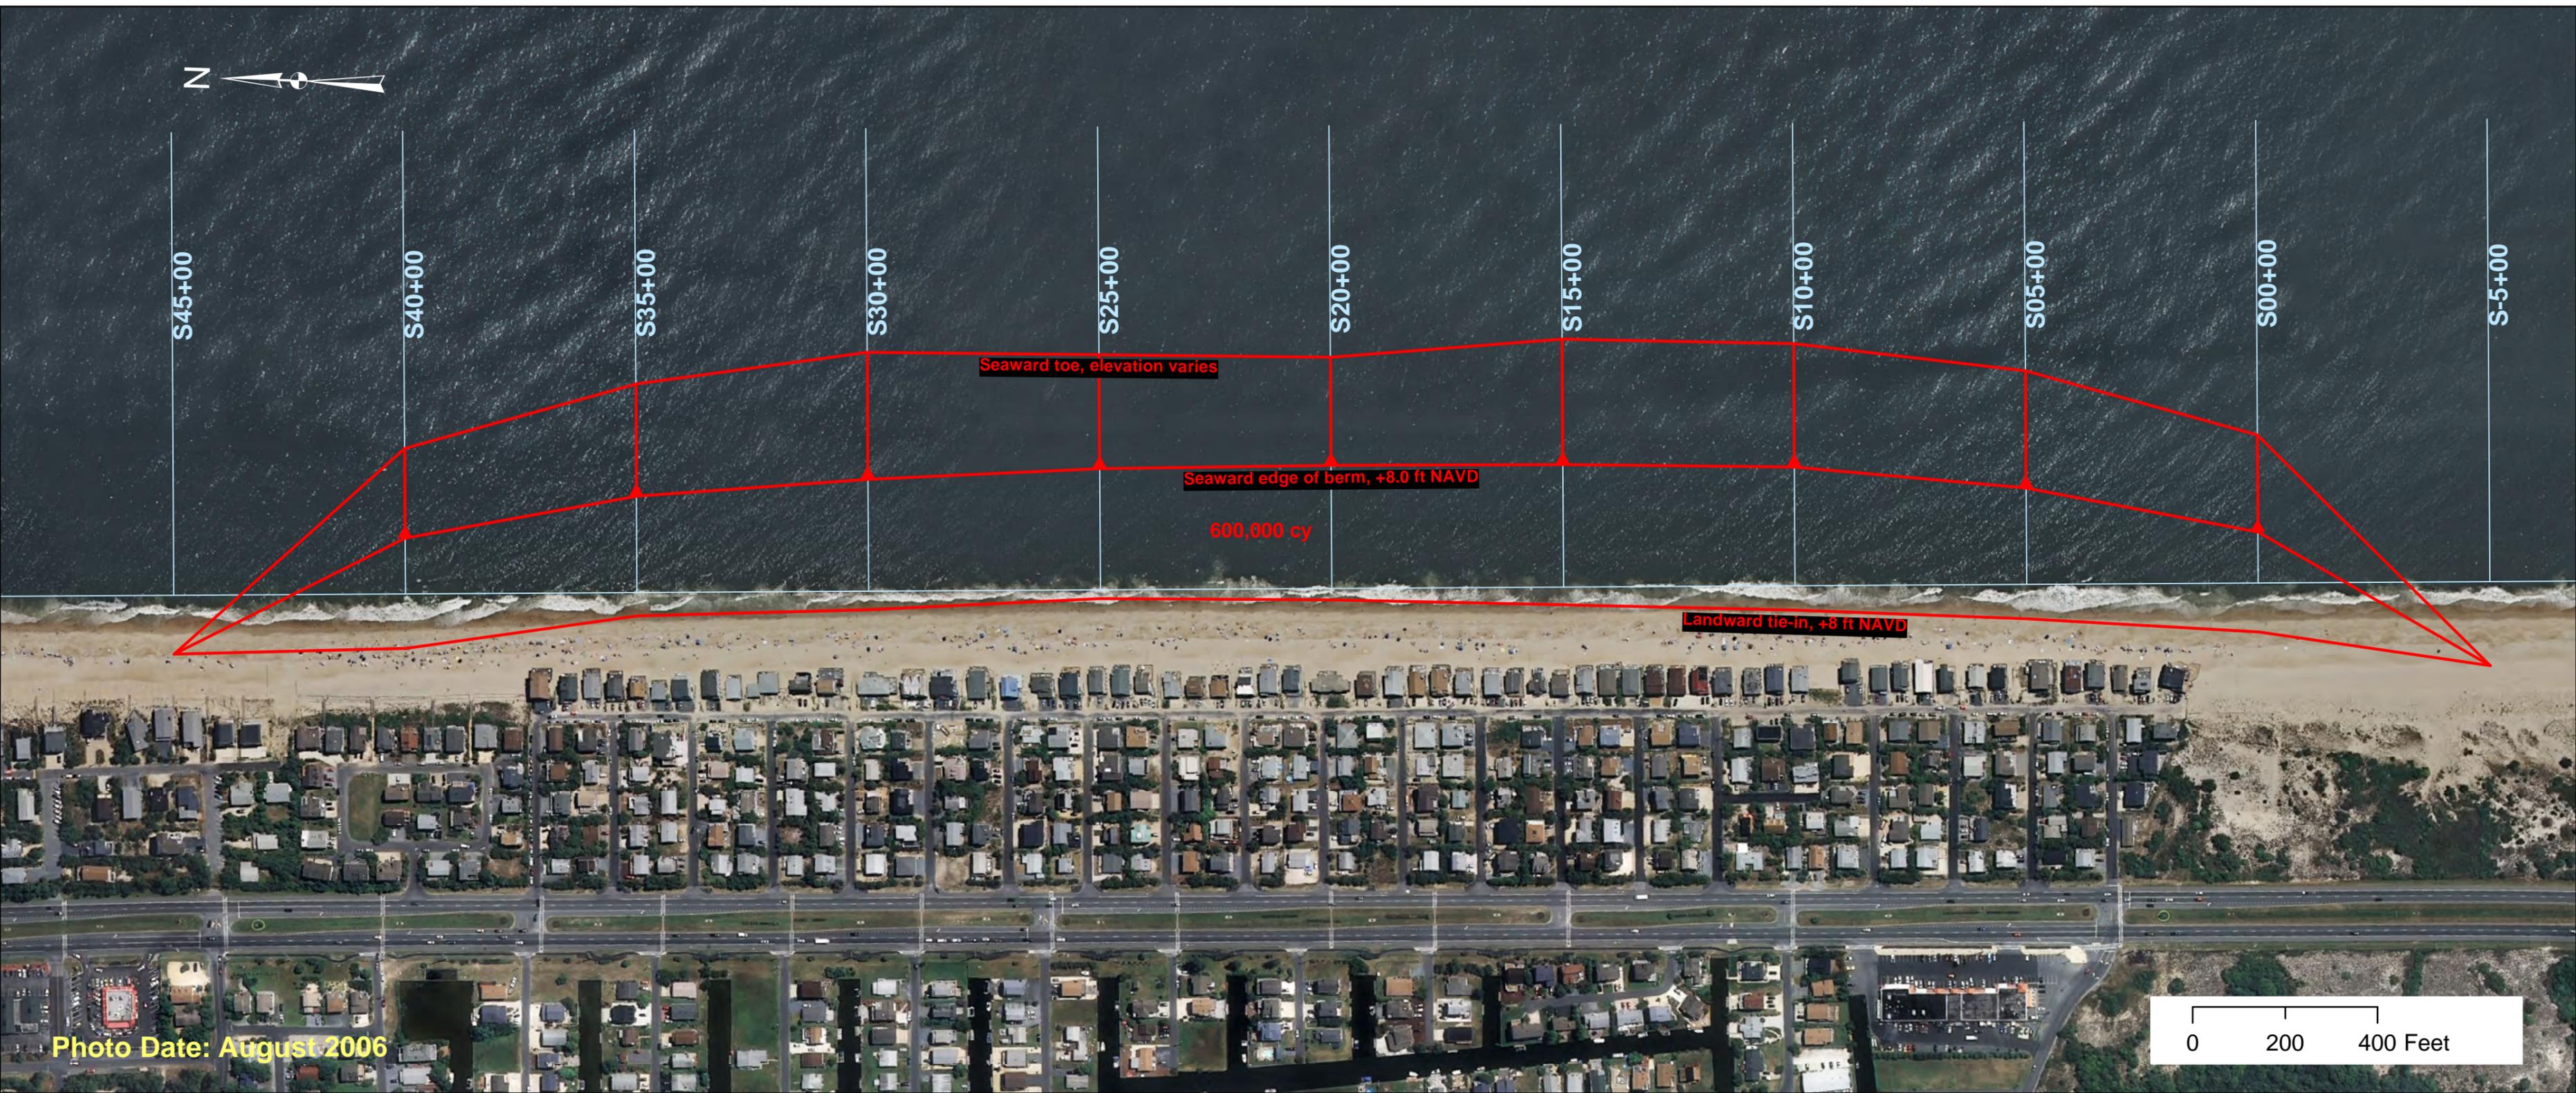
Seaward toe, elevation varies

Seaward edge of berm, +8.0 ft NAVD

600,000 cy

Landward tie-in, +8 ft NAVD

Photo Date: August 2006
