## **Appendix 21**

# **NECASTRO AUTO SALVAGE PROPERTY WILMINGTON, DELAWARE**

**SIRS ID: DE-0283**

PCB Mass Loading Phase II  
Necastro Auto Salvage Property  
SIRS ID: DE-0283  
Wilmington, Delaware

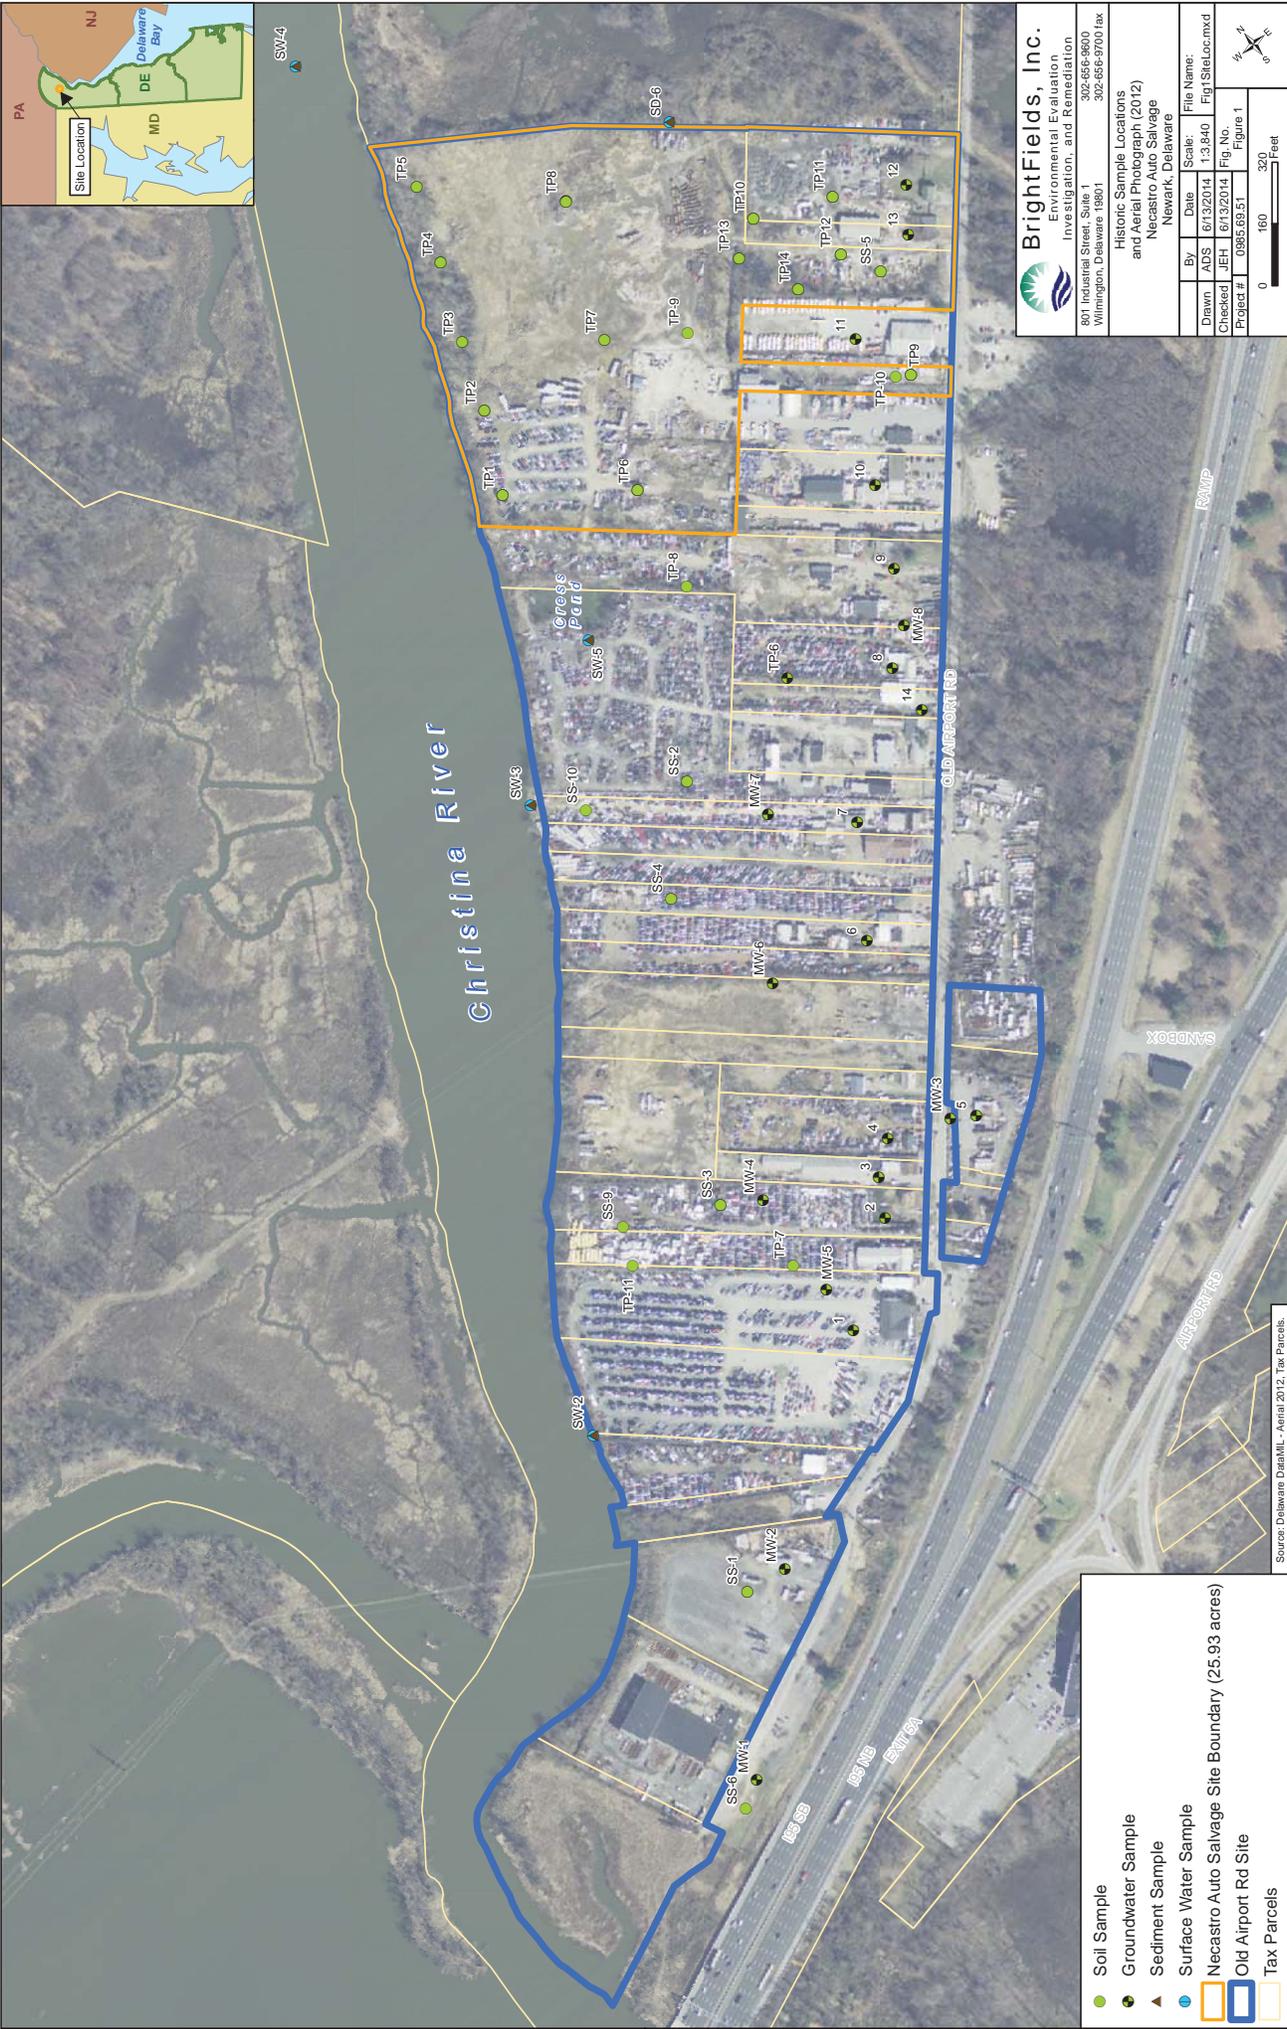
By	Date	File Name:
ADS	6/13/2014	Fig1 SiteLoc.mxd
Checked	JEH	6/13/2014
Project #	0985.69.51	Figure 1

Historic Sample Locations  
 and Aerial Photograph (2012)  
 Necastro Auto Salvage  
 Newark, Delaware
