STRUCTURAL SURVEY

FORT DUPONT STATE PARK

GREDELL & ASSOCIATES
STRUCTURAL ENGINEERS

AUGUST 1993

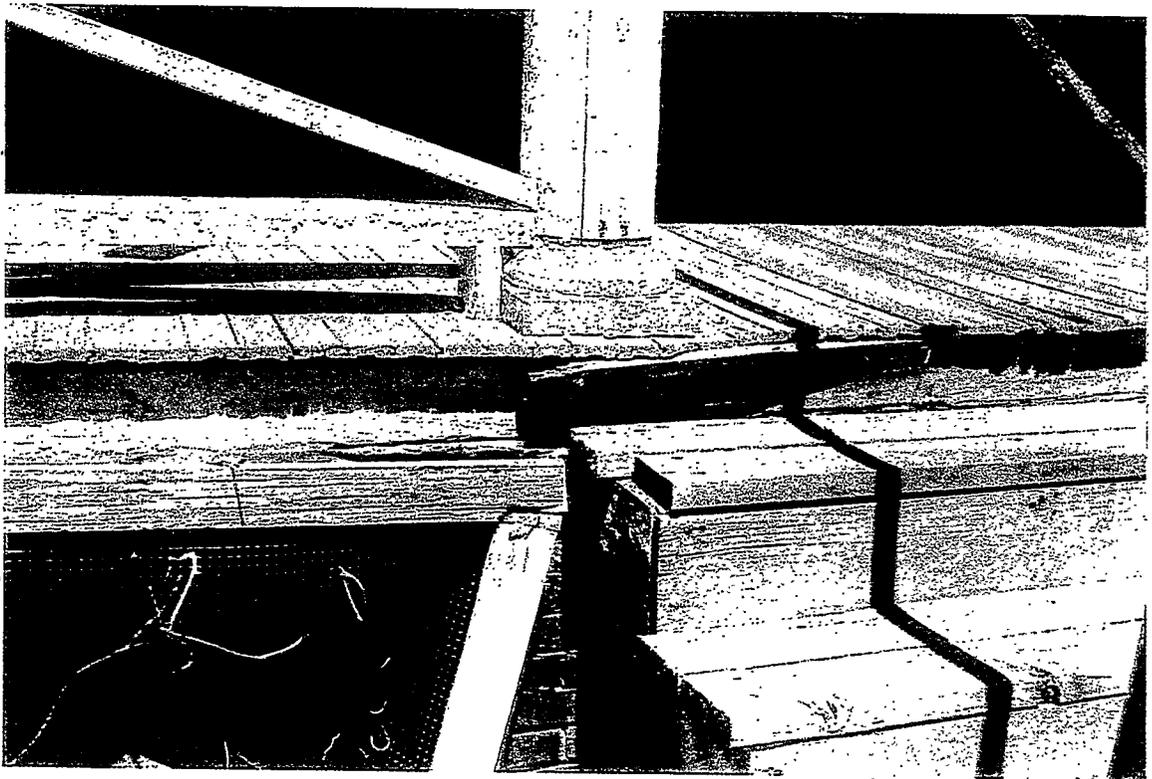
6

A majority of the porch decking is severely weathered with portions of the decking cupped and/or rotted. The porch framing at the outboard sections is deteriorated; especially at the post bearings.

See photos 6, 7, and 8. The porch stairs have several rotted/deteriorated treads and risers. See photo 7. At the front porch railing there is an accumulation of wood dust directly below the railing on the deck structure; evidence of an active infestation of wood boring insects (probably carpenter bees). See photos 9 and 10. The porch skirting frames are broken and cracked at several locations. See photo 6. The interior floor framing is in relatively good condition. There were no indications of structural distress.

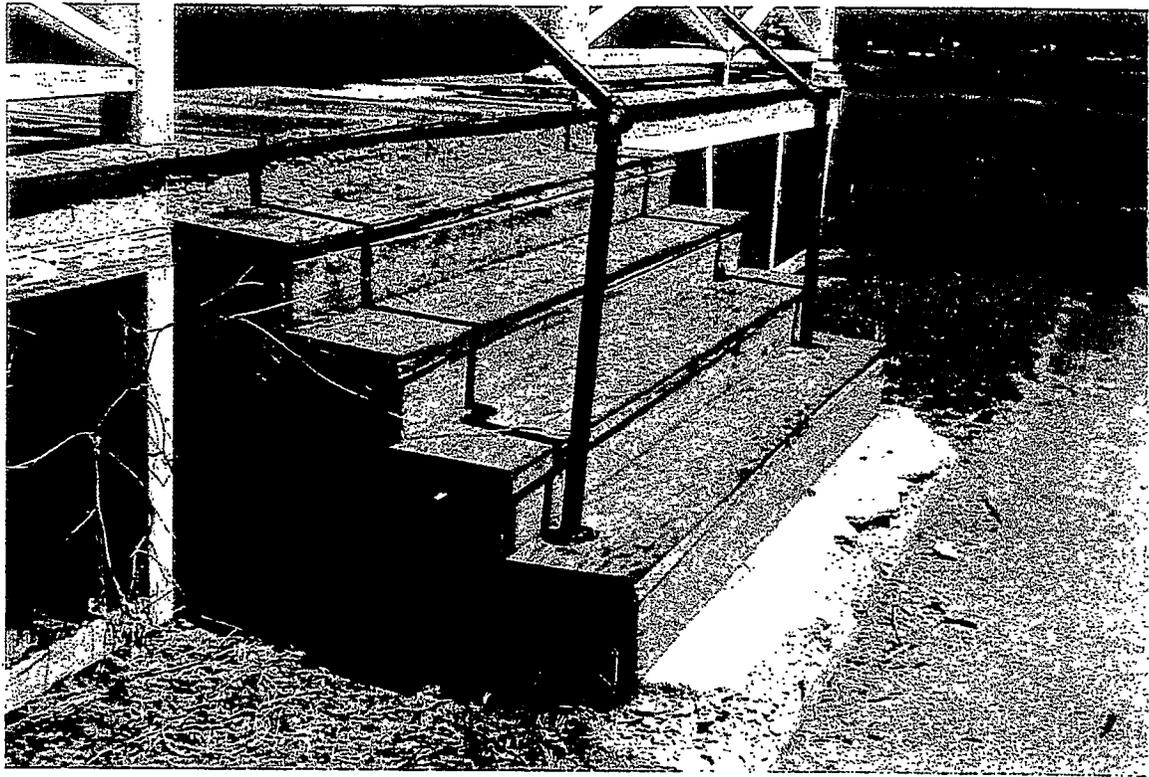
7

The concrete step located at the bottom of the front porch stairway is severely deteriorated due to freeze/thaw damage. See photos 7, 15 & 16. There are three piers supporting the rear deck that exhibit loose, spalled concrete which requires repair.

1. Repoint exterior walls. (Approximately 100 sq. ft. req'd.)
2. Repoint front porch piers.
3. Remove deteriorated concrete at porch step landings. Provide similar repairs at rear deck piers.

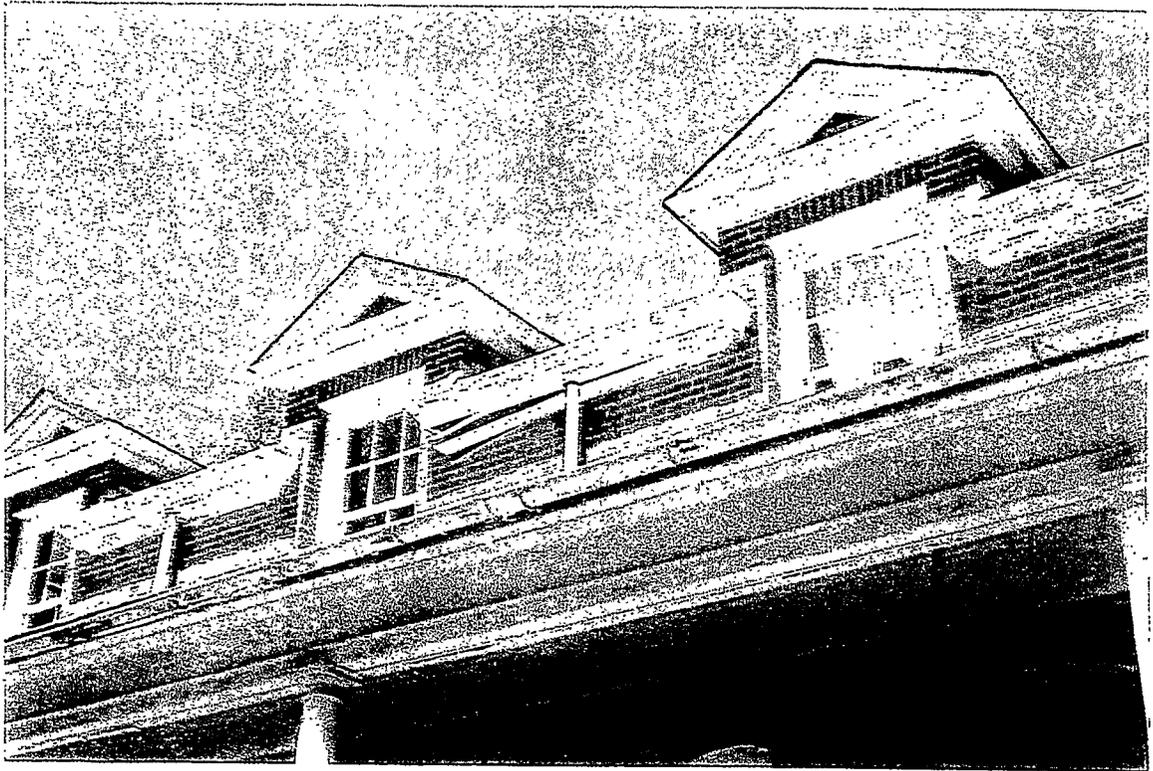
12

At the eaves, the cornice molding, fascia and especially soffit boards are deteriorated requiring replacement. See photo 12.

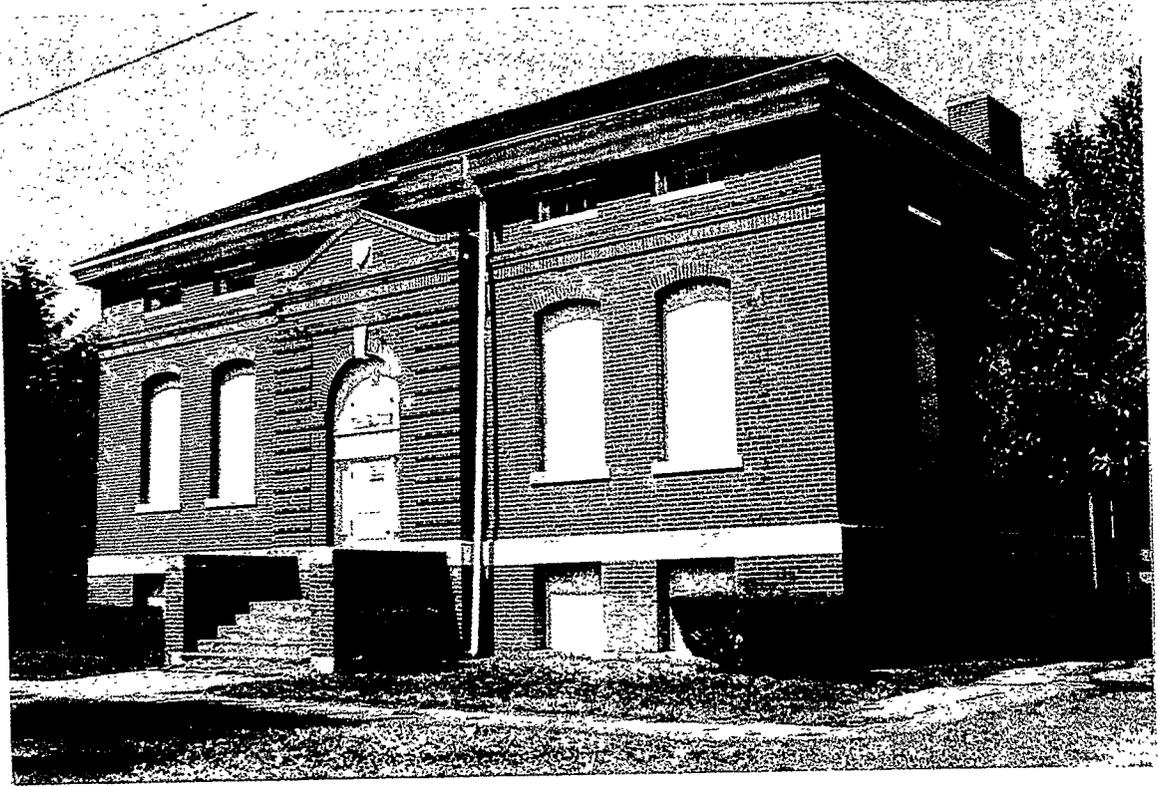
2

With the exception of the attic windows, all the windows and doors have been boarded up. Many windows have broken glass and require repair and reglazing. See photos 1, 2, 4, 5 & 19. The areaway doors leading into the boiler room are boarded up. See photos 9 & 17.

10. Repair windows and doors to match original photograph.

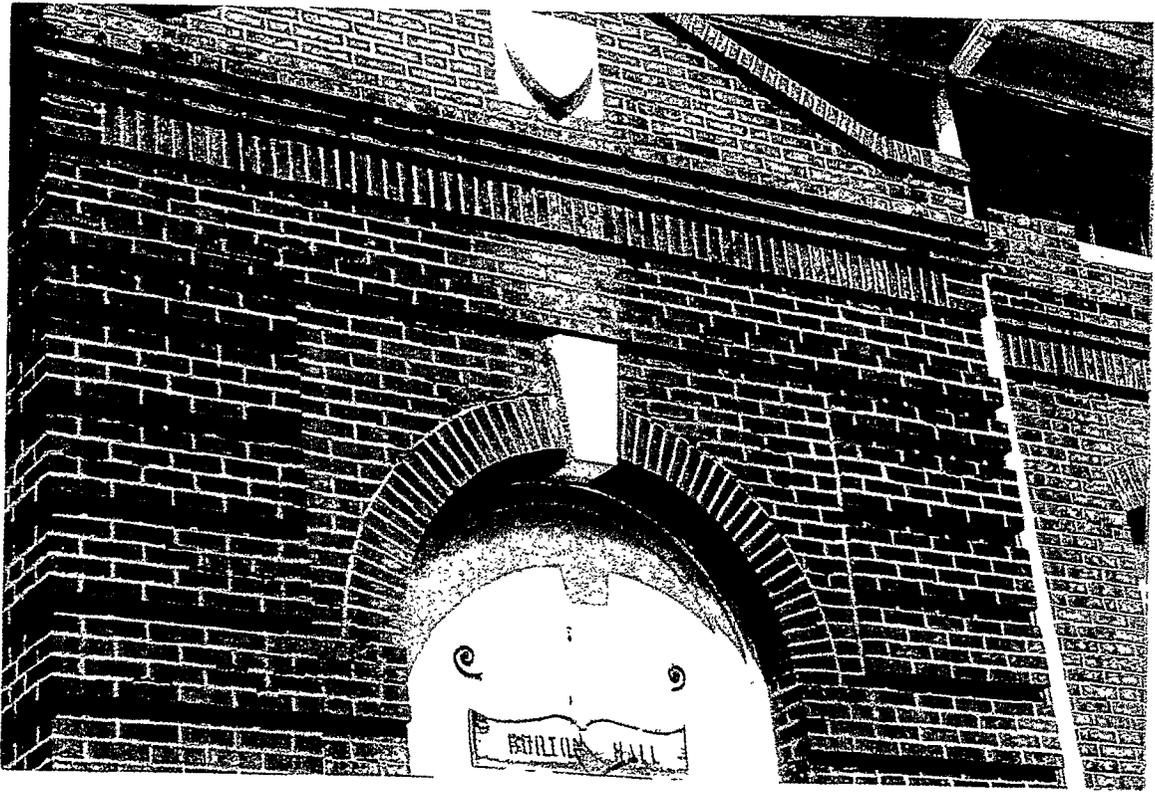
Approximately 25 percent of the total building exterior brick masonry requires repointing especially at the upper 10 feet of wall. See photos 6 and 7. There are some loose bricks observed above the lintel at the doorway between the boiler room and the coal room.

2. Repoint approximately 25% of total exterior brick masonry.
3. Remove loose spalled concrete on exterior stairs and repair at front entrance and side areaway.
4. Replace west elevation shed roof shingles and deteriorated sheathing.
5. Replace gutters and downspouts.
6. Repair/replace rotted cornice molding, fascia and soffits.
7. Repair all windows and doors.
8. Repaint exterior millwork, windows and doors.
9. Obtain inspection services of an exterminator to ascertain extent, if any, of an active infestation.

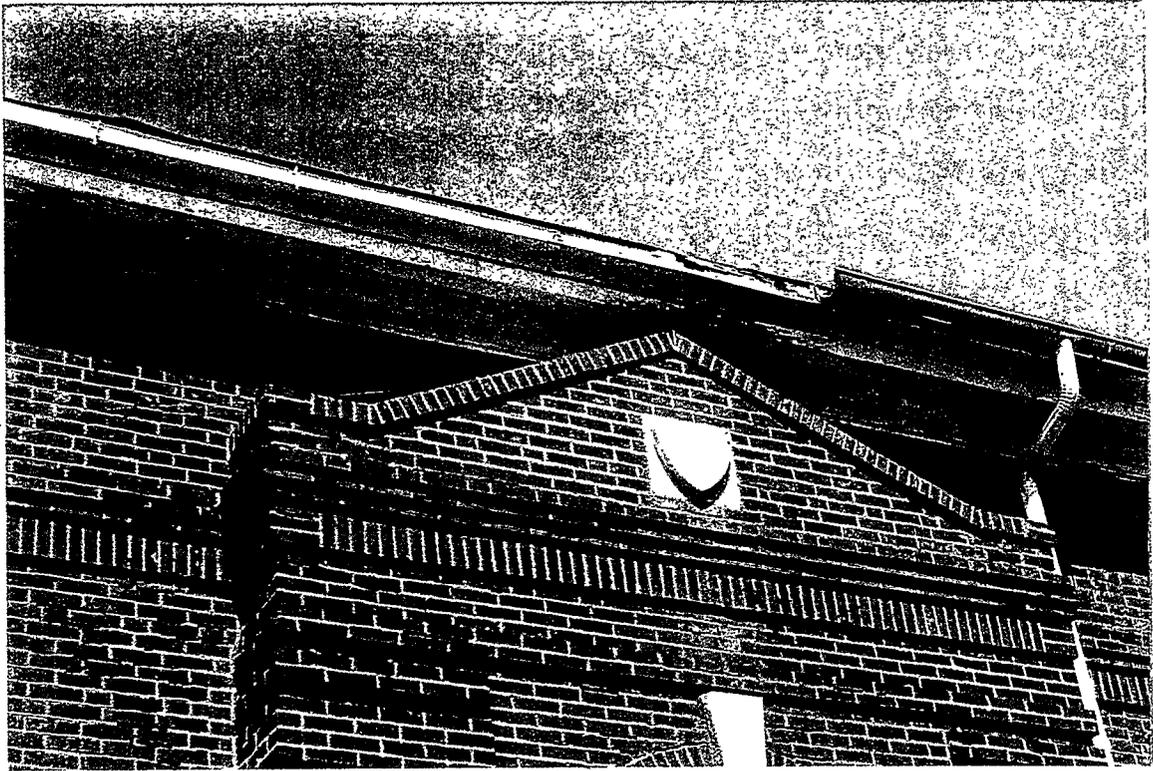
The cornice molding, fascia and soffit are rotted and deteriorated at several locations. See photo 12 and 13. All exterior wood trim, doors and windows require stripping and repainting. We suspect that the existing paint is lead based. Portions of the front door are missing and is need of paint and caulking. See photo 8. At the exterior gymnasium door, the head molding is missing exposing the wall cavity to the elements.

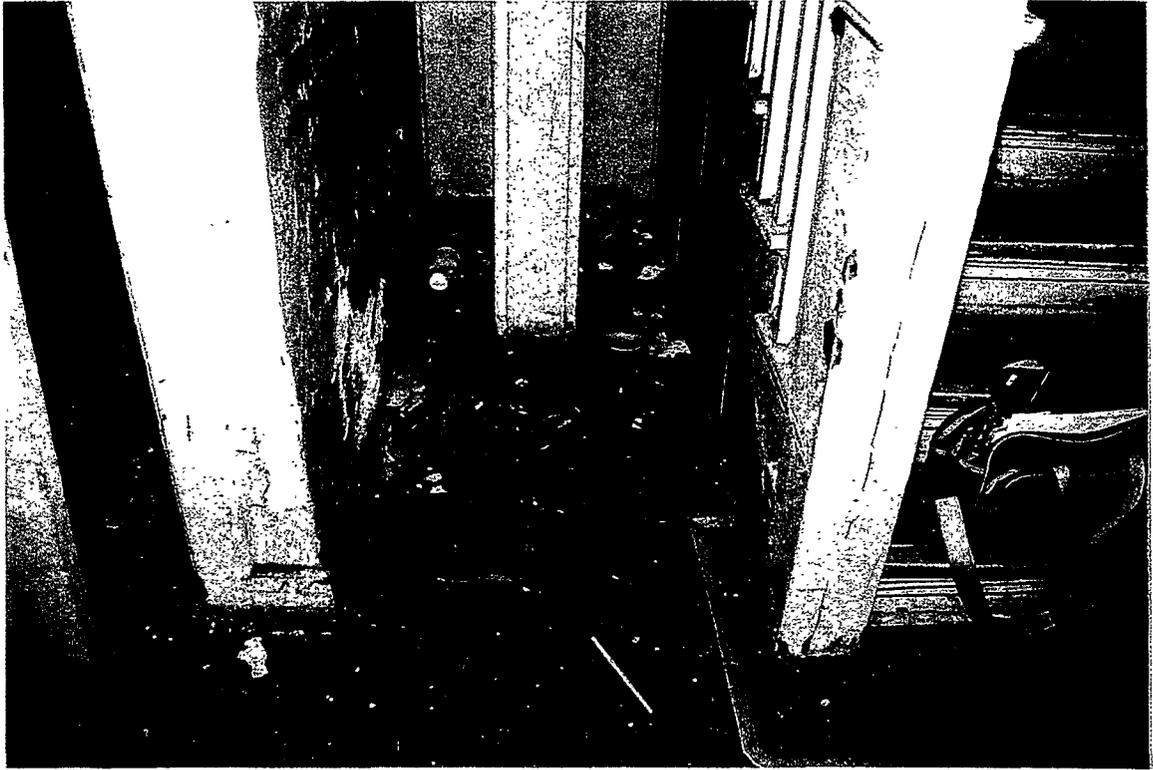
14

The gym flooring although worn, appears to be in sound condition. At the base of the stairs in the basement floor, there is a large amount of rot observed in the wood flooring. See photo 14. The first floor joists are 2x12's spaced at 16" o.c. and appear to be in good condition since most framing is concealed by finishes. The bowling alley floors are deteriorated and show signs of rot. There is evidence of water damage which does not appear recent. See photo 16. The floor tiles are cracked and chipped in front rooms, hallway and entrance foyer.

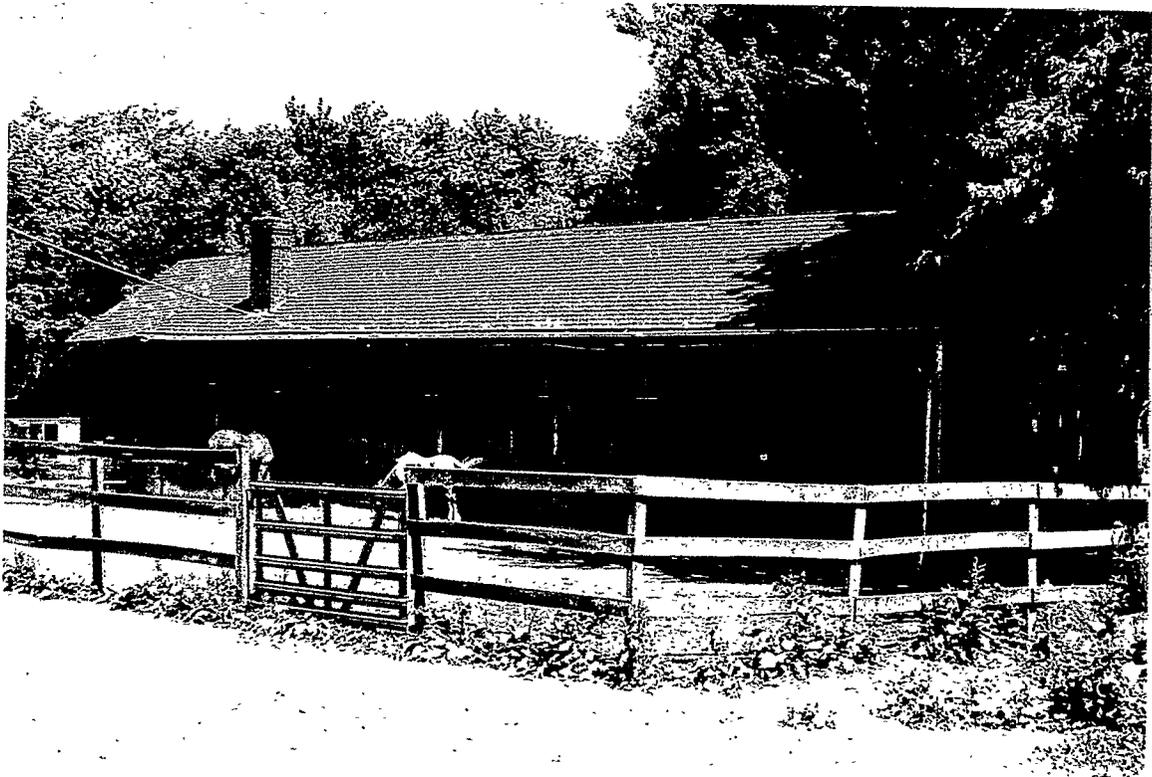
The existing roofing is slate which in general, is in fair condition. There are, however, individual slates which have become loose, especially near the chimney on the east elevation. Photo 6. There is a section of flashing at the roof which is missing at the chimney. Photo 5 & 6. Gutters along the east elevation are nonexistent. A section of gutter is missing along the west elevation. The downspouts are either missing or unconnected to the gutters. See photos 5 & 7.

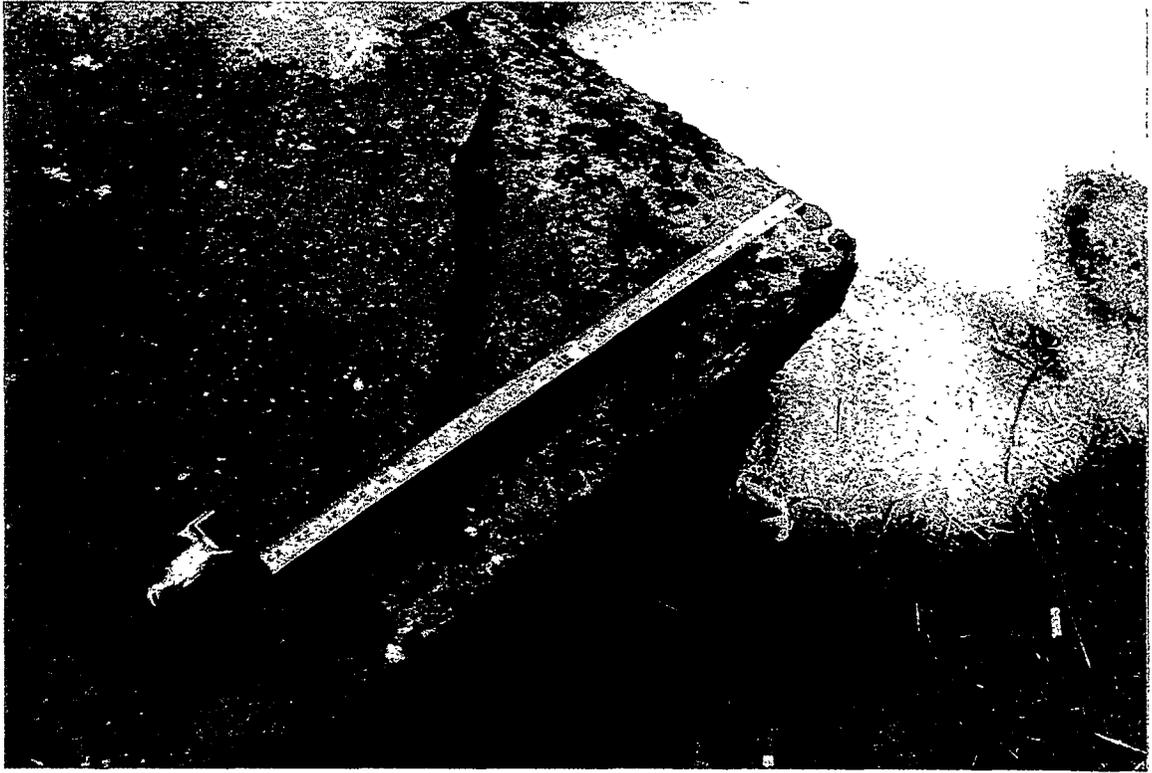
12

At the front entrance, a concrete slab 8 feet wide is situated and is elevated approximately 18 inches above grade. There is a portion of the concrete topping which has disbonded and requires repair. See Photo 12. The floors are concrete slab on grade which appear in good condition.

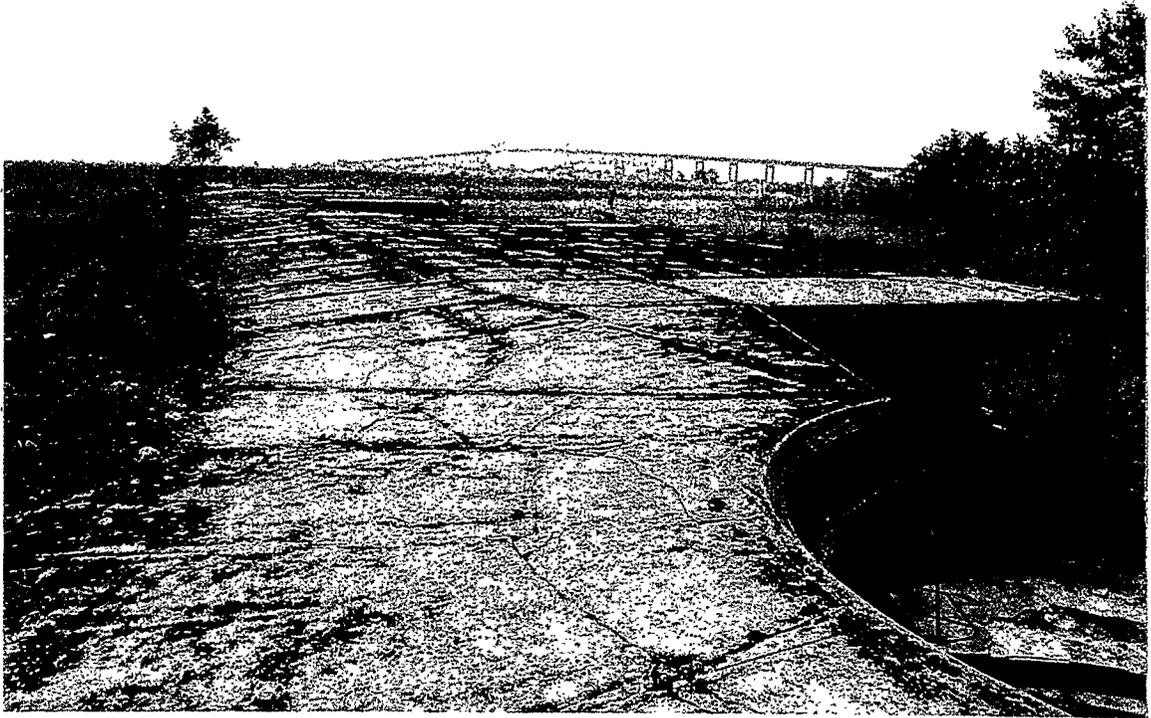
4

1. At several locations, construction joints have opened allowing vegetation to grow in the cracks. Photo 4.
2. The roof of the structure was at one time coated with a bitumastic coating. Practically none of this coating currently remains. Photo 4.

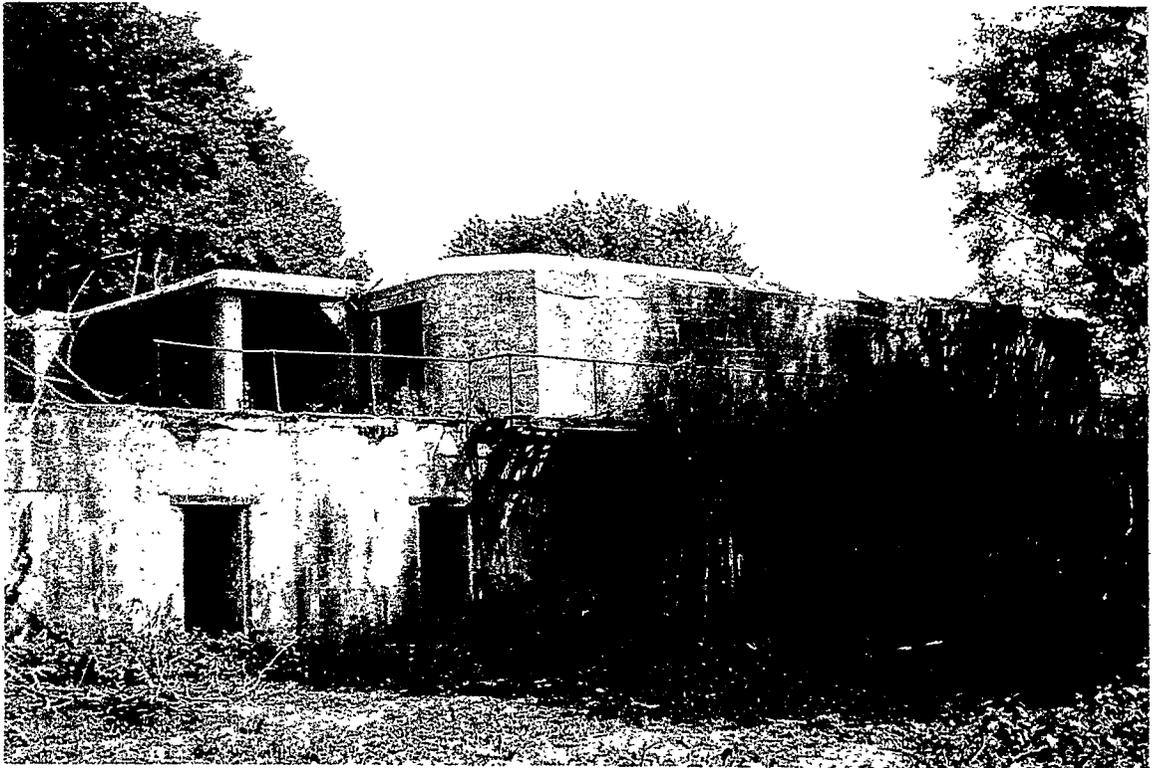
5

4. The concrete has deteriorated at several locations. Cracks and spalls from freeze/thaw damage are visible throughout the entire structure. Photos 7, 8, 9, 11 & 13.
5. Vegetation has grown in several cracks, and in the bituminous coating on the rifle mount level. Photos 9 & 12.
6. At each gun mount, several projecting anchor bolts occur which pose a safety hazard. Photos 8, 9 & 14.
7. Attached to the western wall, a wood and steel angle frame walkway connects adjacent emplacements. This deck is severely decayed and rotted and is impassible. The steel is in fair condition; however, the timber requires replacement. Photo 16.
8. There is a pipe railing along the western elevation, however, several portions are missing and the post mountings have deteriorated. Photos 5, 10, 15 & 17.

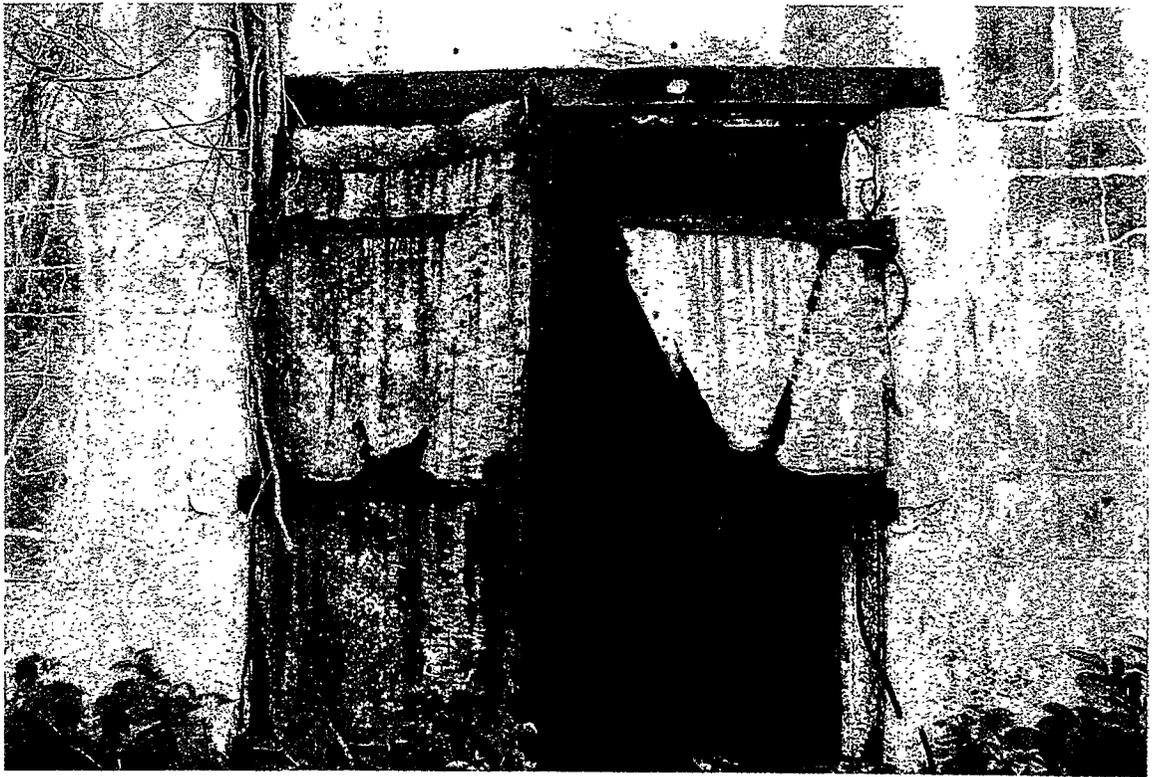
18

9. Many doors are either deteriorated or are missing. Photo 18.
10. External stairways leading up to the rifle mount level are missing. Photo 17.
11. Entering the various chambers, the ceilings are moist, with visible calcium deposits forming stalactites. The ceiling structure is comprised of cement plaster over steel, wide flange beams and hollow clay tile arches. Due to the presence of moisture, several areas of plaster have collapsed. The steel beams are severely corroded. Photos 19 & 21.

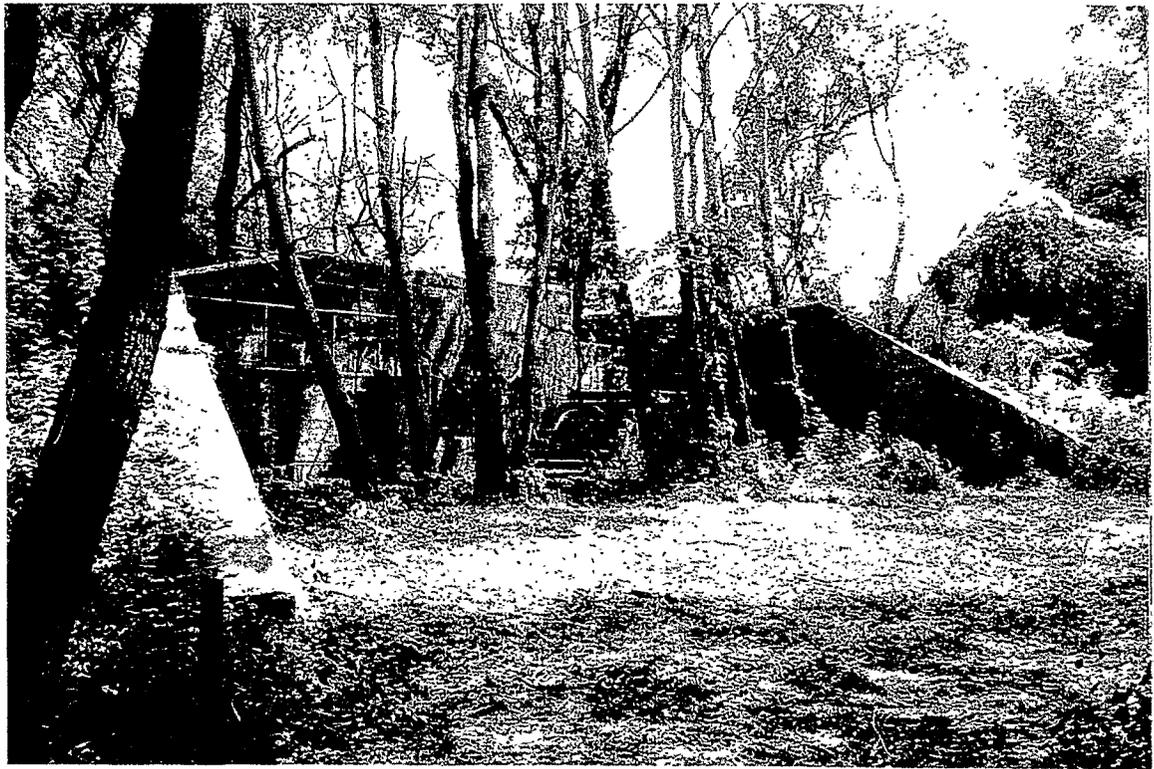
②

6. Portions of the handrailing are missing on the north side. See photos 2 & 3.
7. There is an armored cable draped across the west elevation which obstructs access to doorways and the steps. See photos 3 & 4.

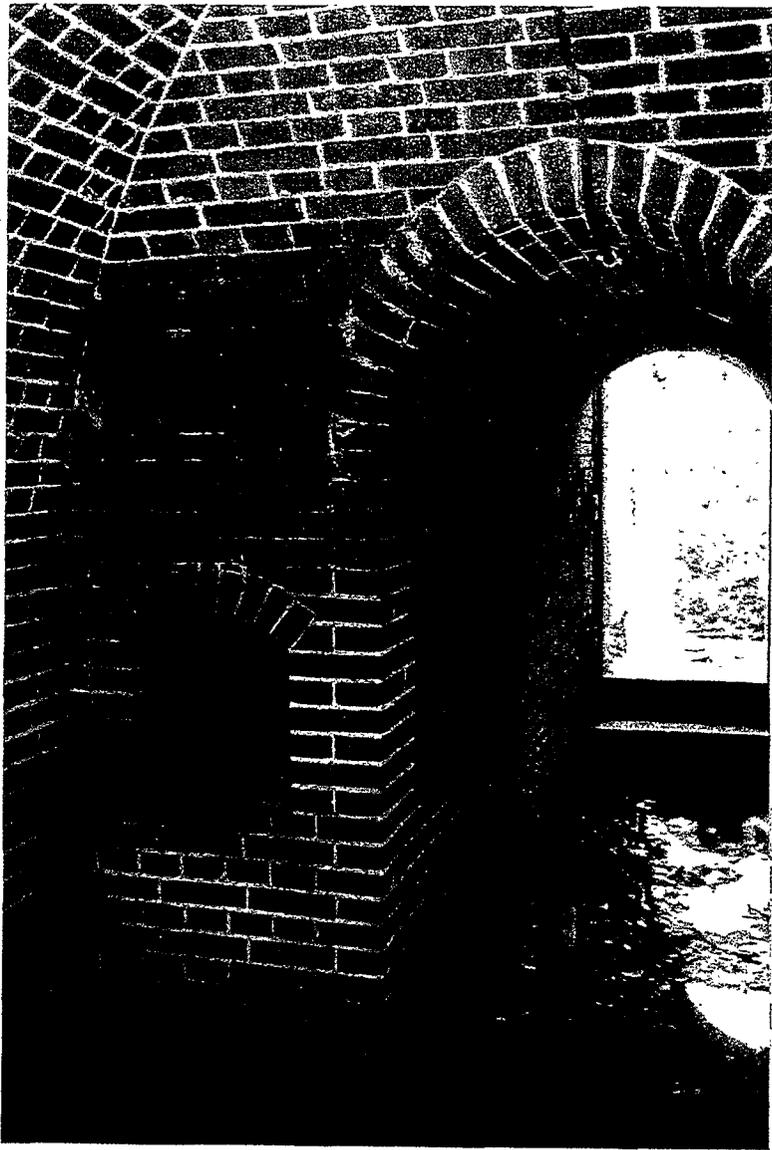
For the most part, the structures are in good condition (see photos 5 and 6) except at the westernmost location where the entranceway to the double vault has been partially demolished.

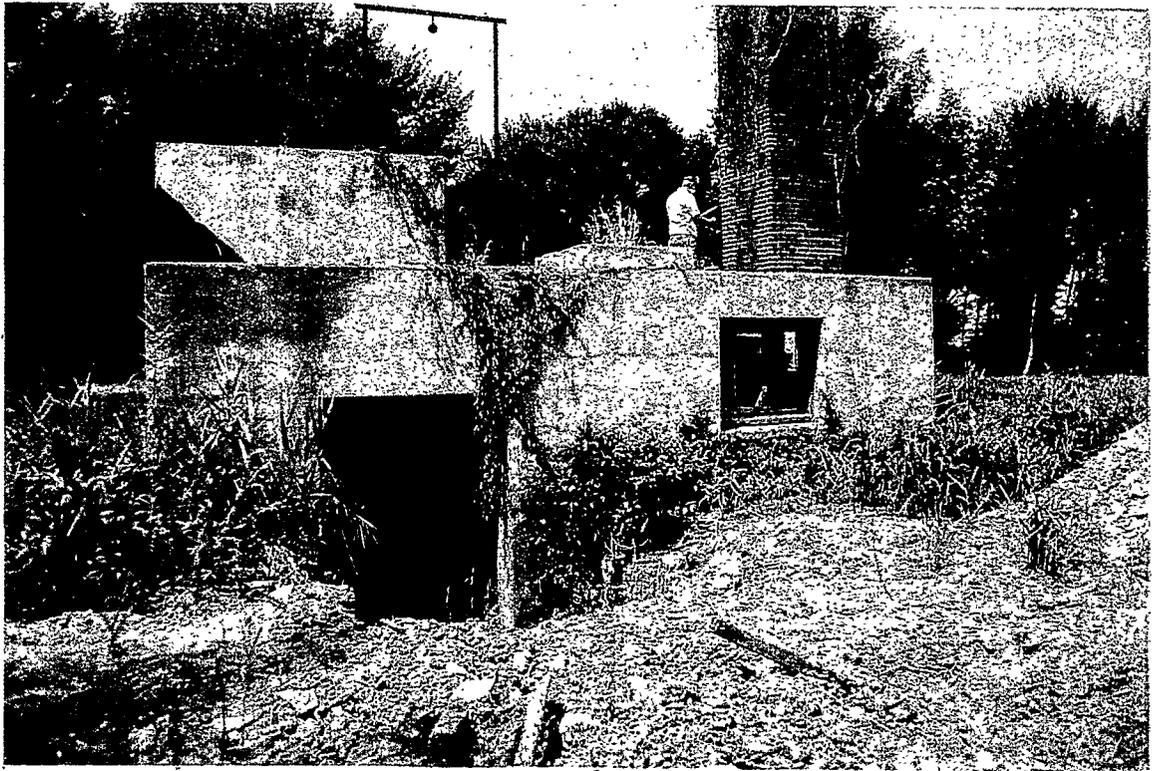
At the elevated loading dock area, the concrete is deteriorated due to freeze/thaw action. See photos 2, 3, 5, 7 & 8.

For the most part, window frames are in place, however, they are in bad condition. See photos 2 & 3.

The site requires regrading to provide positive drainage from the doorway. Although no documentation is available, it appears that an exterior stairway has been removed from the lower level doorway, allowing the surrounding earth to be eroded by rainwater and carried into the oven room. See photos 2 & 6. The site is littered with debris which requires removal both inside and out. See photos 9 & 10.

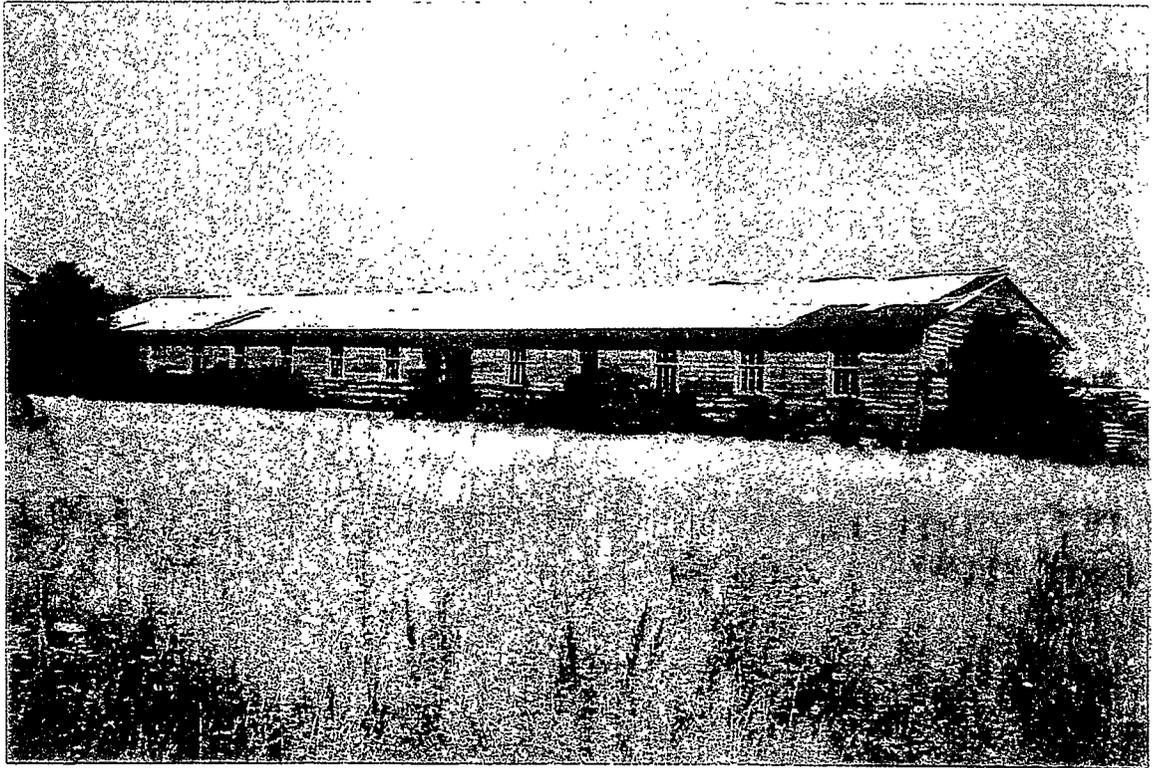
5

The exterior walls are framed by 2x4 studs spaced at 24" o.c. and are sheathed by 1x6 tongue and groove decking laid diagonally (See photo 20). At every fourth roof rafter, there is a knee brace which extends to the wall stud. These braces only occur in the longer building. The exterior walls are clad with wood clapboard siding. The existing paint is severely weathered and the entire exterior requires repainting. See photos 1 & 5. Approximately 25% of the clapboard siding of the lower portion of the wall requires replacement. See photos 5, 16 & 22. The loading dock at the rear of the west building appears to have been added after the building was constructed. Creation of the loading dock caused the foundation wall to be undermined and now requires underpinning. See photo 5. The entire perimeter of the complex requires that all the overgrown vegetation be removed. At portions of the structure, vines have actually grown up under the siding and has caused the siding to separate from the sheathing. See photos 5, 9 and 10.

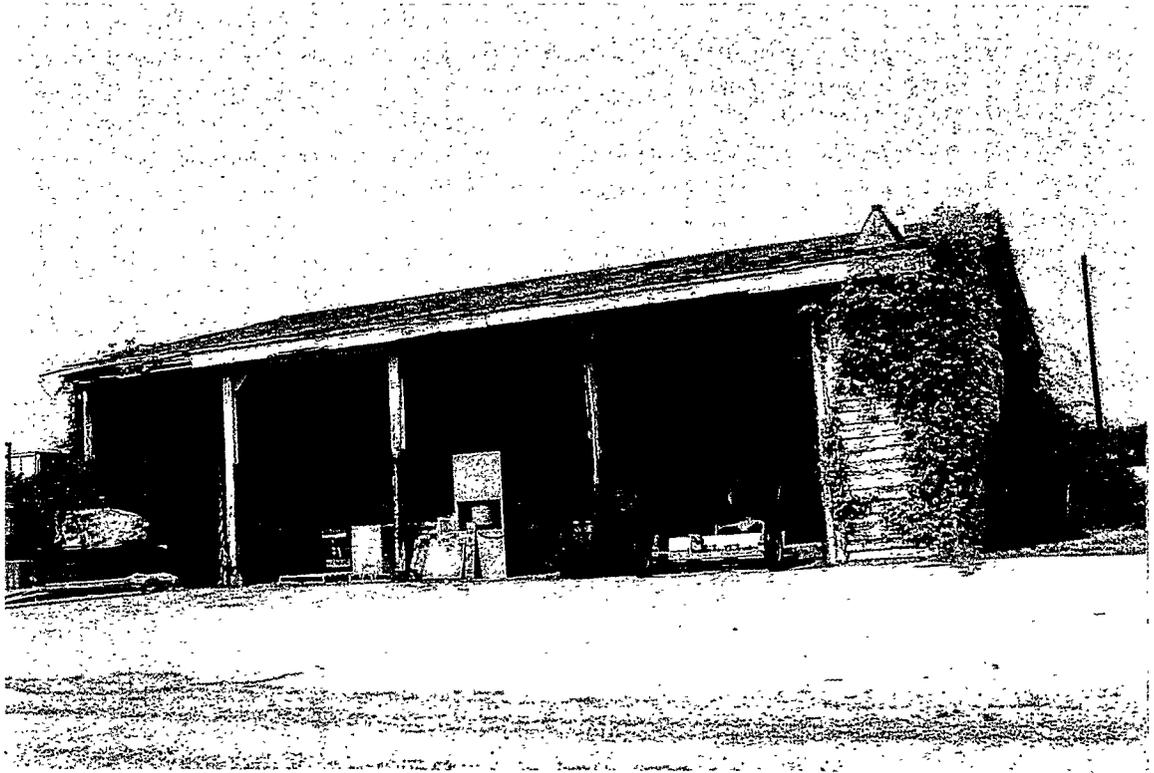
2

The end walls are framed with 2x6 studs spaced 24" o.c. and are doubled at window openings. The walls are overgrown with vegetation which requires removal. See photos 1, 2, 3, 4, & 7. Portions of the siding are missing on the east wall. See photos 3 & 5. Forty percent of the exterior siding is in need of replacement. The building needs to be repainted. See photo 5.

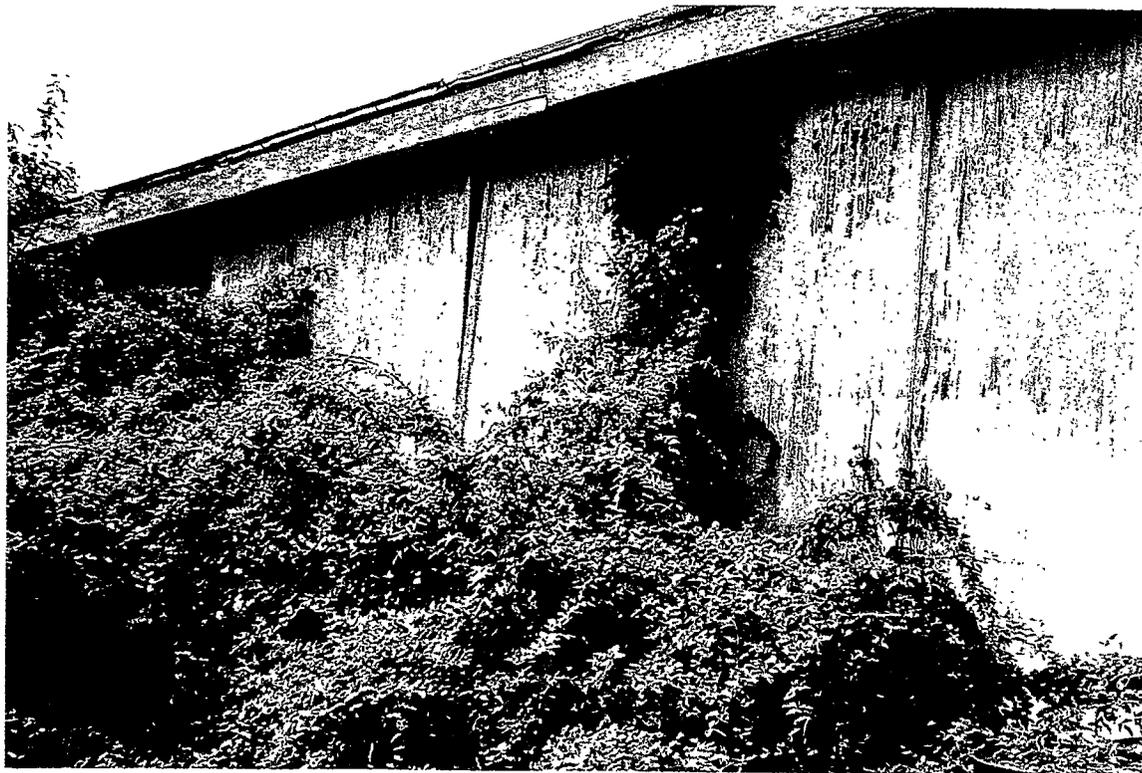
6

The four large doors across the rear of the building are observed to be derailed from their tracks. There are portions of these doors which have deteriorated timber. See photos 1, 6, & 7. The door trim is severely weathered and requires painting. See photo 1. The right end wall exhibits evidence of originally having windows. The existing headers are still visible and the openings have since been infilled.

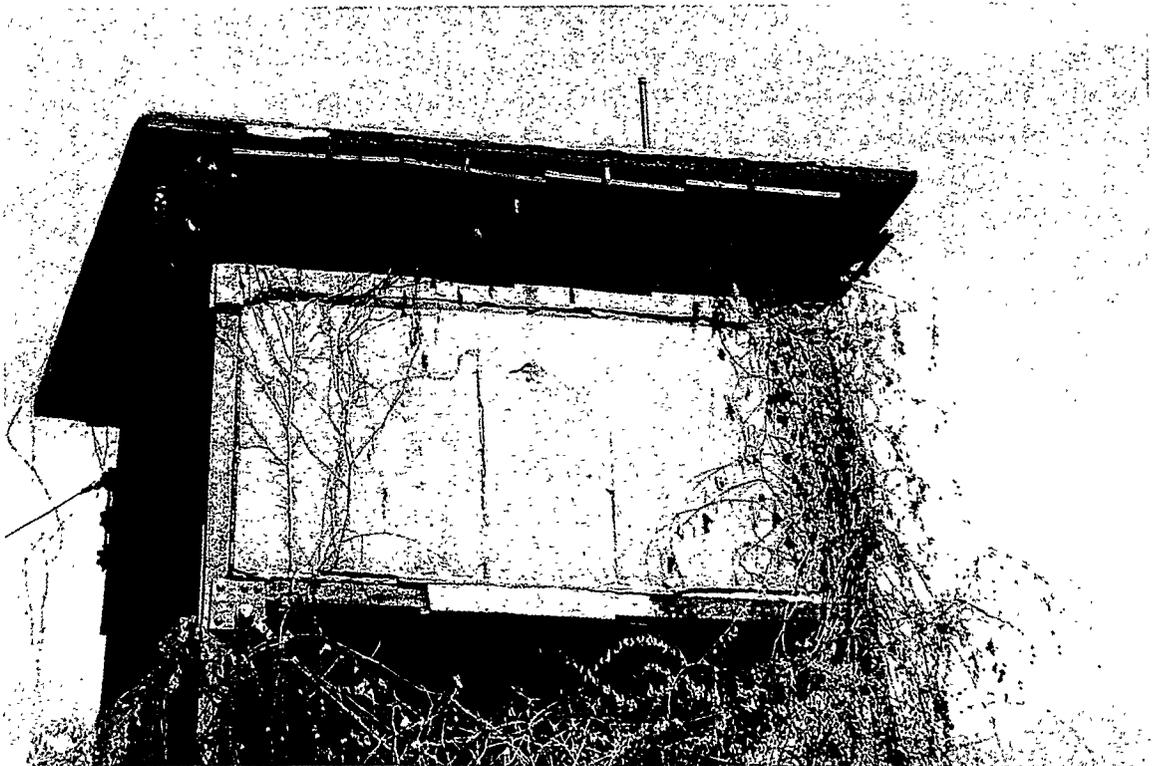
3

The concrete deck is in fair condition. The concrete wall infill and roof deck have spalled and/or cracked primarily due to the expansive forces accompanying the steel frame corrosion.

1. Remove all loose, spalled and otherwise distressed concrete.
