PCB Mass Loading Phase II  
Donovan Salvage Works Property  
SIRS IDs: DE-0338, DE-0349  
Georgetown, Delaware

# **DONOVAN SALVAGE WORKS PROPERTY GEORGETOWN, DELAWARE**

**SIRS IDs: DE-0338, DE-0349**

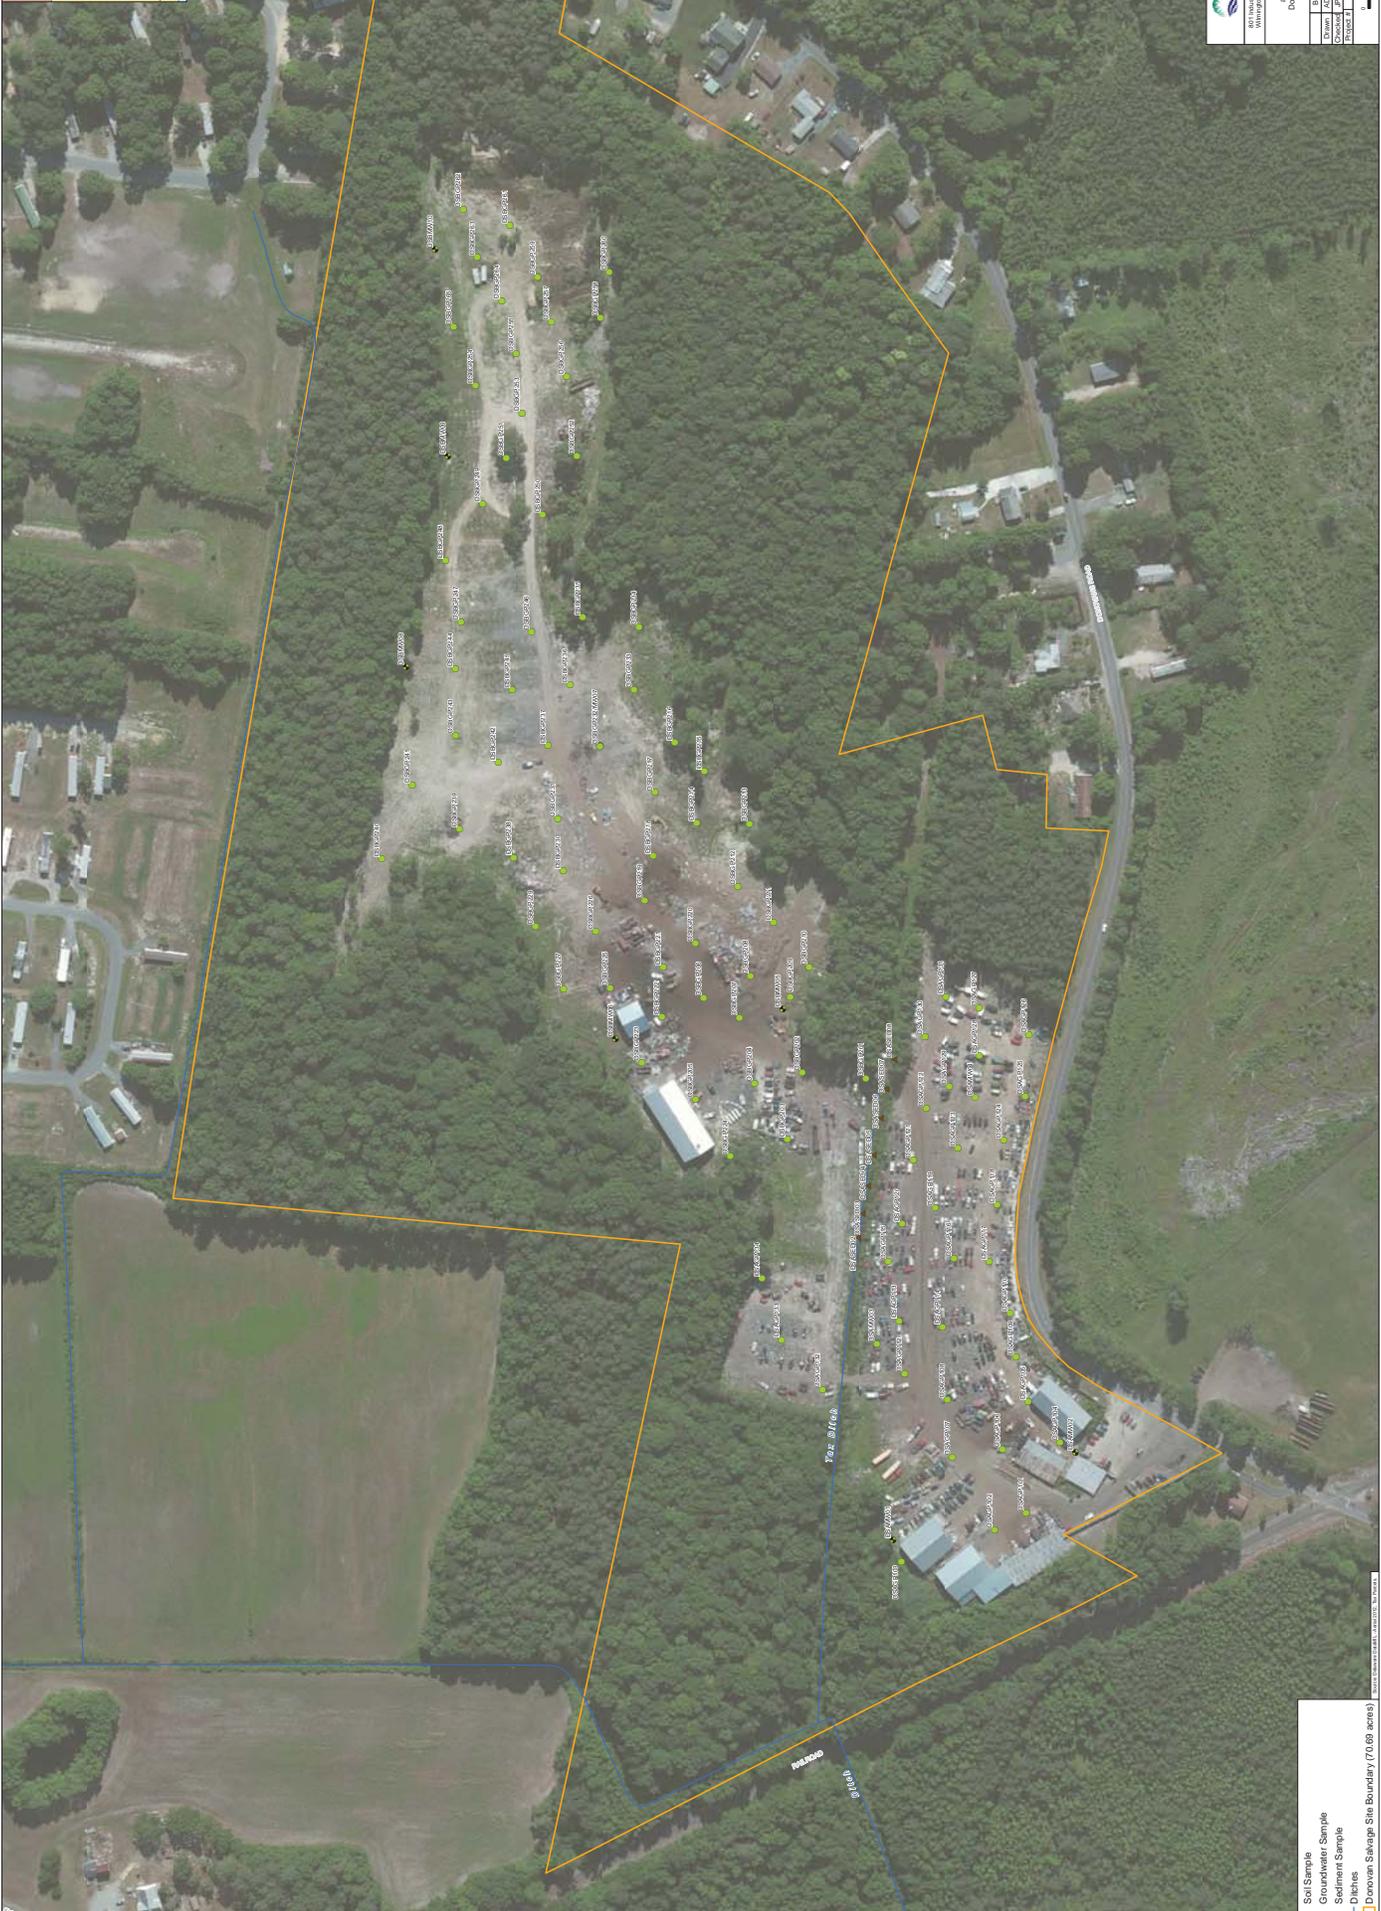
**Historic Sample Location**  
 Donovon Salvage Yards Property  
 Georgetown, Delaware

- Soil Sample
- ▲ Groundwater Sample
- ▲ Sediment Sample
- Ditches
- Donovon Salvage Site Boundary (70.69 acres)

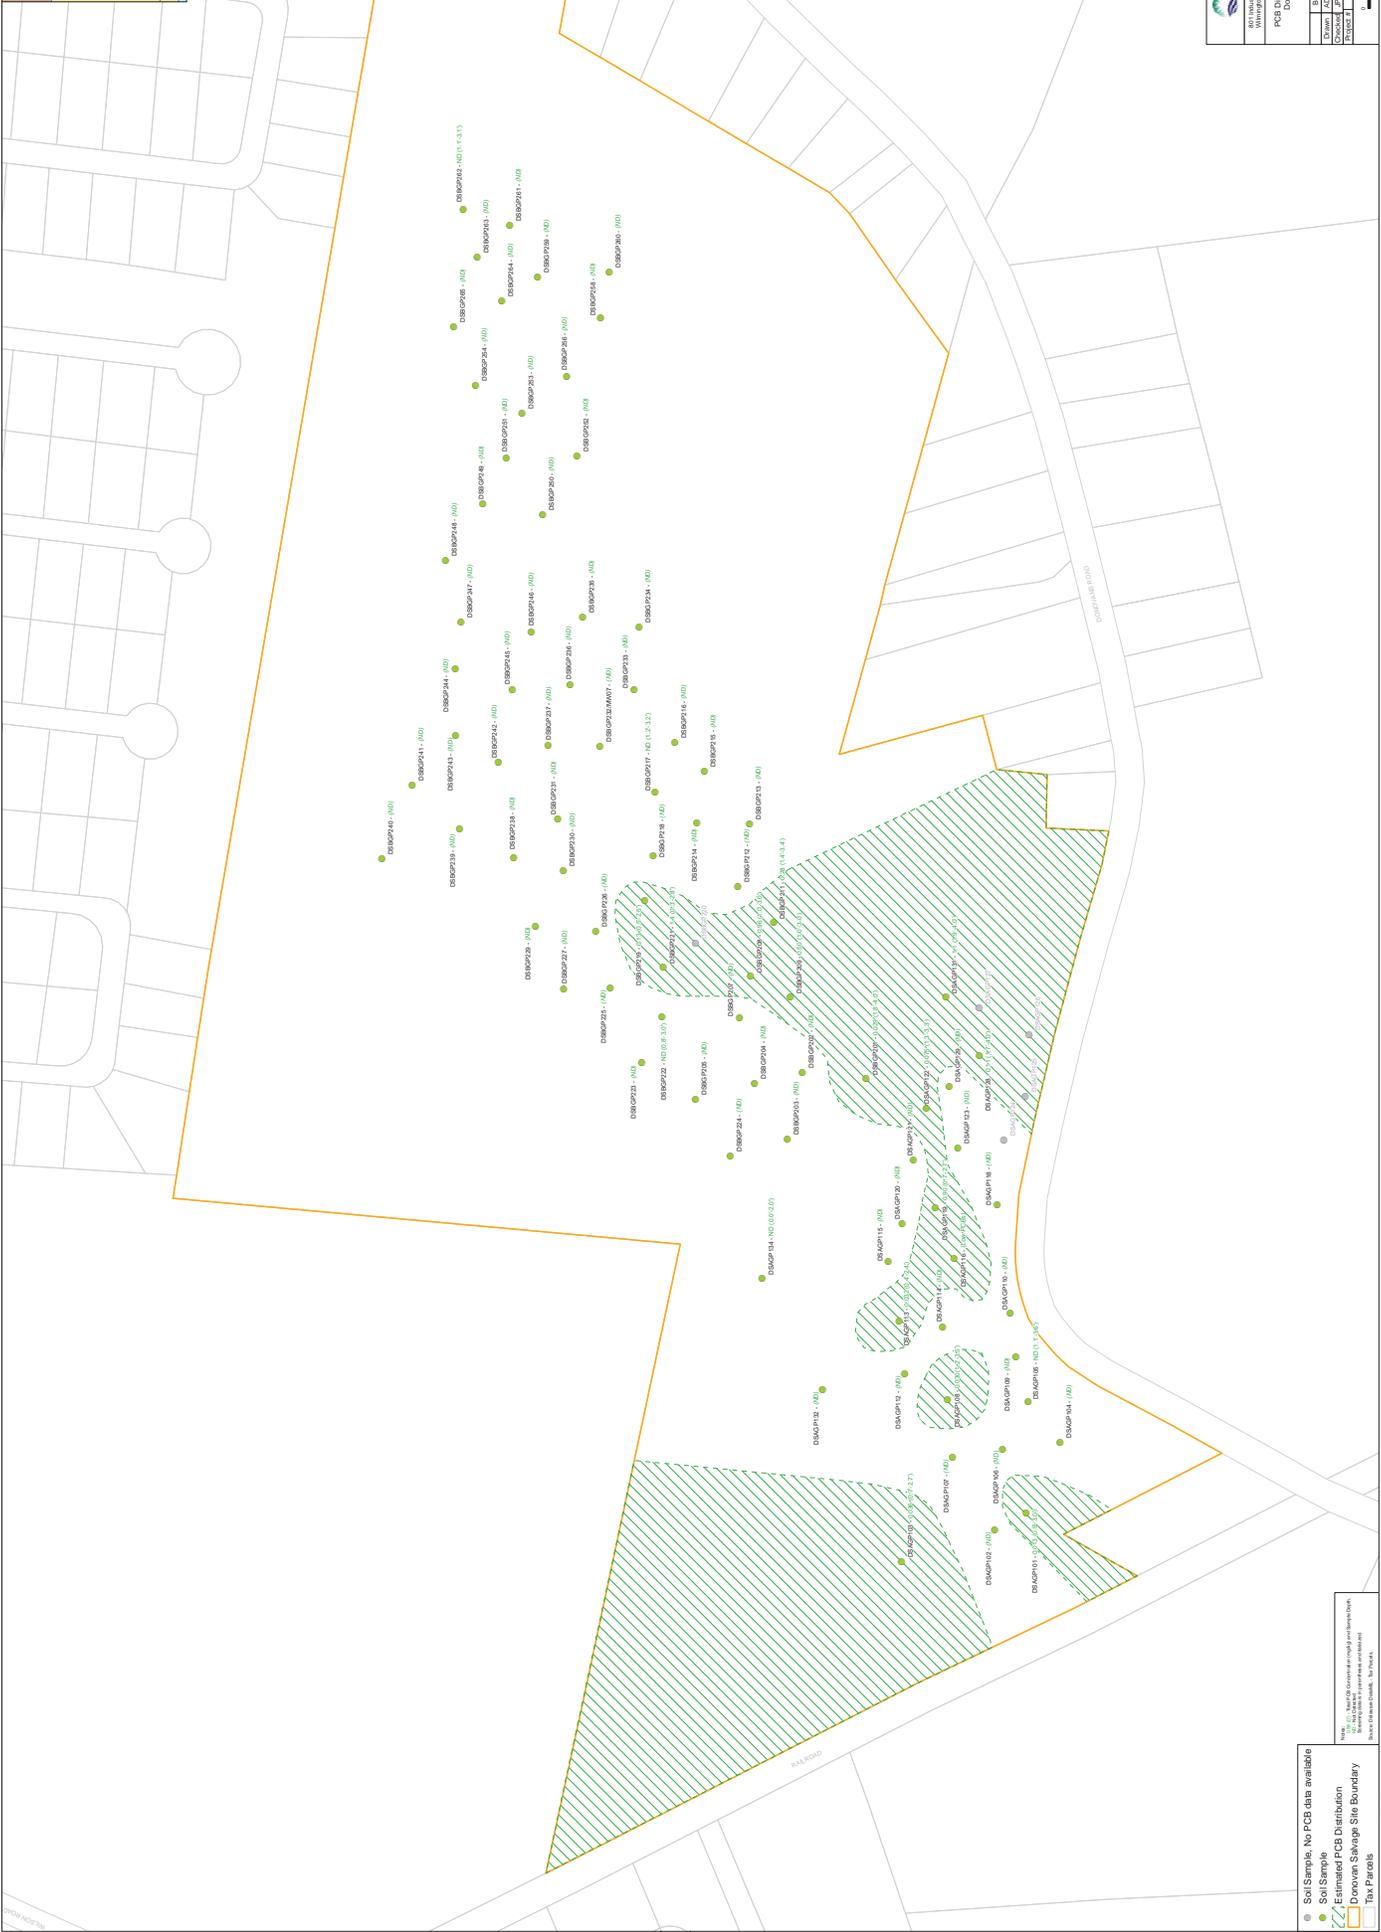
PCB Distribution in Surface Soil (P-2 bp)  
 Donovan Salvage Works Property  
 Geopengen, Luzerne County  
 PA 18202

- Soil Sample, No PCB data available
- Soil Sample
- ▨ Estimated PCB Distribution
- ▭ Tax Parcels

<b>Concentrations of PCBs on Site</b>			
<b>Sample Matrix</b>	<b>Corresponding Figure</b>	<b>Analytical Methods</b>	<b>Range of Total PCBs</b>
Surface Soil	Figure 2	Method 8082 and Screening Data	Not detected to 1.4 mg/kg
Subsurface Soil (unsaturated)	Figure 3	Method 8082 and Screening Data	Not detected to 1.4 mg/kg
Subsurface Soil (saturated)	Figure 4	Method 8082 and Screening Data	Not detected to 0.14 mg/kg
Groundwater	Figure 5	Method 8082	Not Detected

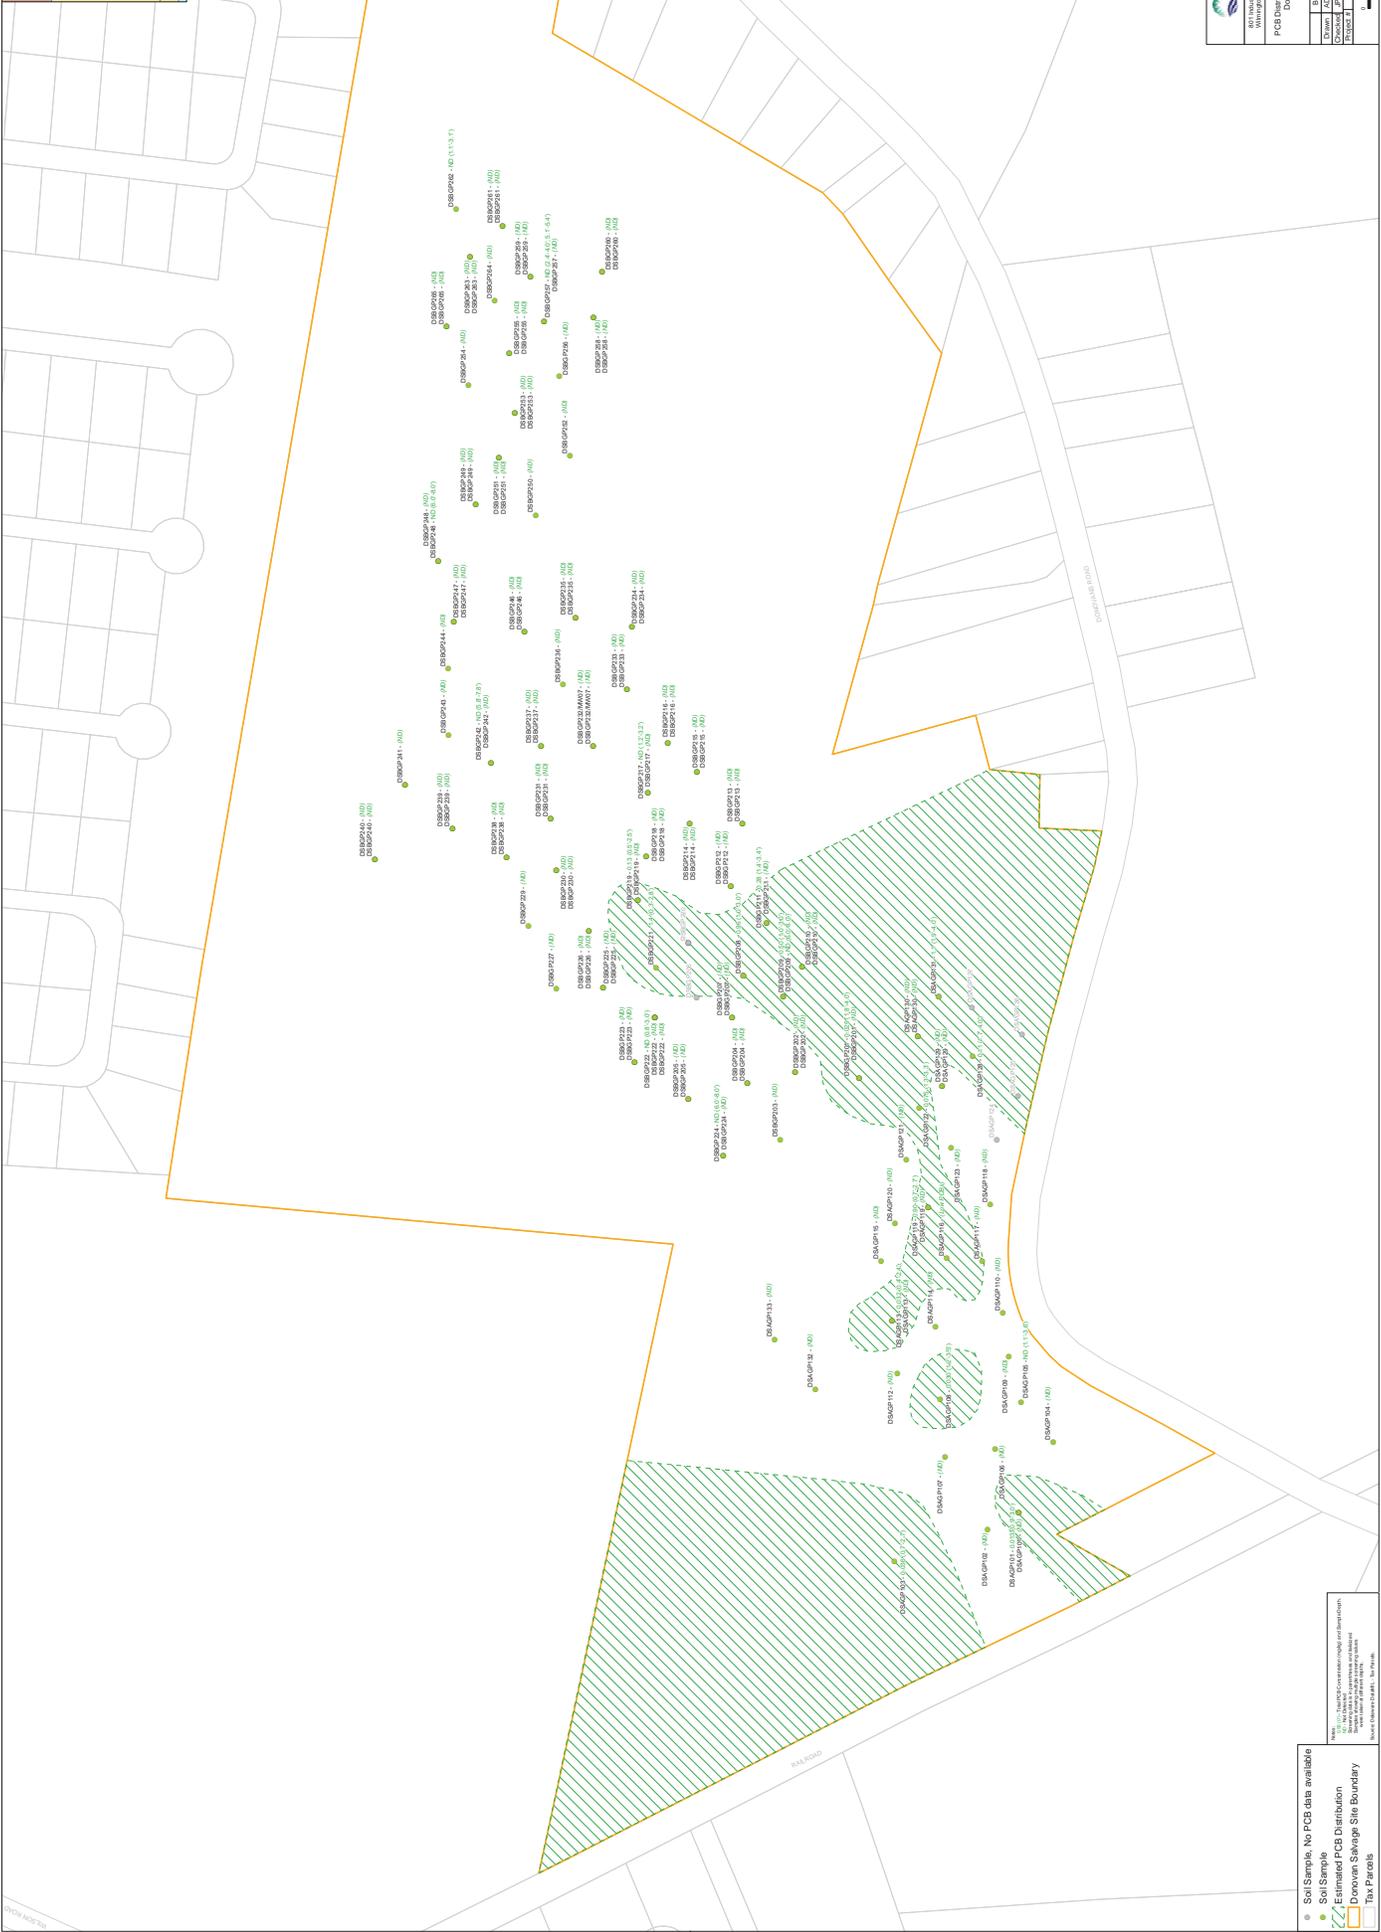
PCB Distribution Subsurface Uncontaminated Soil  
Donovan Salvage Vehicle Property  
Georgetown, Delaware

- Soil Sample, No PCB data available
- Soil Sample
- Estimated PCB Distribution
- Tax Parcels

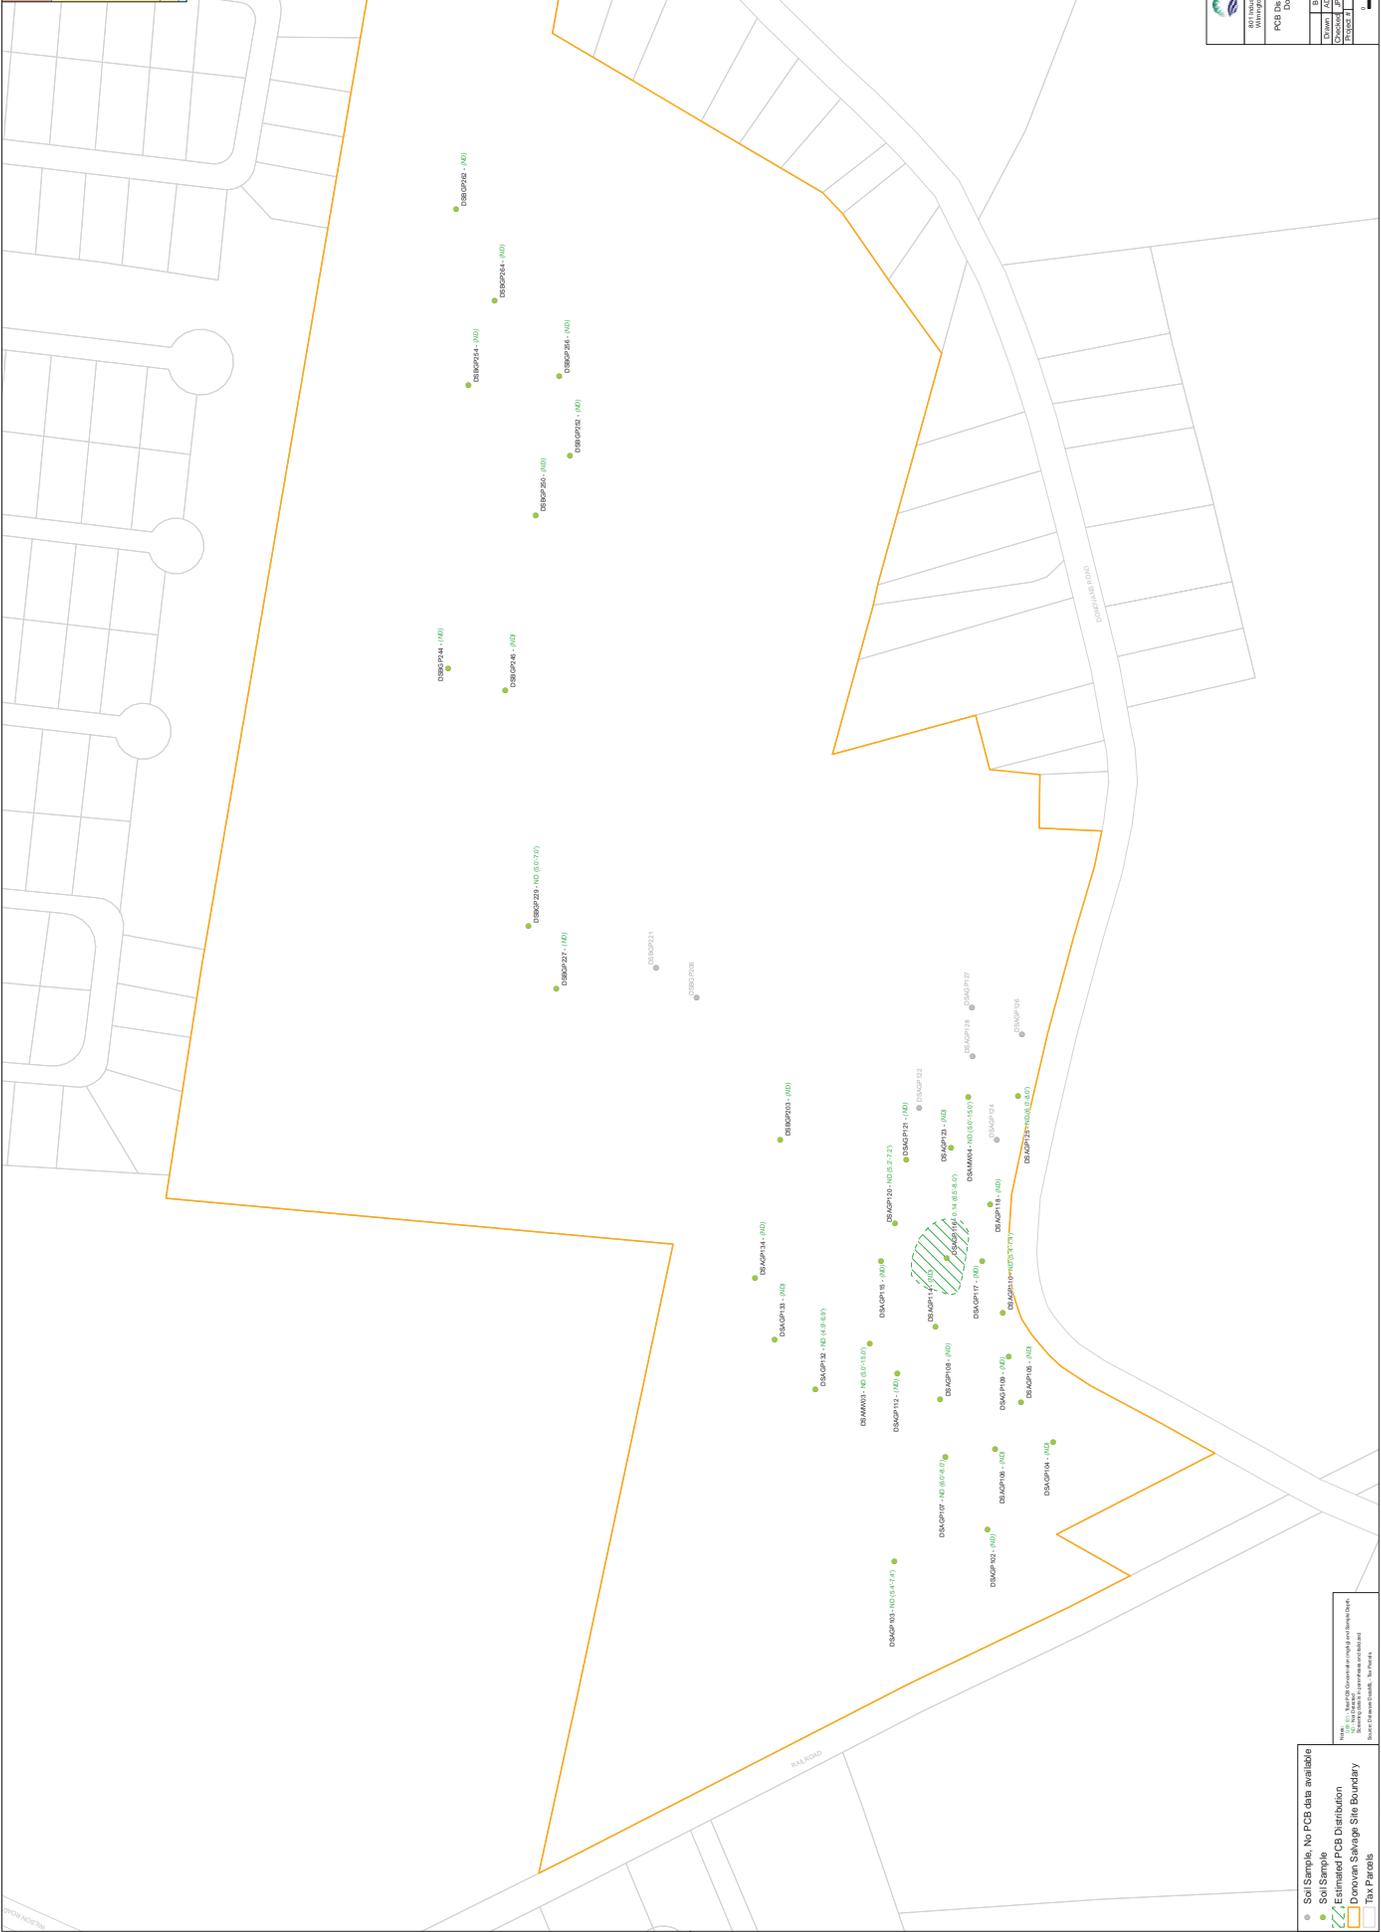
PCB Distribution in Subsurface Salvage Site  
 Donovan Salvage Works Property  
 Geoprocessing Database

- Soil Sample, No PCB data available
- Soil Sample
- ▨ Estimated PCB Distribution
- ▭ Donovan Salvage Site Boundary
- ▭ Tax Parcels

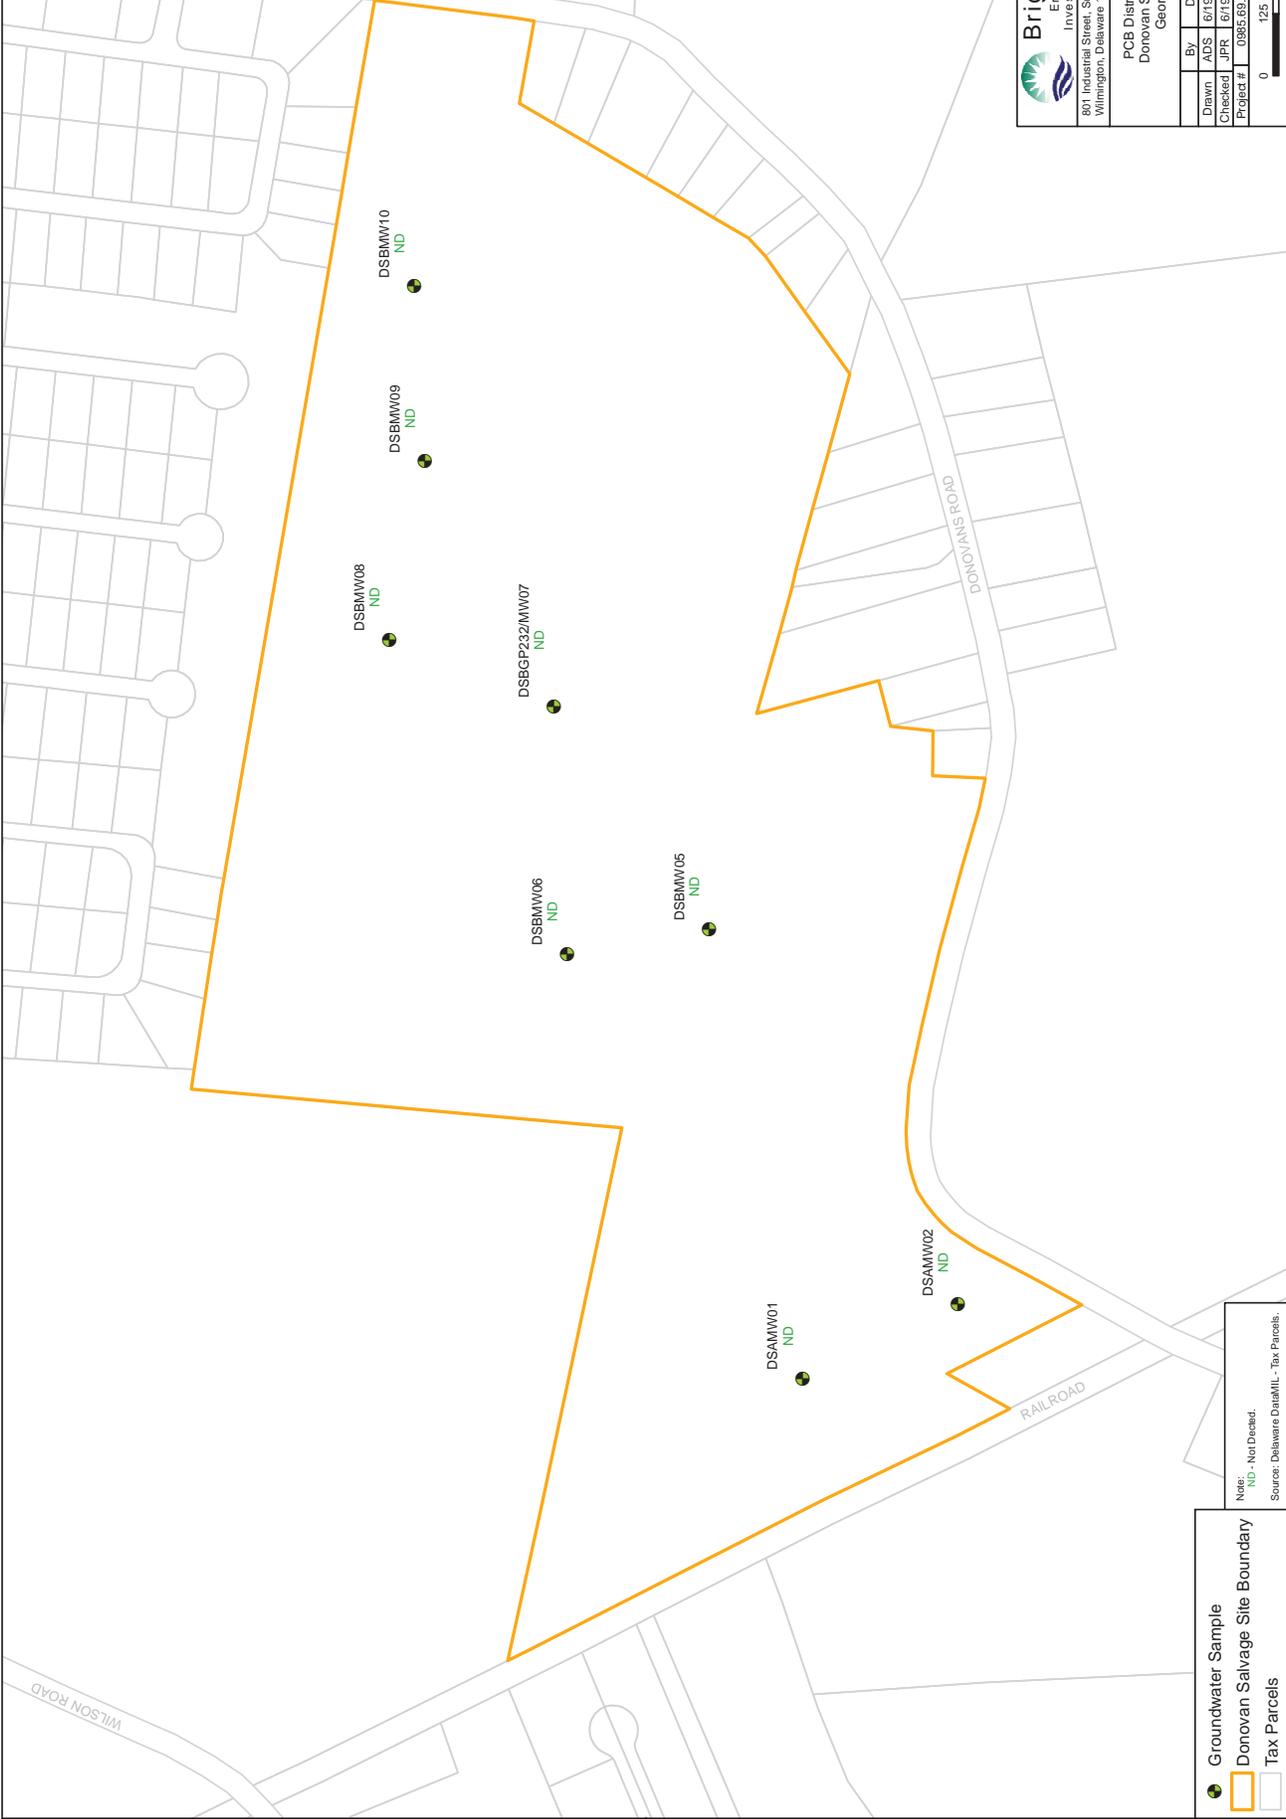
PCB Distribution in Groundwater  
 Donovan Salvage Works Property  
 Georgetown, Delaware

**Groundwater Sample**  
 Donovan Salvage Site Boundary  
 Tax Parcels

Note: ND - Not Detected.  
 Source: Delaware DATABILL - Tax Parcels.

The calculated 95% upper confidence limit (UCL) of the mean of the concentration of total PCBs observed in the surface soil (for overland flow calculations) is 0.6 mg/kg. There were no PCBs detected in groundwater.

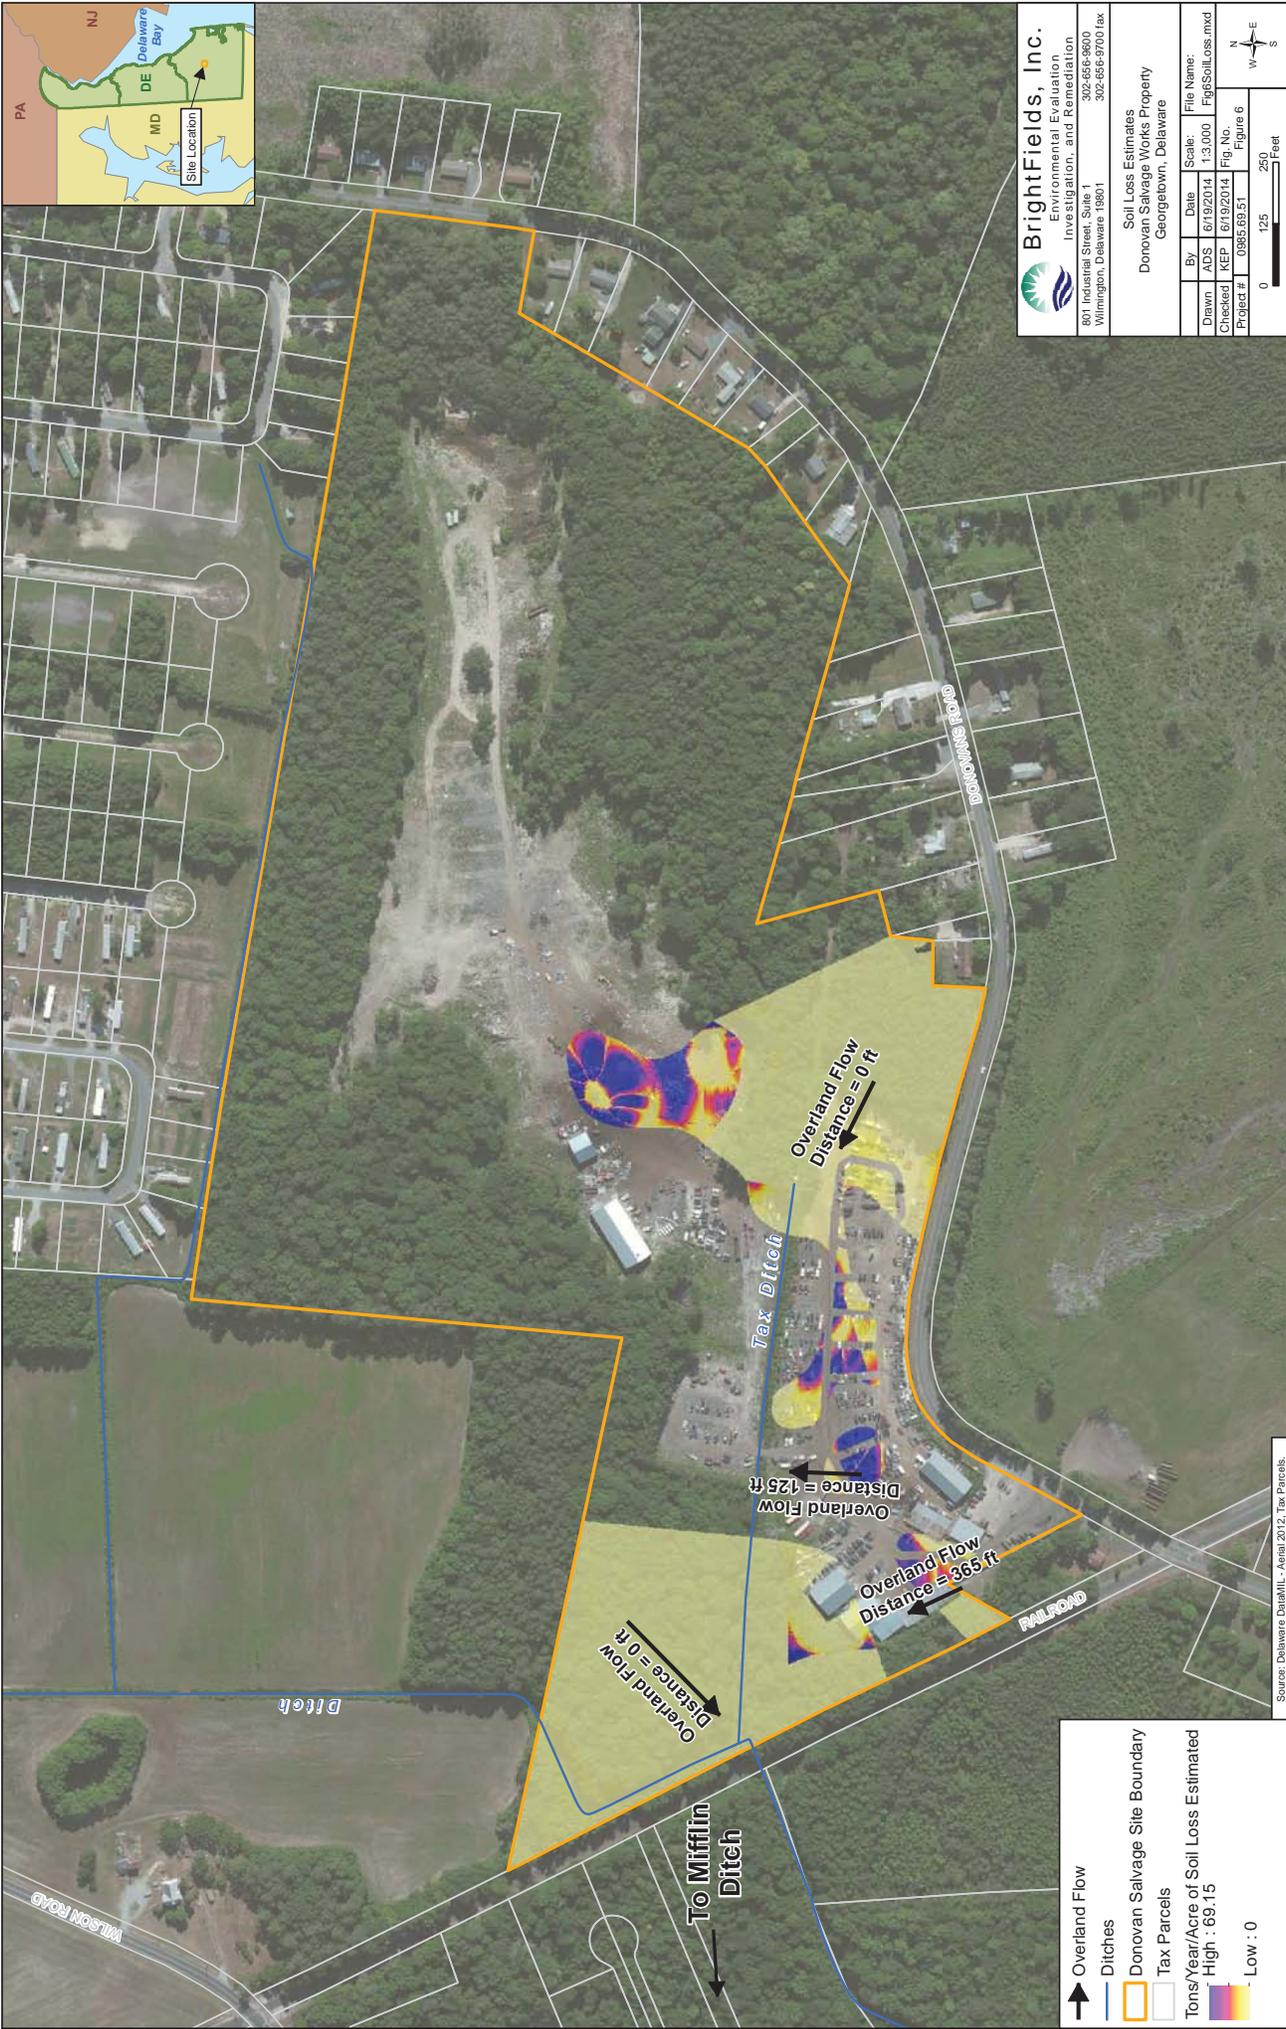
Soil Loss Estimates  
 Donovan Salvage Works Property  
 Georgetown, Delaware

↑ Overland Flow  
 — Ditches  
 □ Donovan Salvage Site Boundary  
 □ Tax Parcels  
 Tons/Year/Acre of Soil Loss Estimated  
 High : 69.15  
 Low : 0

P = support practice factor (dimensionless)	1	No documentation was provided indicating that any sediment and erosion controls are in place.
A = average annual soil loss estimate (ton/ac-yr)	0.50	The average soil loss estimate was generated by ArcGIS using the input factors listed above.
Erodible Area (acres)	14.5	The erodible area was calculated based on the pervious surfaces within the area of concern polygon for surface soil (Figure 6).
