## PROPOSED PLAN OF REMEDIAL ACTION

Krewatch Farm Site  
Seaford, Delaware

DNREC Project Nos. DE 0109 & DE 1077

April 2002

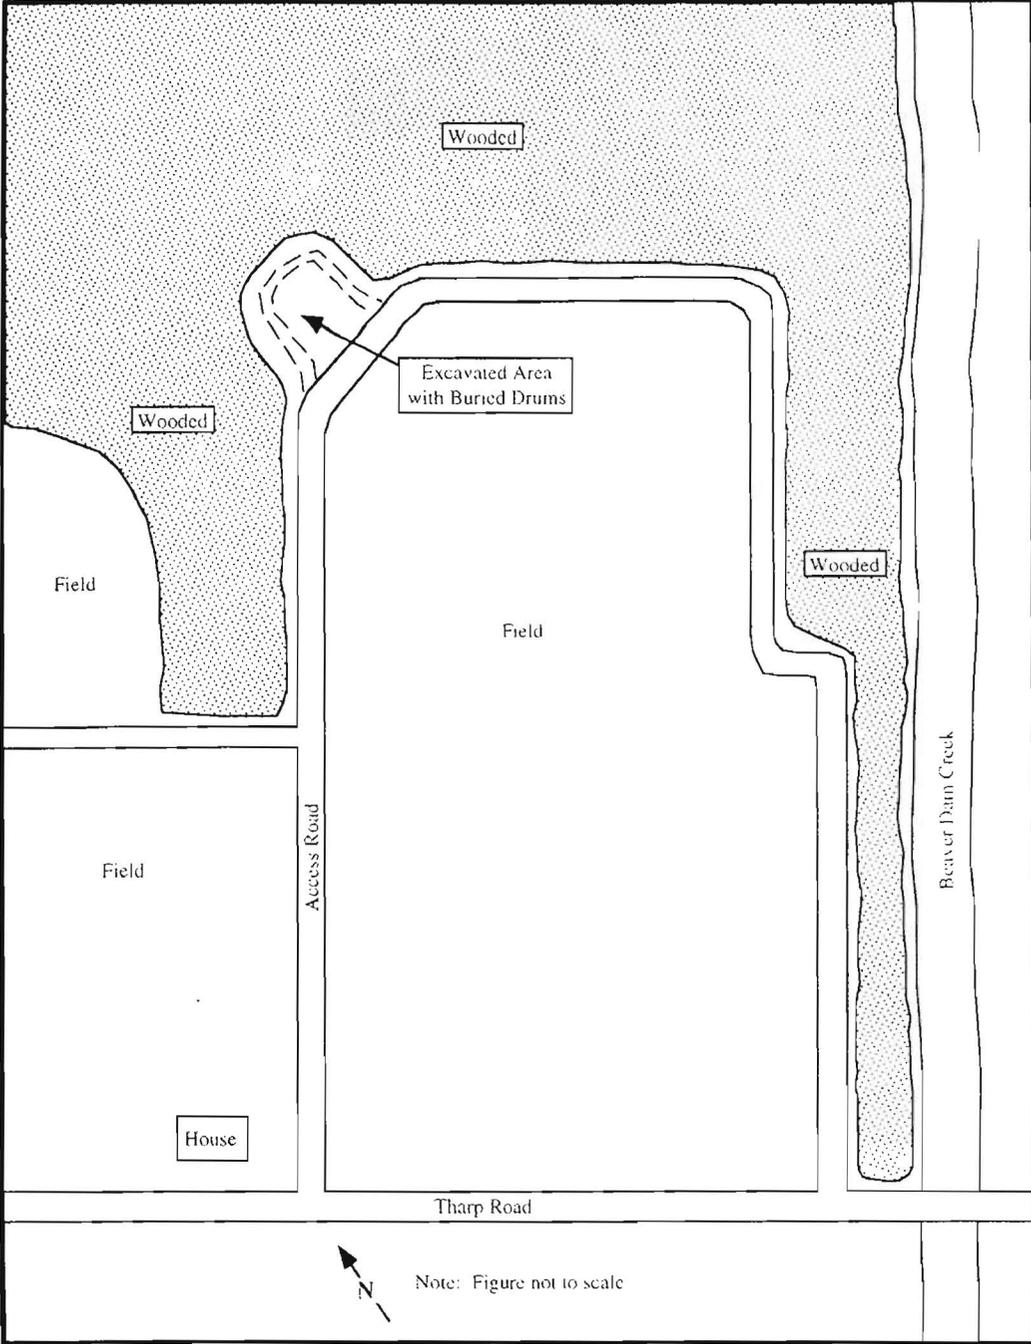
Figure 2: Location of Drum Burial Area at Krewatch

Krewatch Drum Site  
Seaford, Delaware

- Drum burial area located on the northwestern portion of the property (Figure 2);
- Drum storage area located on the southwestern portion of the property (Figure 3); and
- Oil spill area located on the southern portion of the property (Figure 4, the trailer area).

In addition to the cleanup effort, the EPA conducted a magnetometer survey to locate any buried drums. The survey detected a drum burial area on the northwestern portion of the farm. (Figure 2) This location is approximately 300 yards north of the area of the trailer fire and is considered to be a separate source area.

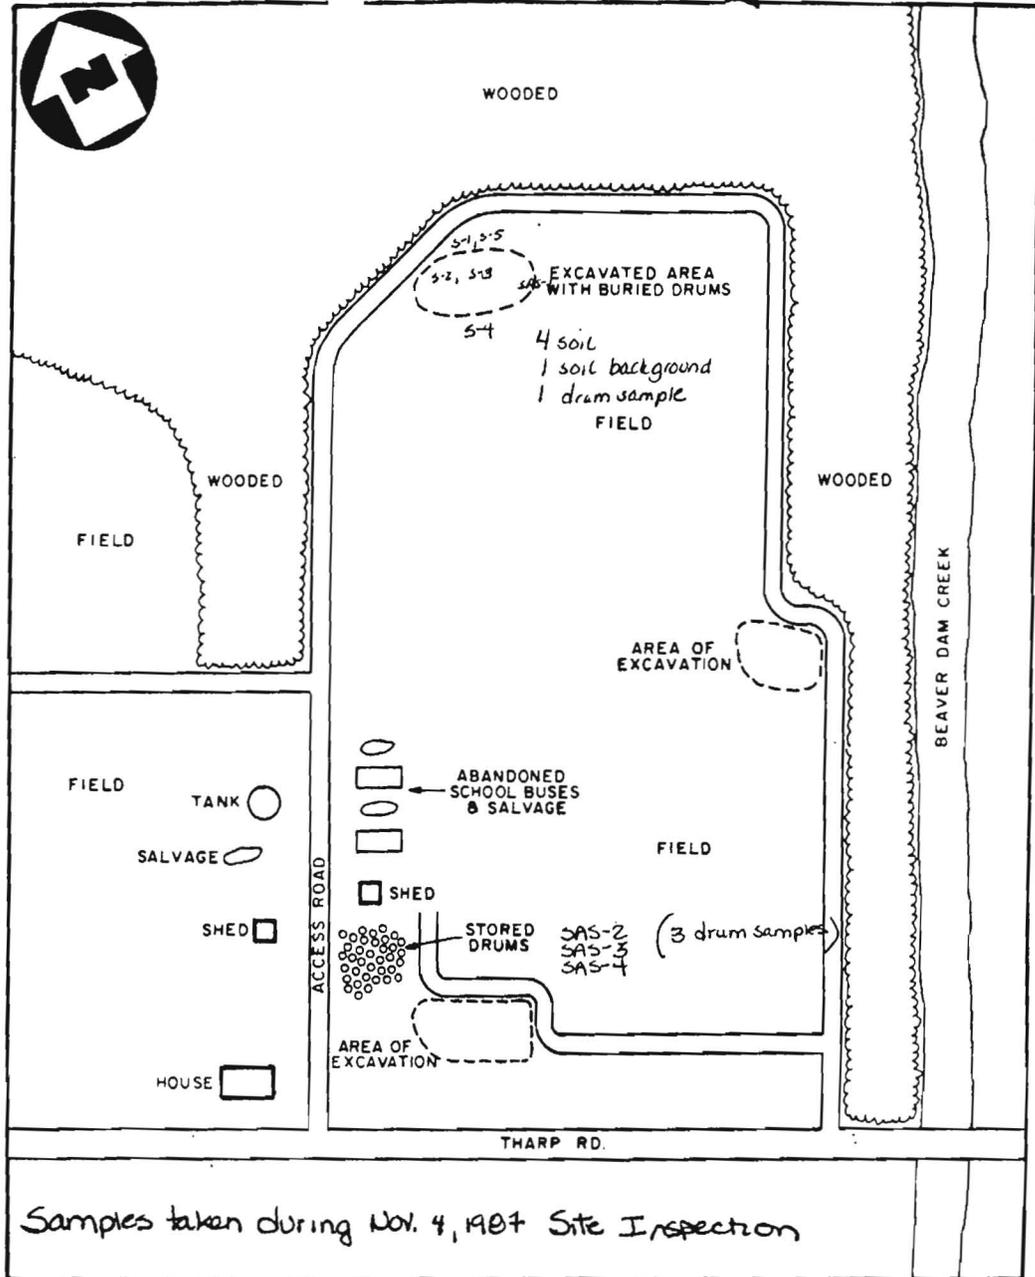
Figure 3: Location of Stored Drums and Oil Spill

SITE SKETCH  
SEAFORD DRUM SITE, SEAFORD, DEL.  
 (NO SCALE)

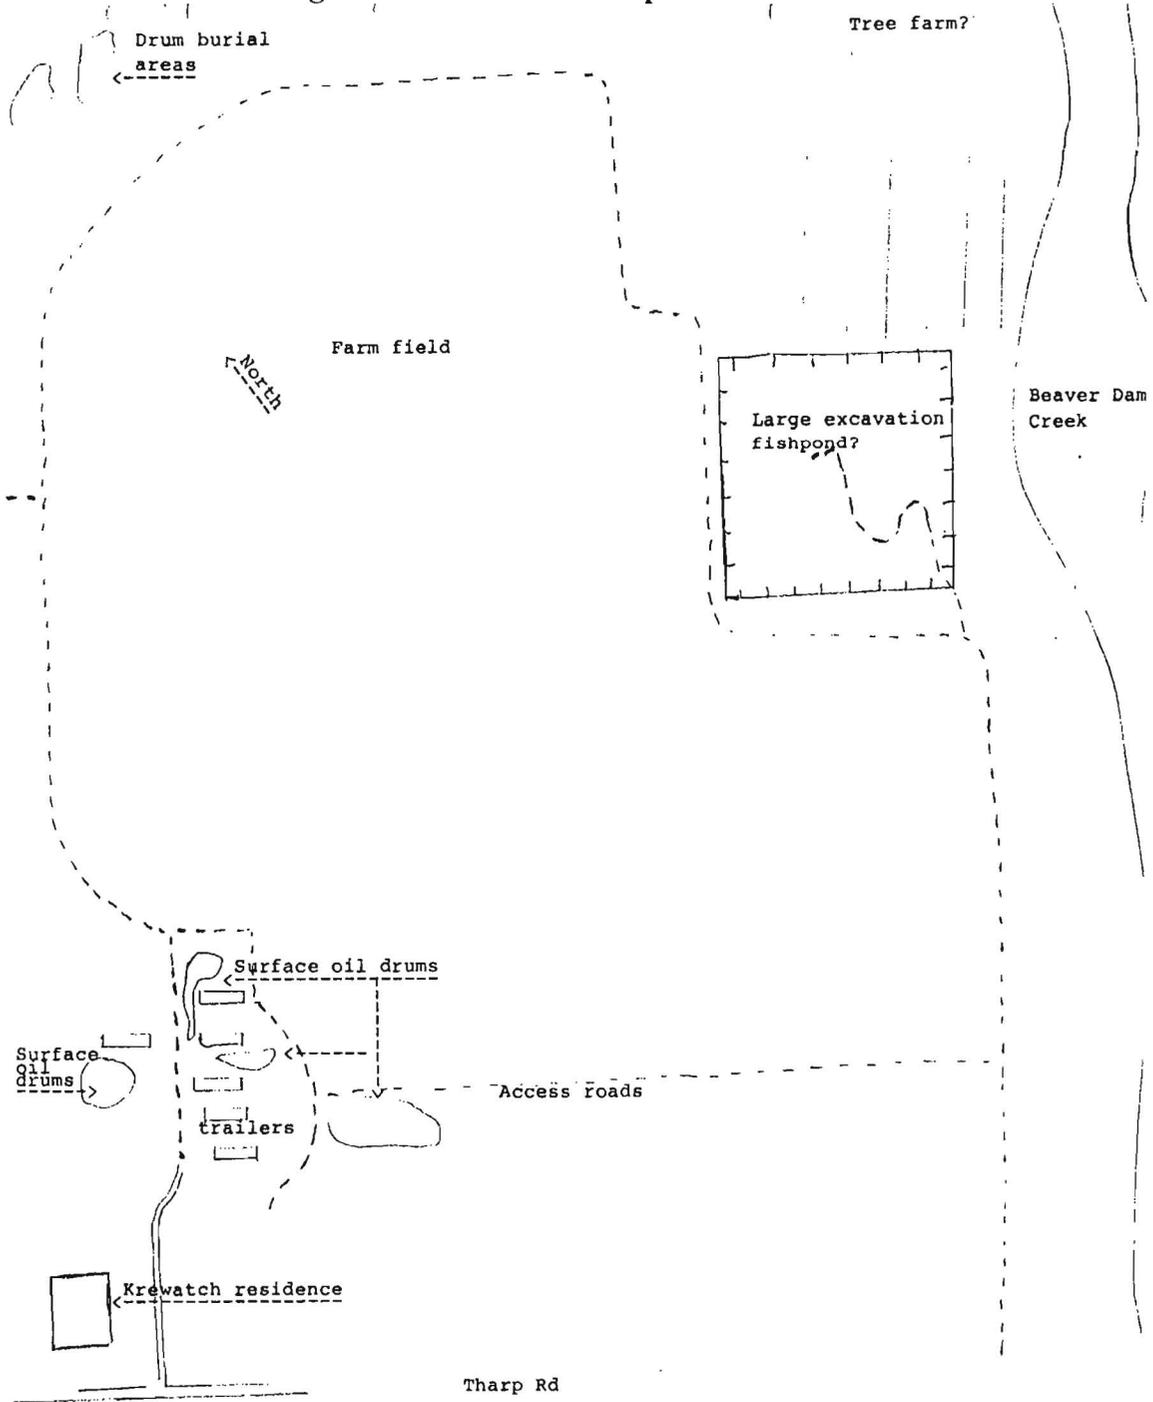
Figure 4: Location of Oil Spill at Krewatch

Site Sketch Map Seaford Drum Site  
NO SCALE

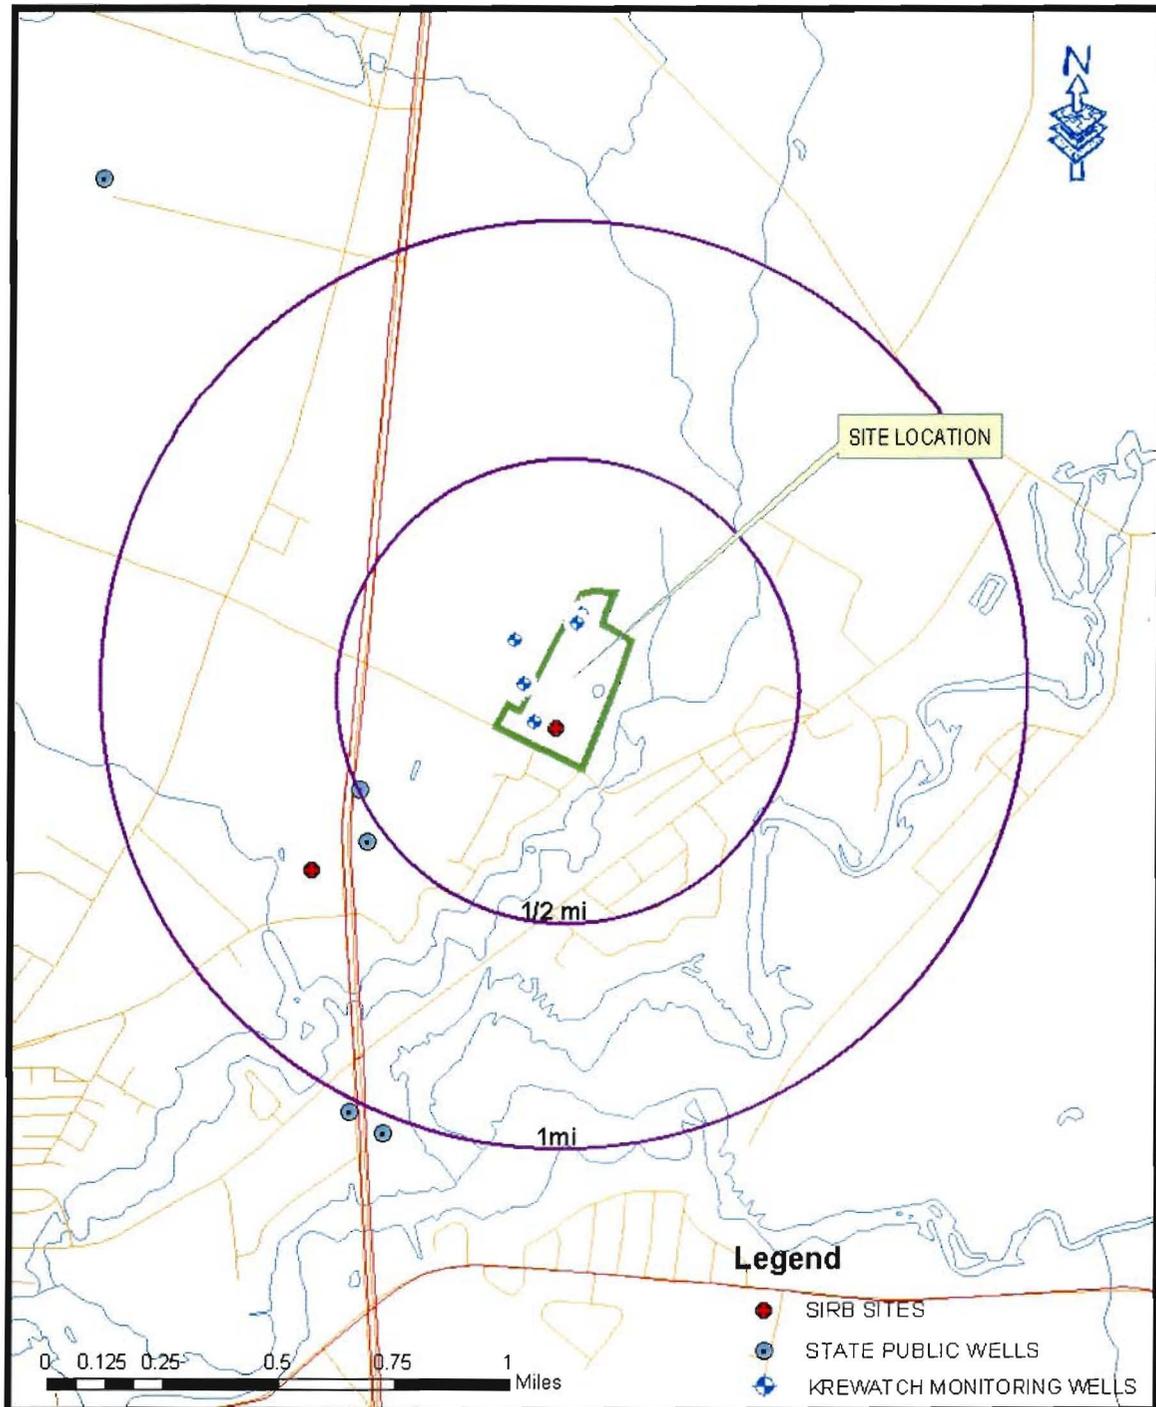
Figure 5: Location of Monitoring and Domestic Wells

**MONITORING WELLS AND DOMESTIC WELLS  
AROUND THE KREWATCH PROPERTY IN SUSSEX COUNTY DELAWARE**

In 1998, DNREC performed a groundwater investigation of the area by installing three monitoring wells around the drum burial portion of the site. DNREC installed a cluster well consisting of one shallow well (screened at 25-35 feet) and one deep well (screened at 55-65 feet) between the drum burial area and the homes along Tharp Road, and one shallow background well (screened at 15-25 feet). Four (4) residential wells were also sampled as shown in (Figure 5). Samples collected from the monitoring wells were analyzed for volatile and semivolatile organic compounds, pesticides/polychlorinated biphenyls (PCBs), and metals while samples collected from the residential wells were analyzed for volatile and semi-volatile organic

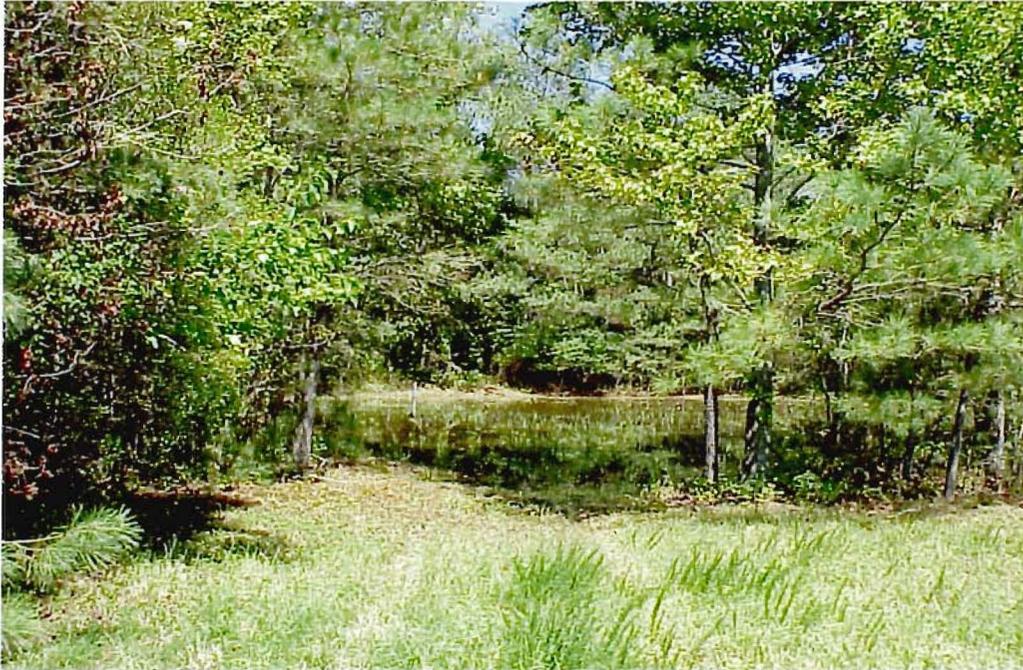
**Former Drum Burial Area**  
September 5, 2002

DNREC conducted a follow-up field visit on September 5, 2002. During this inspection, DNREC surveyed the site and took photographs of the site and the monitoring wells (Inspection Photos). The inspection showed that the monitoring wells were intact and that the site was used only for farming purposes.

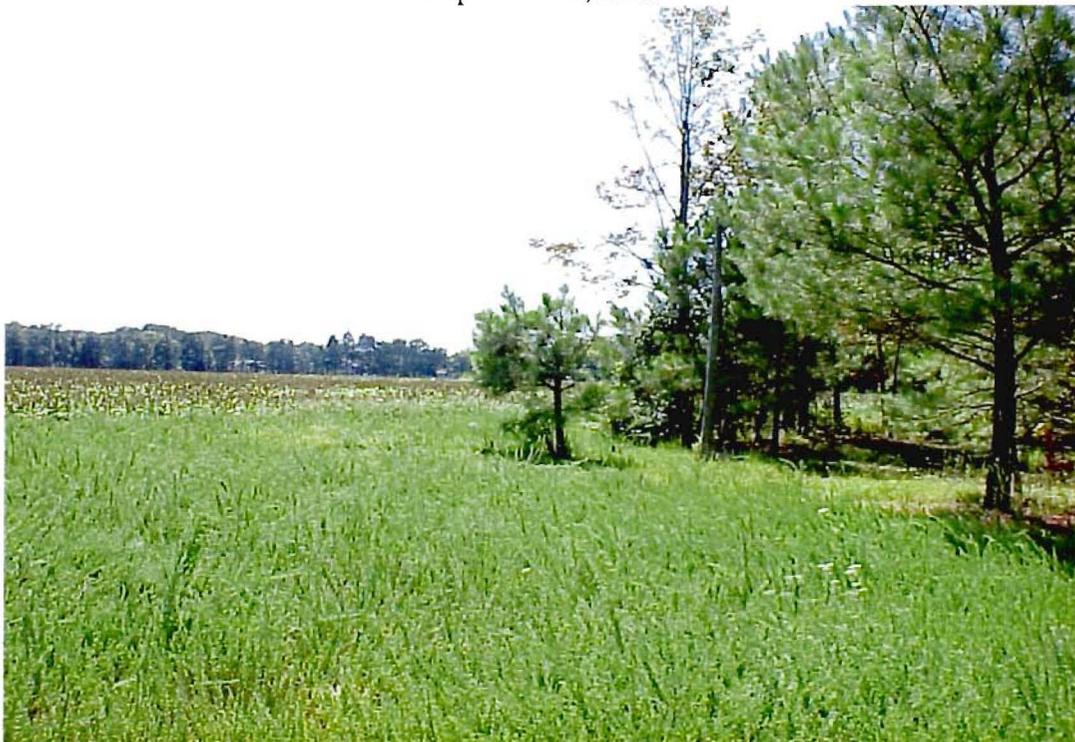
**Former Drum Storage and Oil Spill Areas**  
September 5, 2002
