FINAL PLAN OF REMEDIAL ACTION

State Archives Building Site
Dover, Delaware

DNREC Project DE 1133

Prepared by:
Delaware Department of Natural Resources & Environmental Control
Division of Air and Waste Management
Site Investigation & Restoration Branch

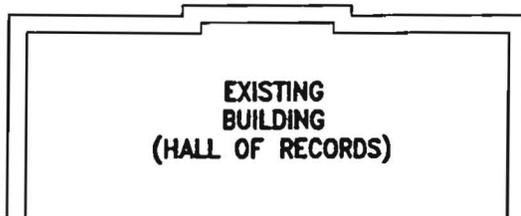
Drawn: JJV	Chk'd:	Date: 15 MARCH 1999
Scale: NONE		W.O.: 3846.EB
Drawing No: A-3846EB-3		FIGURE 2

- AUGER CAST PILE LOCATION
- ⊙ GEOPROBE BORING LOCATION
- ⊠ TEST PIT LOCATION

GEOPROBE BORING AND TEST PIT LOCATION SKETCH
PUBLIC ARCHIVES BUILDING ADDITION

Soil contamination in the building area was not anticipated prior to the start of construction. However, stained soils were observed during a review of auger cast pile installations near the new stairwell area of the building addition (see Duffield Figure 2). On the recommendation of Duffield Associates, a sample of this soil was taken on August 14, 1998 for laboratory analysis. The analytic results indicated the presence of coal tar related compounds in the soil. The installation of auger cast piles was suspended and Duffield Associates reported the findings to DNREC-SIRB.
